# Inspection Photos

4/17/2023

Operator: CAERUS PICEANCE LLC #10456

Location #334342

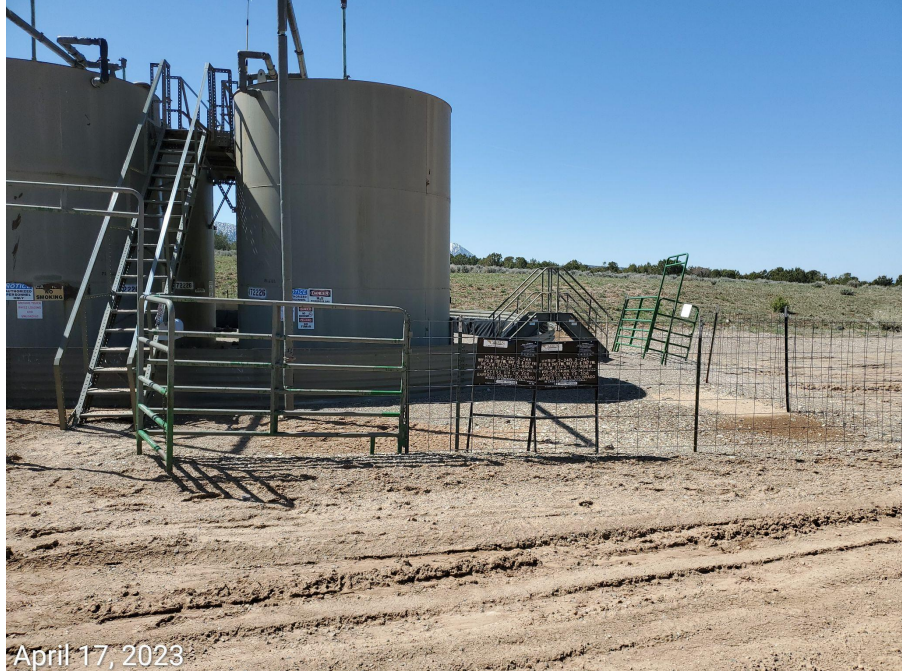
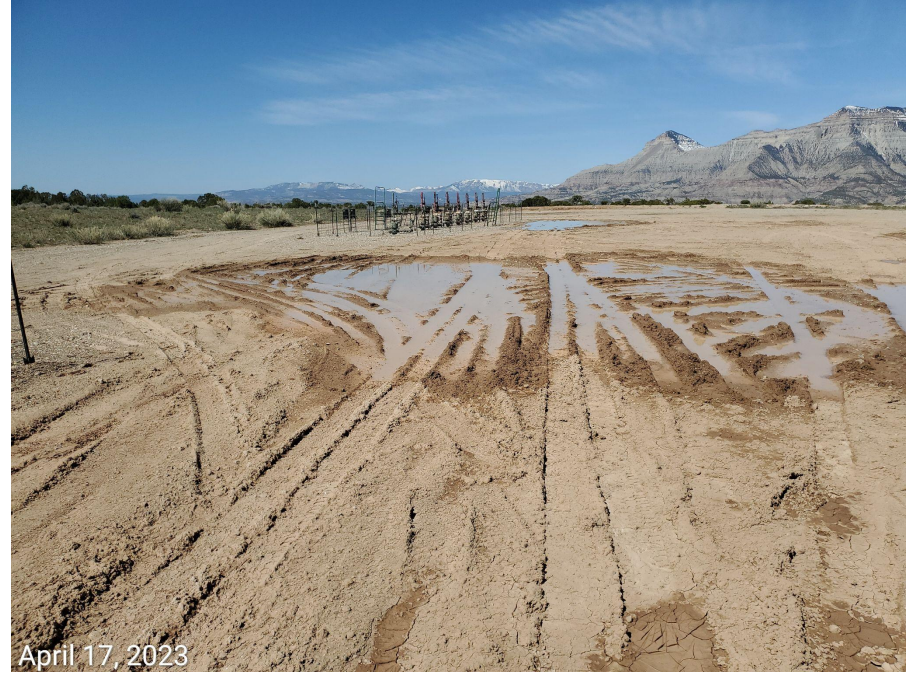
**Photo 1:** Photos 1-2 taken from the Location entrance. Photos provide an overview of the Location from west, northwest, northeast to east. Photos also examples showing BMPs to stabilize, as well as to minimize erosion, degradation and off-site sediment transport are missing or insufficient; pad lacks stabilization. Tracking controls not observed.

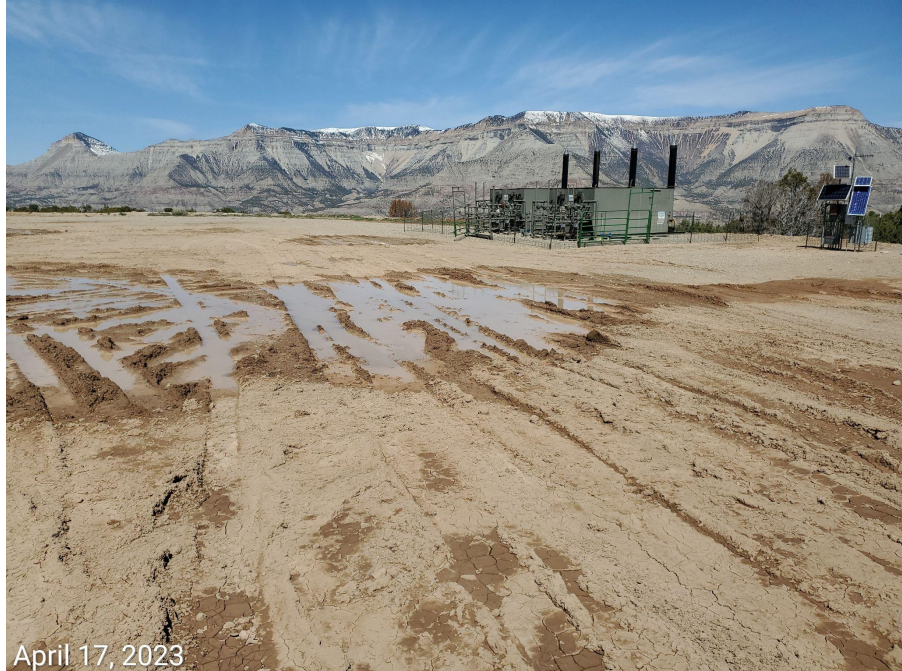
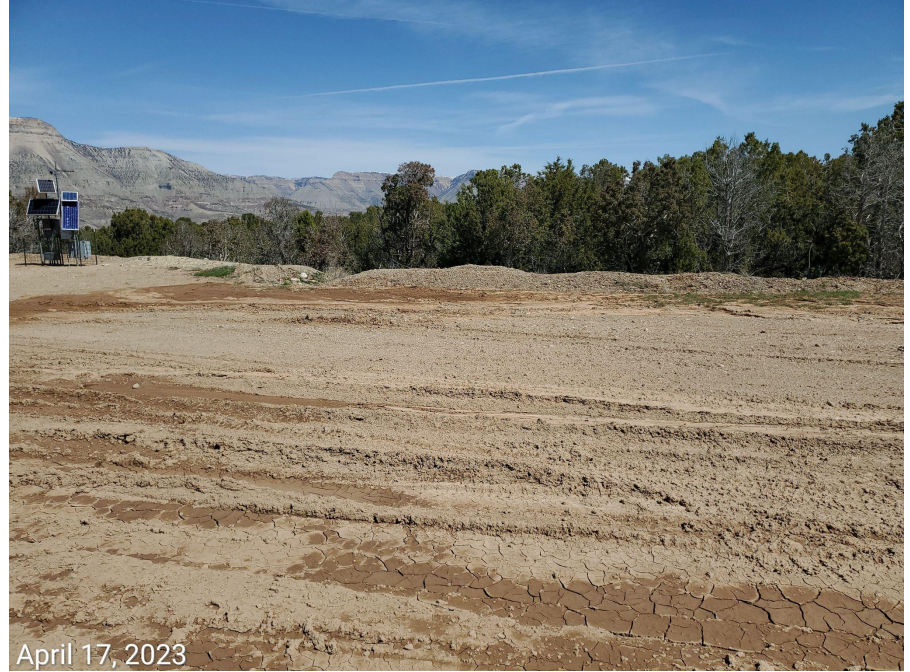
**Photo 2:** See comments under photo 1.

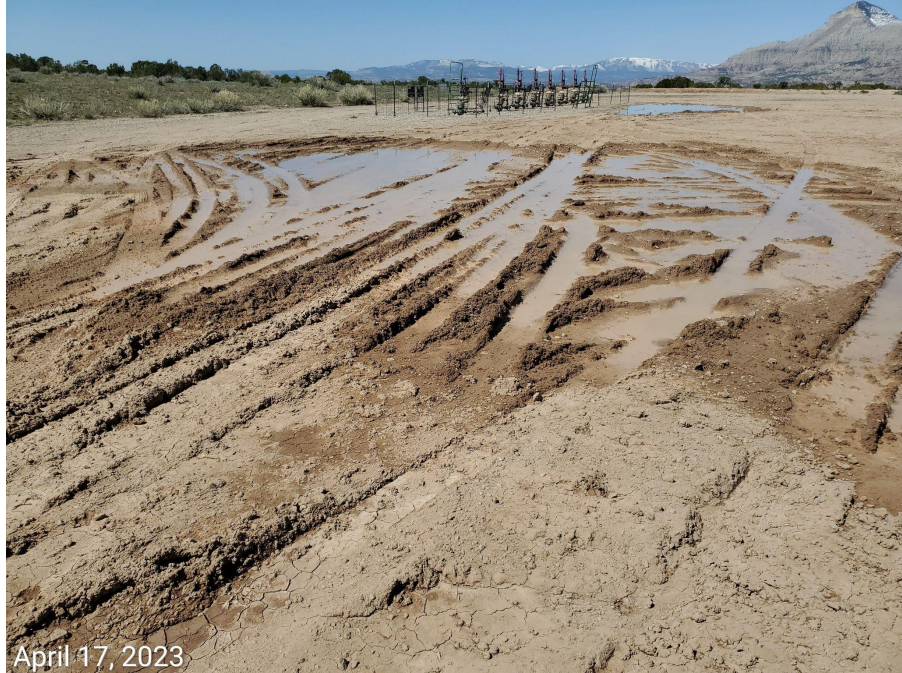
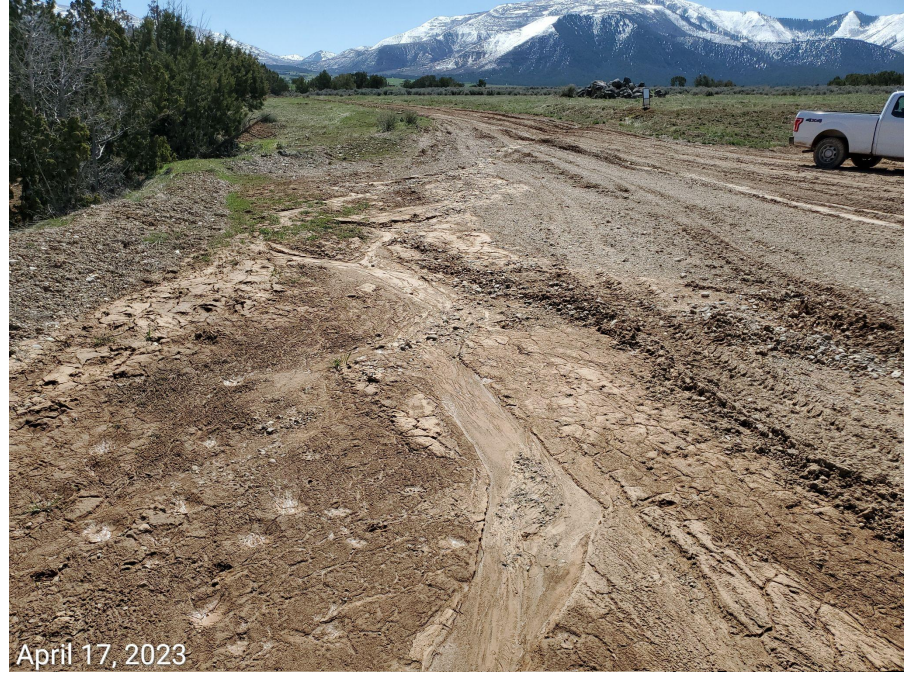
**Photo 3:** Pad lacks stabilization. Stormwater and erosion controls missing or insufficient.

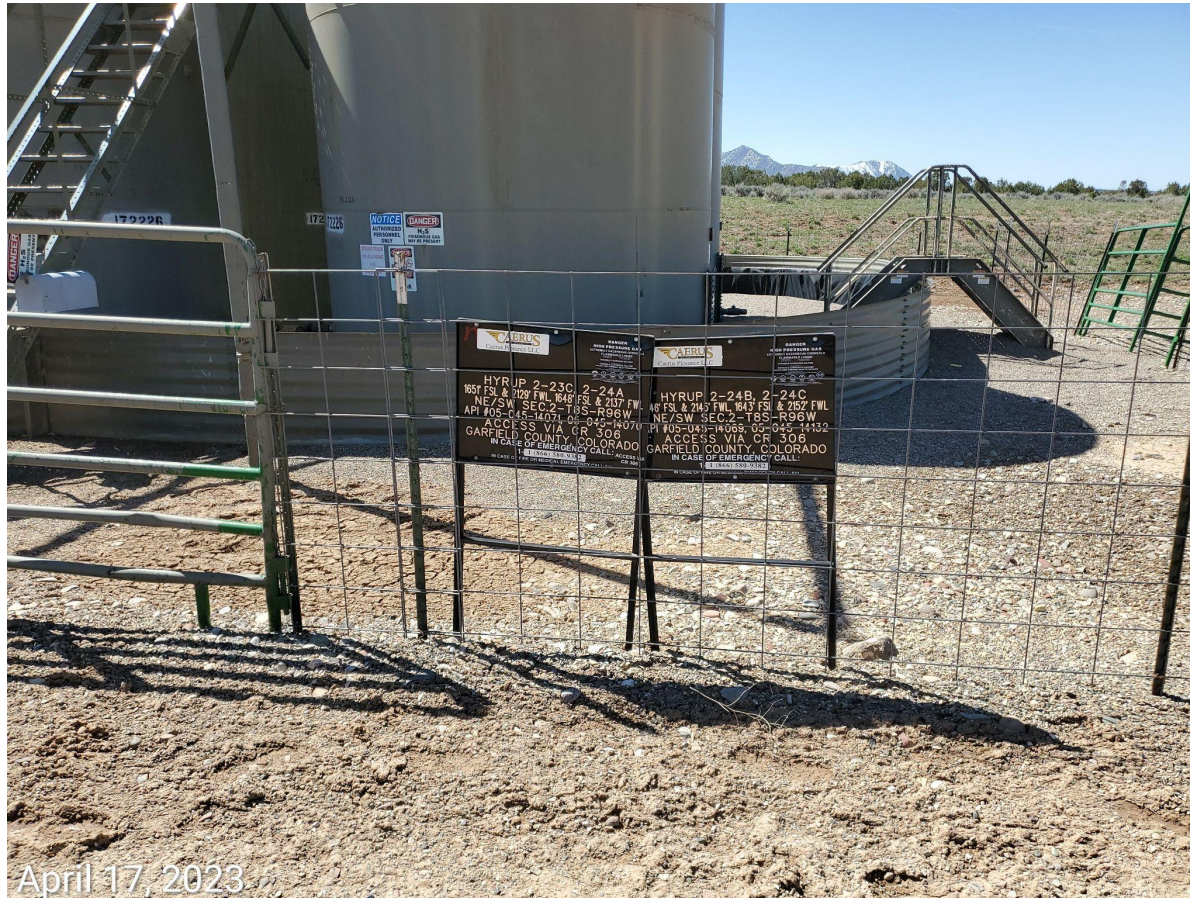
**Photo 5:** Tank battery signage. Photo also show signs or labels at tanks not posted or information too small to read at distance or installed in place where not visible.

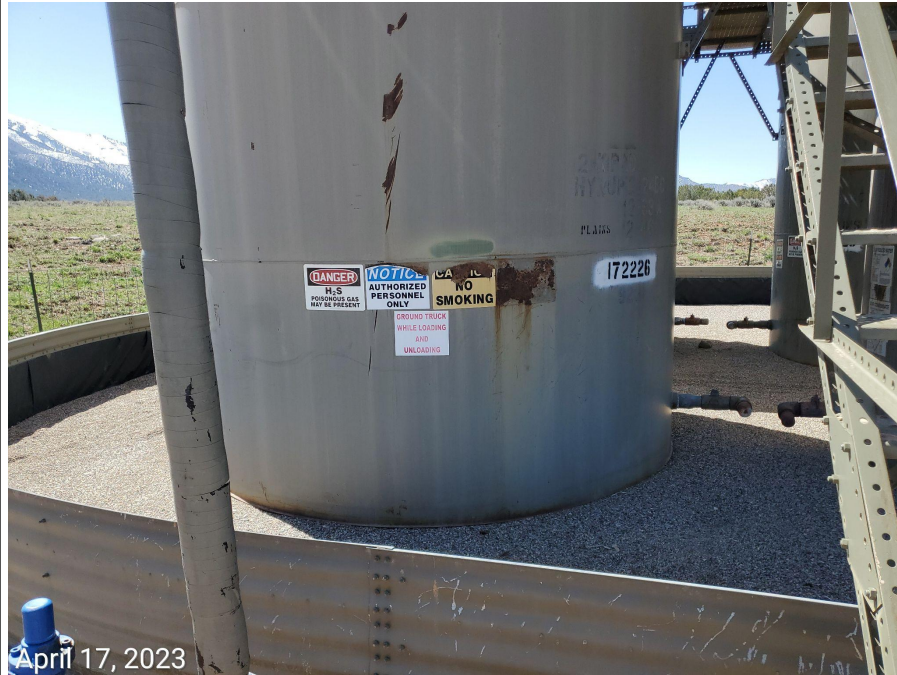
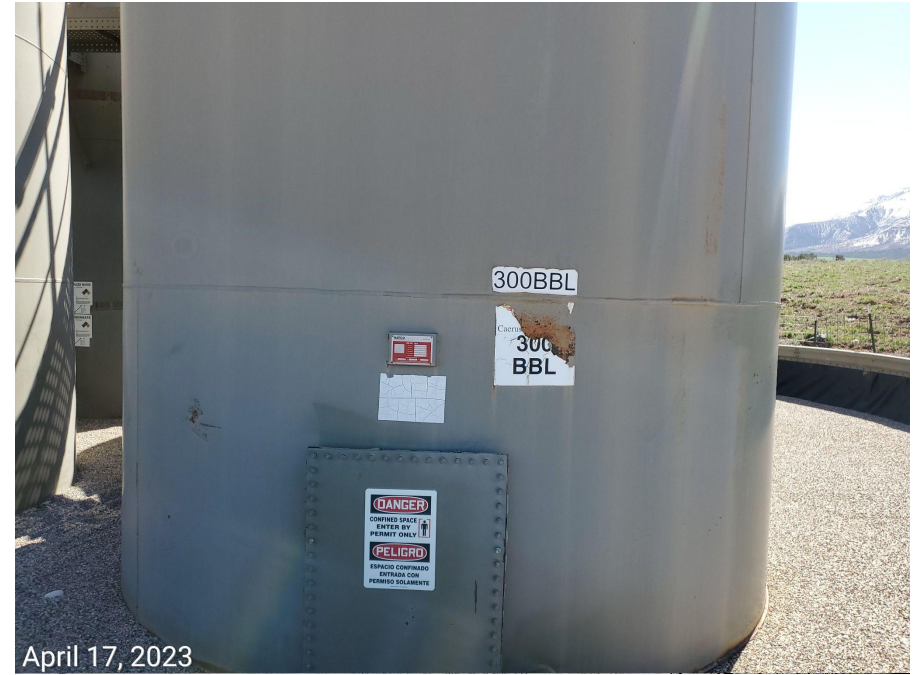
**Photo 4:** Signs or labels at tanks not posted or information too small to read at distance or installed in place where not visible. Most of the required labeling information posted towards center of the battery, and not visible from beyond the facility.

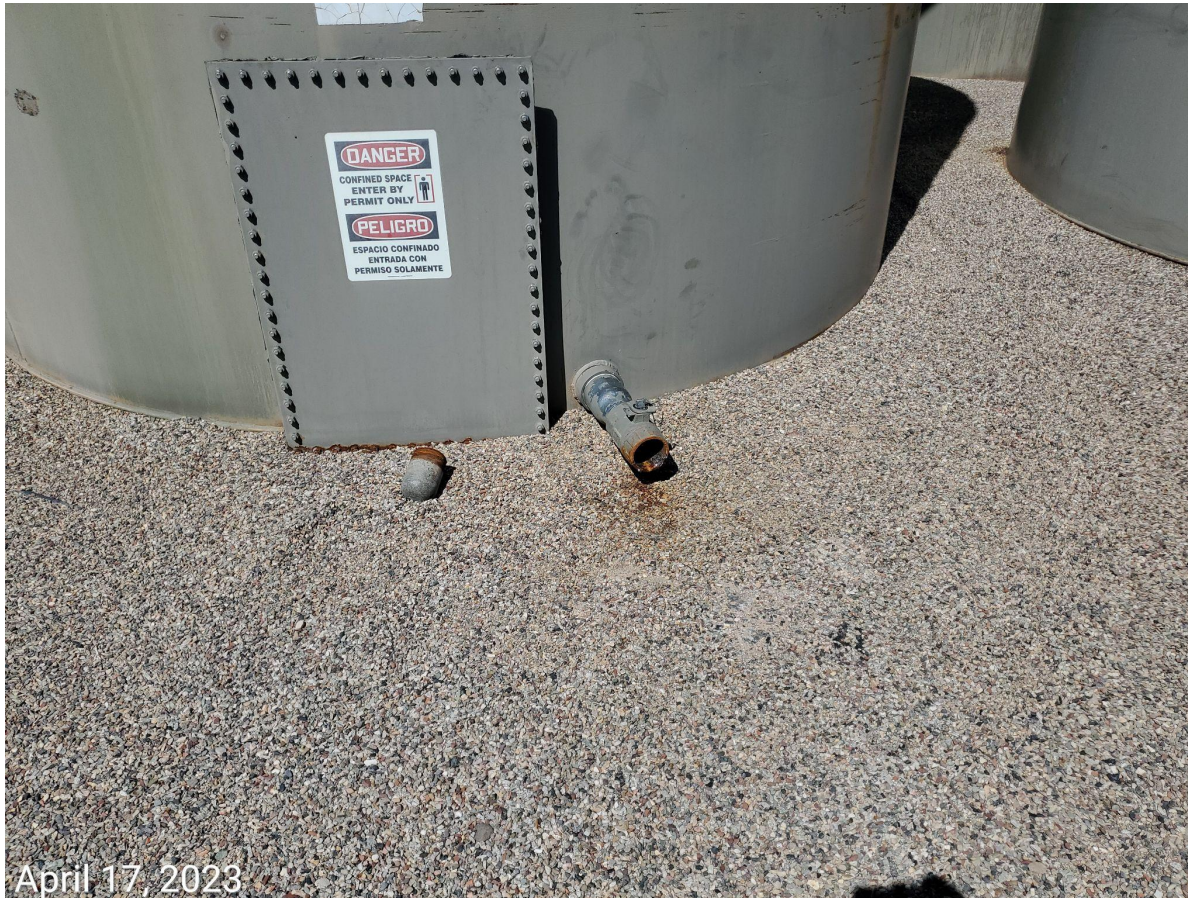
**Photo 7:** Plug removed from tank. Small leak appears evident. Plug requires replacement and impacted materials removed.

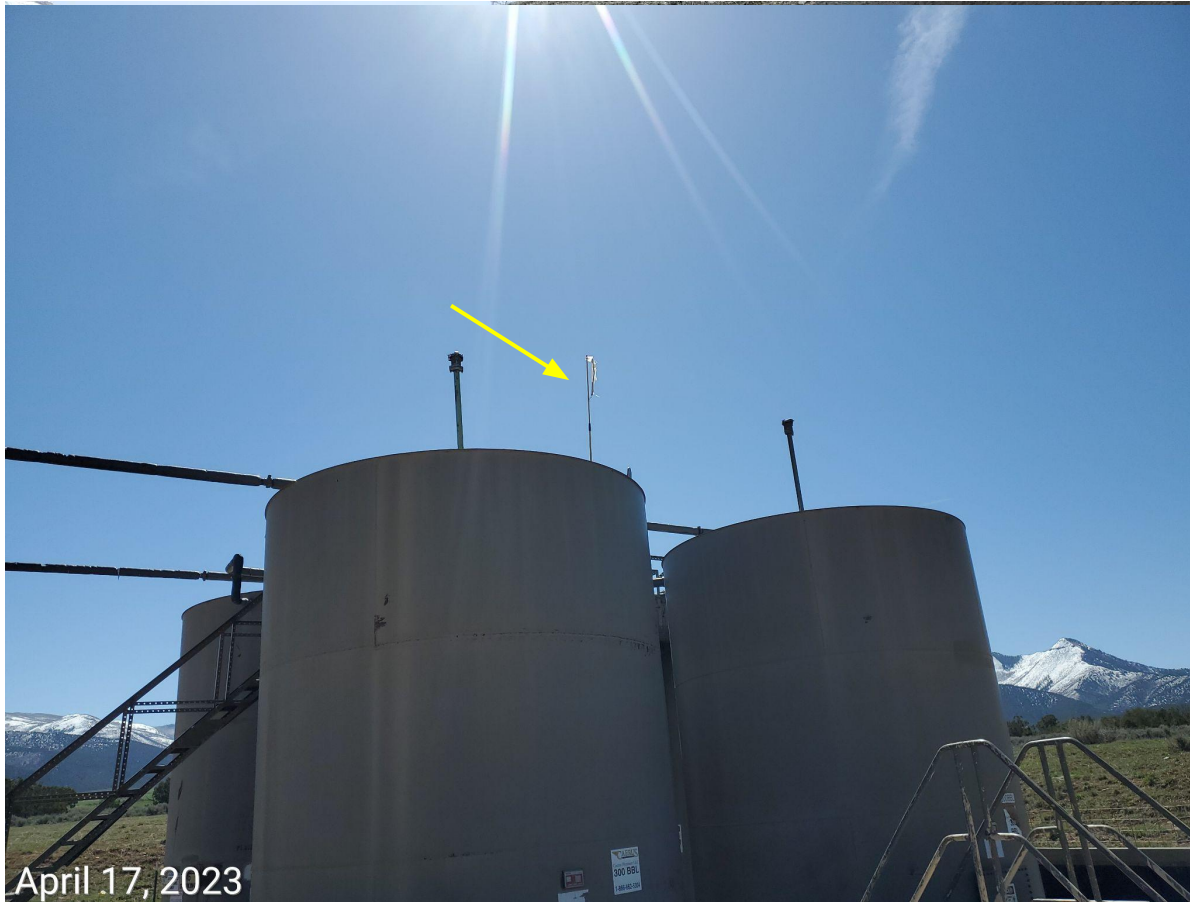
**Photo 8:** Wind indicator safety equipment not in proper functioning condition.

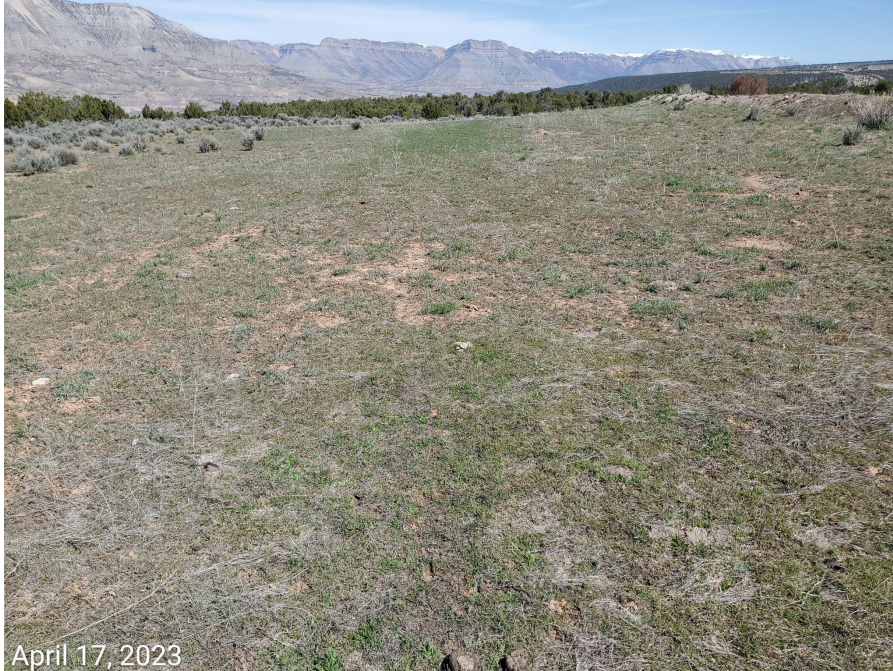
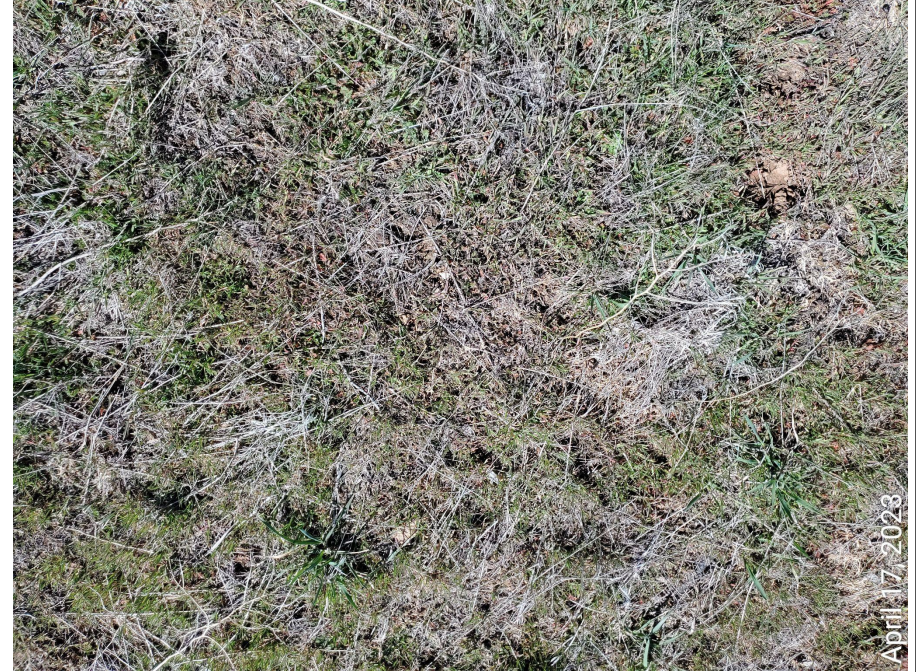
**Photo 9:** Photo examples of the interim areas of the Location. Perennial vegetation evident, however vegetation observed predominantly undesirable plant species such as cheatgrass.

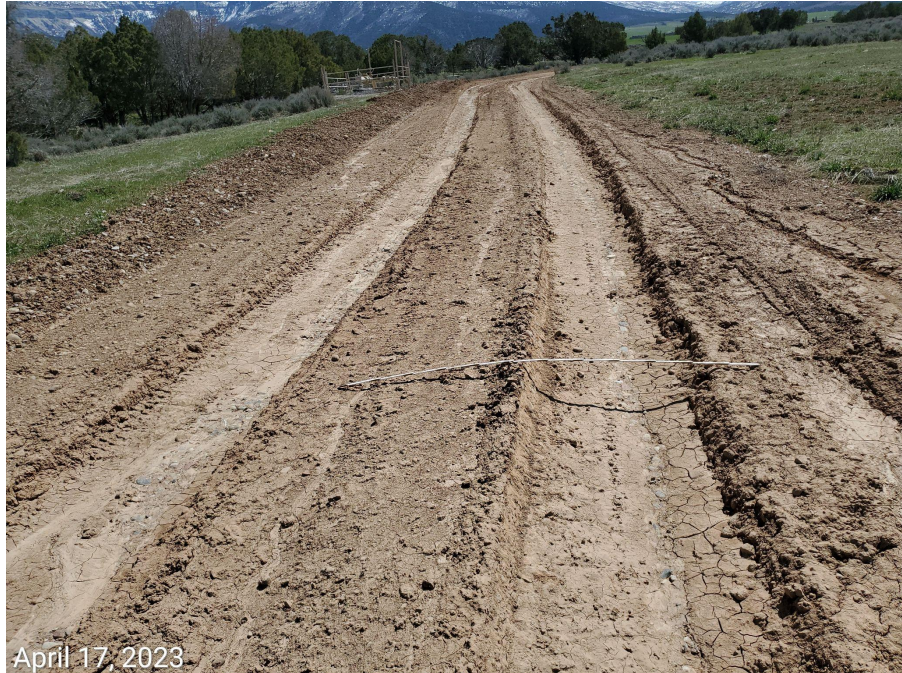
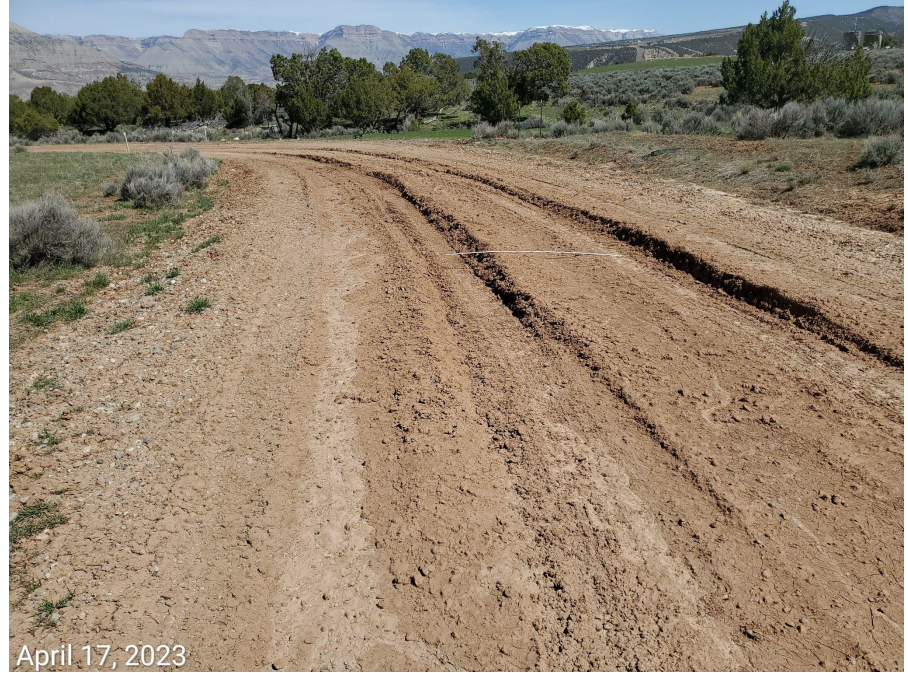
**Photo 11:** Photos examples showing stormwater and erosion control BMPs along access road are missing or insufficient. 6 foot measuring stick for reference.
