Final Reclamation Inspection

Operator: GADECO LLC - 10673

Location ID: 331970

Inspection Photos
Location Name: Croissant #4
Location ID: 331970

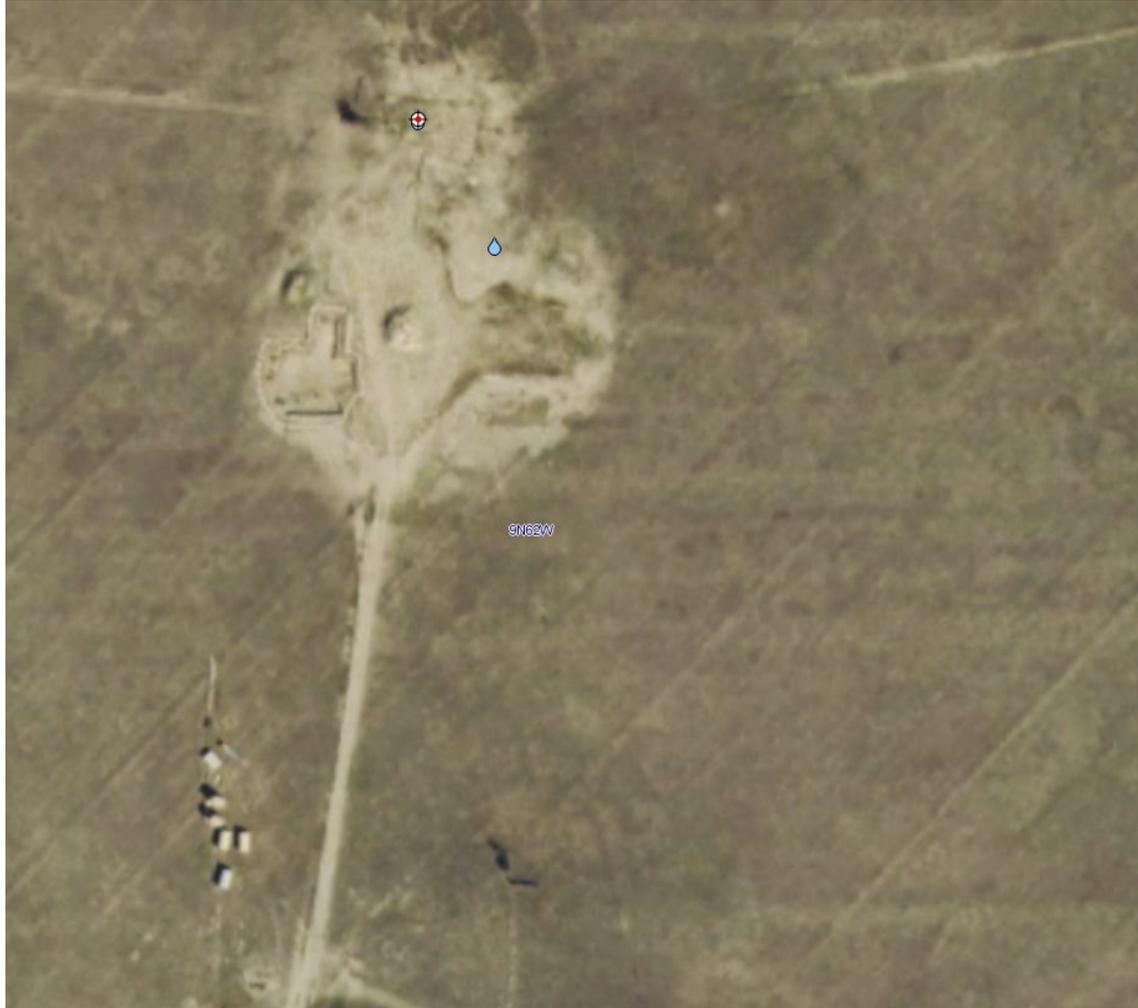
Photo 1. ECMC GISOnline aerial imagery from 2019. Photo illustrates the approximate surface disturbance extent of two historic releases, including the well location access road.

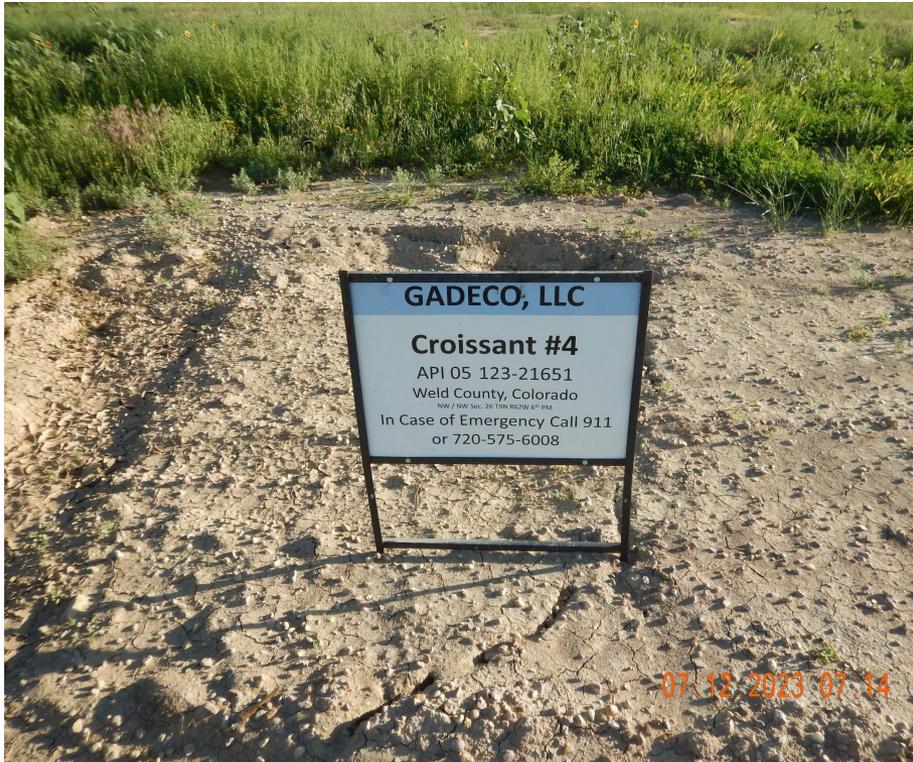
Photo 2. Photo taken from the well location.

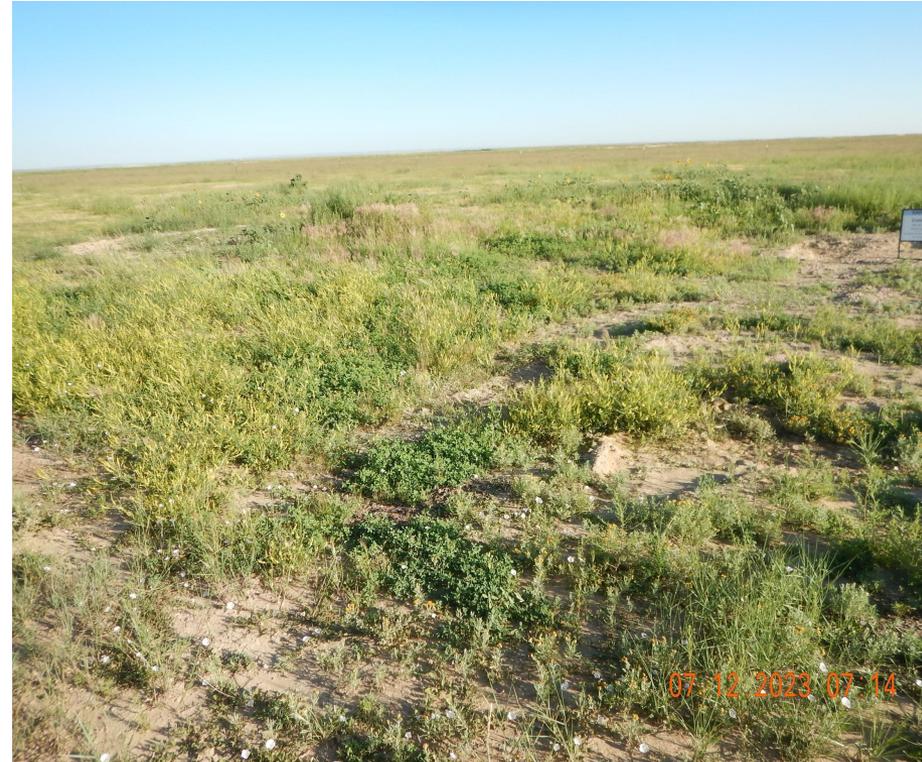
Photo 3. Photo taken from the well location, facing Northwest. Photo illustrates an excavation around the wellhead that has not been properly contoured.

Contractor on location stated fill material will be imported from a local source.

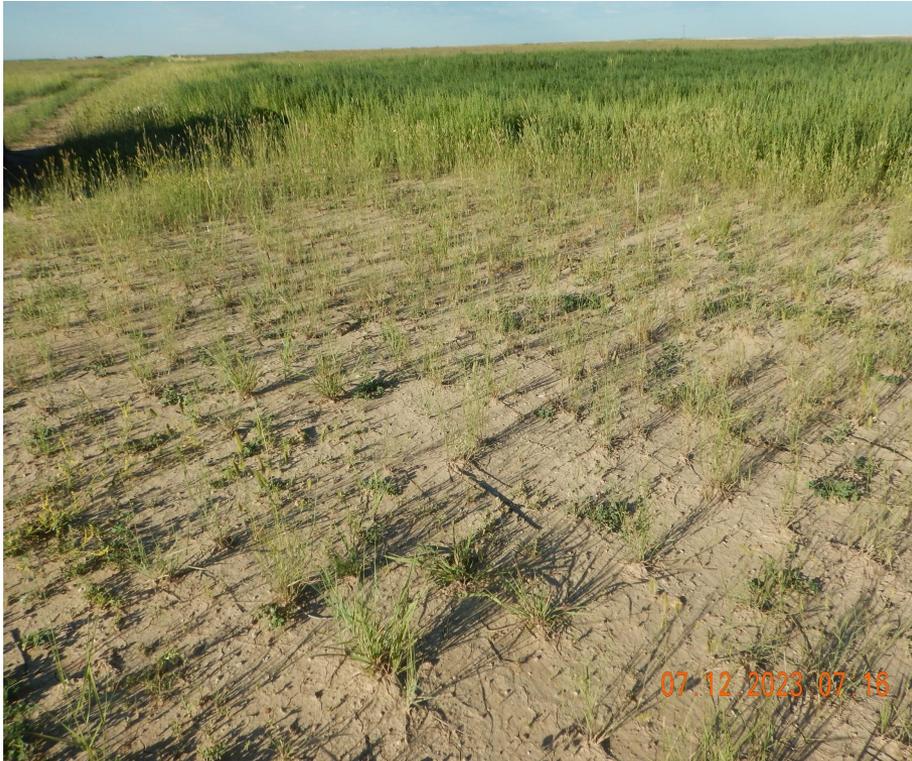
Photo 4. Photo taken from an area of the excavation, facing South. Photo illustrates the excavation area was seeded but with introduced species that is not reflective of reference area species.

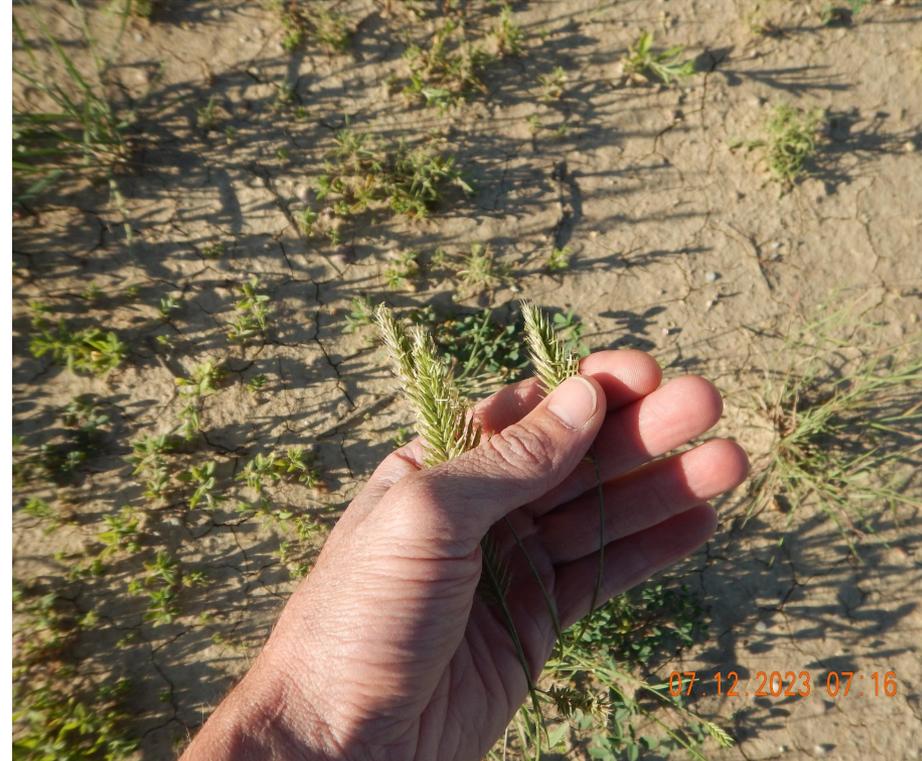
Photo 5. Photo illustrates an introduced grass species, Crested wheatgrass, that was planted.

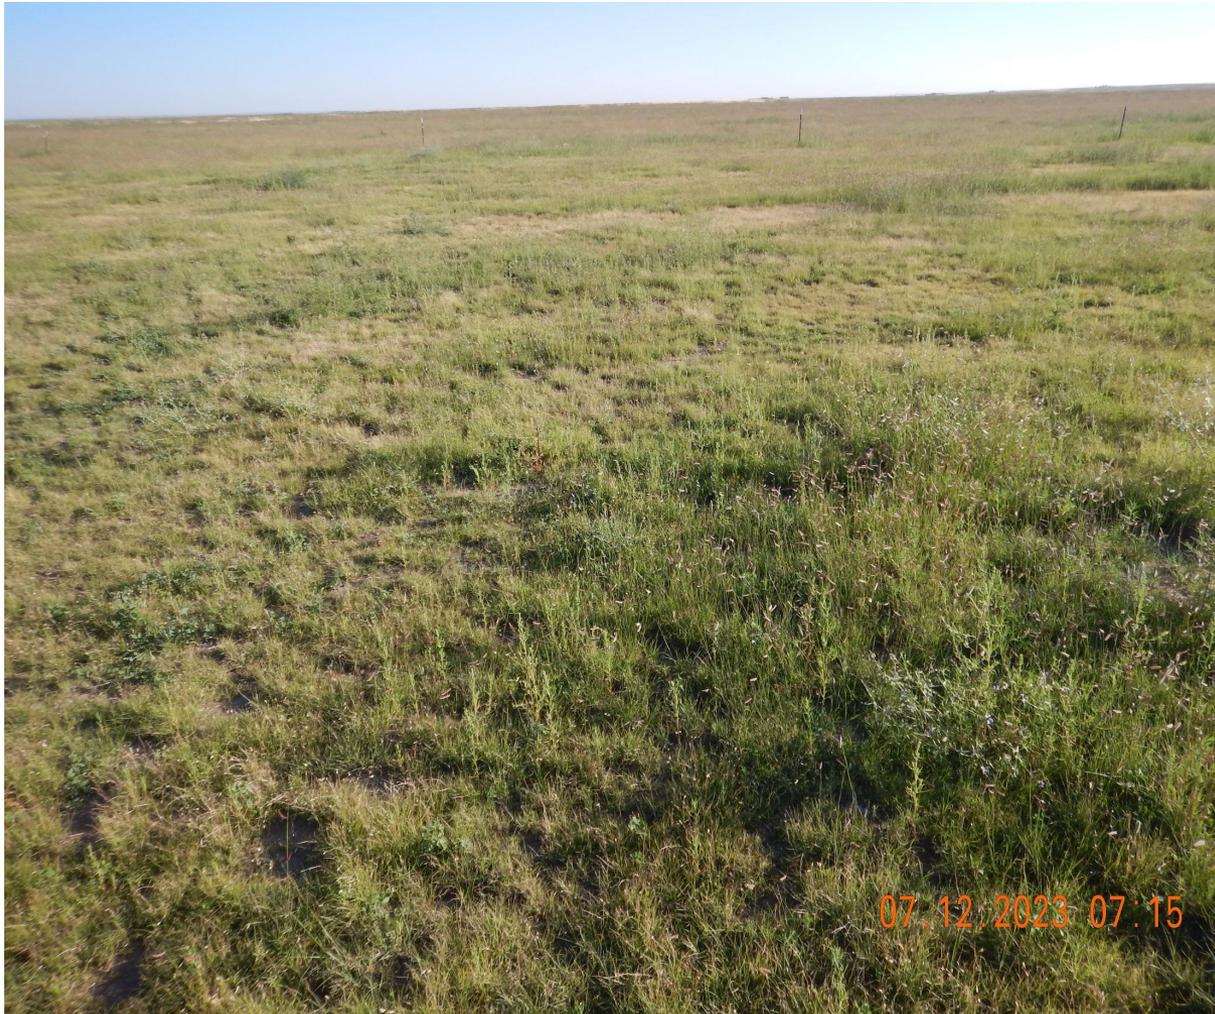
Photo 6. Reference vegetation photo taken west of the wellhead, facing North.
Photo illustrates native perennial grasses.

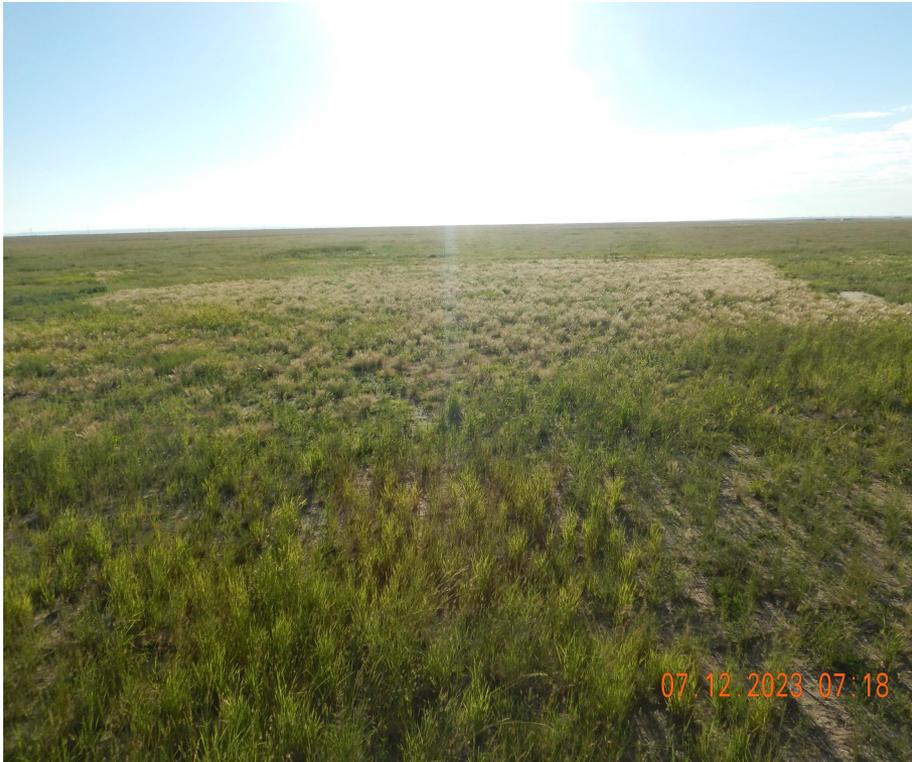
Photo 7. Photo taken from southern excavation extent, facing East. Photo illustrates vegetation has established but it's not reflective of reference area vegetation.

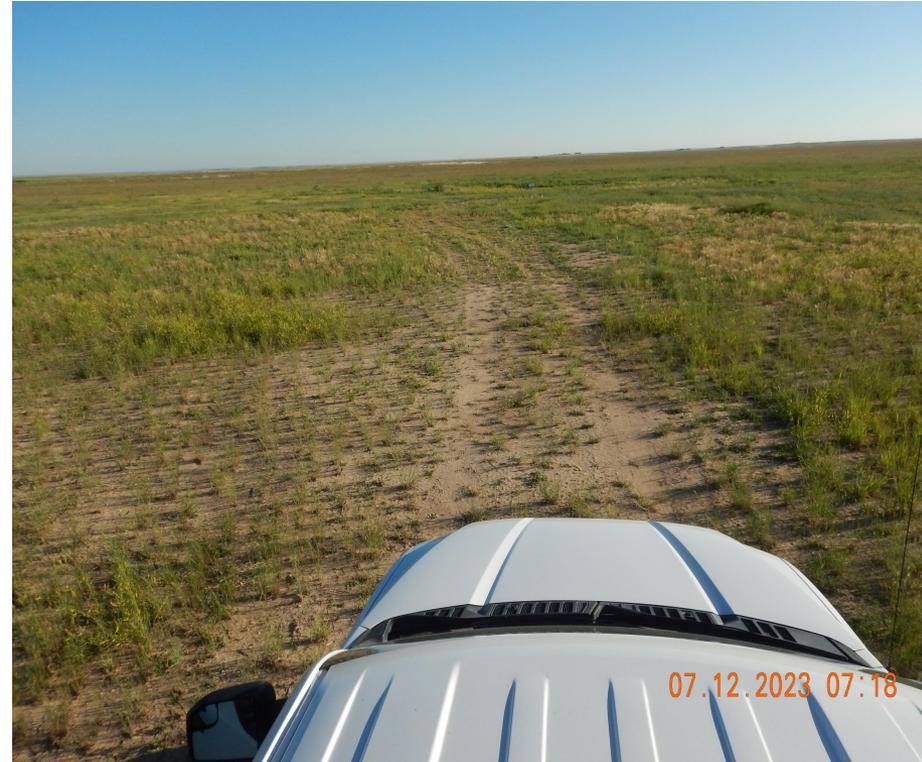
Photo 8. Photo taken from southern excavation extent, facing North. See comments under Photo 7.

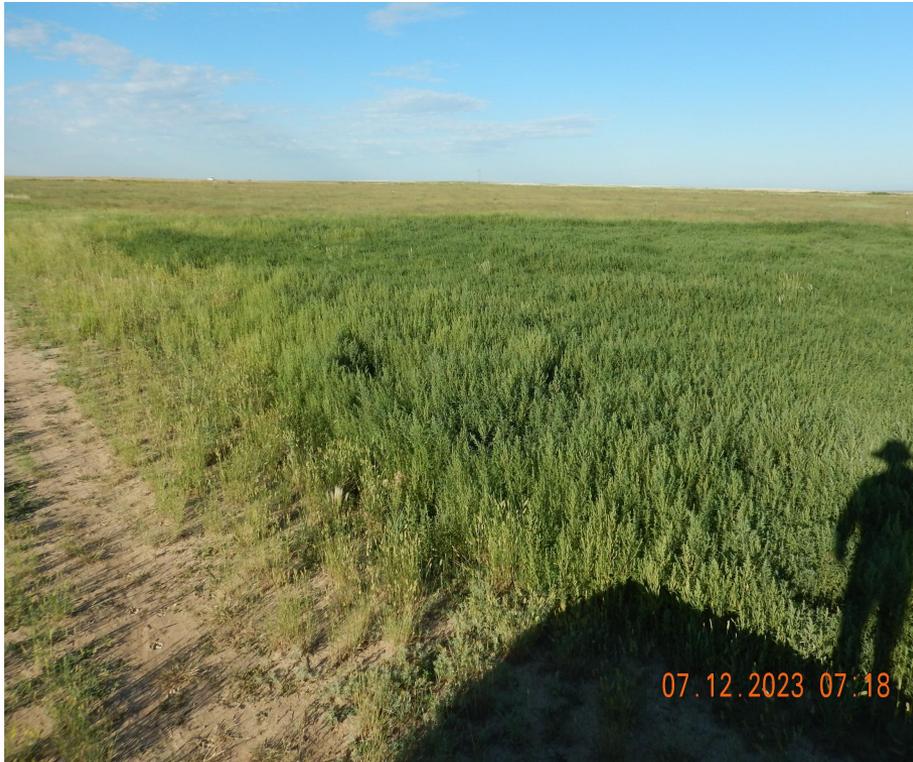
Photo 9. Photo taken from southern excavation extent, facing West. Photo illustrates the western excavation area is dominated by weedy, annual vegetation, which needs to be managed.

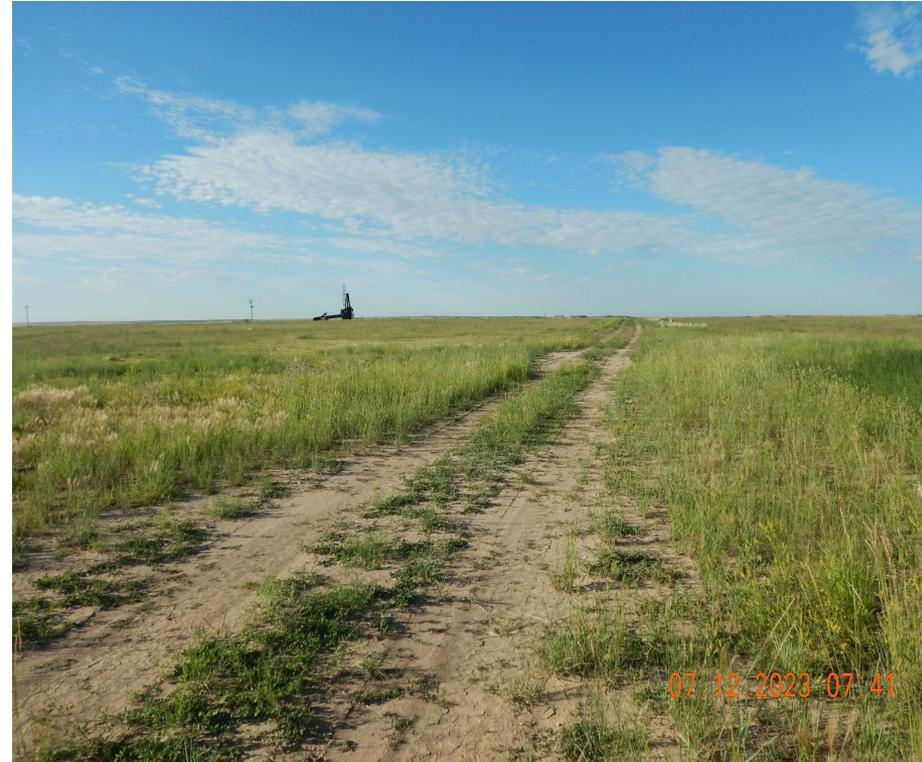
Photo 10. Photo taken from southern excavation extent, facing South. Photo illustrates the access road needs to be reclaimed per Rule 1004.
