Inspection Photos  
well 057-06281  
Inspection  
Date:8/18/2023

**COLORADO**  
Oil & Gas Conservation  
Commission  
Department of Natural Resources

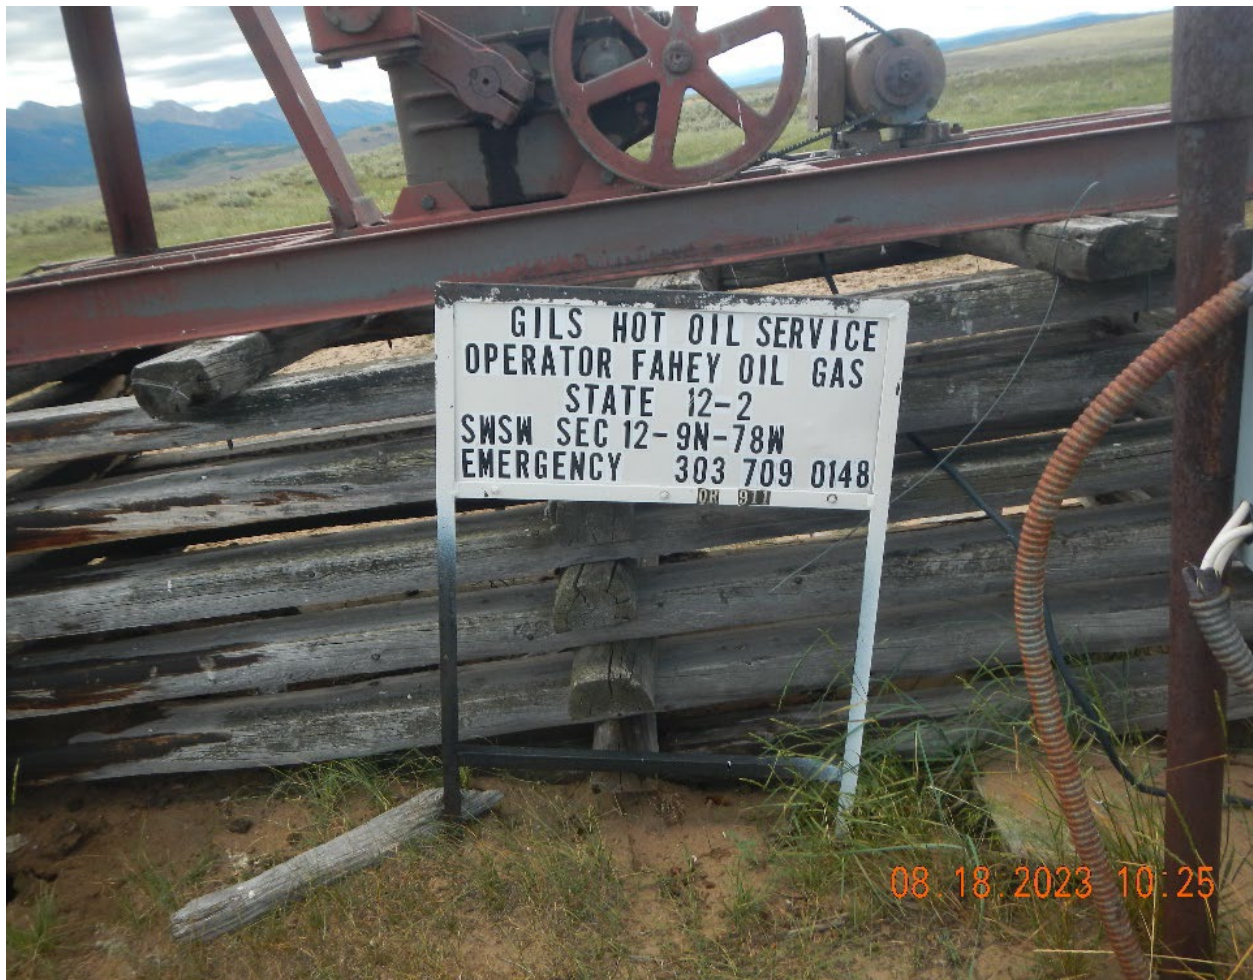
Photo #1 Sign at Wellhead.

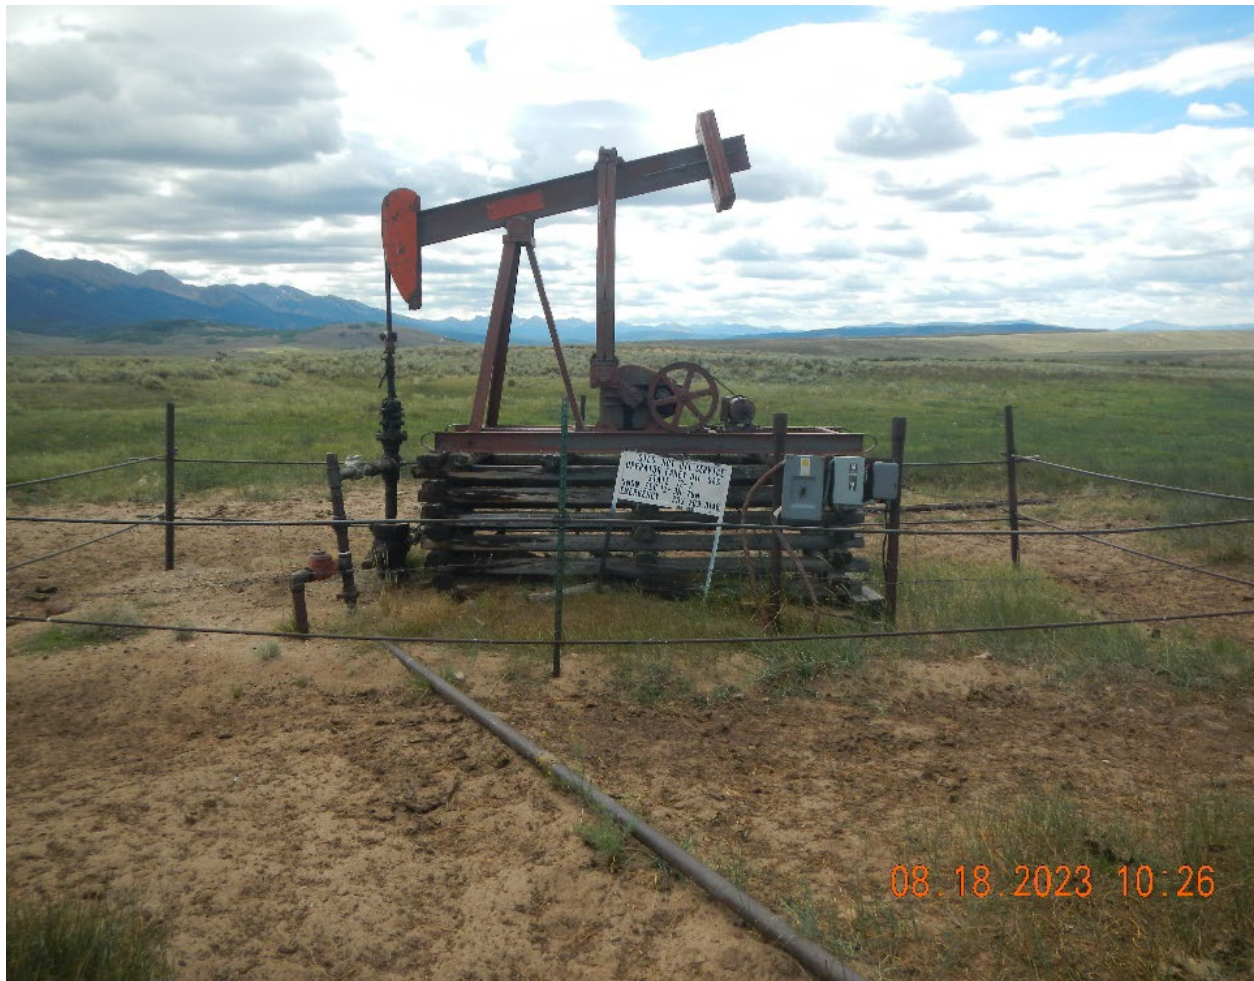
Photo #2 photo of well. Tank is behind photo.

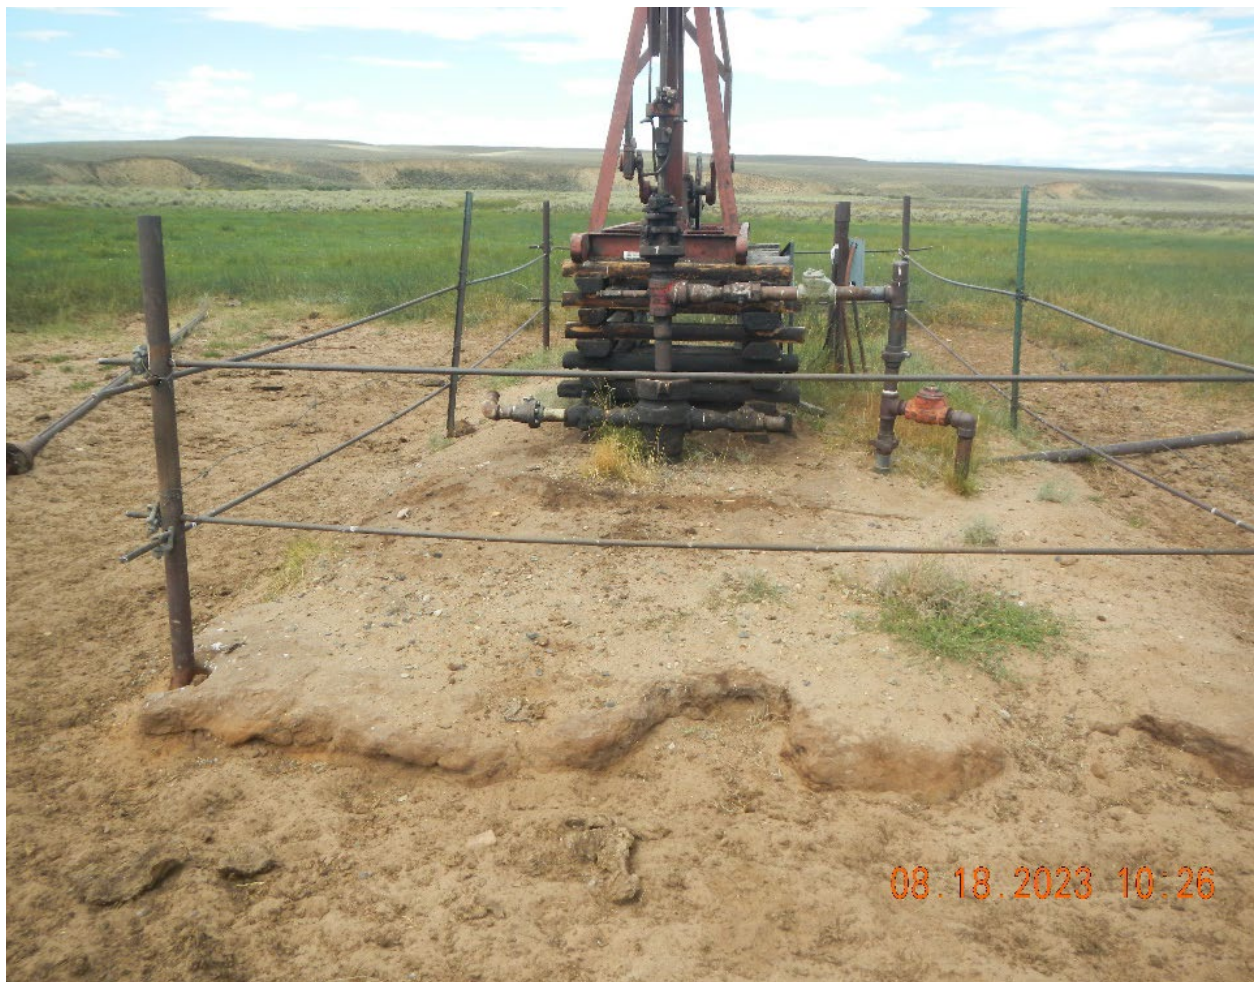
**Photo #3 wellhead. Flowline on right of photo goes to the Tank. The flowline on the left goes to the South.**

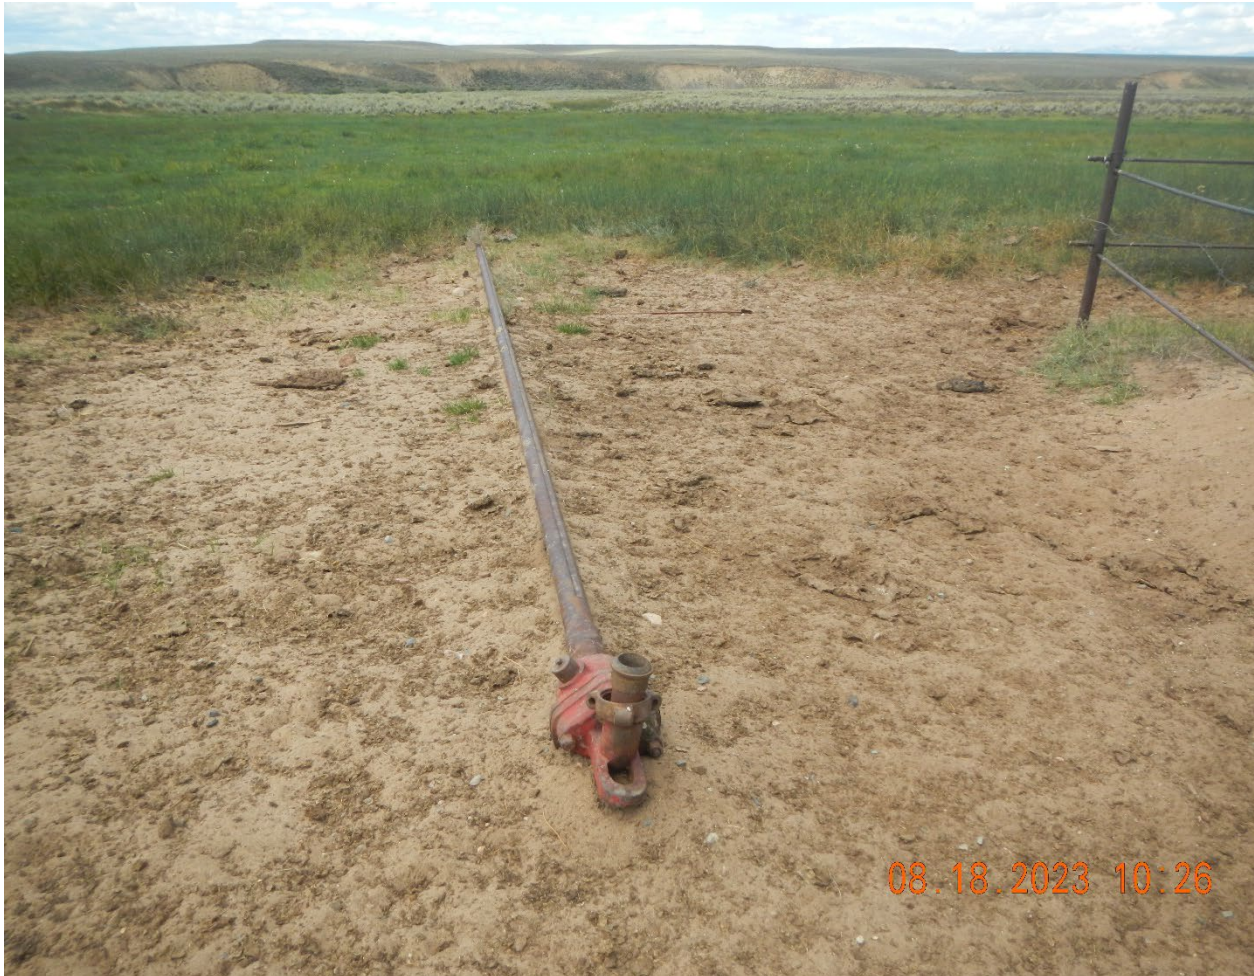
**Photo #4 Off location flowline. Flowline heads off to the south and below ground.**

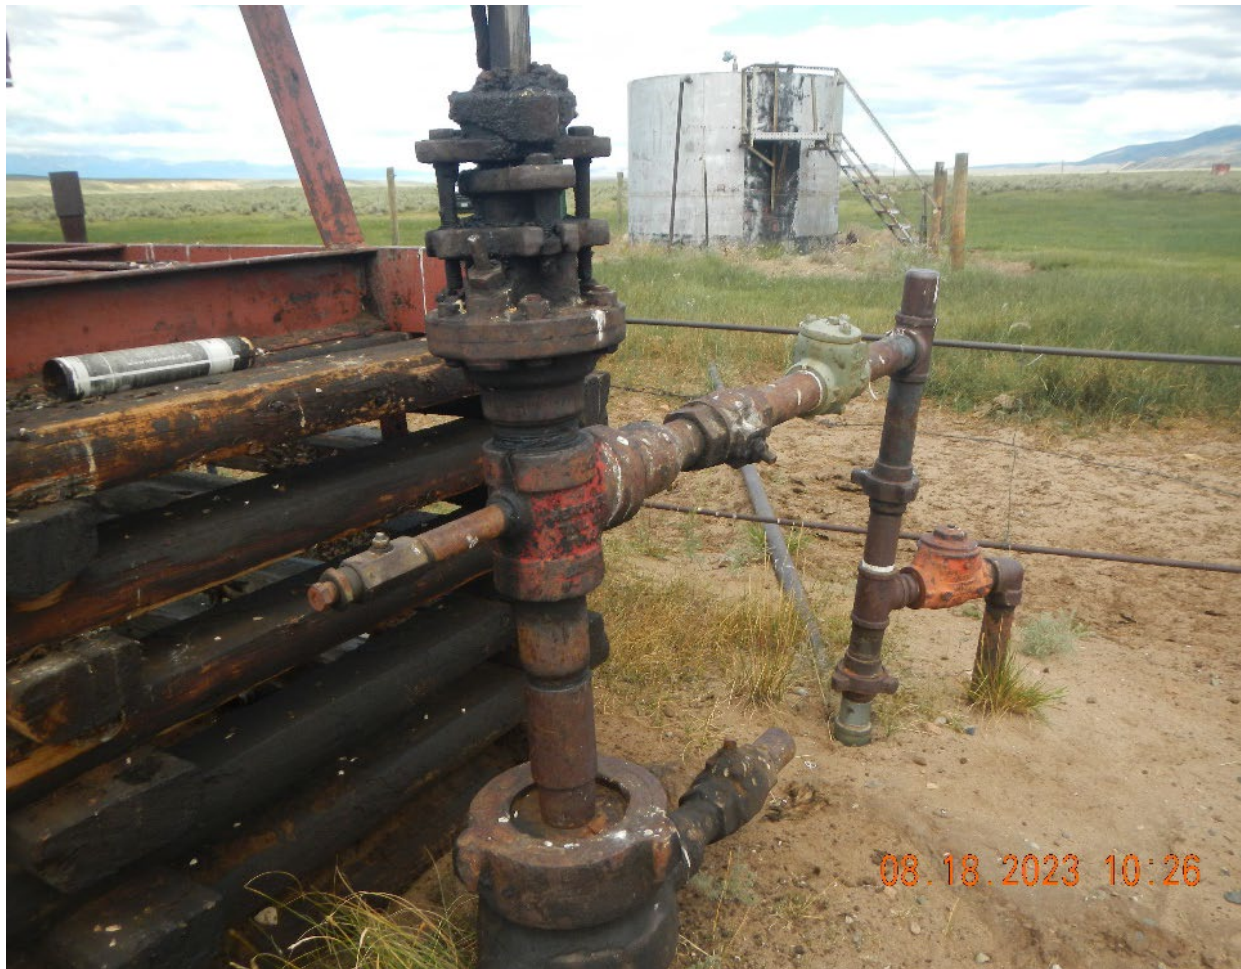
**Photo #5 Close up of wellhead. Flowline was a shallow burry.**

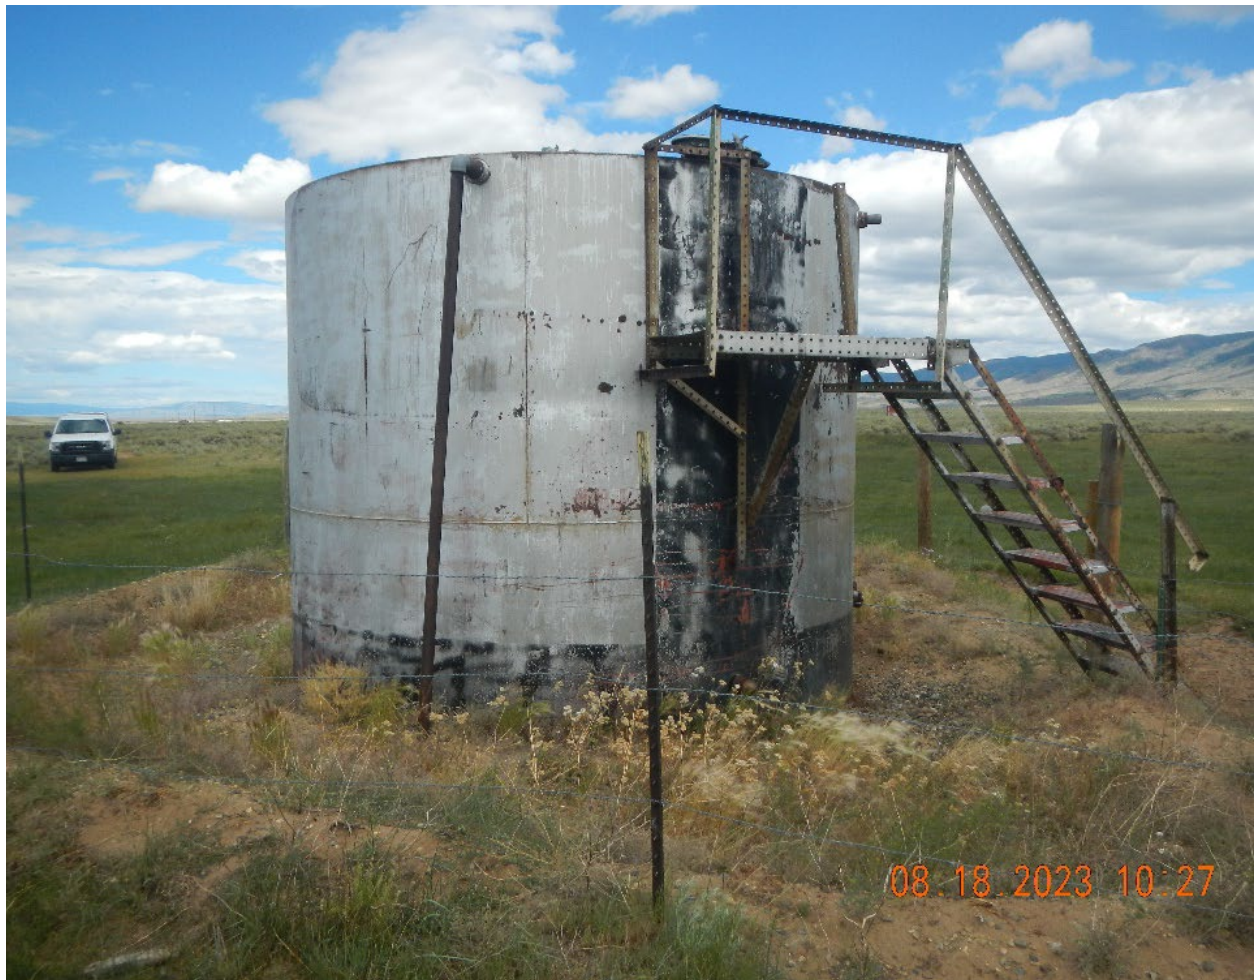
**Photo #6 Tank with subsurface flowline to well.**

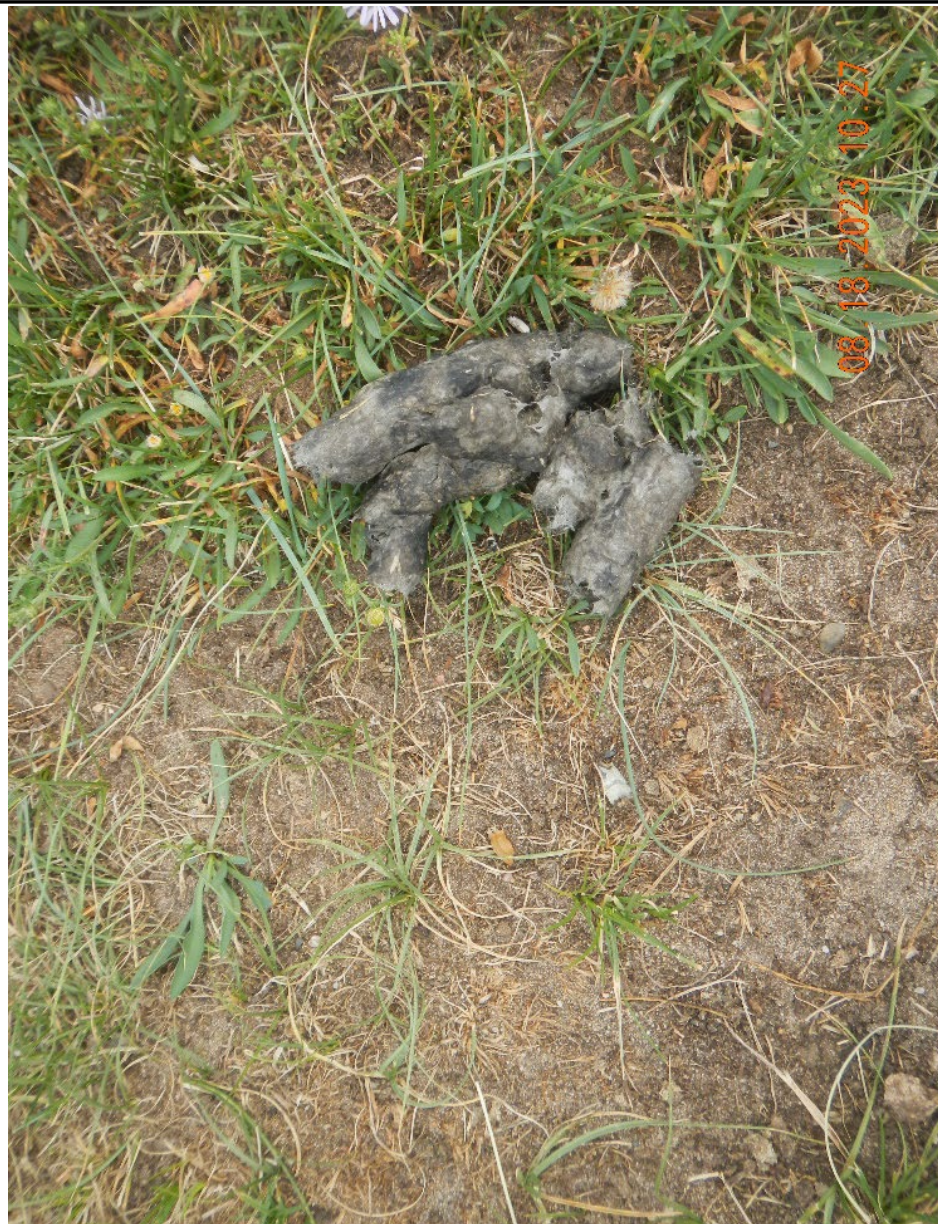
Photo #7 Scat on location.

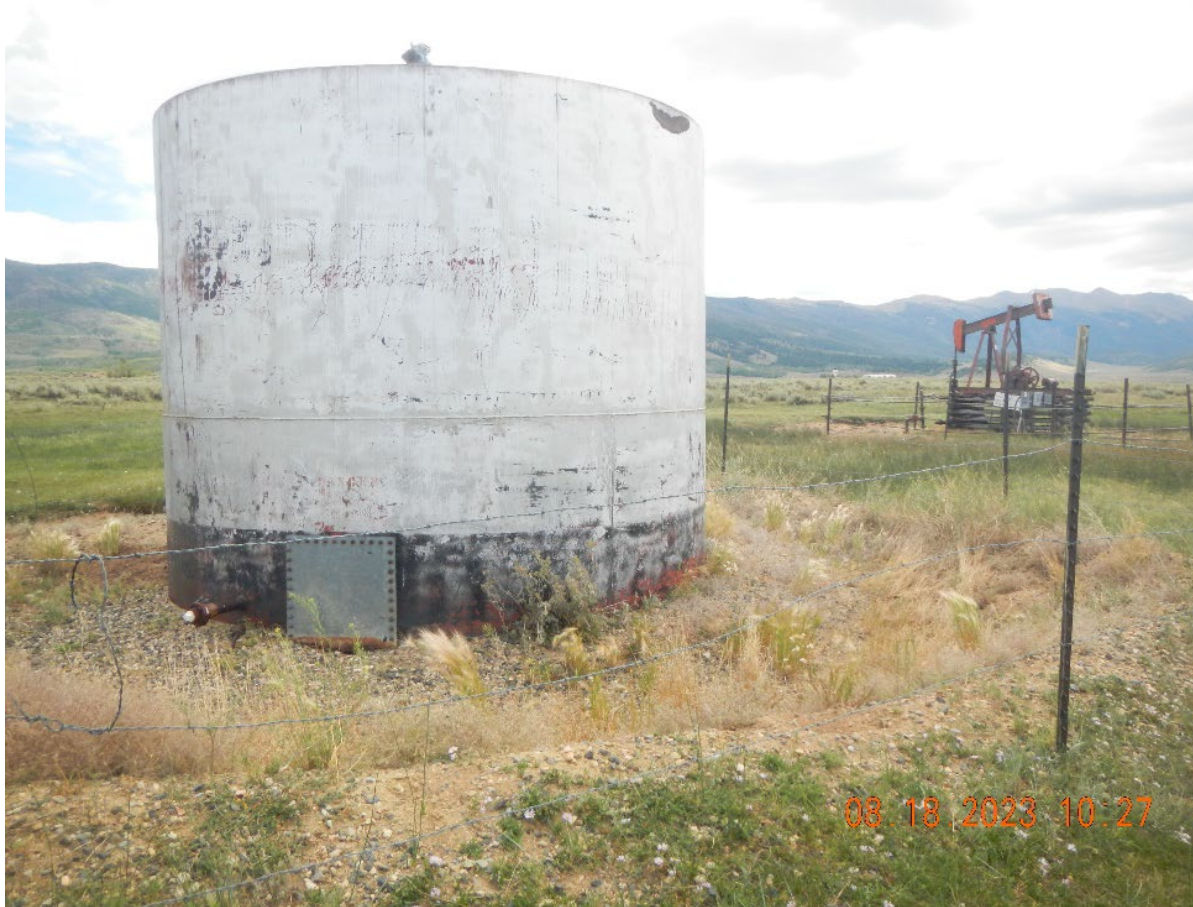
**Photo #8 photo showing proximity of tank to well.**
