Inspection Photos

Location Name: TEP ROCKY MOUNTAIN LLC, WILLIAMS-67S96W/1NWNW

Location ID: 334871

Date: 8/22/2023

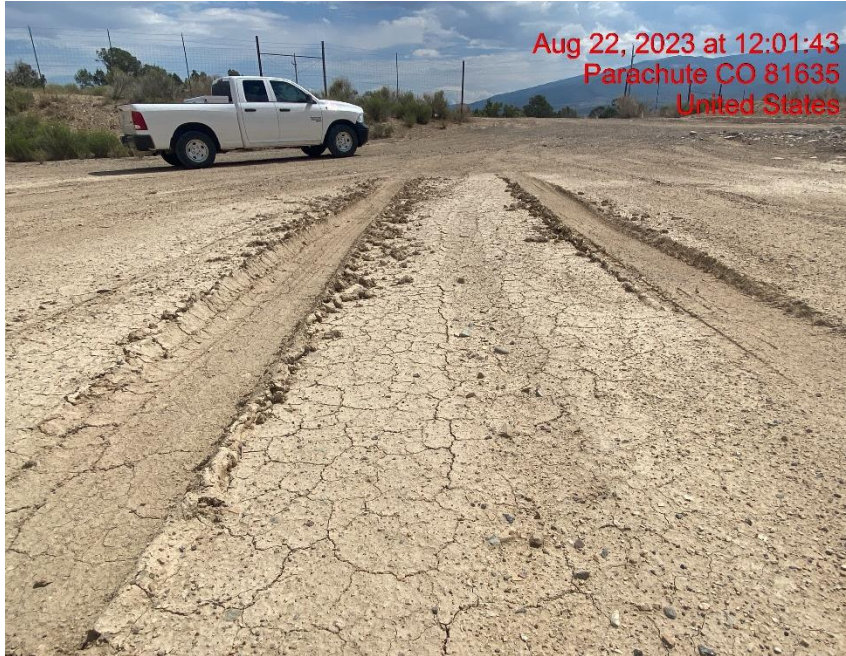
Location Lacks Stabilization – Photo #06059

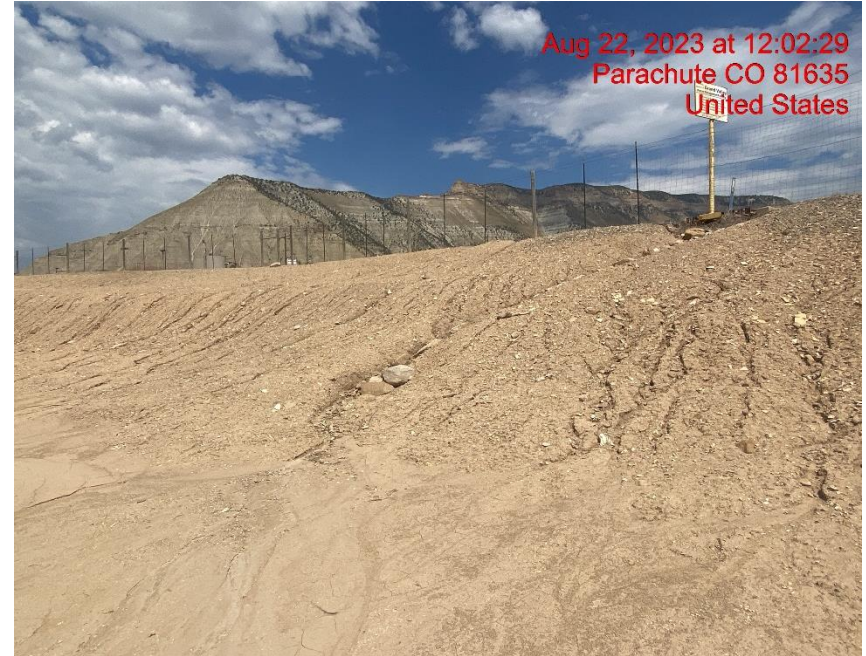
Insufficient Erosion Control on East Berm/Cut Slope – Photo #06061

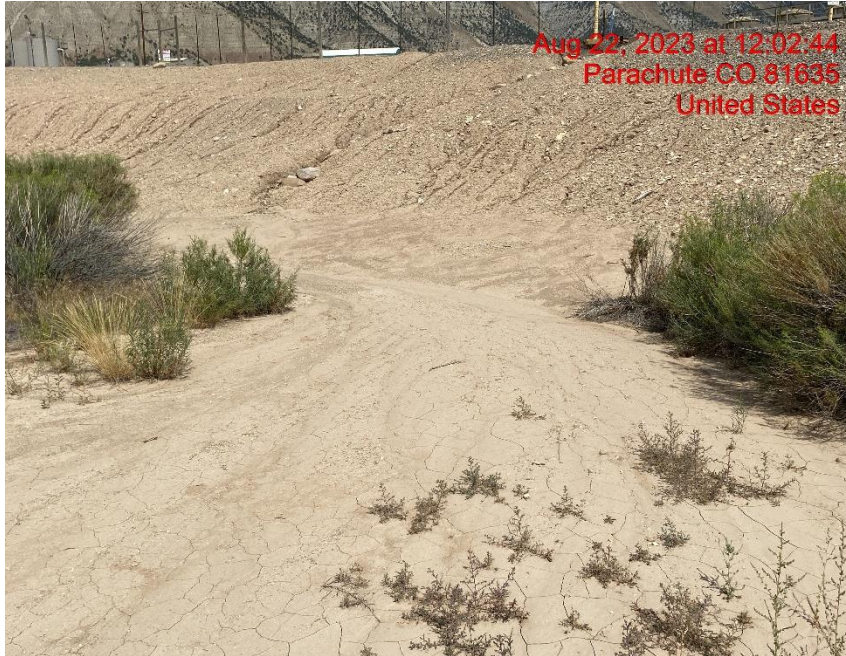
Insufficient Erosion Control on East Berm/Cut Slope – Photo #06062

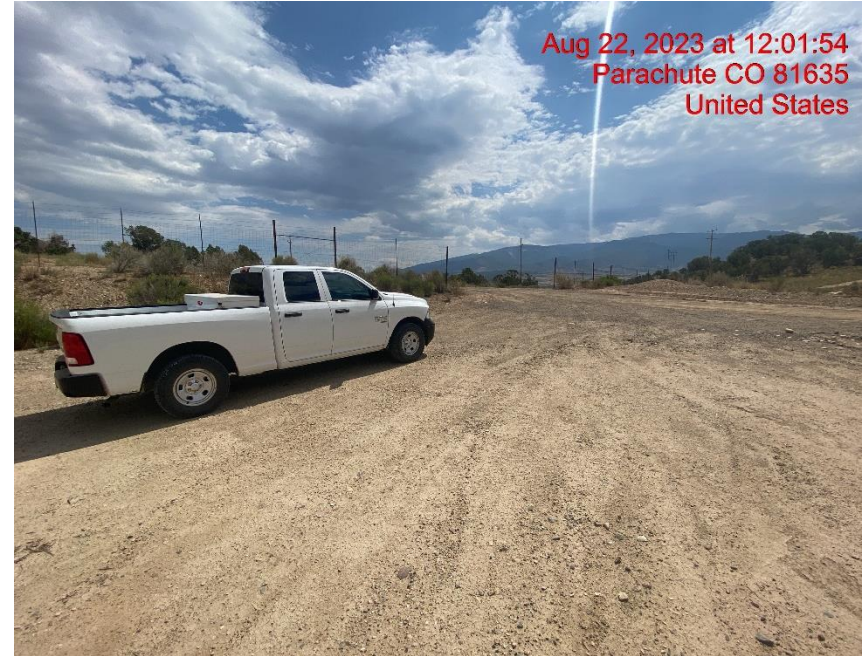
Insufficient Vehicle Tracking BMPs at Location Entrance/Exit – Photo #06060
