Inspection Photos

Location Name: TEP ROCKY MOUNTAIN LLC, BARRETT ET AL-66S96W/35SESE

Location ID: 334743

Date: 8/23/2023

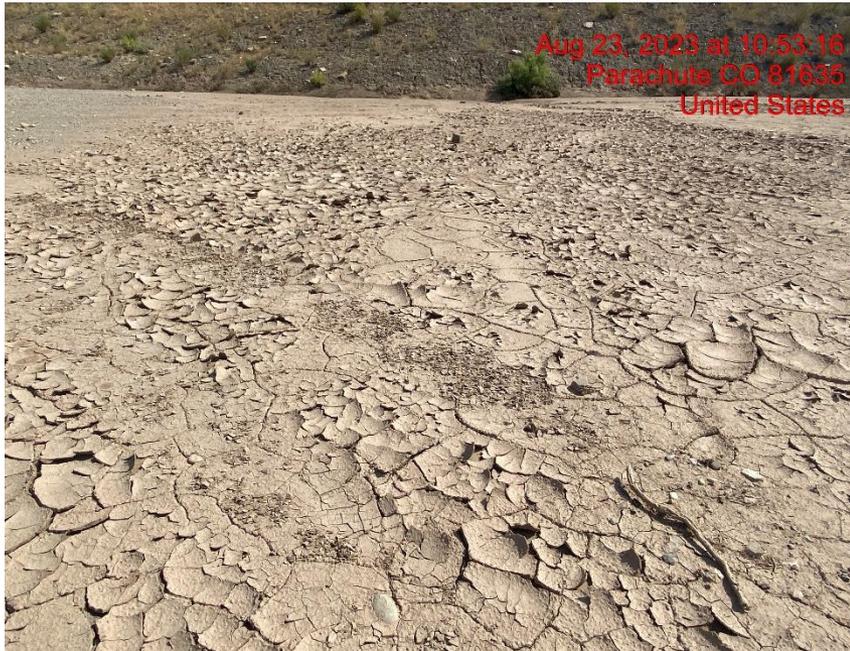
Location Lacks Stabilization – Photo #06077

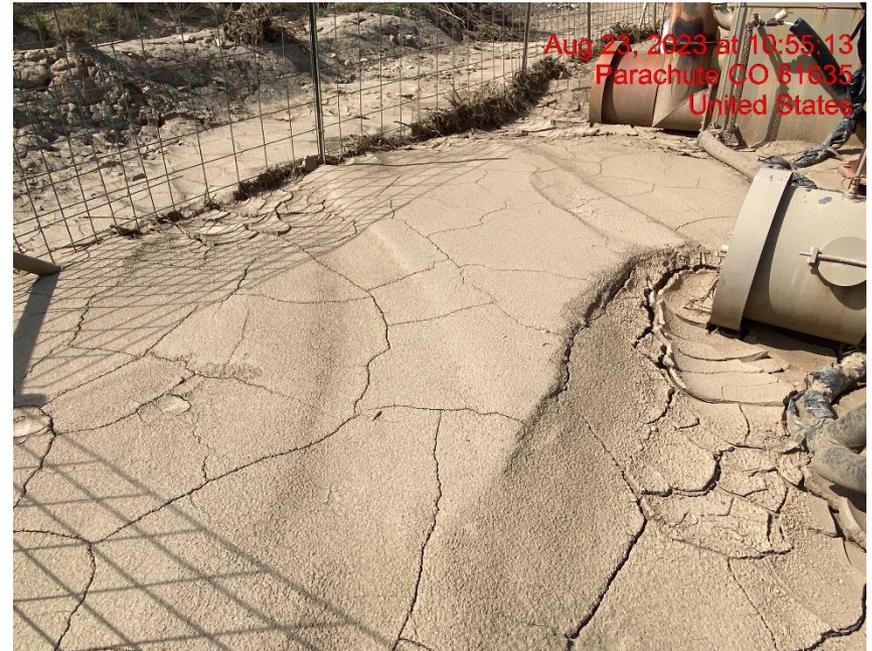
Insufficient Erosion Control/Sediment Run-On to Location – Photo #06079

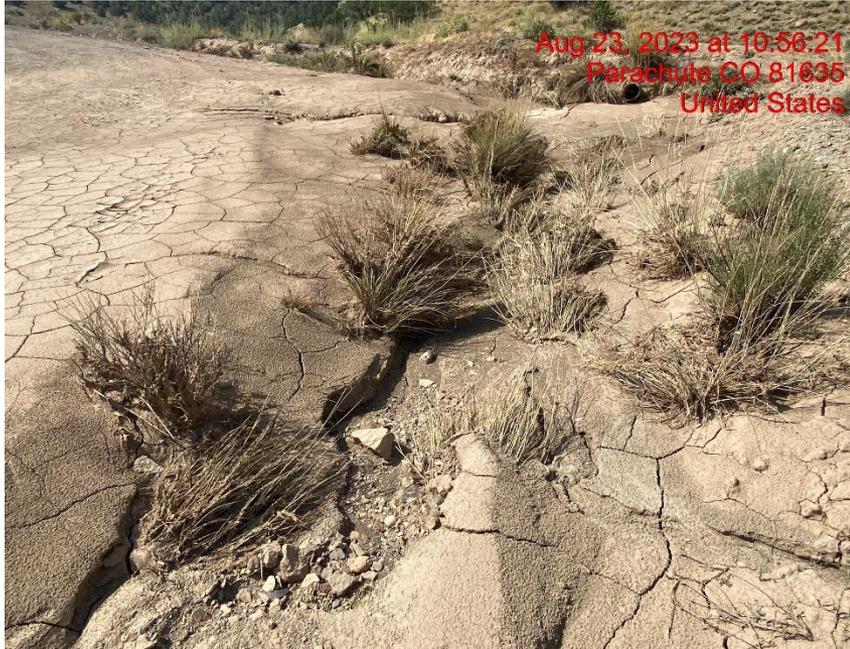
Insufficient Erosion Control – Photo #06080

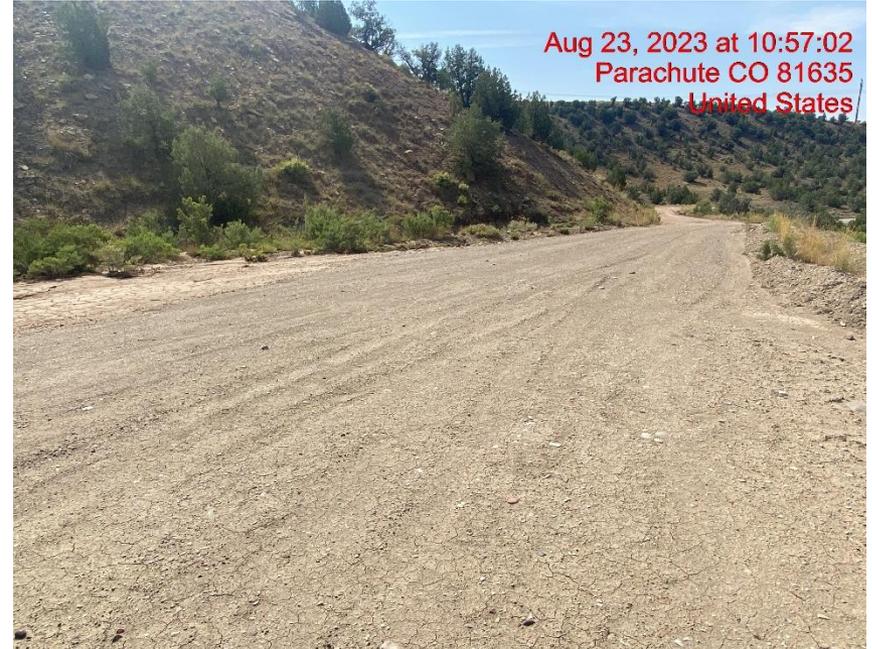
**Insufficient Vehicle Tracking BMPs at Location Entrance/Exit
– Photo #06081**

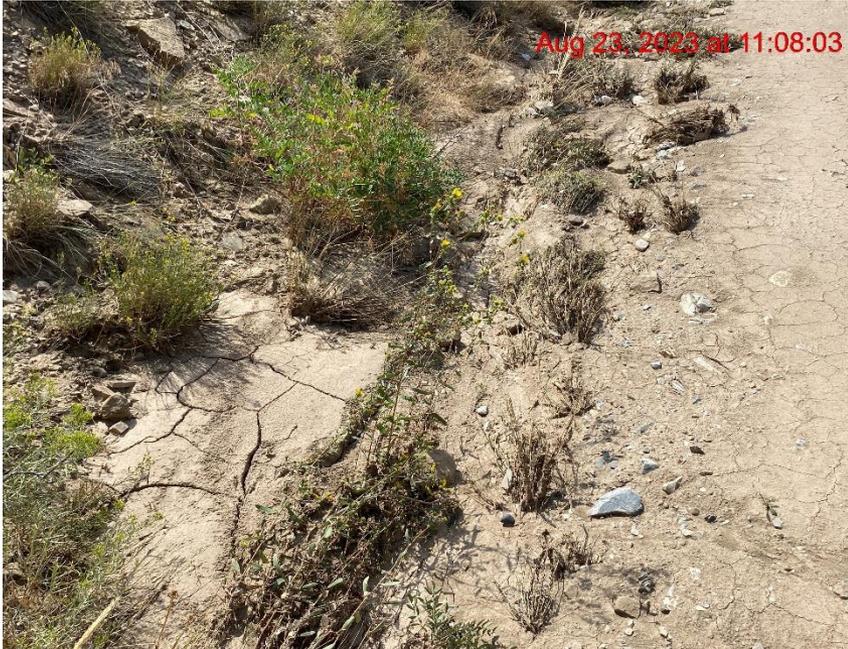
**Degradation of Access Road/Insufficient Erosion Control –
Photo #06084**

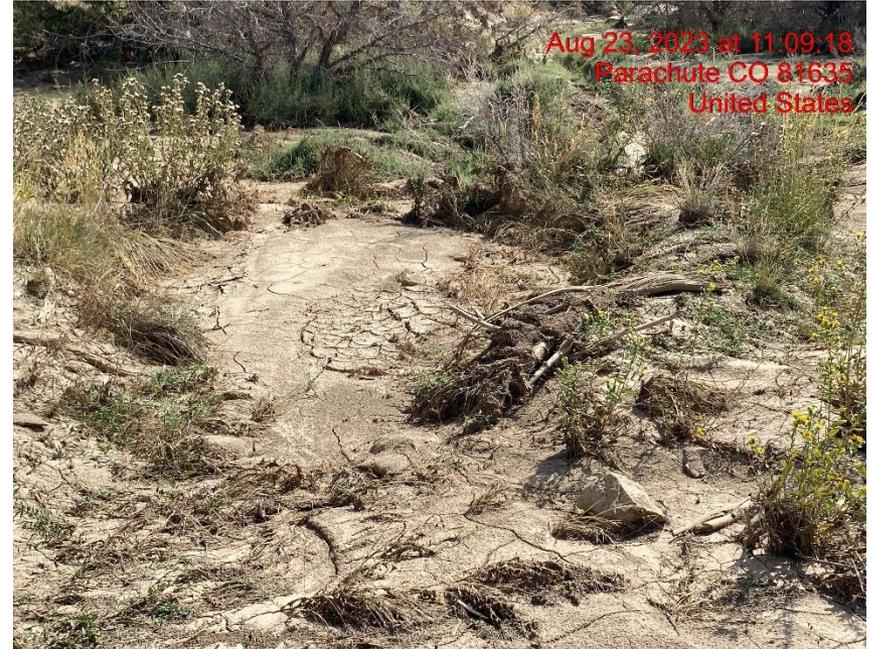
**Degradation of Access Road/Insufficient Erosion Control –
Photo #06087**

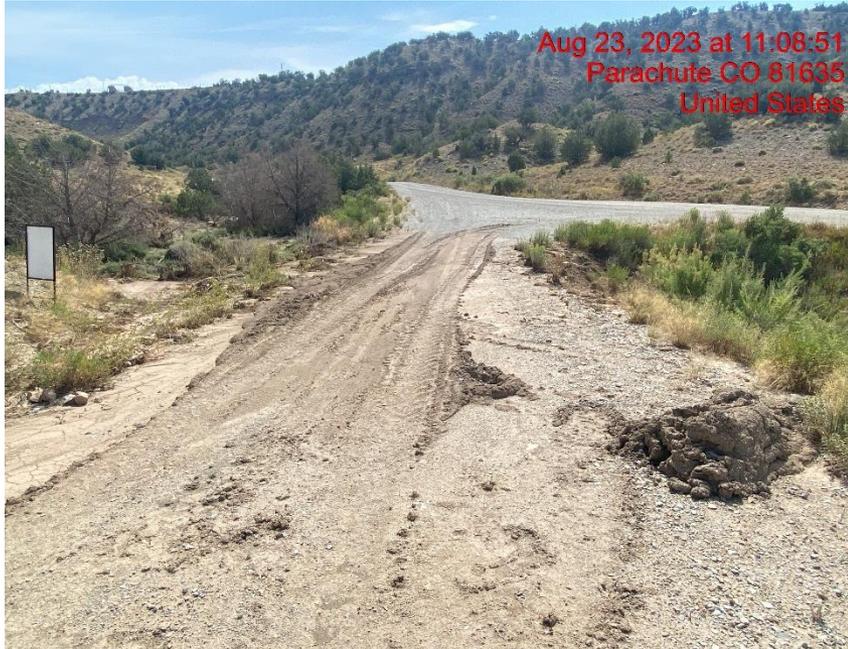
**Degradation of Access Road/Insufficient Erosion Control –
Photo #06085**

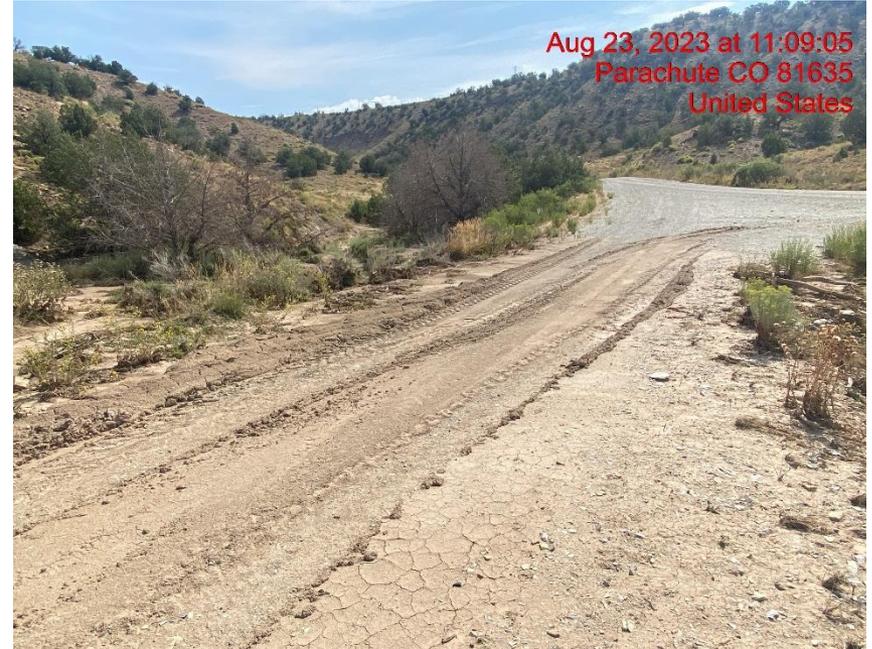
**Insufficient Vehicle Tracking BMPs at Location Entrance/Exit
– Photo #06086**
