Inspection Photos

Loc: 308892

Operator: XTO ENERGY INC

Inspection Date: 9/28/2023

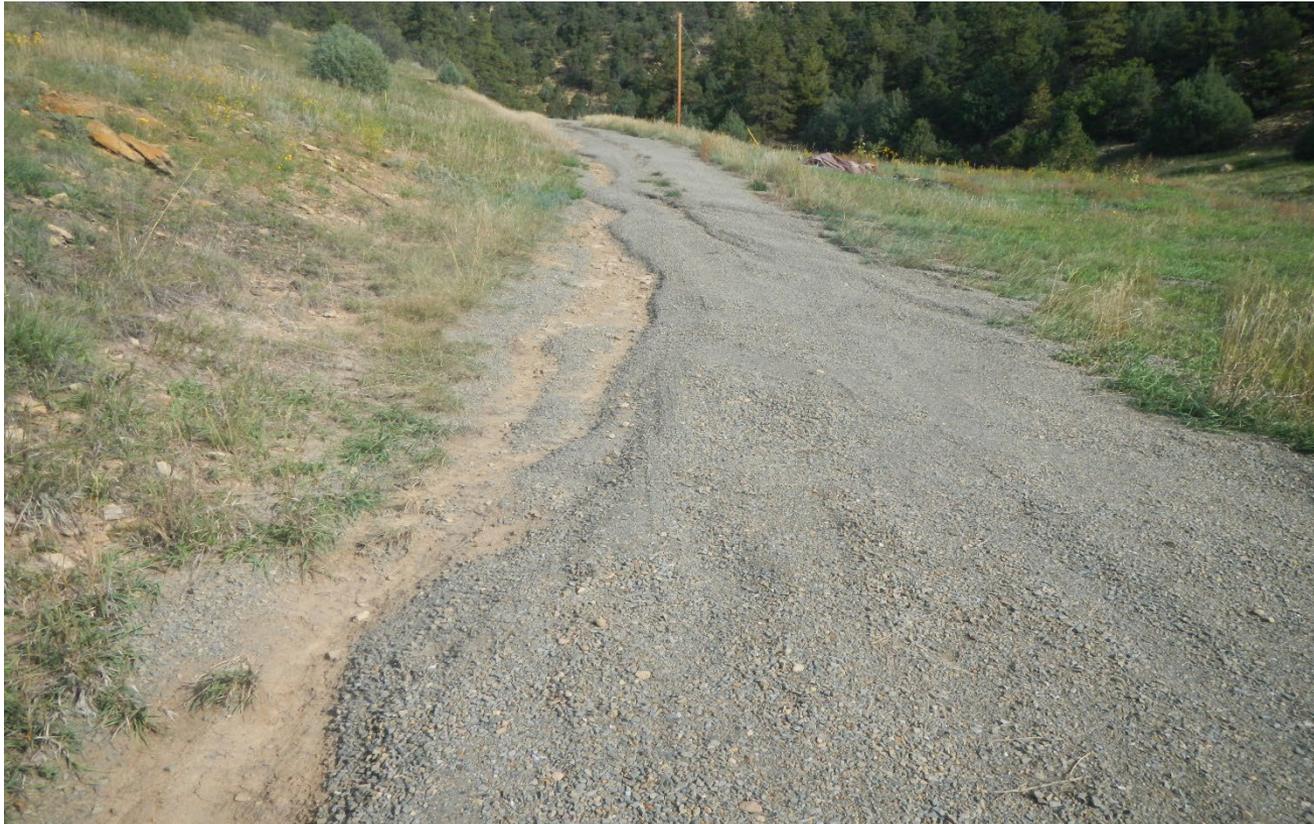
Photo 1. Facing north at the beginning of the access road. Stormwater run-on has caused erosion along the road.

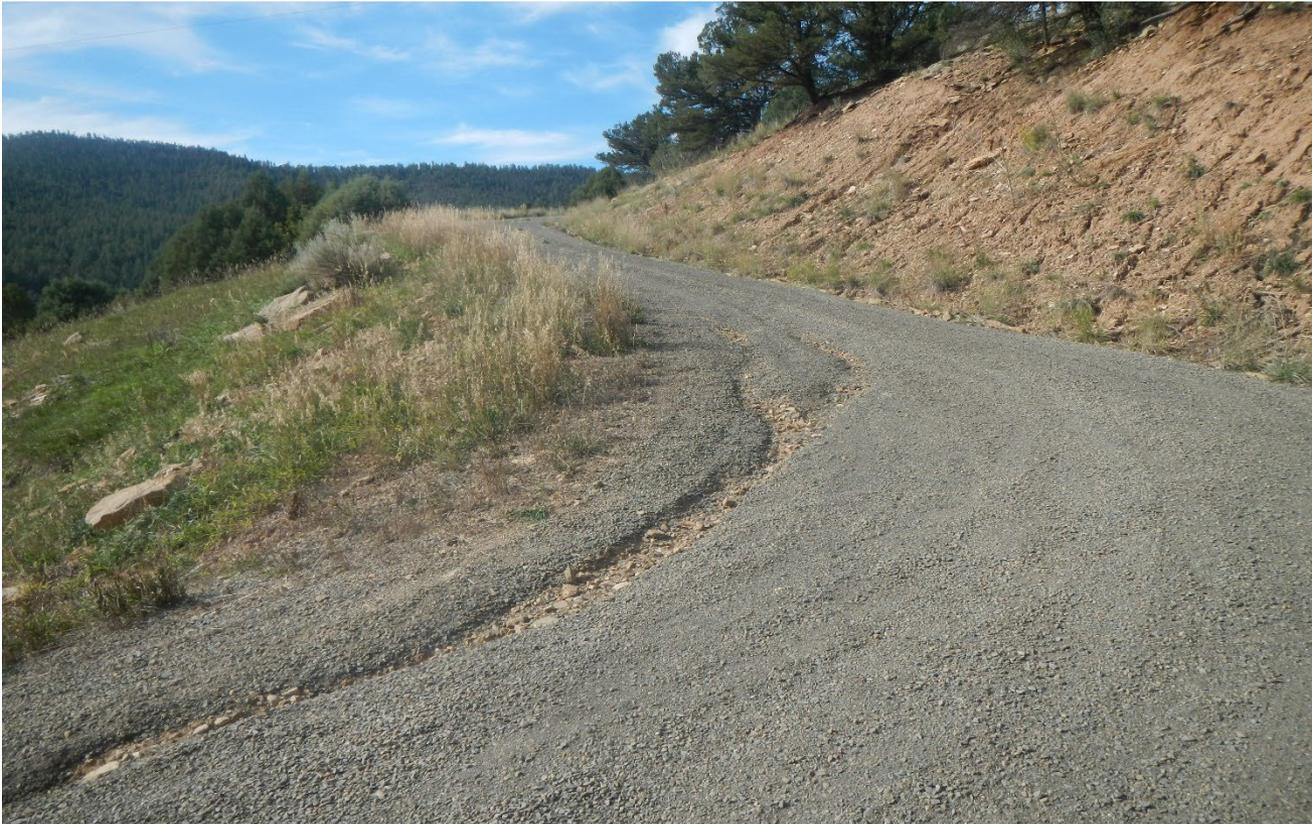
Photo 2. Facing southwest along the access road. There is an erosion channel down the road.

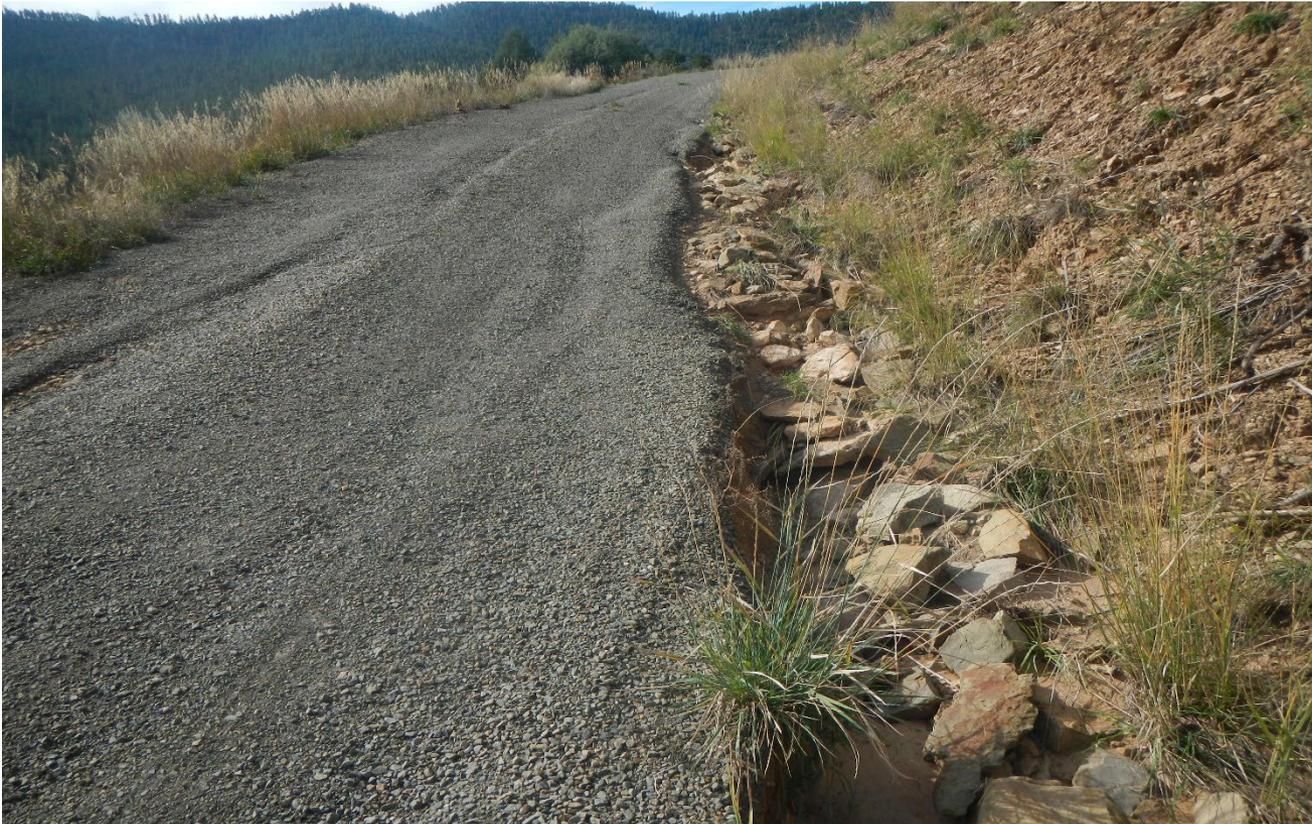
Photo 3. Facing southwest along the access road. Stormwater is cutting into the side of the road in this area. BMPs need to be installed to prevent further erosion.

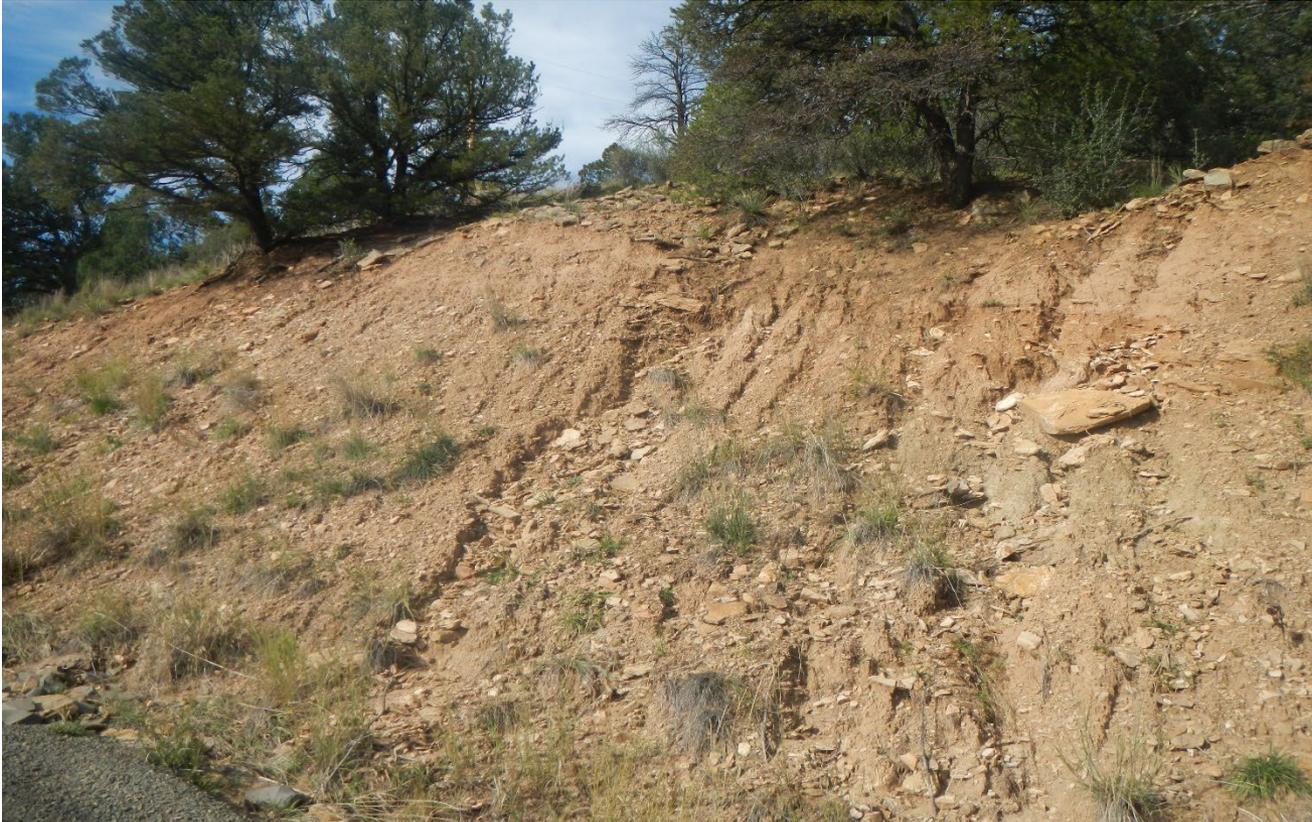
Photo 4. Stormwater run-on from the road that switches back above is causing erosion in this area along the road cut slope.

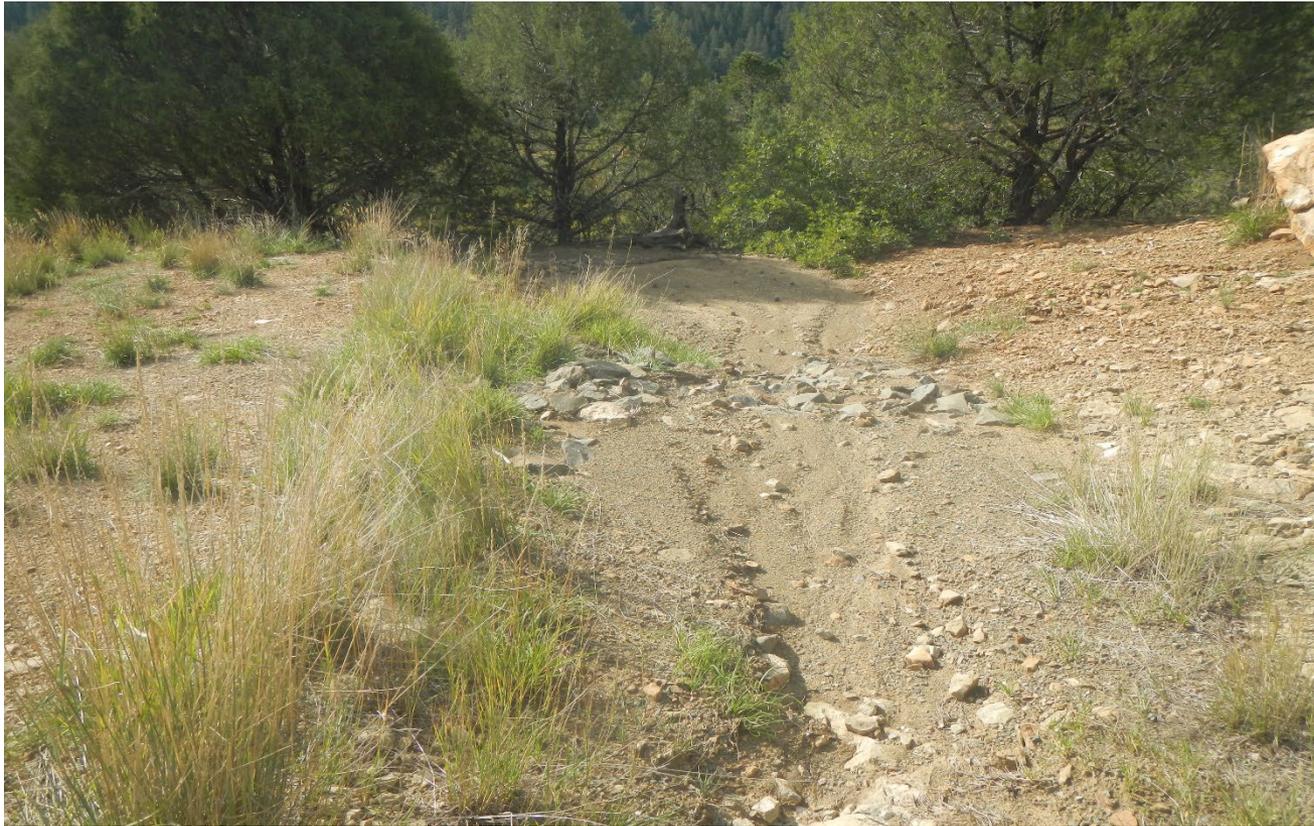
Photo 5. There is sediment accumulation along this rip/rap outlet which needs maintenance (shoveled/cleaned out).

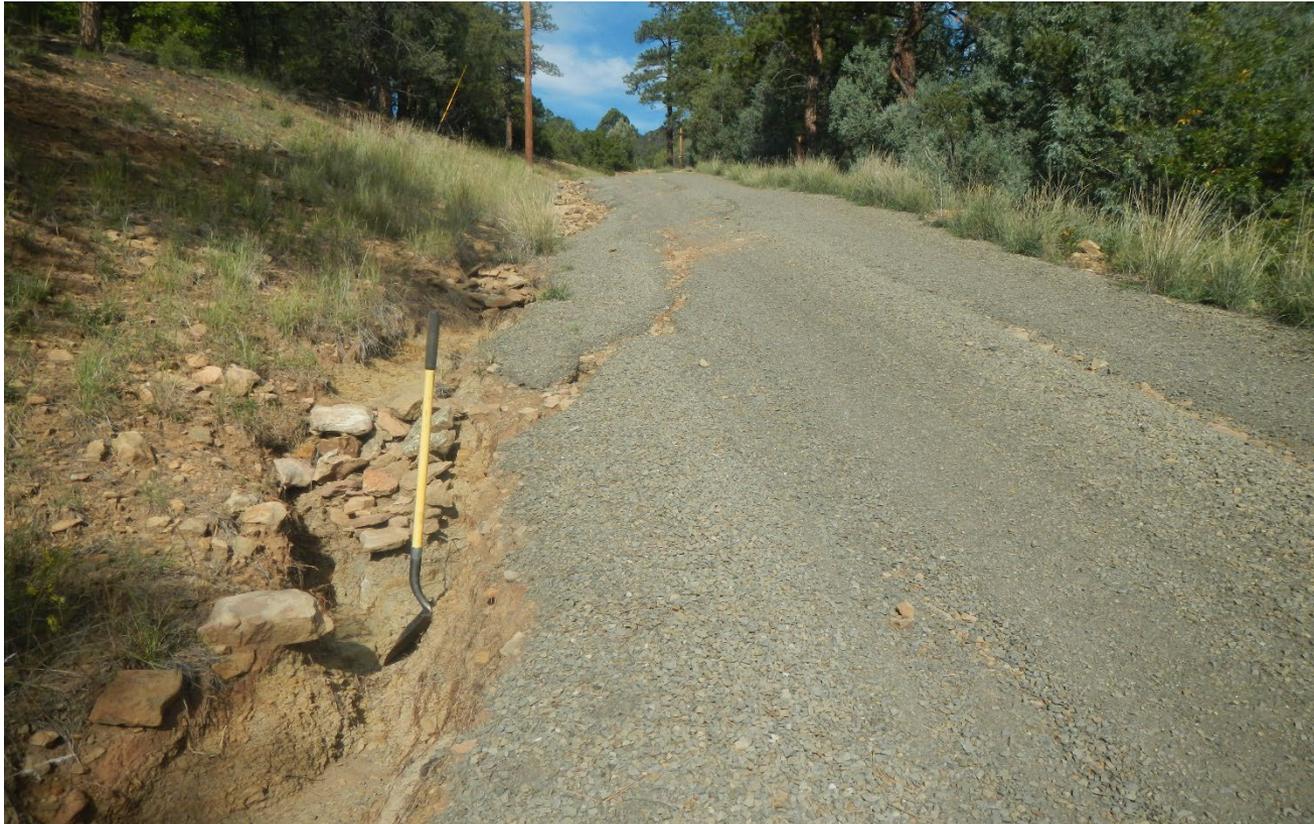
Photo 6. Facing northwest along the access road. There is erosion along the road side at this area. BMPs need to be installed to prevent further erosion.

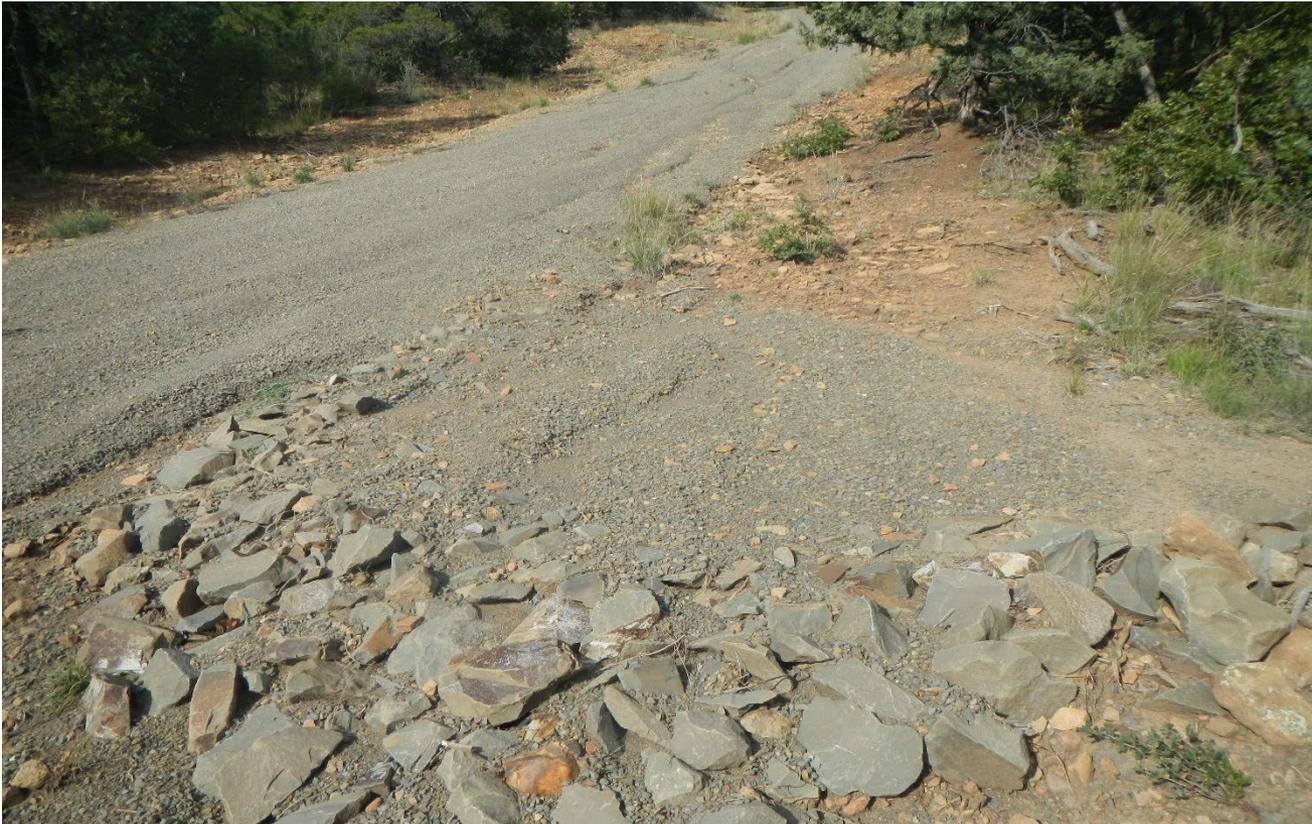
Photo 7. Facing west along the road. The rock check dams have filled in with gravel and sediment.

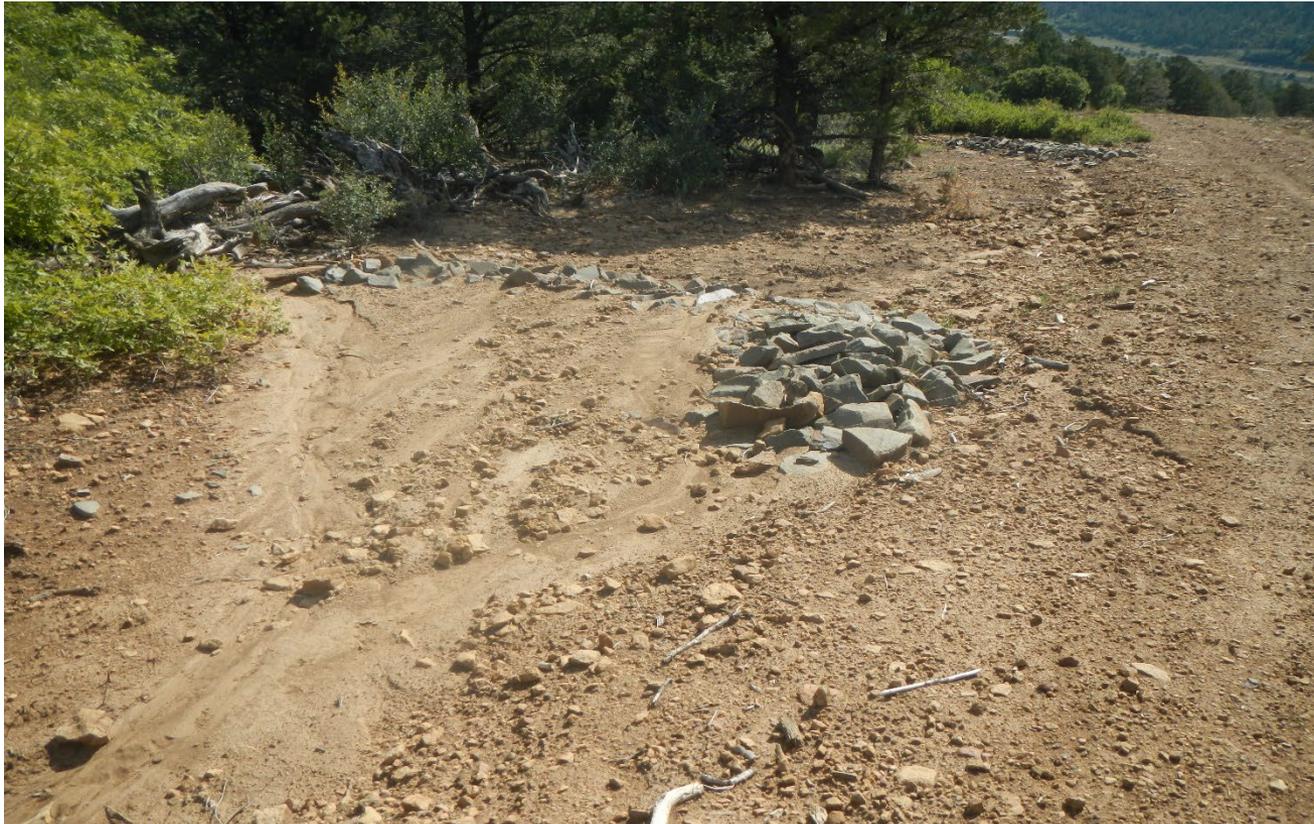
Photo 9. There is sediment accumulation along this rip/rap check dams which needs maintenance (shoveled/cleaned out).
