Inspection Photos

Location Name: CAERUS PICEANCE LLC FEDERAL 16-6 (RD16) Pad

Location #: 334611

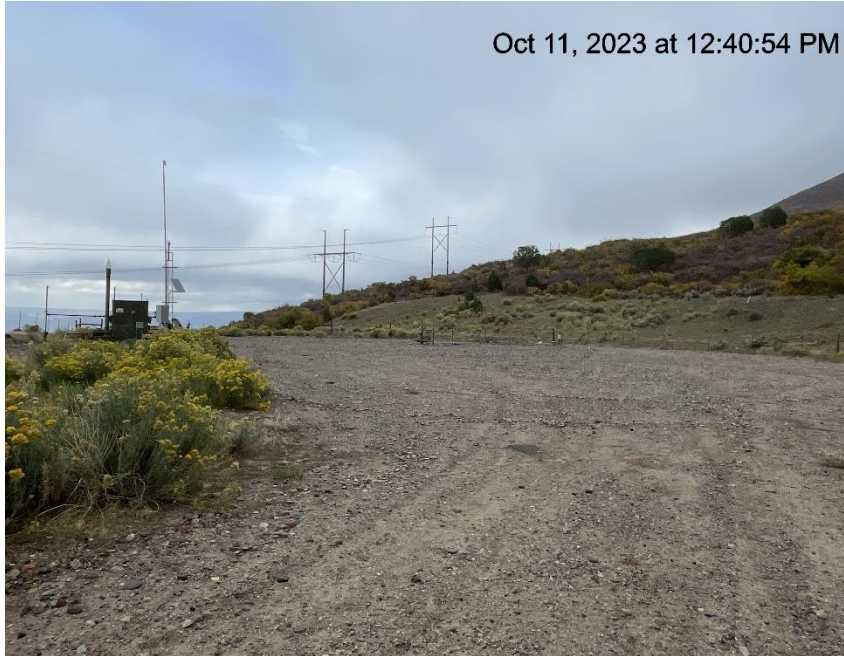
Photo # 2474 From entrance to location

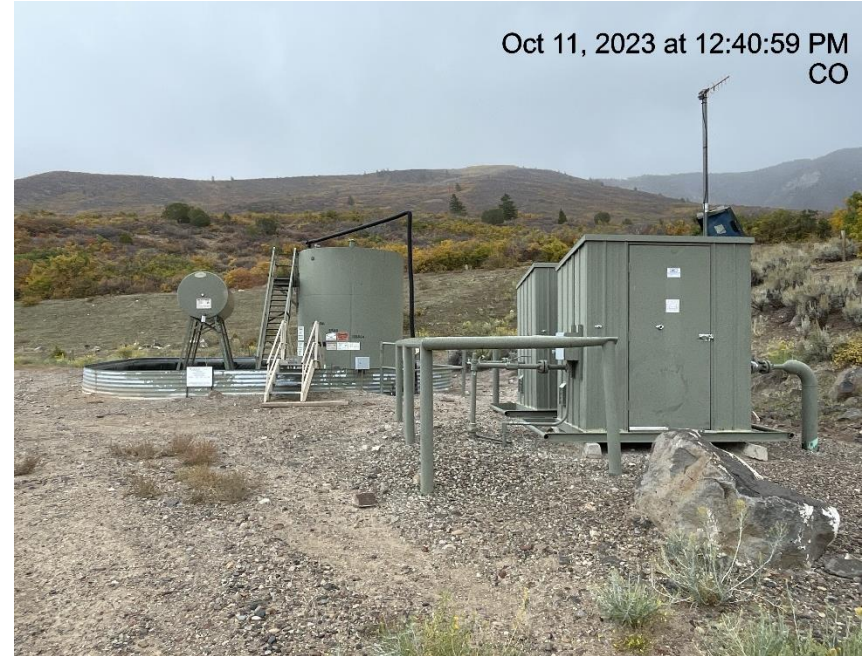
Photo # 2475 From entrance to location

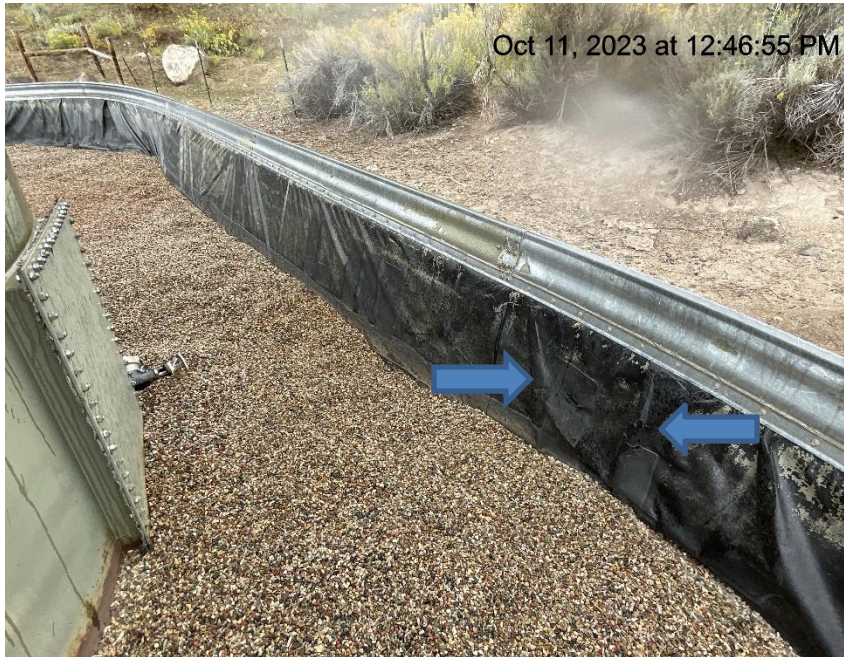
Photo # 2482 Holes in containment liner/liner needs maintenance

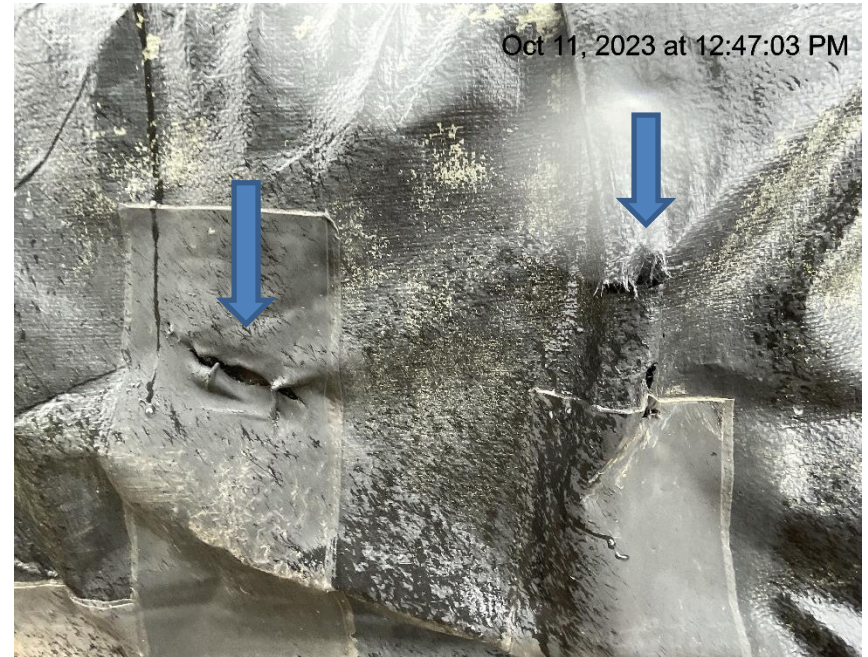
Photo # 2483 Holes in containment liner/liner needs maintenance

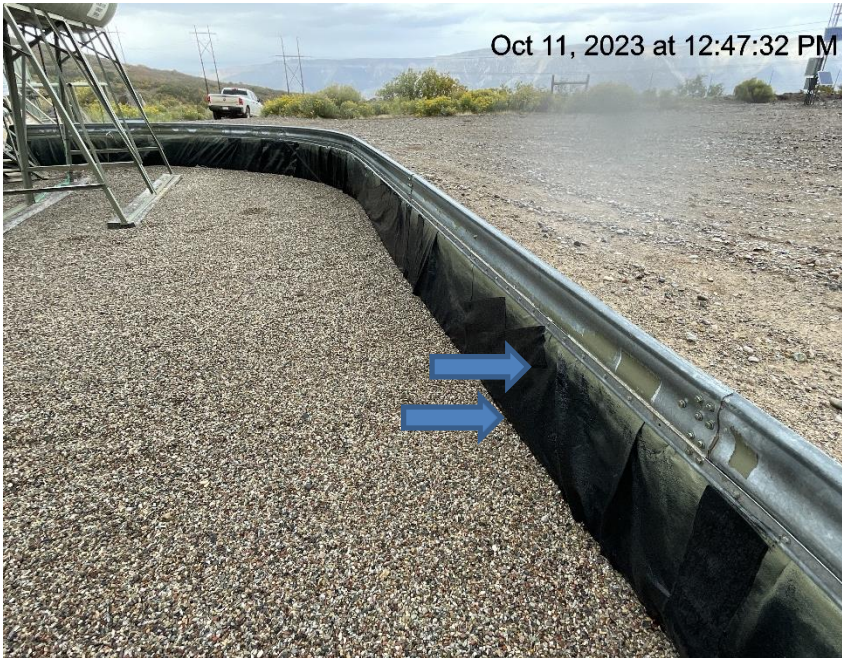
Photo # 2484 Holes in containment liner/liner needs maintenance

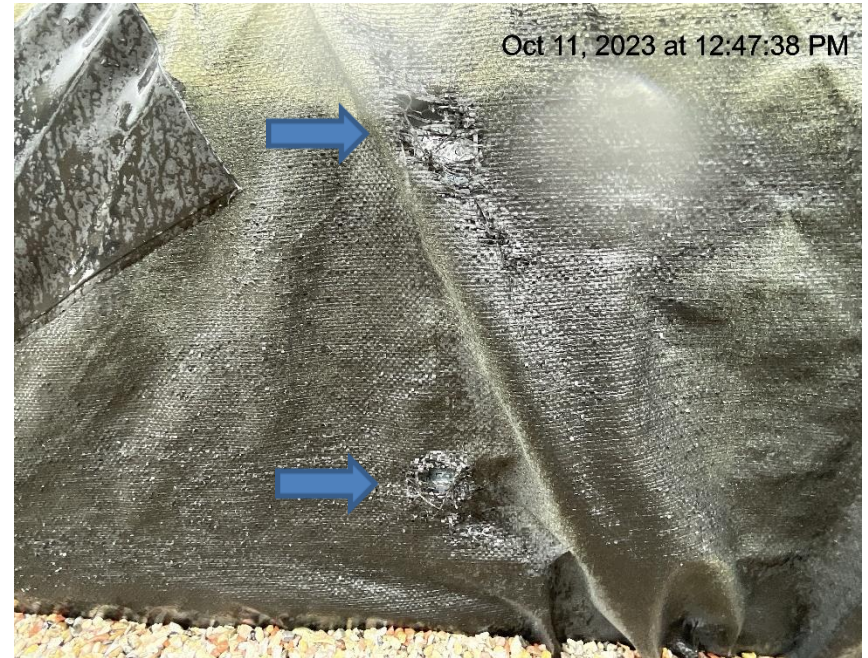
Photo # 2485 Holes in containment liner/liner needs maintenance
