Inspection Photos

Loc: 484360

Operator: DESERT EAGLE OPERATING LLC

Inspection Date: 11/21/2023

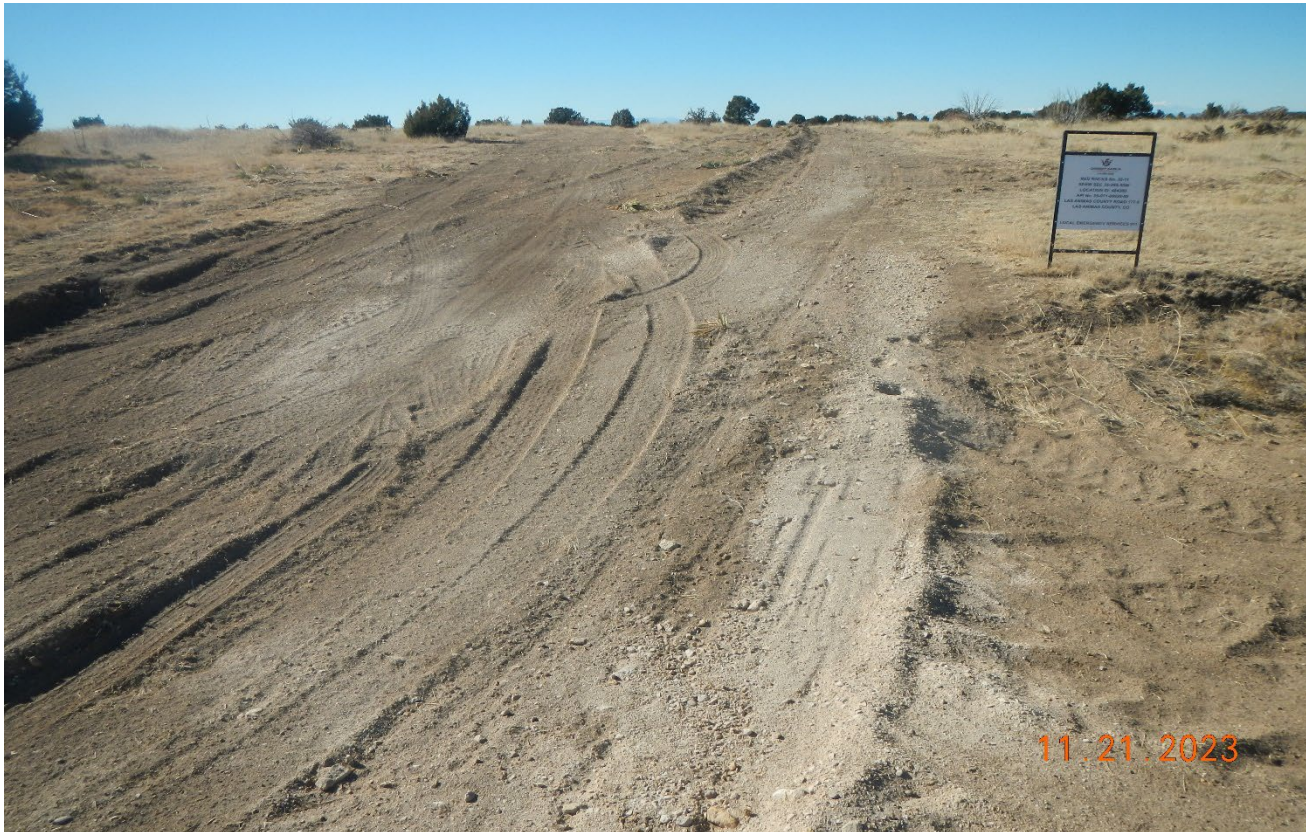
Photo 1. Facing west at the beginning of the access road standing from the County Road. There is a concern of vehicle tracking onto the County Road which will require BMP's.

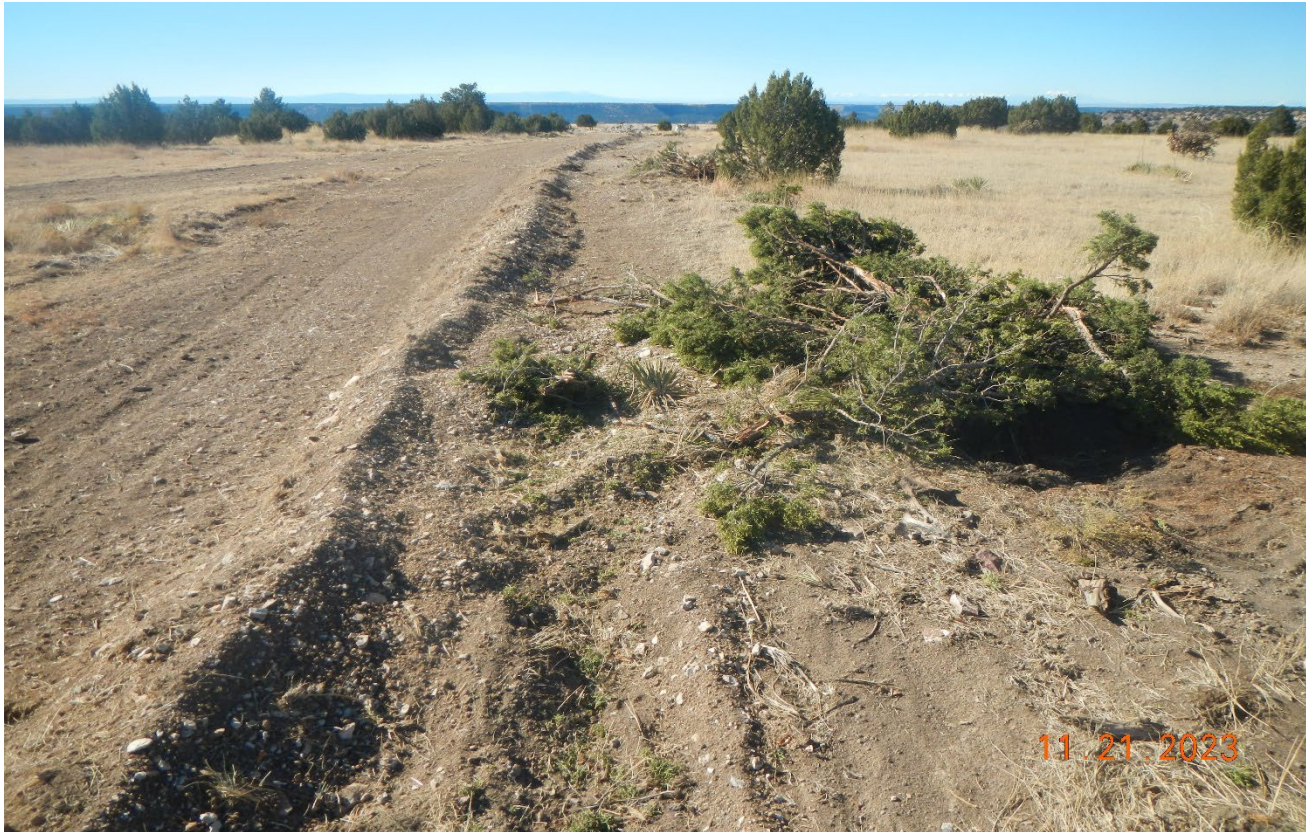
Photo 2. Facing west along the flowline disturbance. There is tree debris along the disturbance which will need to be removed. Additionally it does not appear that topsoil was properly segregated and replaced as there was rocky subsoils observed.

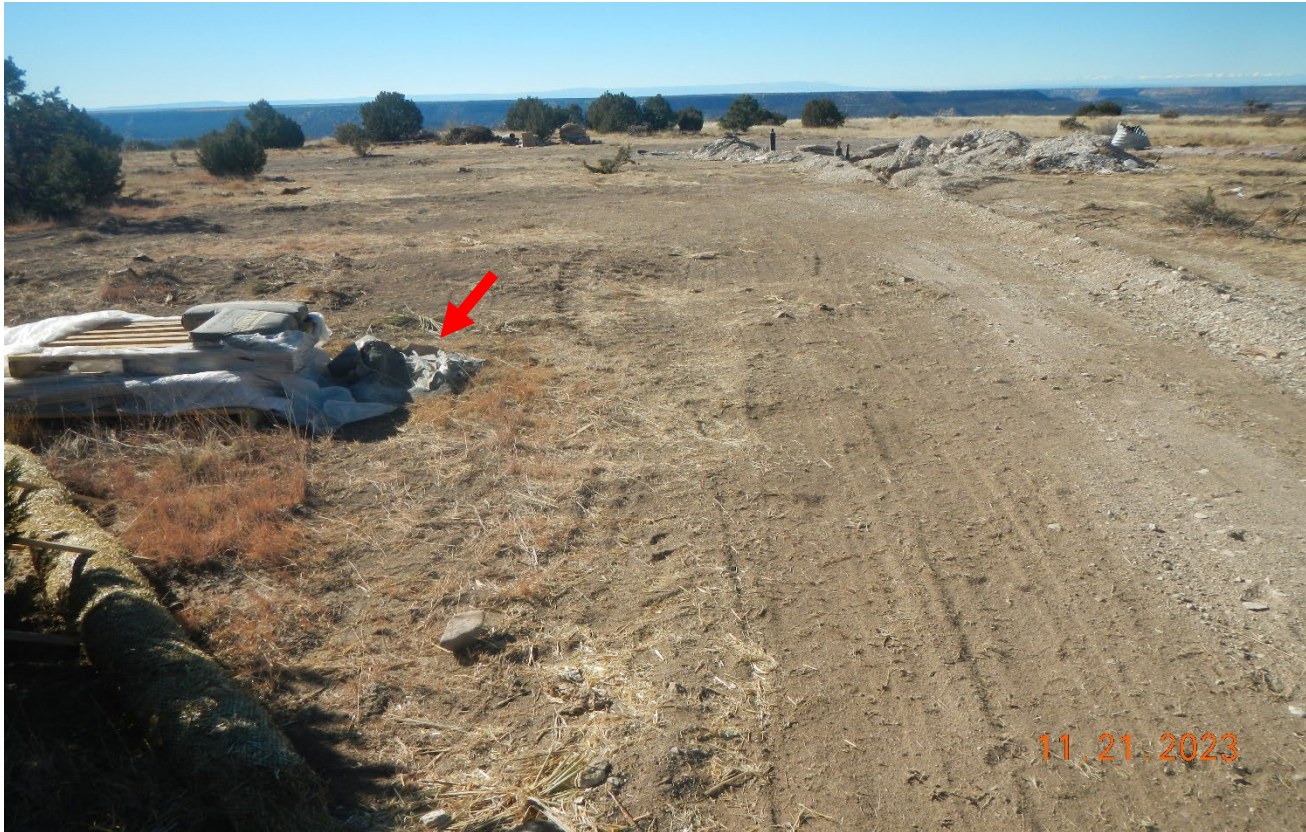
Photo 3. Facing west at the location. There is bags of concrete stored at the location and one of the bags was driven over and torn open. The concrete needs to be properly stored and contained.

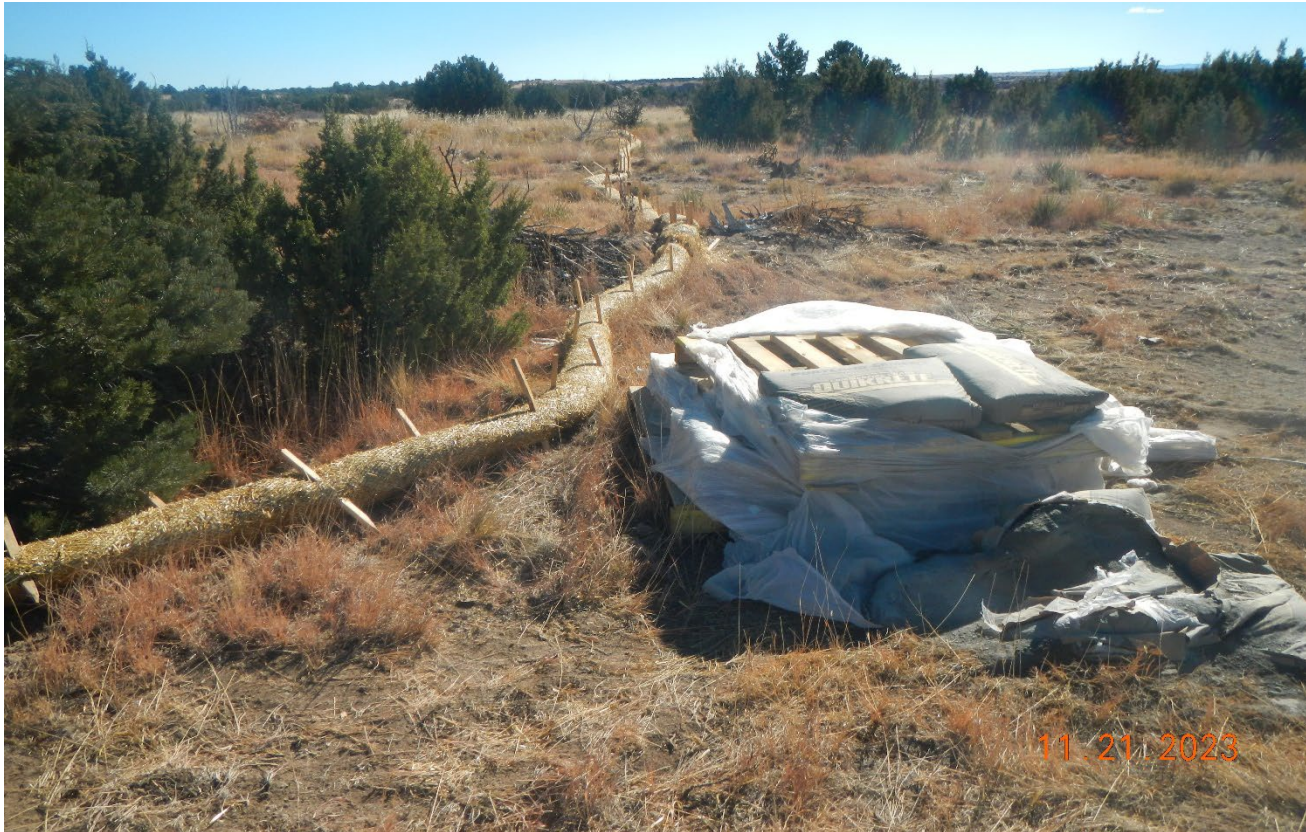
Photo 4. Facing south at the east side of the location. The wattles are displaced and the concrete bags have spilled out onto the soil.

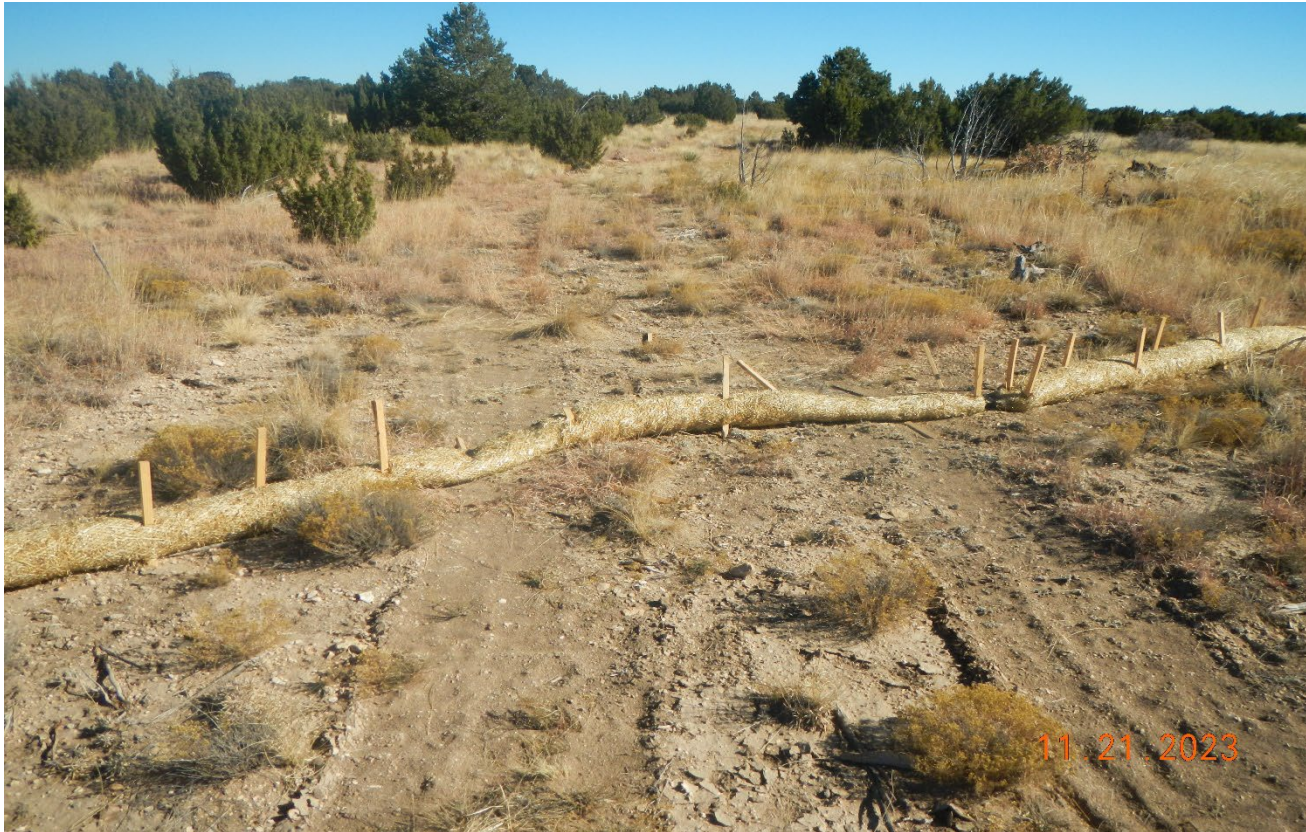
Photo 5. Facing southeast. Vehicle have driven over and displaced the wattles. There was vehicle tracks observed outside of the designated access road boundary.

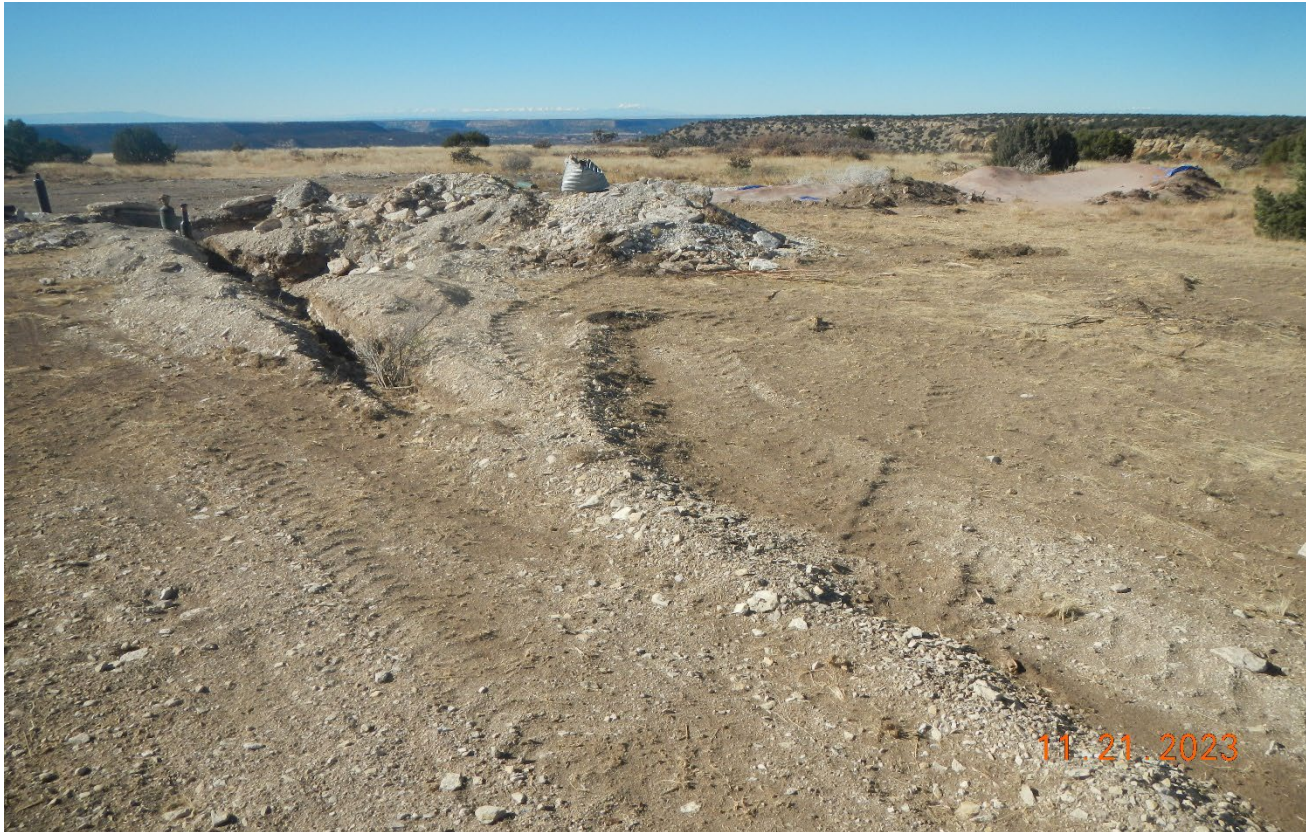
Photo 7. Facing west. There is an open excavation at the wellhead. Excavated soils have been mixed with rocky subsoils.

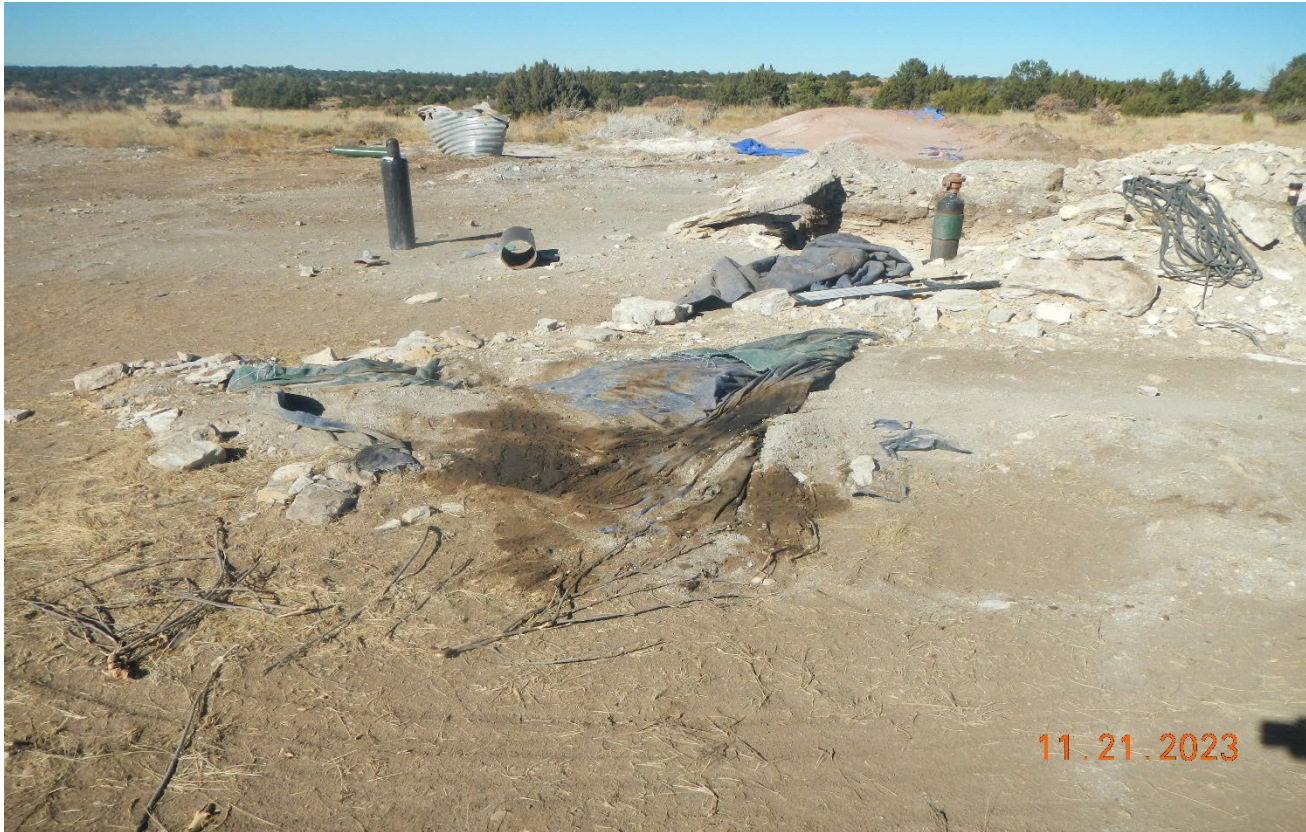
Photo 8. Facing northwest near the wellhead. There is areas of oil stained soils and plastic liner debris left on location.

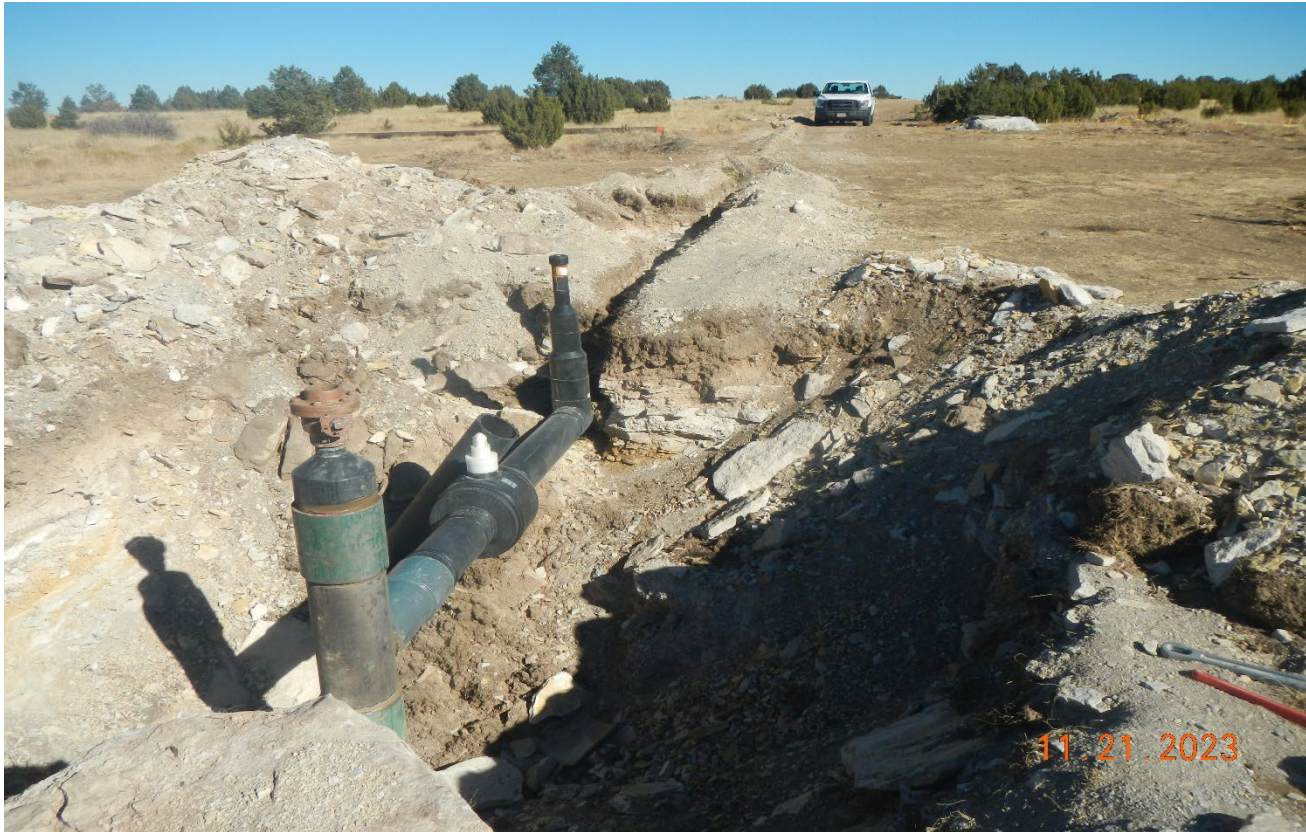
Photo 9. Facing east toward the open excavation at the wellhead. There was a hissing leak coming from the pipe connection and the operator was immediately notified.

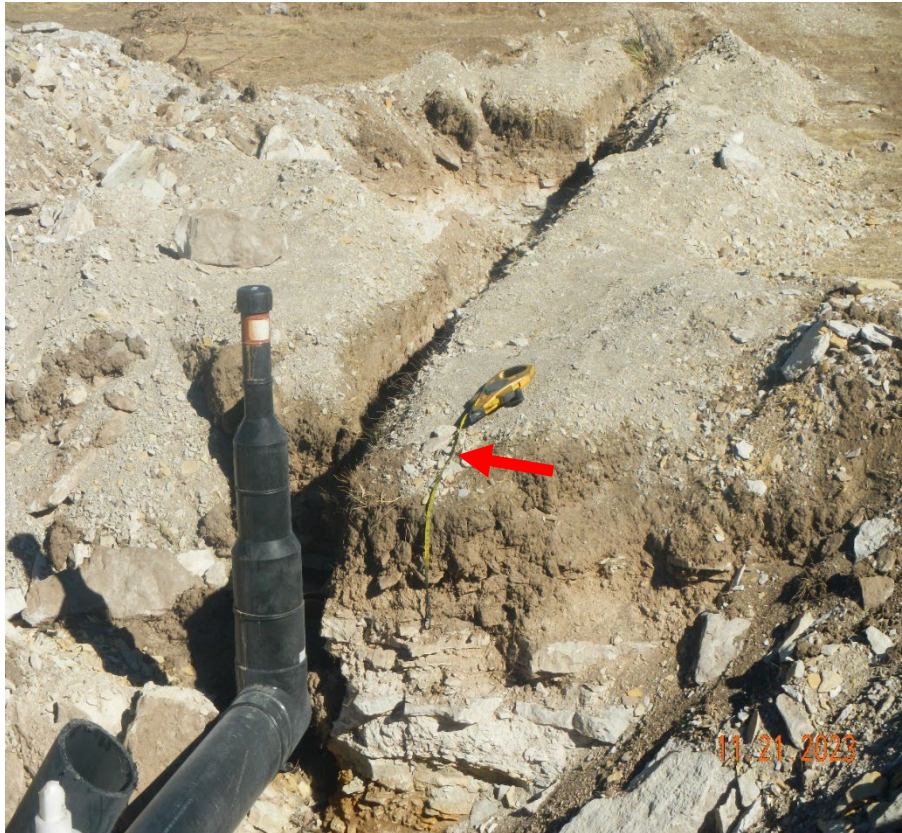
Photo 10. The tap measure shows approximately 6-7 inches of topsoil which was not salvaged at the excavated area of the wellhead or along the flowline trench.

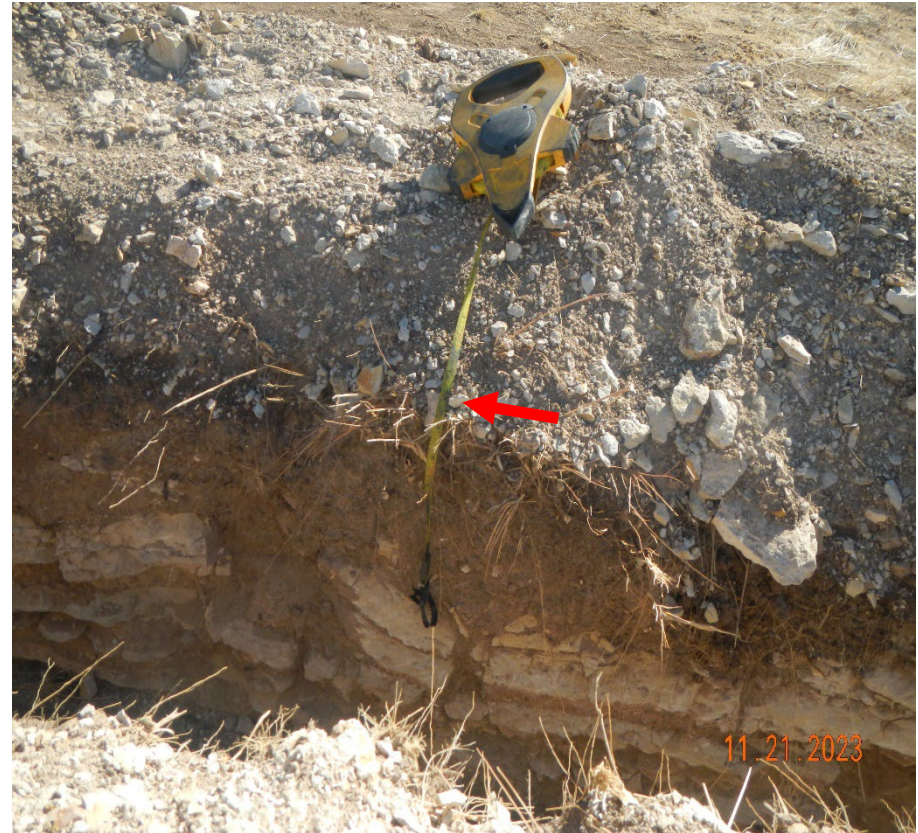
Photo 11. Another view of the topsoil horizon shows 6-7" of dark topsoil before rocky subsoils are encountered. Operator failed to salvage topsoil at the location..

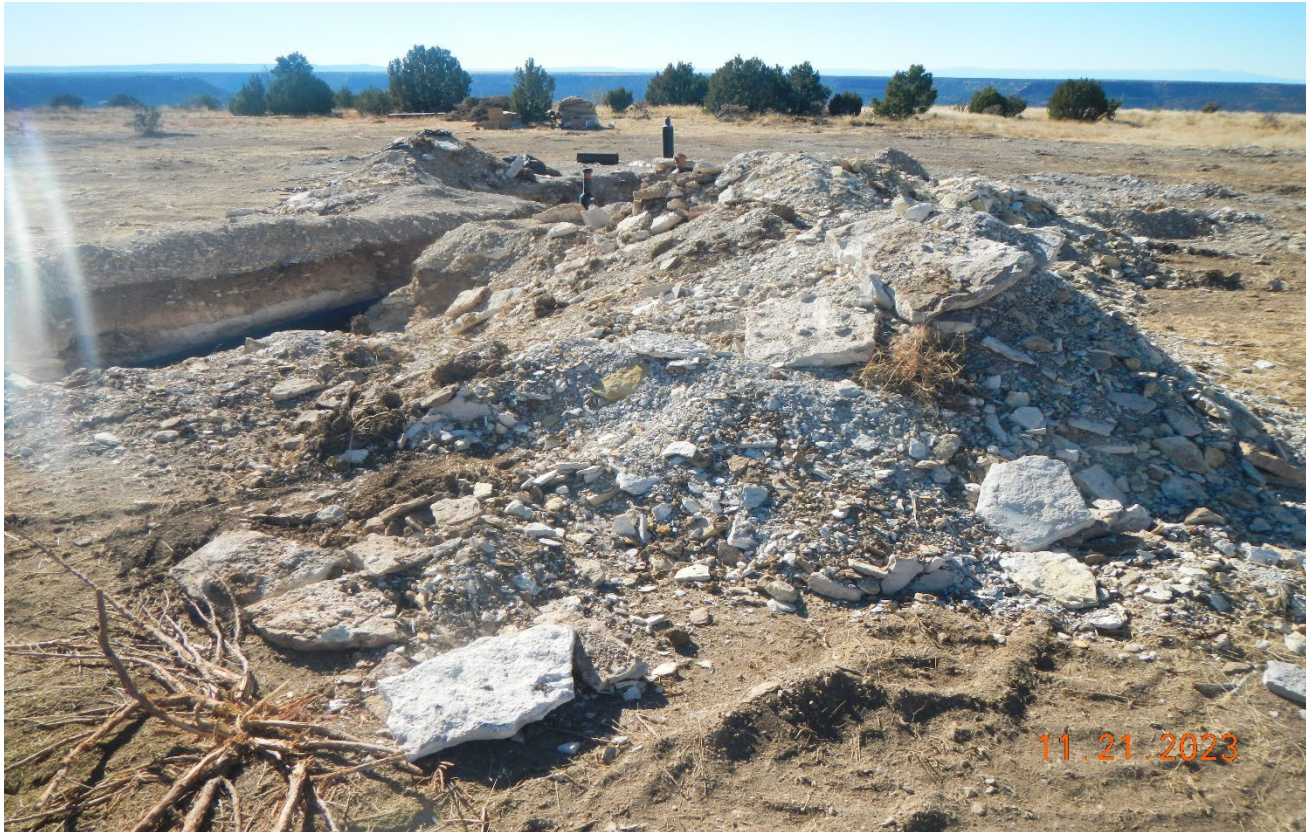
Photo 12. Facing southwest at the location. The rocky subsoils have been mixed with the topsoil which was not salvaged per the rules.

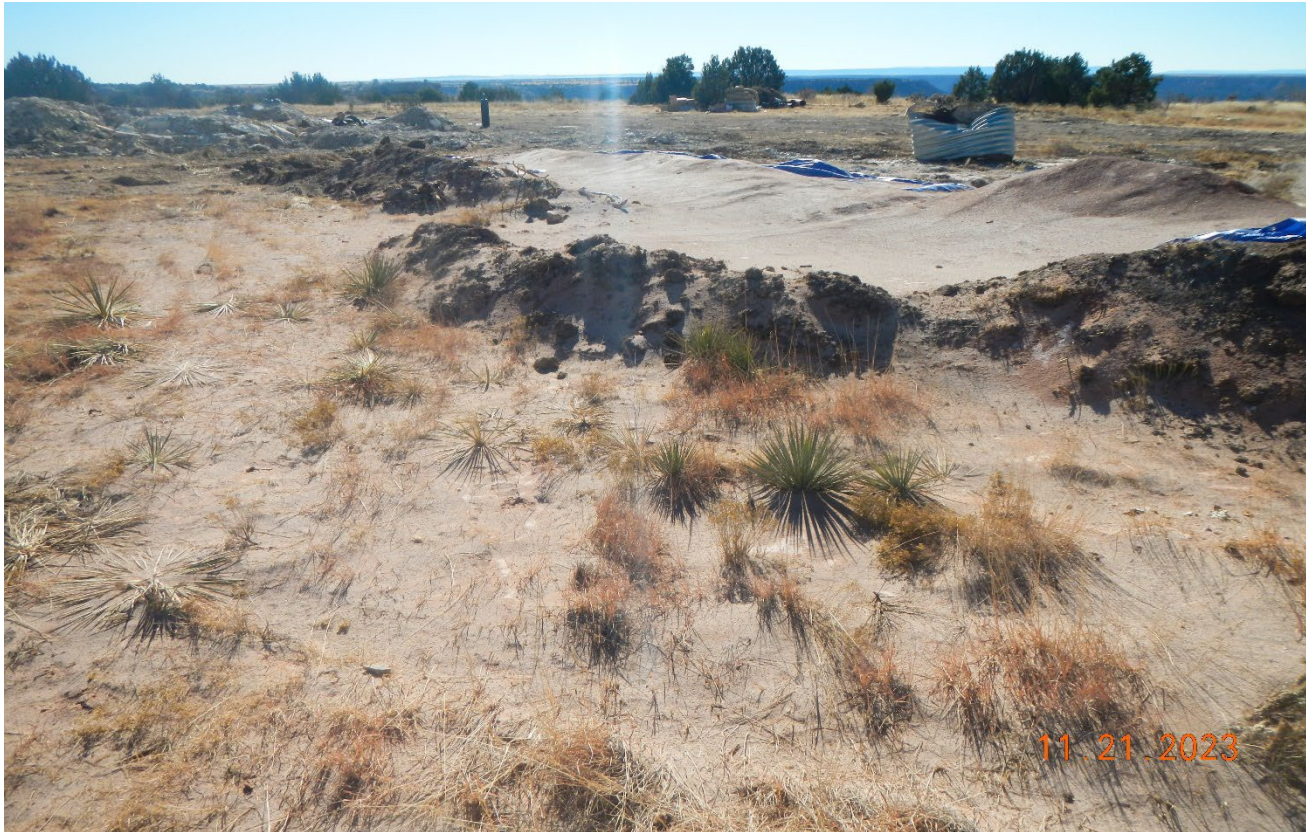
Photo 13. North side of the location facing southwest. The cuttings pile has blown off the blue tarp which was not properly stored and contained.

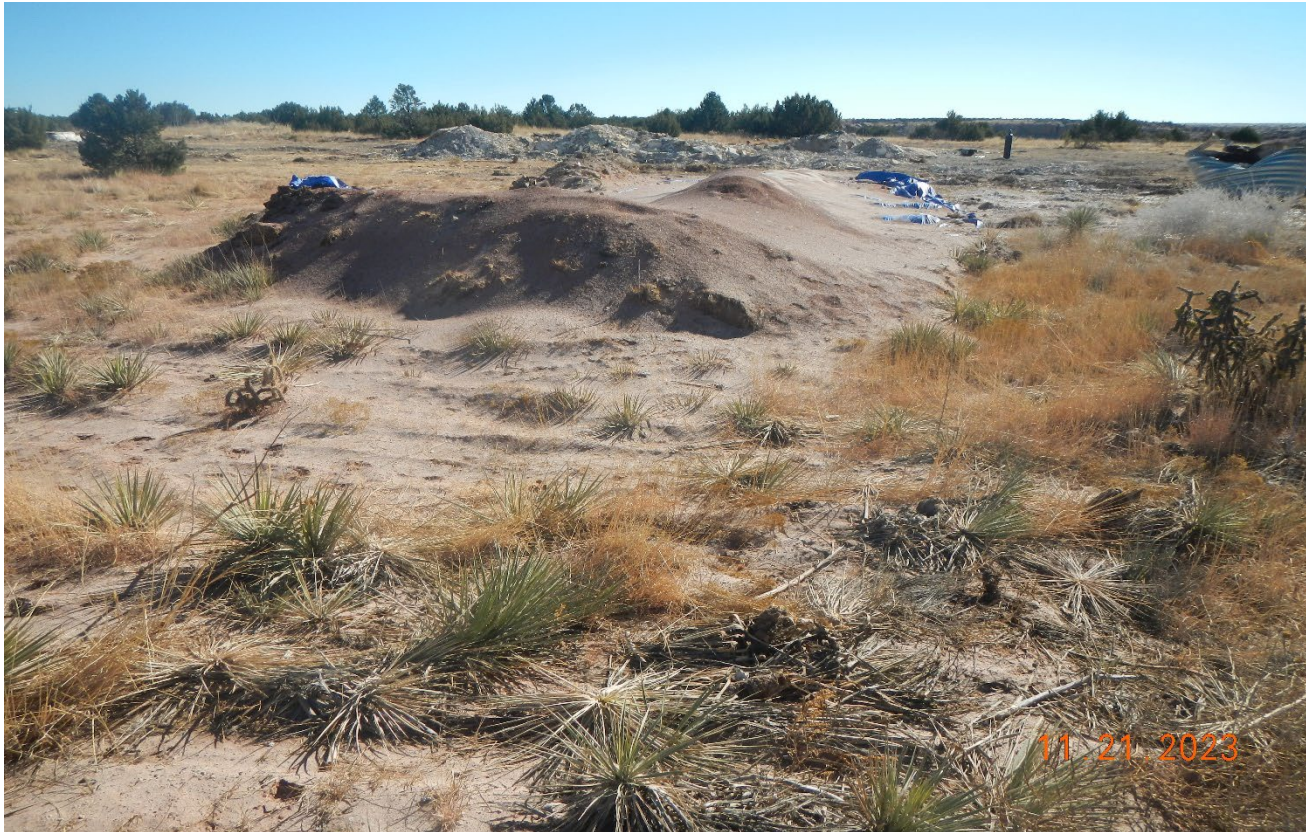
Photo 14. North side of the location facing south. The cuttings pile has blown off the blue tarp which was not properly stored and contained. .

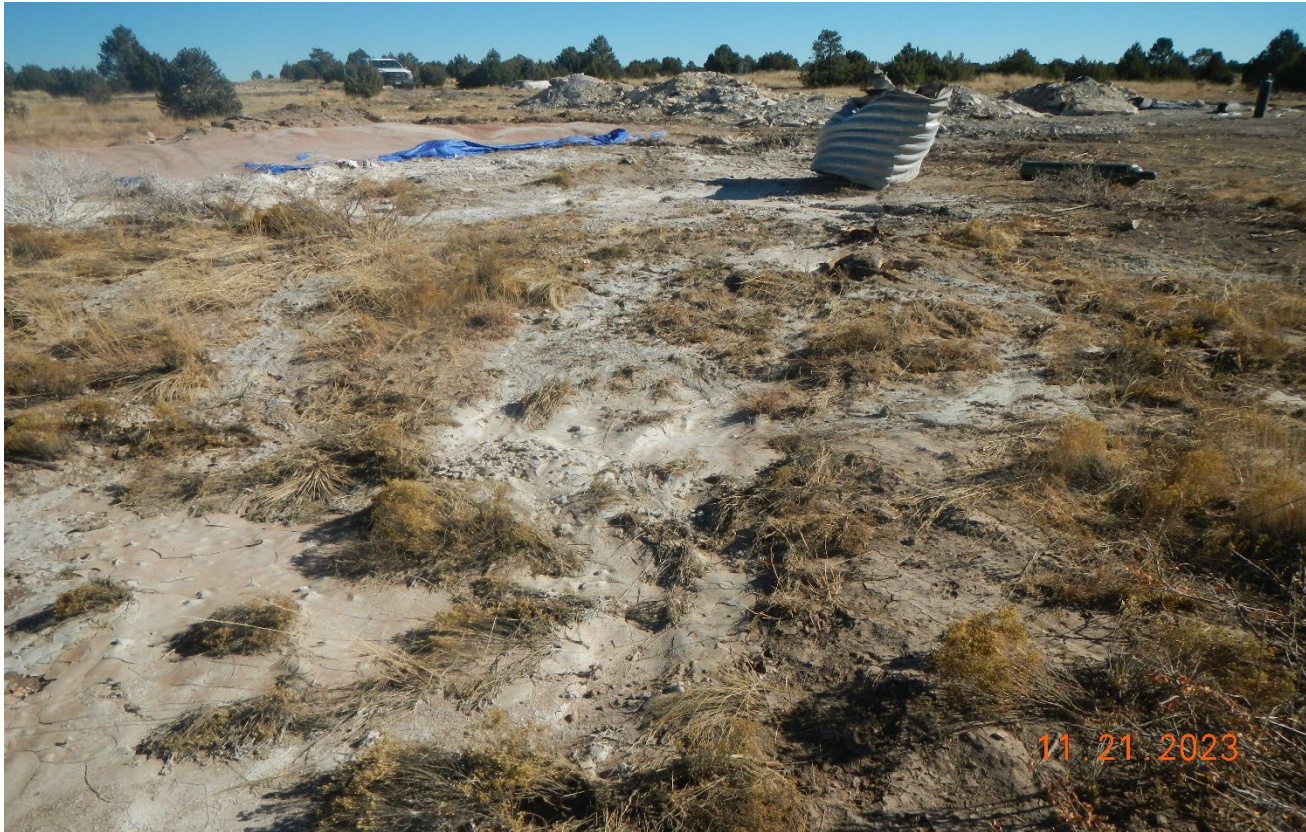
Photo 15. Facing southeast at the location. There is white substance in this area which appears to have washed out further out to the northwest due to evidence of a flow pattern.

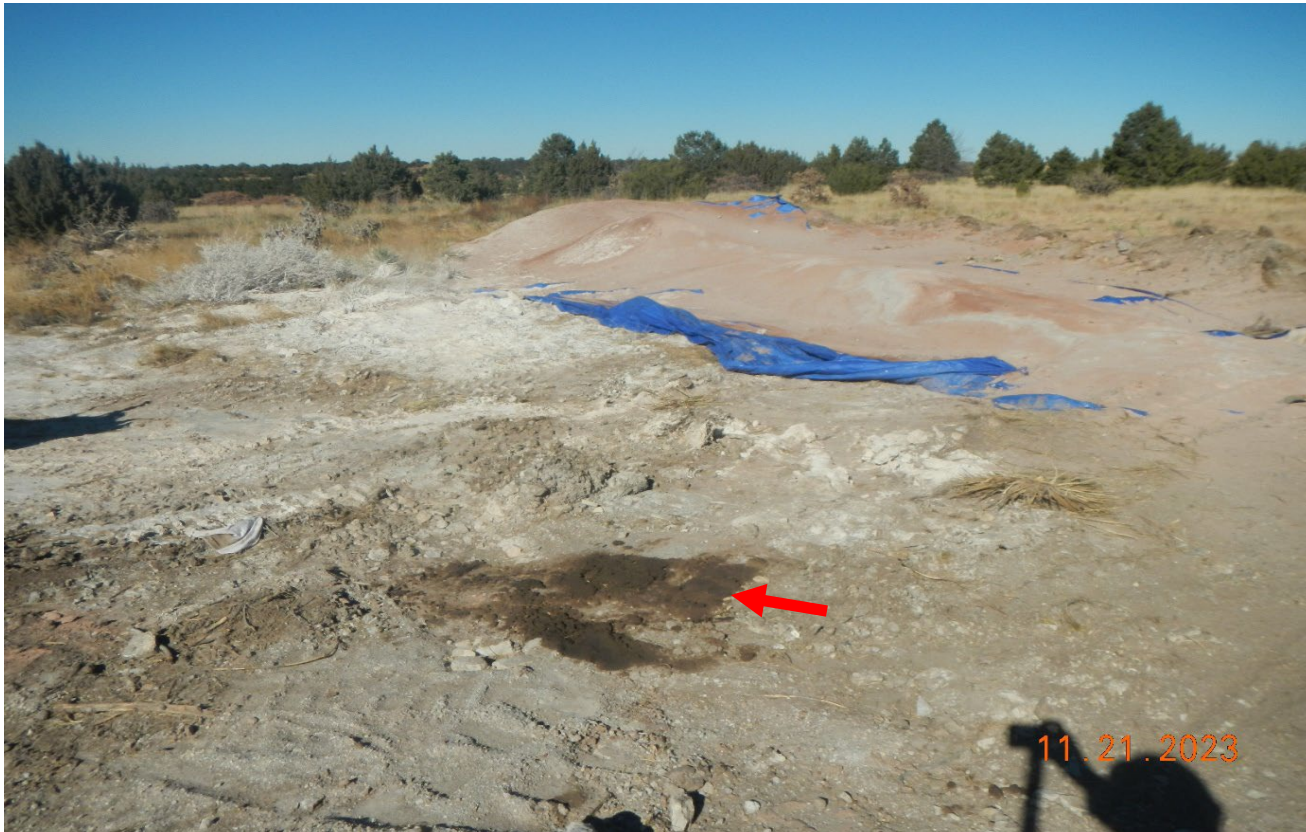
Photo 16. Facing northeast toward the cuttings pile. The drill cuttings was placed on a blue tarp with no berms or containment and has spread outside of the tarp. There is also oil stained soils at red arrow and a white unknown material.

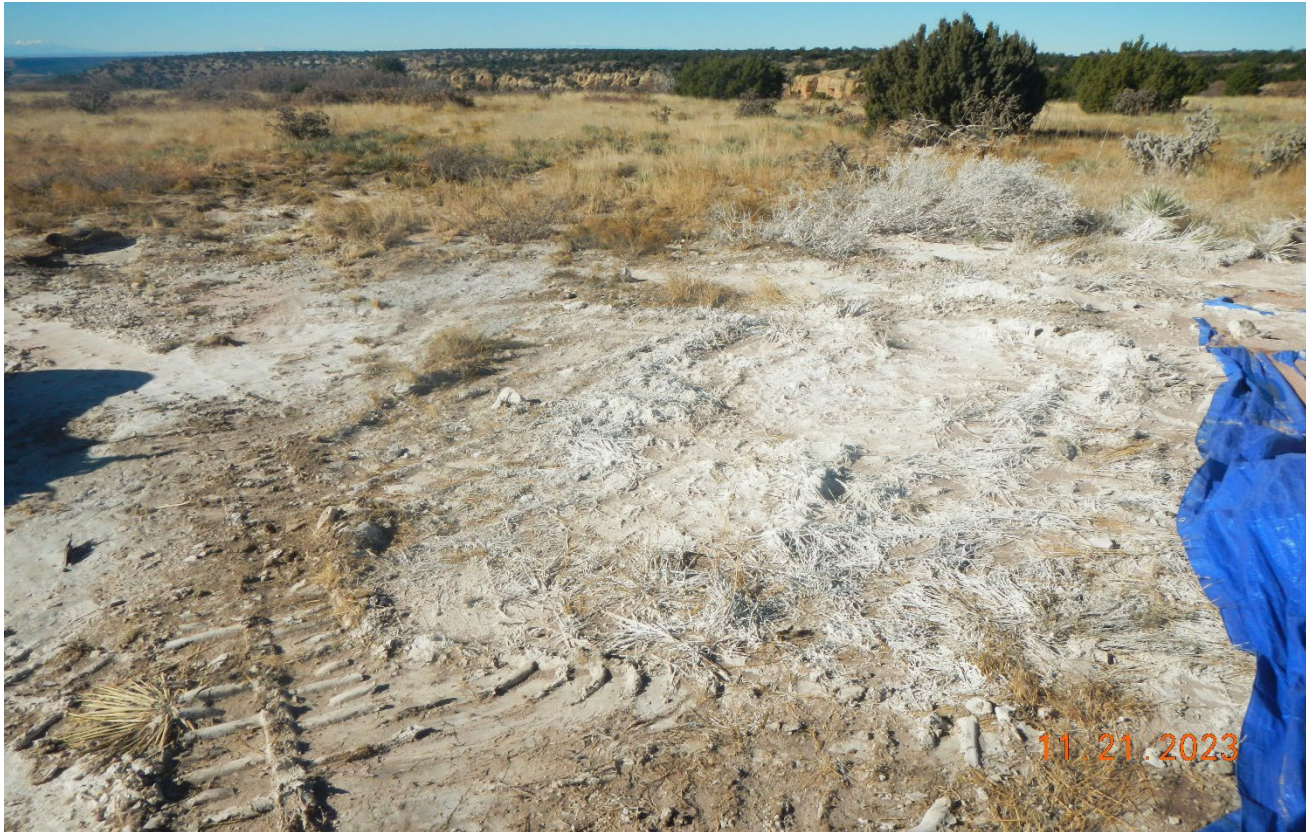
Photo 17. Facing toward the northwest. The white unknown substance is spread over this area. There are no stormwater controls around this perimeter to prevent stormwater transport offsite. The topography also slopes down to the northwest.

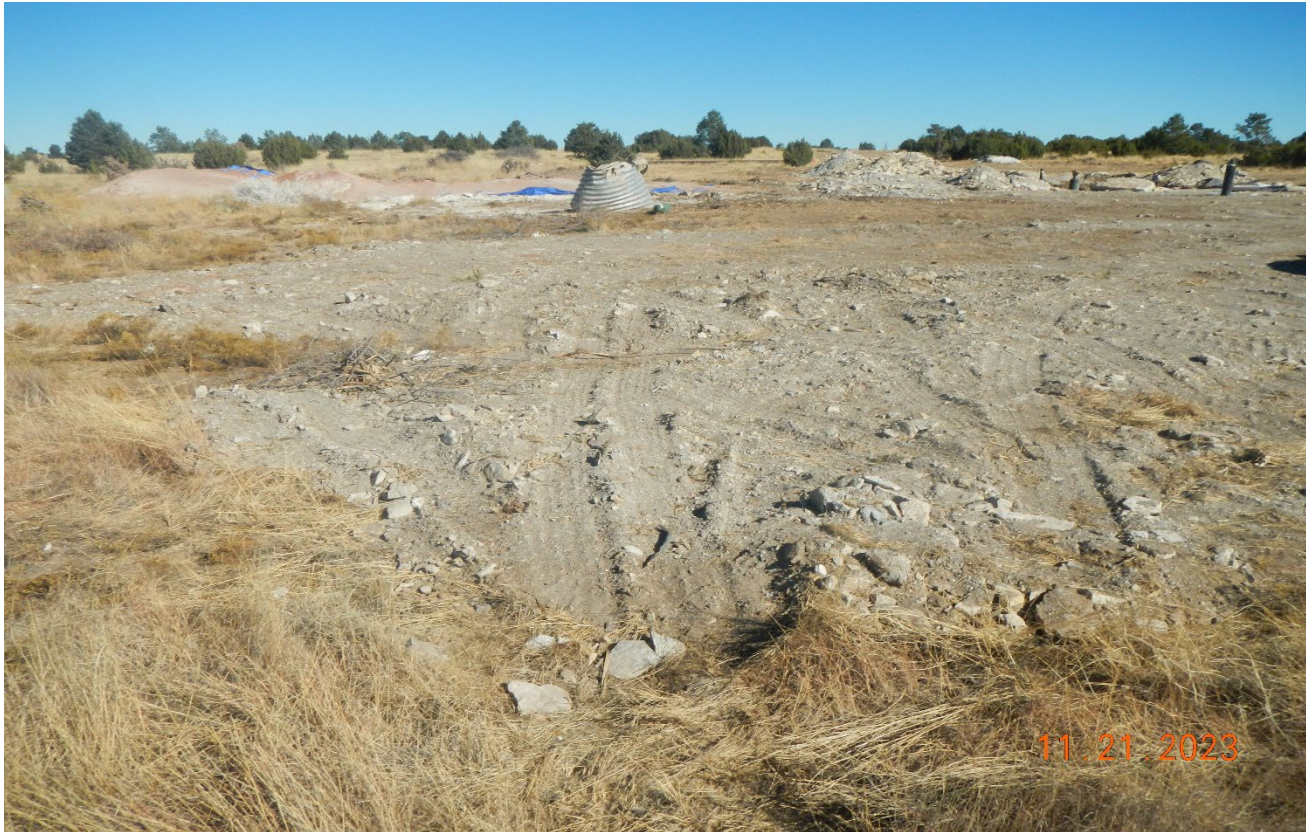
Photo 18. West side of the location facing east. There are rocky subsoils that have been pushed out to this area. No stormwater BMP's are installed in this area.

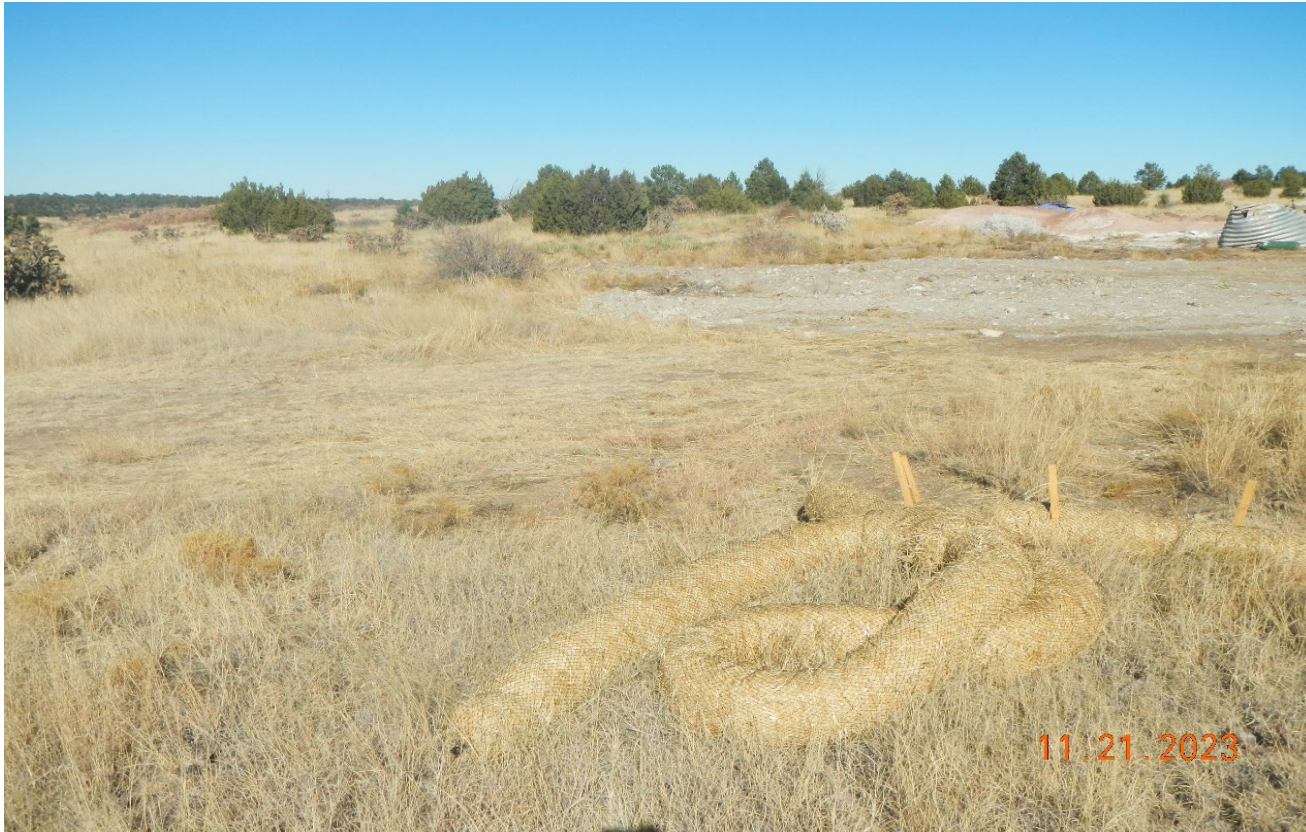
Photo 19. Facing northeast at west side of the location. The straw wattles area not installed at the northwest side of the location which the topography slopes toward.

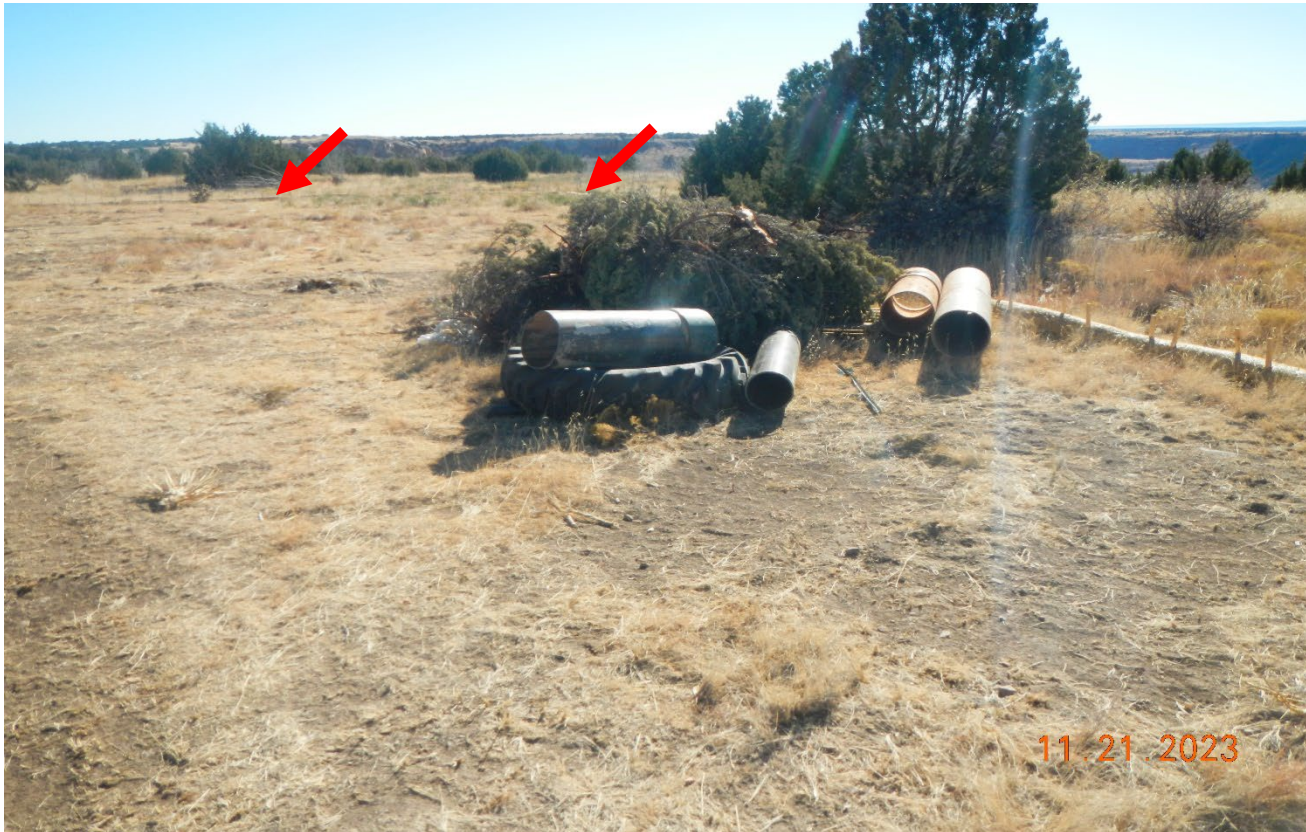
Photo 20. Facing south at the west side of the location. There is tree debris and plastic trash in this area that needs to be removed. The straw wattles shown at red arrow need to be installed closer to the disturbance area to prevent disturbed soils from migrating further out into the vegetation.

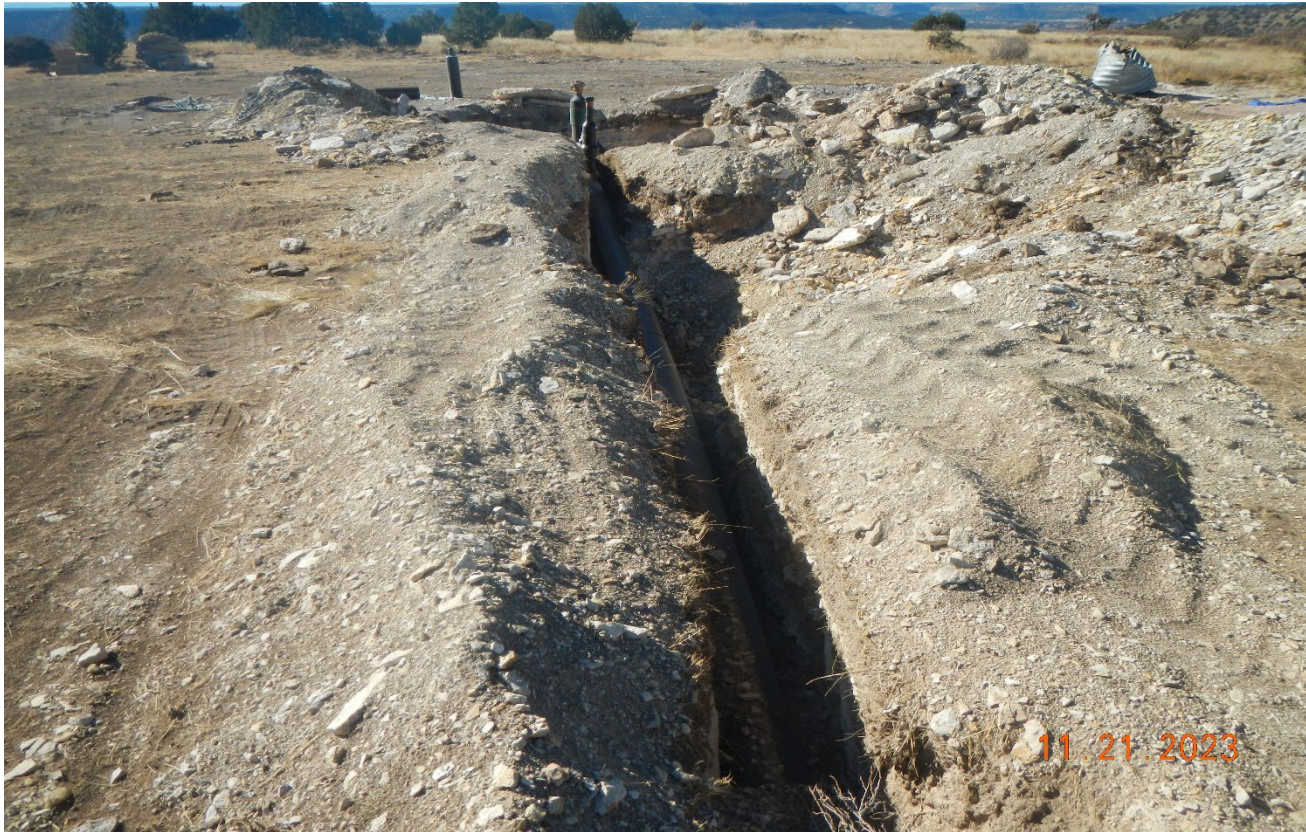
Photo 22. Facing west toward the open excavation area. There are concerns that wildlife or livestock could fall into the open excavation.
