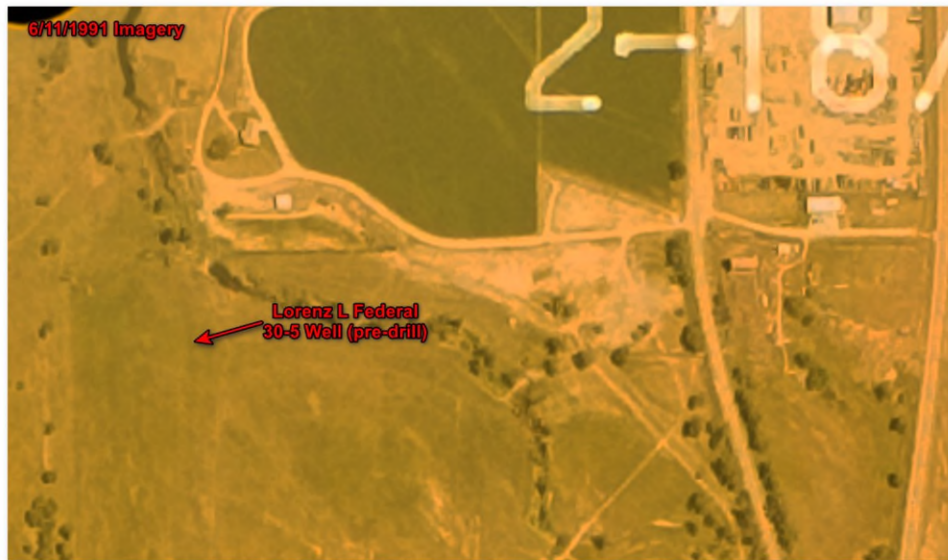
1991 Imagery (prior to well installation). Area appears to have been grass/hay

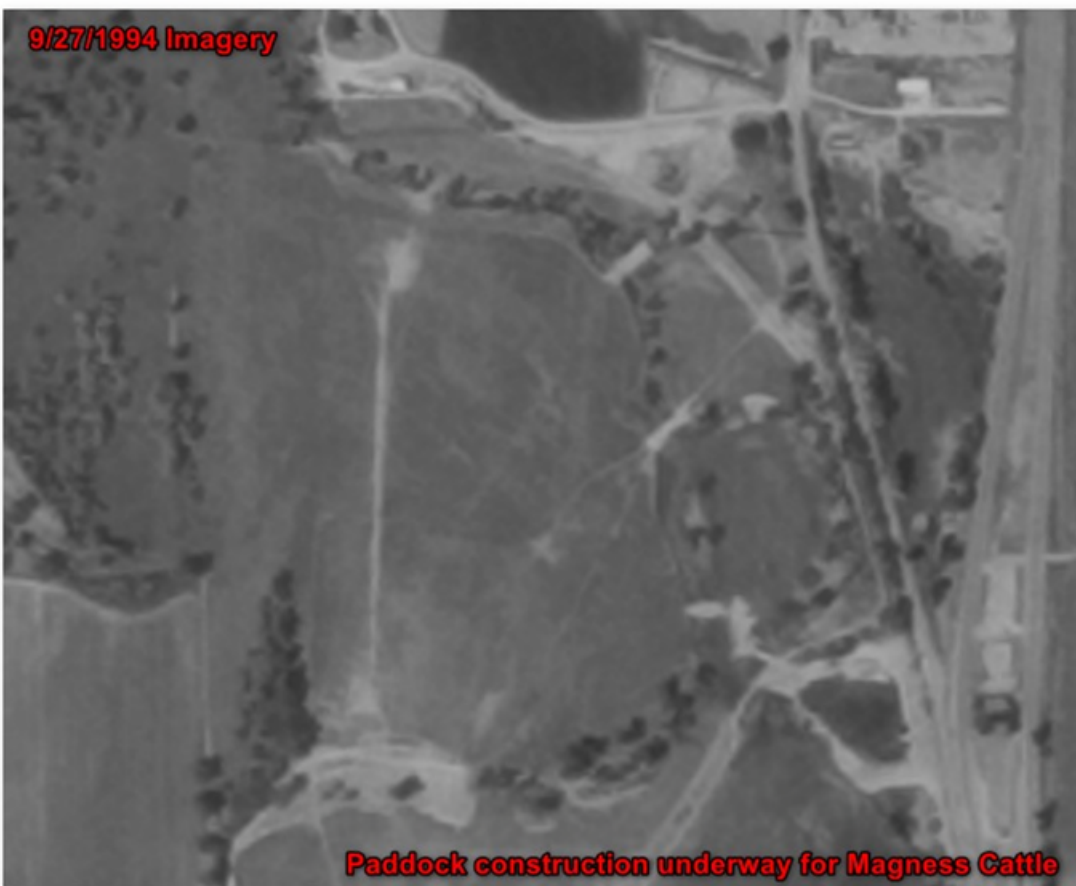
1994 Imagery (converted to livestock, paddocks installed w/ fencing and corral)

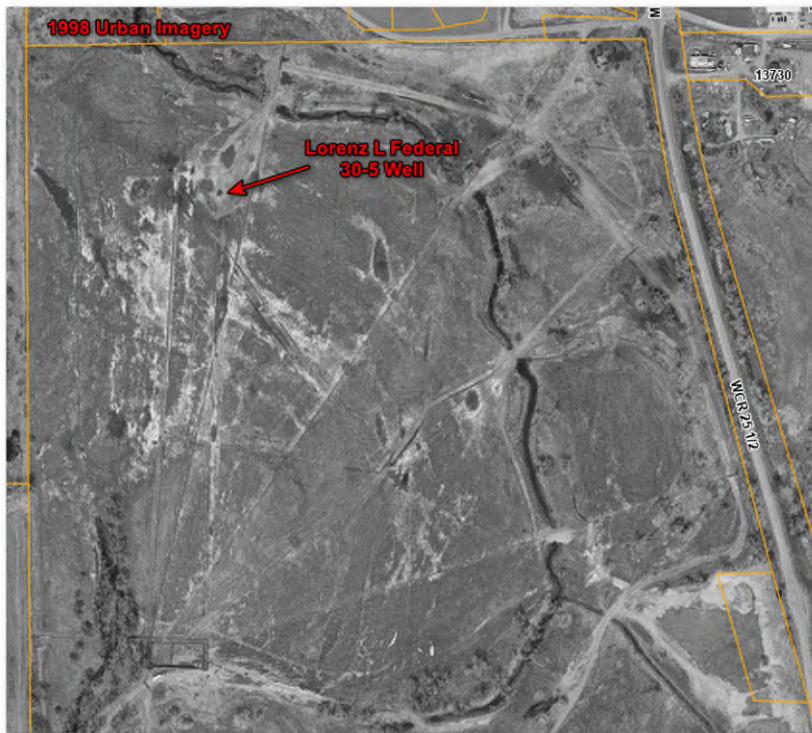
1998 Imagery (livestock operations occupy land. Alkali soils well visible in floodplain.

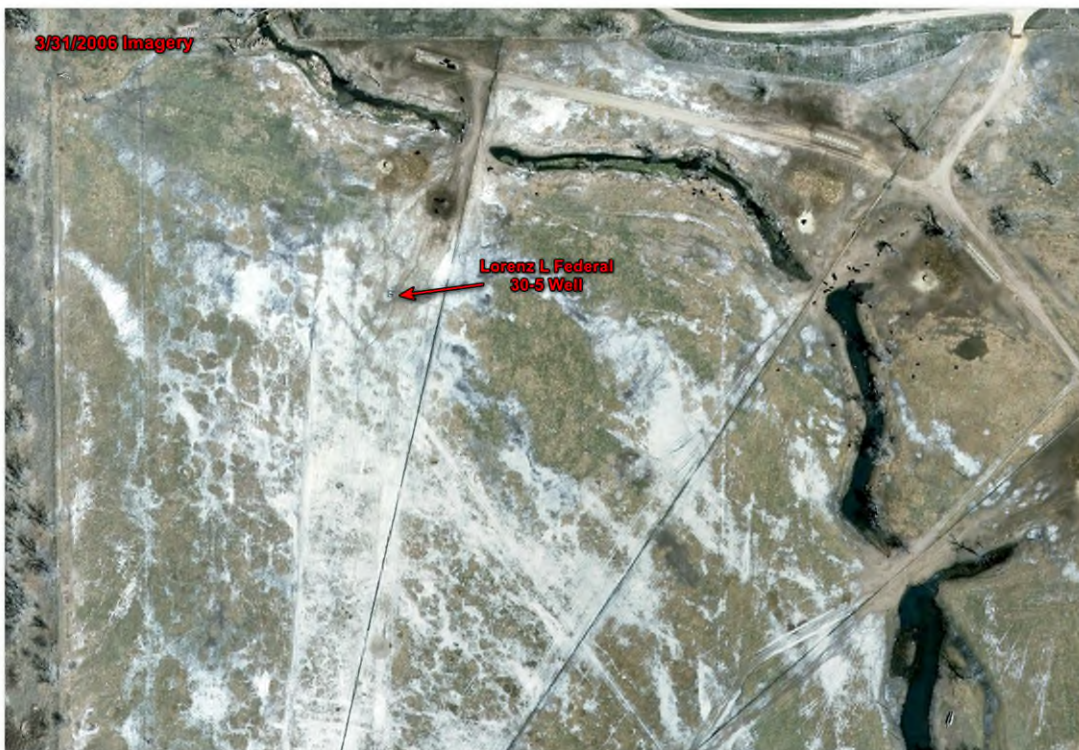
2006 Imagery (overall field conditions reference)

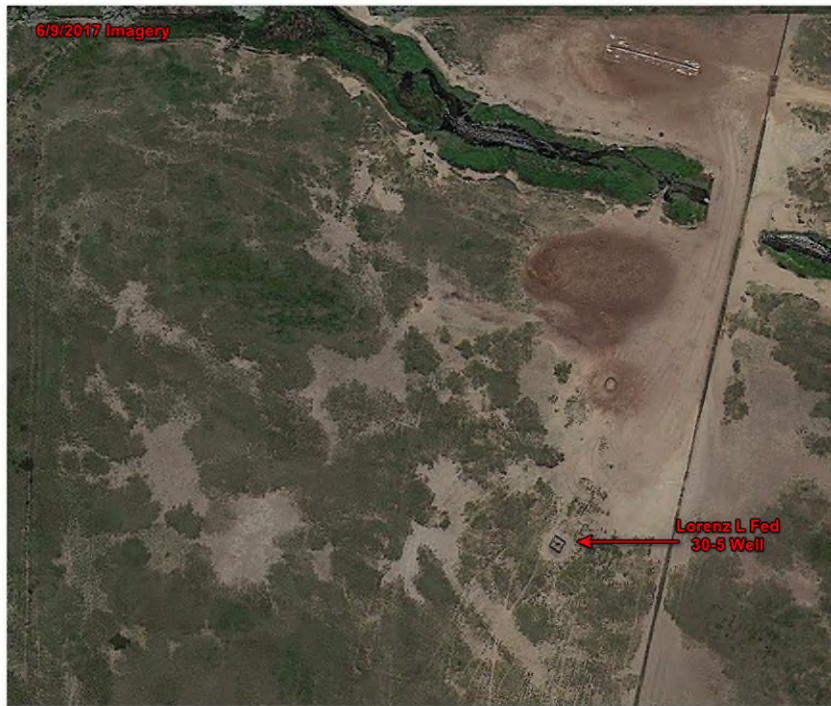
2017 Imagery (well footprint minimal, property dominated by livestock)

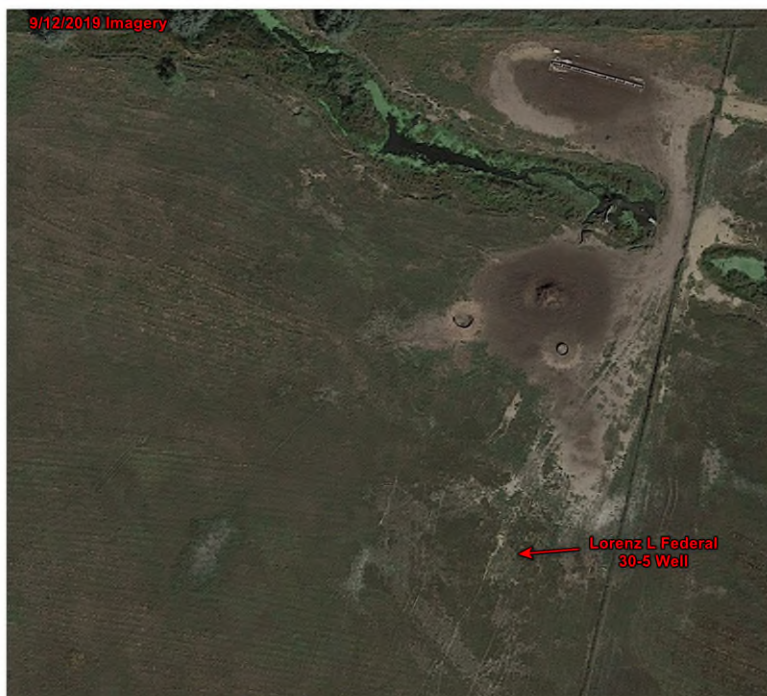
2019 Imagery (fields mowed (likely due to undesirable cover), resembles surrounding)

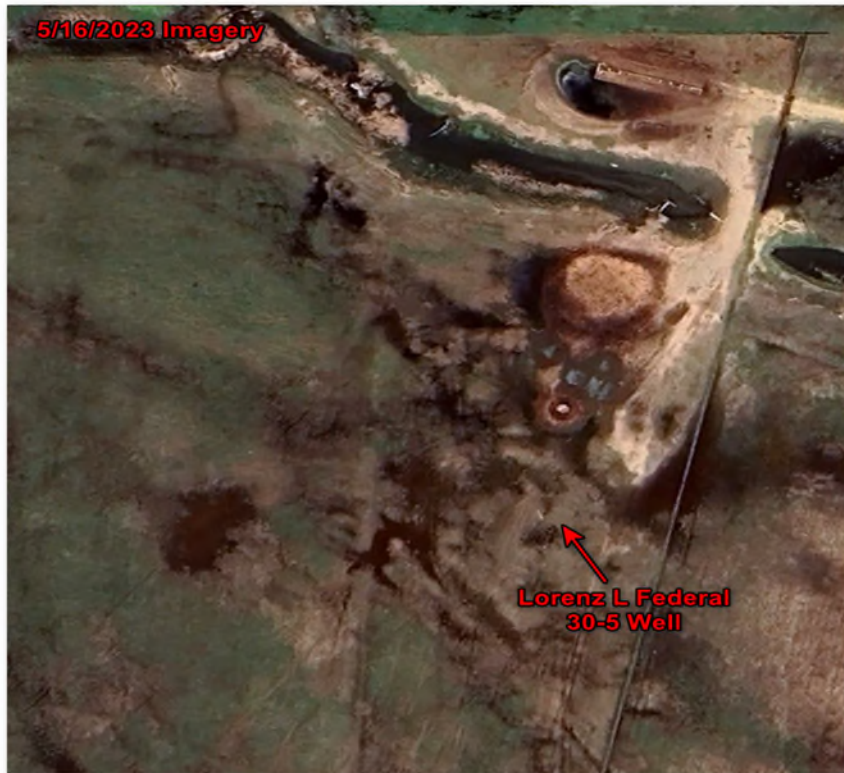
2023 Imagery (field inundated by precip and flooding; indication of Fall '23 vegetation health)
