Inspection Photos

Loc: 322215

Operator: JAVERNICK OIL

Inspection Date: 12/12/2023

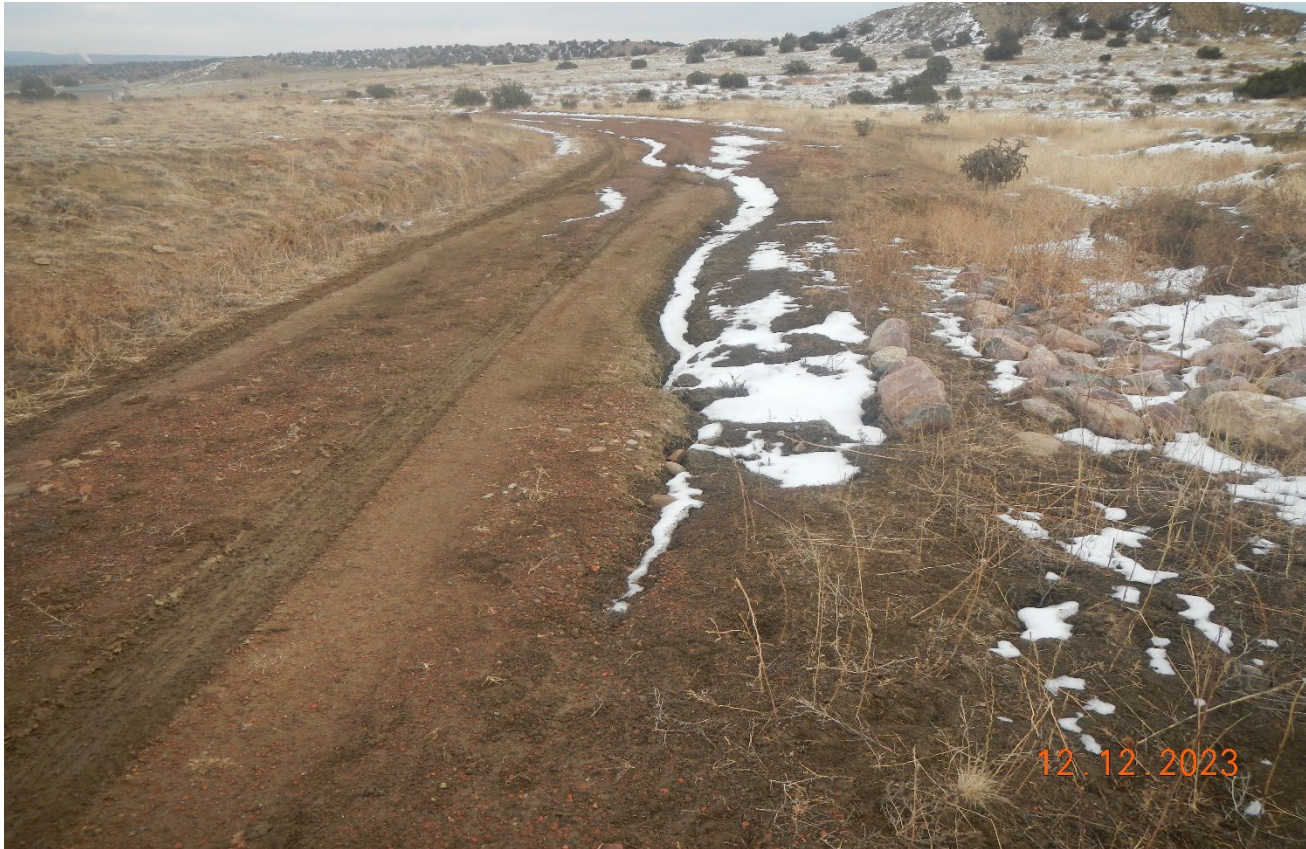
Photo 1. Facing north along the access road. A recent storm event has created an erosion gully along the roadside which needs to be repaired.

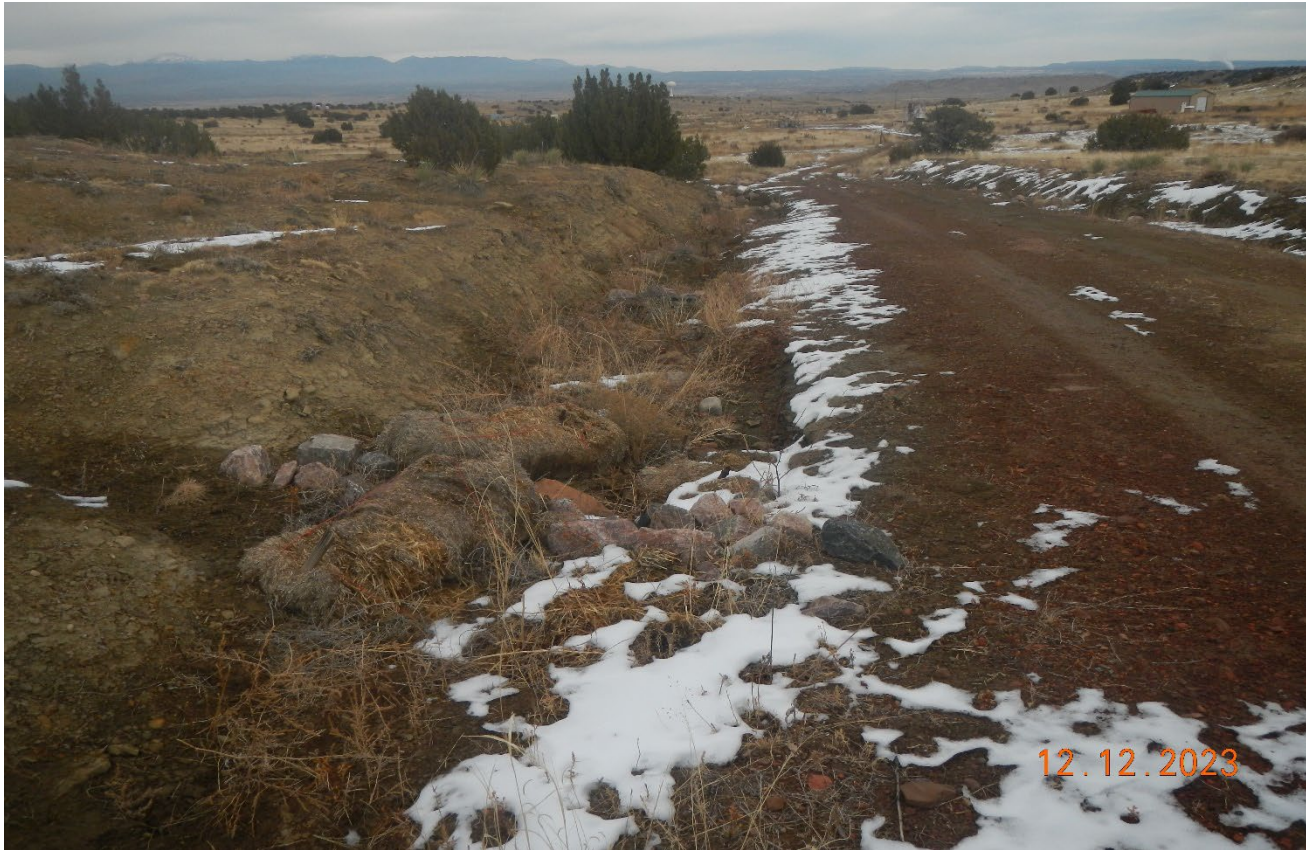
Photo 2. Facing back south toward the erosion gully along the roadside which needs to be repaired. A 4.5 ft. shovel shows depth of erosion.

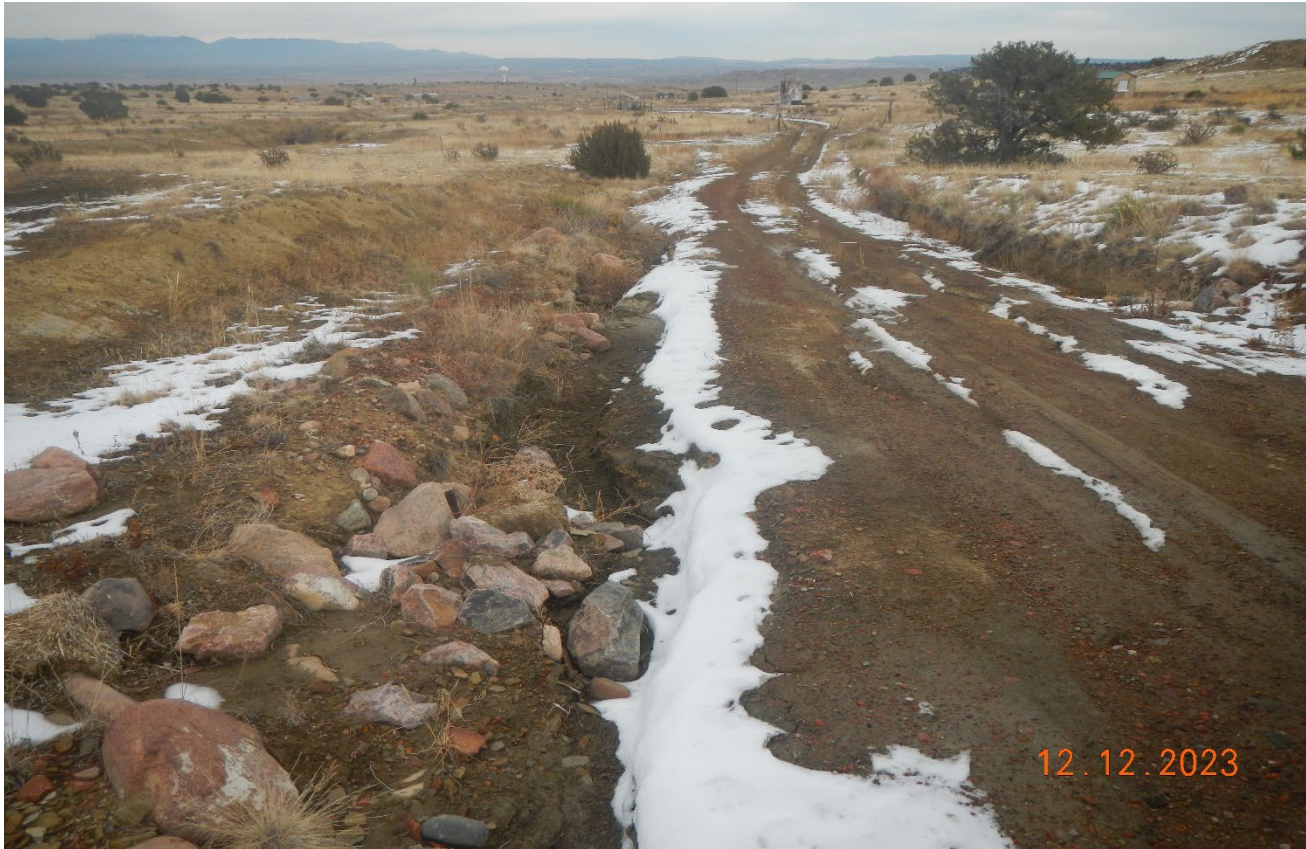
Photo 3. The culvert at this drainage crossing has filled in with sediment and debris and must be cleaned out.

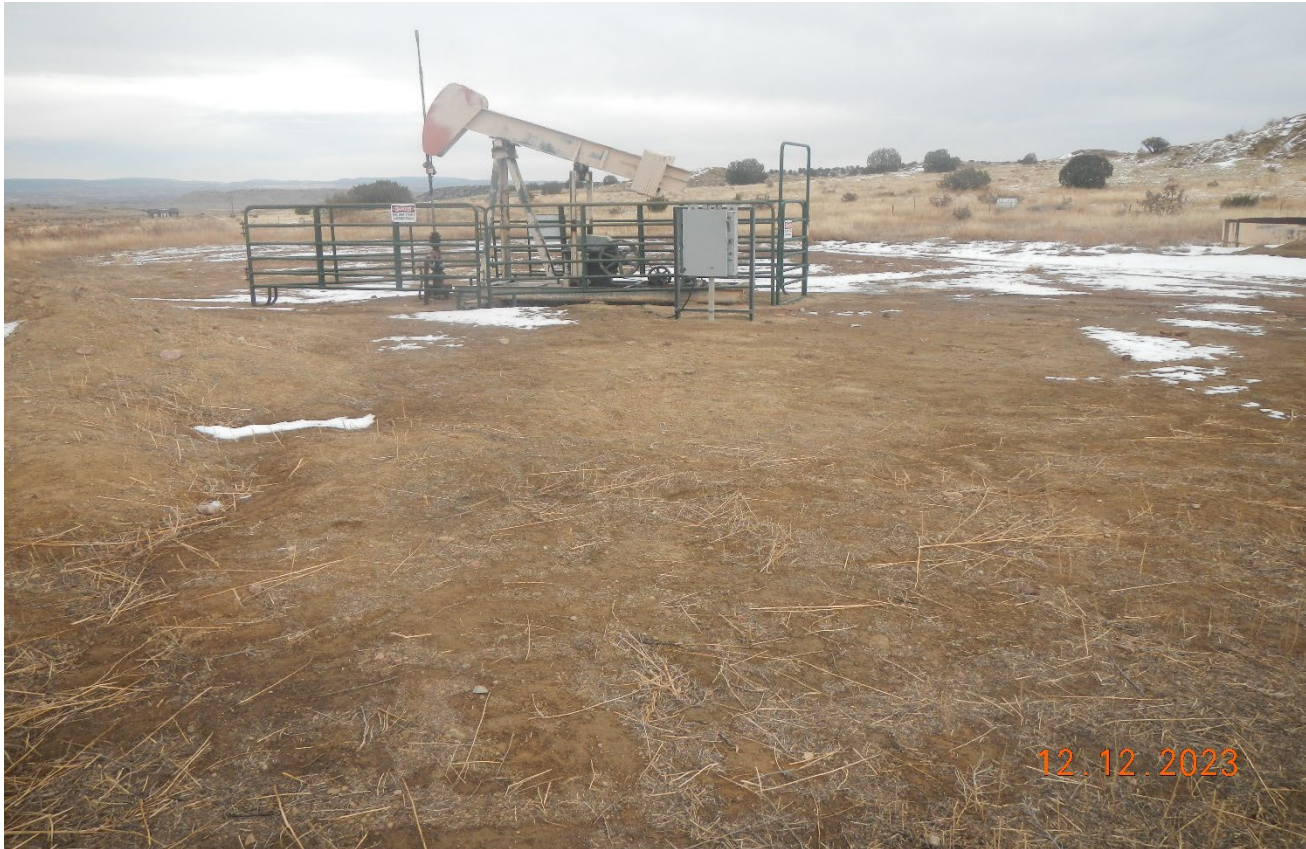
Photo 4. Facing northeast toward the wellsite. This area near the well will need to be stabilized with vegetation. There was marks in the soil that may have been recently seeded.

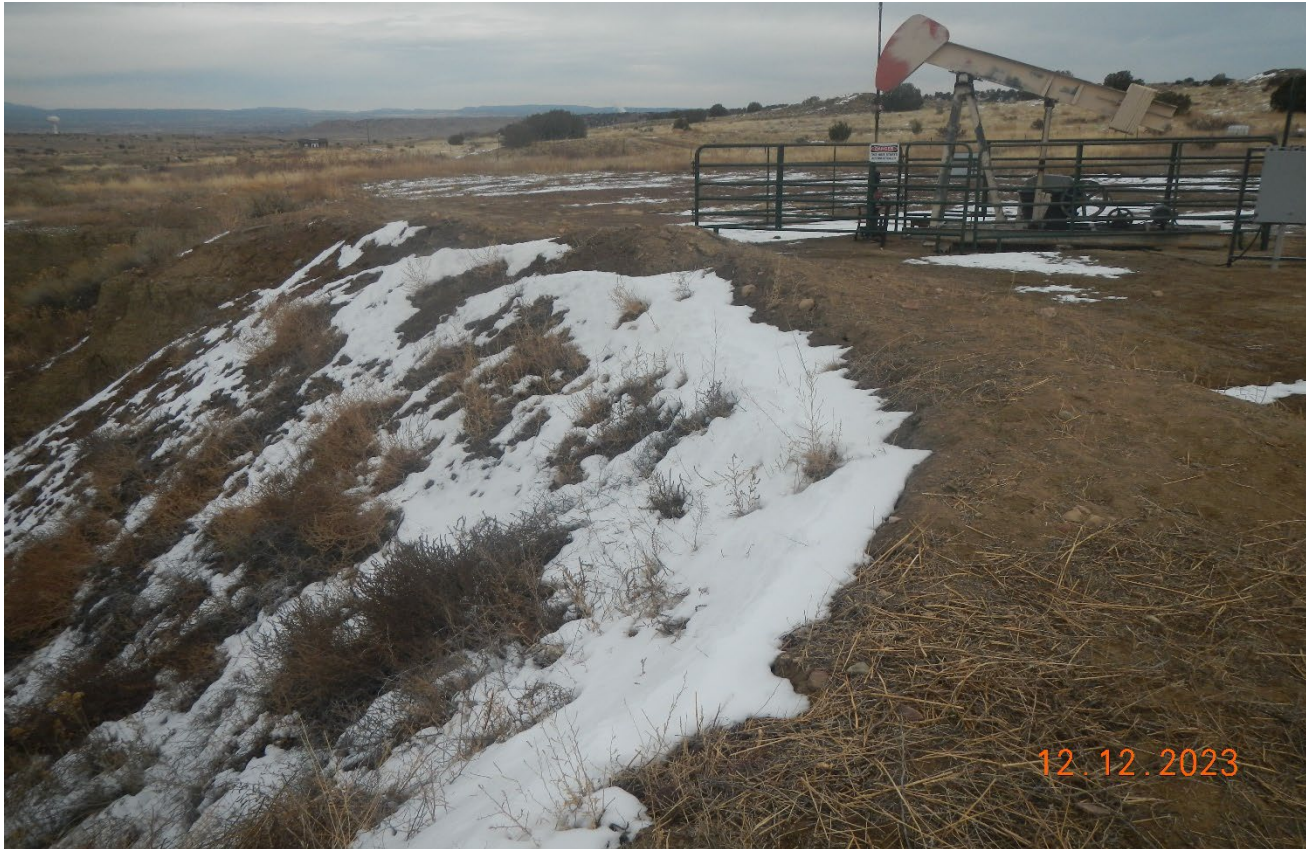
Photo 5. Facing toward the embankment. This area needs to be seeded for stabilization of the embankment or other BMP may be utilized. Shrubs in the area that are easily established include Rubber rabbitbrush and Four wing salt brush.

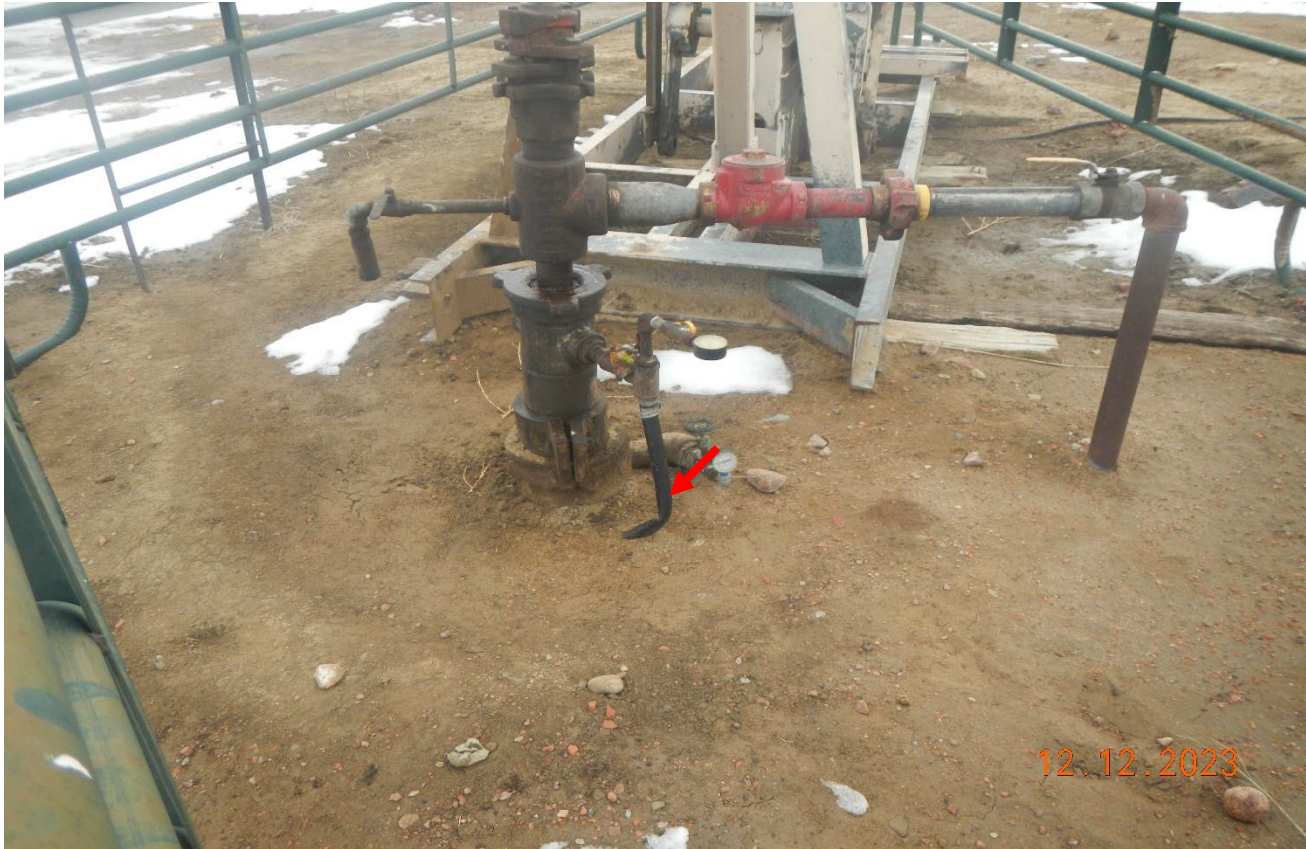
Photo 6. There is a black plastic pipe that is bent and an audible leak was heard from this area.
