Inspection Photos
Location Name: Pappenheim 6-62-23 PAD
Location ID: 432757

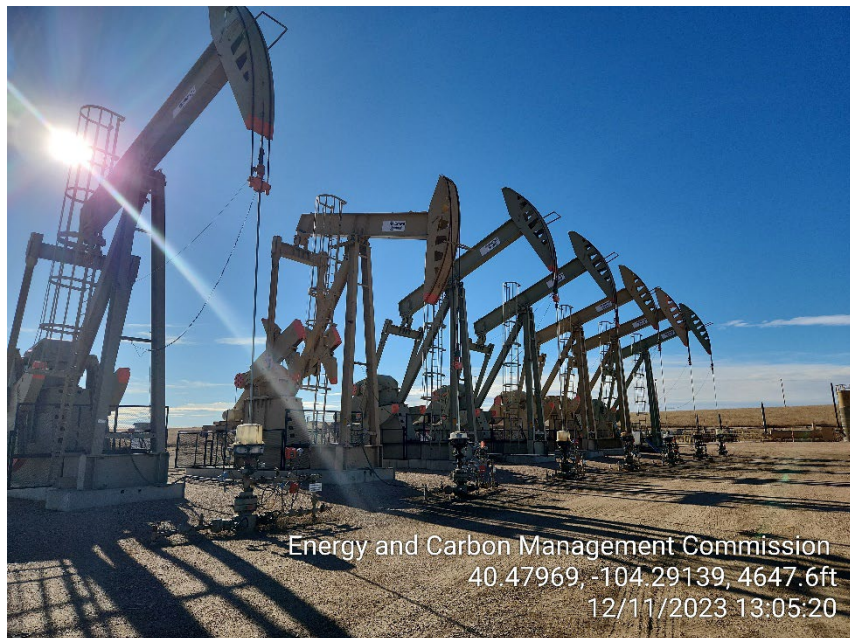
Photo 1 – Pumping Units

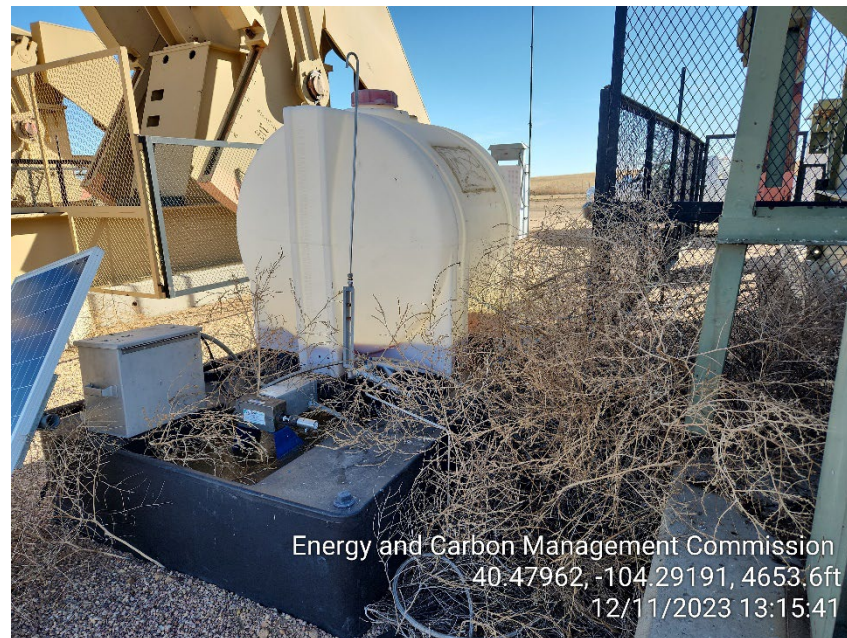
Photo 2 – 6-62-23-0164CDH Pumping Unit – Tumbleweeds and Container Label

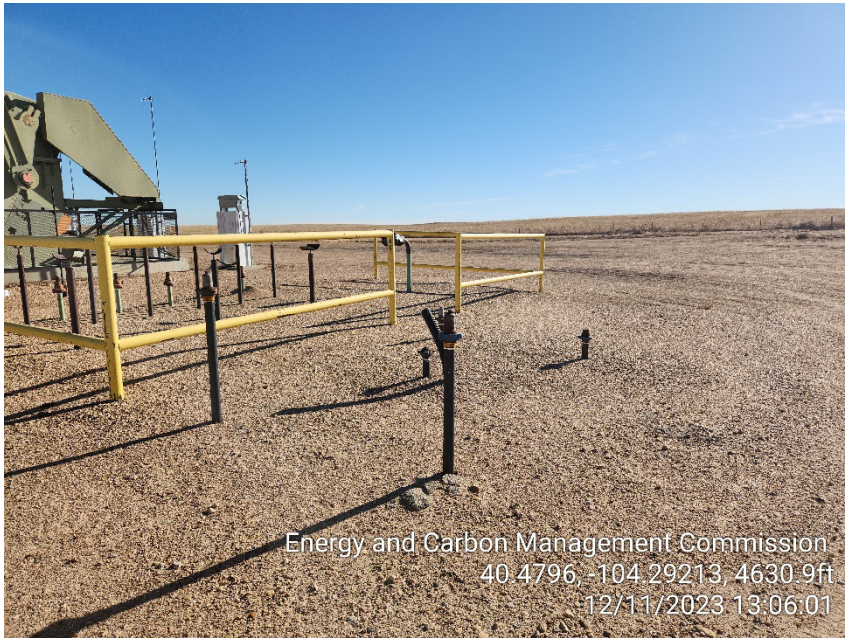
Photo 3 – 2” Riser West of Pumping Units not OOSLAT

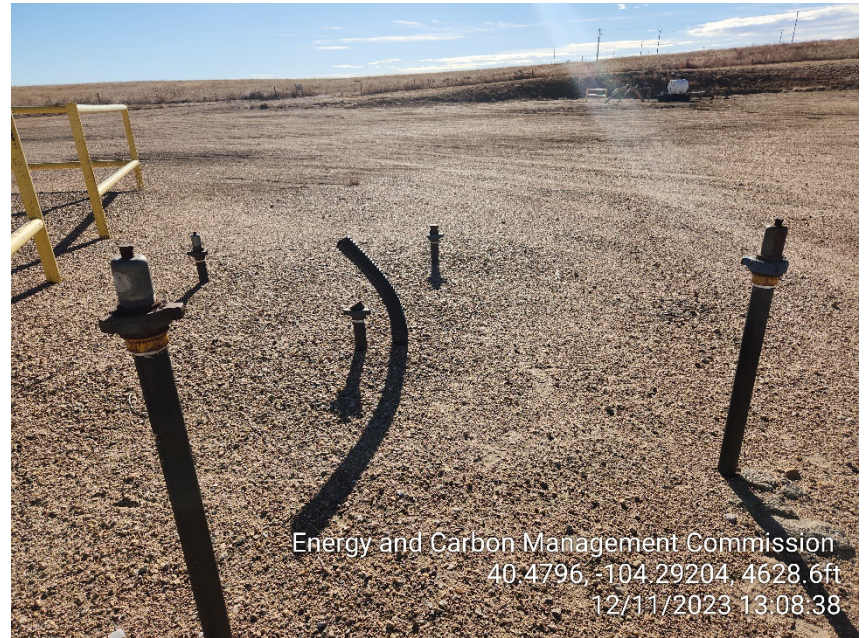
Photo 4 – 2” Riser West of Pumping Units not OOSLAT

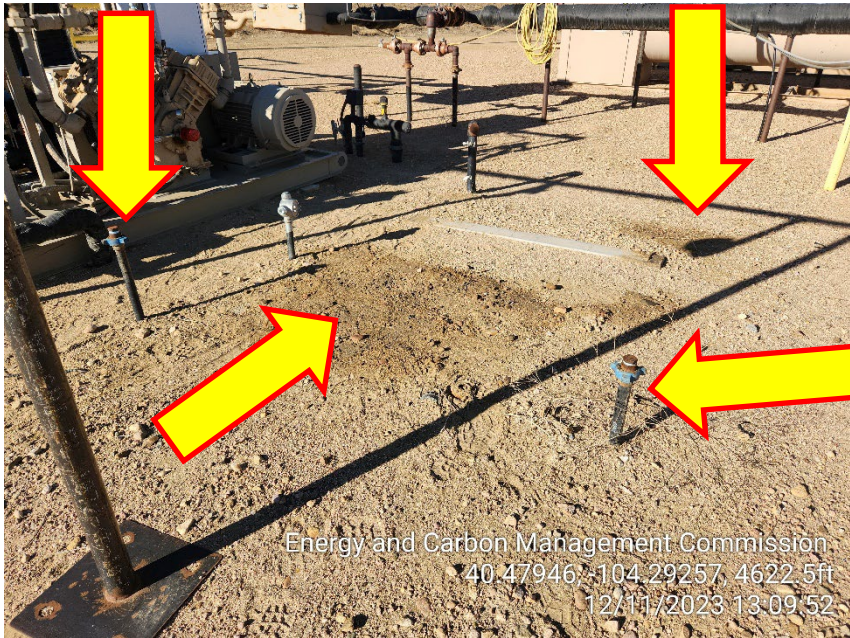
Photo 5 – 1" Riser at VRU not OOSLAT – Stained Soil

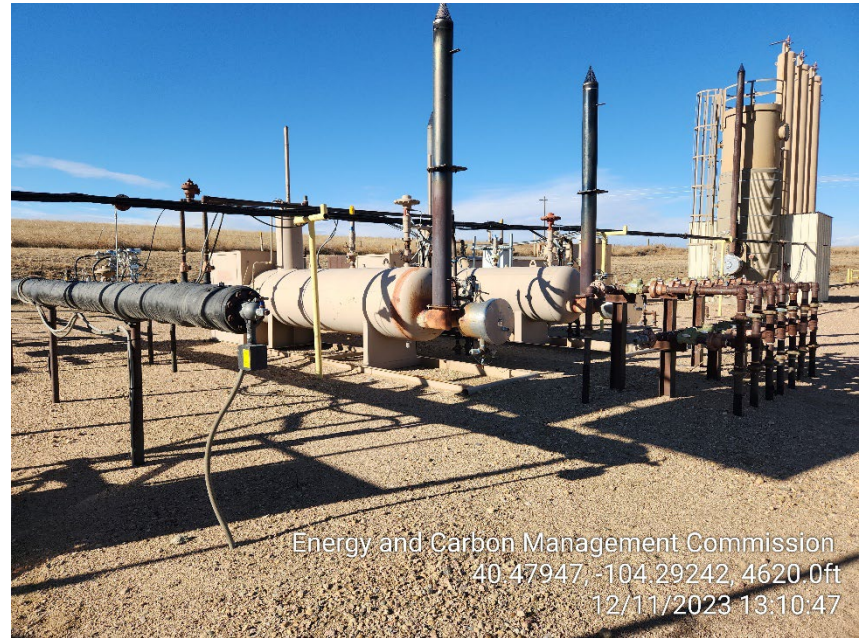
Photo 6 – Separators

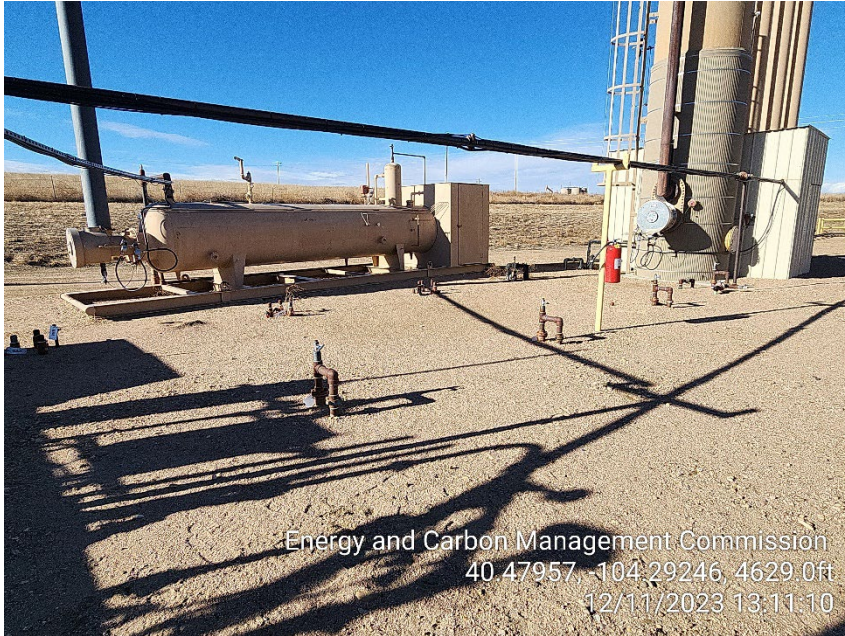
Photo 7 – Separator and Heater Treater

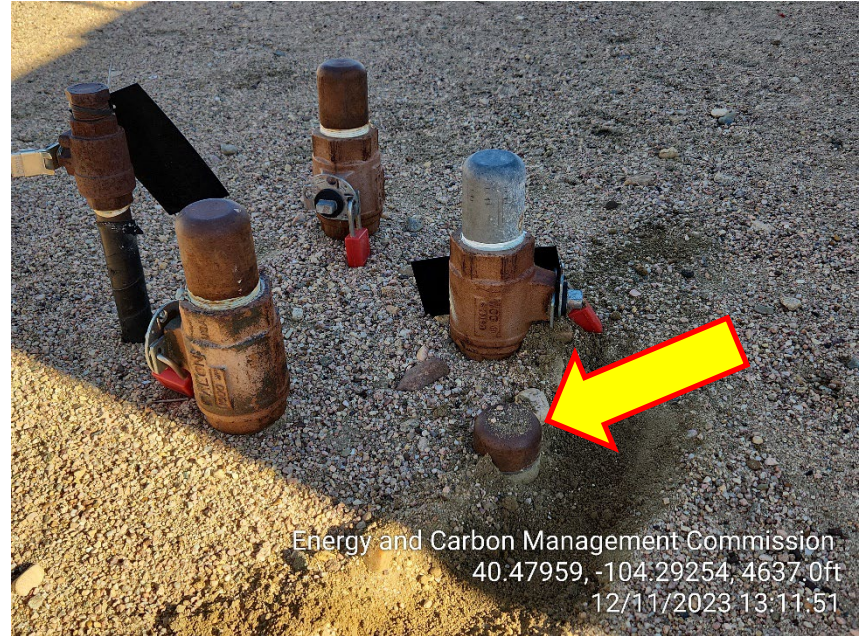
Photo 8 – 2" Buried Riser not OOSLAT

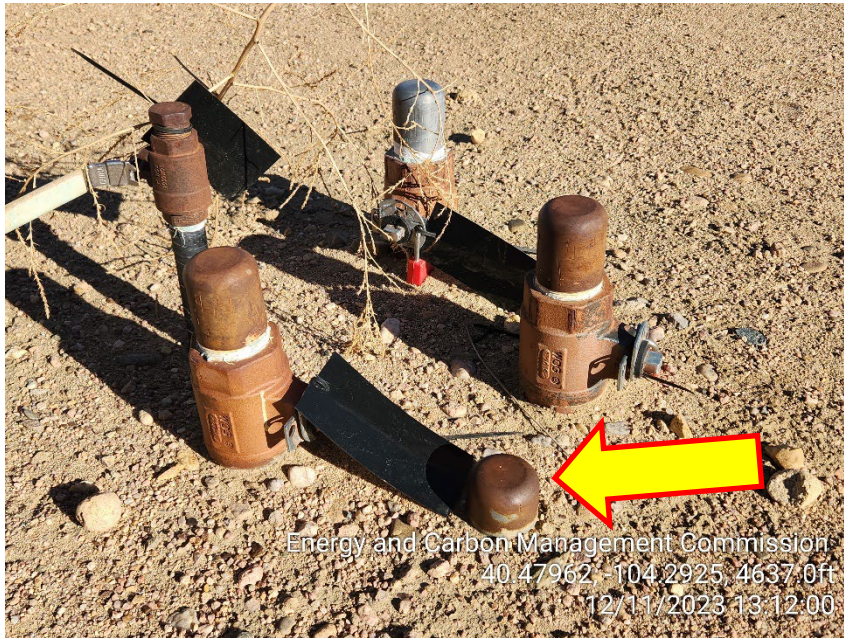
Photo 9 – 2" Buried Riser not OOSLAT

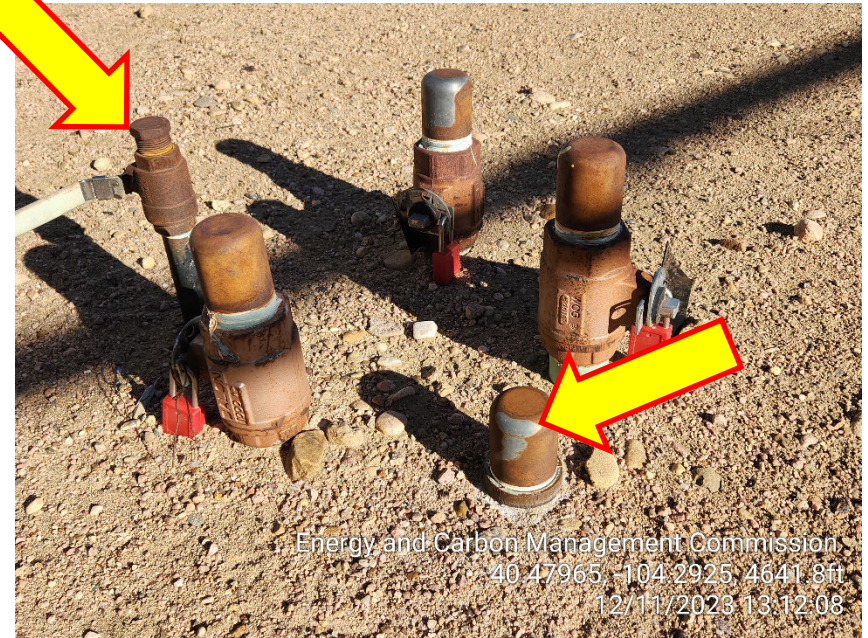
Photo 10 – 2" Buried Riser and 1" Riser not OOSLAT

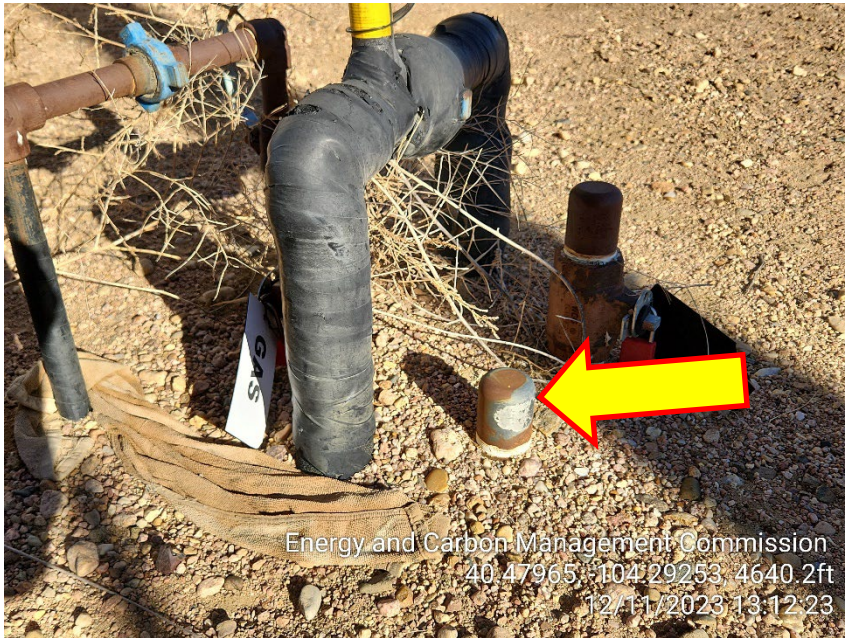
Photo 11 – 2" Buried Riser not OOSLAT

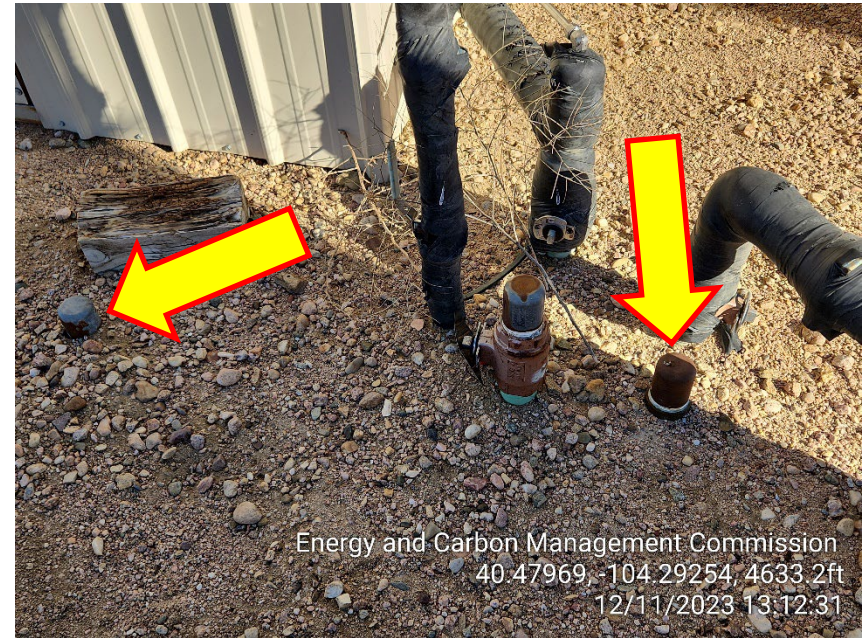
Photo 12 – 2" Buried Risers not OOSLAT

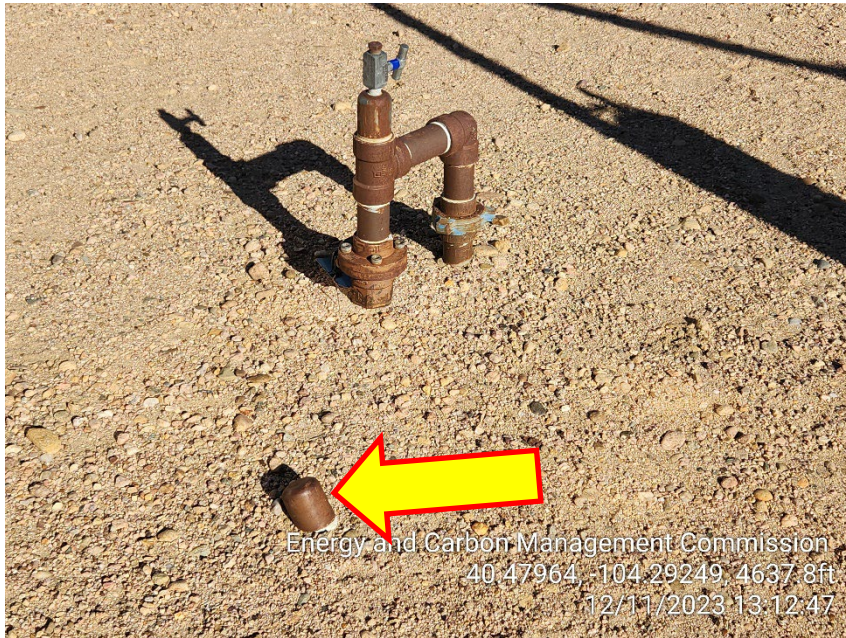
Photo 13 – 2" Buried Riser not OOSLAT

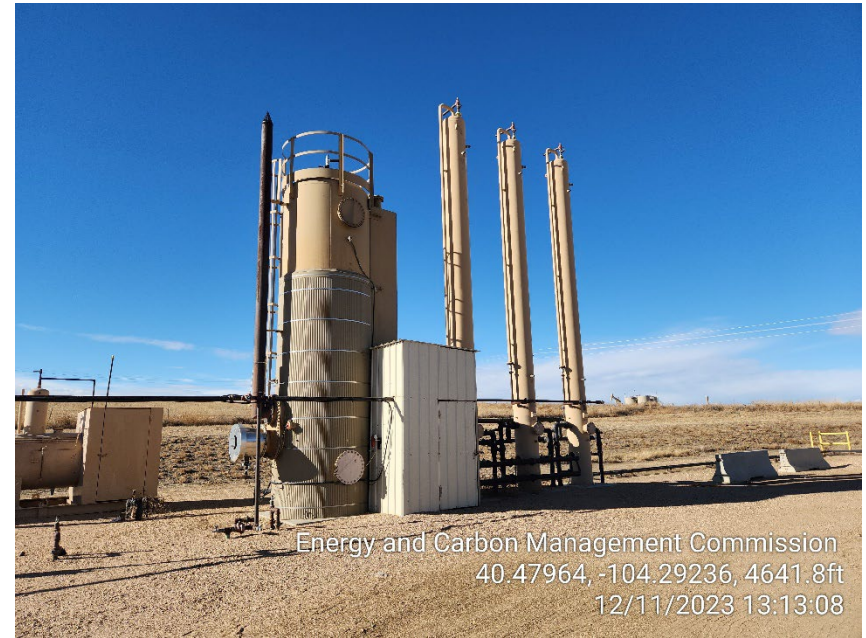
Photo 14 – Heater Treater and VRTs

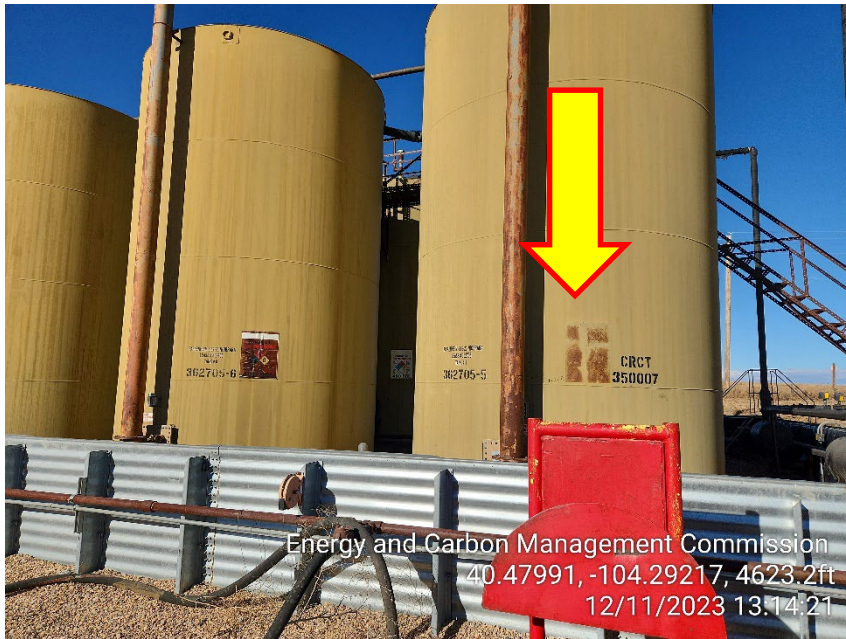
Photo 17 – NFPA, Content and Capacity Labels missing on SE Tank

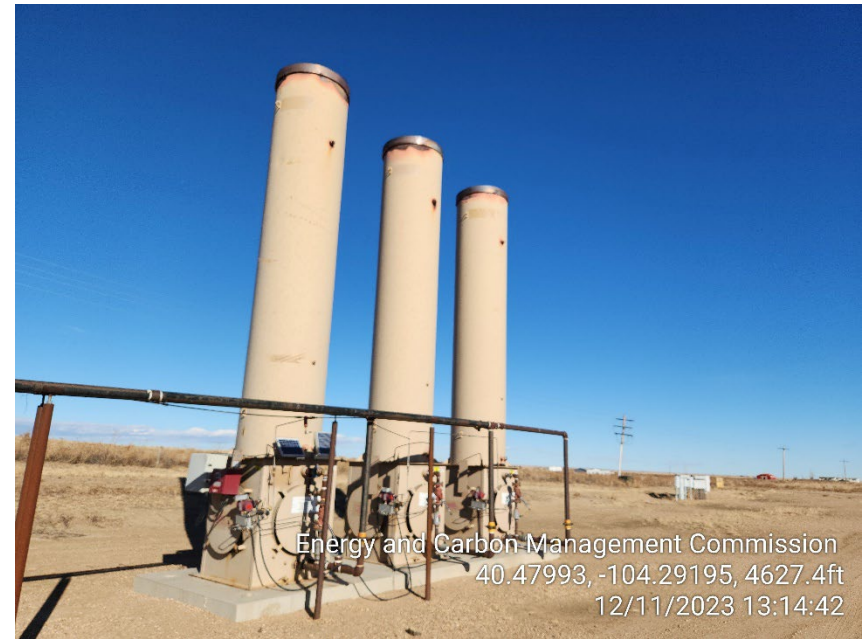
Photo 18 – ECDs
