Inspection Photos  
REM #28246  
Facility #116587  
Inspection  
Date:12/21/2023

All Photos taken  
by ECMC staff, Kris  
Neidel

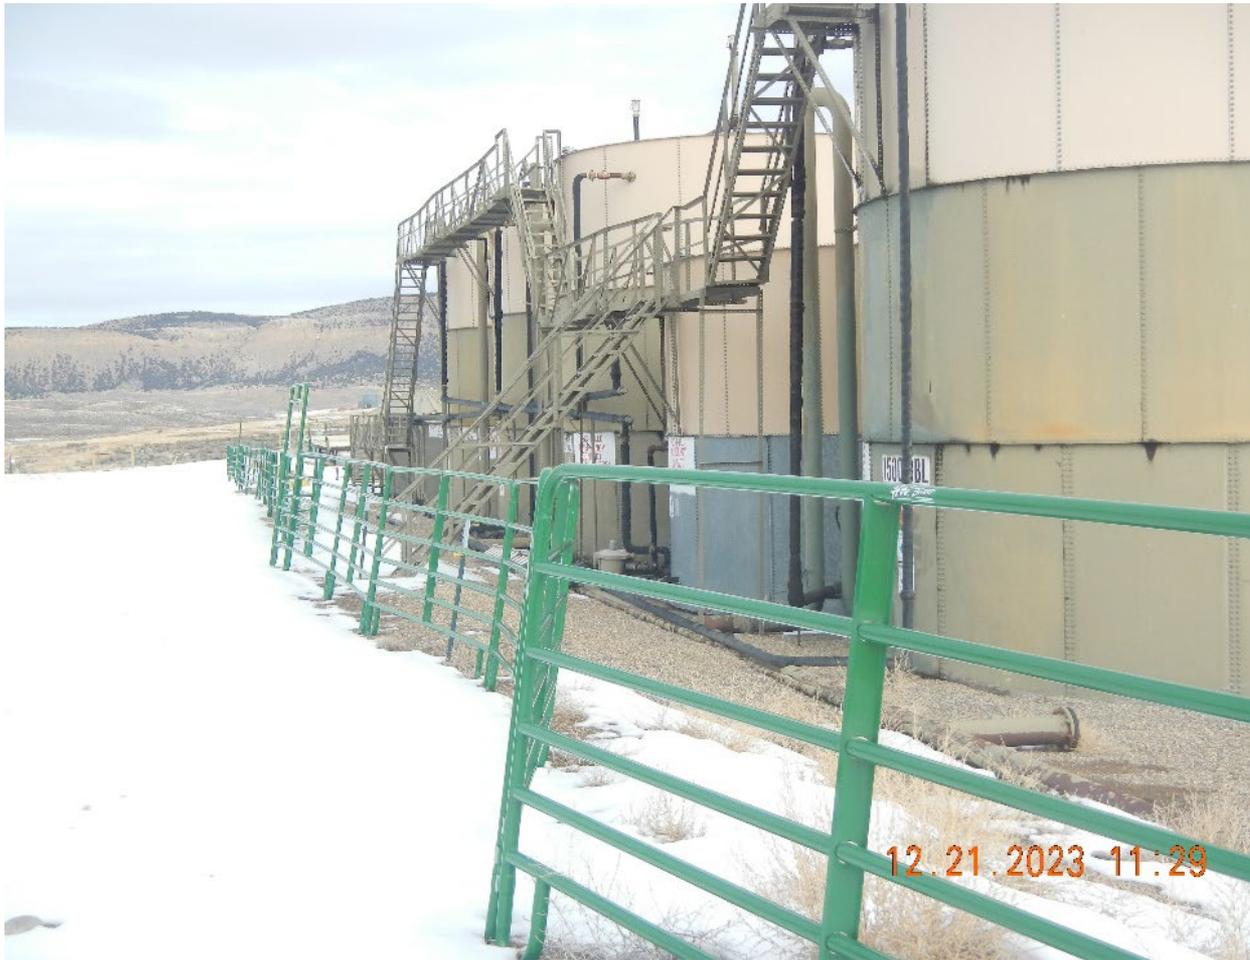
**Photo #2 Tank Battery. The tank battery was inspected for fencing and general observation.**

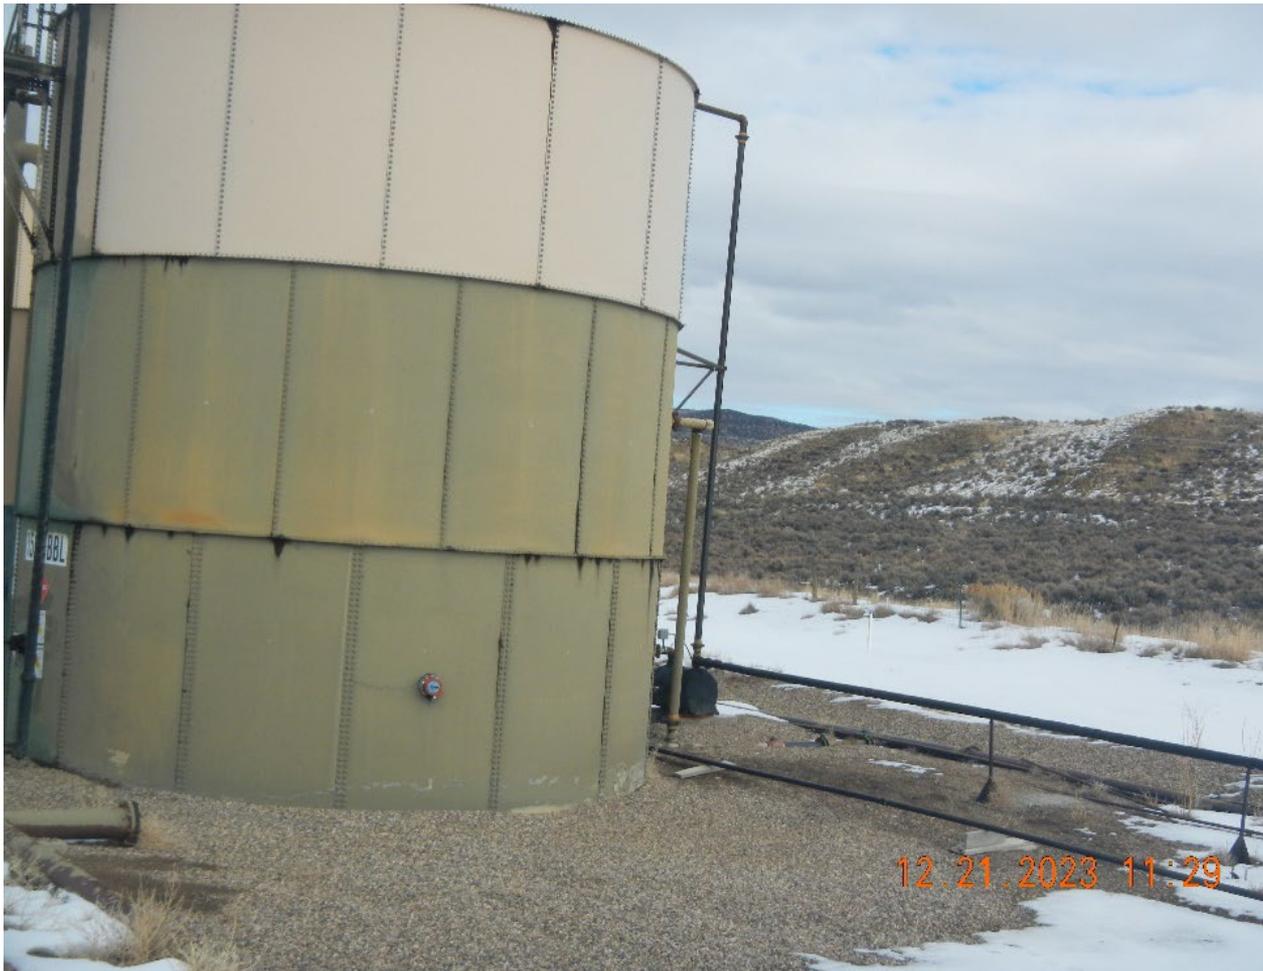
**Photo #3 Tank Battery. The tank battery was inspected for fencing and general observation.**

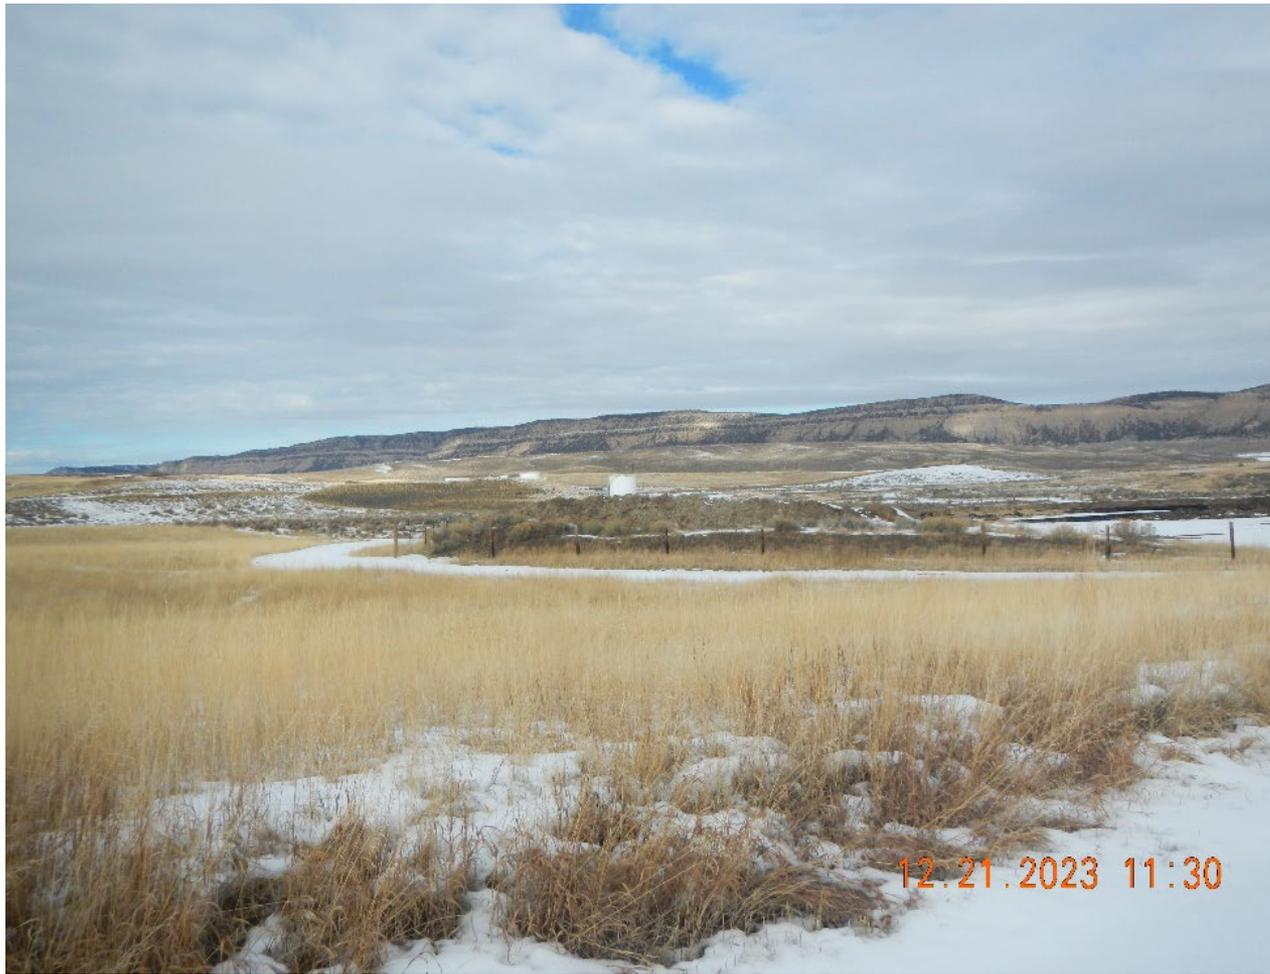
**Photo #4 looking north at Pit complex.**

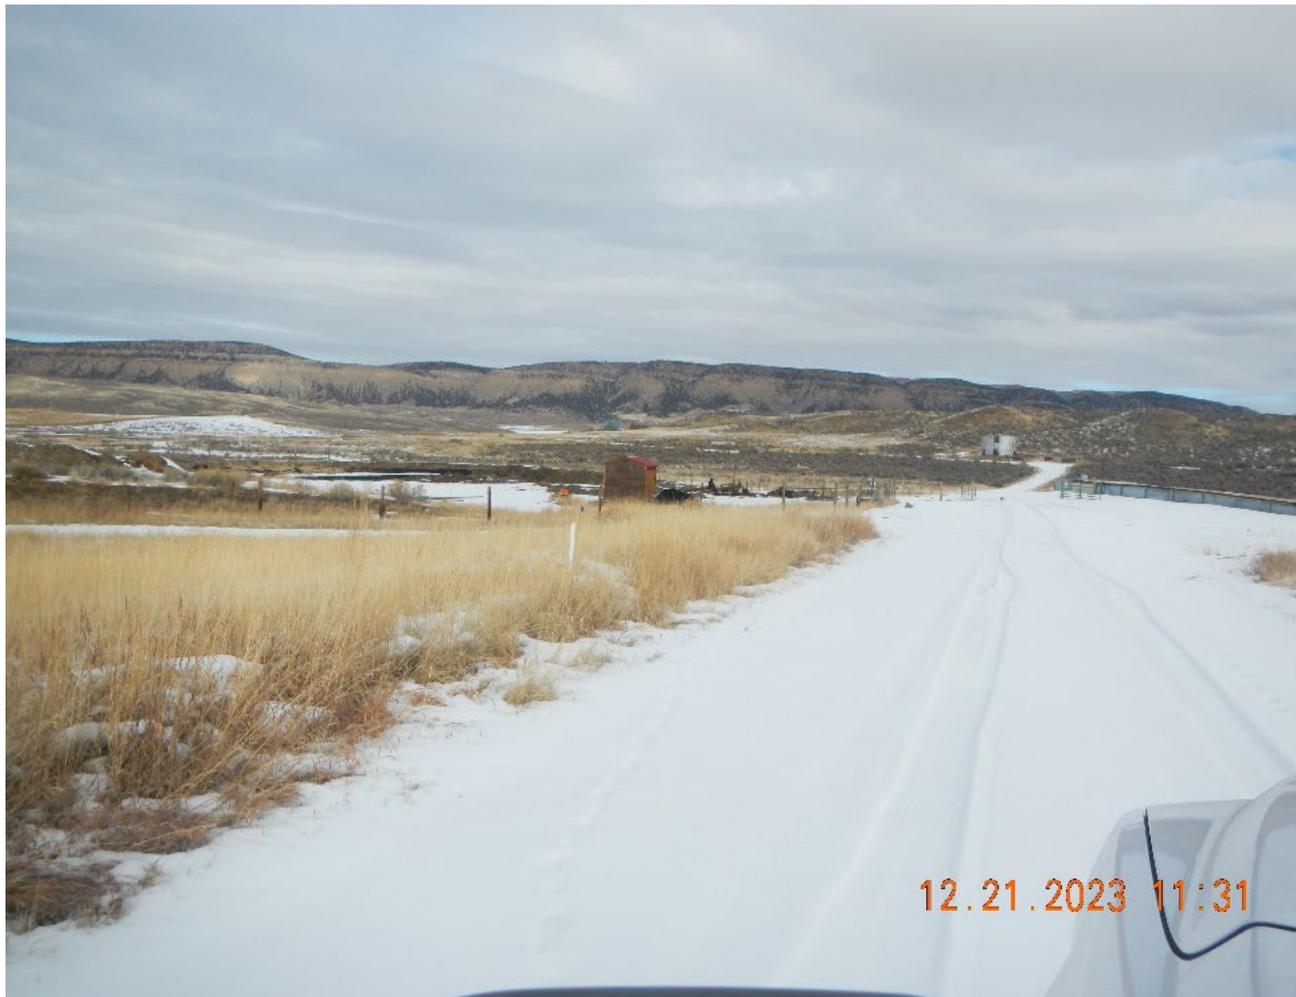
**Photo #5 looking north at pit facility and cement vault on right.**

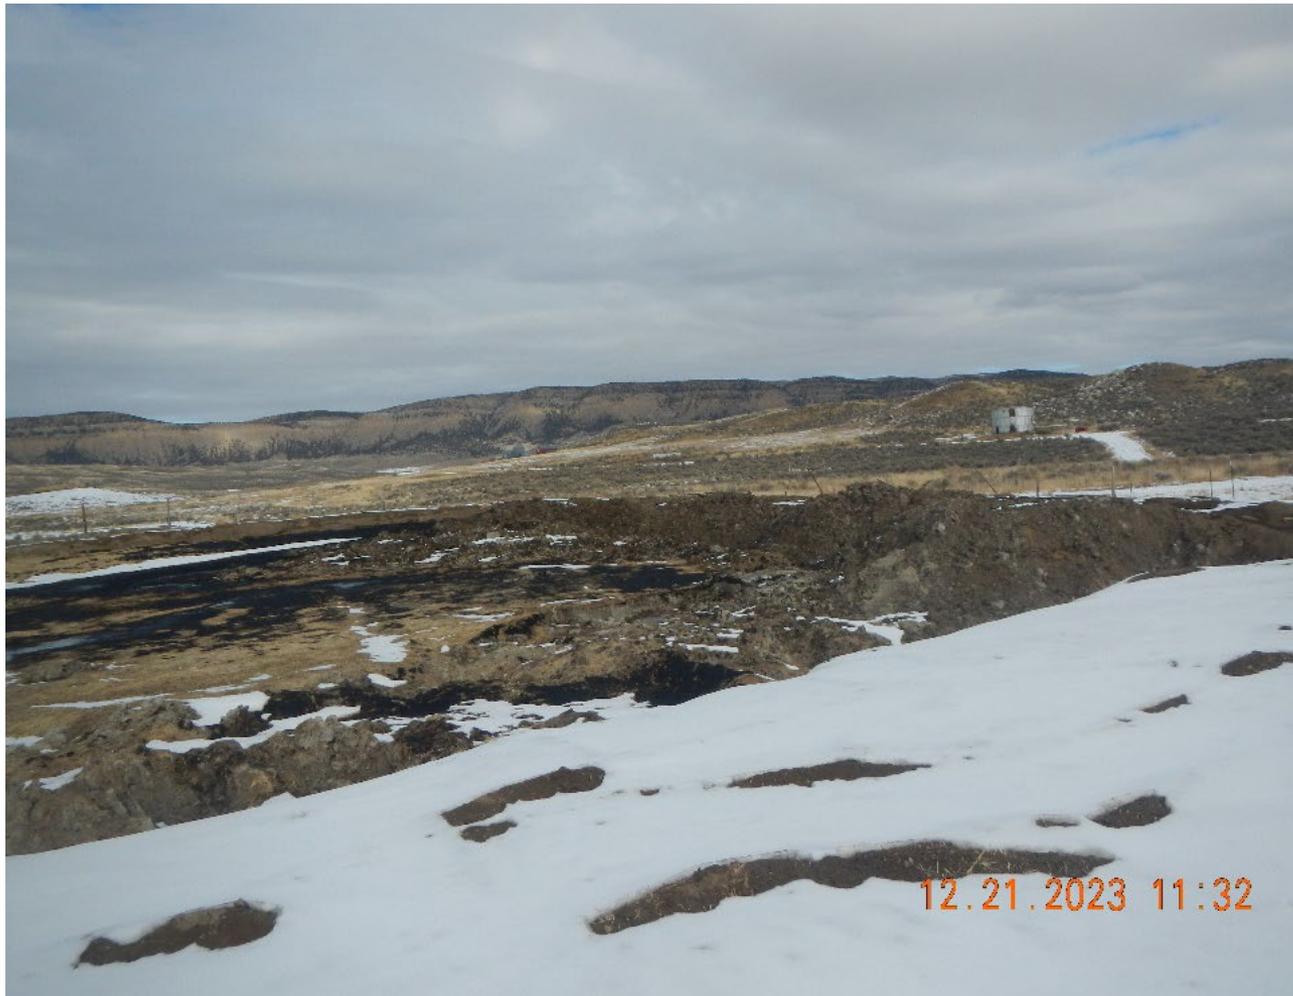
**Photo #6 Pit inside of fenced complex. Looking northeast across the pit. Note: visible hydrocarbon on pit.**

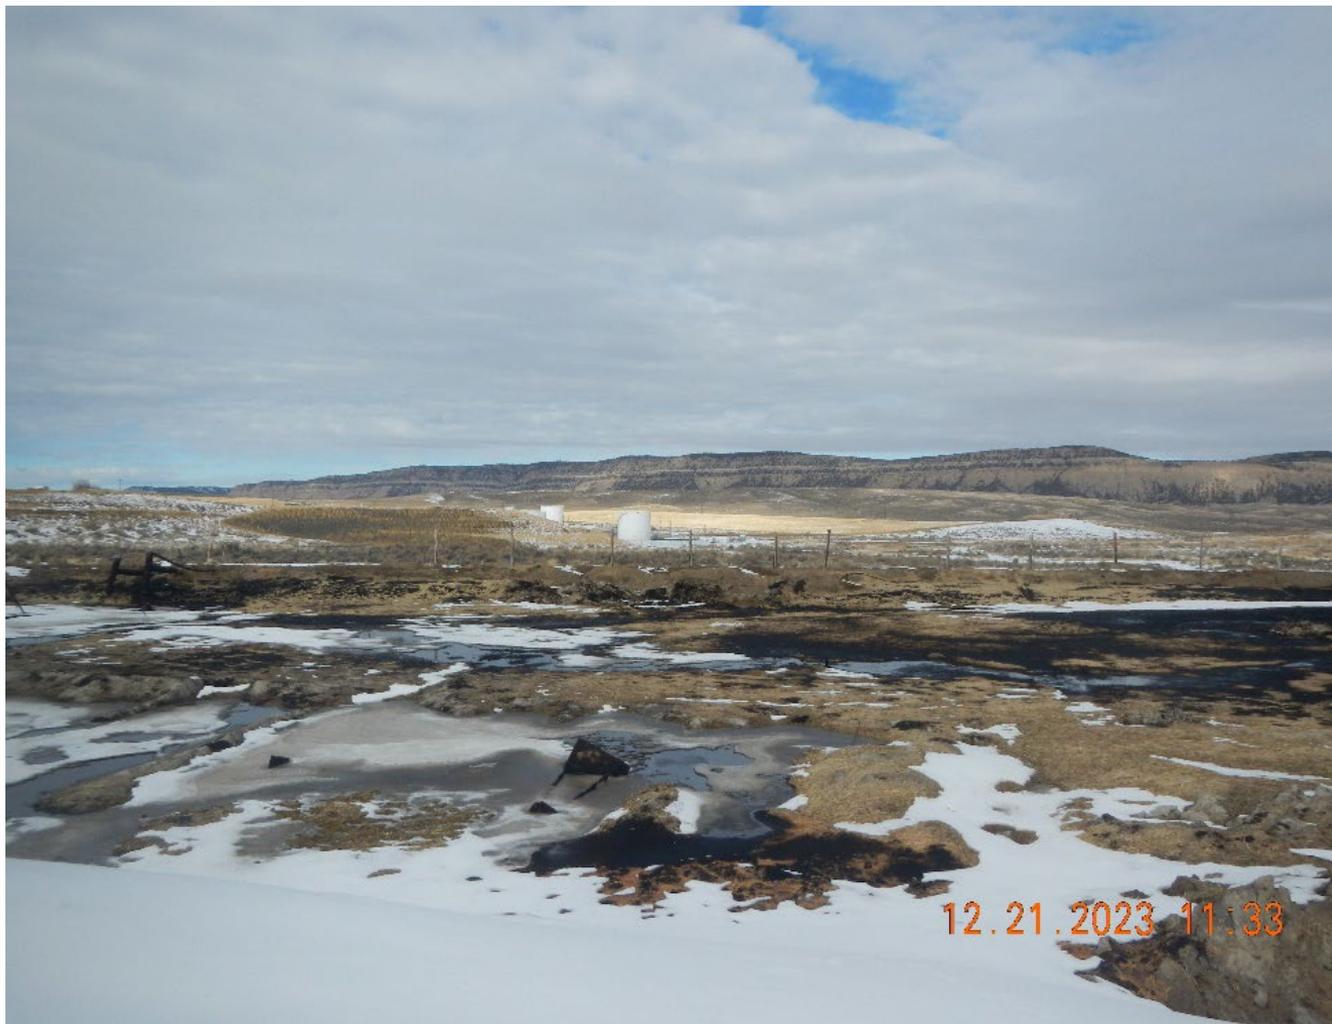
**Photo #7 looking across the pit to the northwest. Note: visible hydrocarbon on pit.**

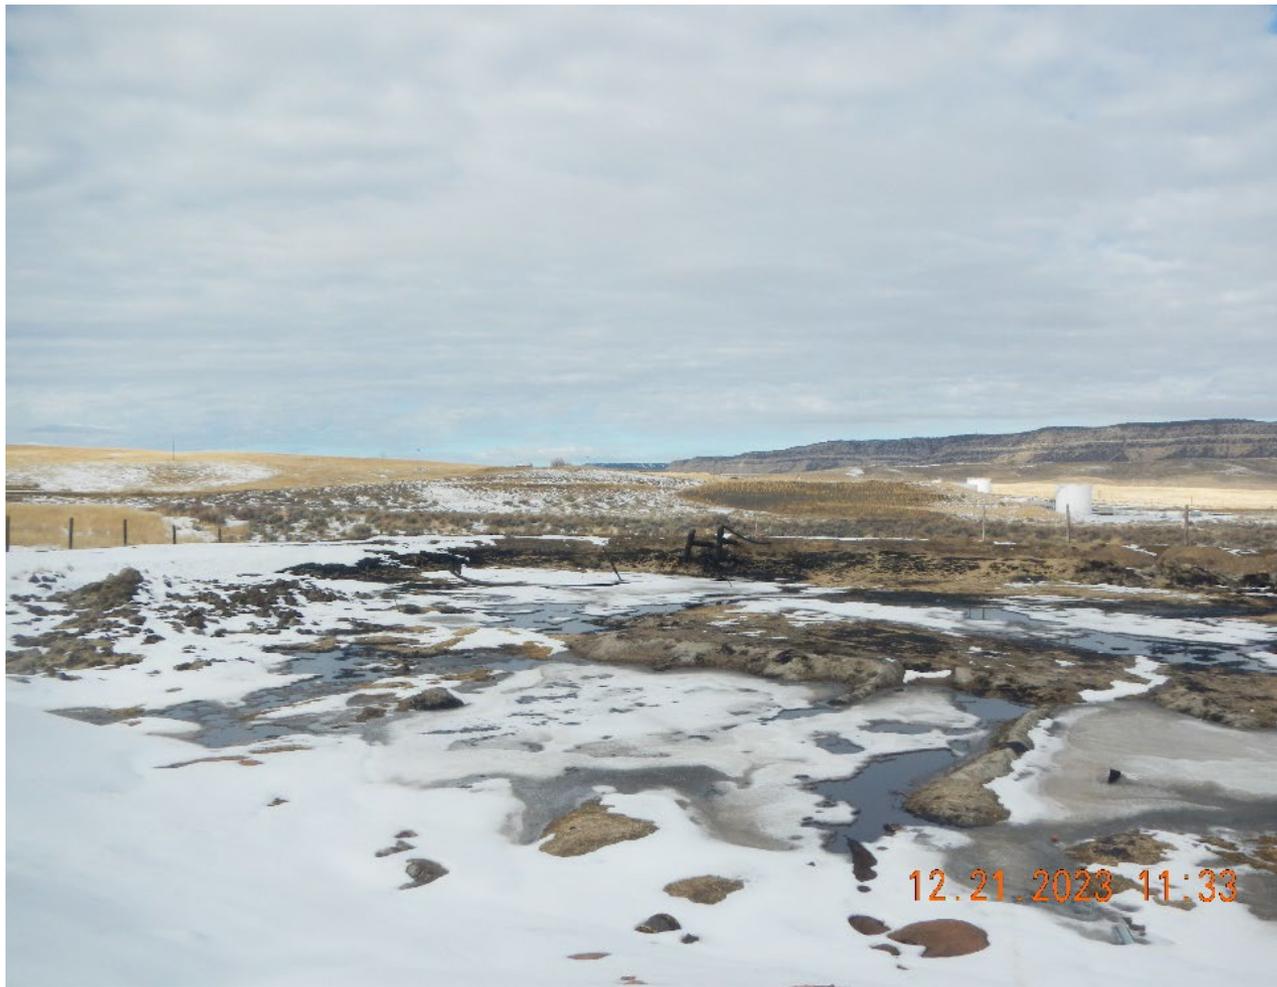
**Photo #8 Looking across pit. Fence seen at left of photo is the western side of pit.**

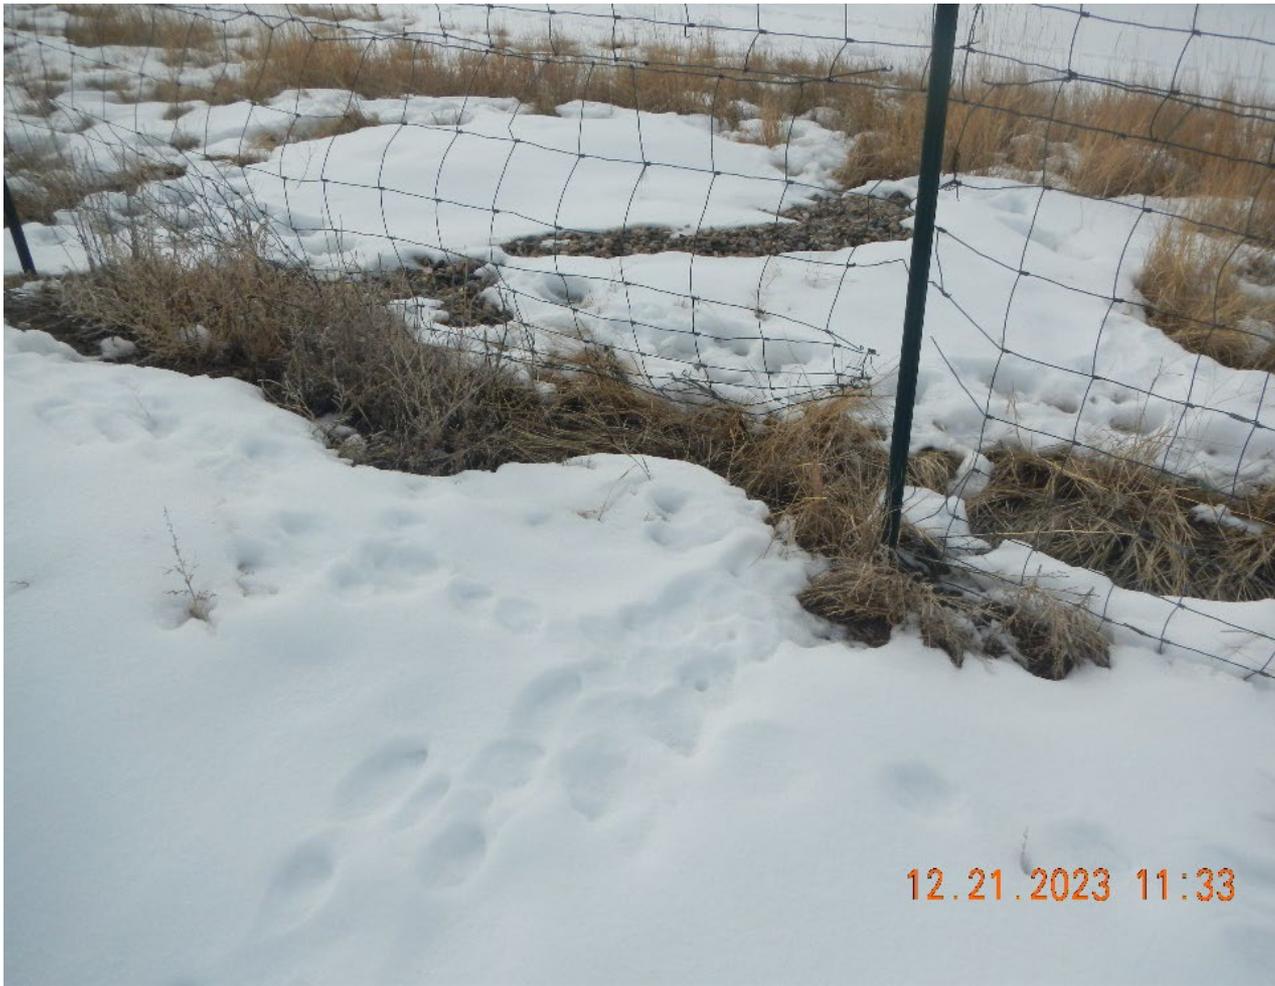
**Photo #9. Close up of the western portion of fence. Note: wildlife tracks crossing under the fence. The track Path went from the main access gate (on east side) across the access drive inside the facility and under the fence seen here.**

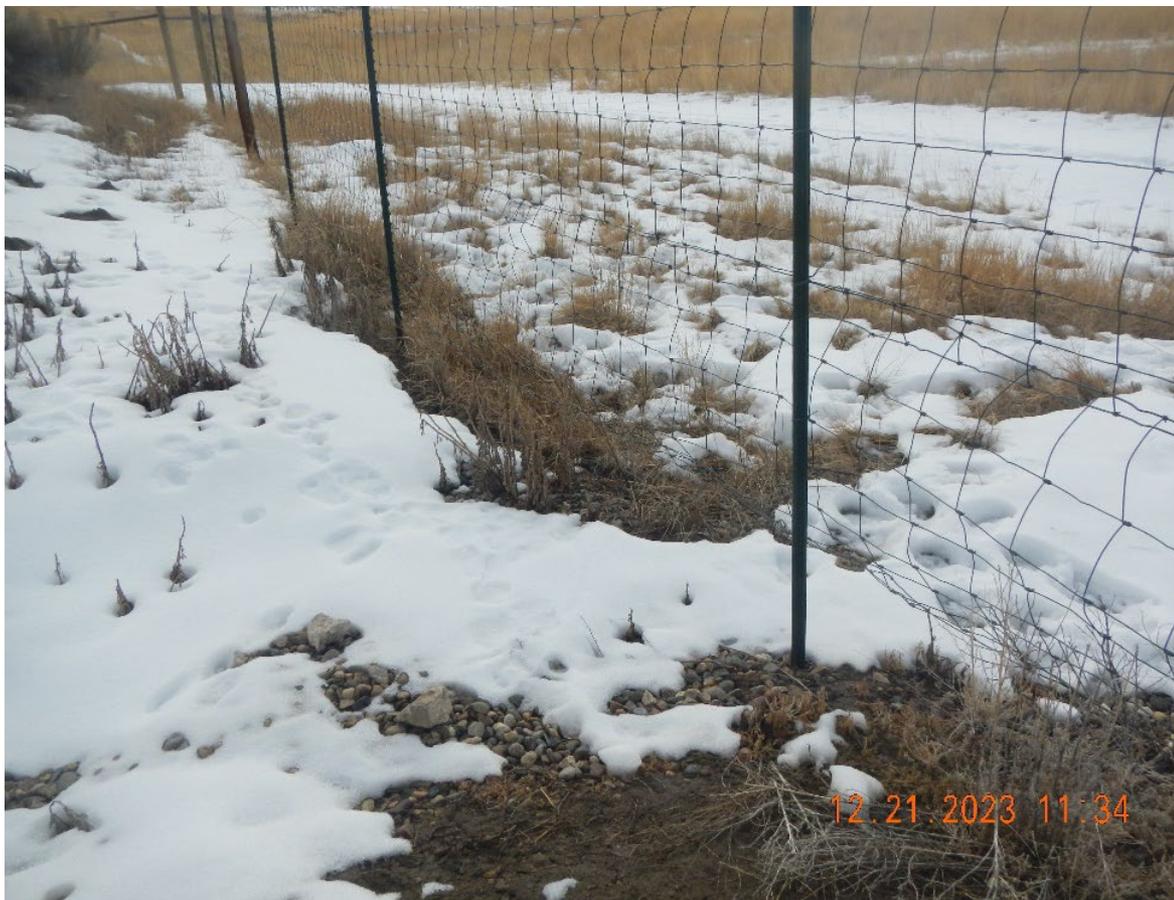
**Photo #10 Photo is attempting to show the bottom of the west side fence. The fence is curled up allowing access (or egress) through fence.**

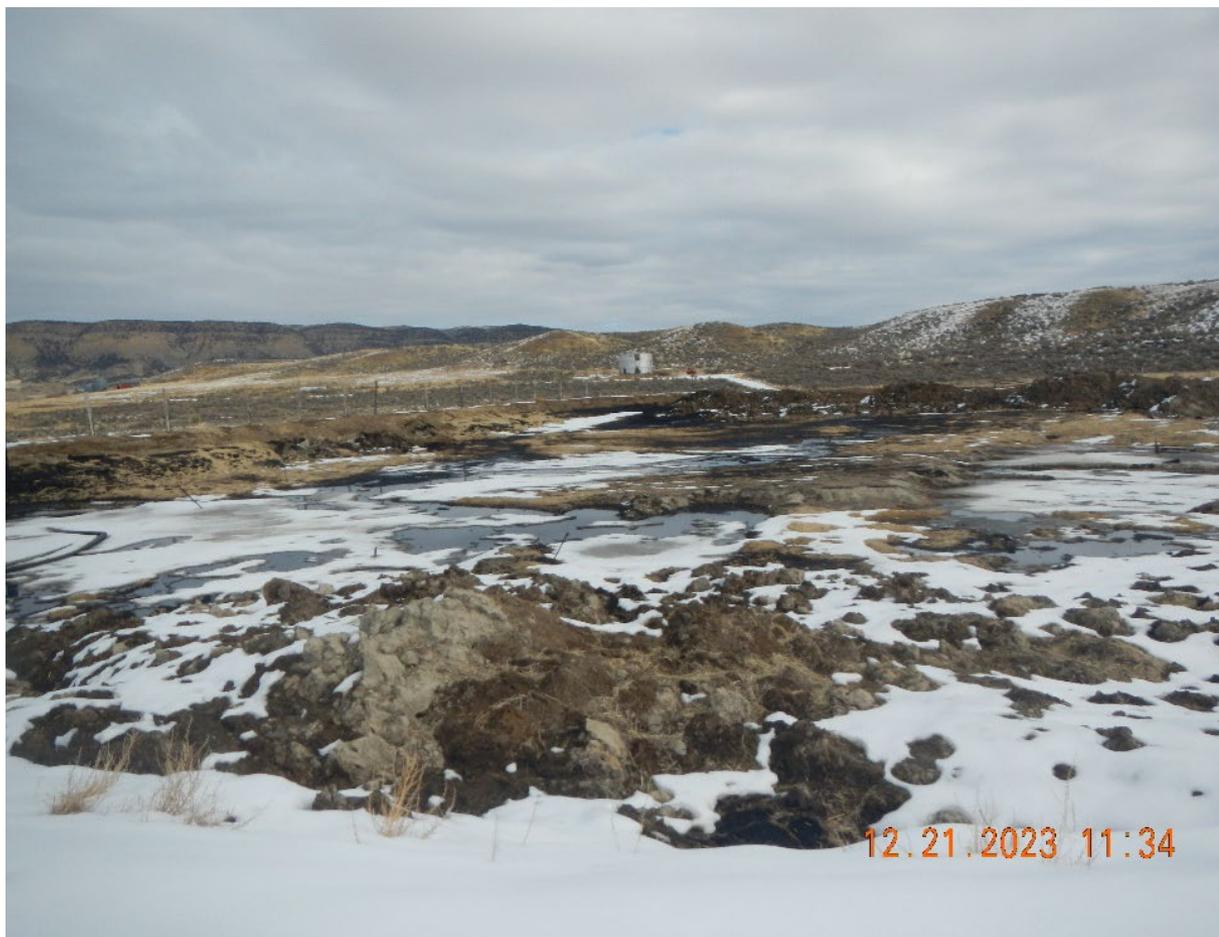
**Photo #11 Photo of Pit. Note: black hydrocarbon.**

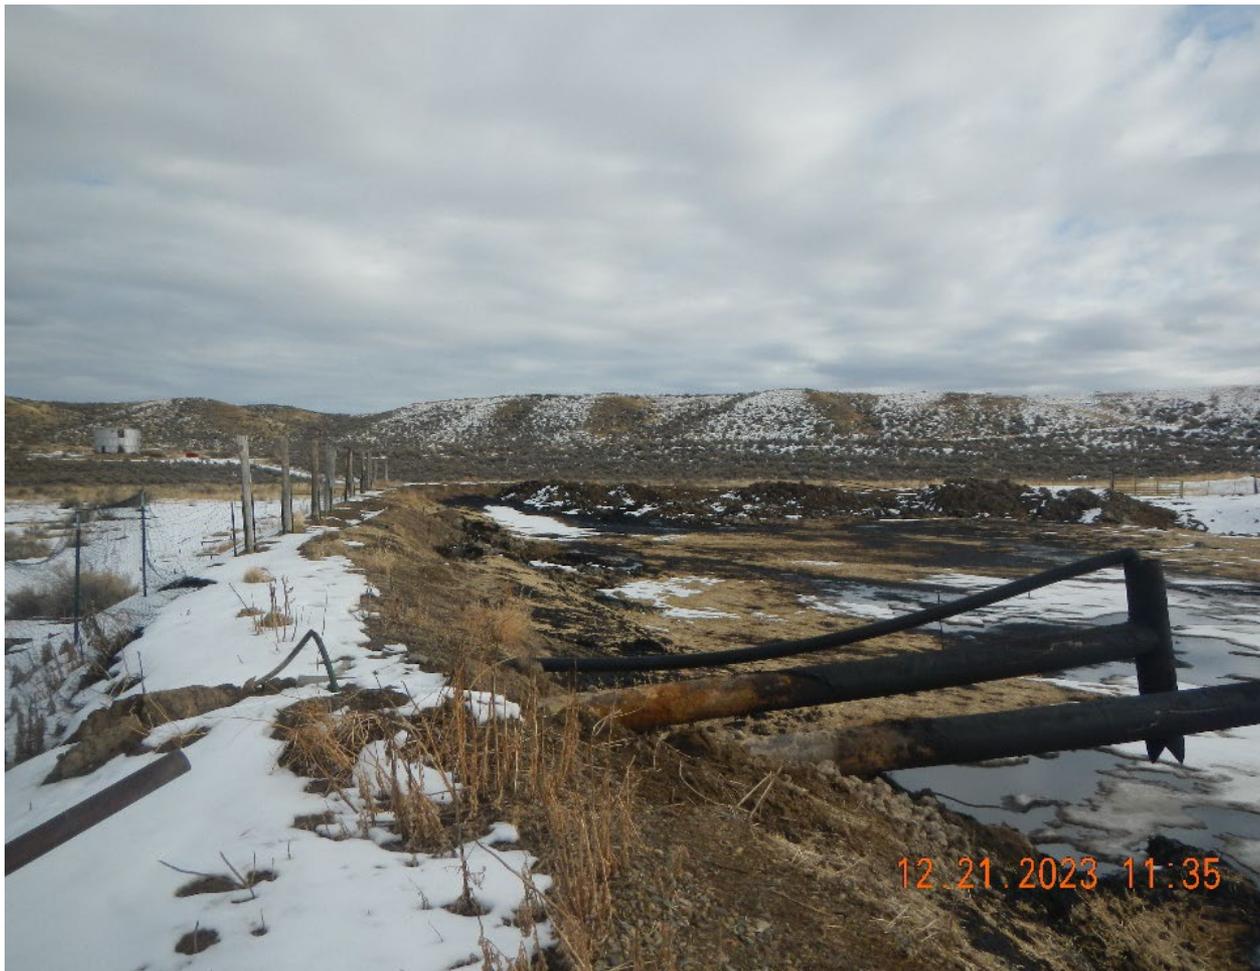
Photo #12 photo of former discharge from pit. Discharge point to seeping springs gulch is to left of photo.

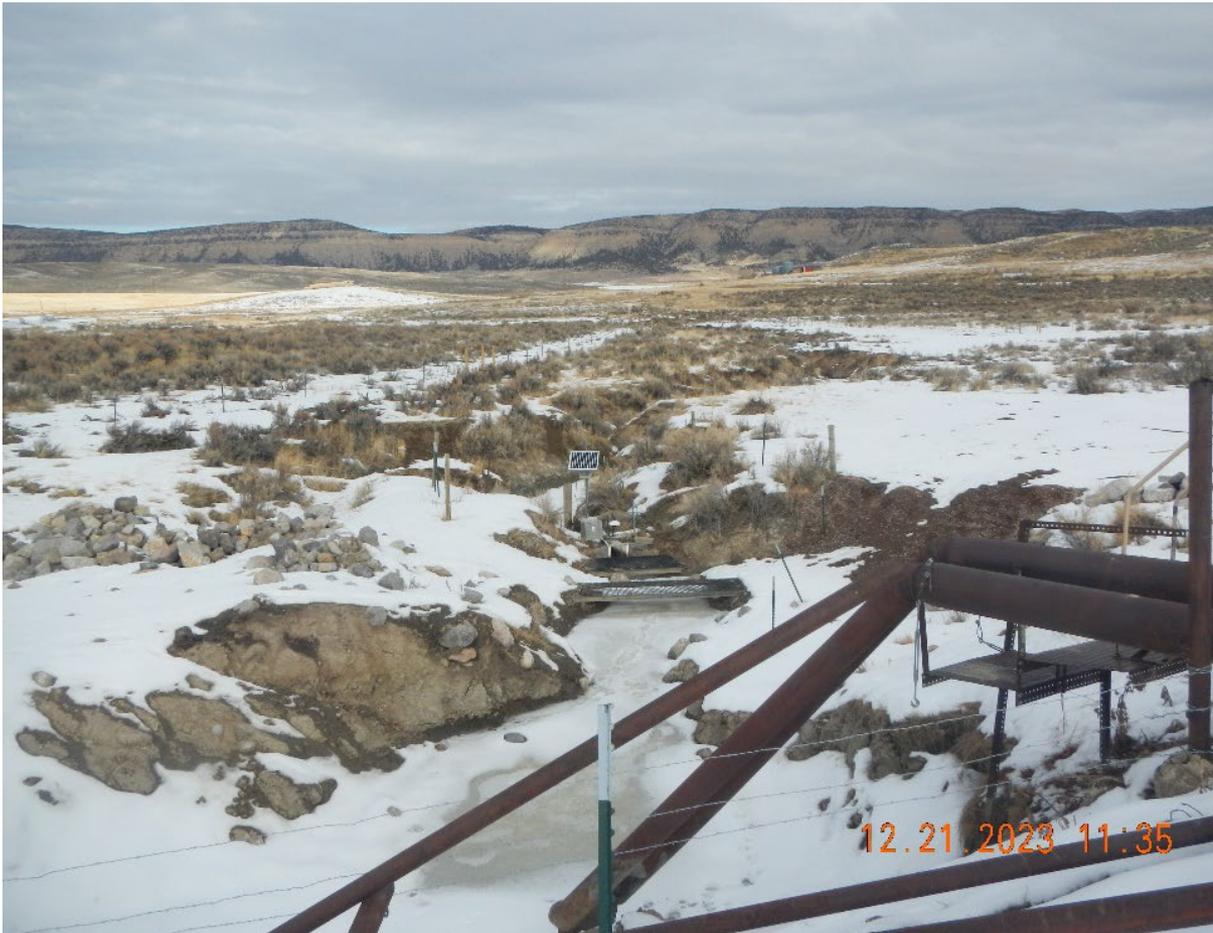
**Photo #13 Piping in foreground is same piping that is observable in Photo #12**

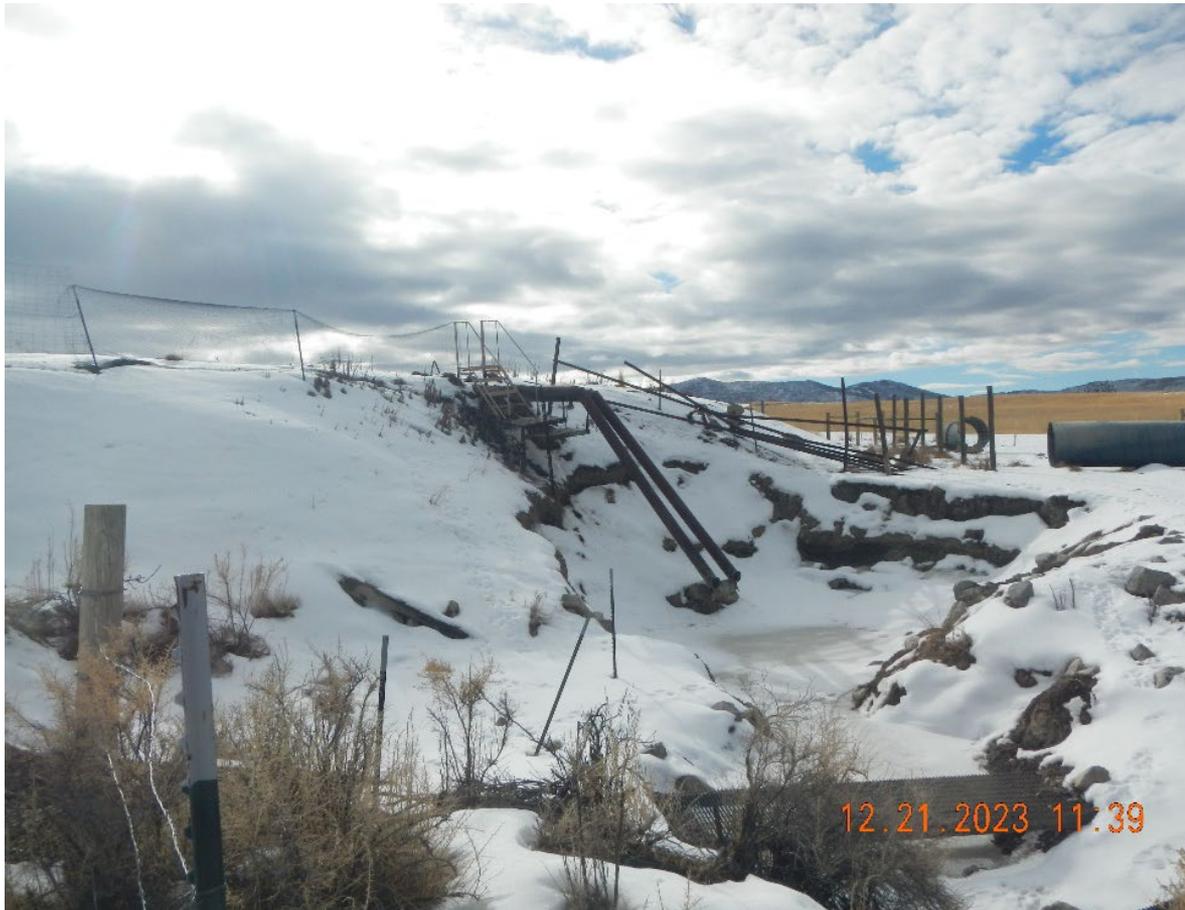
**Photo #14 Photo below discharge to Seeping Springs Gulch. Note: netting used for fencing.**

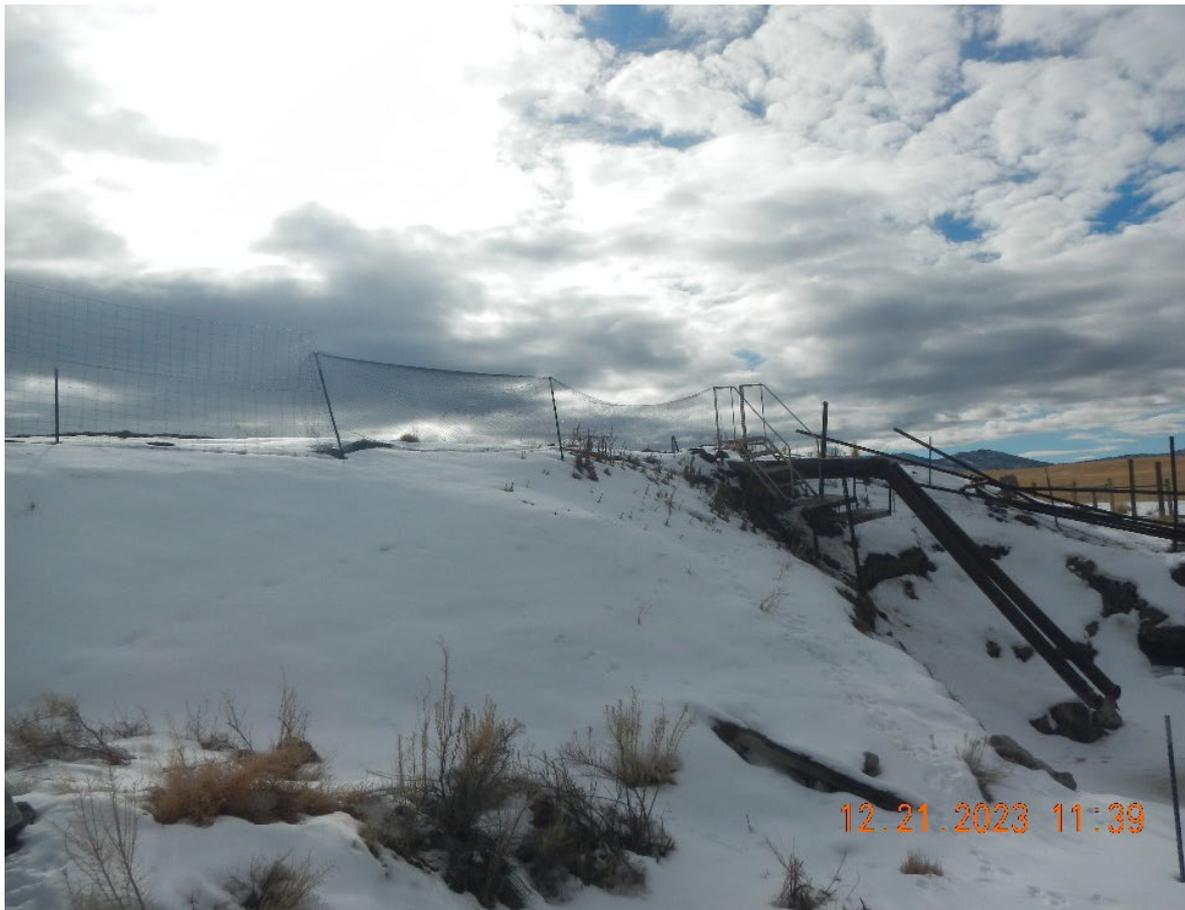
**Photo #15 Netting used as fencing at discharge to seeping springs gulch.**

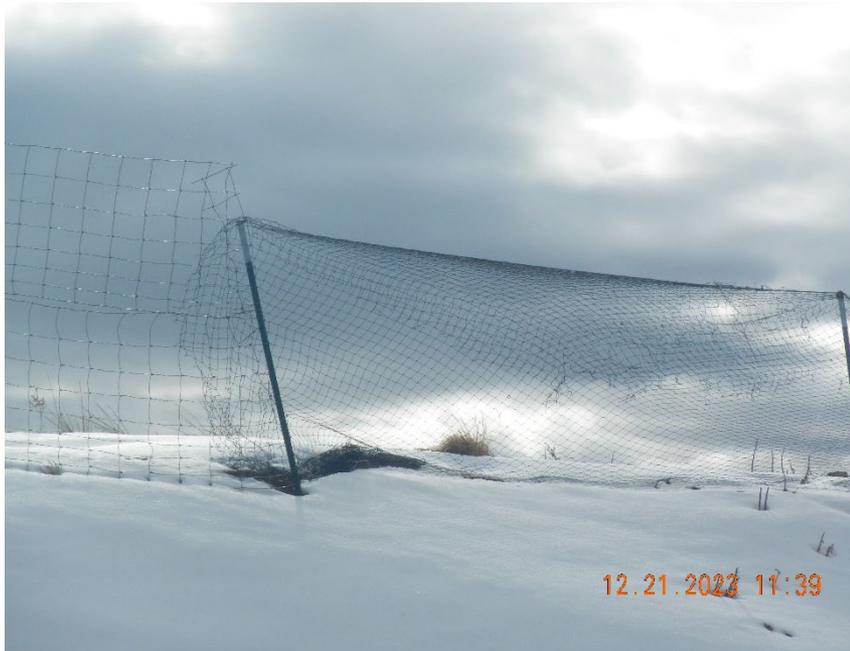
**Photo #16 Close up of fencing at discharge. Old netting used as fence.**

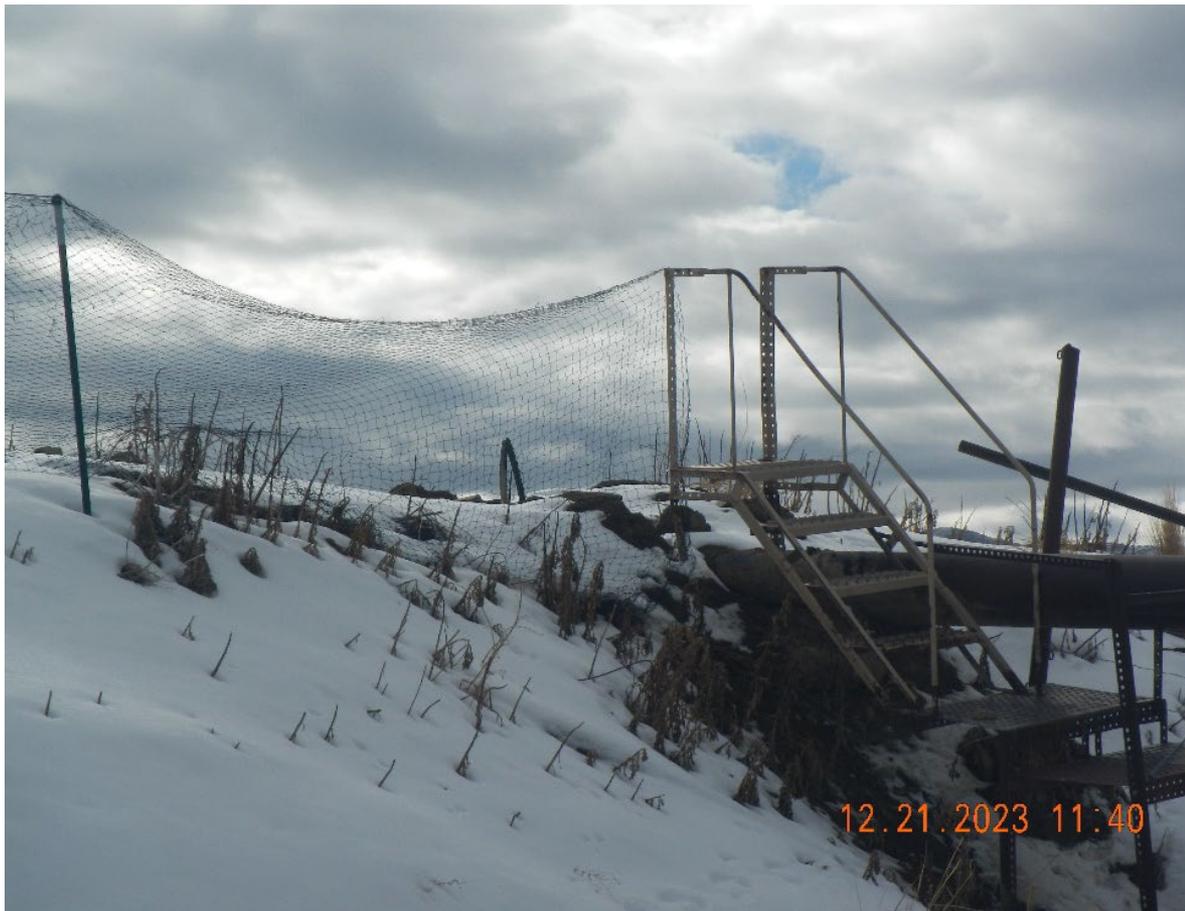
**Photo #17 Close up of fencing at discharge. Old netting used as fence.**
