Colorado Oil and Gas Conservation Commission

Monitor Wells Summary Report
2020

4M Project Monitoring Program
Archuleta and La Plata Counties
Colorado

April 23, 2021

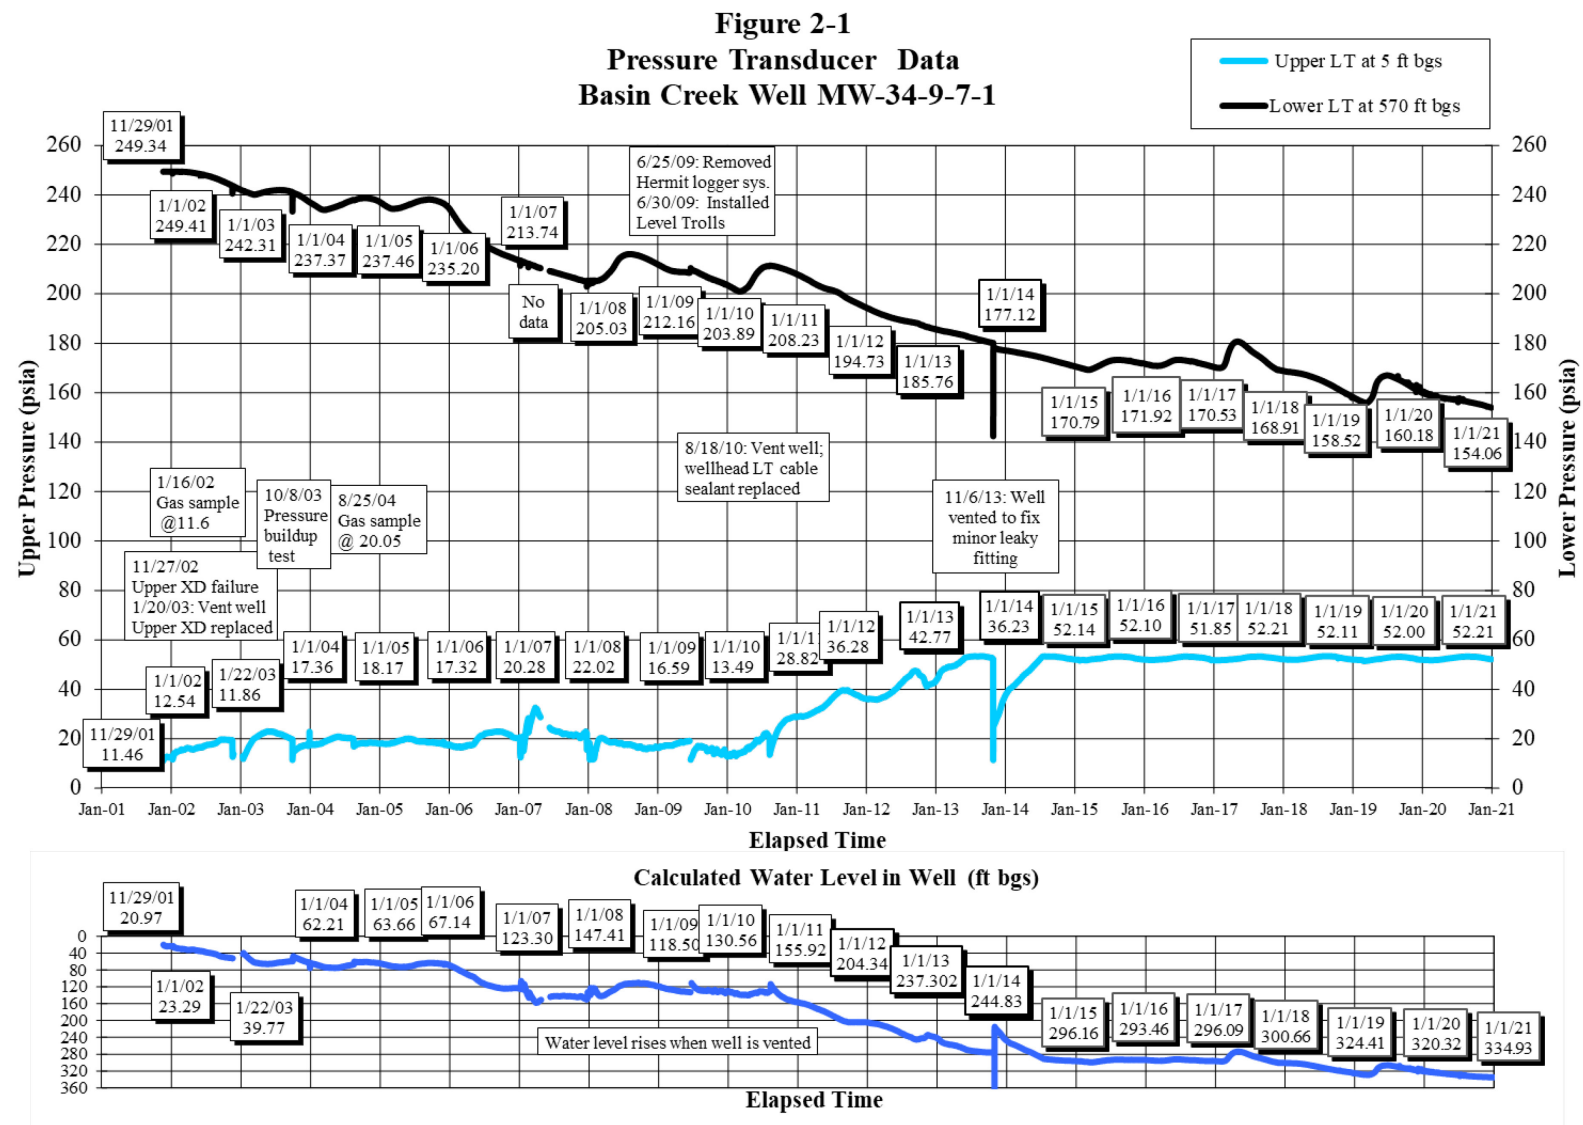
Figure 2-1
Pressure Transducer Data Basin Creek Well MW-34-9-7-1

Figure 2-1 charts the upper and lower pressure transducer data and the calculated water level in the well. Table 2-1 and Figure 2-1 show a net increase of 40.75 psi in wellhead pressure for the entire 19-year period of record from November 29, 2001 (11.46 psia) to January 1, 2021 (52.21 psia). Figure 2-1 generally shows a pattern of minor seasonal fluctuations within an overall stable trend in wellhead pressure prior to wellhead cable gland seal replacement on August 18, 2010, followed by a rise in wellhead pressure to a recorded high of 53.42 psia on September 11, 2013. A very minor leak persisted so on November 6, 2013 the well was vented to allow a safe condition to repair leaking threads at the wellhead. Recovery of the previous wellhead pressure occurred for about nine months following this wellhead venting. Since

recovery in the second half of 2014, wellhead pressure has remained relatively stable. 2019 data demonstrated a groundwater recharge response to the very wet winter of 2018-2019; this effect was greater in magnitude than a similar pressure and water level response to the wet winters of 2007-2008, 2009-2010, 2016-2017.

In contrast to the wellhead pressure patterns, Table 2-1 and Figure 2-1 show a substantial net decline of 313.96 feet in the calculated well water level and a corresponding net decline in downhole pressure of 95.28 psi for the period of record. Figure 2-1 also shows a pattern of slight seasonal fluctuations within the overall declining trend in the water level and corresponding downhole pressure for the period of record.

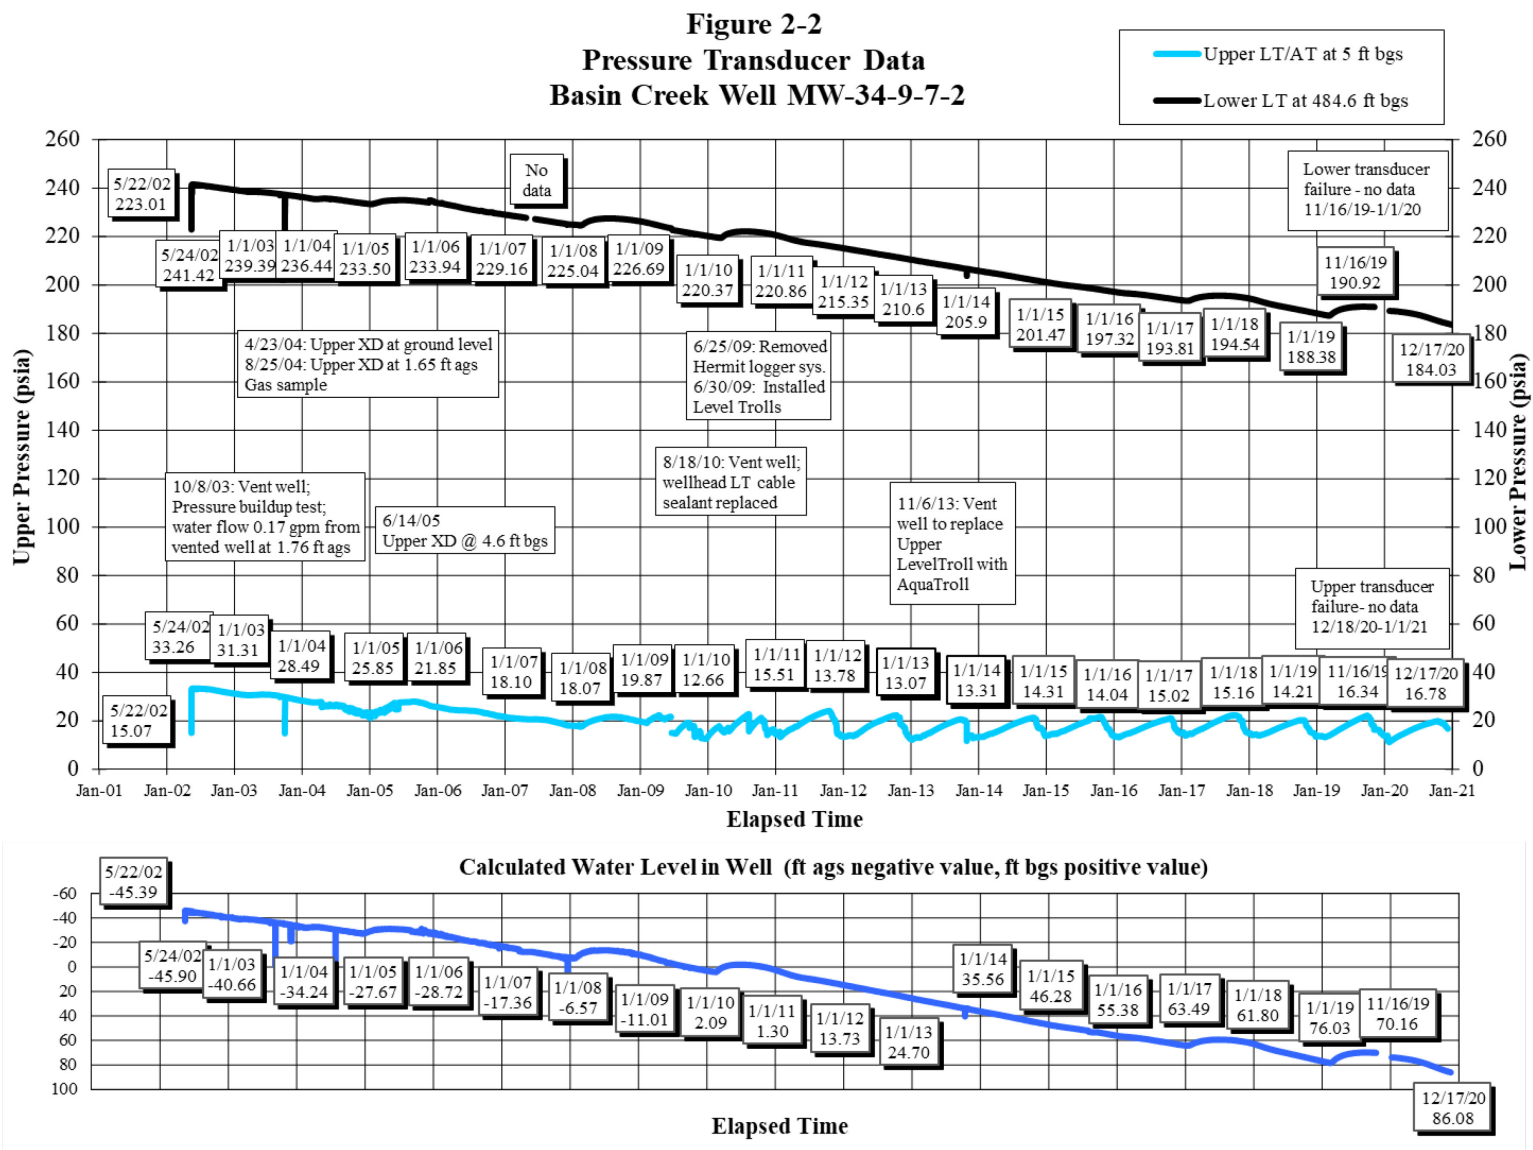
Figure 2-2
Pressure Transducer Data Basin Creek Well MW-34-9-7-2

A small amount of gas was released and artesian flow (~0.2 gpm) from the well consistently occurred each time the well was vented for maintenance during the period of record between 2002 and 2010. The pressure regime documented was relatively high pressure but low volume based on the head pressure versus artesian flow. Artesian flow from the well did not occur when the wellhead was vented on August 18, 2010 to replace the Level Troll wellhead cable Conax gland sealants. The final recorded upper transducer pressure in 2011 of 13.7 PSI was very near atmospheric pressure indicating the well was essentially in hydrostatic balance. The pressure fluctuations since early 2009 suggest that ambient surface temperatures may be affecting the gas pressure as measured by the upper transducer. In order to attempt to distinguish water pressure versus gas pressure being recorded by the upper transducer, the Level Troll was replaced by an Aqua Troll, which records specific conductance (SC) in addition to pressure and temperature. The concept was that if water was present at the Aqua Troll, it would record an SC value greater than zero. If a value of zero was recorded for SC, then a pressure greater than atmospheric pressure would be gas pressure only. The Aqua Troll was installed on November 6, 2013, but it appears by this time the static water level in this well had dropped from the near-surface balance of 2009-2011. 2017 brought a change in trend of the downhole pressure; it increased slightly throughout the first half of 2017, plateaued and then continued to decrease in the linear trend followed since mid-2011. This was a similar trend as observed in 2010. 2019 data demonstrated a groundwater recharge response to the very wet winter of 2018-2019, similar to that observed after the wet winters of 2007-2008, 2009-2010, 2016-2017.

Substantial water level decline has been documented in this well, going from artesian flowing with a calculated shut-in head of approximately 53 feet above ground surface just after construction to 86.08 feet below ground surface on December 17, 2020. This calculated water level data set has been verified by a manual open-well water level measurement on November 6, 2013 of 40.20 ft bgs used as a calibration point for water level calculation using the lower Level Troll data within fifteen minutes on the same date of 40.46 feet below ground surface.

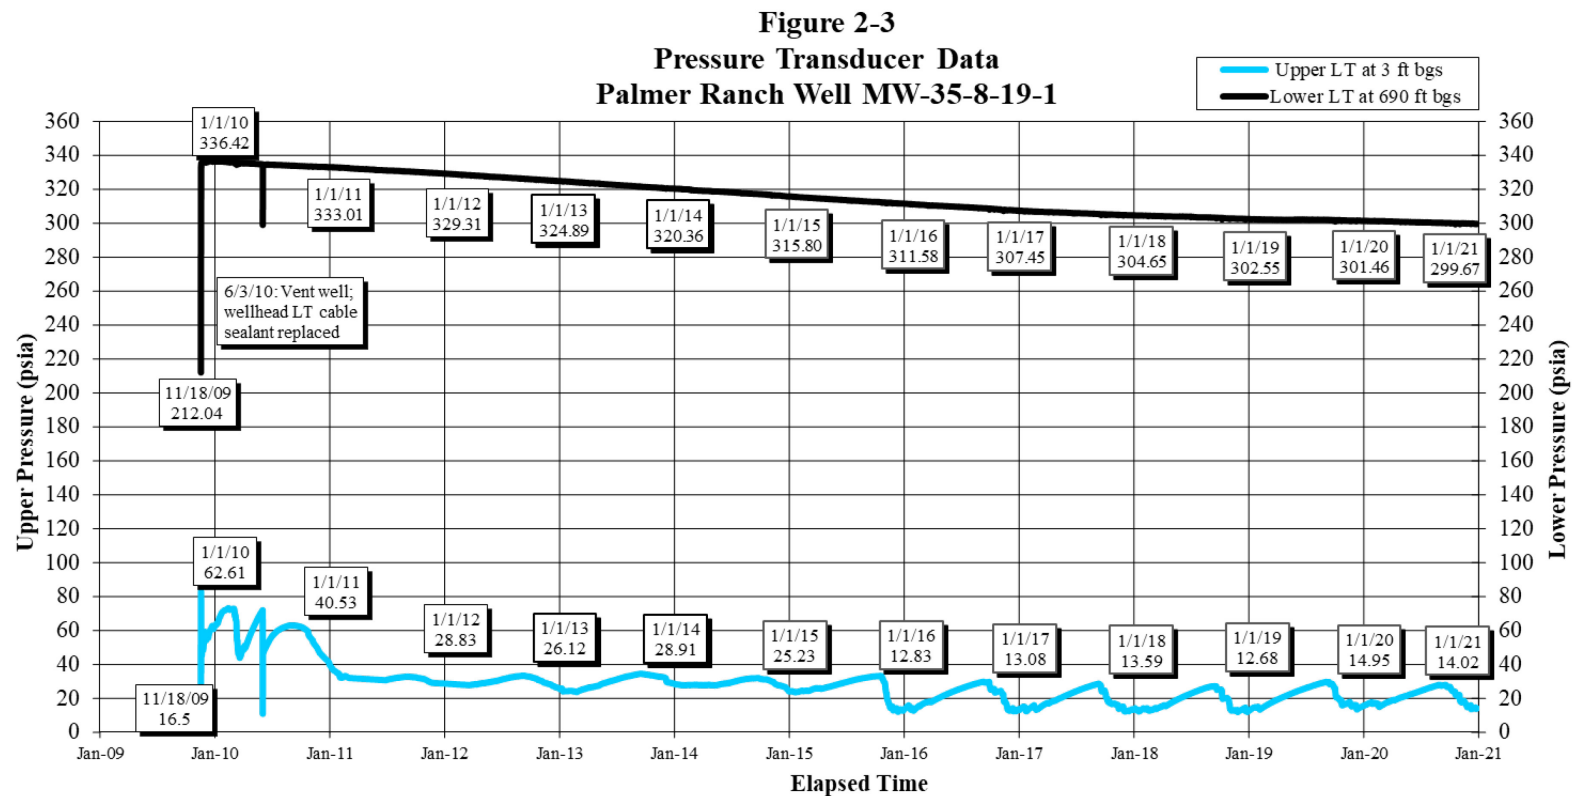
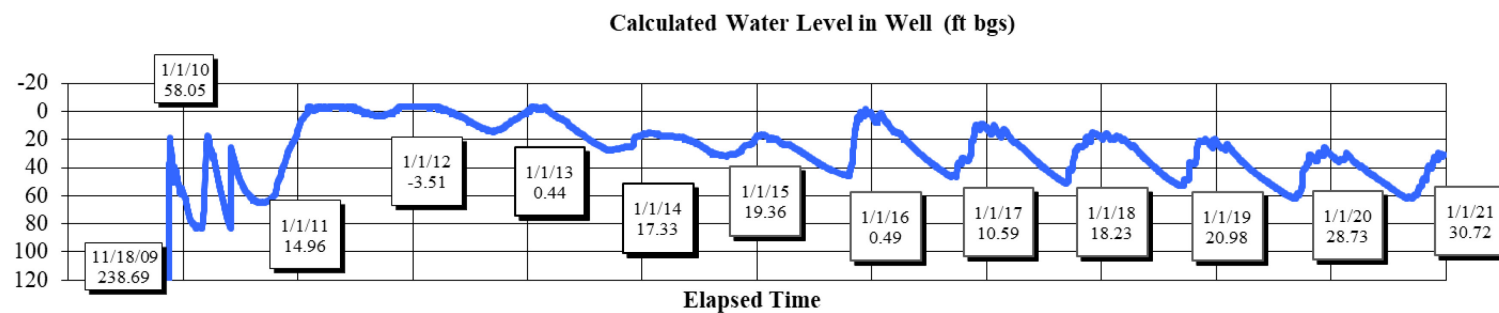
Figure 2-3
Pressure Transducer Data Palmer Ranch Well MW-35-8-19-1

In late October 2015, wellhead pressure apparently began dropping slowly from approximately 33 psi to approximately 12 psi in mid-December 2015. Wellhead pressure then was fairly stable through the winter and then slowly built up from late winter through late summer. The pressure trend appears to be similar but stronger seasonal trend that has been occurring since 2011. The trend repeated through 2020 and

suggests the well has been demonstrating an apparent increased response to seasonal groundwater level changes, increased local groundwater production effects or coal seam reservoir pressure fluctuations. The Florida River runs immediately adjacent to the well and flows are significantly impacted by agricultural irrigation schedules, which may have both direct and indirect effects on observed Fruitland coal seam reservoir pressure and water levels.

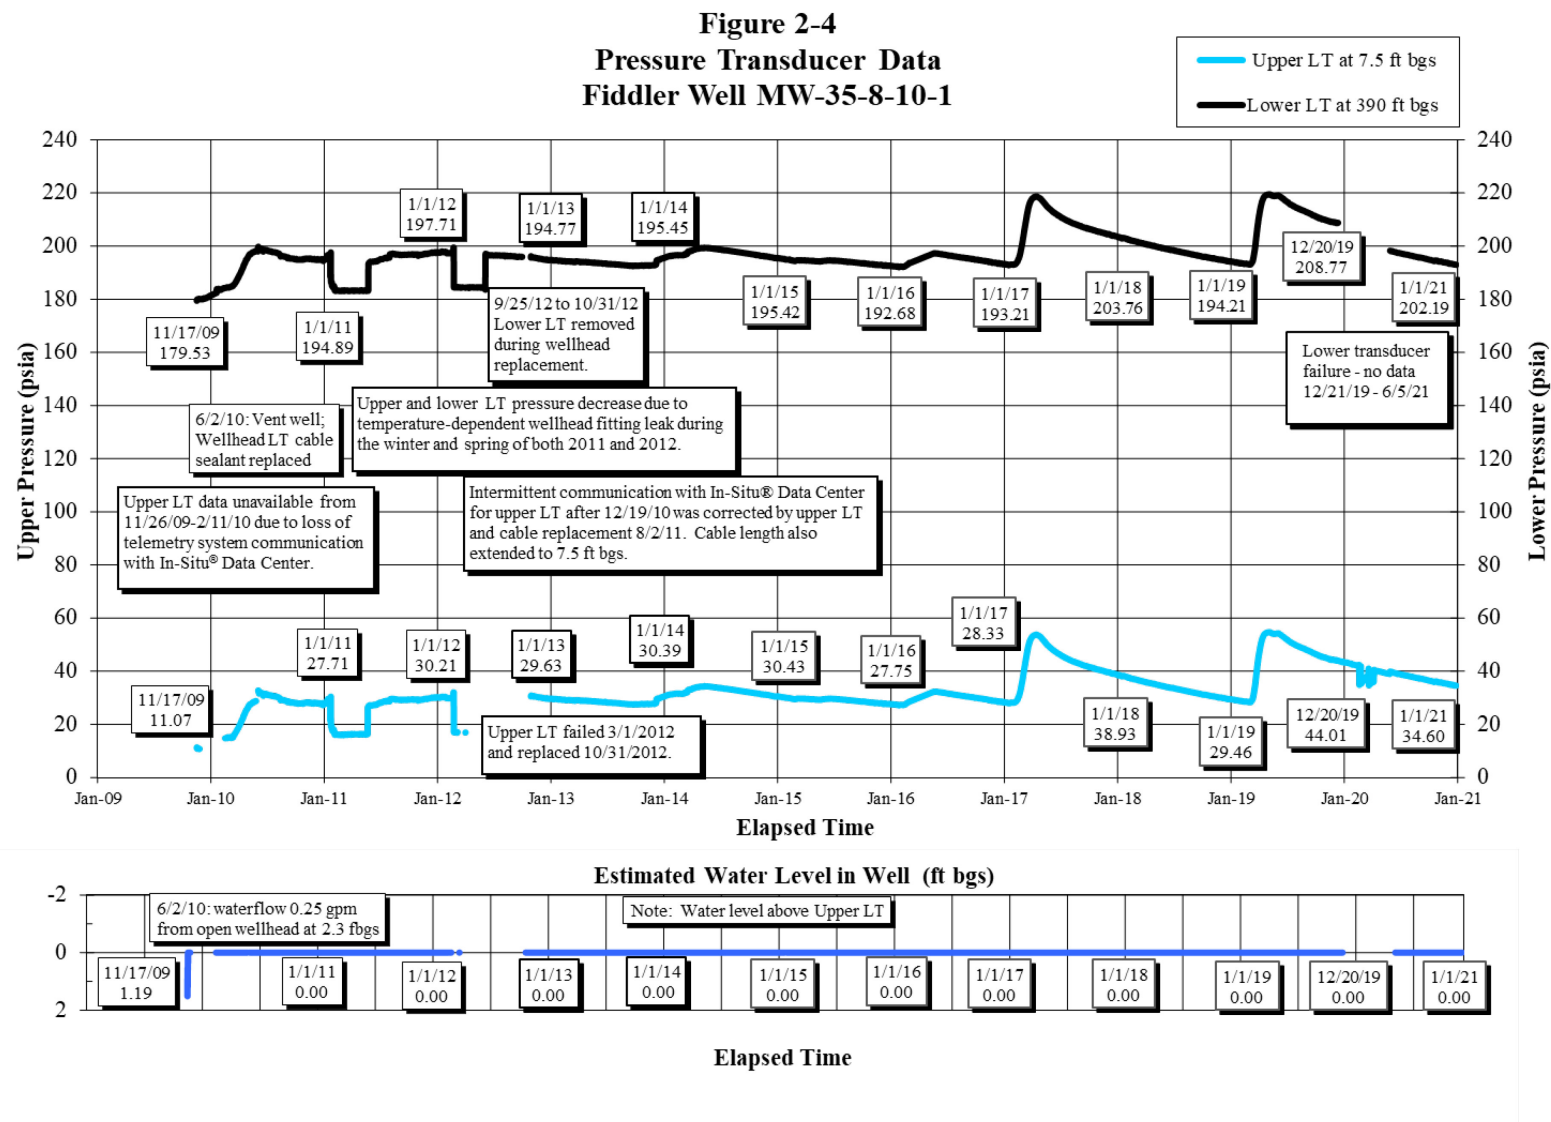
Figure 2-4
Pressure Transducer Data Fiddler MW-35-8-10-1

Monitoring data for MW 35-8-10-1 are plotted in Figure 2-4. The net change in wellhead pressure is 19.76 psi and the net change in downhole pressure is 17.89 psi for the 11-year period of record. As Figure 2-4 shows, both the wellhead pressure and downhole pressure steadily increased from installation on November 17, 2009 to early June, 2010. This well has seen moderate fluctuation in the pressure regime, however instrumentation problems and wellhead leakage occurred until 2013. These issues are discussed below.

As noted on Figure 2-4 the lower Level Troll was removed during wellhead maintenance on September 25, 2012 and reinstalled on October 31, 2012. A net water level change was not calculated because the upper transducer is below the water level in the well. Figure 2-4 documents a natural flow rate from the well at a rate of 0.25 gallons per minute (gpm) when the well was vented for maintenance on June 2, 2010. At the time of the well inspection on October 31, 2012, the flow rate was measured at 0.14 gpm. For charting purposes, the water level in the shut-in well is estimated to be at or near ground surface above the upper pressure transducer (set at 7.5 ft bgs).

Also noted on Figure 2-4, telemetry system communication with the In-Situ® Data Center for the upper transducer was lost from November 26, 2009 through February 11, 2010 due to cable connection problem and was intermittent from December 19, 2010 to January 1, 2011. The upper transducer and cable were replaced during the 2011 well inspection and the cable length was extended from 3 ft bgs to 7.5 ft bgs. Additionally, a wellhead fitting leak during the winter and spring of 2011 through the summer of 2012 caused a pressure decrease observed on both the upper and lower transducers. Related to the freeze-thaw cycles the upper transducer failed again March 1, 2012. Inspection of the wellhead on June 6, 2012

revealed the minor water leak at an estimated flow rate of 0.1 to 0.2 gpm. Evidence of the wellhead freezing and then popping the wellhead seal is observed by the minor pressure spiking on both transducers in January 2011 and February 2012. The tubing head threading was cleaned in an attempt to achieve a pressure tight seal at the mandrel head, but both the rubber seals and threading had deteriorated significantly. Documentation was conducted for a later wellhead replacement. Souder Miller Associates supervised installation of the new wellhead on September 25, 2012, which required removal of all instrumentation from the well. Rather than reset the instrumentation at that time, it was planned to remain out of service until the well inspection conducted by COGCC, Norwest and In-Situ, Inc. on October 31, 2012. During that well inspection the upper transducer was replaced with a new 100 psia Level Troll. Also, as planned, the lower transducer and cable was reset, however the new set depth was approximately 15 feet deeper than the previous set depth, so the proper offset has been incorporated into the lower transducer data in Figure 2-4.

Since mid-2014, the Fiddler monitoring well showed a fairly steady decline in bottom-hole and wellhead pressure of approximately 6 psi through January 1, 2016. However, bottom hole and wellhead pressure measurements show a steady increase of approximately 5 psi from late February 2016 through May 2016. This could have been a response related to temporary shut-in of one or more nearby coal bed methane production wells. A similar pressure decline trend as the 2014-2015 resumed in June 2016.

2017 demonstrated a substantial pressure build-up measured on both the upper and lower transducers. It appears to represent significant groundwater recharge to at least one, if not all of the five Fruitland coal seams monitored in the Fiddler well following the wet winter of 2016-2017. This effect is observed again with similar magnitude following the very wet winter of 2018-2019.

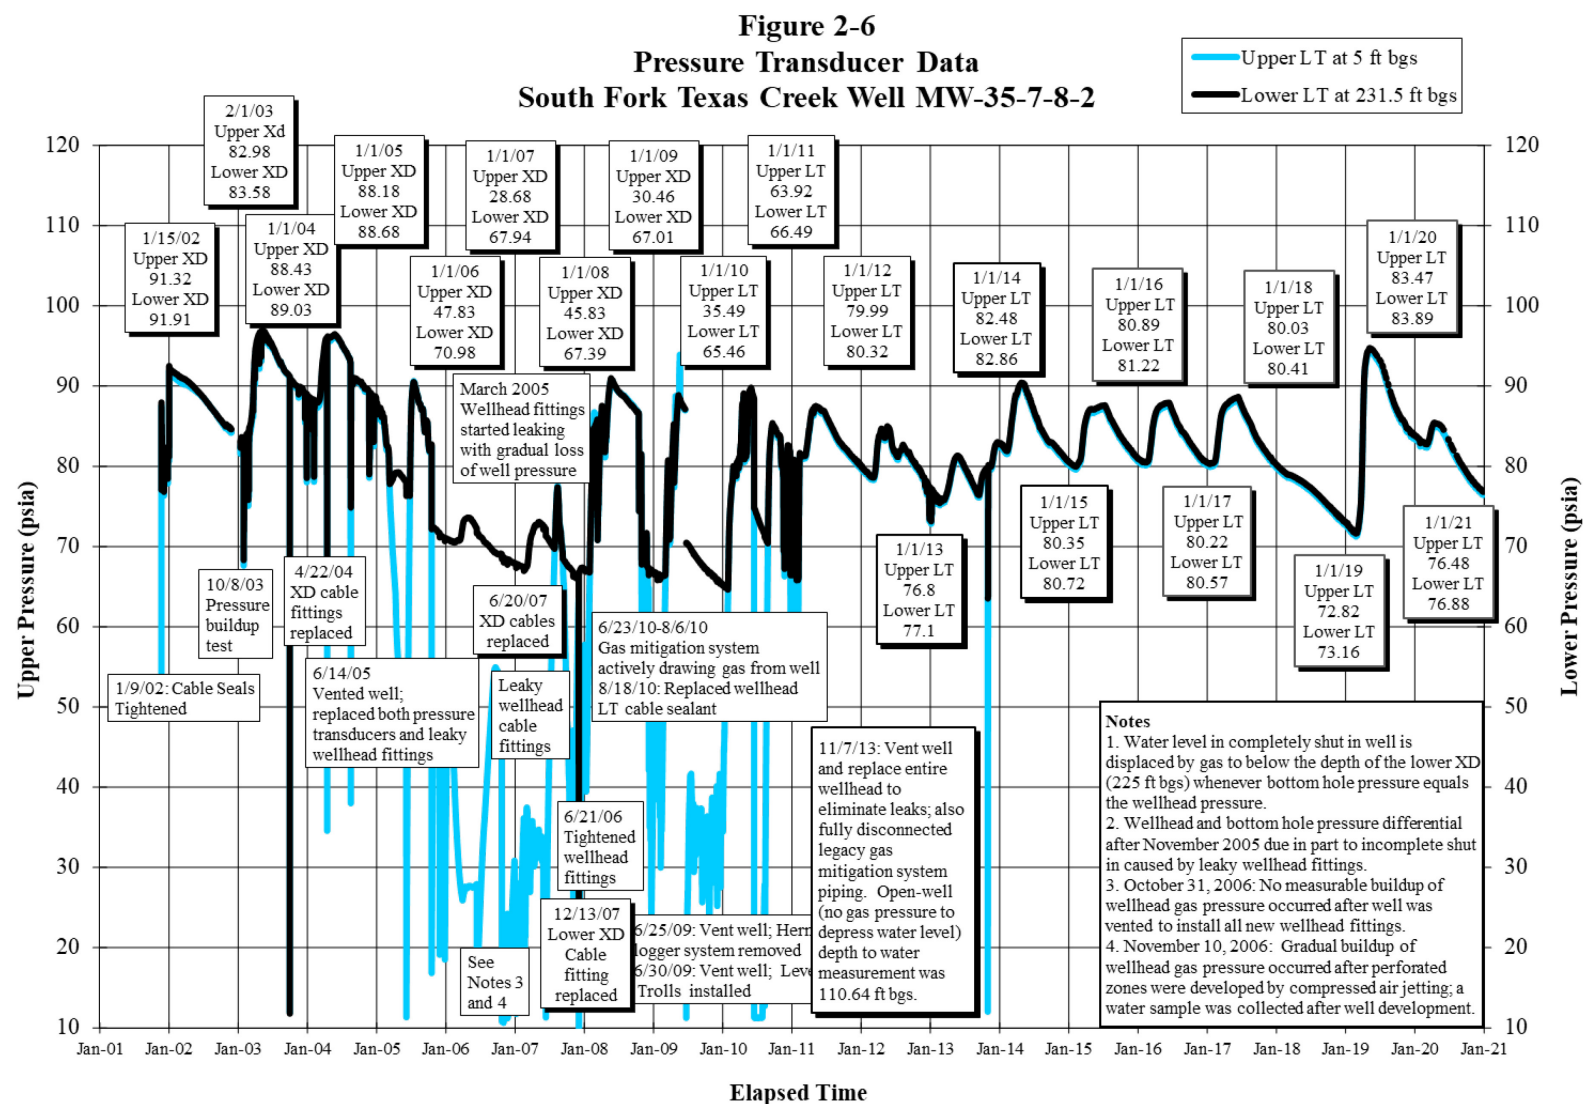
Figure 2-6
Pressure Transducer Data South Fork Texas Creek Well MW-35-7-8-2

Figure 2-6 charts the pressure data for well MW 35-7-8-2, which exhibits an entirely different pressure regime than the deeper monitoring well MW 35-7-8-1. Figure 2-6 shows nearly equal wellhead and downhole pressures for the period of record when the well is completely shut in. For example, wellhead and downhole pressures recorded on January 1, 2021 were 76.48 psia and 76.88 psia respectively under shut-in conditions. Based on the period of record to date, incomplete well shut-in is indicated whenever the well pressure drops below about 70 psia.

Figure 2-6 shows a fairly rapid increase in well pressure after the well was shut in on August 18, 2010. The peak build-up pressure of about 85 psia on September 28, 2010 was followed by an erratic decline in well pressure. The inspection of the well in 2013 documented a minor fitting leak at that time; this was a consistent leak on a pipe fitting that has been attempted to be tightened in the past years but required significant replacement of numerous wellhead fittings. The colder air temperatures occurring with early winter of 2012 and again in 2013 appeared to cause some erratic pressure fluctuations documented with the upper and lower transducers in Figure 2-6. This seemed to indicate that the leak was becoming more significant. On November 7, 2013 a site-specific follow-up trip was conducted to repair the leak that had been most recently documented on September 30, 2013. The well gas pressure was allowed to safely bleed down, with continuous gas detector monitoring. Both upper and lower Level Trolls were removed from the well and the wellhead was completely removed down to the 2-inch line pipe that is the well

A fairly consistent well pressure trend was observed for the previous four years, 2014 – 2017, whereby the well pressure builds in the first two quarters of the year and then falls off during the second two quarters. This trend may be documentation of seasonal effects of groundwater recharge and discharge, natural or otherwise. As 2018 was documented with extreme drought conditions, it appears that the monitored interval did not receive the typical magnitude of recharge. The pressure trend continued to decrease during the usual recharge period of early 2018, with minimal superimposed recharge noted as a slight reversal in the pressure curve character. The excessively wet winter of 2018-2019 appears to have caused a substantial well pressure increase in the late winter and early spring of 2019, with the usual pressure fall-off occurring following for the remainder of the year. The pressure record appears to show that in 2020 the trend was similar to 2019, however more spring season pressure buildup occurred.

casing extending up from the cement pad. The threads were reconditioned with a hand-operated 2-inch pipe die. The wellhead was reconstructed using all new carbon steel pipe fittings, with the exception of the Conax compression fittings secured around each Level Troll Rugged Cable, as they had not been documented as leaking. Several manual water level measurements were taken while the wellhead was open. Initially, the water level recovered fairly quickly as the gas pressure was vented. After approximately 2.5 hours open during the new wellhead installation, the water level was relatively stable and measured 110.64 ft bgs. This is the static water level when no gas pressure is allowed to depress the water column in the well. As can be seen in Figure 2-6, the upper and lower Level Troll pressure readings diverge at this time indicating that for the short period following well shut-in the lower Level Troll was actually submerged in water. The lower Level Troll pressure reading was approximately 63.6 psia, which calculates to 111.06 ft bgs. This gives good confidence in the calculated versus measured water level in this well, given error in the assumption of atmospheric pressure which is not currently recorded at this location. To prevent damage to the existing lower Level Troll cable, the Conax compression fitting was not adjusted to offset the new wellhead's increased height above ground surface of 0.25 feet, so the new set depth is 231.25 ft bgs. No leaks have been detected at this wellhead since the replacement.

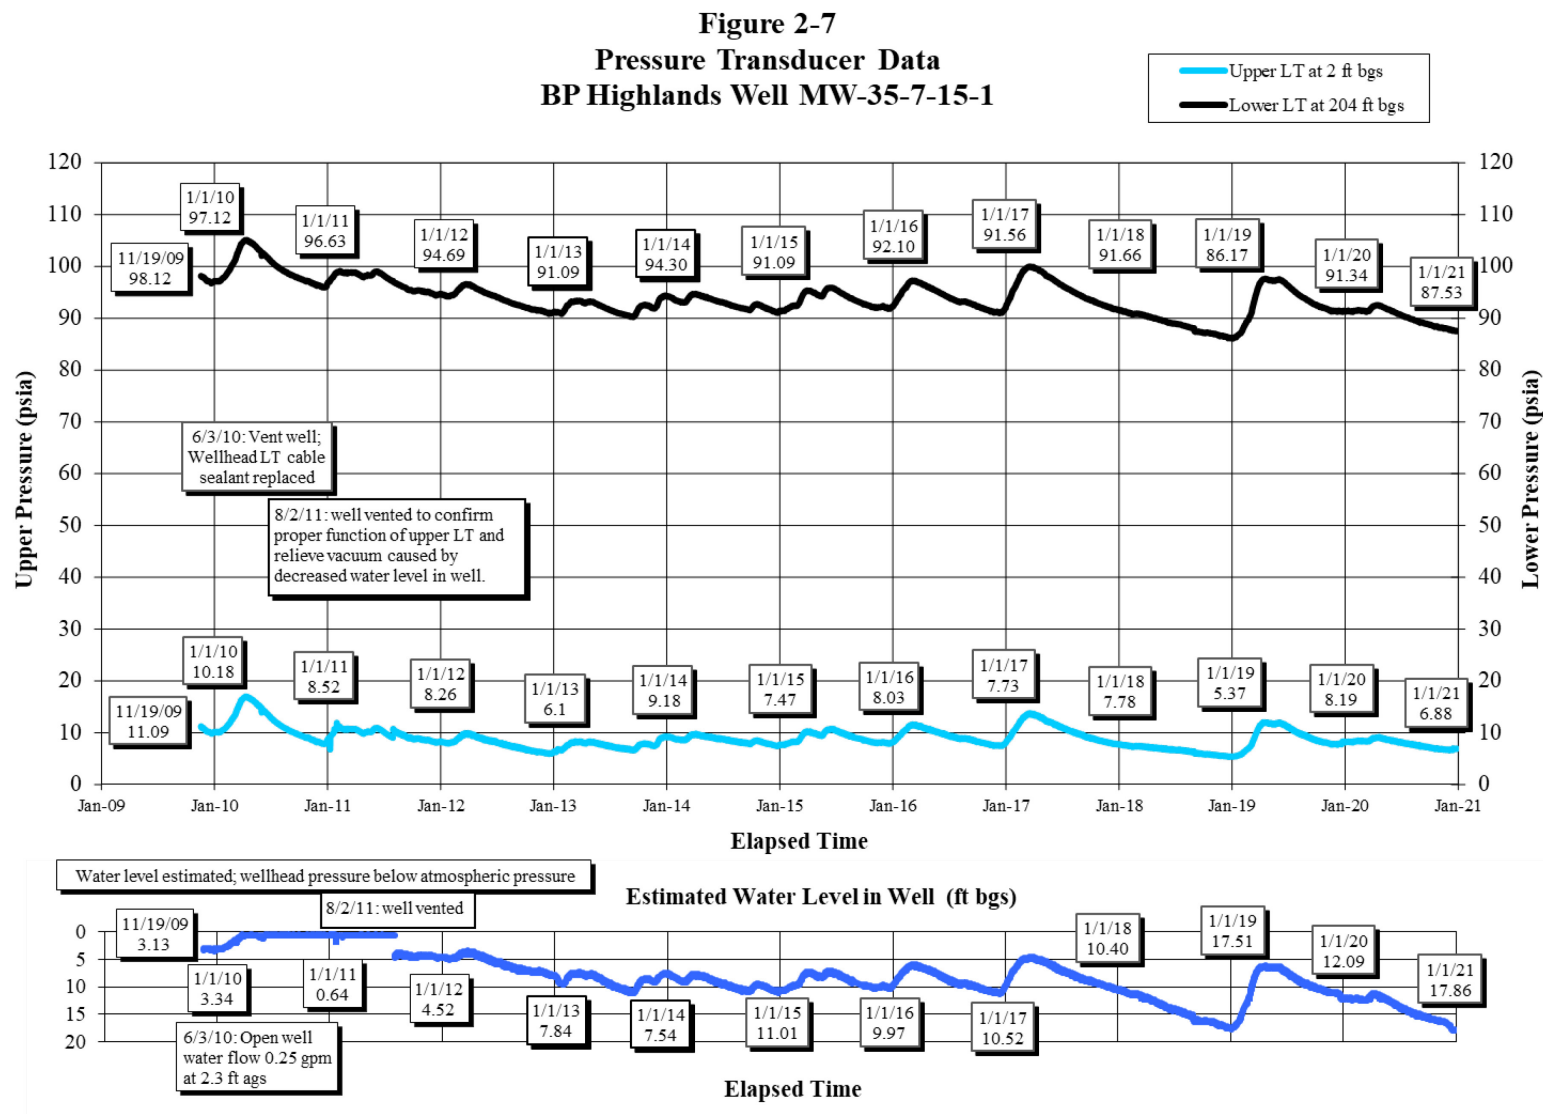
Figure 2-7
Pressure Transducer Data BP Highlands Well MW-35-7-15-1

Monitoring data for MW 35-7-15-1 are plotted in Figure 2-7. As summarized in Table 2-5 for the 11-year period of record, the net change in downhole pressures is a decrease of 10.59 psi. The well follows an overall decreasing pressure trend with seasonal variability dominated by late winter/early spring. The net change in the calculated water level in the well is a decrease of 14.73 feet. The magnitude of this decrease was approximately doubled in 2018 due to extreme drought conditions and complete lack of observable recharge. This all but repeated again in 2020, with a very muted recharge trend when compared to 2016 and 2017. As noted on Figure 2-7, water flowed from the well at a rate of 0.25 gallons per minute (gpm) when the well was vented for maintenance on June 3, 2010. For charting purposes, the water level in the shut-in well at that time was estimated to be slightly above ground surface with the upper transducer under water at 2 ft bgs.

The wellhead pressure started dropping below atmospheric pressure around August 12, 2010. This condition suggested either a potential problem with the upper transducer or a well pressure vacuum effect created in a completely shut-in well under declining water level conditions. A well instrumentation inspection and atmospheric pressure check conducted during each subsequent site visit through 2013 has confirmed the proper function of the upper transducer. Venting the well allowed for physical confirmation that the well was under vacuum pressure conditions which have continued through January 1, 2021.

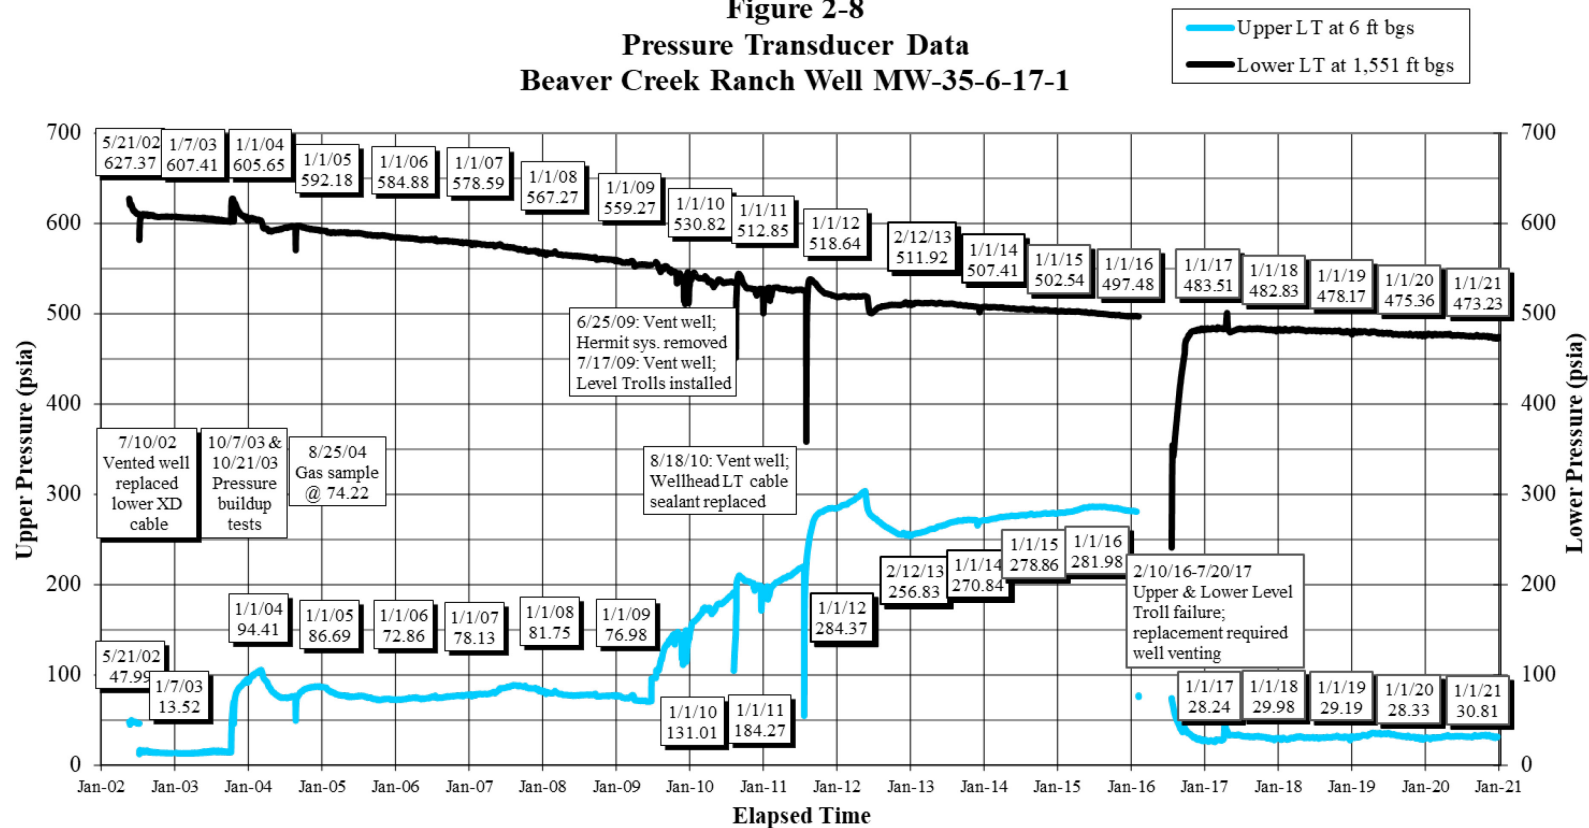
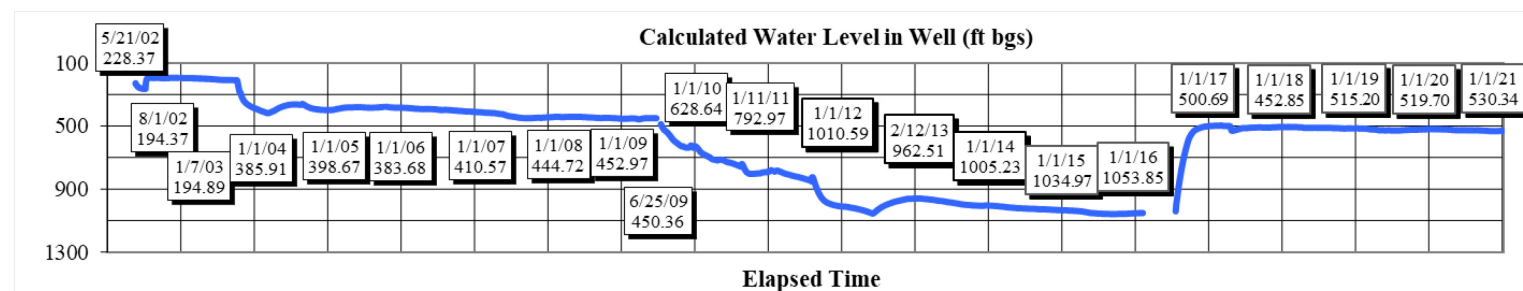
Figure 2-8
Pressure Transducer Data Beaver Creek Ranch Well MW-35-6-17-1

data demonstrates that following this bleed-off the wellhead pressure has remained depressed at approximately 30 psi and relatively stable. This is likely because the water head pressure of approximately 500 feet (215 PSI) is effectively preventing significant gas build-up at the wellhead.

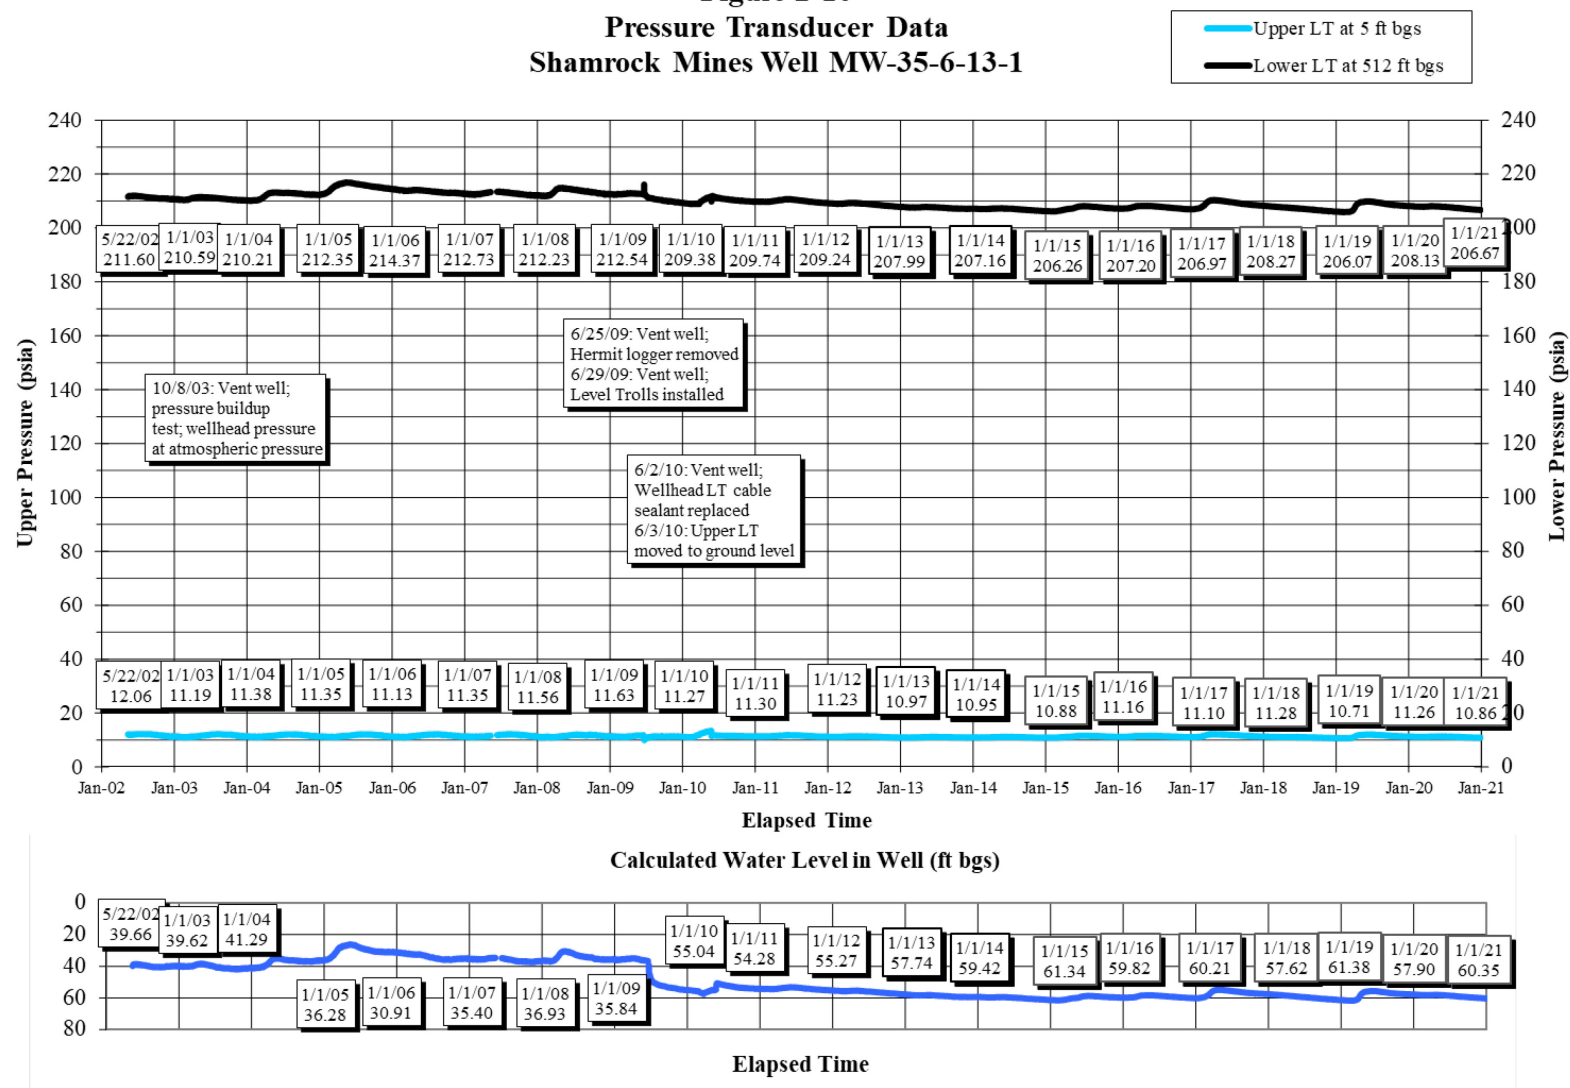
Figure 2-10
Pressure Transducer Data Shamrock Mines Well MW-35-6-13-1

Figures 2-10 shows the wellhead pressure regime continues to be at atmospheric pressure and fluctuates within a range of 2 psi (between 10 psia and 12 psia). During the months of April and May 2010, the wellhead pressure steadily increased to around 13.4 psia. Wellhead pressure returned to the historic atmospheric pressure trend after the Level Troll wellhead cable sealants were replaced on June 2, 2010.

Figure 2-10 also shows the downhole pressure and calculated water level in the well continued to exhibit an overall declining well pressure trend for the period of record since April 2005. With wellhead pressure equal to atmospheric pressure, fluctuation of downhole pressure is associated with the fluctuation of the water level in the well. Downhole pressure and corresponding calculated water levels have documented seasonal groundwater recharge events following the wet winters of 2007-2008, 2009-2010, 2016-2017 and 2018-2019.

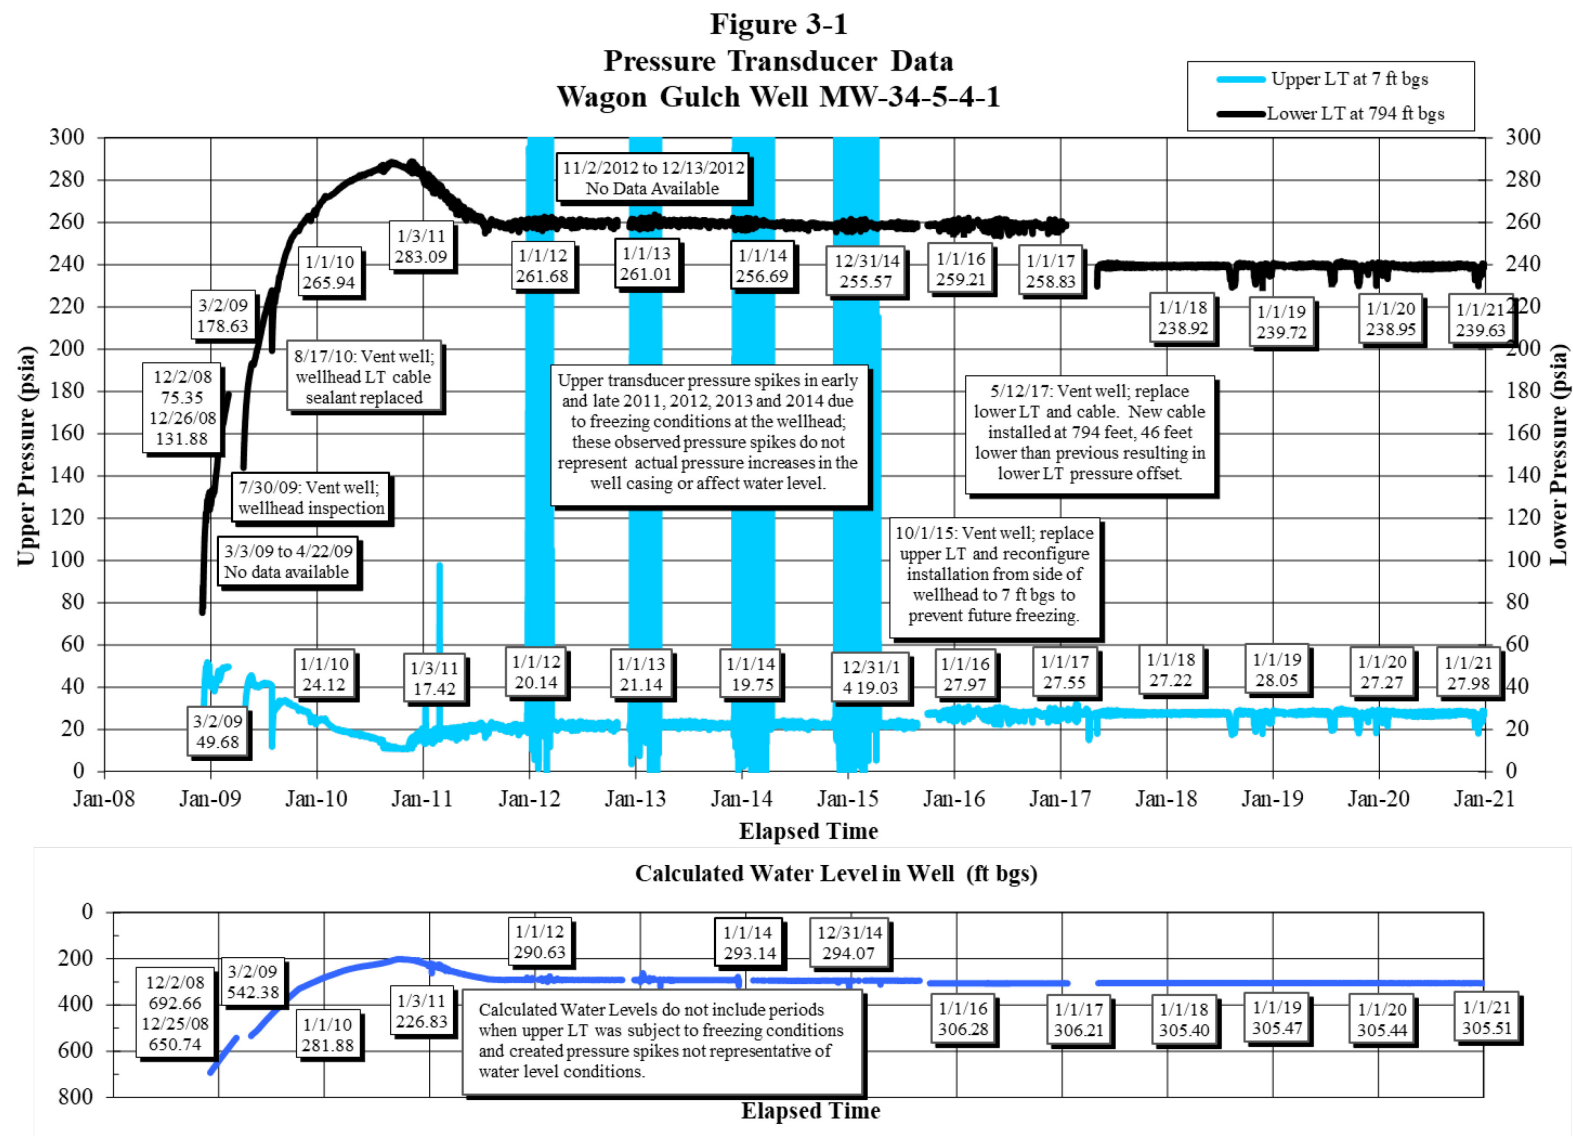
Figure 3-1
Pressure Transducer Data Wagon Gulch Well MW-34-5-4-1

2008. Figure 3-1 shows the trend of rising water level with corresponding increasing downhole pressure continued in 2010 until the trend reversed in mid-September 2010. This may have been related to the transducer cable sealant being changed on August 17, 2010 and possibly eliminating a partial shut-in condition. No leaks were detected during the site inspections in 2012-2014. Between October 1, 2010 and December 31, 2010, Figure 3-1 shows the water level decreased about 21.2 feet while the downhole pressure decreased about 2.7 psia.

During the winters of 2011-2012, 2012-2013, 2013-2014 and 2014-2015 pressure spikes in the upper transducer occurred due to the pressure transducer freezing within its deployment location in the wellhead 2.3 feet above ground surface. These are not actual increases in gas pressure within the well casing, but rather caused when the air volume next to the transducer inlet is trapped and then compressed by expanding frozen water condensate. When the 2011 well inspection was conducted at MW 34-5-4-1 the well was vented to ensure that the transducer would return to atmospheric pressure; this test successfully showed that the transducer continued to function properly and was not damaged. The transducer recovered after surface temperatures warmed each spring. The transducer was inspected for damage in each subsequent site visit since this problem began in 2011 until the 2015 site inspection when the Level Troll was replaced and lowered into the well to 7 ft bgs. As evidenced by the winter 2015 data shown in Figure 3-1, the condensate freezing problem in this location has been corrected by lowering the Level Troll below the ground surface.

Several pressure decreases on the order of 10 psi were observed by both the upper and lower transducers in the second half of 2018, 2019, and 2020. The duration of each event was on the order of days to weeks and full recovery to static pressure conditions occurred after each event. These are likely observed interference effects from nearby groundwater production.
