Colorado Oil and Gas Conservation Commission

Monitor Wells Summary Report
2020

4M Project Monitoring Program
Archuleta and La Plata Counties
Colorado

April 23, 2021

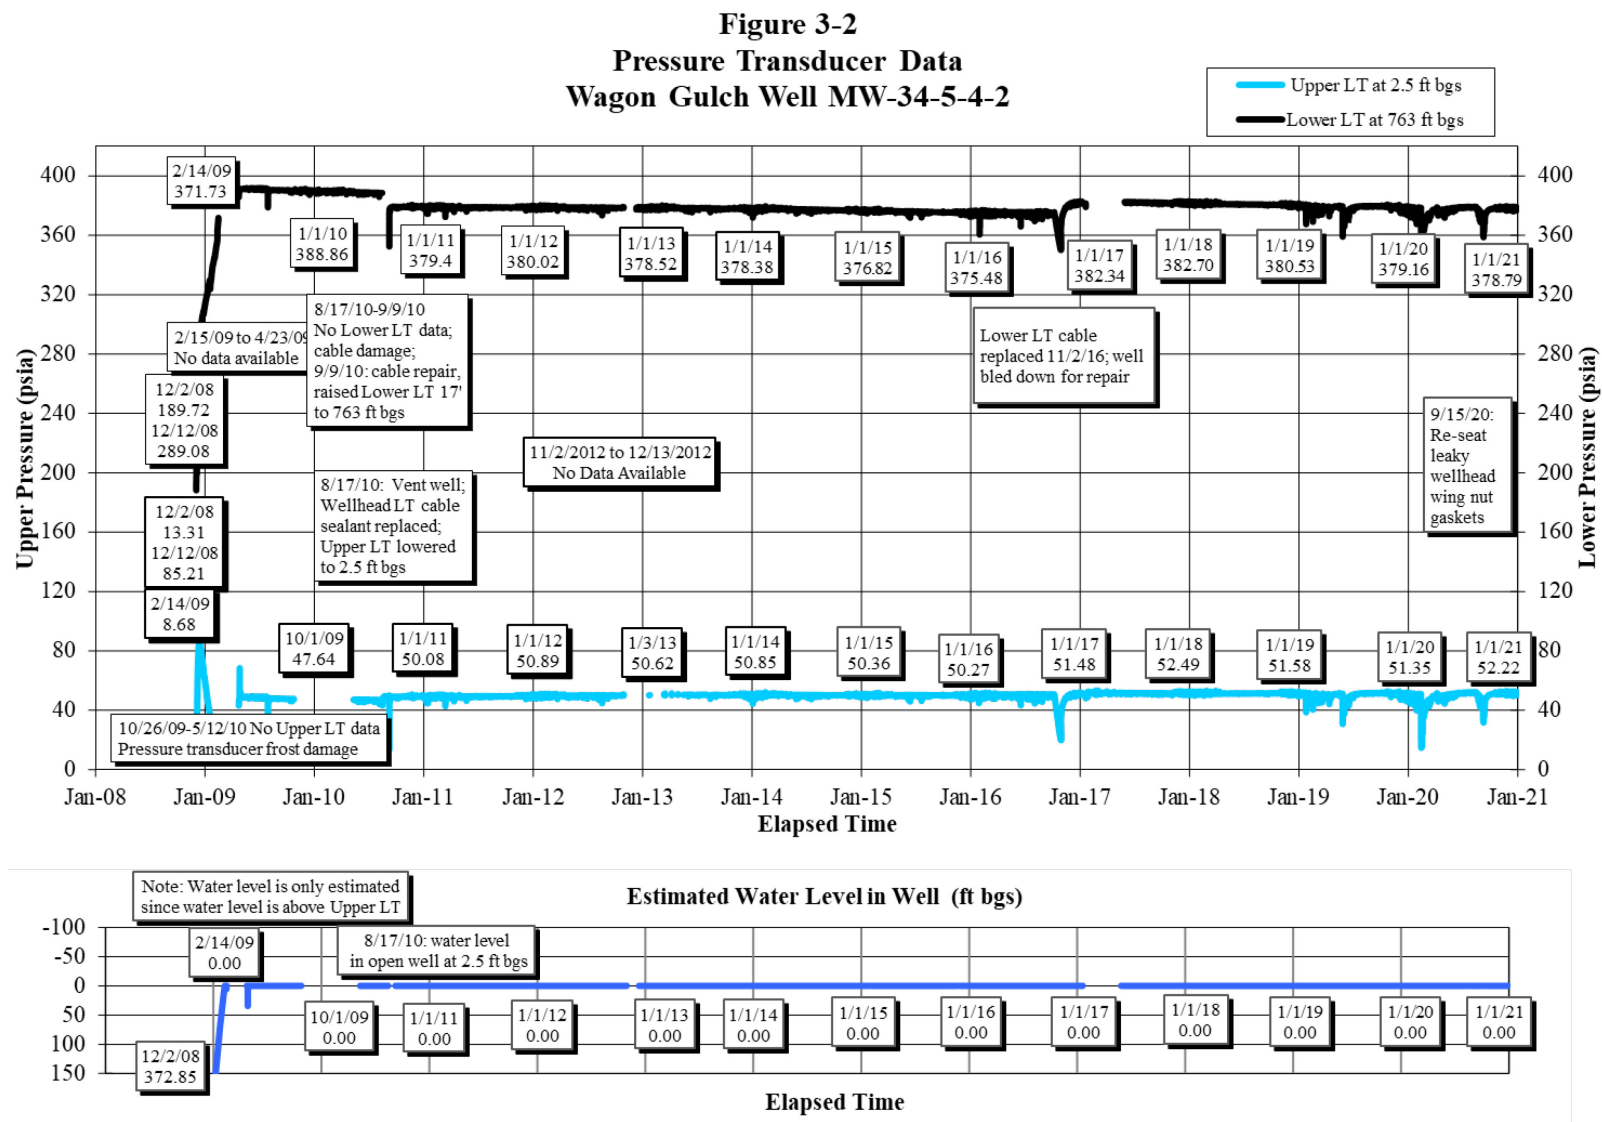
Figure 3-2
Pressure Transducer Data Wagon Gulch Well MW-34-5-4-2
3-5

Figure 3-2 shows a relatively constant wellhead pressure of about 47 to 48 psia between April 24, 2009 and October 25, 2009. An erratic pressure spiking pattern between October 26, 2009 and May 12, 2010 suggested wellhead Level Troll pressure sensor freeze damage, so the data were omitted from Figure 3-2. Between May 13, 2010 and August 16, 2010, the wellhead pressure remained fairly constant at around 47 psia.

Freeze damage to the upper Level Troll pressure transducer sensor was confirmed after the well was vented on August 17, 2010. As noted on Figure 3-2, the water level inside the open wellhead was at a height of about 2.5 feet above ground level. The new upper Level Troll was changed from an external mount to an internal depth setting of 2.5 ft bgs on August 17, 2010 to protect the transducer sensor from freezing conditions. After well shut-in on August 17, 2010, Figure 3-2 shows a relatively rapid return of wellhead pressure to an average constant pressure of about 50 psia.

The lower Level Troll cable was damaged during replacement of Level Troll wellhead cable sealants on August 17, 2010. Cable repair performed on September 9, 2010 included raising the Level Troll 17 feet from 780 ft bgs to 763 ft bgs. As a result of this change, Figure 3-2 shows a shift in the downhole pressure curve to a corrected constant downhole pressure regime of 378 to 379 psia.

As noted above, the water level was inside the open wellhead at a height of about 2.5 feet above ground level on August 17, 2010. The wellhead pressure build-up after shut-in may reflect water and/or gas pressure build-up. For charting purposes, the water level in the shut-in well is estimated to be at or near ground surface above the upper Level Troll (set at 2.5 ft bgs). However, there is a possibility that the observed build-up in wellhead pressure is from gas pressure, which could result in a downward displacement of the water in the well to some level below the upper Level Troll.

The pressure regime observed in 2020, as well as for the full period of record since post-completion stabilization in 2009, has been quite stable with an overall minor decreasing trend. The exception is apparent multiple drawdown cycles observed in 2019 and 2020, which are likely observed interference effects from nearby groundwater production.

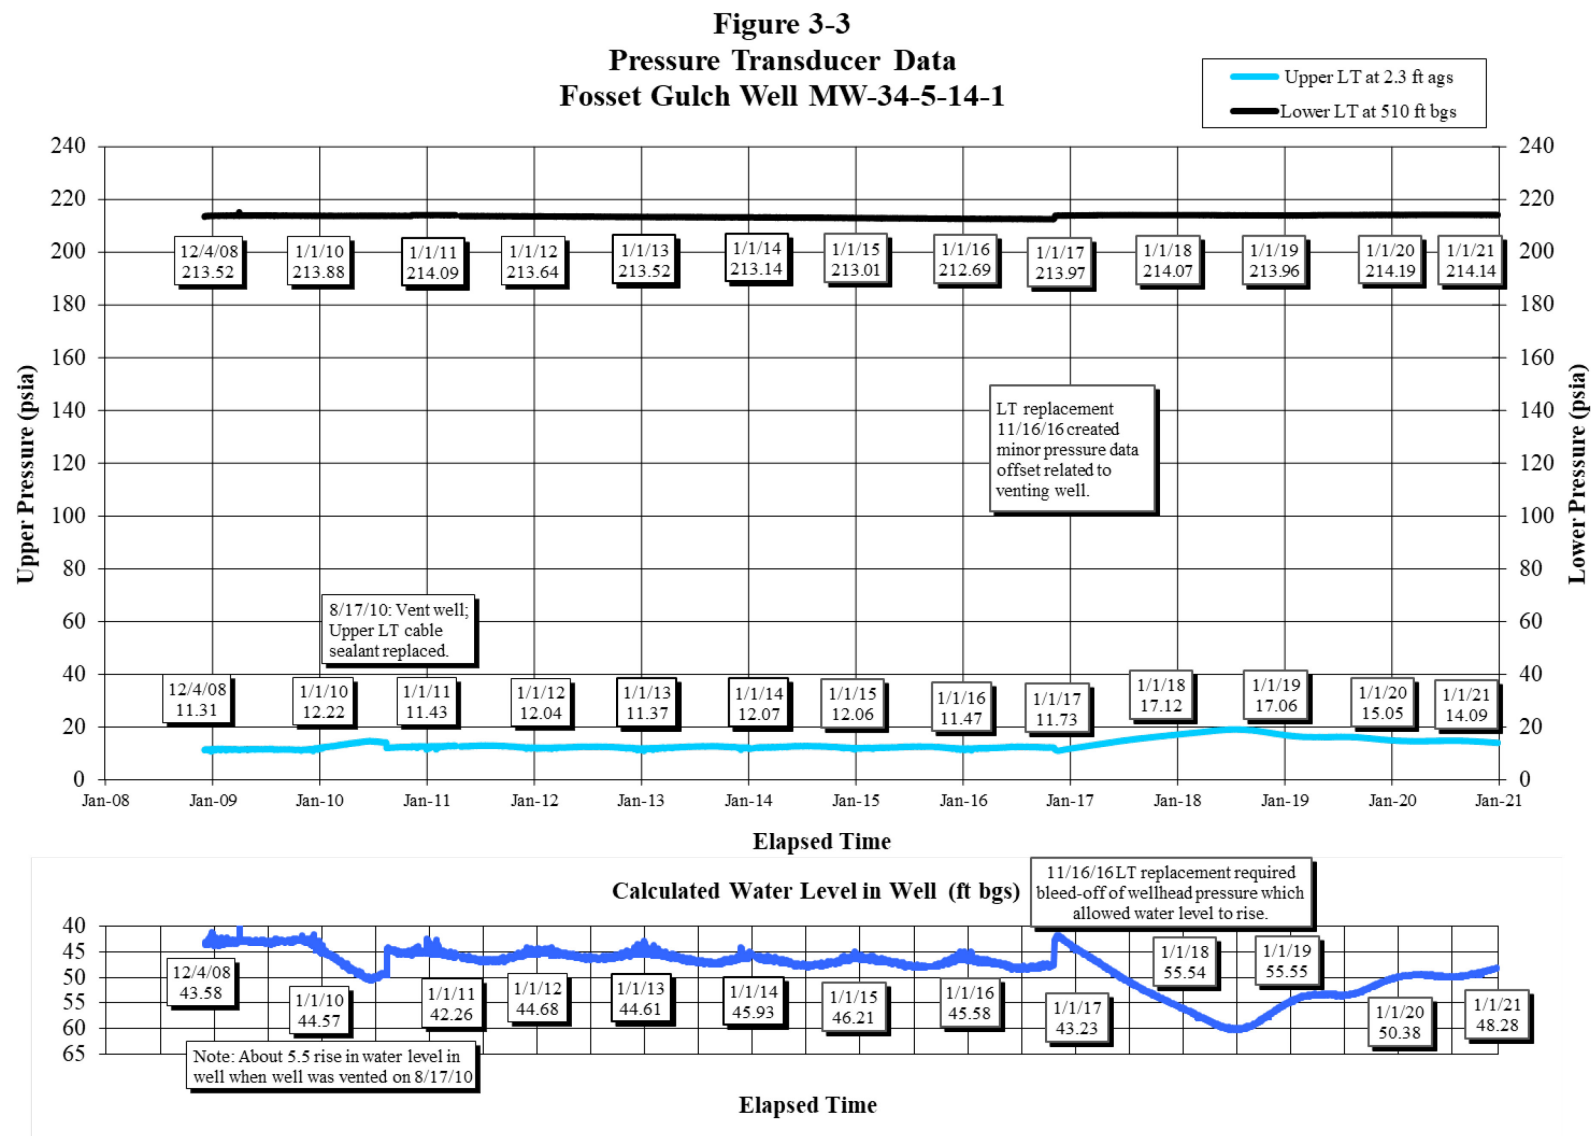
Figure 3-3
Pressure Transducer Data Fosset Gulch Well MW-34-5-14-1

Figure 3-3 charts the upper and lower pressure transducer data and the calculated water level in the well. Table 3-2 and Figure 3-3 show the wellhead pressure at atmospheric pressure prior to 2010 followed by a gradual increase in pressure through August 16, 2010 to 14.19 psia. Following the August 17, 2010 well maintenance event including venting, the wellhead pressure has remained relatively constant within a normal atmospheric pressure range through November 16, 2016. At that time, upper transducer replacement required venting the wellhead. Following the maintenance, the wellhead pressure increased slowly until July 2018 when it began to trend down. This is likely a response to gas production stimulation that occurred when the well was vented. Figure 3-3 shows a stable downhole pressure trend (213.52-214.19 psia) for the entire period of record. Figure 3-3 also shows a stable water level averaging 43.0 ft bgs until November 2009, followed by a gradually declining water level trend through July 1, 2010 (50.13 ft bgs). The water level increased to 49.28 ft bgs until the well was vented on August 17, 2010. The water level immediately rose to 44.36 ft bgs when the well was vented on August 17, 2010 but has since followed apparent gentle seasonal fluctuation until November 16, 2016. At that time, the well was vented to replace the upper pressure transducer. Upon replacement, the pressure measured at the wellhead has steadily increased from approximately 12.20 psi to 17 psi on January 1, 2019 and then changed to a decreasing pressure trend. As such, the calculated water level was in steady decline during this time period as gas pressure has apparently depressed it. Likewise, with the 2018 reversal of the wellhead gas pressure

increase trend to a decreasing trend, the calculated water level is now shown to be increasing through 2020 superimposed over seasonal fluctuations.

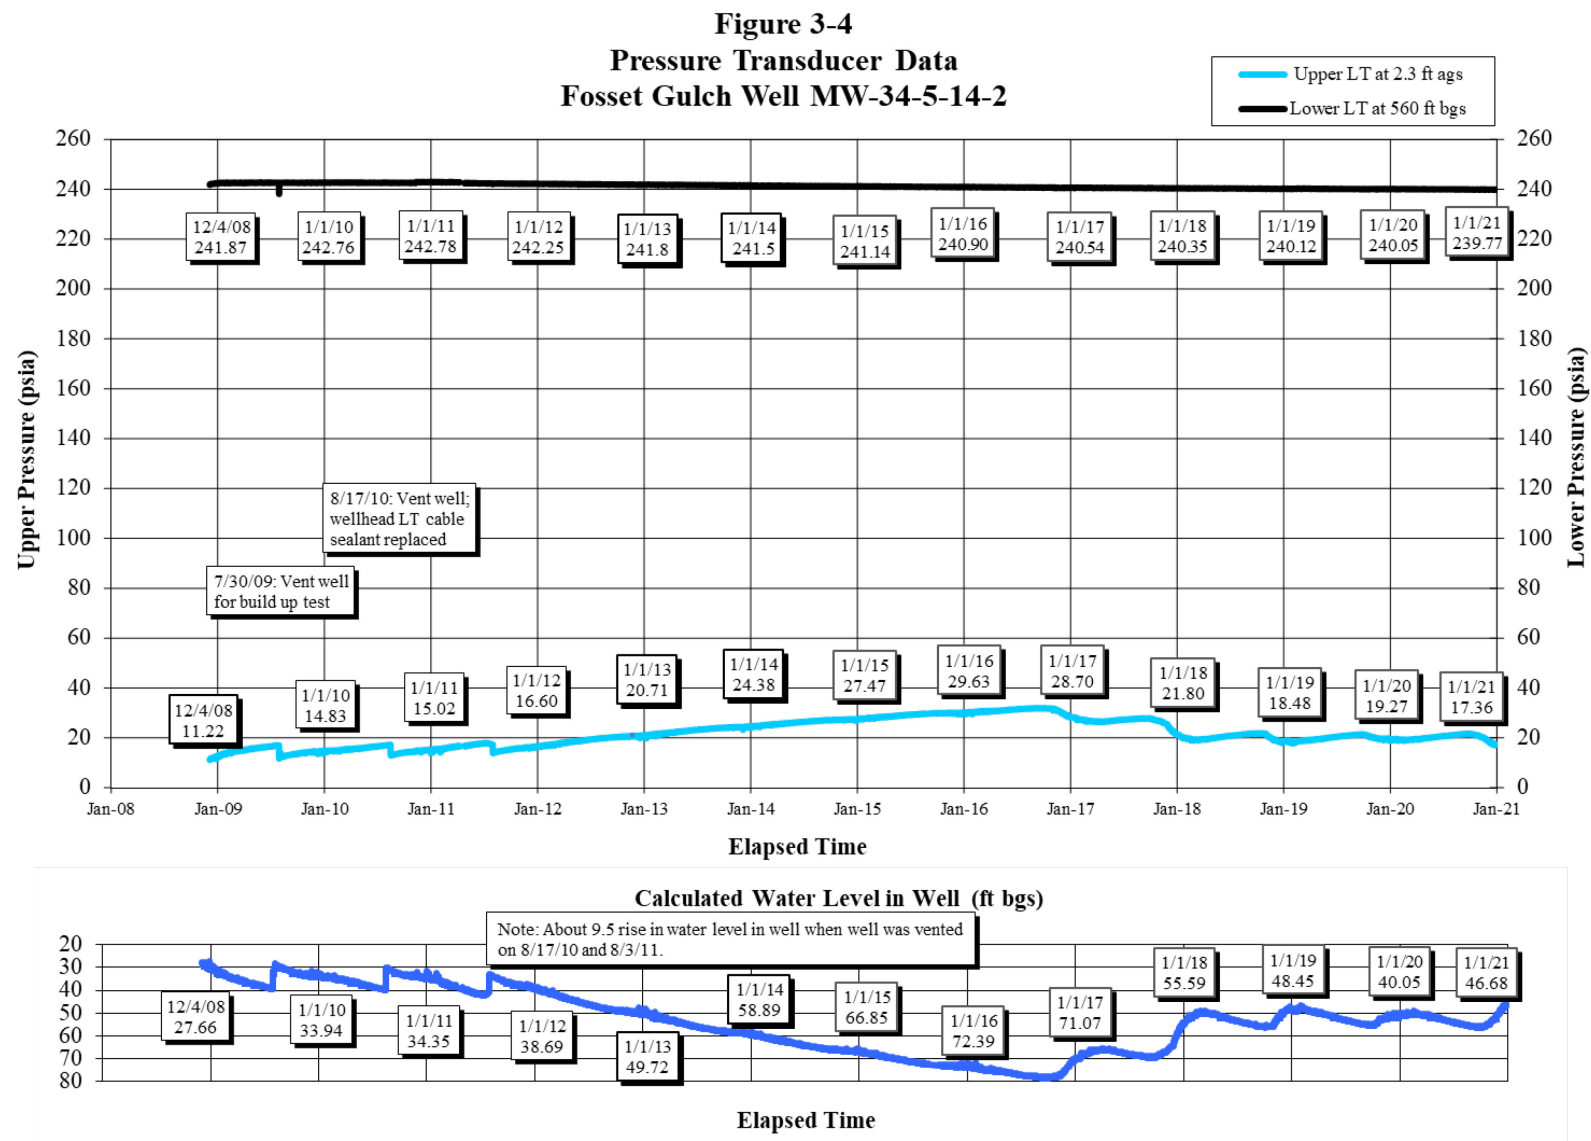
Figure 3-4
Pressure Transducer Data Fosset Gulch Well MW-34-5-14-2

Figure 3-4 plots the upper and lower pressure transducer data and the calculated water level in the well. Although the well was shut in for monitoring on December 4, 2008, wellhead pressure did not stabilize at about 17 psia until July 2009. Table 3-2 and Figure 3-4 show a net increase of 7.13 psi in wellhead pressure for the period of record between December 4, 2008 (11.35 psia) and January 1, 2019 (18.48 psia). Figure 3-4 shows a stable but slightly declining downhole well pressure trend for the entire period of record, with fluctuations ranging between a minimum pressure of about 239.77 psia to a maximum pressure of 242.78 psia. The downhole pressure was 239.77 psia on January 1, 2021, a new low as the pressure trend has been very slightly decreasing over 12 years of monitoring.

Table 3-2 indicates a net water level drop of 7.39 feet in the well as of January 1, 2021. However, Figure 3-4 shows that the wellhead pressure and water level in the last four years has apparently shown an effect of venting MW 34-5-14-1 for maintenance on 11/16/16. This would suggest some amount of hydraulic connection between the two wells. Although there is an immediate drop in wellhead pressure and corresponding rise in the water level each time the well is vented to the atmosphere in the past, Figure 3-4 also shows the build-up in wellhead pressure takes approximately 12 months to return to the pressure exhibited prior to each venting event so unless required for servicing the instrumentation, the well will not be vented in attempt to determine the static wellhead pressure.

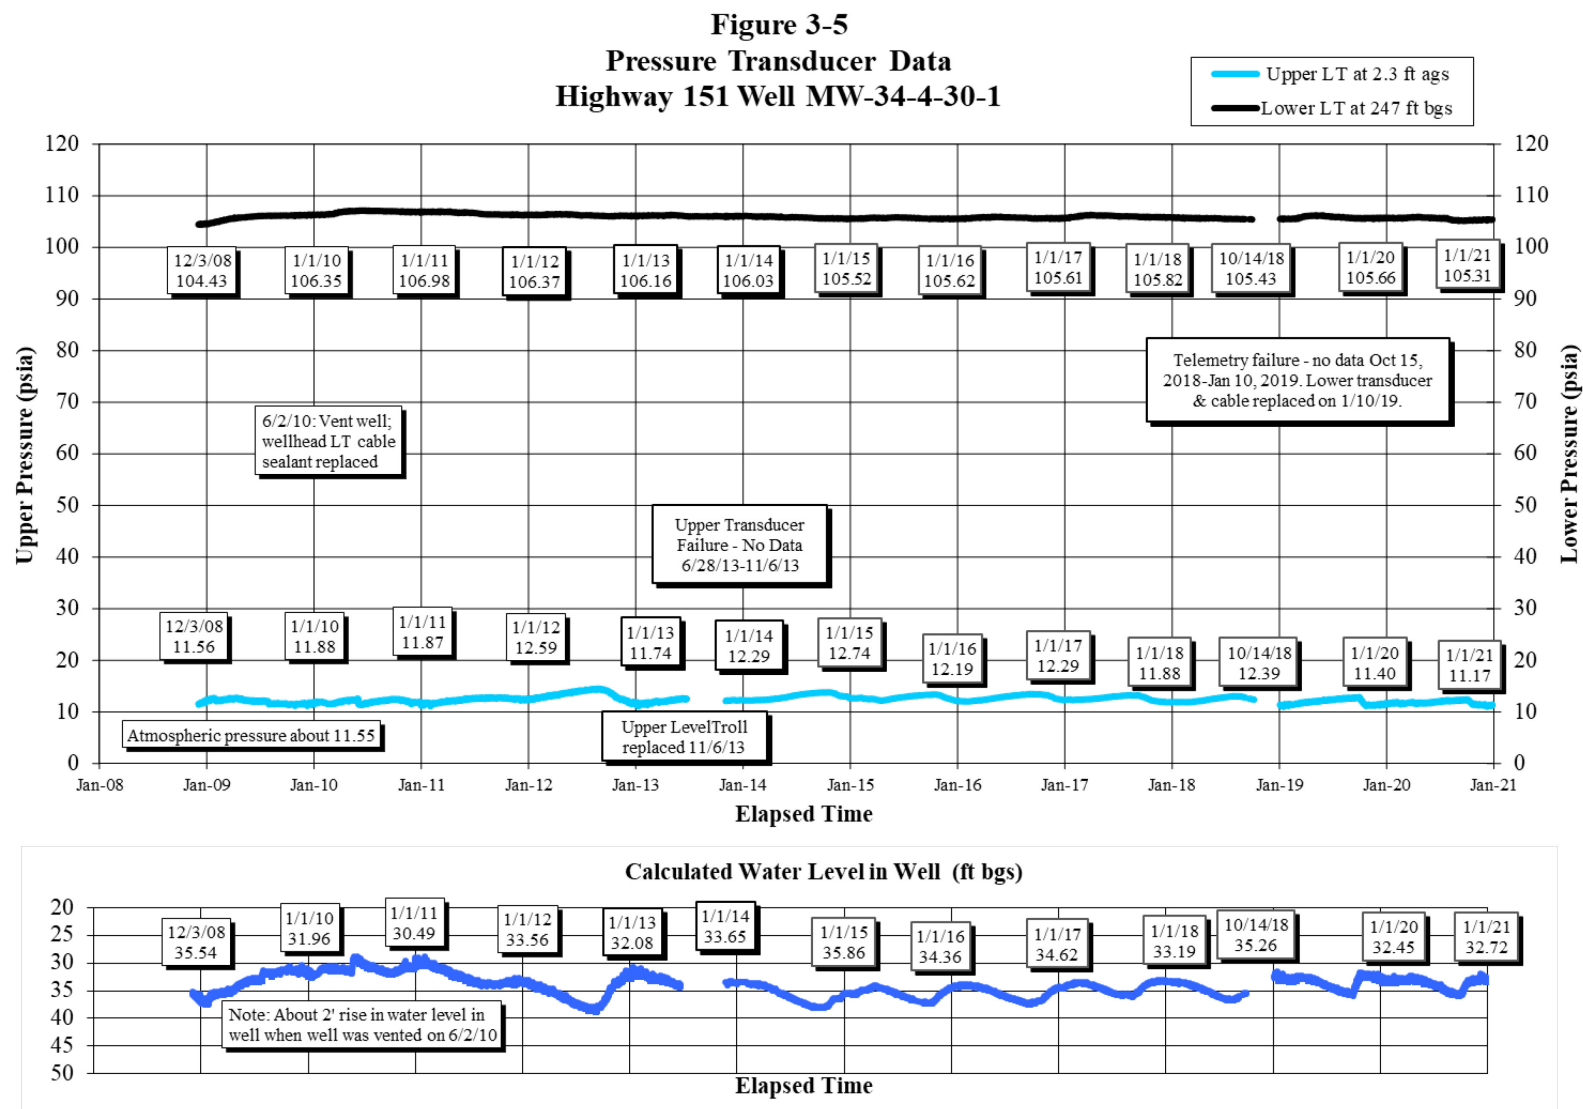
Figure 3-5
Pressure Transducer Data Highway 151 Well MW-34-4-30-1

Figure 3-5 charts the upper and lower pressure transducer data and the calculated water level in the well. Table 3-3 and Figure 3-5 show a relatively stable well pressure regime with a stable wellhead pressure trend at atmospheric pressure, a stable downhole pressure trend of about 104-107 psia, and a fluctuating water level trend of 30-39 ft bgs since August 2009. Sharp fluctuations in both wellhead pressure and the calculated water level shown on Figure 3-5 correspond to the immediate loss of pressure when the well is vented (e.g., June 2, 2010), followed by a gradual return to the well pressure regime exhibited prior to venting the well.

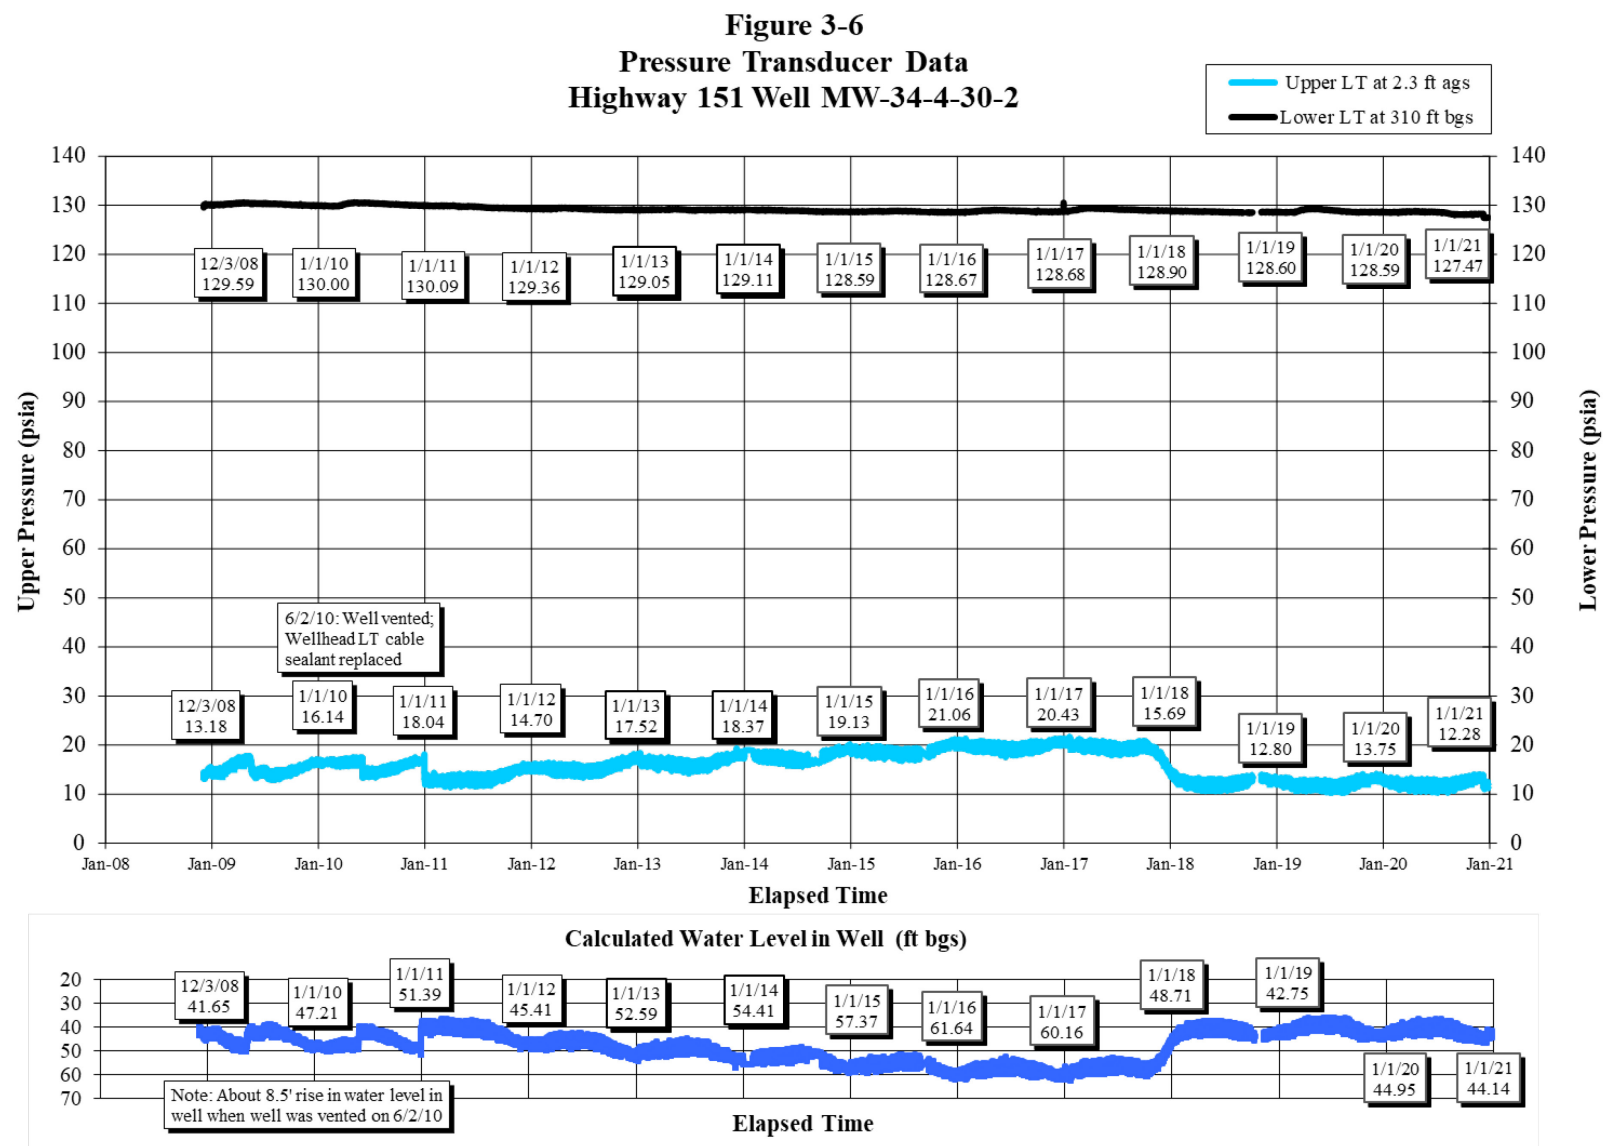
Figure 3-6
Pressure Transducer Data Highway 151 Well MW-34-4-30-2
3-14

Figure 3-6 charts the upper and lower pressure transducer data and the calculated water level in the well. Table 3-3 and Figure 3-6 shows a stable downhole pressure trend with 2.12 psi change from 129.59 psia on December 3, 2008 to 127.47 psia on January 1, 2021. In addition, there was a net wellhead pressure decrease of 0.90 psi with a corresponding net water level decline of 2.49 feet for the entire period of record from December 3, 2008 to January 1, 2021. However, the wellhead pressure decreased slowly in the fourth quarter of 2017 with a loss measured at approximately 4.3 psi in 3 months. The pressure then stabilized at atmospheric pressure and has remained in that range through 2020. The well was inspected in 2019 during routine maintenance and no wellhead pressure leaks were found.

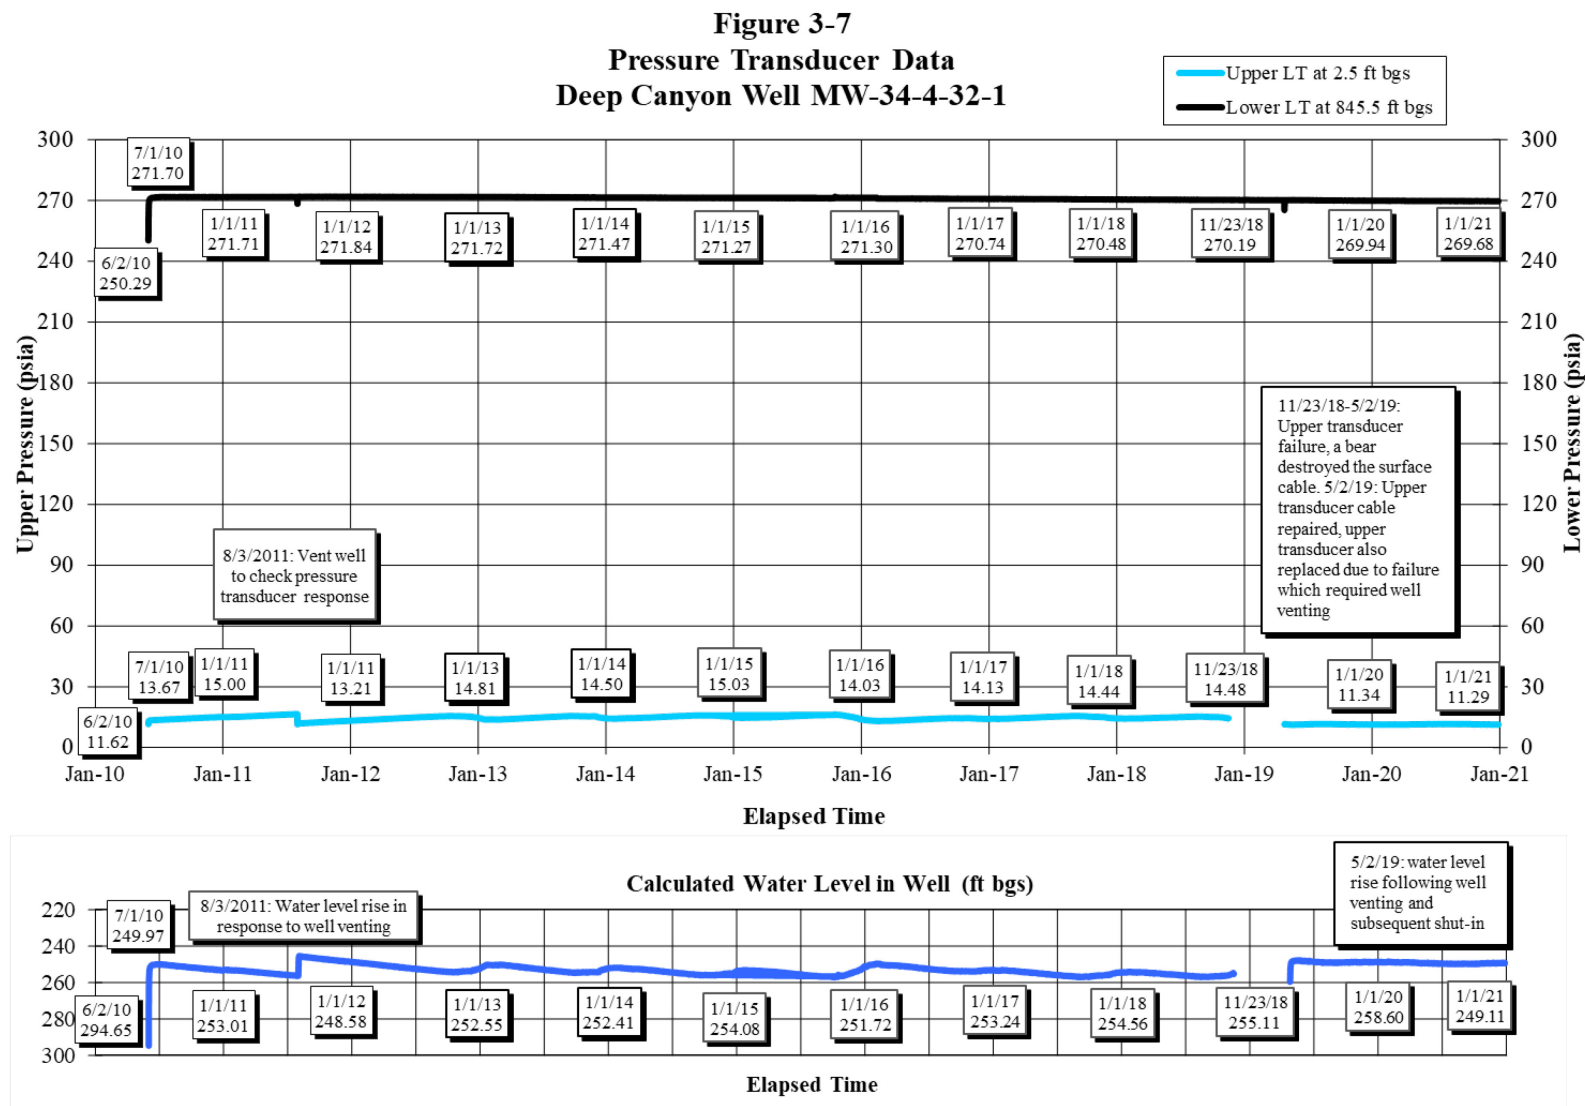
Figure 3-7
Pressure Transducer Data Deep Canyon Well MW-34-4-32-1
3-16

Figure 3-7 charts the upper and lower pressure transducer data and the calculated water level in the well. Table 3-4 and Figure 3-7 show the well pressure initially stabilized on June 8, 2010, six days after the well was shut in for monitoring on June 2, 2010. Table 3-4 and Figure 3-7 also show a relatively stable well pressure regime for the 10.5-year period of record through November 23, 2018 with only a slight increase in well pressure and a corresponding net water level decrease of 7.39 feet in the well. Data for this well is limited from November 23, 2018 due to an upper Level Troll transducer failure. When investigated in early 2019 after the location was accessible it was found that the surface cable for this Level Troll was damaged by what appeared to be a bear mauling of the telemetry station based on the type of cable damage and muddy paw prints on the telemetry instrumentation enclosure. At that time the cable was repaired, the Level Troll was replaced and full function has resumed.
