**Dugan Production Co Operator #25250  
Tiffany #1 API# 05-067-06498  
Follow Up Inspection #674601361**

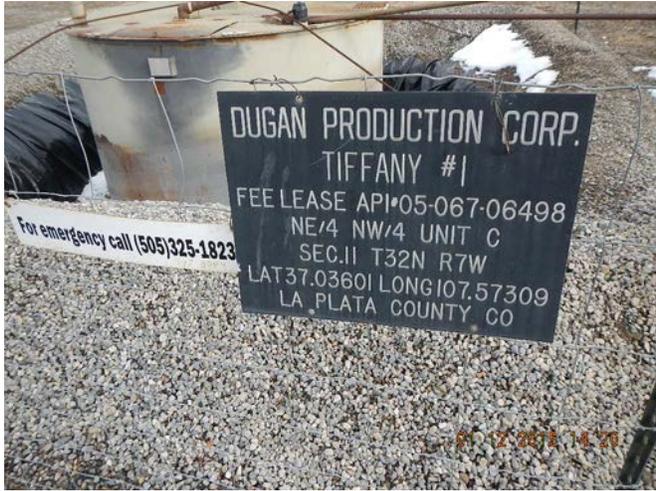
Existing well sign and operator emergency contact number.

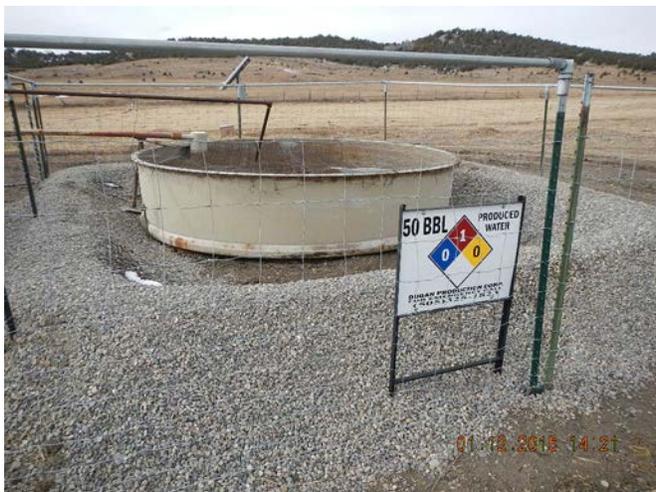
Open top tank where spill was observed; No stained soils observed; New earthen berm in place; Wildlife screen repaired; New tank signage.

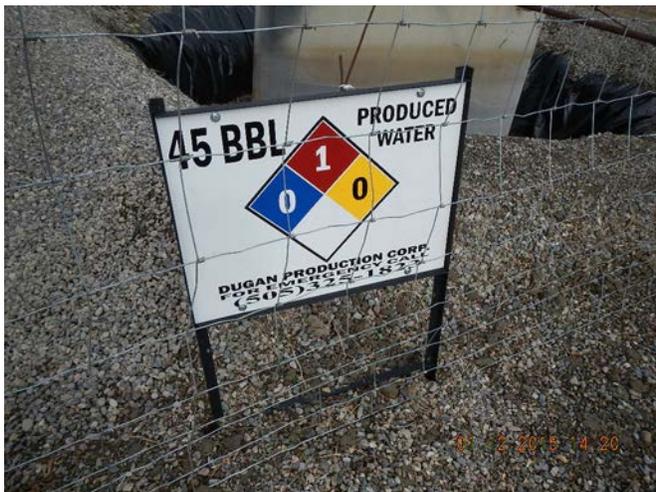
New produced water tank signage installed at facility near dehydrator.

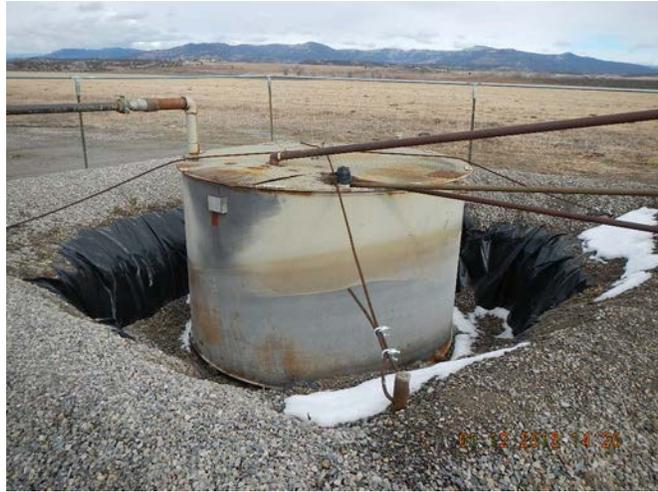
45 bbl open top tank re-leveled;  
maintenance performed on berm and  
liner; unused parts/ trash cleaned up.

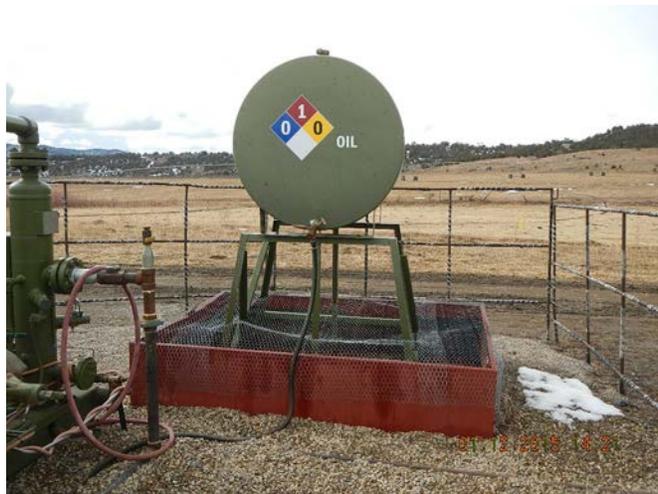
Compressor lube oil container  
labeled; Fluid removed from  
containment.

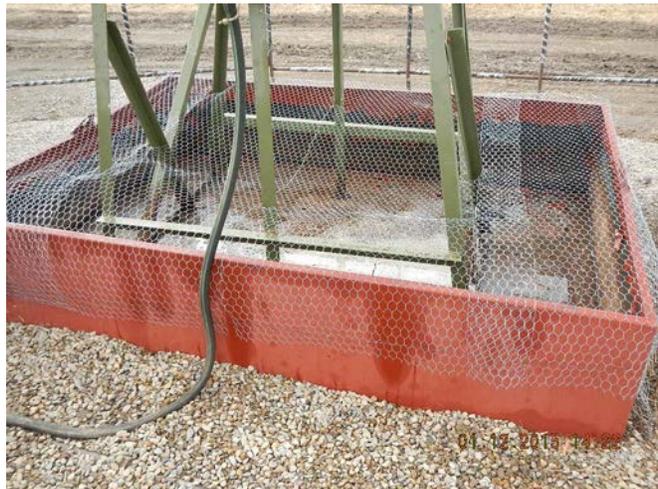
Wildlife screen in place over lube oil  
drum containment.

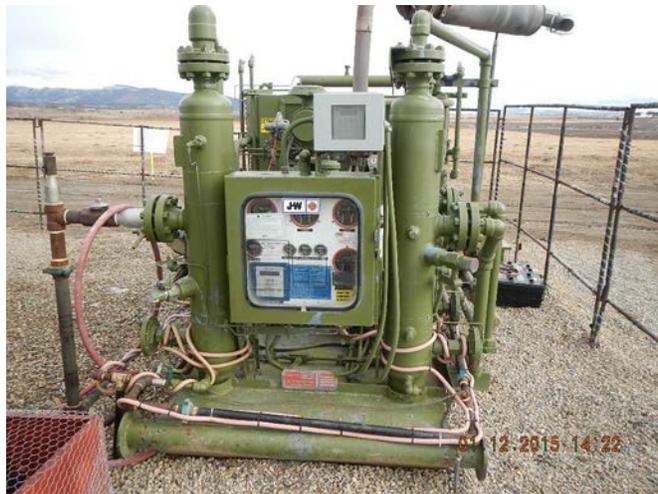
Compressor skid cleaned; free of oil;  
No evidence of stained soils observed  
around equipment.

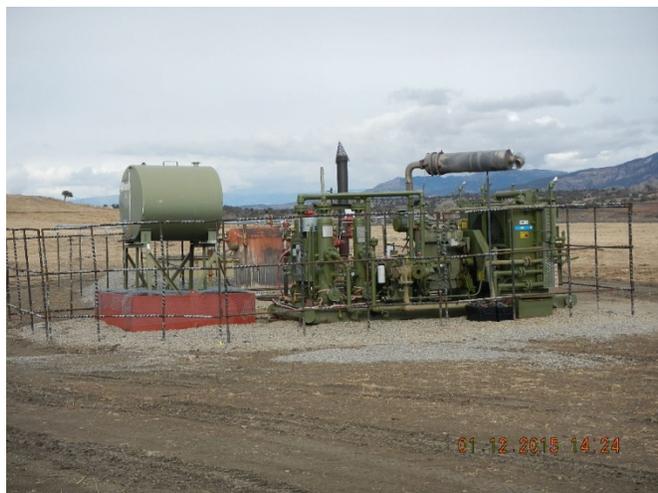
General housekeeping performed;  
Weeds removed from around (fired)  
equipment; Unused equipment and  
trash removed from well site.

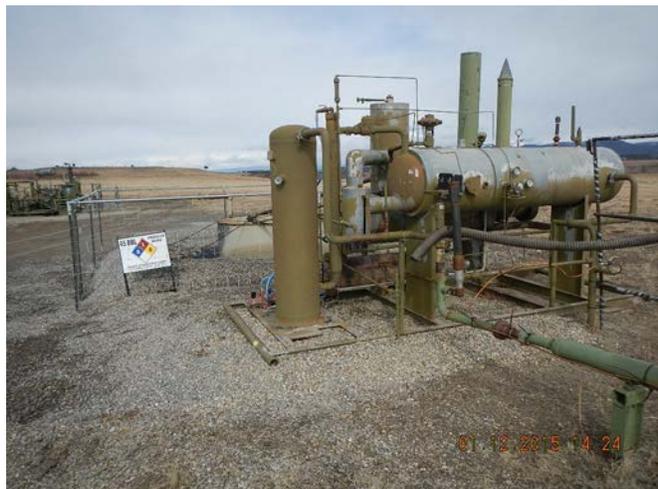
Fuel containers have been removed  
from under equipment; Paint peeling  
from and rust forming on Dehydrator

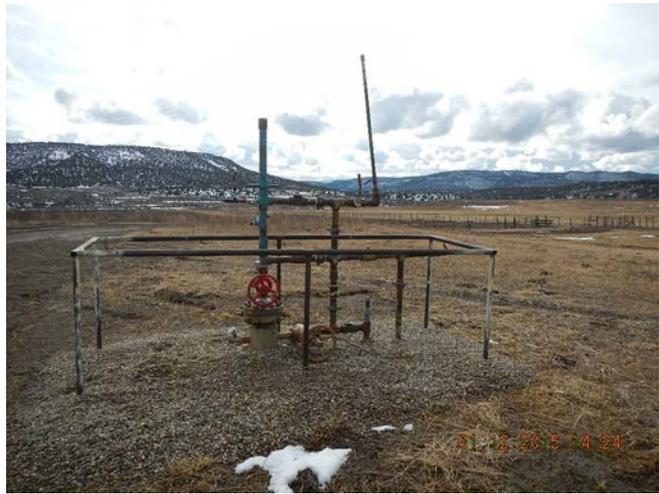
View of wellhead; Weeds have been removed from area.

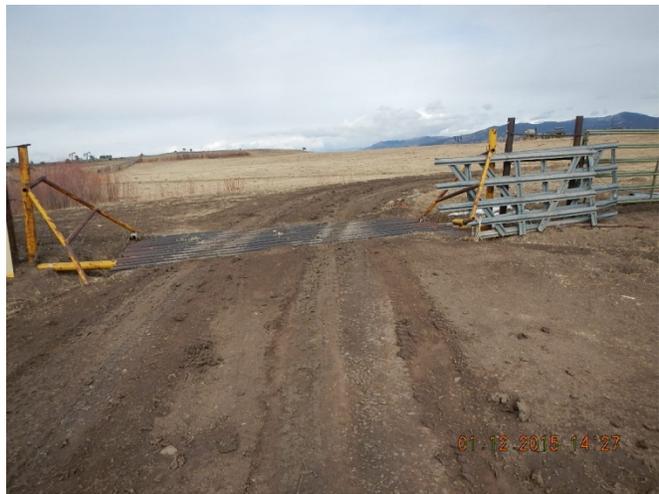
Gate on well site access road has been removed/ secured.

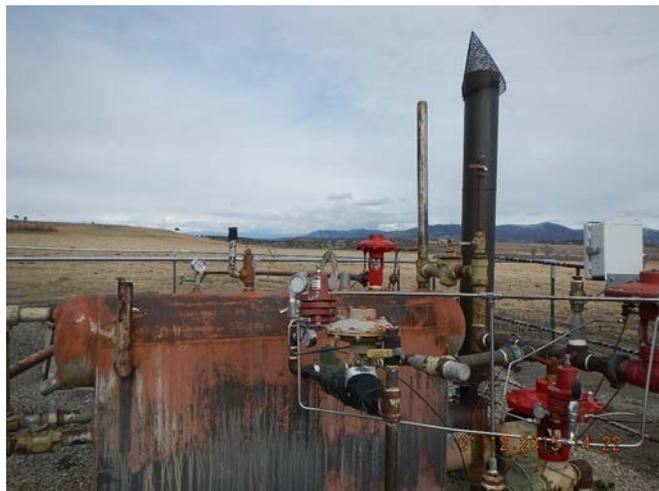
Unpainted and rusting equipment;  
Horizontal heated separator.
