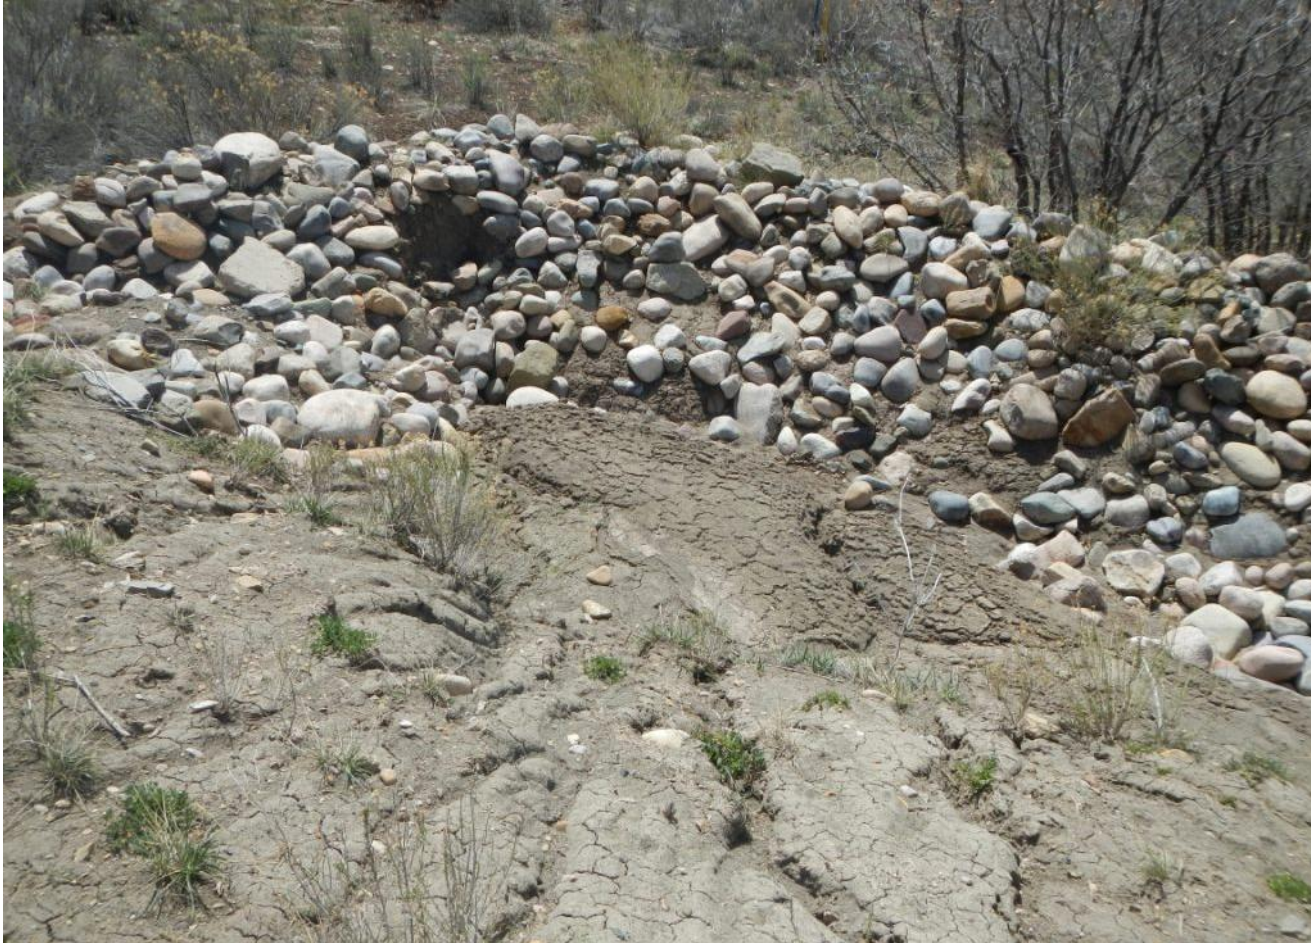
Photo 1. View of silt trap in southern portion of project area that is full of sediment and needs maintenance.

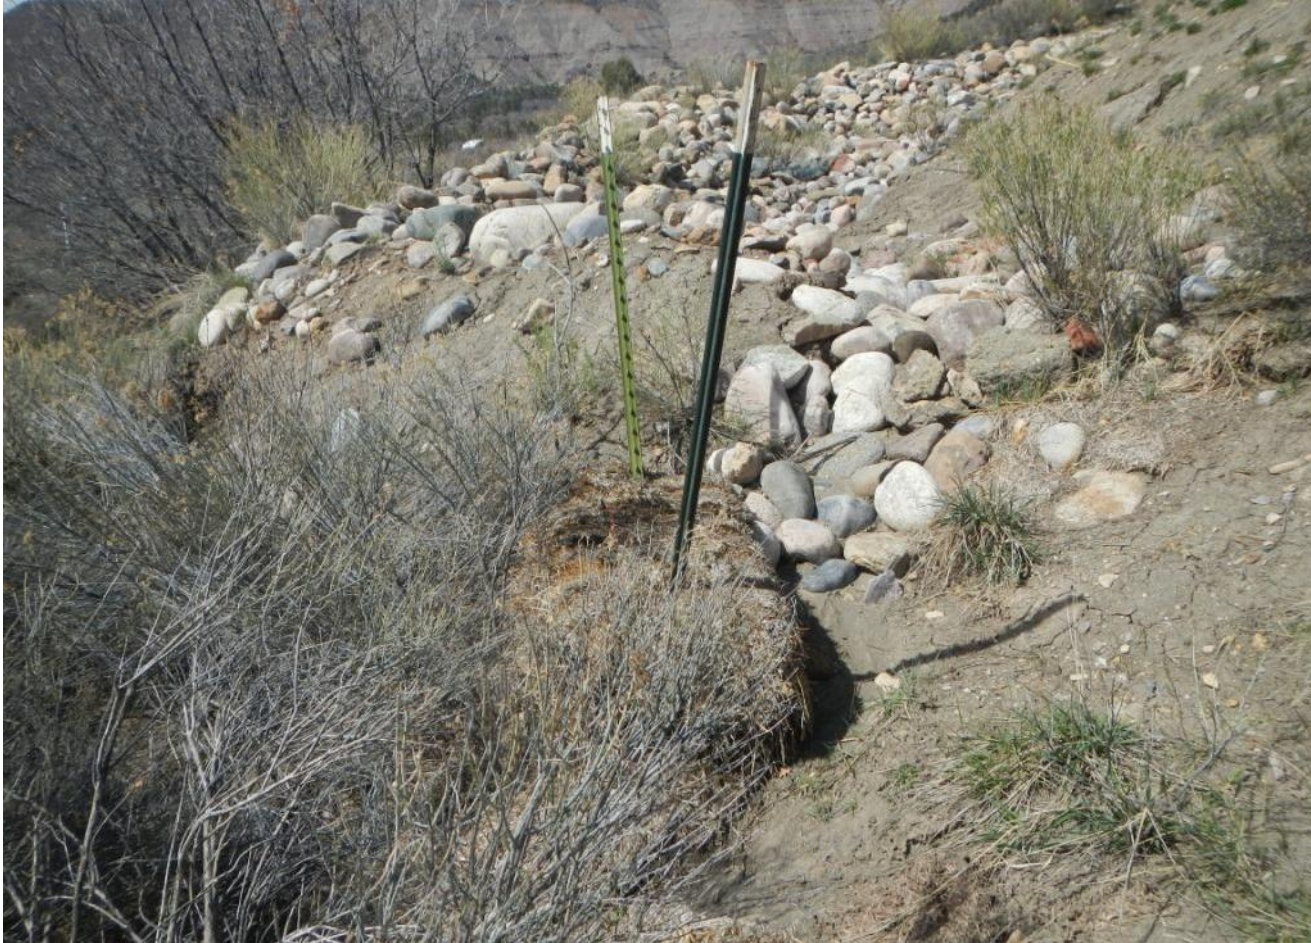
Photo 2. View of area in silt trap shown in Photo 1 where stormwater has breeched and eroded the silt trap berm.

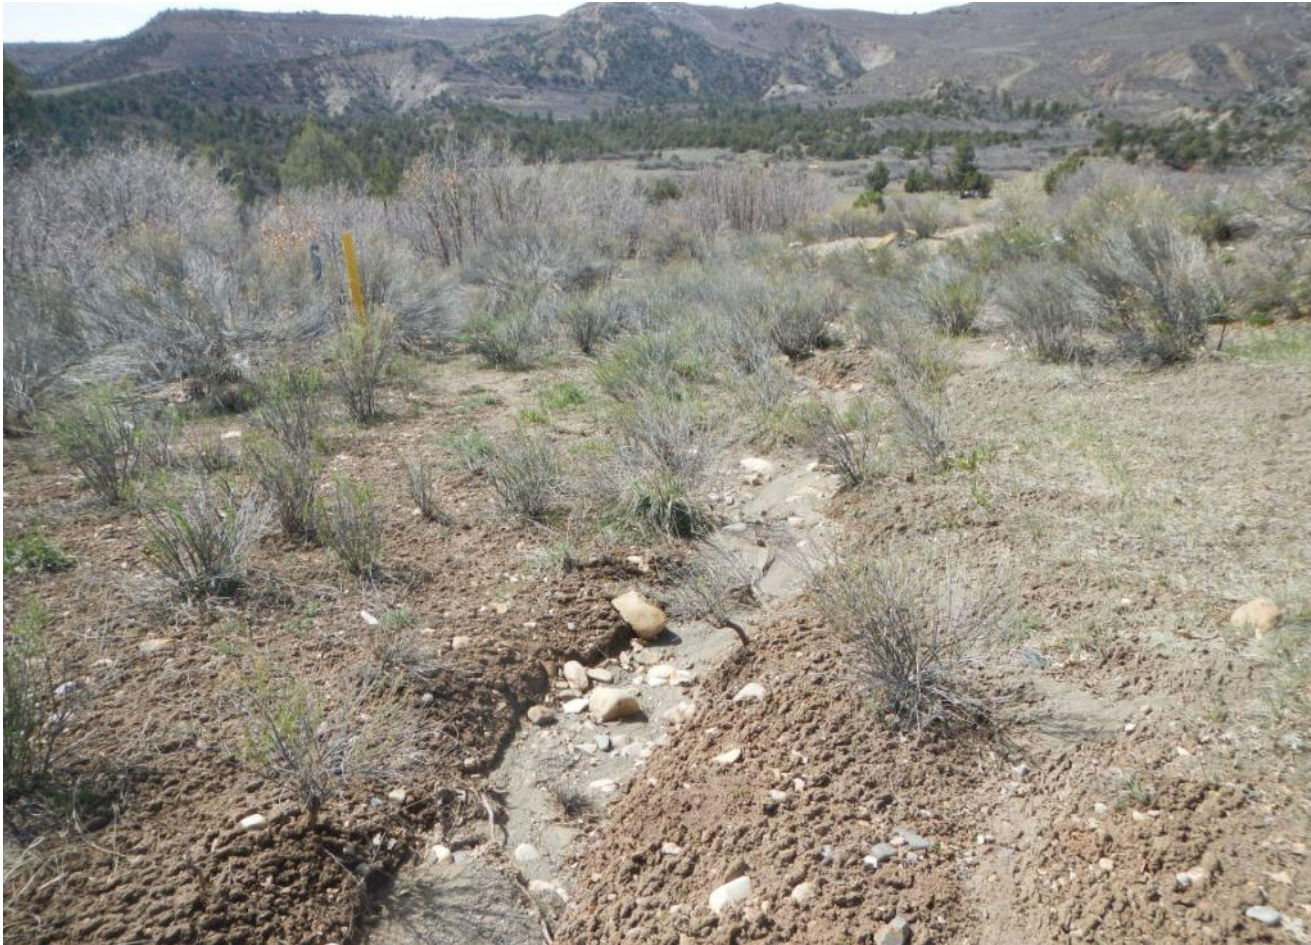
Photo 3. View of area downstream from silt trap and southern portion of well pad where channel (approx. 2 to 3 feet wide and 1.5 feet deep) is forming that appears to be caused from concentrated stormwater flows exiting the well pad.

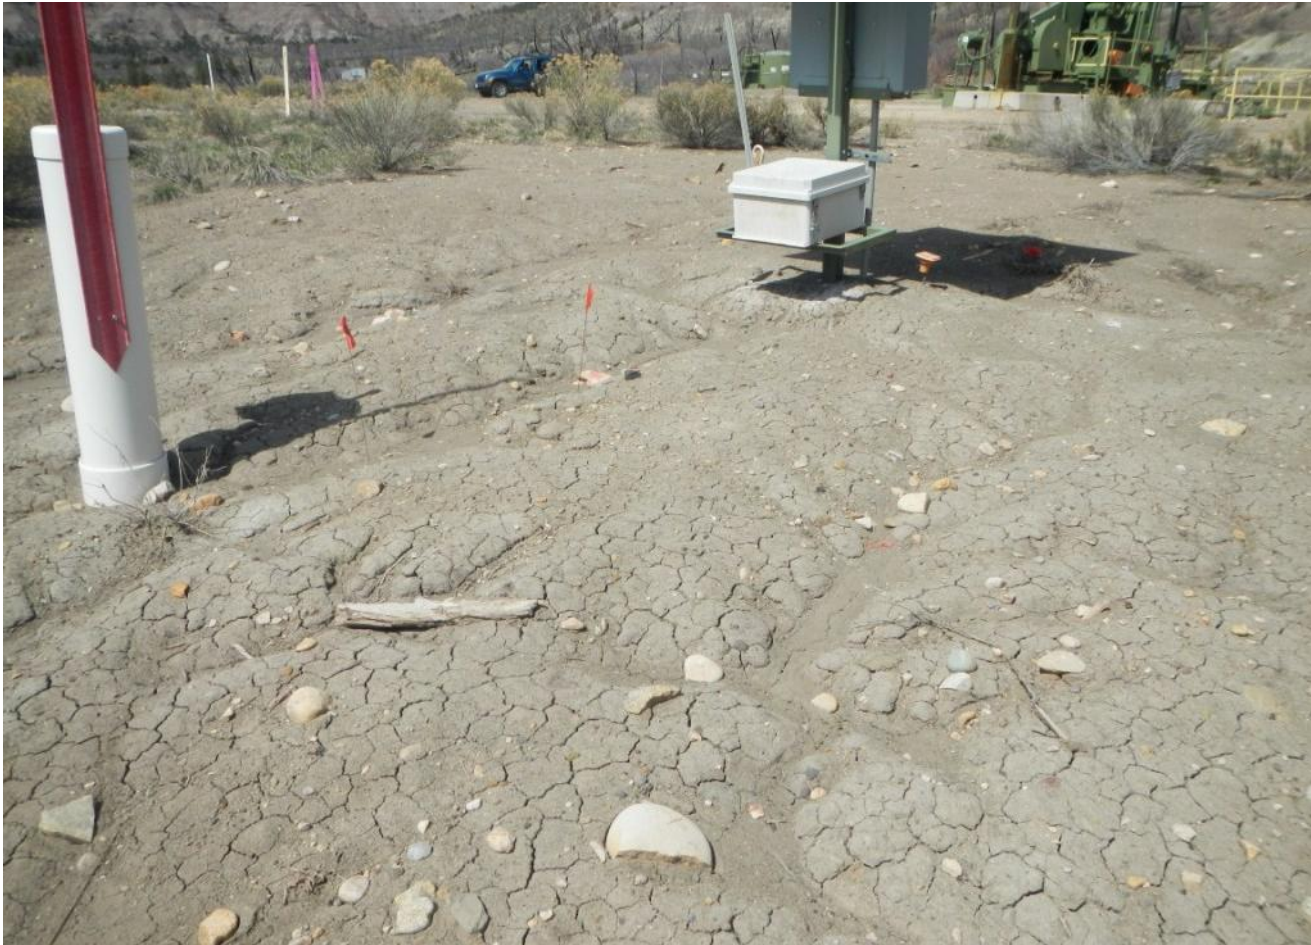
Photo 4. Unvegetated area in southeastern portion of well pad where stormwater channels appear to be eroding the well pad.

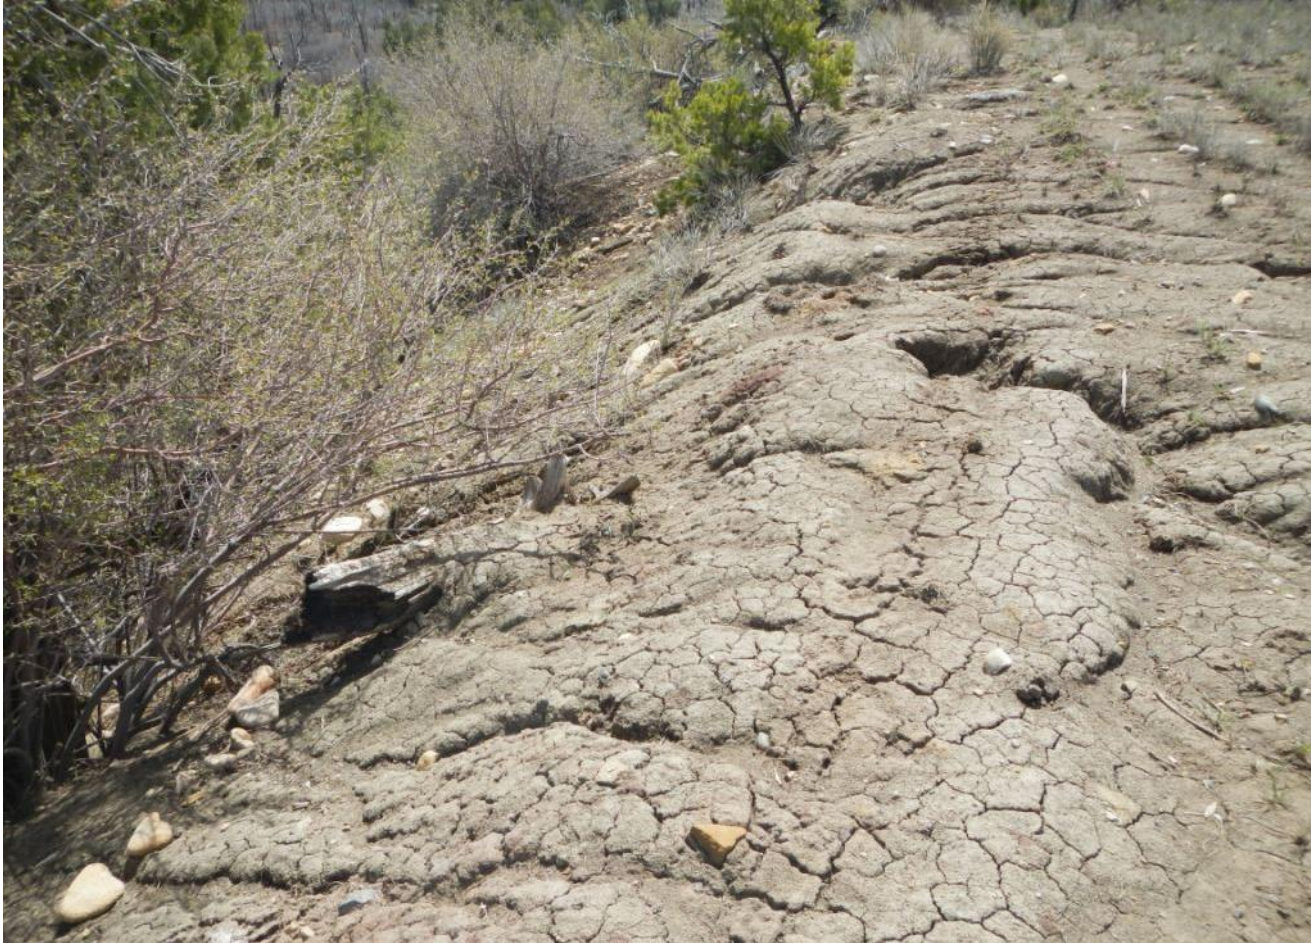
Photo 5. View of eastern edge of project area where stormwater flows exit the eroding well pad surface (on right) and flow down a steep slope (on left).

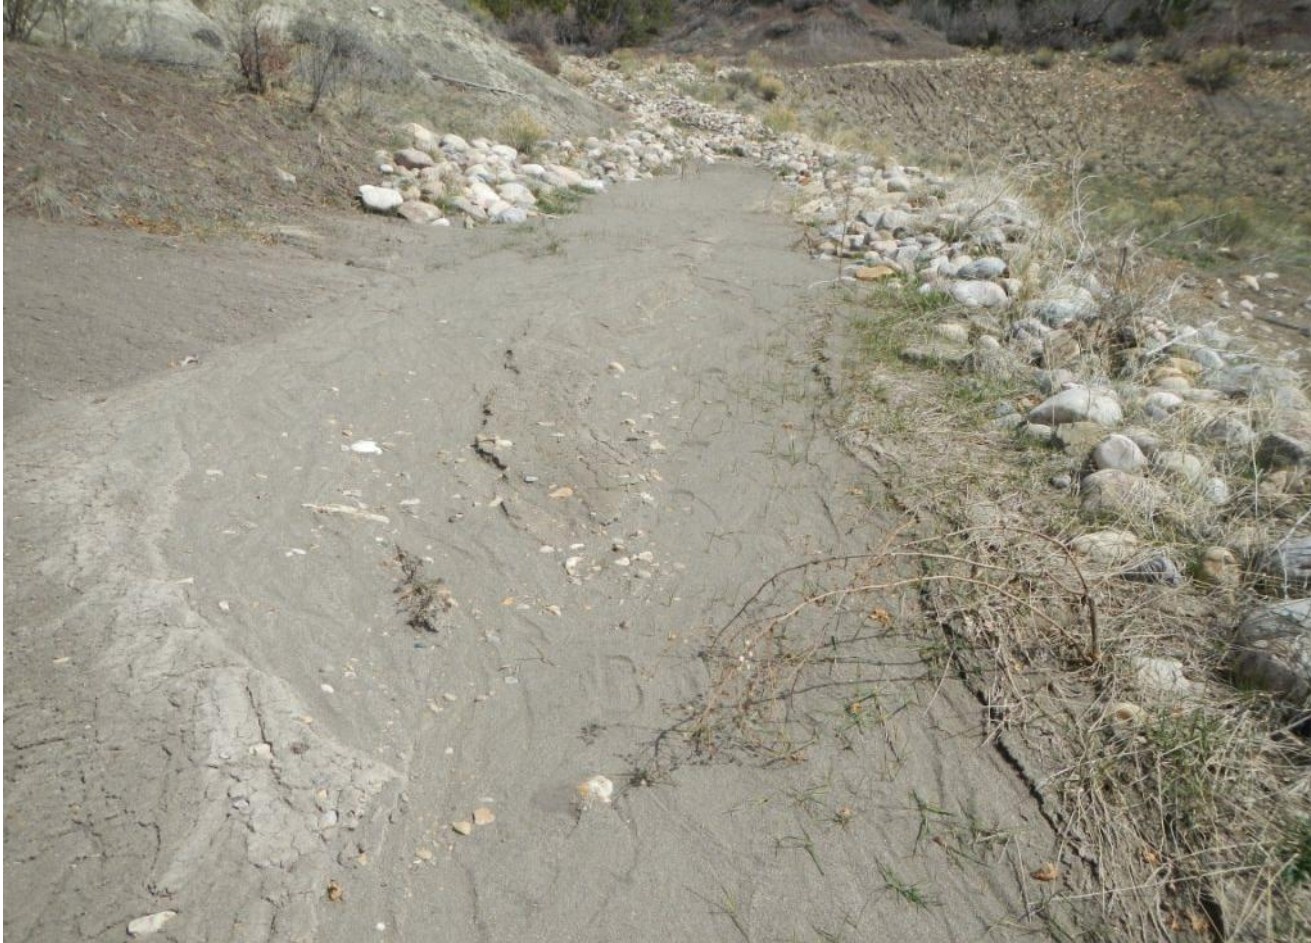
Photo 6. View of cobble stormwater diversion in western portion of project area facing northward. BMP is full of sediment (in foreground) and needs maintenance.

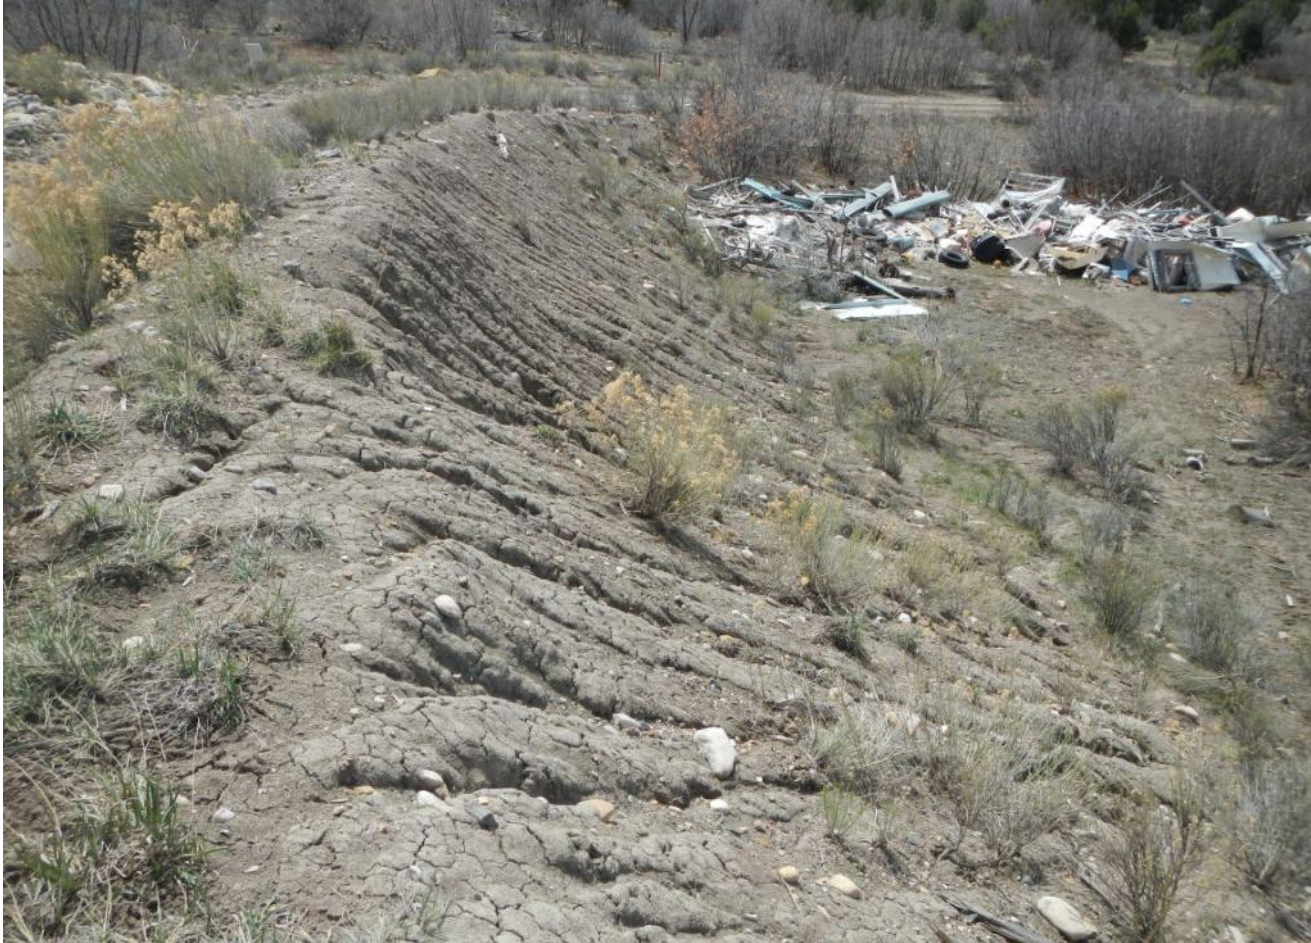
Photo 7. View of erosional channels along access road fill slopes (on left-center).
