Braun Environmental, Inc.

July 28, 2015

**RE: Site Investigation for Pace Well No 2, Weld County, Colorado**

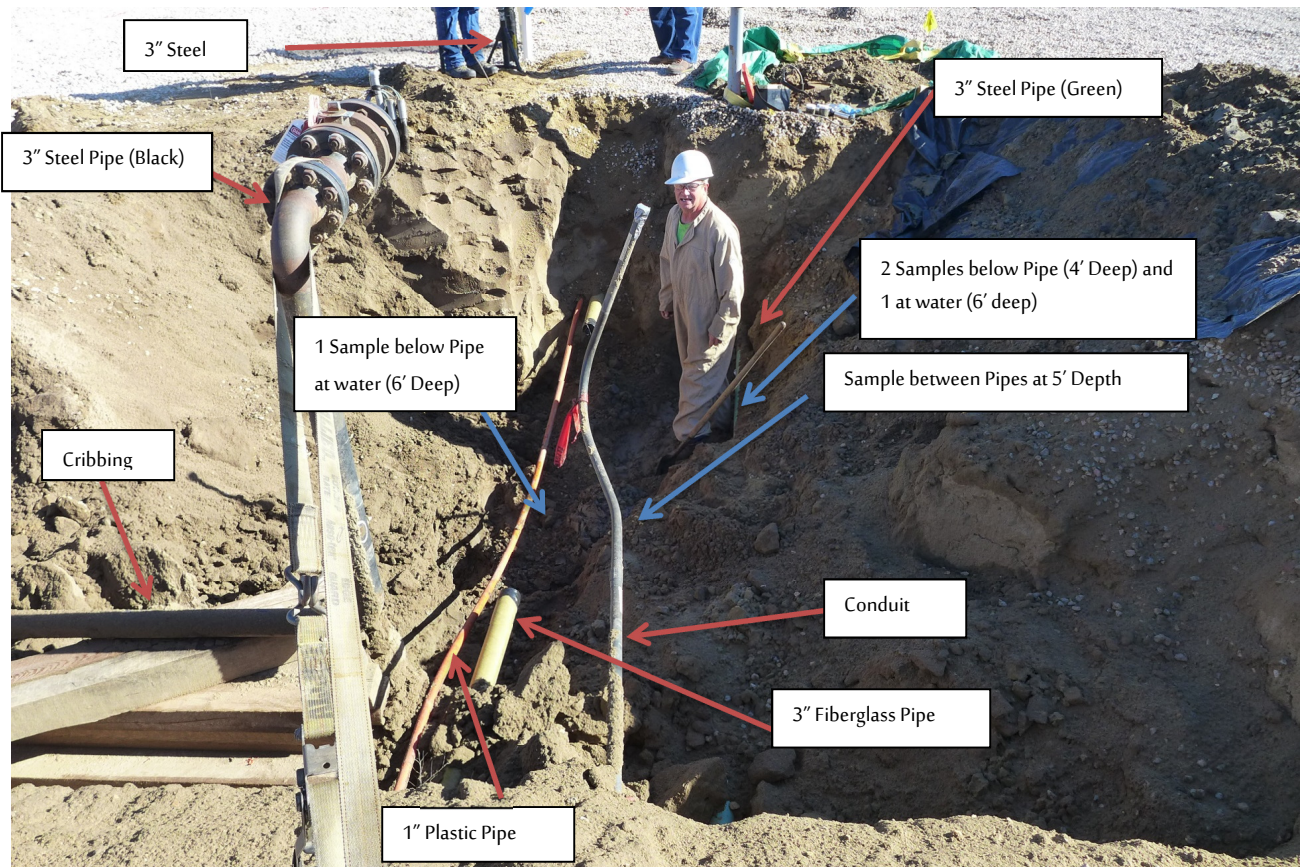
Photo 1 - View North of Excavation

The three-inch diameter fiberglass pipe that services the Pace No 2 well (owned by TTOC) was found to have been buried to a depth of just short of 4 feet (Photo 1). At a point near the center of the excavation, the pipe was said to have contained a slip-on plastic sleeve (a smooth plastic coupling), fit and glued over the fiberglass pipe. A section of that pipe had been removed prior to Braun's visit, so the only in-place portions of the piping remaining at the time of the inspection were where it entered the excavation from the north and south. Adjacent to this pipe on the west was a smaller 1" orange plastic pipe that was reported to have also once contained oil. That pipe was found to be intact with no obvious damage or defects where it has been exposed. Neither the 1" orange pipe, nor the pieces that had been cut from fiberglass pipe were found to contain any visible staining that might suggest that either pipe had leaked oil.

Three feet to the east of the fiberglass pipe was a 3-inch diameter coated steel pipe (green coating) at a depth of 4 feet below ground surface. Near the north edge of the excavation the pipe was covered with a rubberized wrap, having a total length of about 12 inches. Some discussion developed, but it is concluded that this wrap was installed to cover a welded joint. No bare steel was found to be exposed to soils and the wrap appeared to be in good condition. The group stated

that this pipe had been an old Kerr McGee line (still in use), that eventually would wind up belonging to Anadarko. There was no petroleum hydrocarbon staining on the pipe that would indicate that any oil had leaked from it.

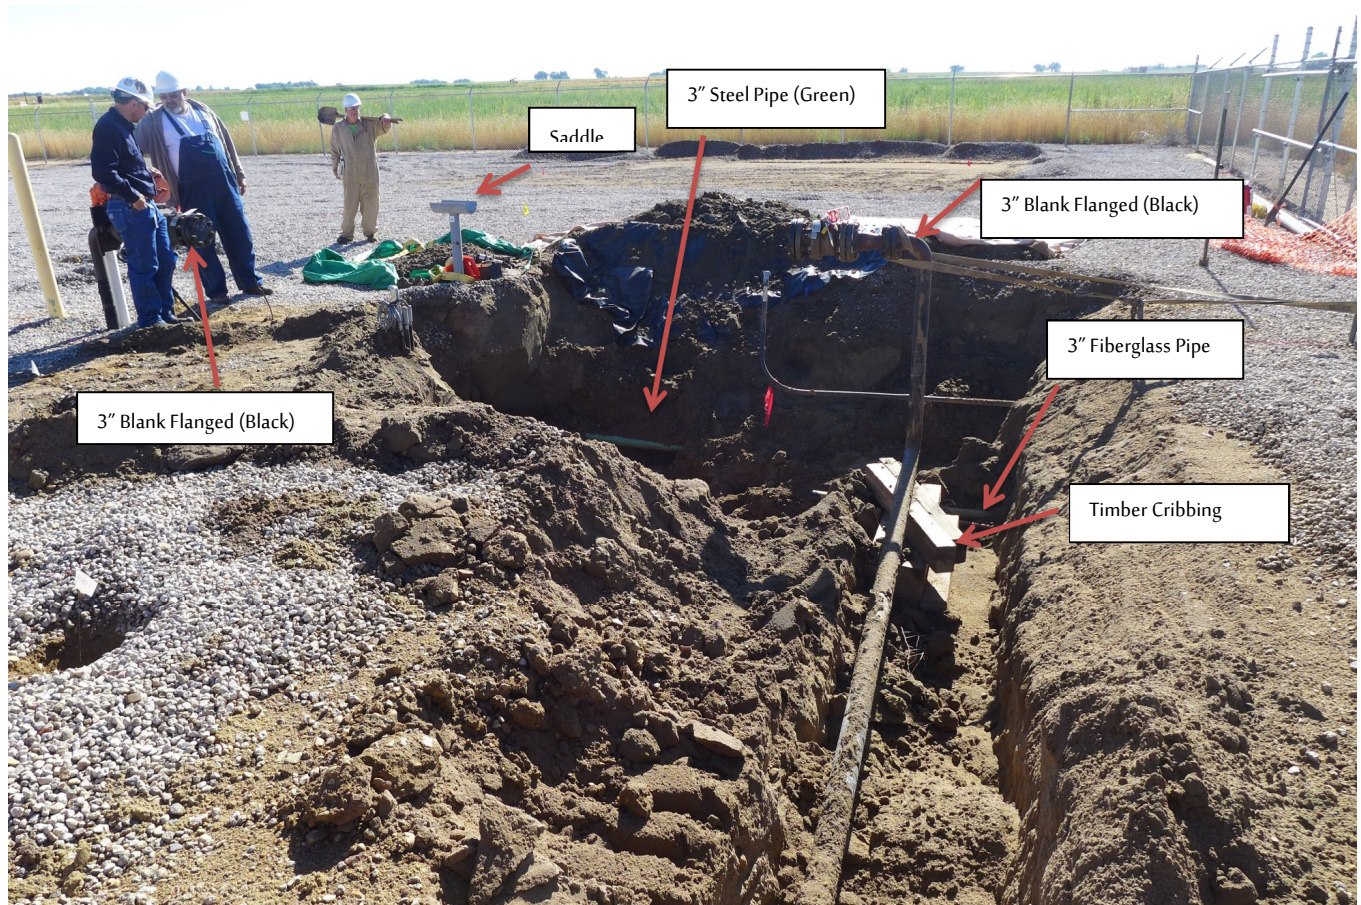
Photo 2 - View East of Excavation

A third 3-inch diameter steel line was found running east-west at a depth of about 2 feet below ground surface, entering the south end of the excavated area. This line belongs to Anadarko and was being excavated at the time the vapors were found. Note that the pipe is at a depth of 2 feet, but the current excavation is at nearly 4 feet at the location of the timber cribbing used to support the pipe (Photo 2). This pipe has a black coating and had been fully exposed in the trench at the time of the site visit (Figure 1). It was supported by wood blocking on the east and was tied to the chain link fence that surrounds the area using a strap. That pipe also appeared to be in good condition with a blank flange on its east end. There was mention that Anadarko was in the process of installing a compressor at this location. The pipe was dead ended at the blank flange and the question arose on what it had been connected to previously. Looking to the north, another blank flanged black colored pipe was stubbed up about 6 feet north of the north edge of the

excavation with the end of the pipe pointing south toward the one terminating in the trench. A grey steel support saddle was also located just north of the center of the excavation approximately over the green steel pipe. It must have also supported a pipe at one time.

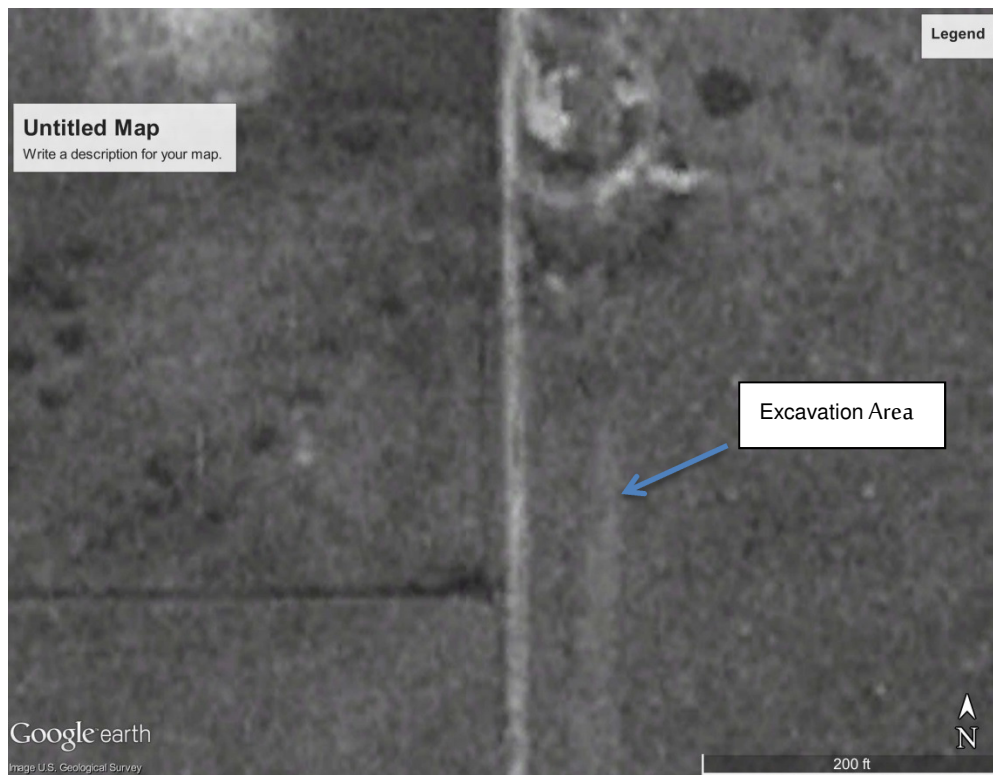
October 3, 1999

The three-inch black steel pipe that was stubbed up and blank flanged on both sides of the excavation might lead to a possible explanation. Review of historical aerial photographs show that in 1999, in the area of the excavation, the only visible non-agricultural feature is the

north-south trench that contains the fiberglass pipe (Attachment A). The area appears to have been first developed to contain its current equipment sometime between 1999 and April of 2003. A white-colored square shaped structure that fits between the two black pipe stubs shown in Figure 1, first appeared in a photo taken on April 13, 2003. Sometime between August of 2006 and March of 2008, the area was fenced to the same configuration as seen today. The area had a surface composed of native soils until sometime, probably in early 2012, when an aerial photo taken in October of that year shows the new gravel surface. The October 6, 2014 photo shows the structure over the trench and current excavation to be still in place. However, the Braun site visit on July 15, 2015 found that the structure has been removed. The photos show that the structure was in place for at least 12 years, and the lines leading to it surely contained oil and gas. Over the life of the structure it is highly likely that some leakage or spills associated with maintenance of piping and equipment occurred. Those leaks or spills could easily have leaked onto the porous sand surface below the structure and migrated downward to the groundwater, alternatively producing those impacts.

One additional question is generated with the help of the historic aerial photos. When and why did the fiberglass pipe get physically breached in the first place? From the photos, the pipe line appears to have already been in place in 1999 with the ground surface above it still devoted to agricultural. Once that pipe had been installed and the trench covered, the operator of the well would have no reason to come back to the line. Since it was buried to a depth of 4 feet, the farmer working the surface would have no reason to plow or dig to a depth of greater than half the depth of the pipe. That leaves the most likely group to have damaged the pipe being the persons that installed the equipment between the two pieces of stubbed up black pipe and directly over the trench containing the fiberglass pipe. In retrospect, it might have been a better idea to install the equipment off to the side of the trench instead of over it. Since the black steel pipe is installed at a depth of 2 feet below ground surface, it would take very little over-excavation by an operator to reach the depth of the fiberglass pipe. An additionally factor that might contribute to the damage seen is that the south leg of the stubbed up black pipe is located perpendicular to the fiberglass pipe. Digging perpendicular to the pipe would make it very easy for the equipment operator to simply rub a tooth over the fragile fiberglass thus breaking a hole. Alternatively, if the digging had been done parallel to the pipe, the operator might have felt the pipe before breaking through it, and the break would have a little different nature than what we see at the repair.
