Construction Inspection

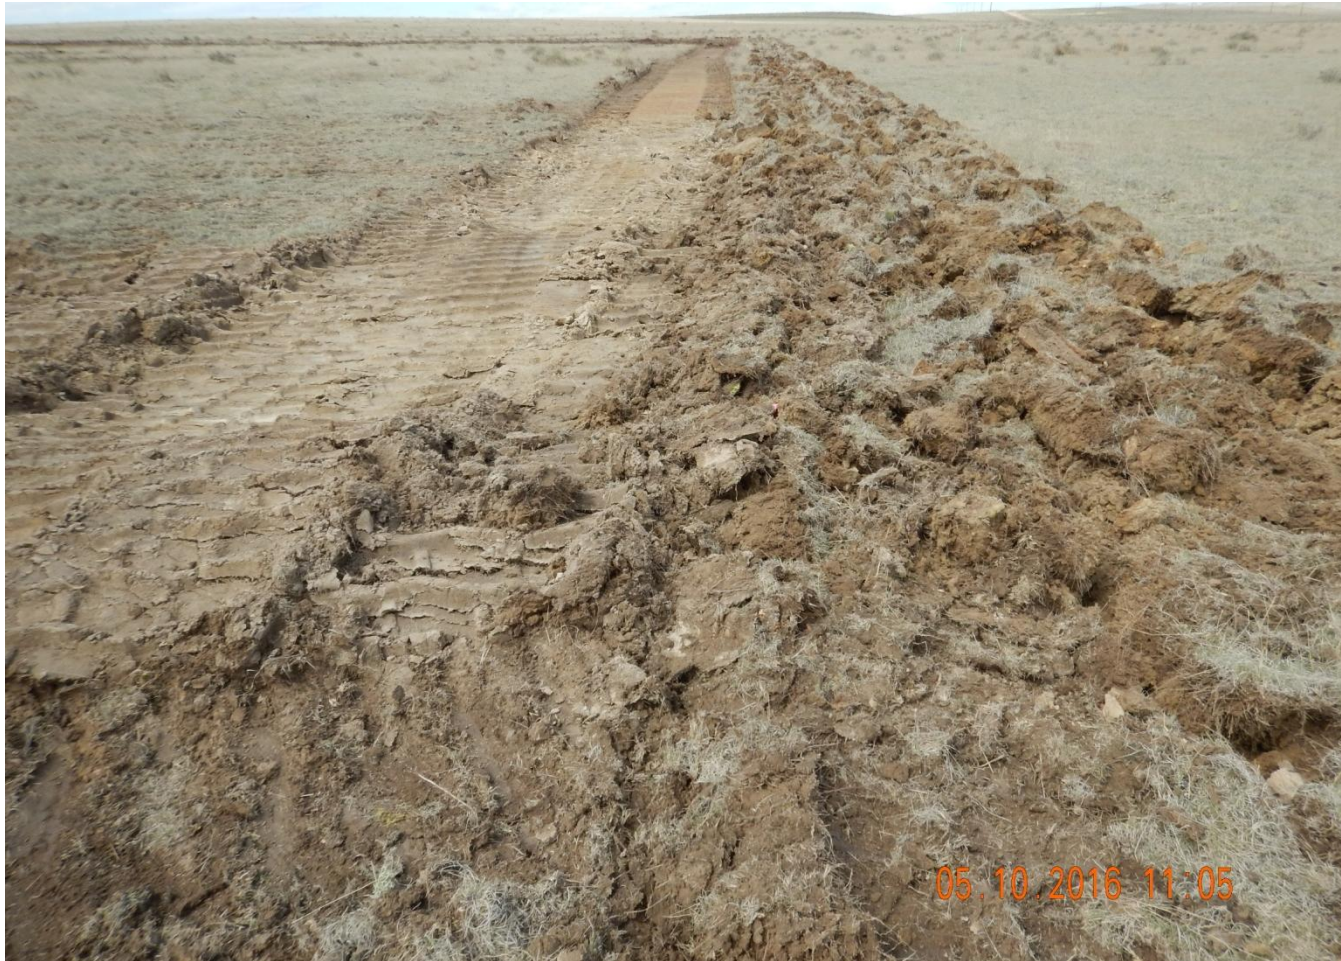
Photo 1. Photo taken from northeast location, facing West. Temporary BMP installed in center of photo while topsoil salvage is in process. Permanent BMPs will be installed upon completion of topsoil salvage.

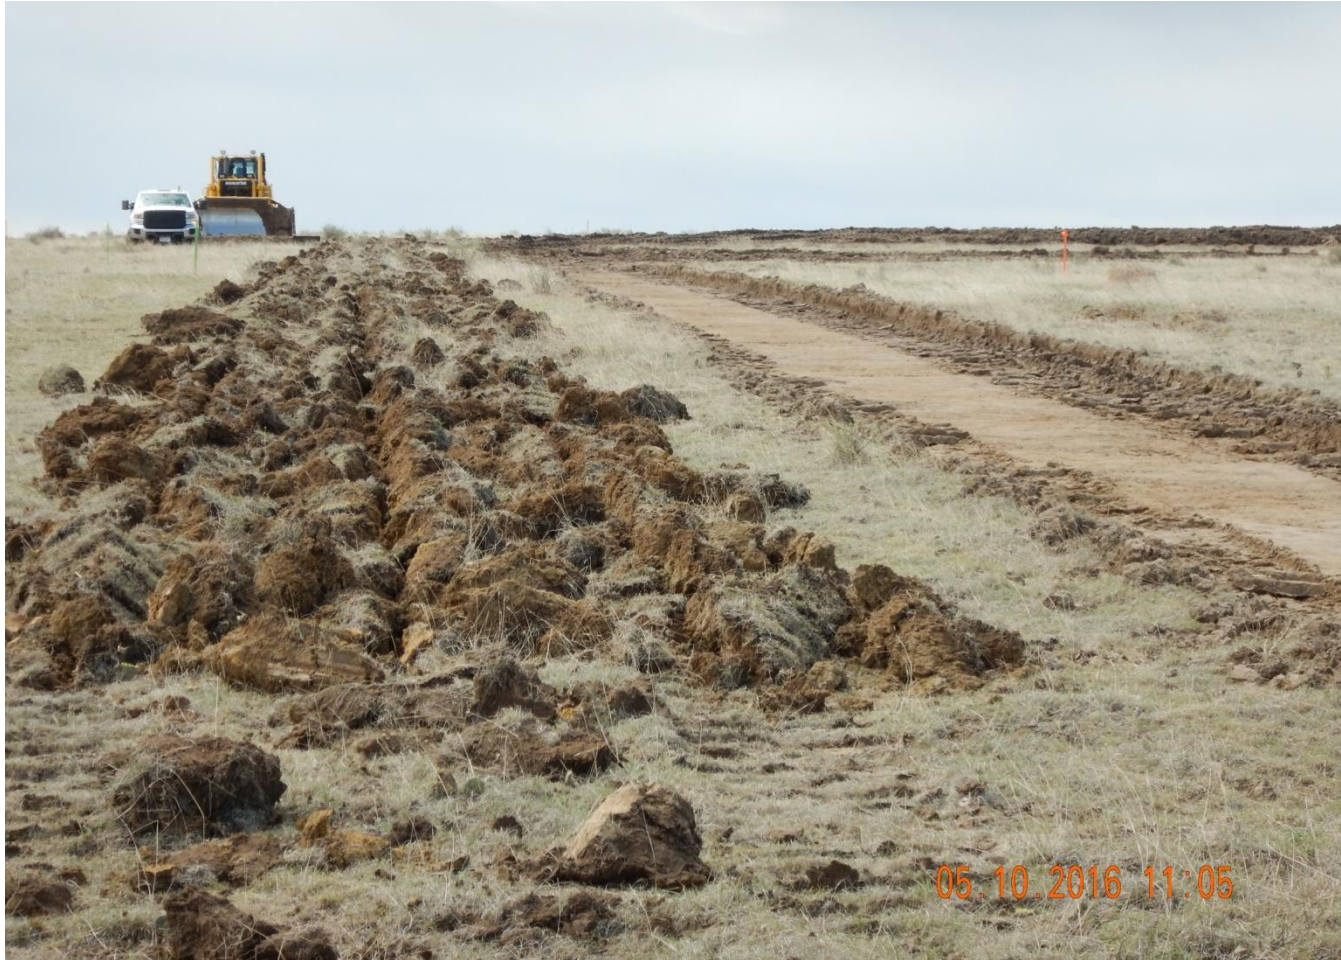
Photo 2. Photo taken from northeast location, facing South. Temporary BMP installed in center of photo while topsoil salvage is in process. Permanent BMPs will be installed upon completion of topsoil salvage.

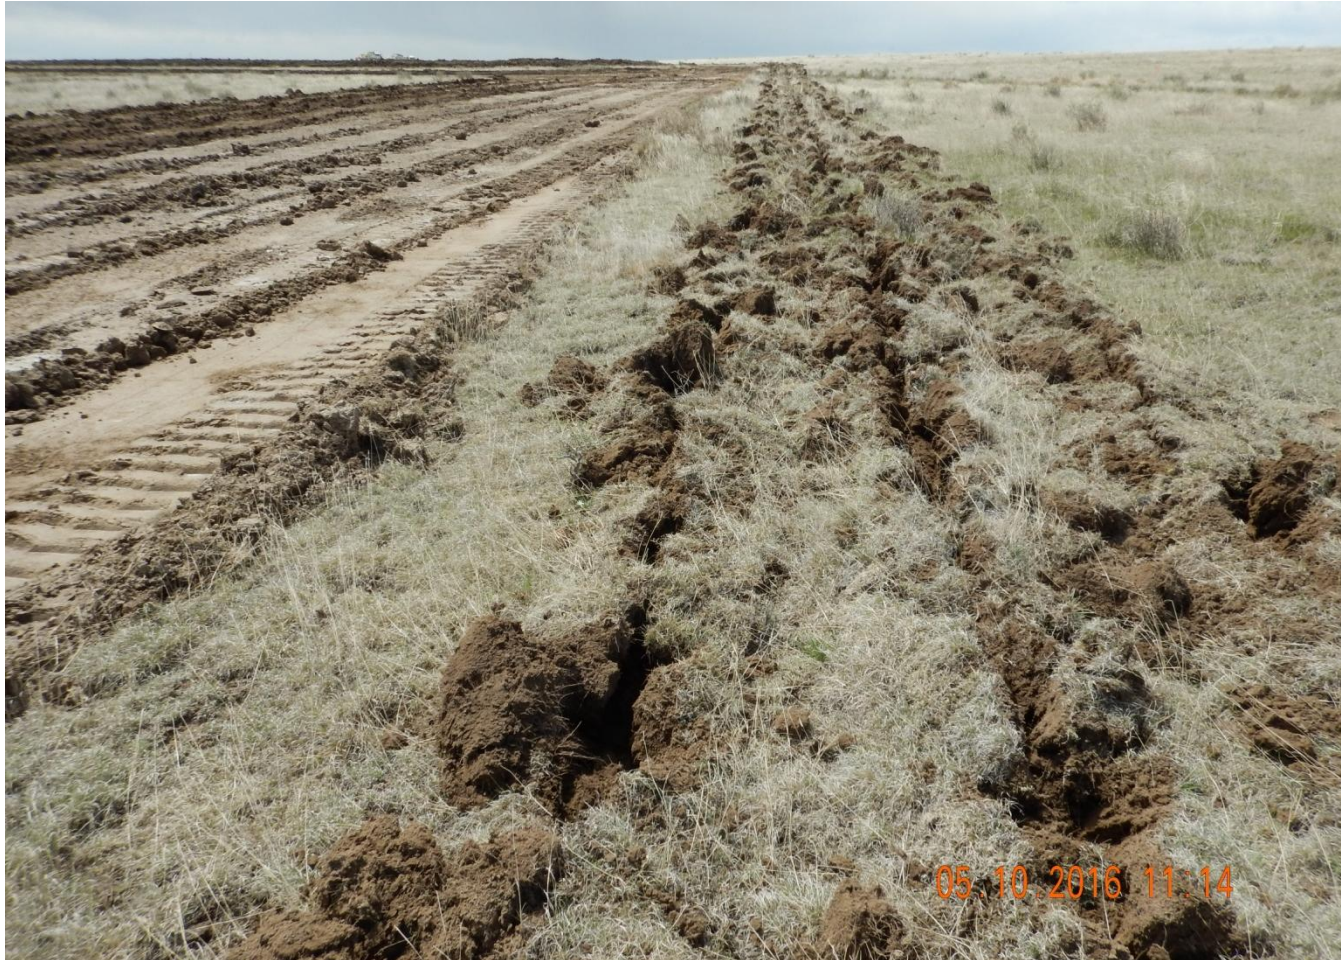
Photo 3. Photo taken from northwest location, facing South. Temporary BMP installed in center of photo while topsoil salvage is in process. Permanent BMPs will be installed upon completion of topsoil salvage.

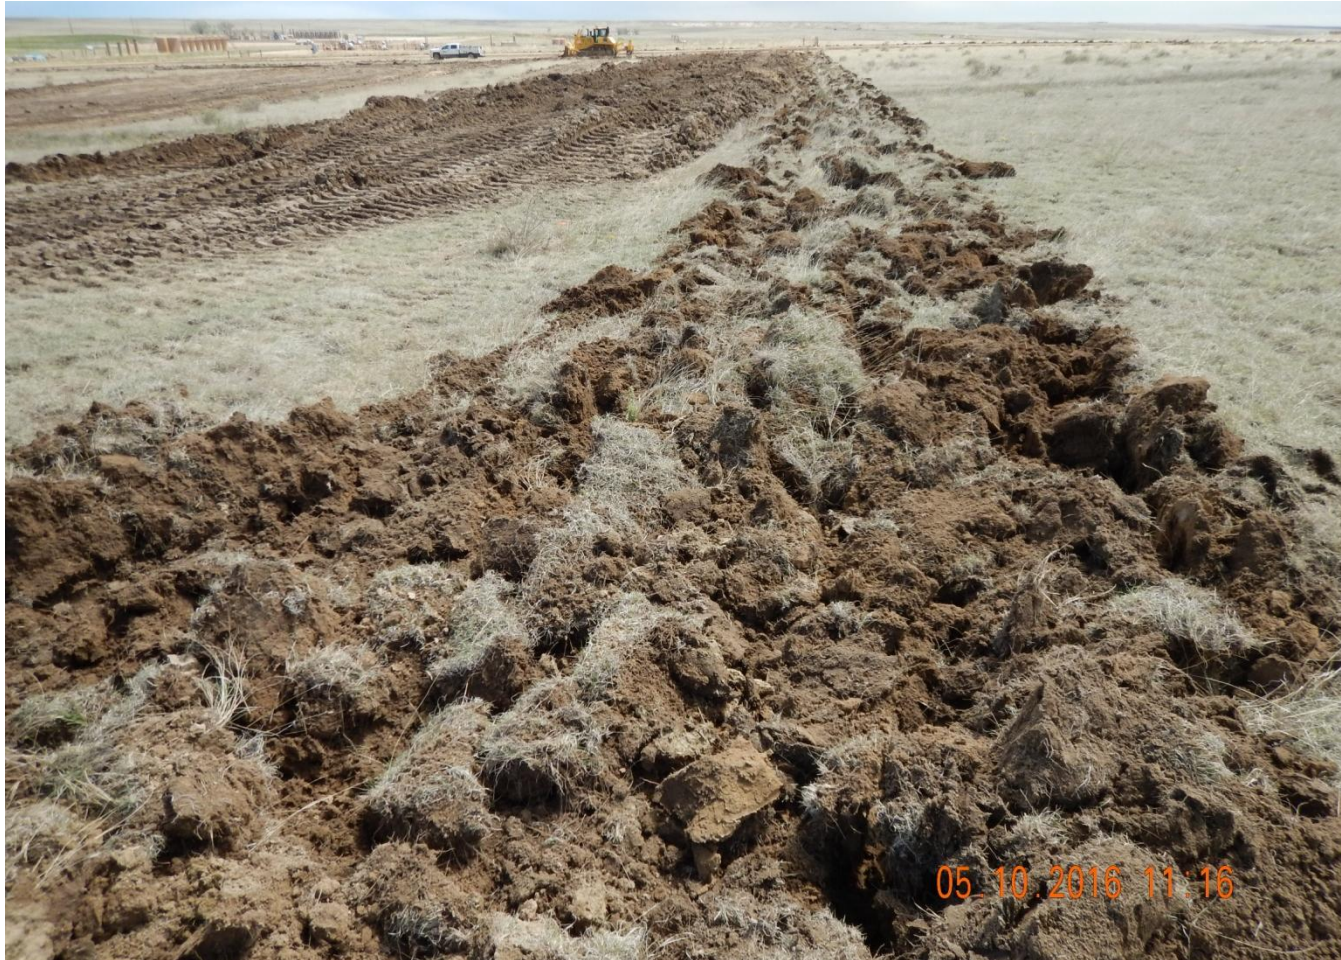
Photo 4. Photo taken from southwest location, facing East. Temporary BMP installed in center of photo while topsoil salvage is in process. Permanent BMPs will be installed upon completion of topsoil salvage.

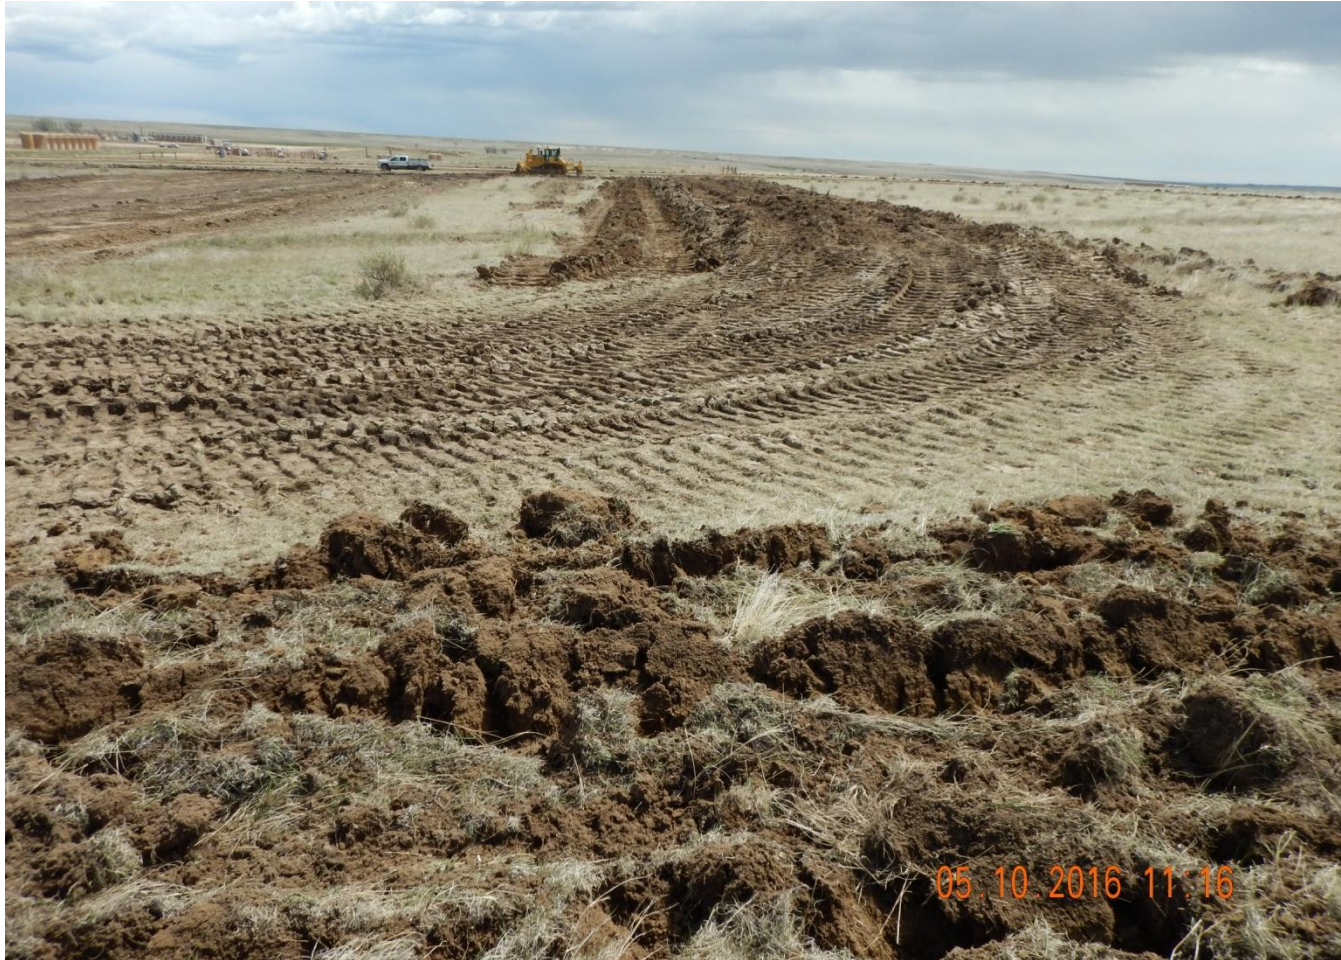
Photo 5. Photo taken from southwest location, facing East. Topsoil stockpile in center of photo.

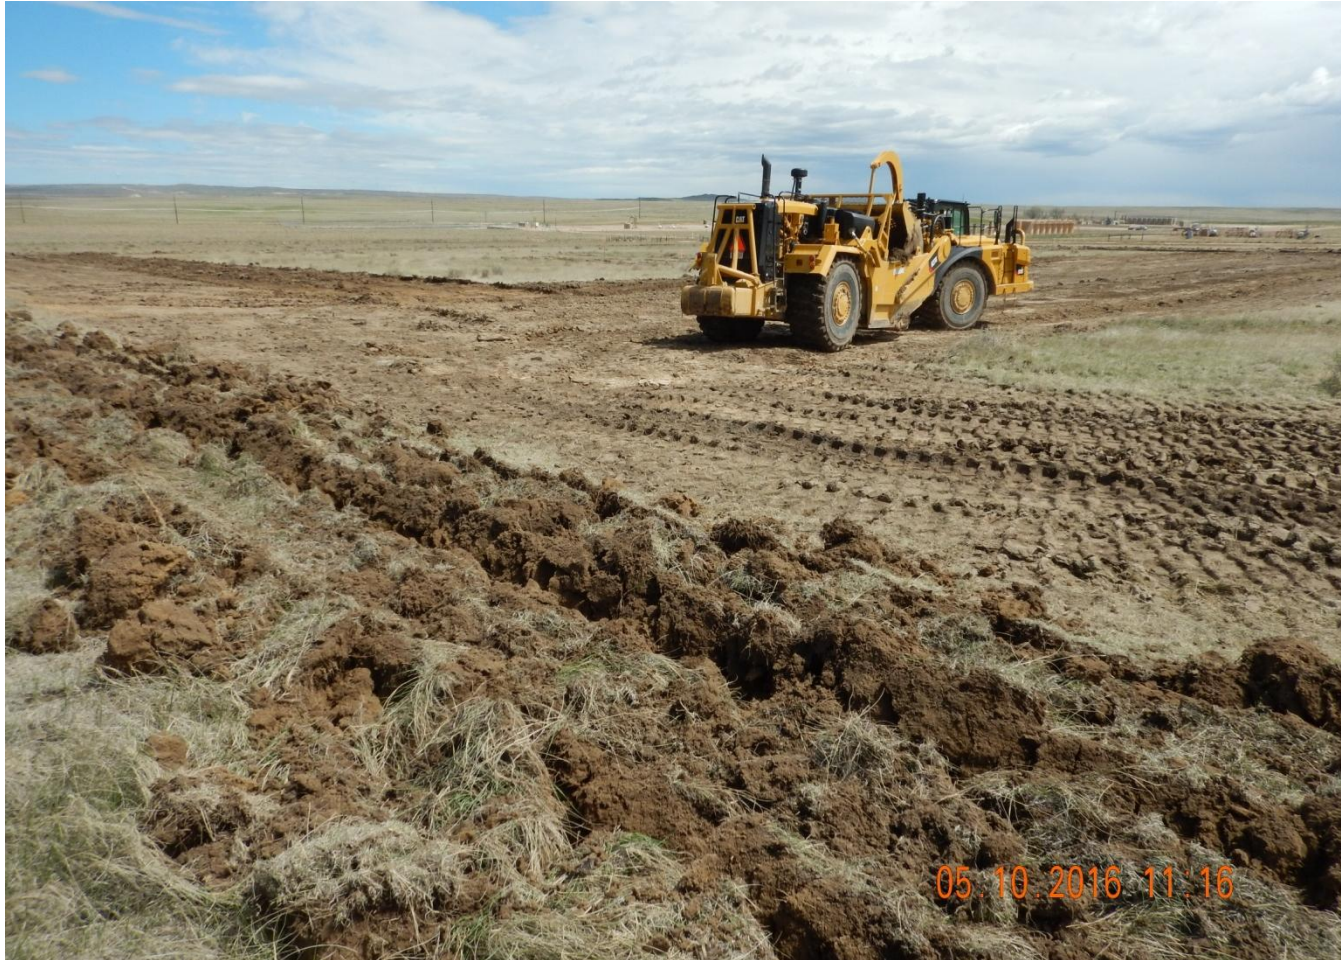
Photo 6. Photo taken from western location, facing East. Topsoil salvage in process.
