September 3, 2016

Inspection Photos: Black Hills PA API#077-08427 Horseshoe Canyon

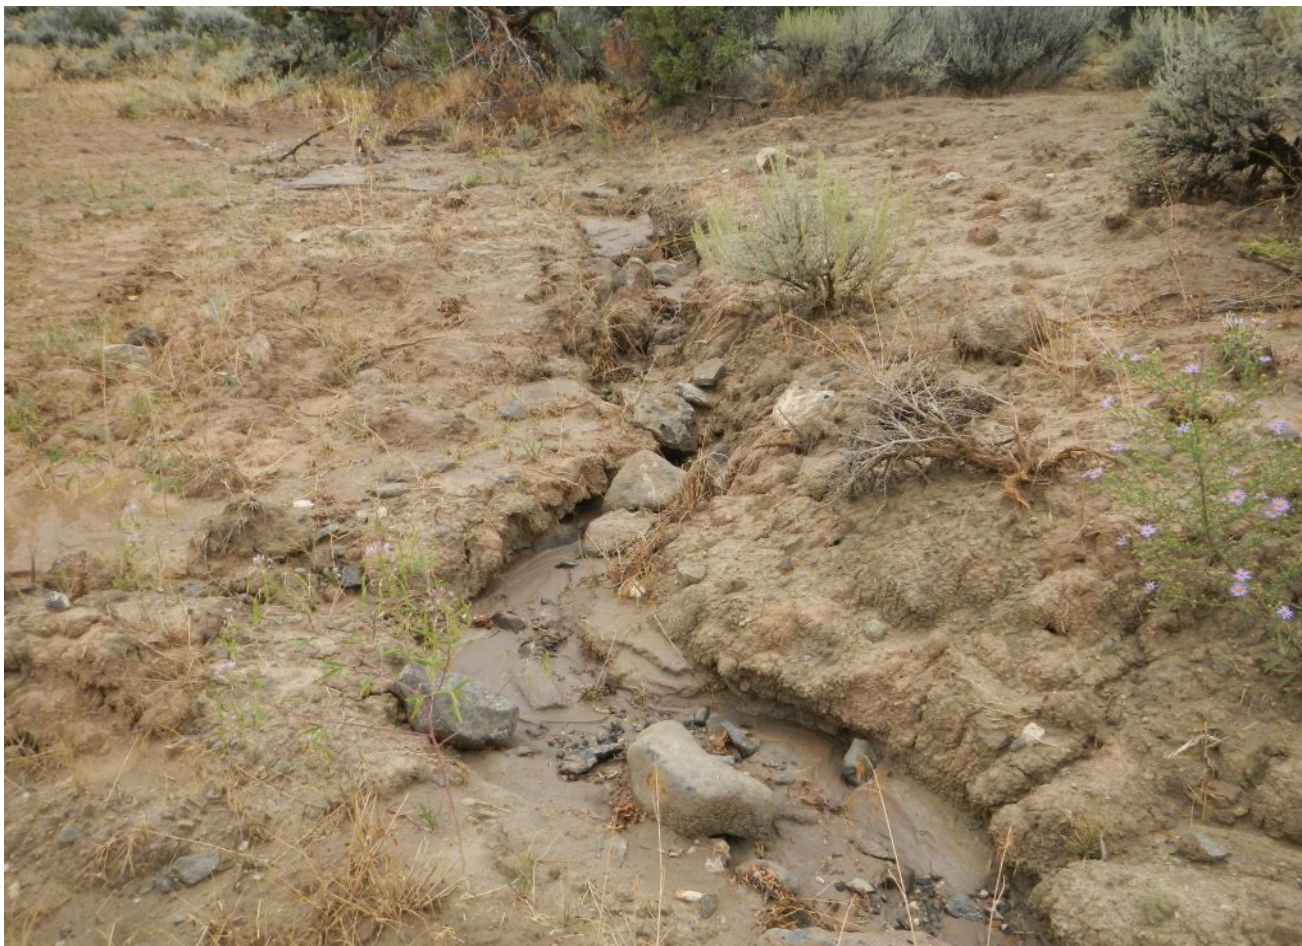
Photo#1: Point where heavy Flow of SW enters Location at NW corner

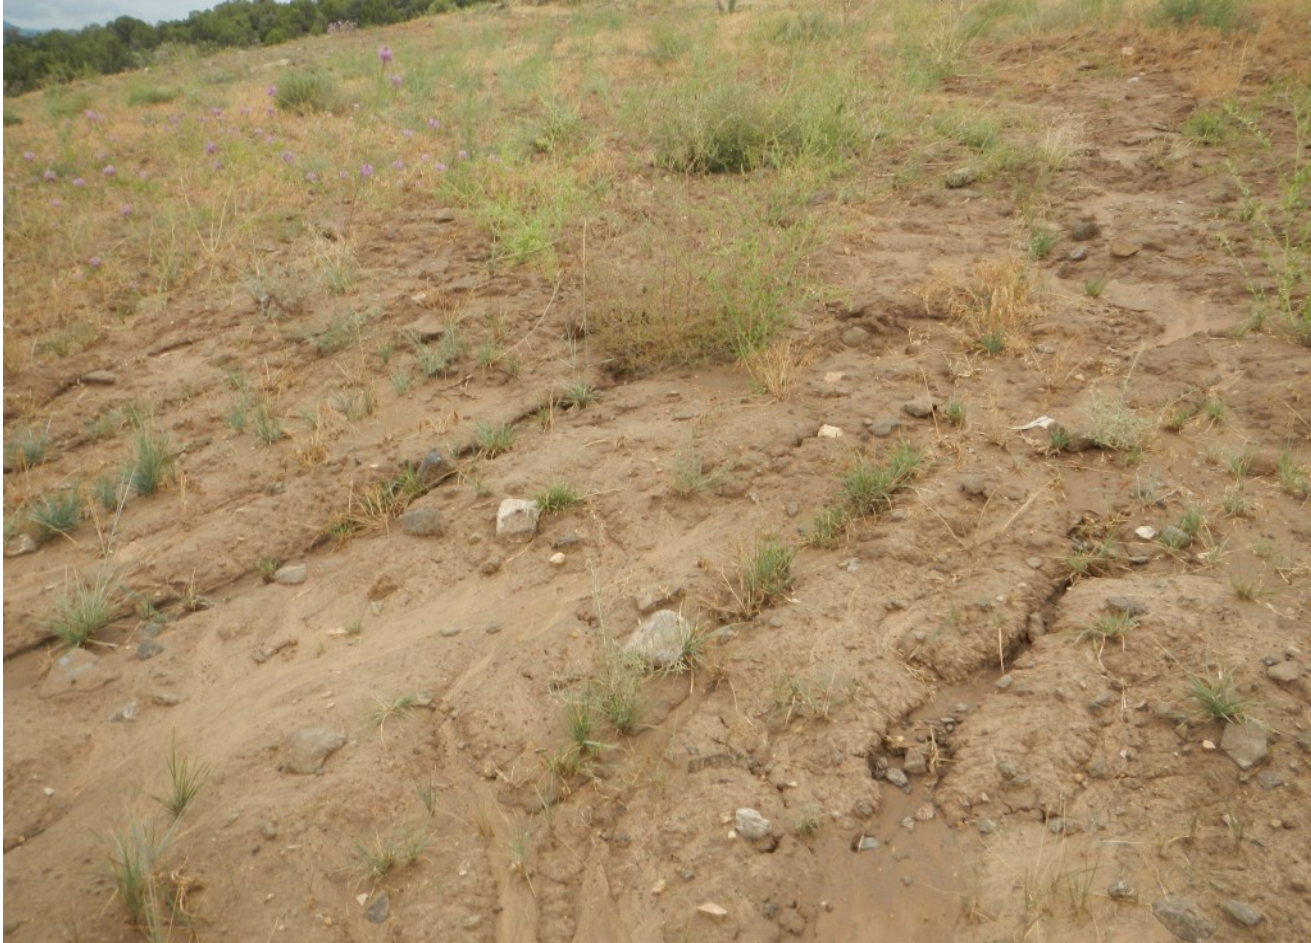
Photo#2: Erosion on Location

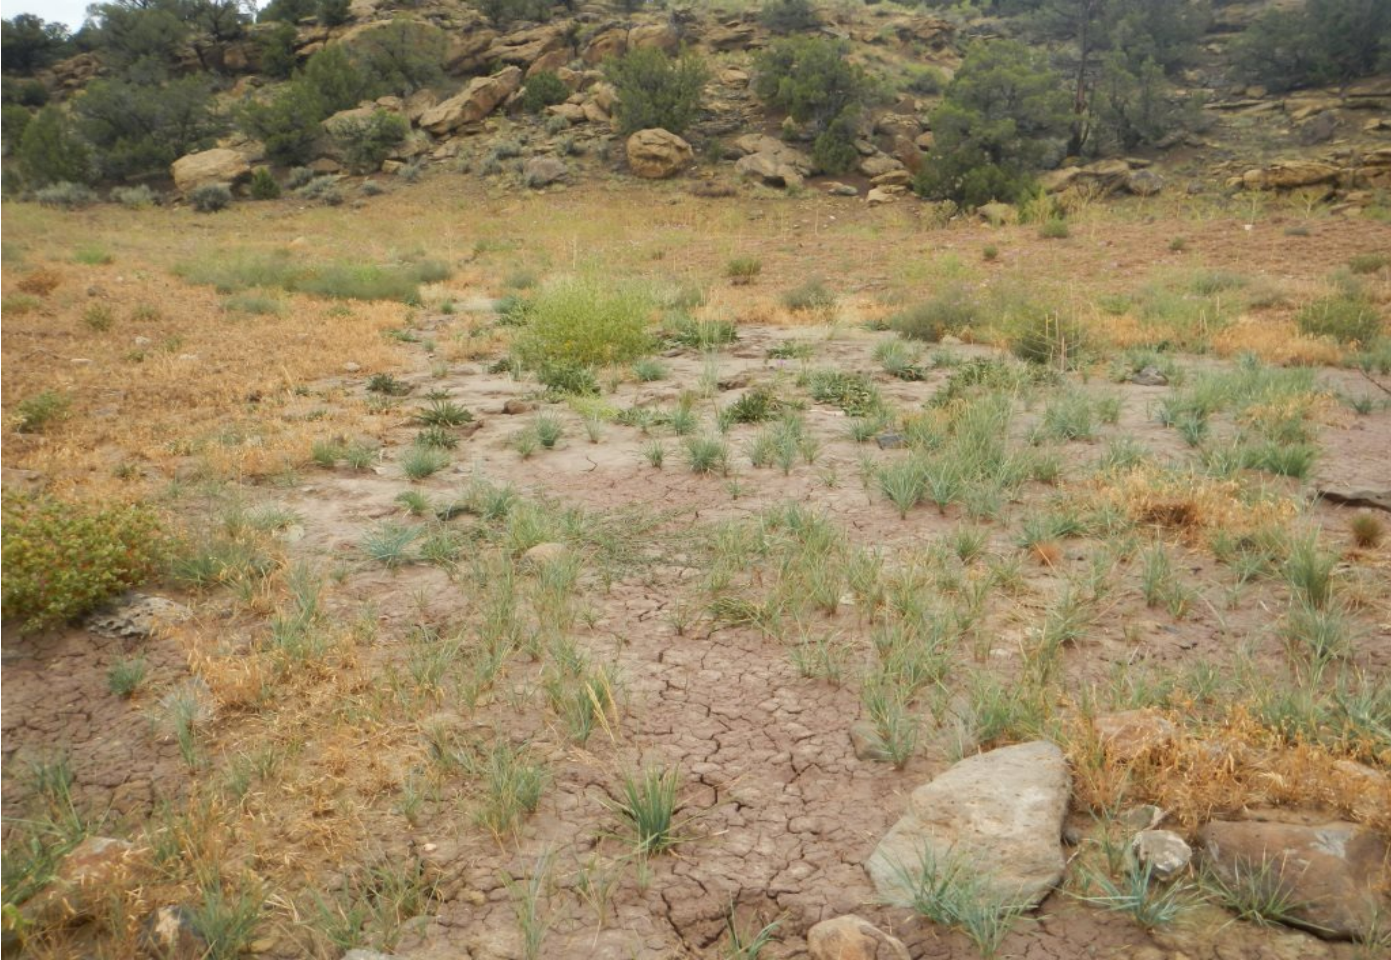
Photo#3: Sediment build up.

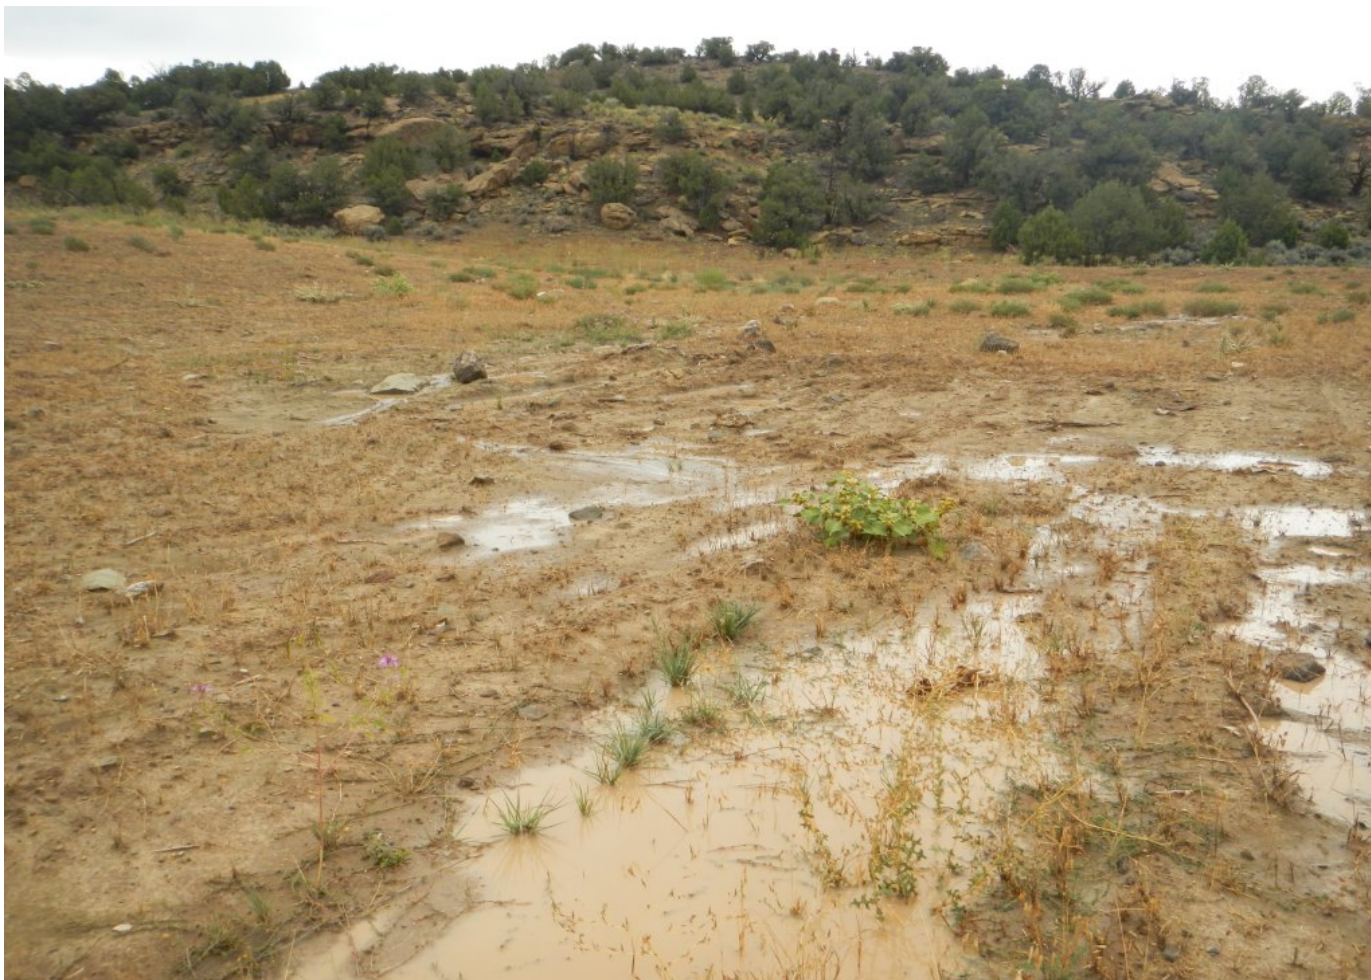
Photo#4: Stormwater still flowing and Pooling through Location.

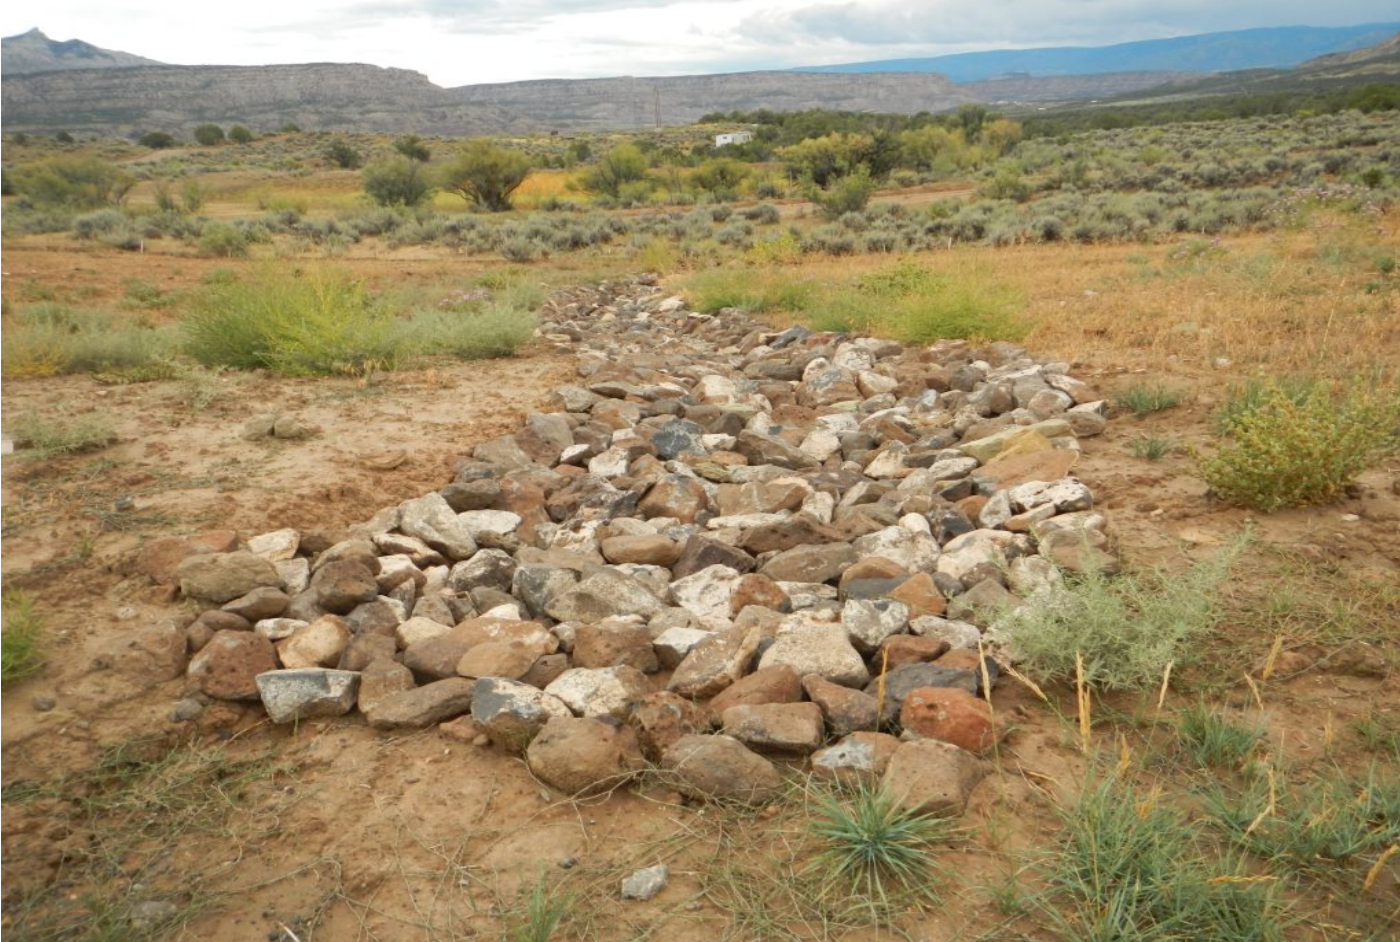
Photo#5: Rocked Drain has been installed since previous Inspection.

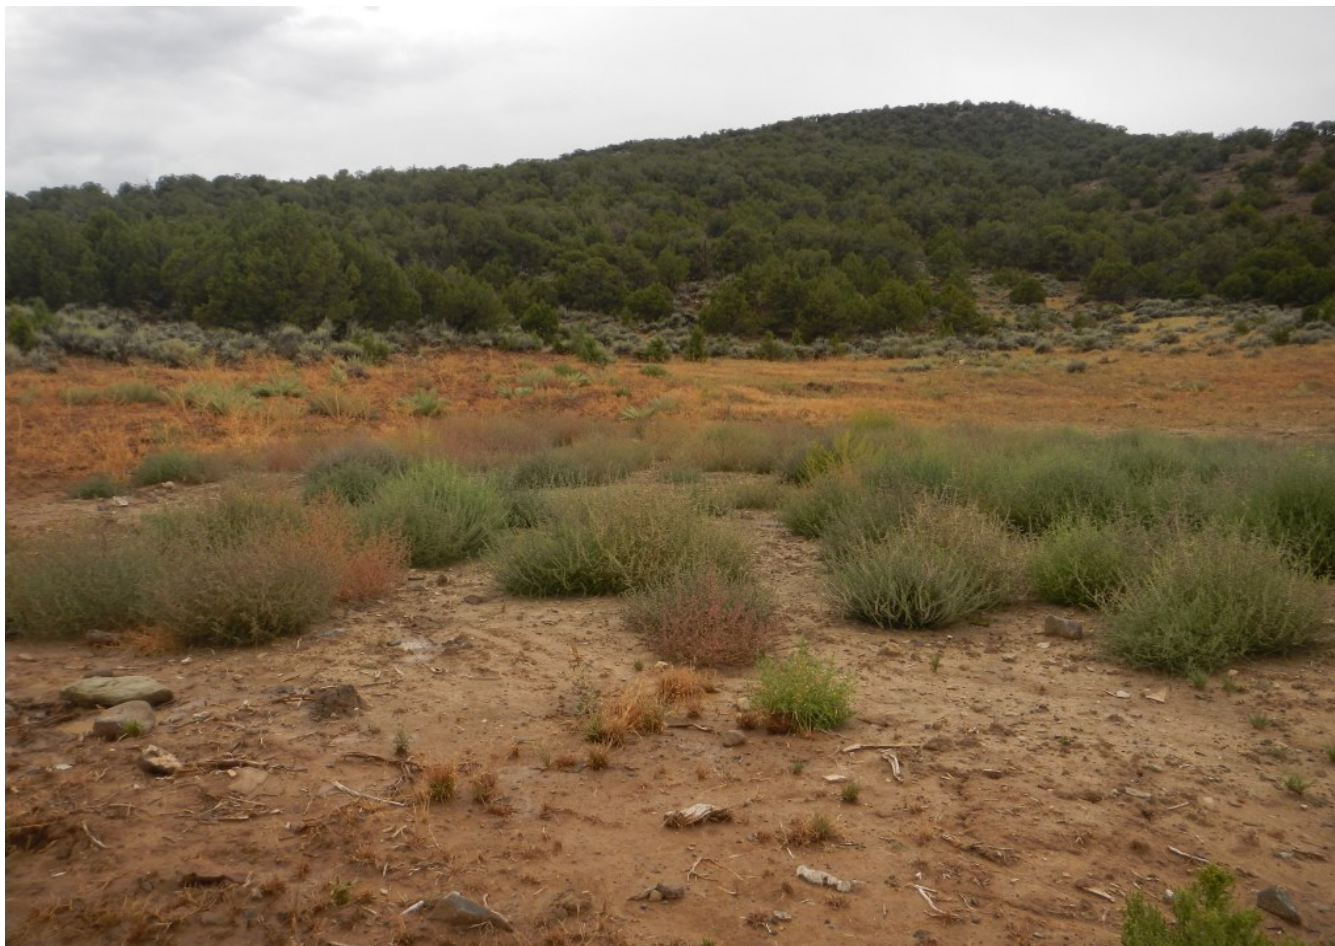
Photo#6: Russian Thistle is establishing on Location.

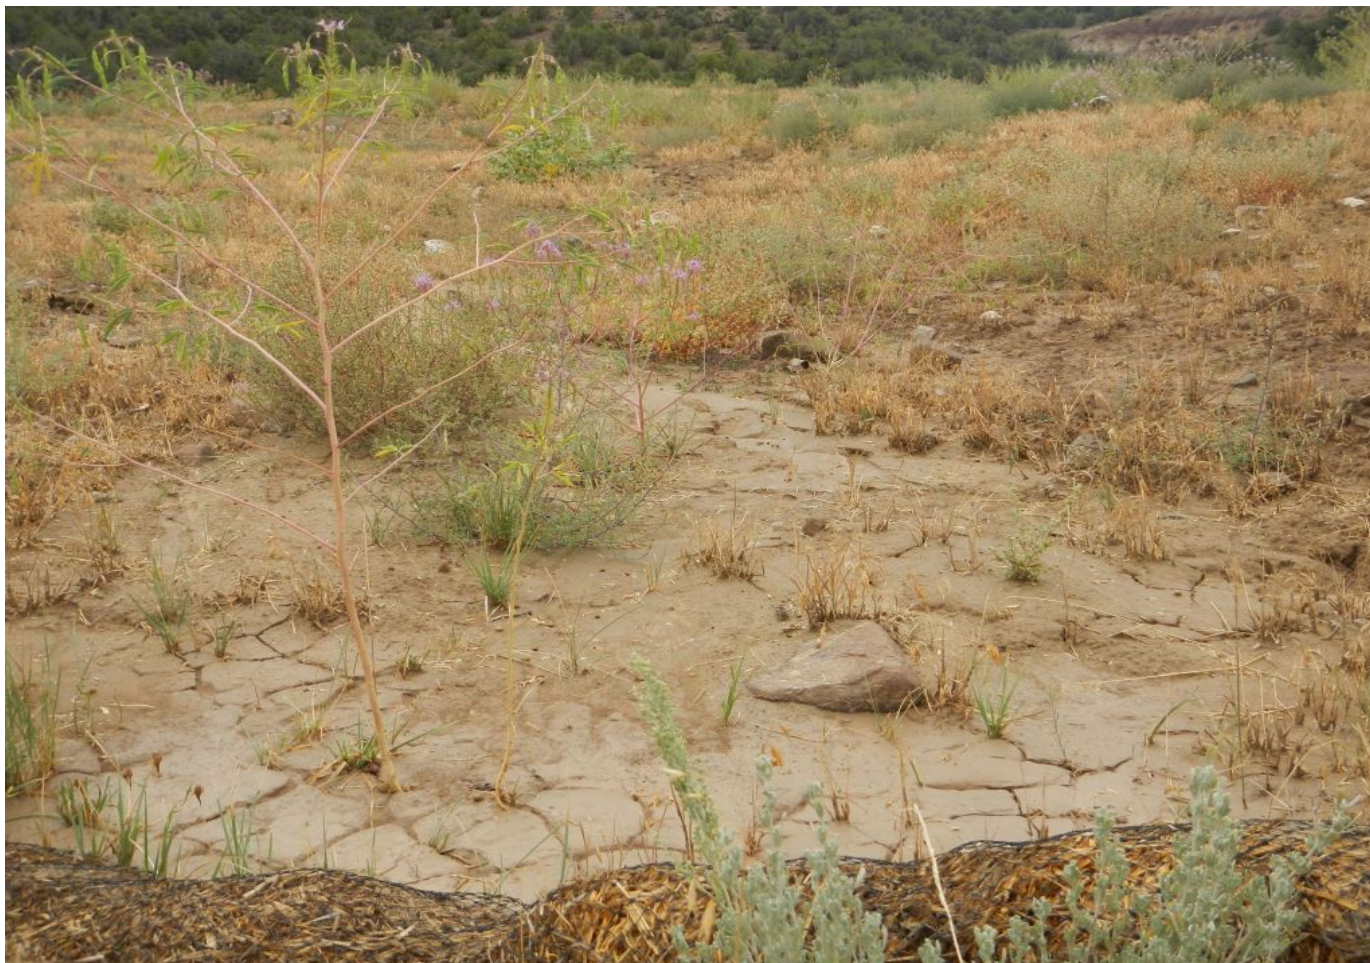
Photo#7: BMPs are containing Sediment; but erosion causing the Sediment migration needs to be controlled.
