Interim Reclamation Inspection

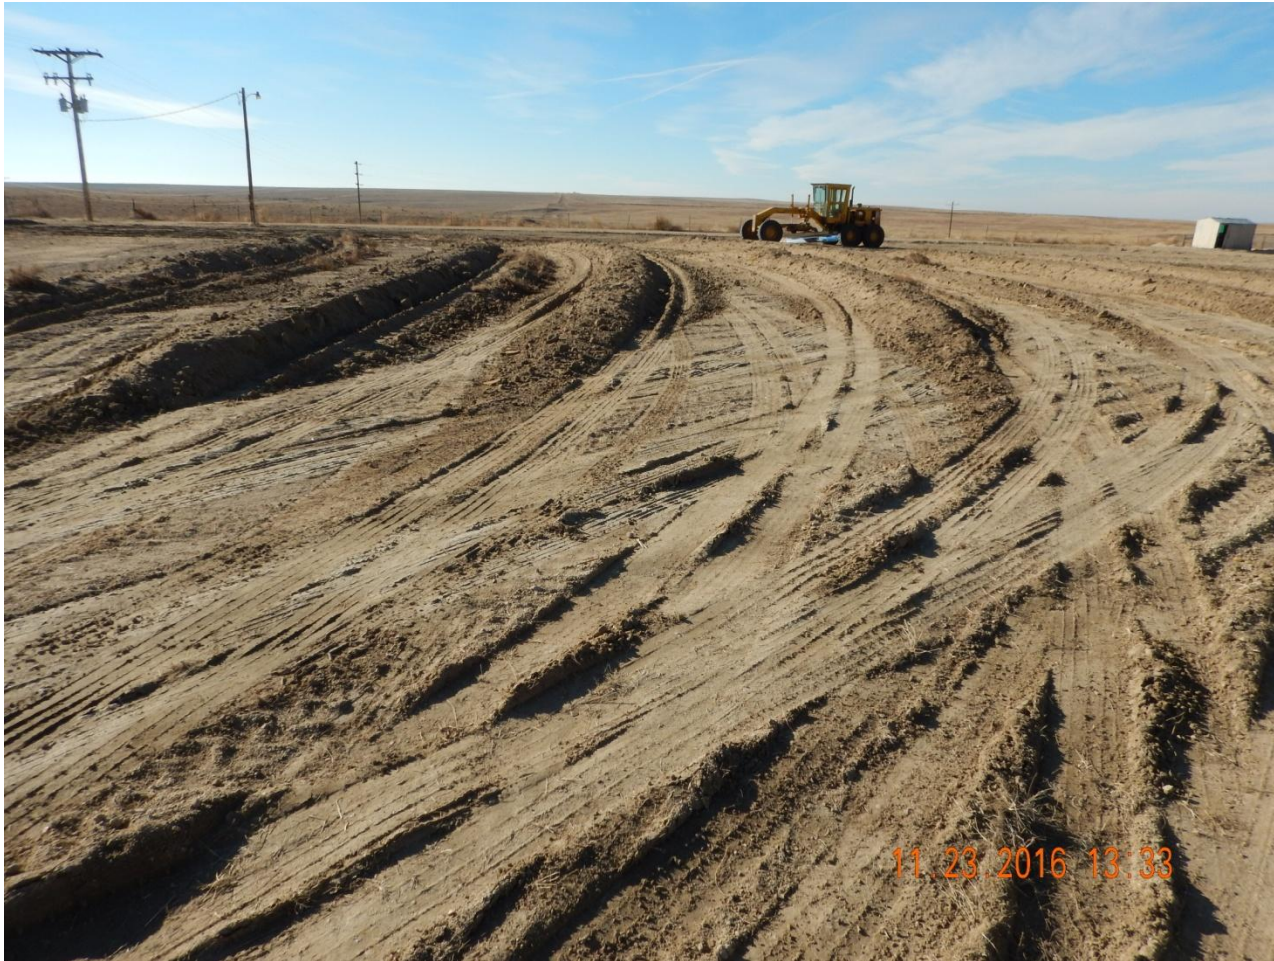
Photo 1. Photo taken from eastern location, facing West. Topsoil brought into location. Interim reclamation IN-PROCESS.

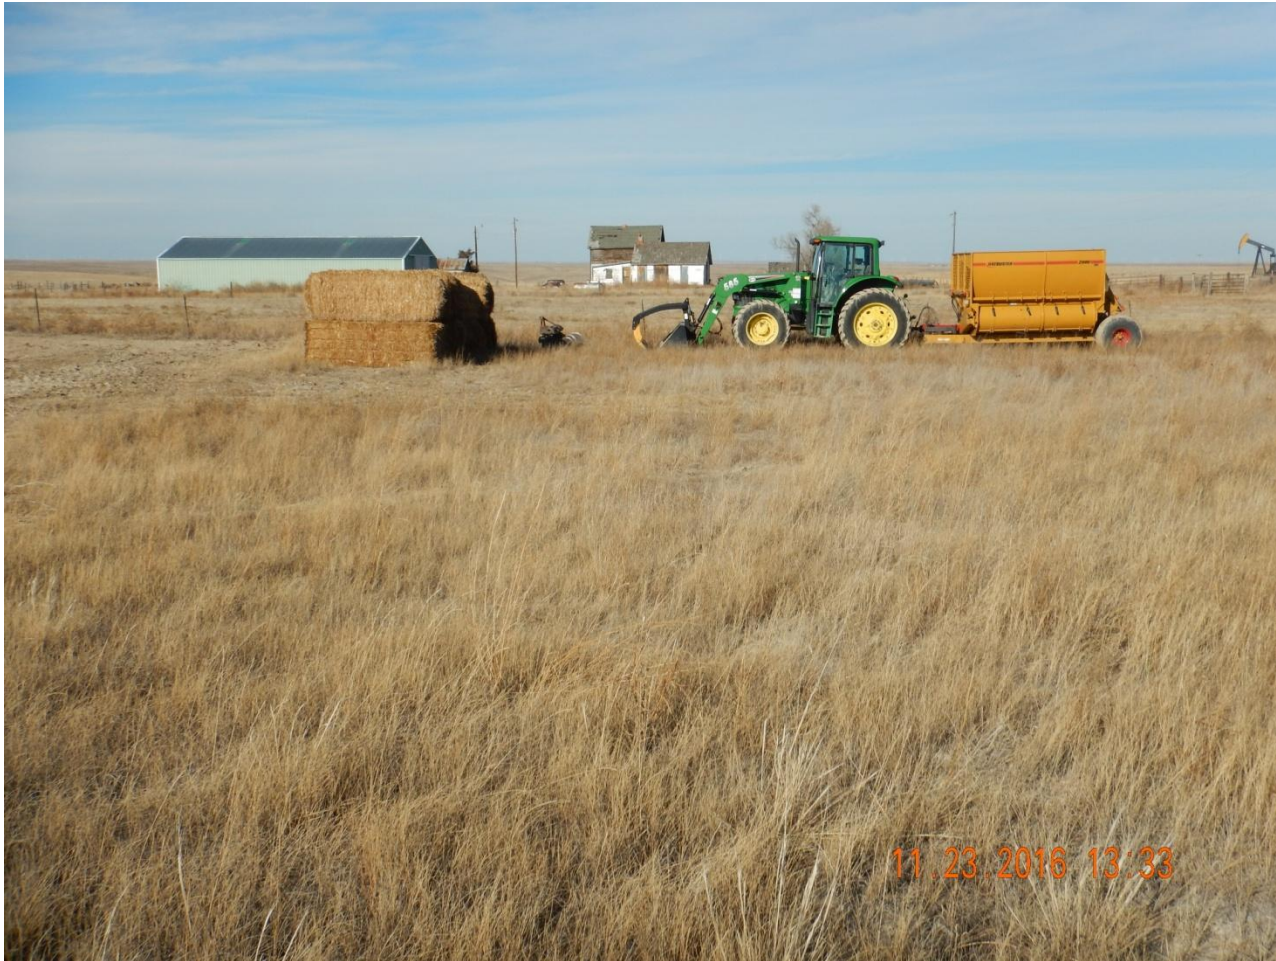
Photo 2. Photo taken of equipment (i.e., hay straw and hay buster) at location for reclamation work.

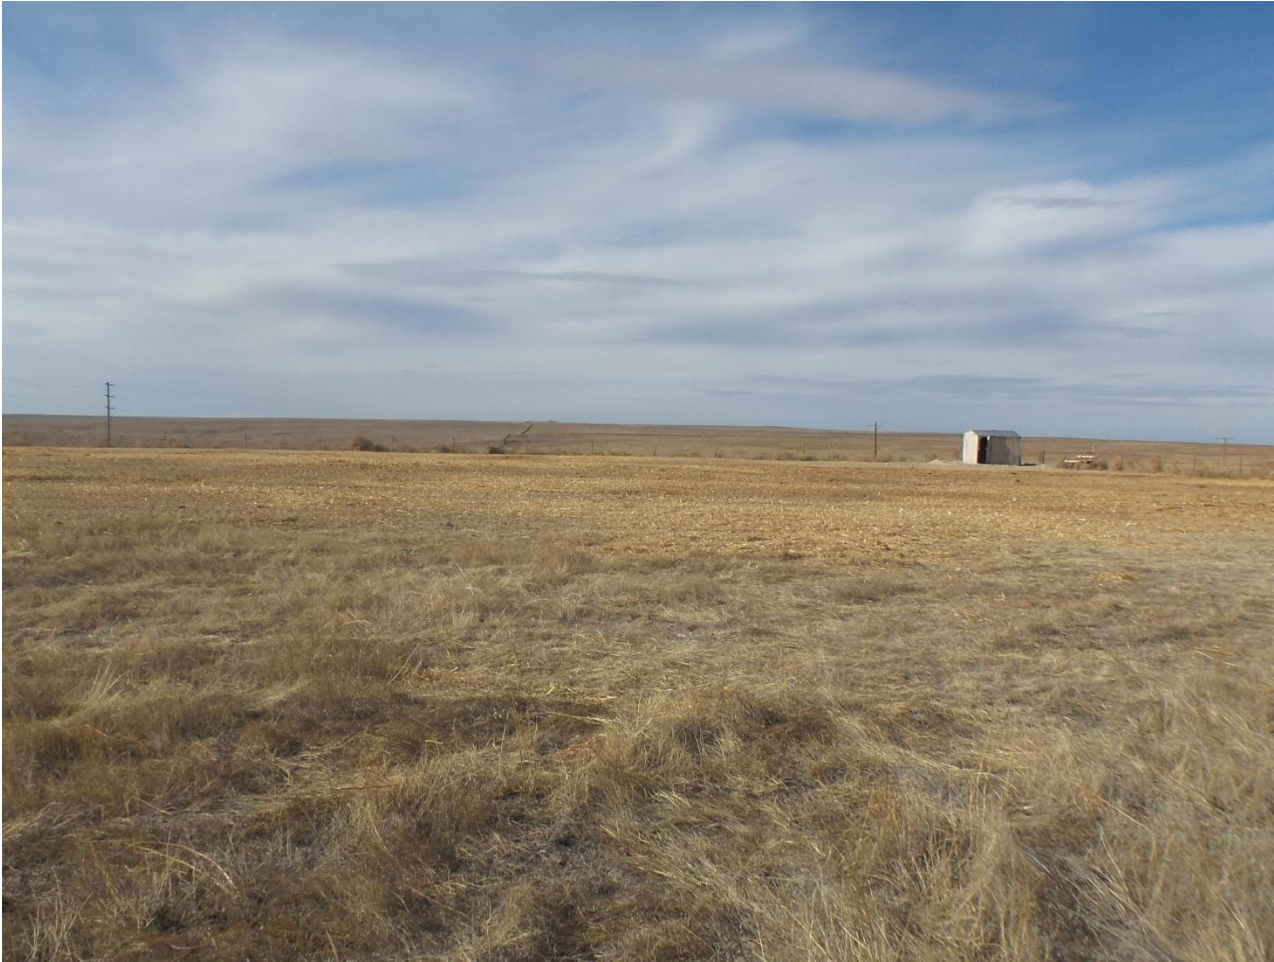
Photo 3. Photo taken 12/1/16 by the Operator and emailed to COGCC staff. Location was graded, seeded, and straw mulched.

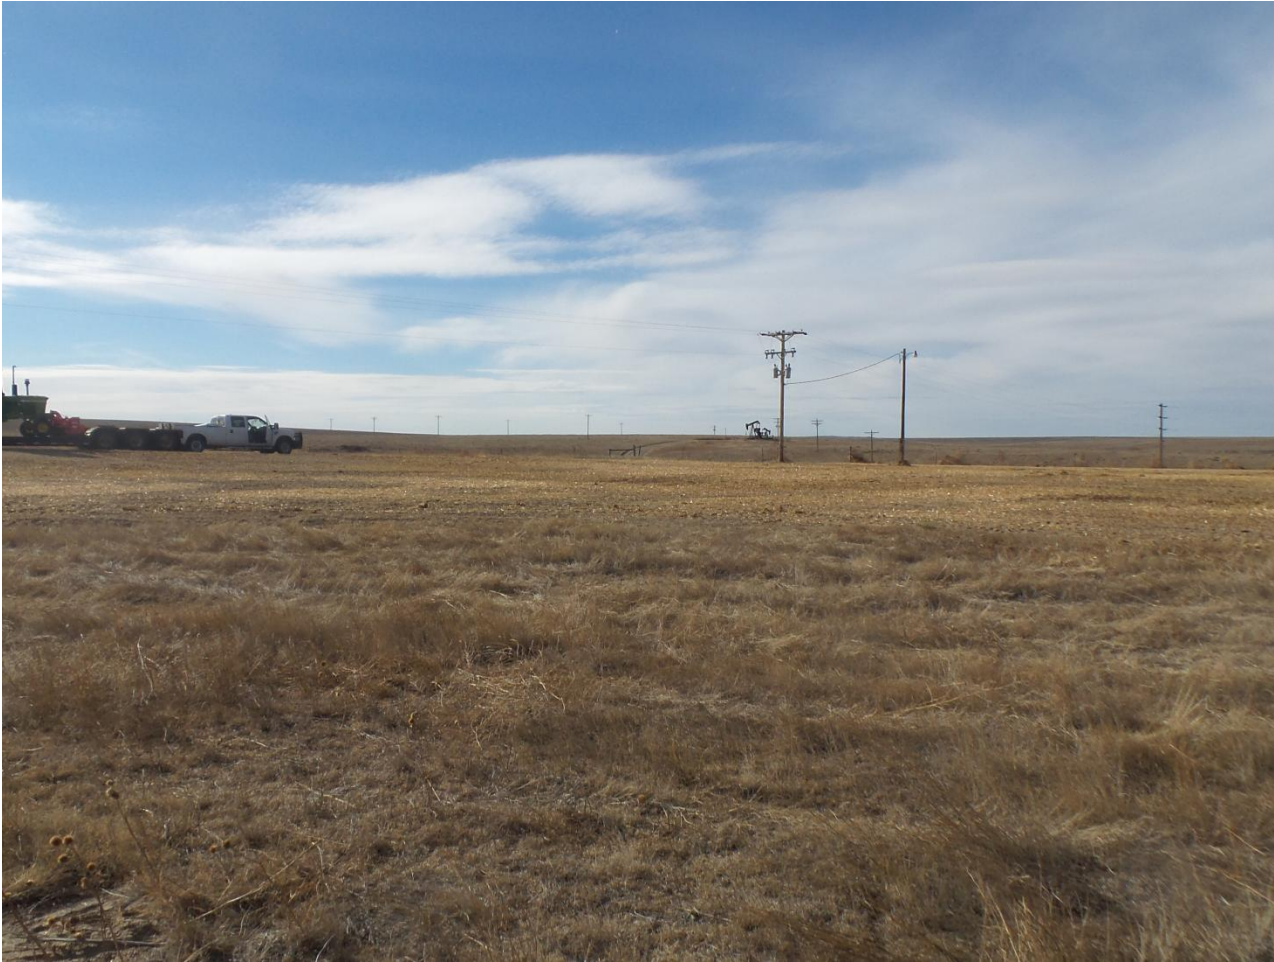
Photo 4. Photo taken 12/1/16 by the Operator and emailed to COGCC staff. Location was graded, seeded, and straw mulched.

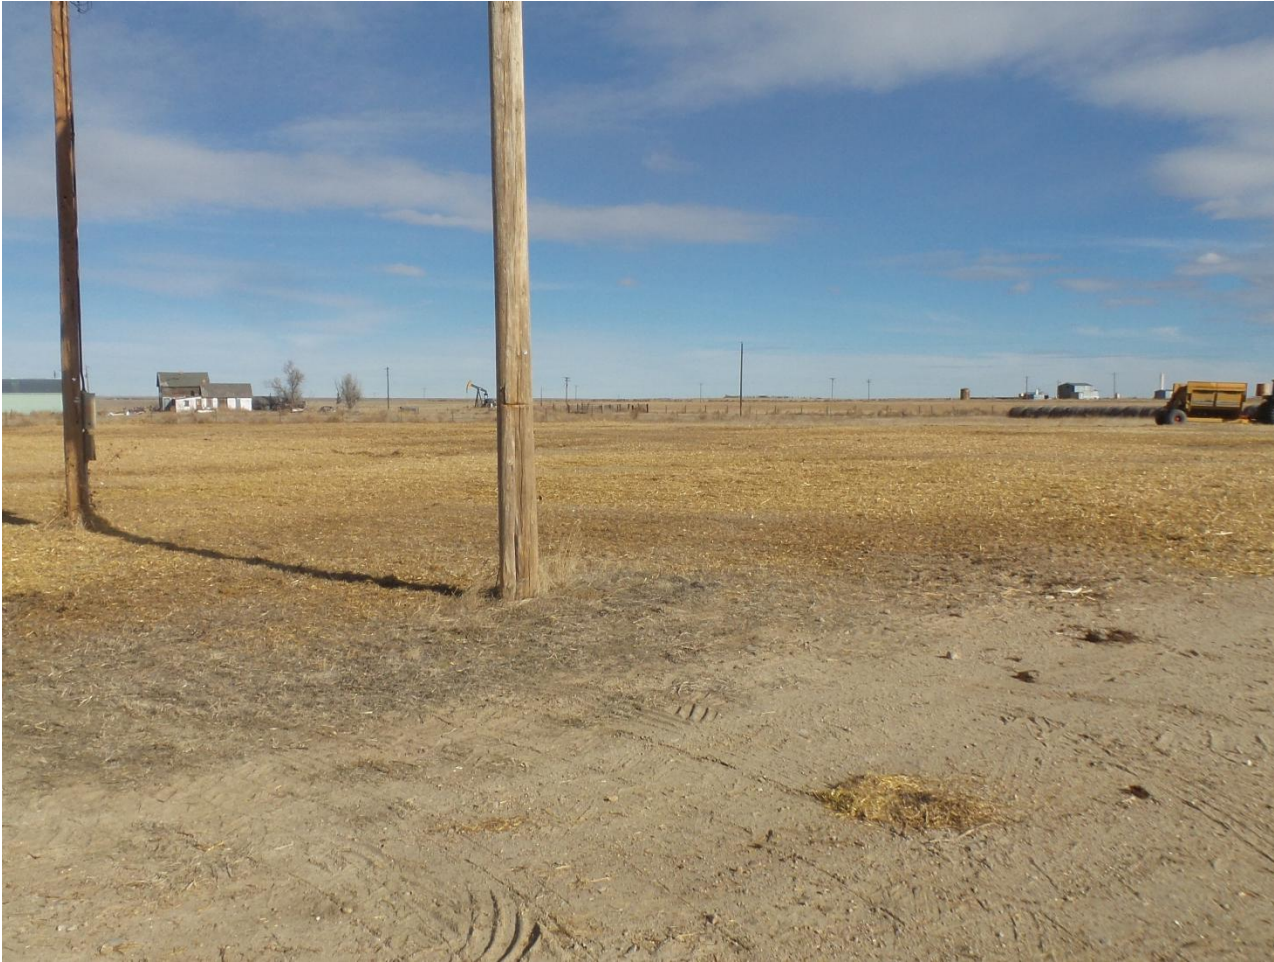
Photo 5. Photo taken 12/1/16 by the Operator and emailed to COGCC staff. Location was graded, seeded, and straw mulched.
