Inspection Photos – 2017 Flowline NTO
Inspection
Location Name: Powder Wash Federal 28-
3
API: 05-081-06434

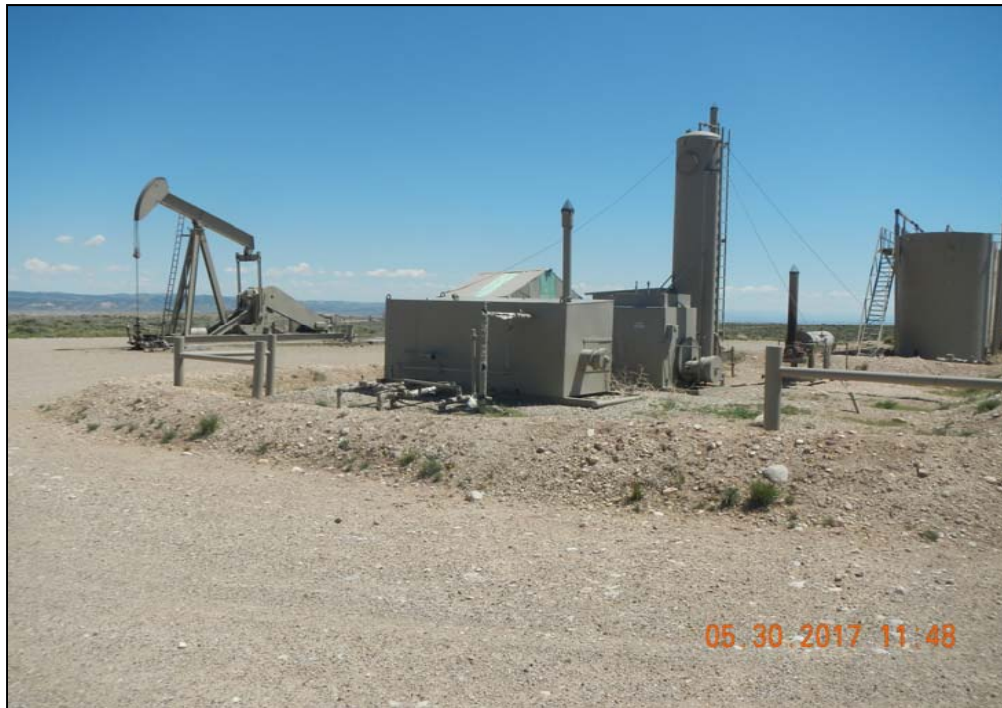
Photo 1. Overview of location taken at entrance to location facing northeast.

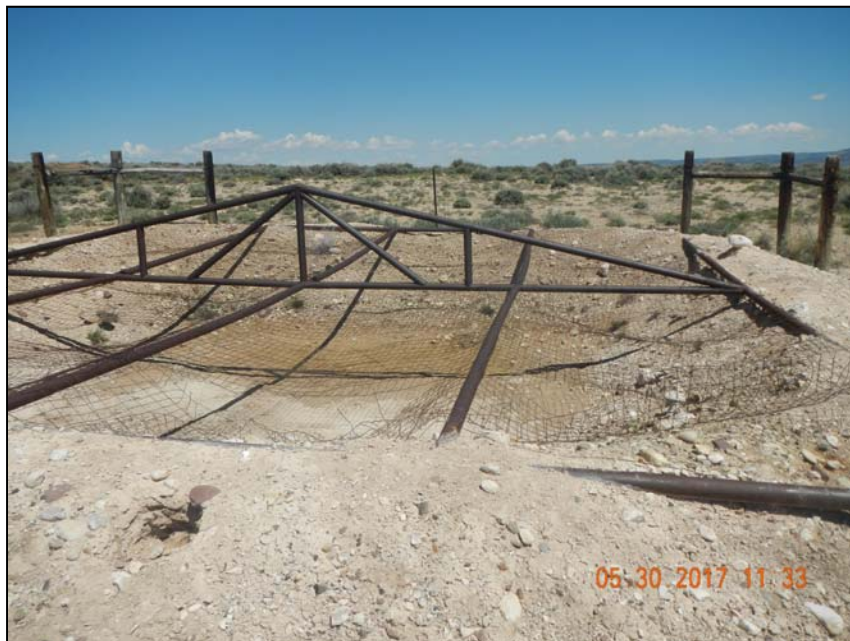
Photo 2. Pit at 40.889770, -108.299390

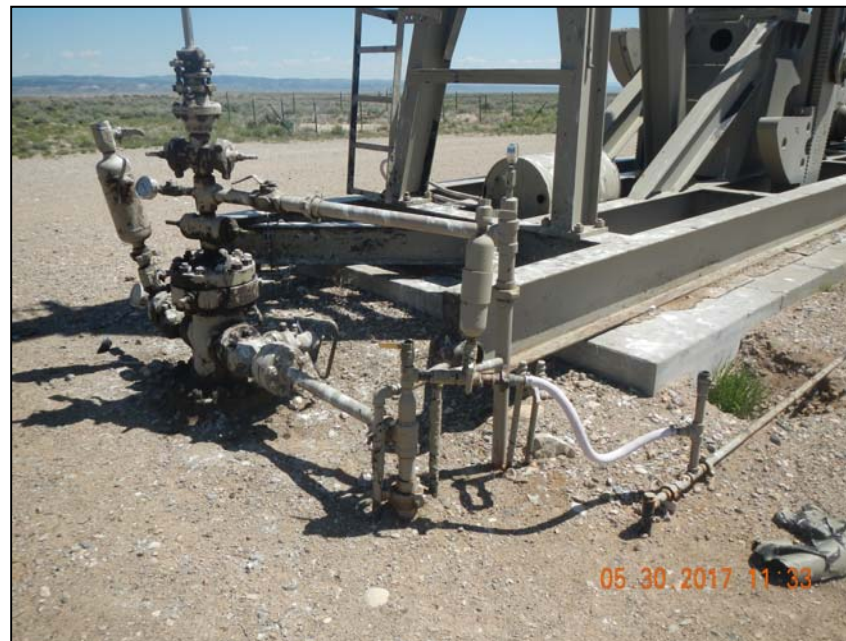
Photo 3. 2 – 2" steel riser, 2 – 1" insulated steel riser, 3 – 1" steel riser at wellhead

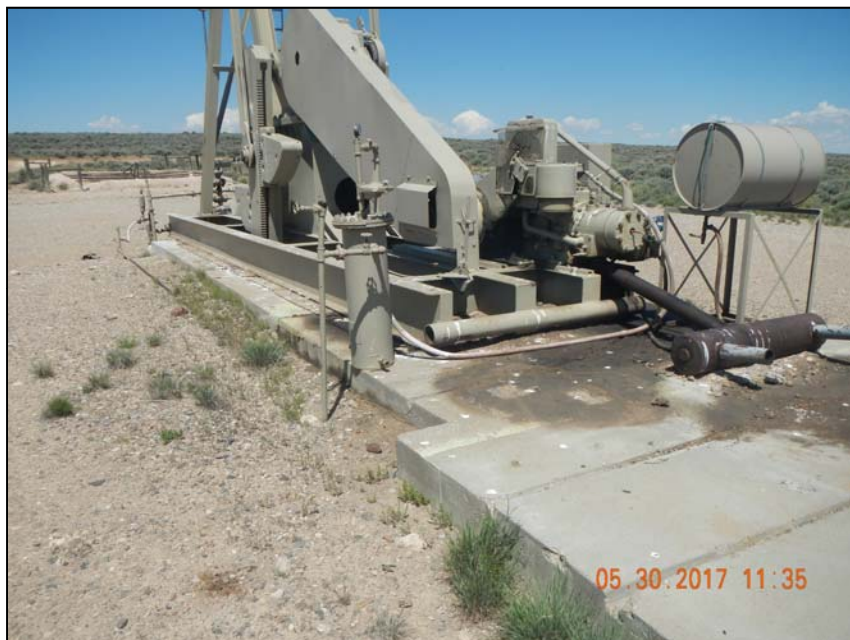
Photo 4. Flowlines to separator and motor for pump jack.

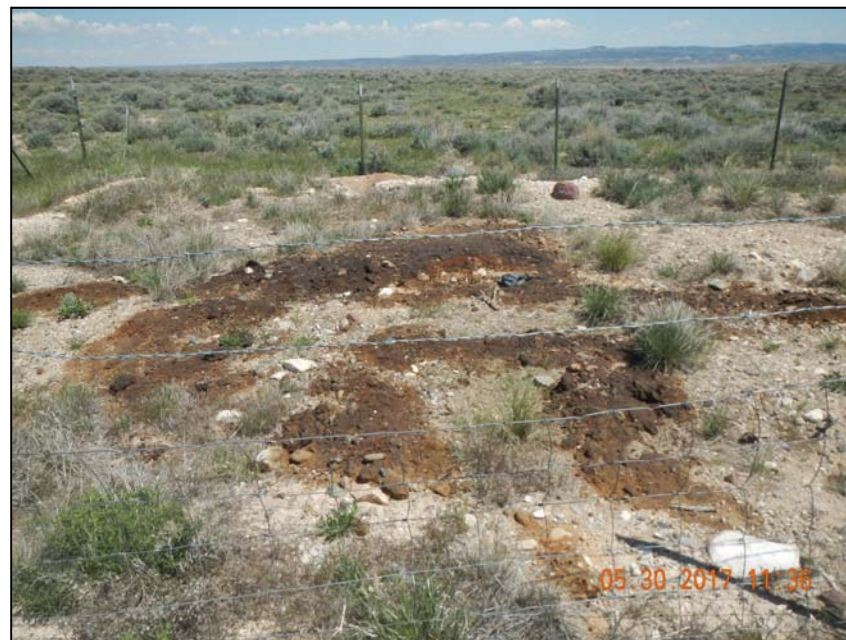
Photo 5. Landfarm at 40.88992, -108.29888.

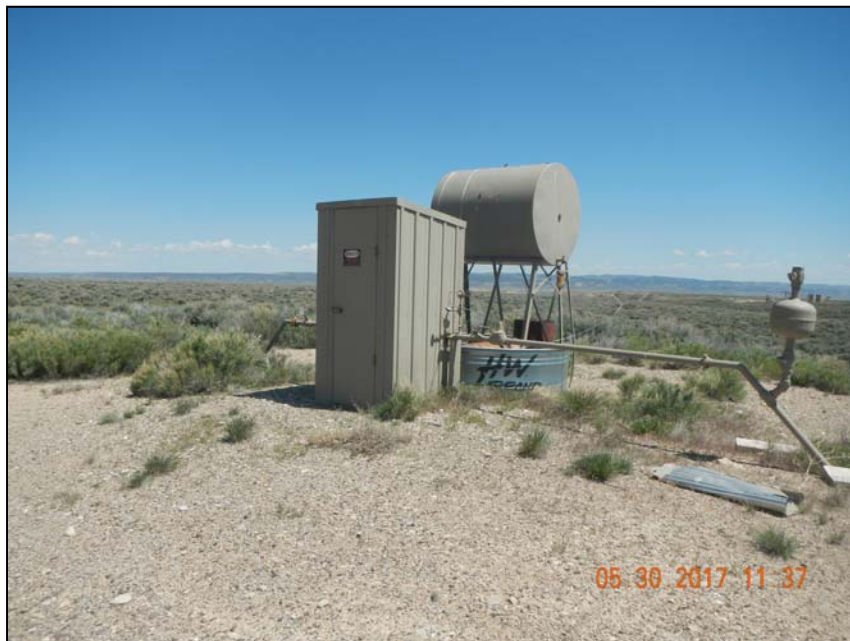
Photo 6. 2 – 2" steel risers at meter run. Unlabeled container in background.

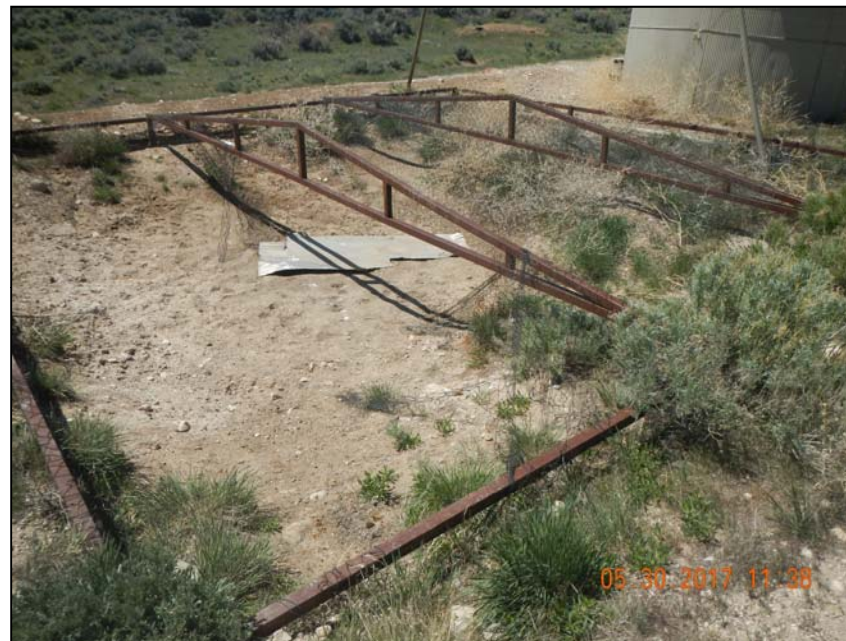
Photo 7. Pit in tank battery at 40.889570, -108.298610

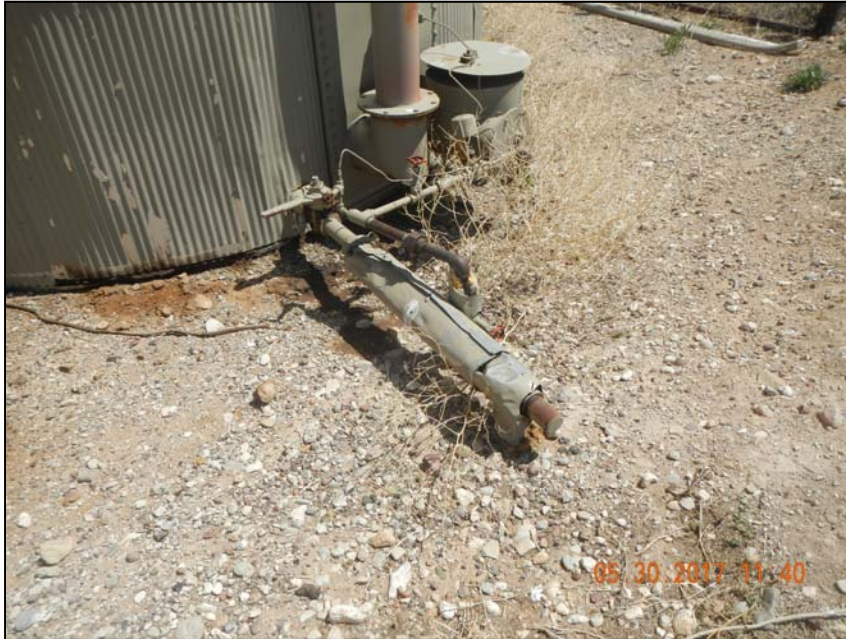
Photo 8. Flowlines and risers at tanks.

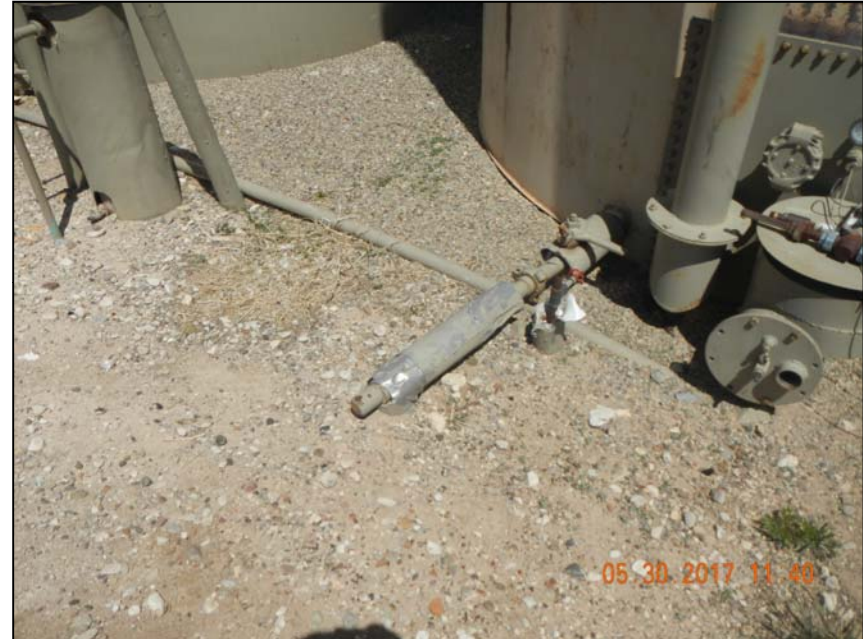
Photo 9. Flowlines and risers at tanks.

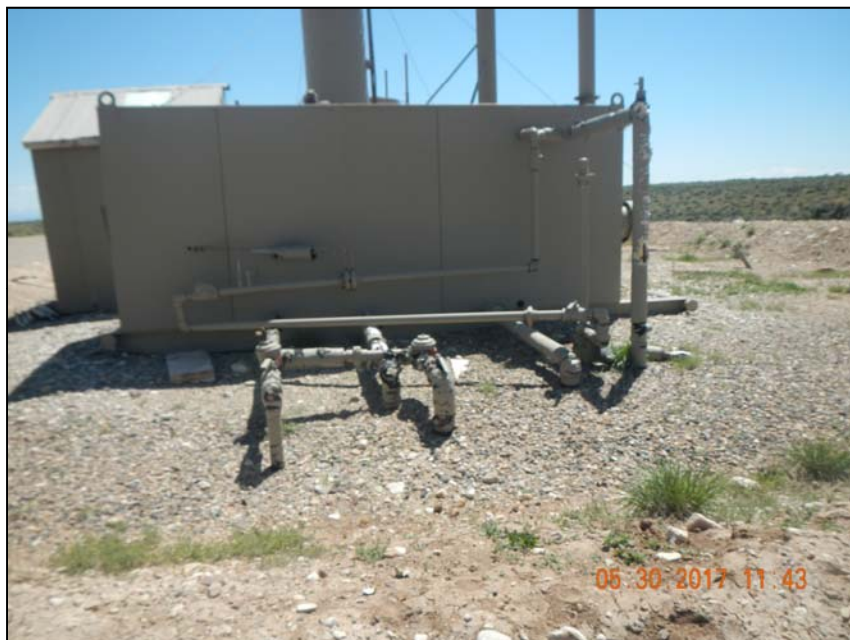
Photo 10. Risers at horizontal separator.

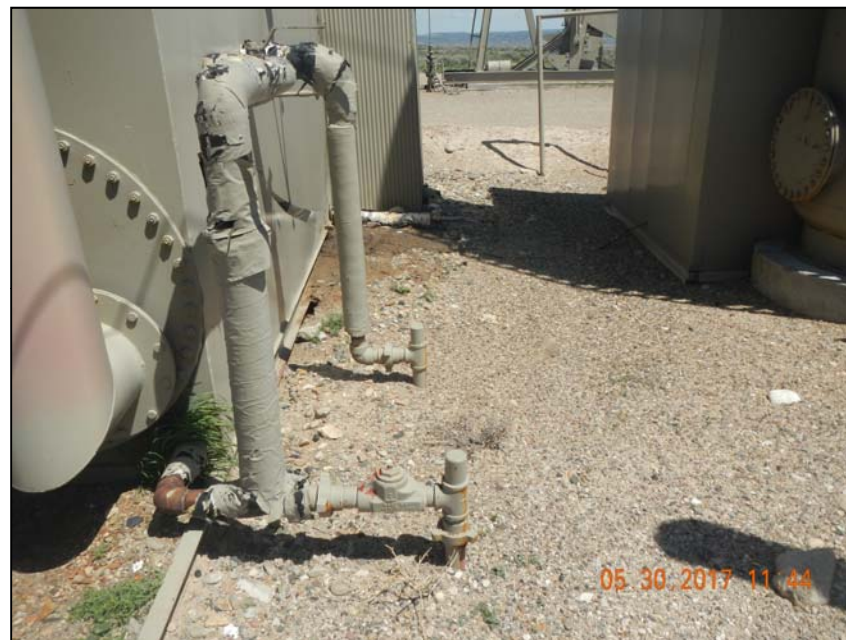
Photo 11. Risers at vertical separator on right and horizontal separator on left.
