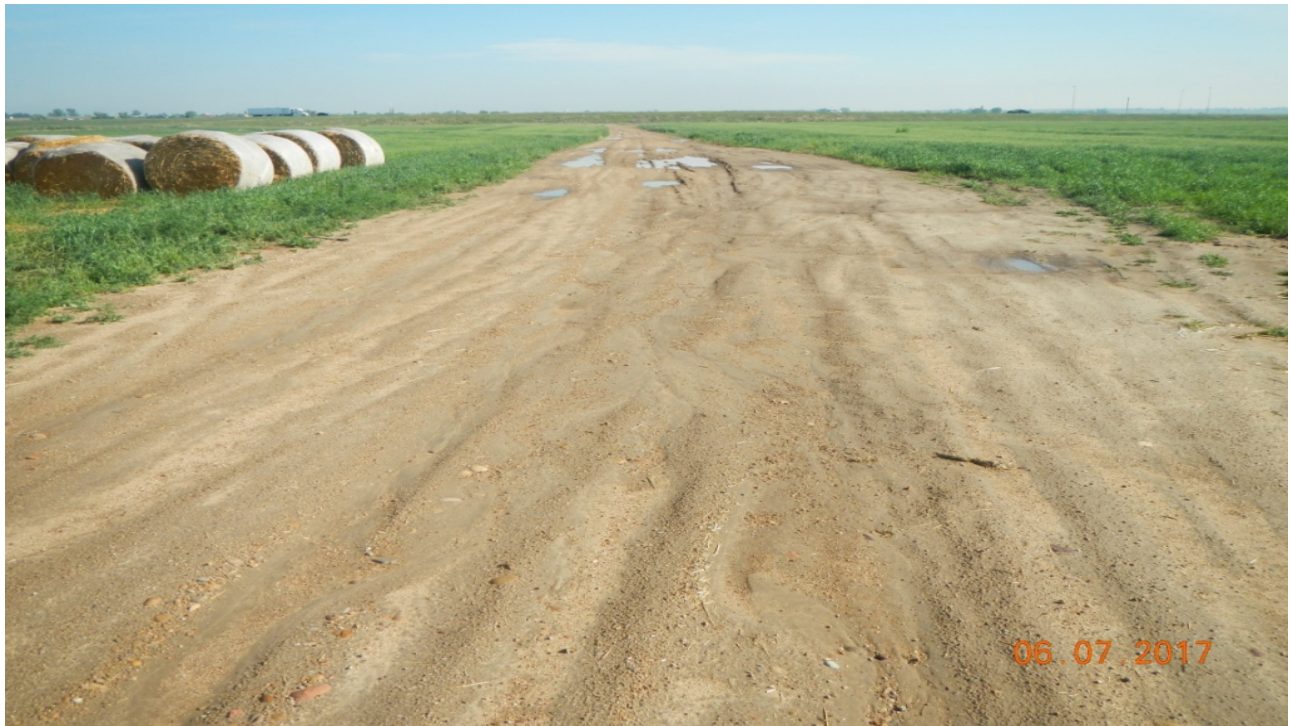
photo 1: Facing north toward the access road.

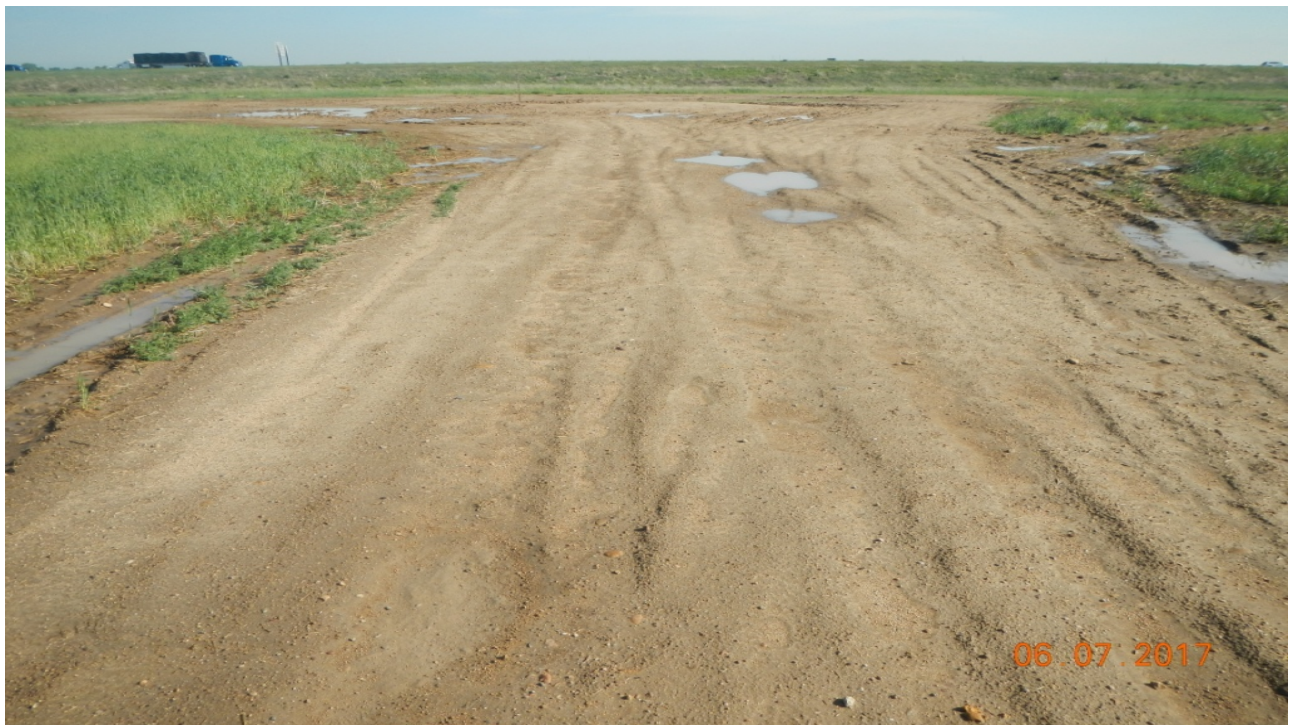
photo 2: Facing north toward the location.

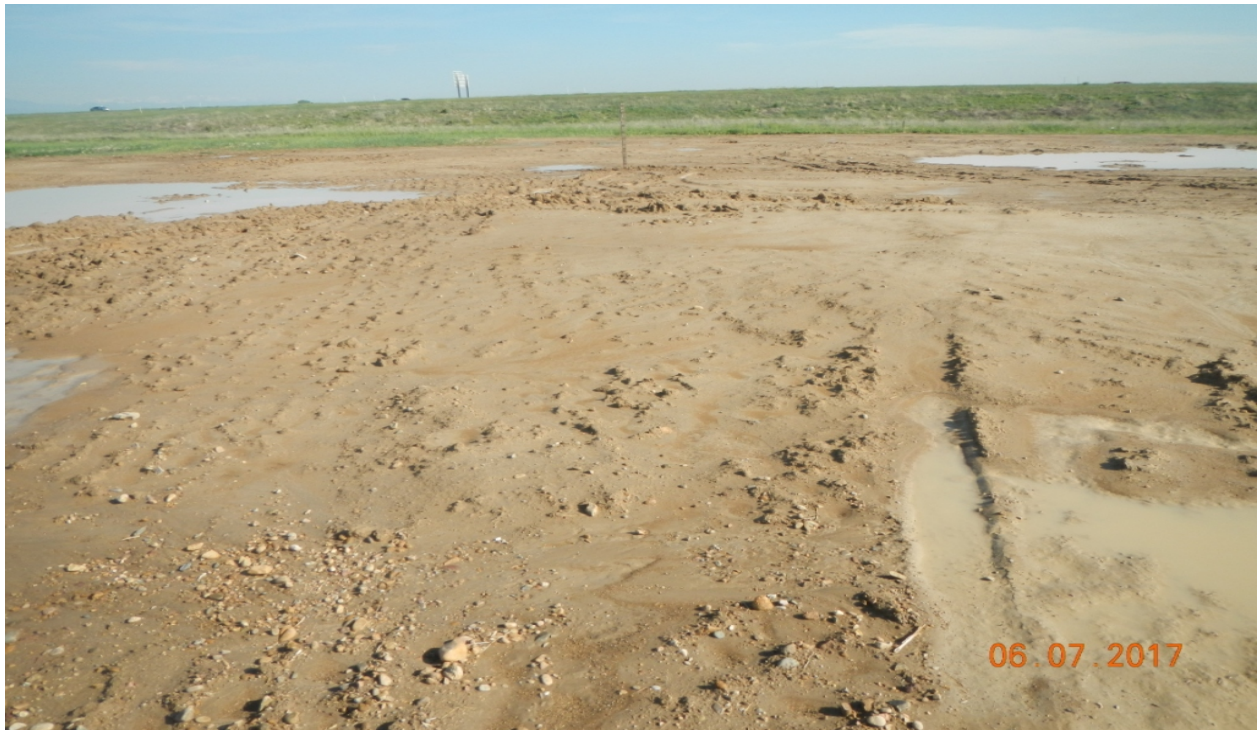
photo 3: Facing north at the location. A wooden post remains at the center of the location.

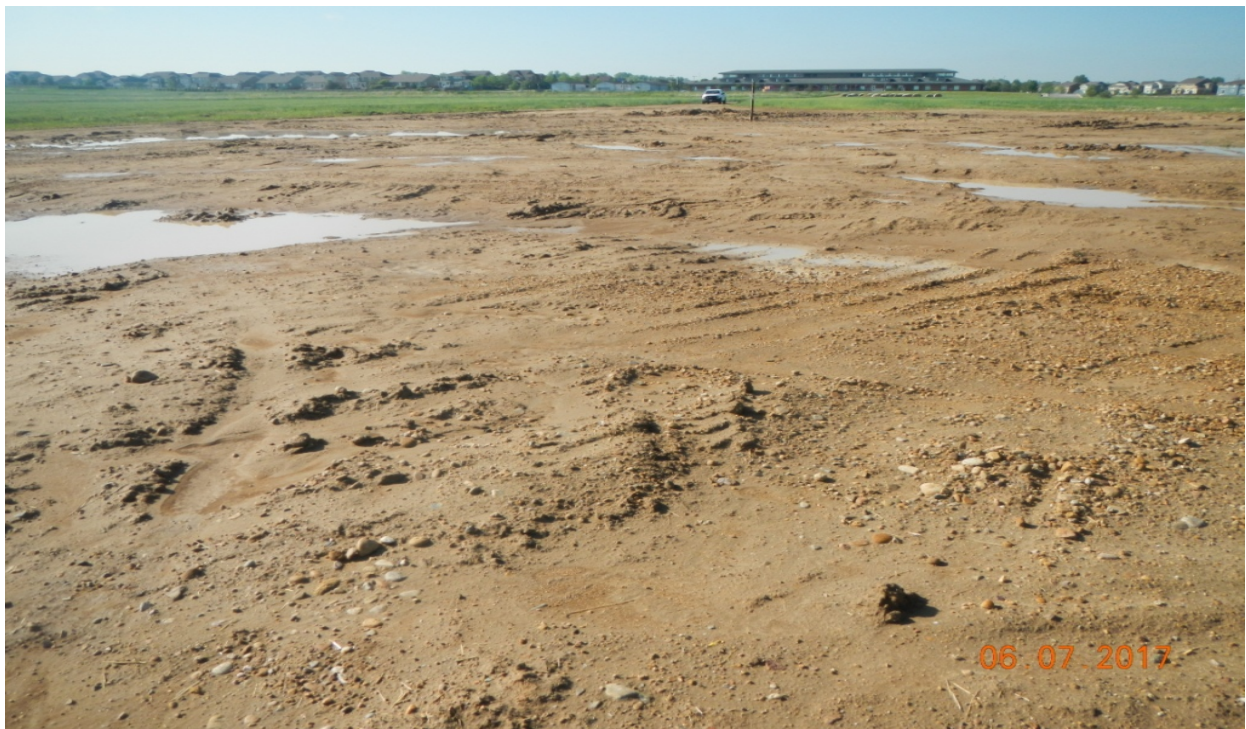
photo 4: North side of the location facing south.

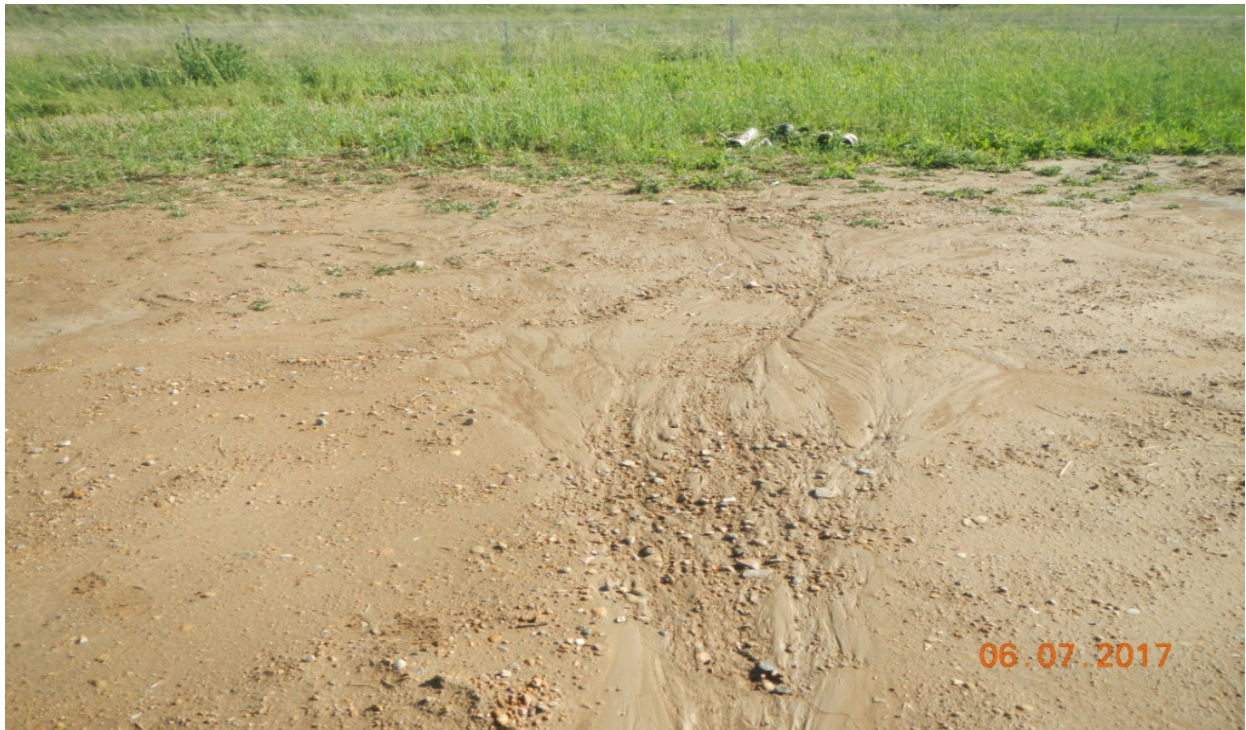
photo 5: There are signs of stormwater flowing off the north side of the location which can create erosion issues.

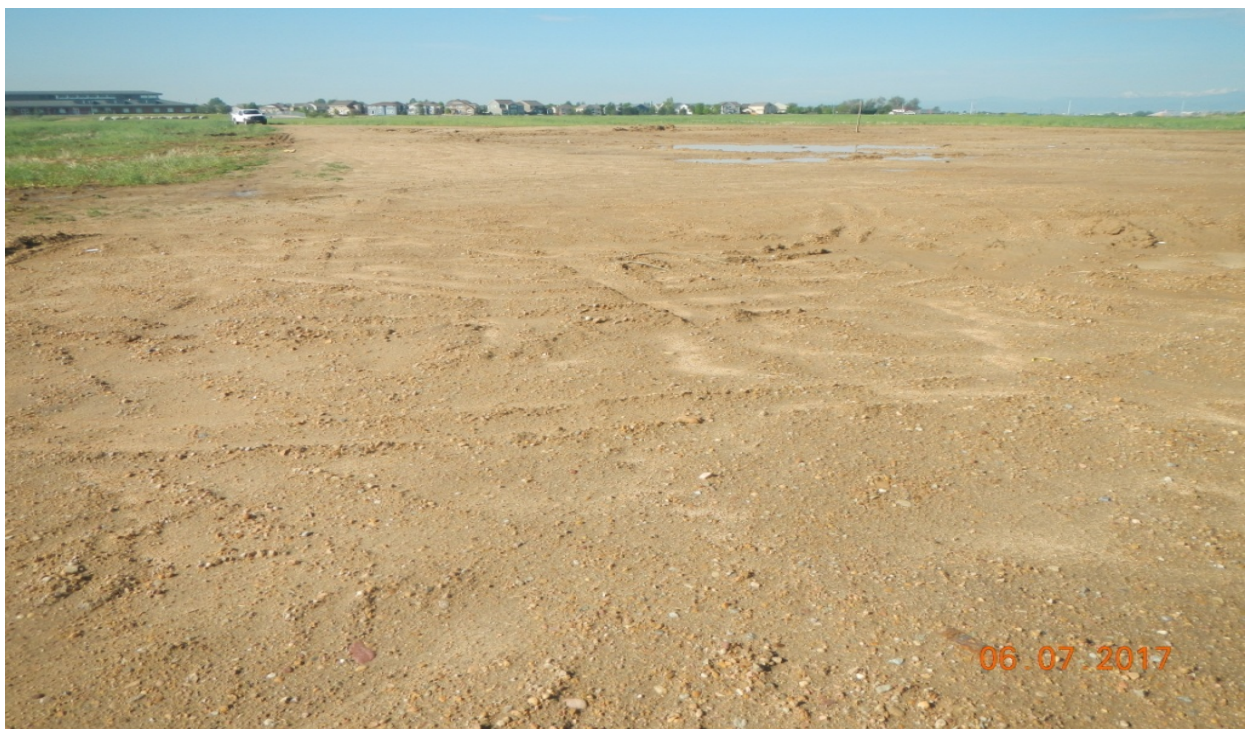
photo 6: Northeast side of the location facing southwest.

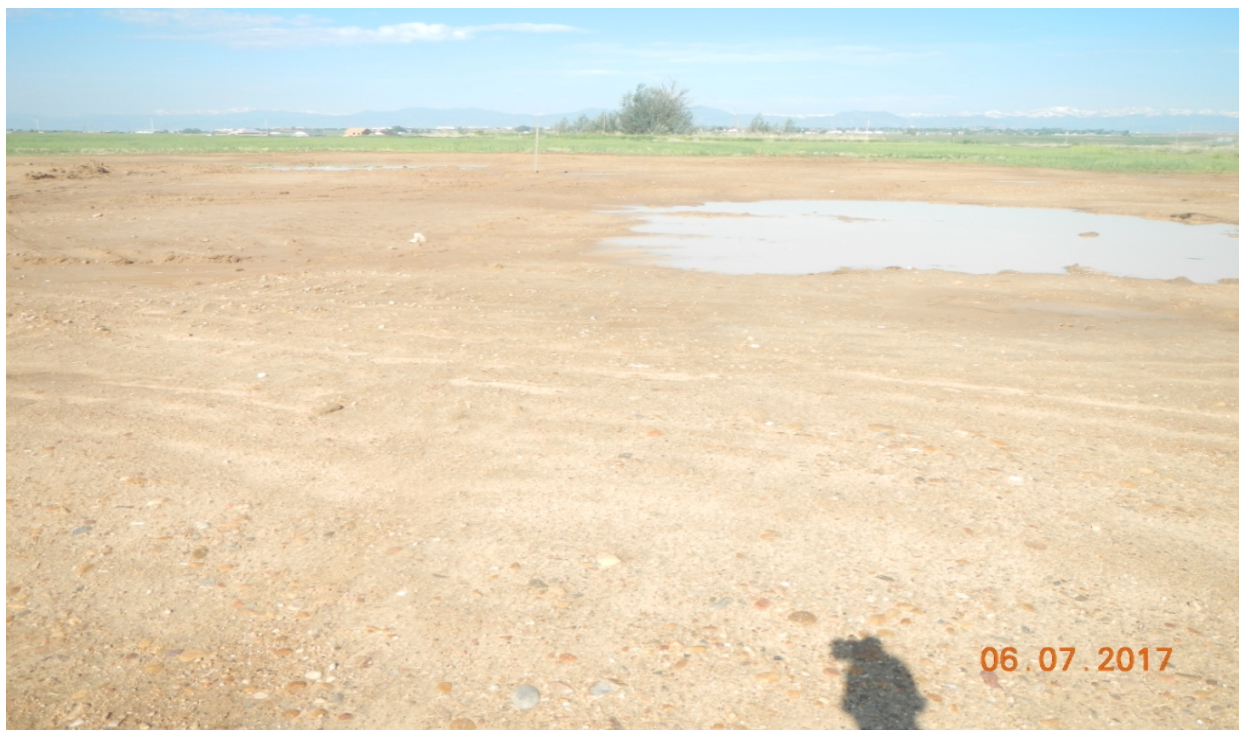
photo 7: East side of the location facing west.

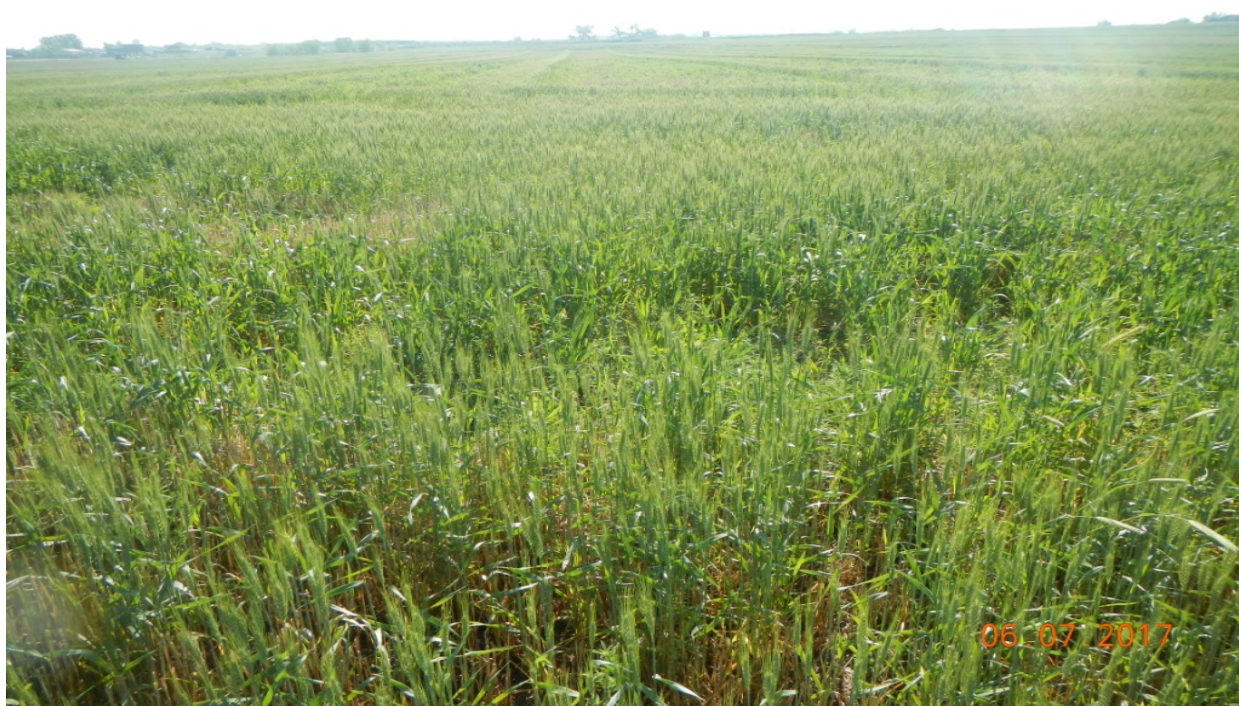
photo 8: Facing east at the surrounding crop field.
