- Sanchez 2 05-067-05345

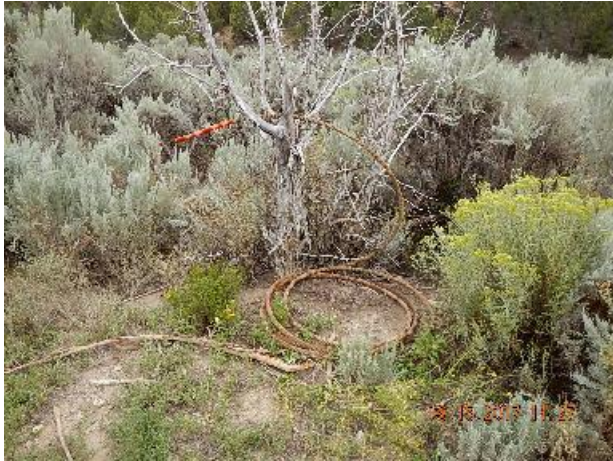
Photo 1: Steel cable at left side of location entrance.

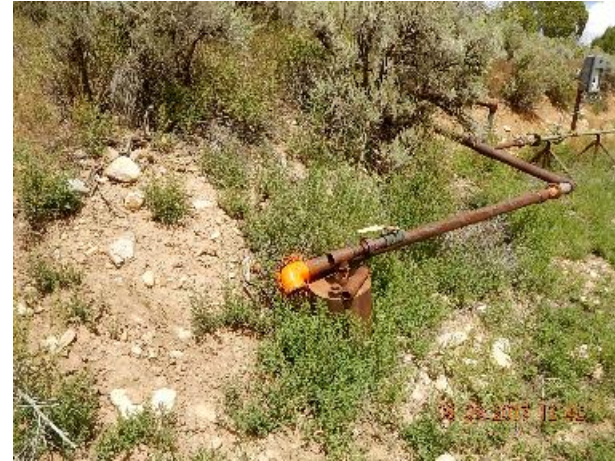
Photo 2: Open ended line.

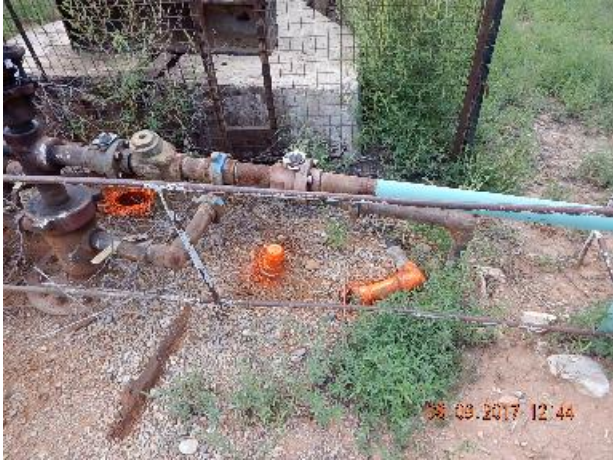
Photo 3: Risers and casing vent at wellhead.

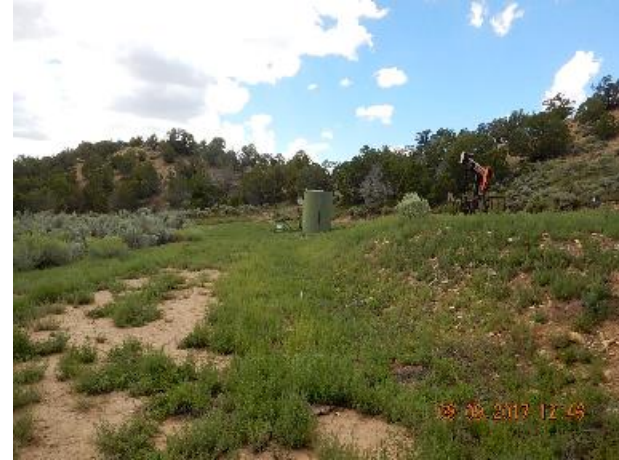
Photo 4: Location overview with weeds.

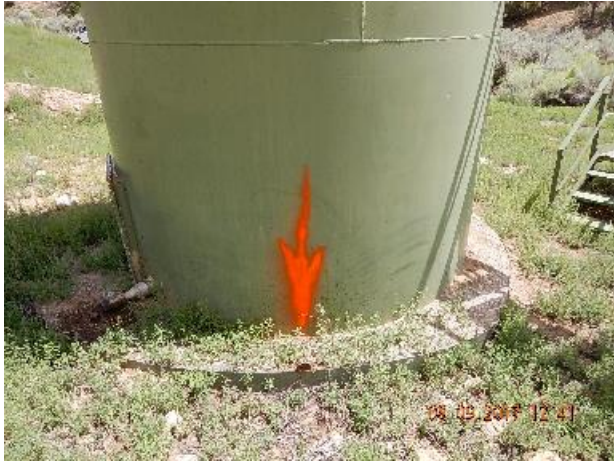
Photo 5: Leaking drain valve on left of frame and open ended riser below arrow.

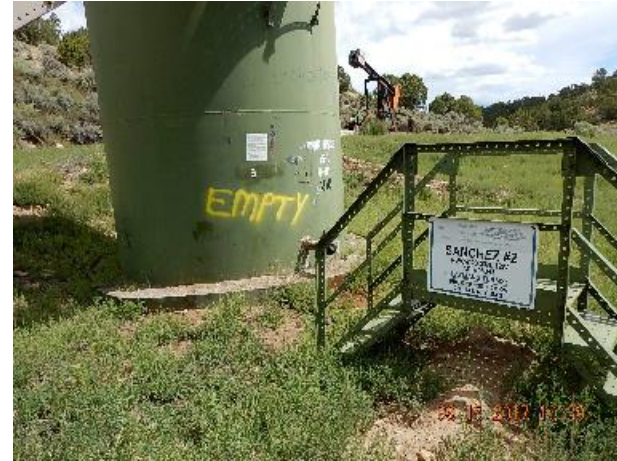
Photo 6: Tank labeled empty.
