Inspection Photos
Location Name: Foster State 1
API: 05-081-07821

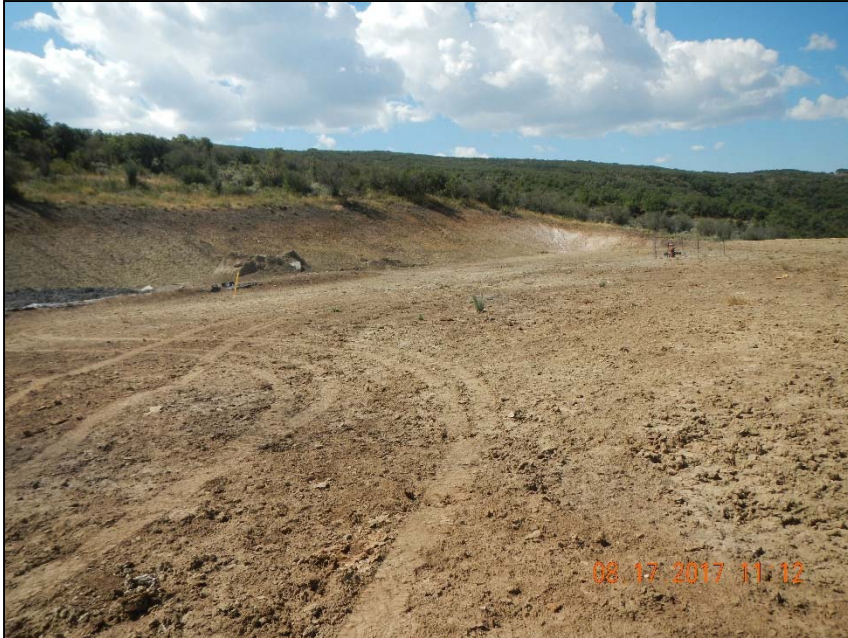
Photo 1. Overview of location taken at entrance facing southwest.

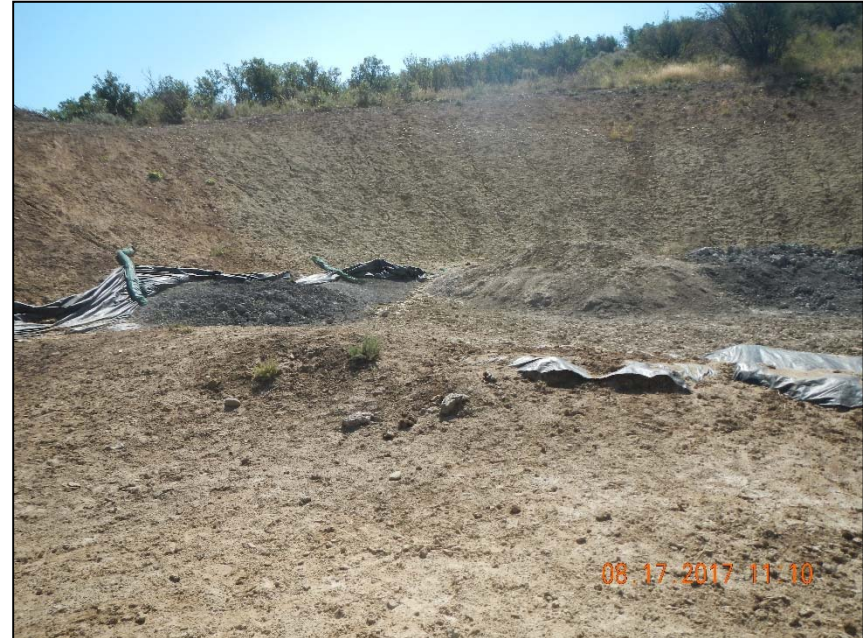
Photo 2. Cuttings storage.

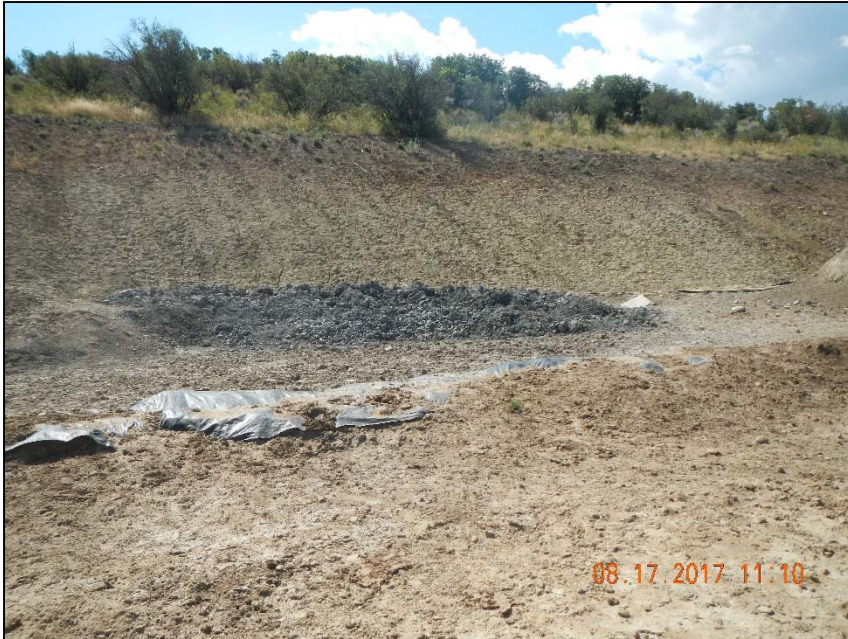
Photo 3. Cuttings storage.

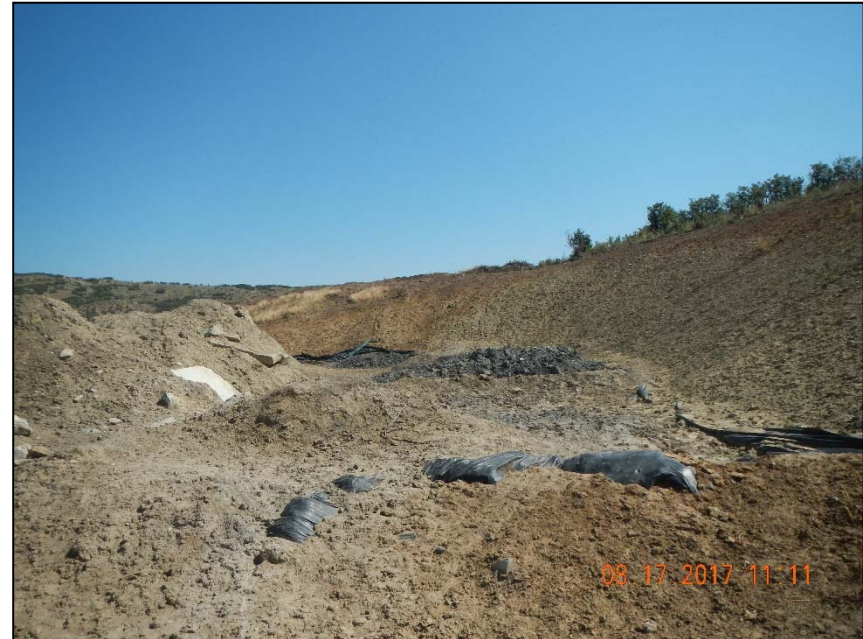
Photo 4. Cuttings storage, debris visible on left.

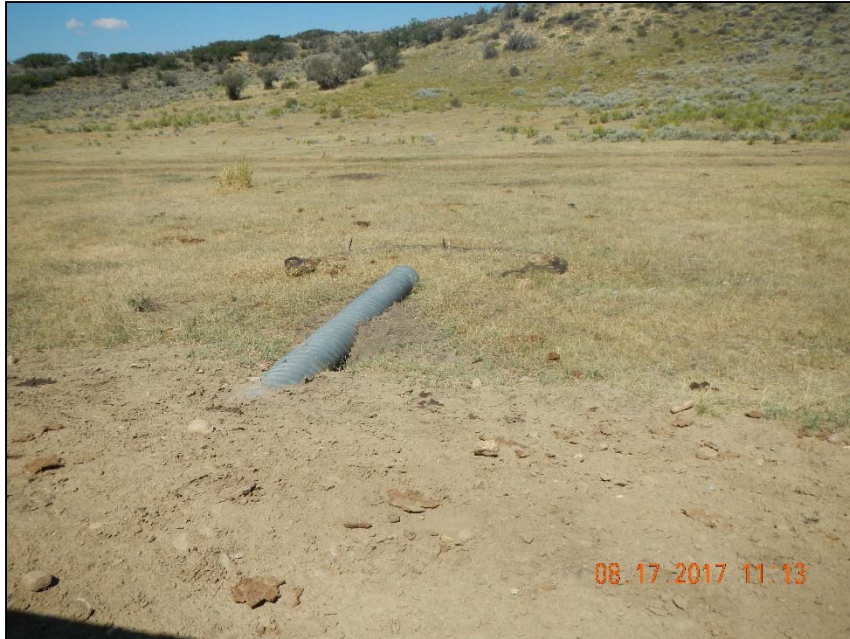
Photo 5. Stormwater BMP- wattles- overwhelmed by sediment.
