Interim Reclamation Inspection

September 22, 2017

Operator: Kerr McGee Oil & Gas ONSHORE LP - #47120

API: 05-123-25854

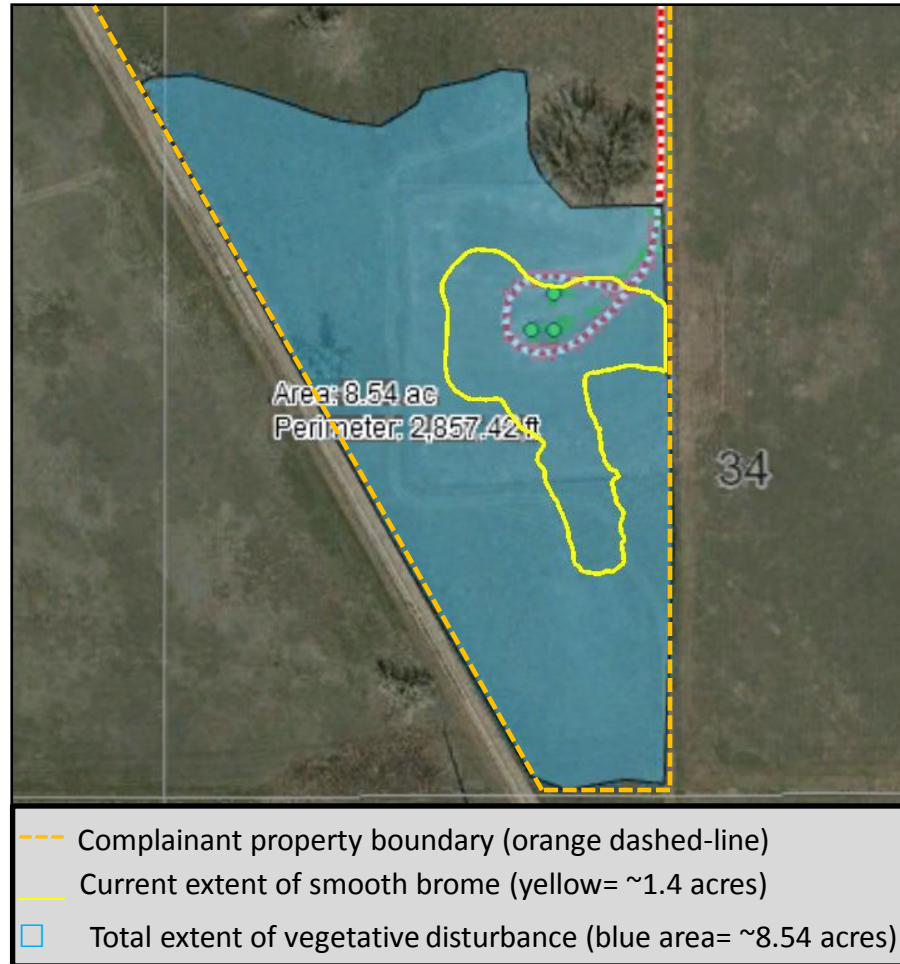
Google Earth aerial imagery overlaid with the total area of vegetative disturbance from the release that occurred in April 2014 and the approximate smooth brome vegetative area, in yellow, that has established after reclamation efforts were performed during Fall 2014- see Photo 1.

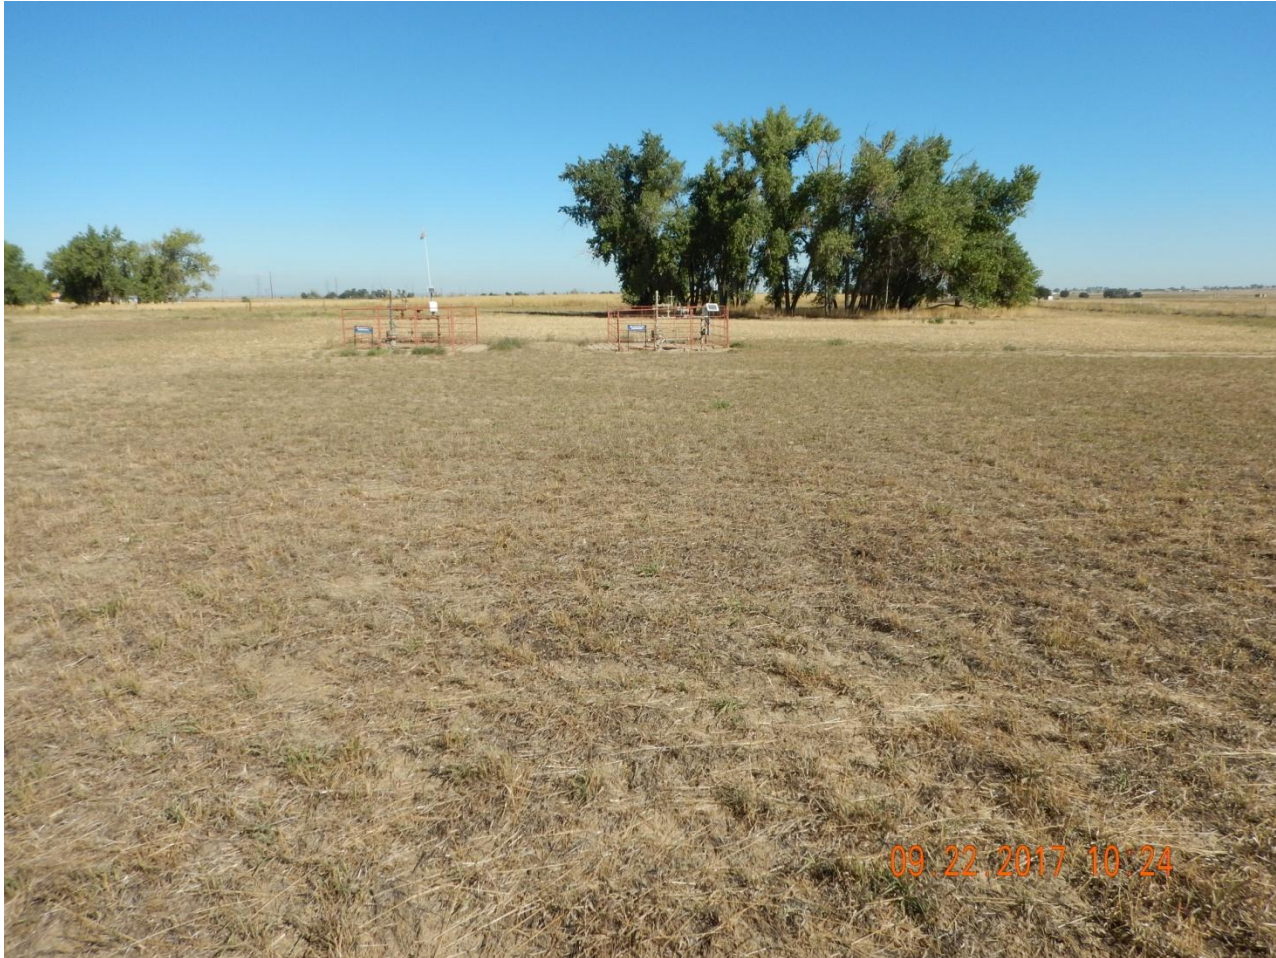
Photo 1. Photo taken approximately 100 feet south of the Turner #21-34 well, facing North. Photo taken within the ~1.4 acre smooth brome area that was previously documented during the January 2017 inspection.

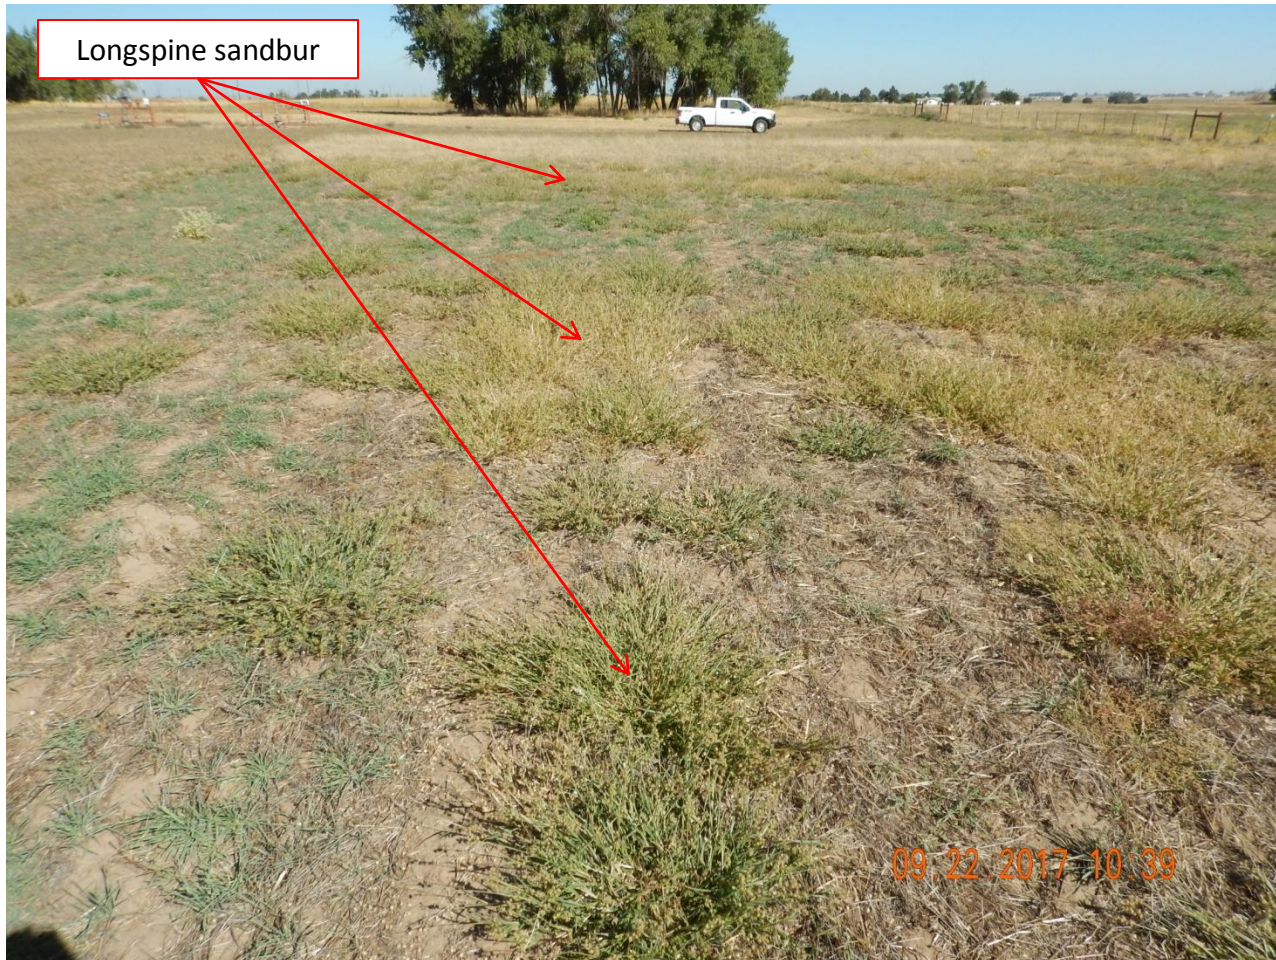
Photo 2. Photo taken from the eastern reclamation area, facing North. Photo illustrates a patch of Longspine sandbur (*Cenchrus longispinus*) approximately ~70' x ~70'. Appears smooth brome, and possibly a wheat grass mix, has established within the patch of Longspine sandbur.

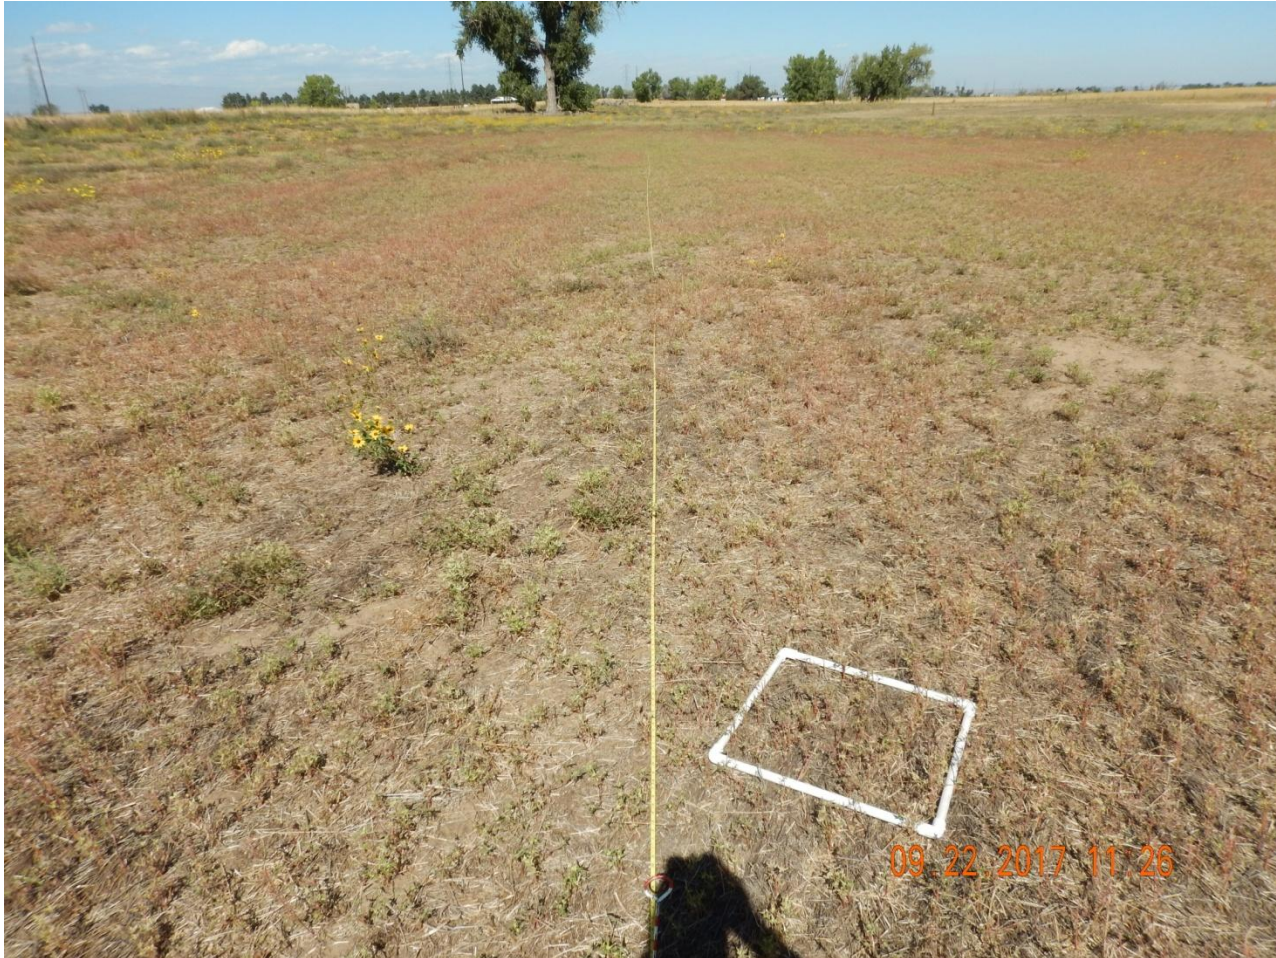
Photo 3. Photo taken from the southern reclamation area, facing Northwest. The red and green foliage illustrated in the photo is that of undesirable weedy plants. There was no germination of smooth brome observed within this area. For reference, that is a $\frac{1}{2}$ meter squared quadrat inside the photo.

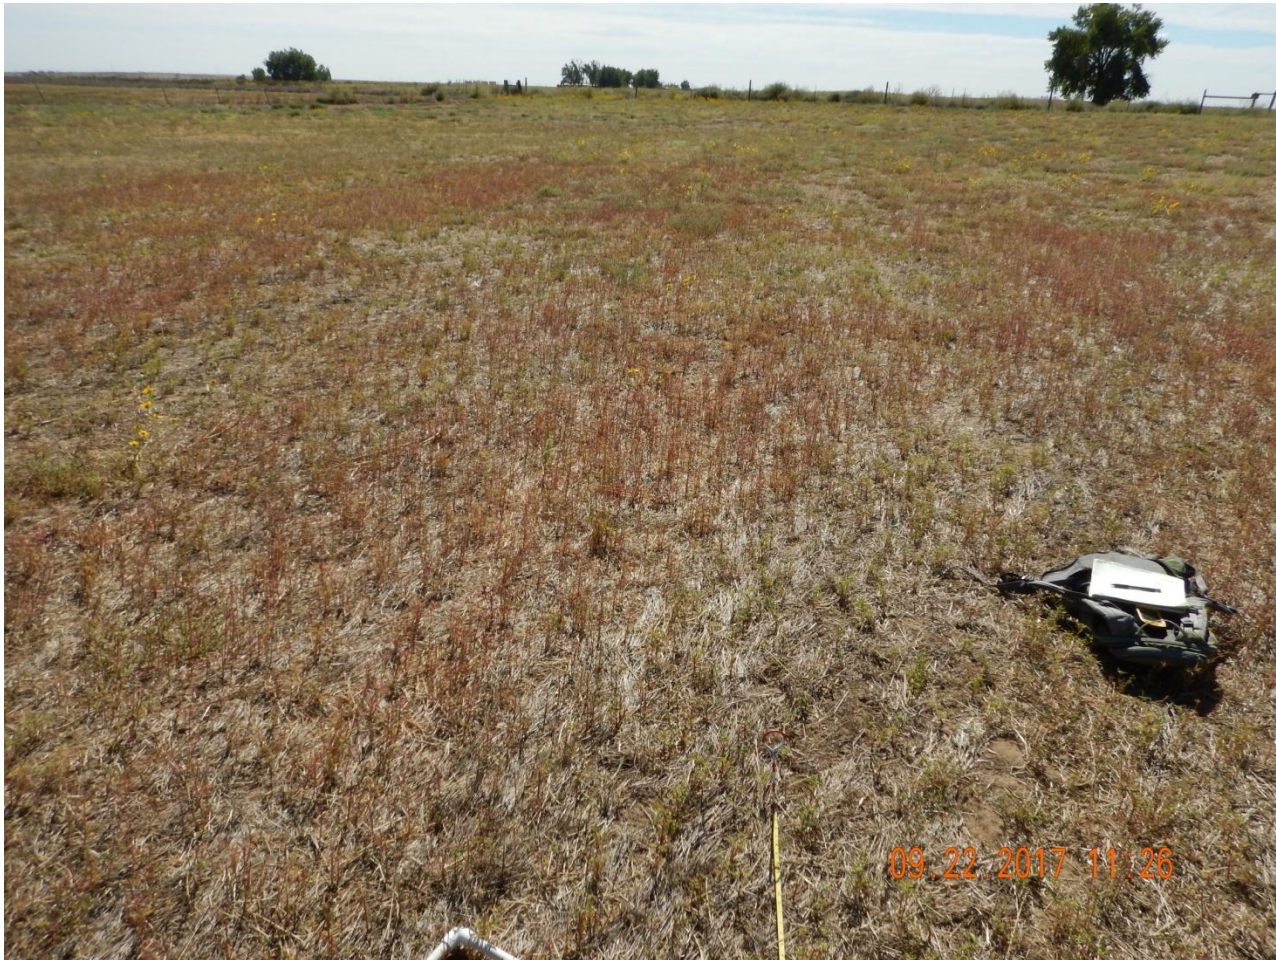
Photo 4. Photo taken from the previous photo location, facing Southeast. The red and green foliage illustrated in the photo is that of undesirable weedy plants. There was no germination of smooth brome observed within this area.

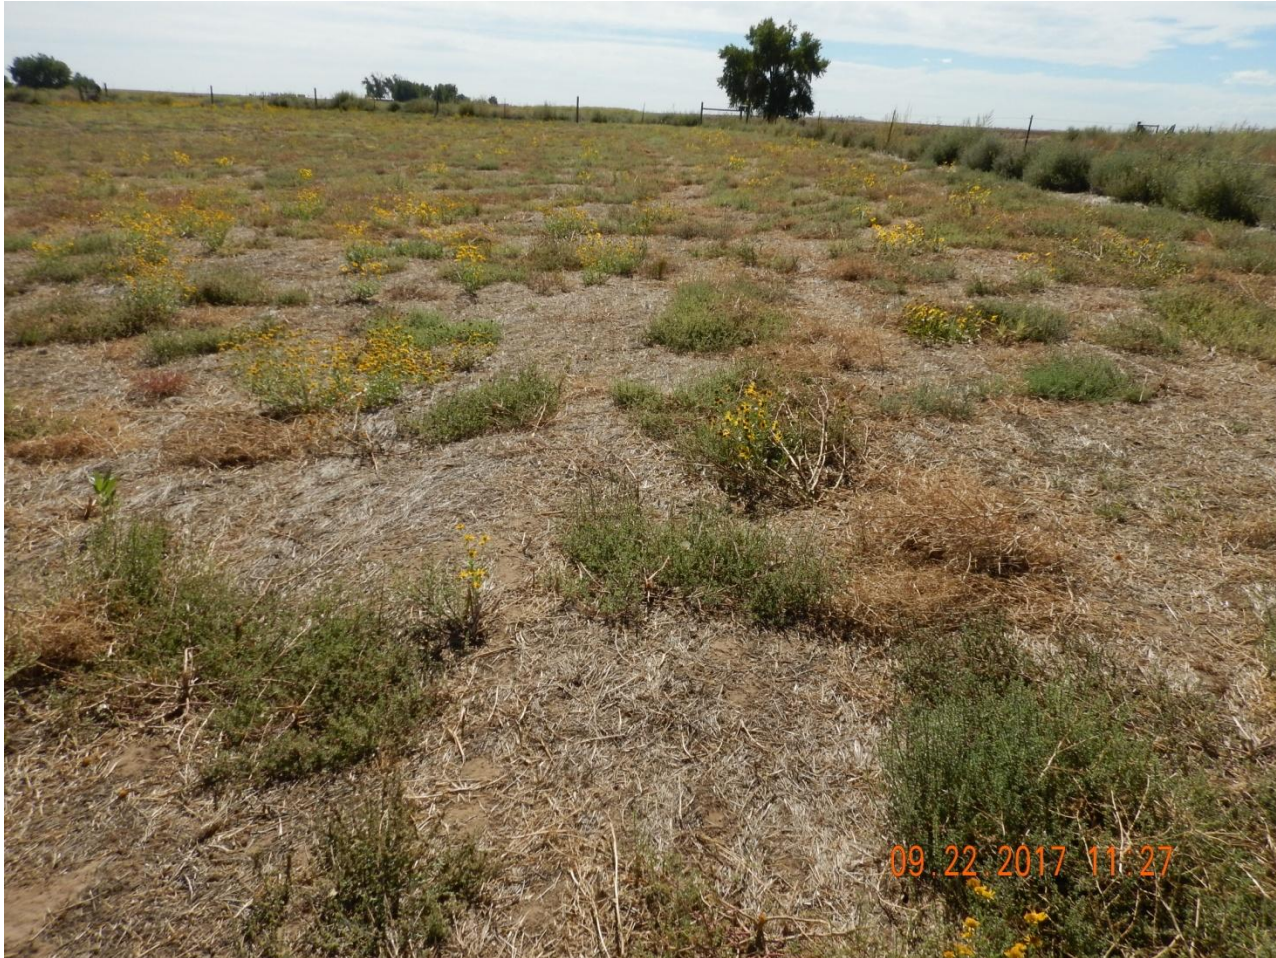
Photo 5. Photo taken from the southwestern reclamation area, facing South. Photo illustrates Russian thistle (*Salsola tragus*) as being the dominant vegetative cover along the western reclamation area with little, to no, germination of smooth brome.

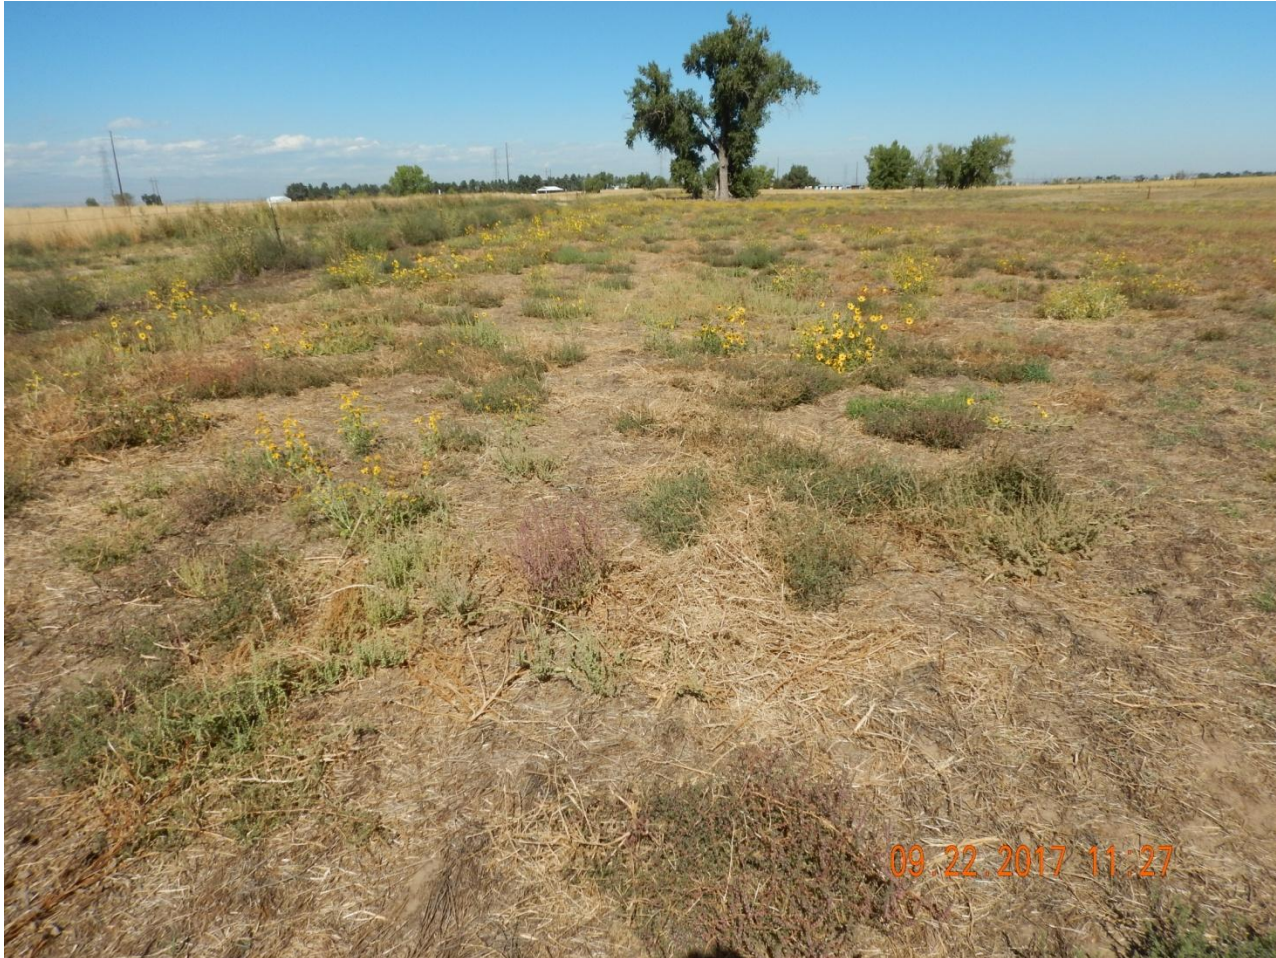
Photo 6. Photo taken from the previous photo location, facing North. Photo illustrates Russian thistle (*Salsola tragus*) as being the dominant vegetative cover along the western reclamation area with little, to no, germination of smooth brome.

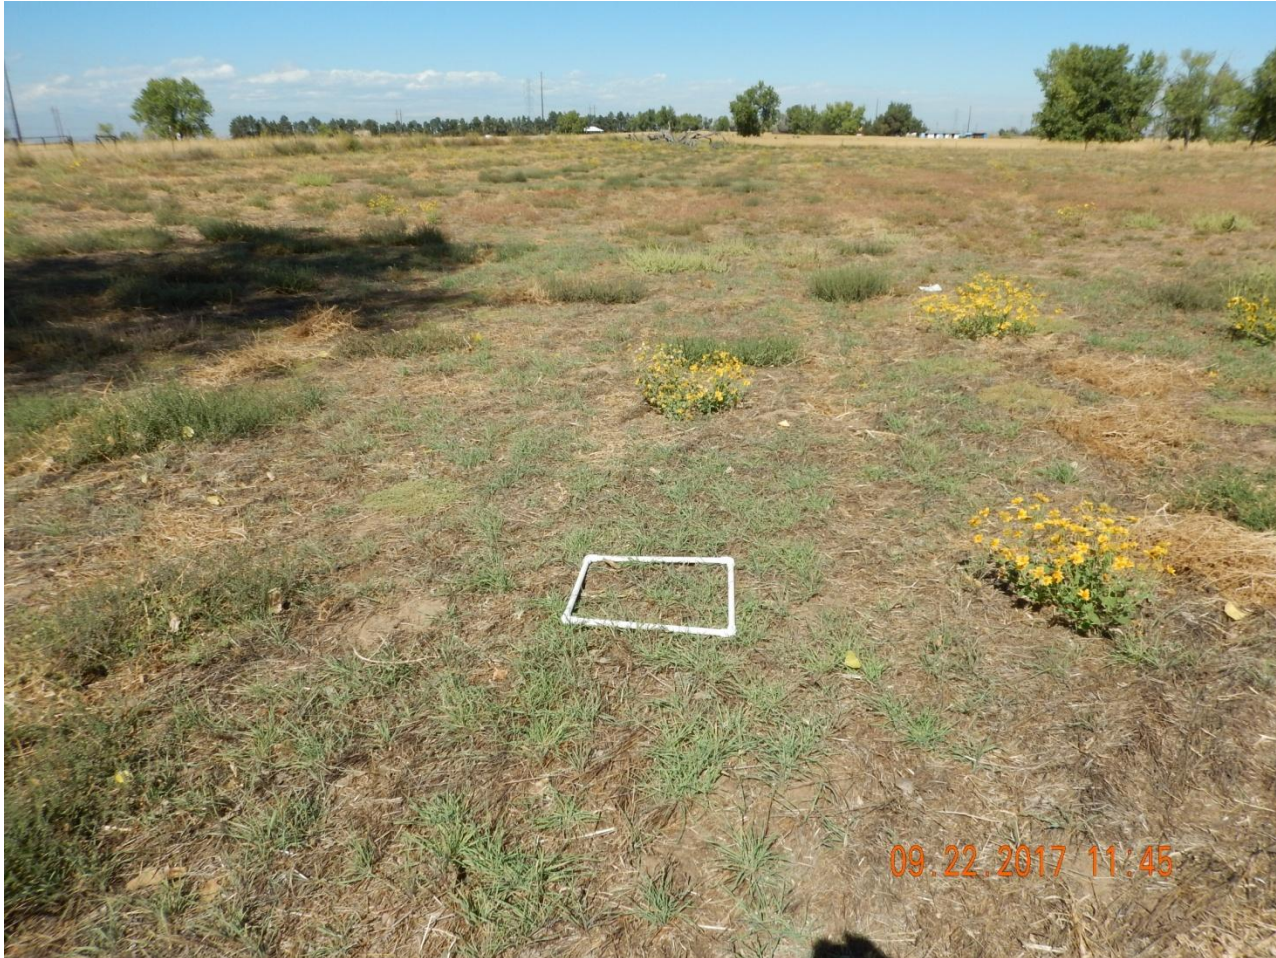
Photo 7. Photo taken from the western reclamation area, facing North. Photo illustrates a patch of smooth brome establishment with a ½ meter squared quadrat placed over the area.

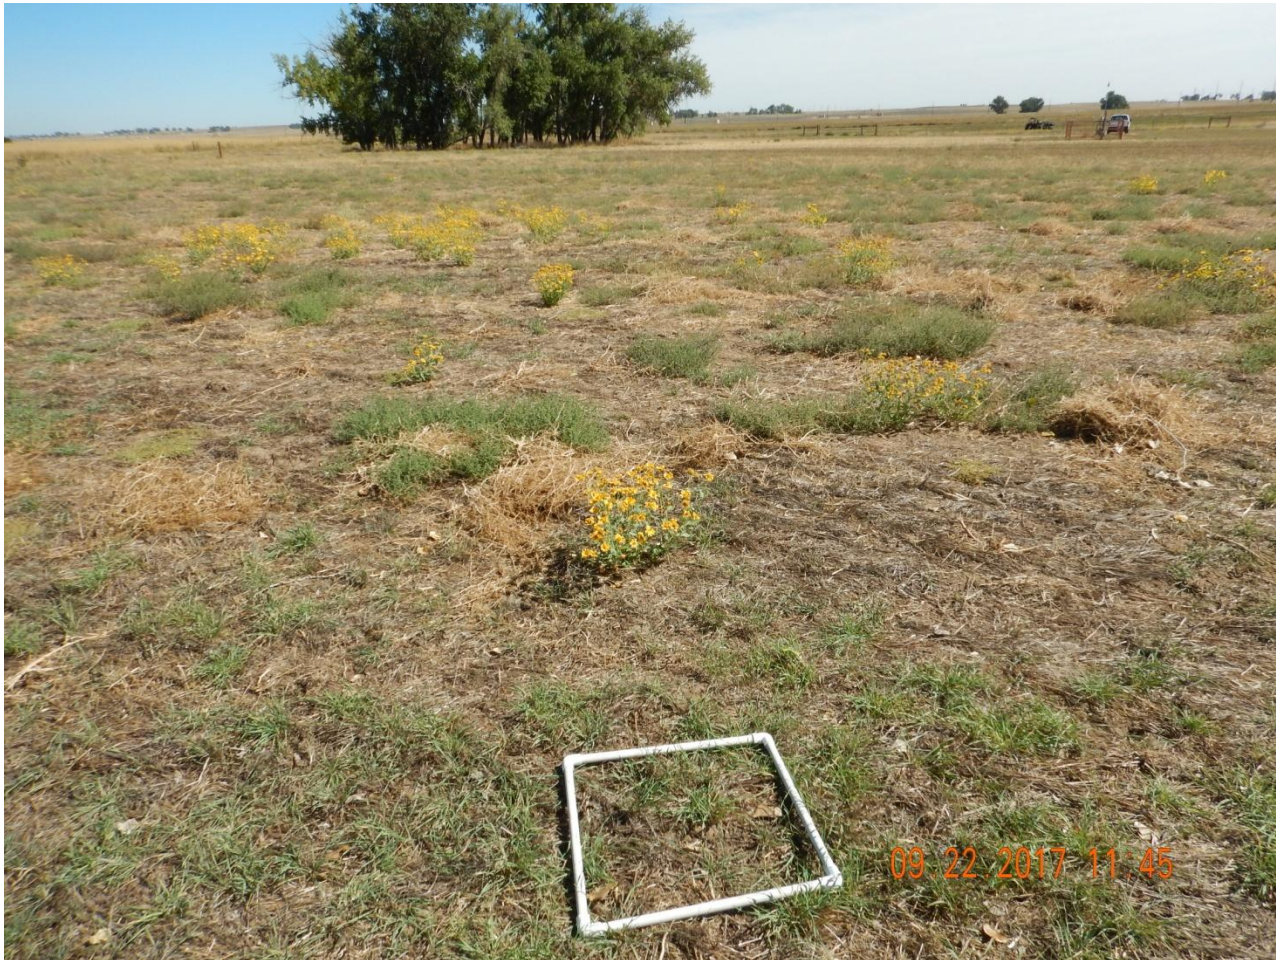
Photo 8. Photo taken from the previous photo location, facing East. Photo illustrates the patch of smooth brome previously shown in Photo 7 and how the vegetative growth east of the smooth brome patch is that of Russian thistle with little, to no, germination of smooth brome.

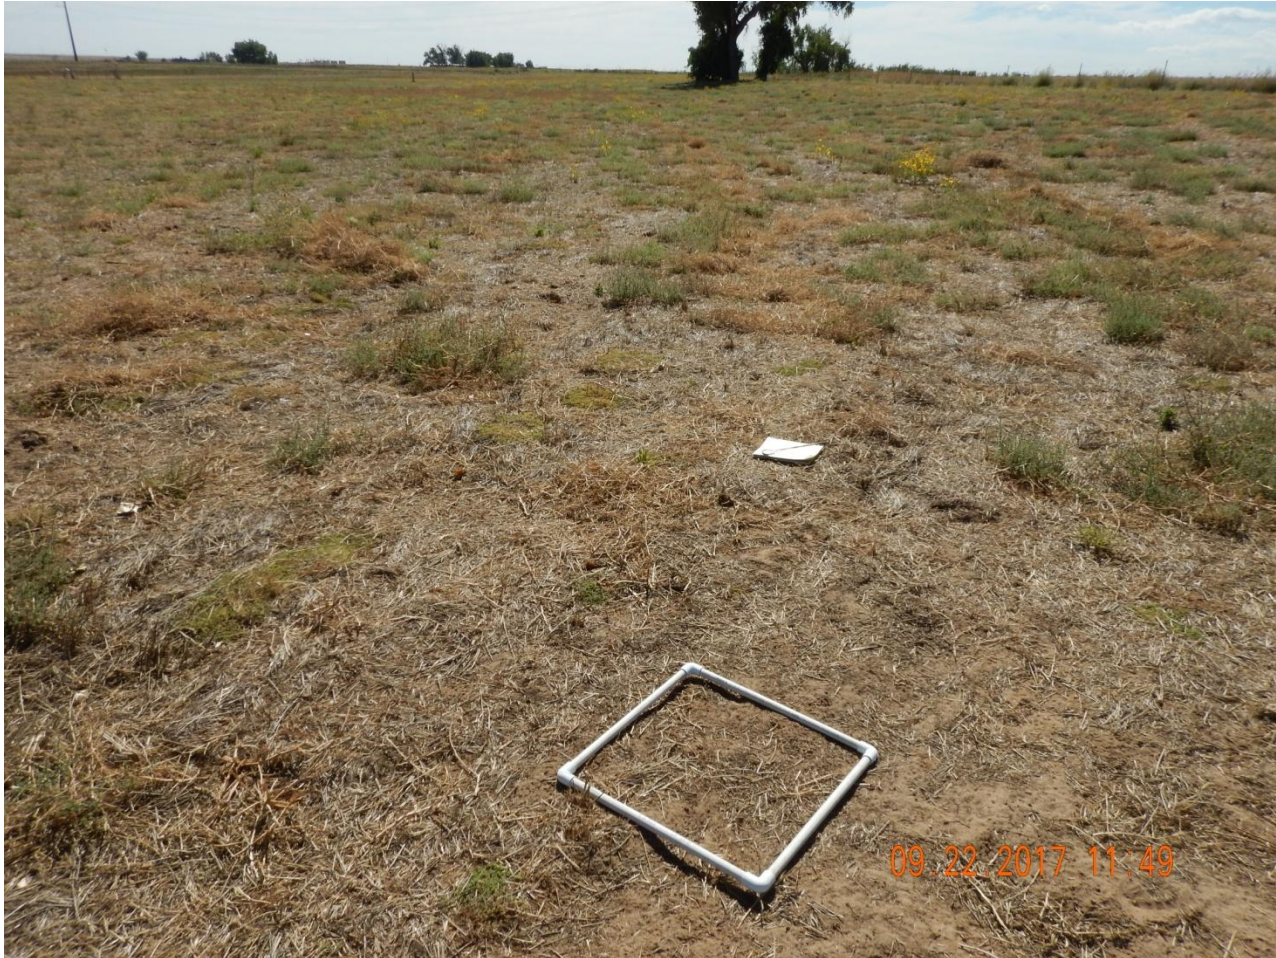
Photo 9. Photo taken from the northwest reclamation area, facing South. Photo illustrates Russian thistle as being the dominant vegetative cover along the western reclamation area with little, to no, germination of smooth brome.

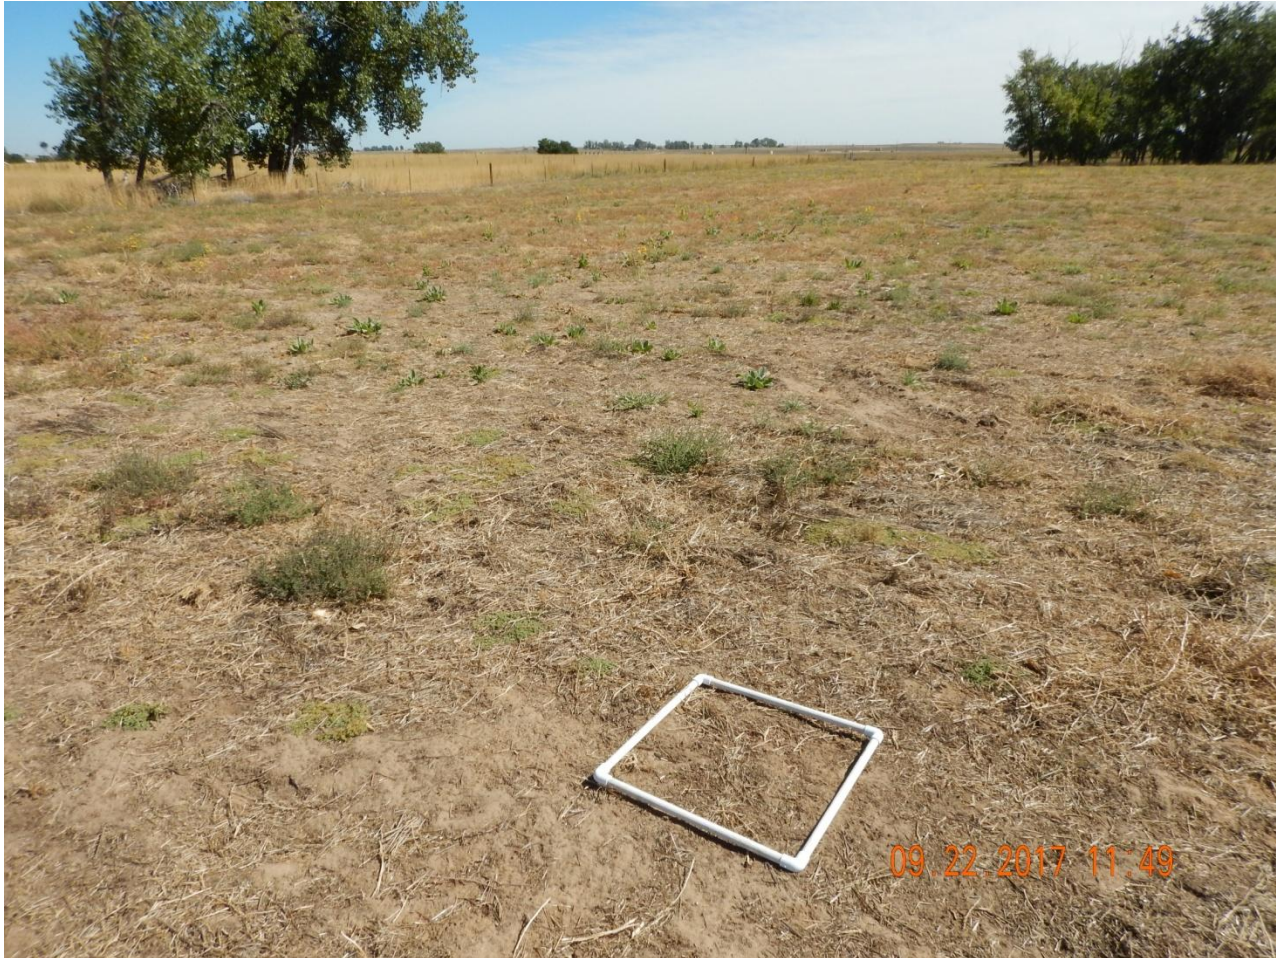
Photo 10. Photo taken from the previous photo location, facing East. Photo illustrates undesirable vegetative cover dominants along the northern reclamation area with little, to no, germination of smooth brome.

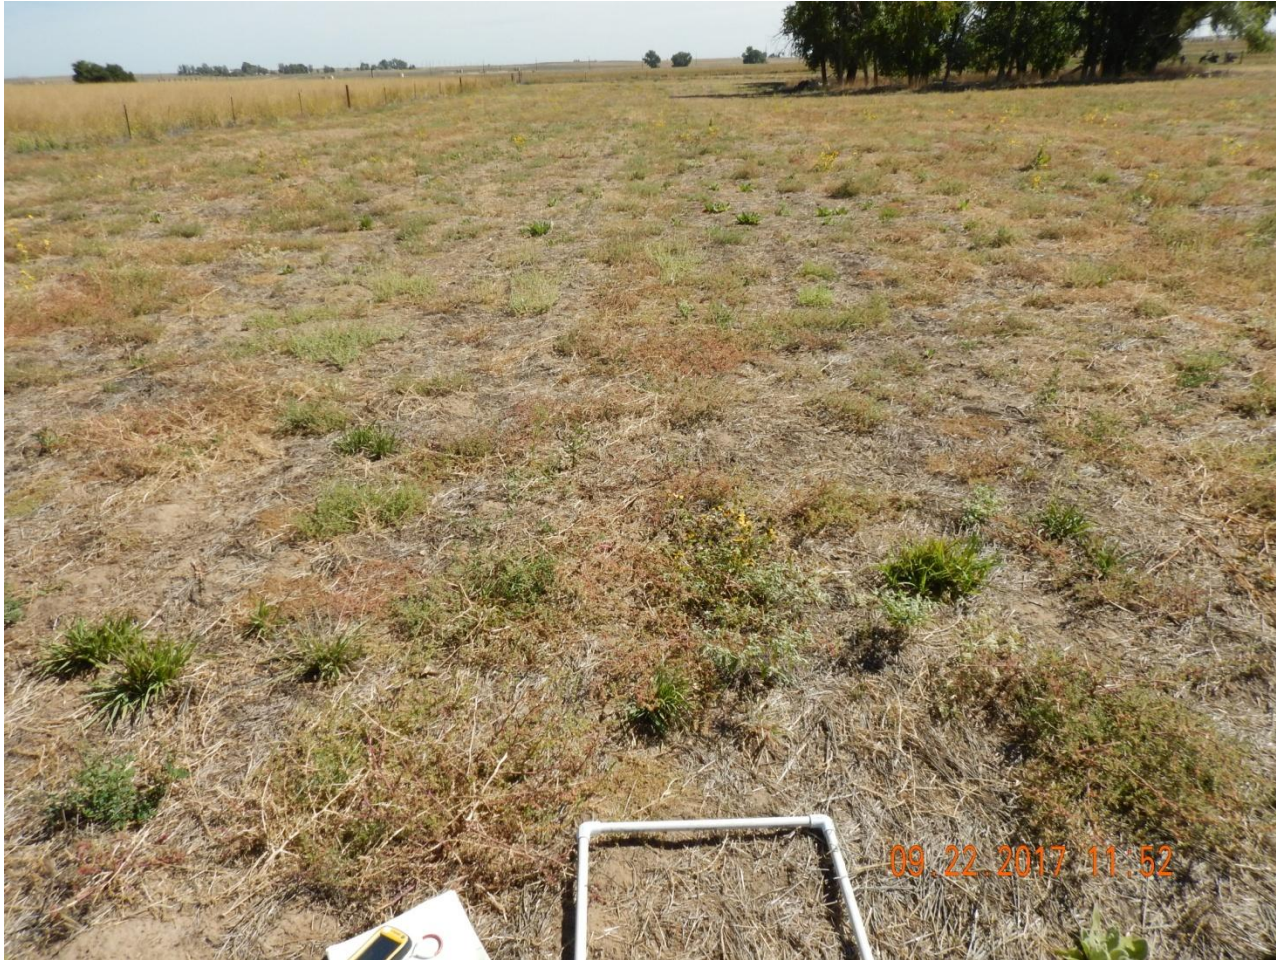
Photo 11. Photo taken from the northern reclamation area, facing East. Photo illustrates undesirable vegetative cover dominants along the northern reclamation area with little, to no, germination of smooth brome.

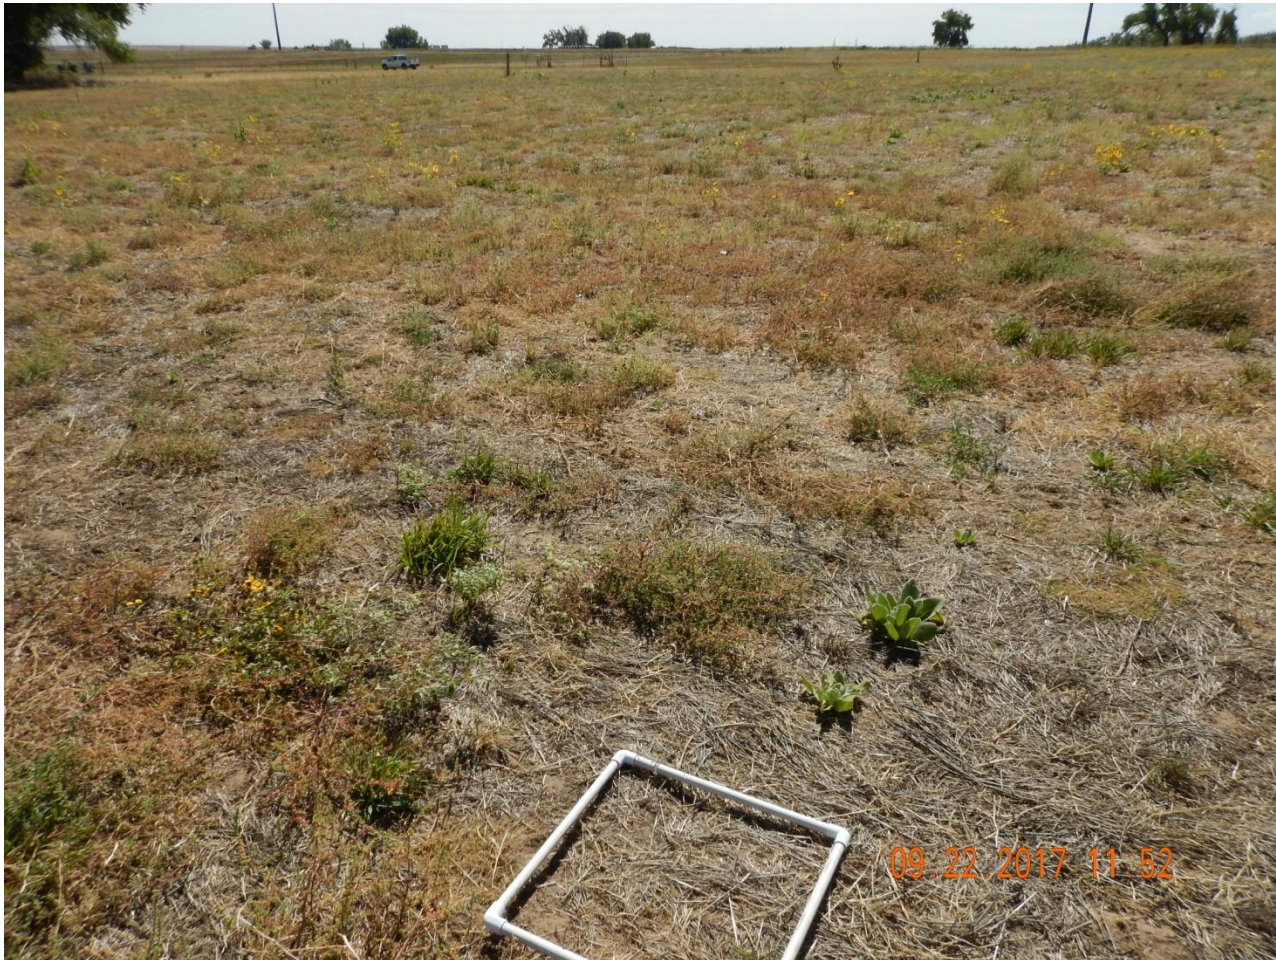
Photo 12. Photo taken from the previous photo location, facing South. Photo illustrates undesirable vegetative cover dominants along the northern reclamation area with little, to no, germination of smooth brome.

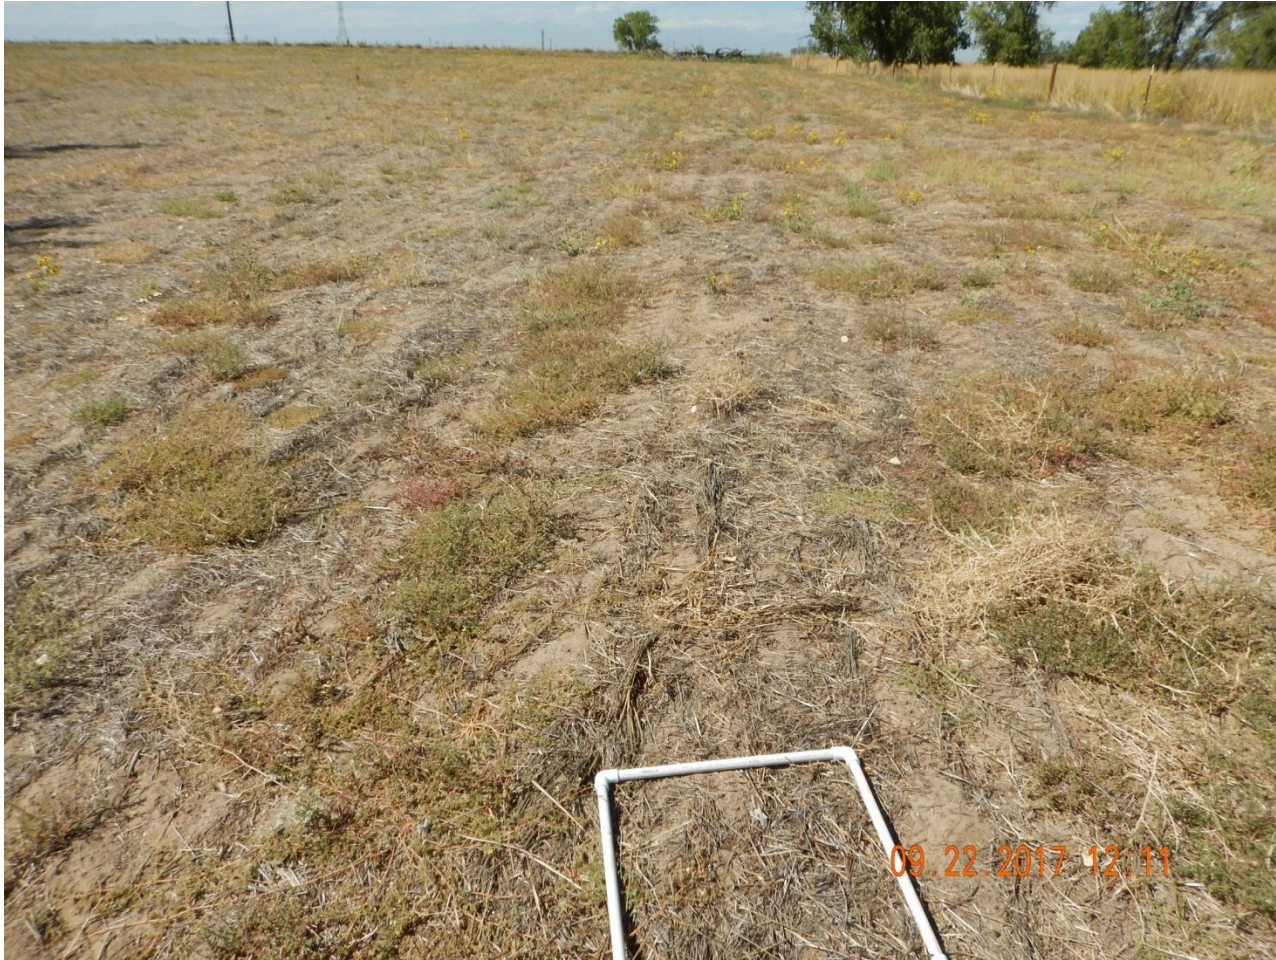
Photo 13. Photo taken from the northeast reclamation area, facing West. Photo illustrates undesirable vegetative cover dominants along the northern reclamation area with little, to no, germination of smooth brome.

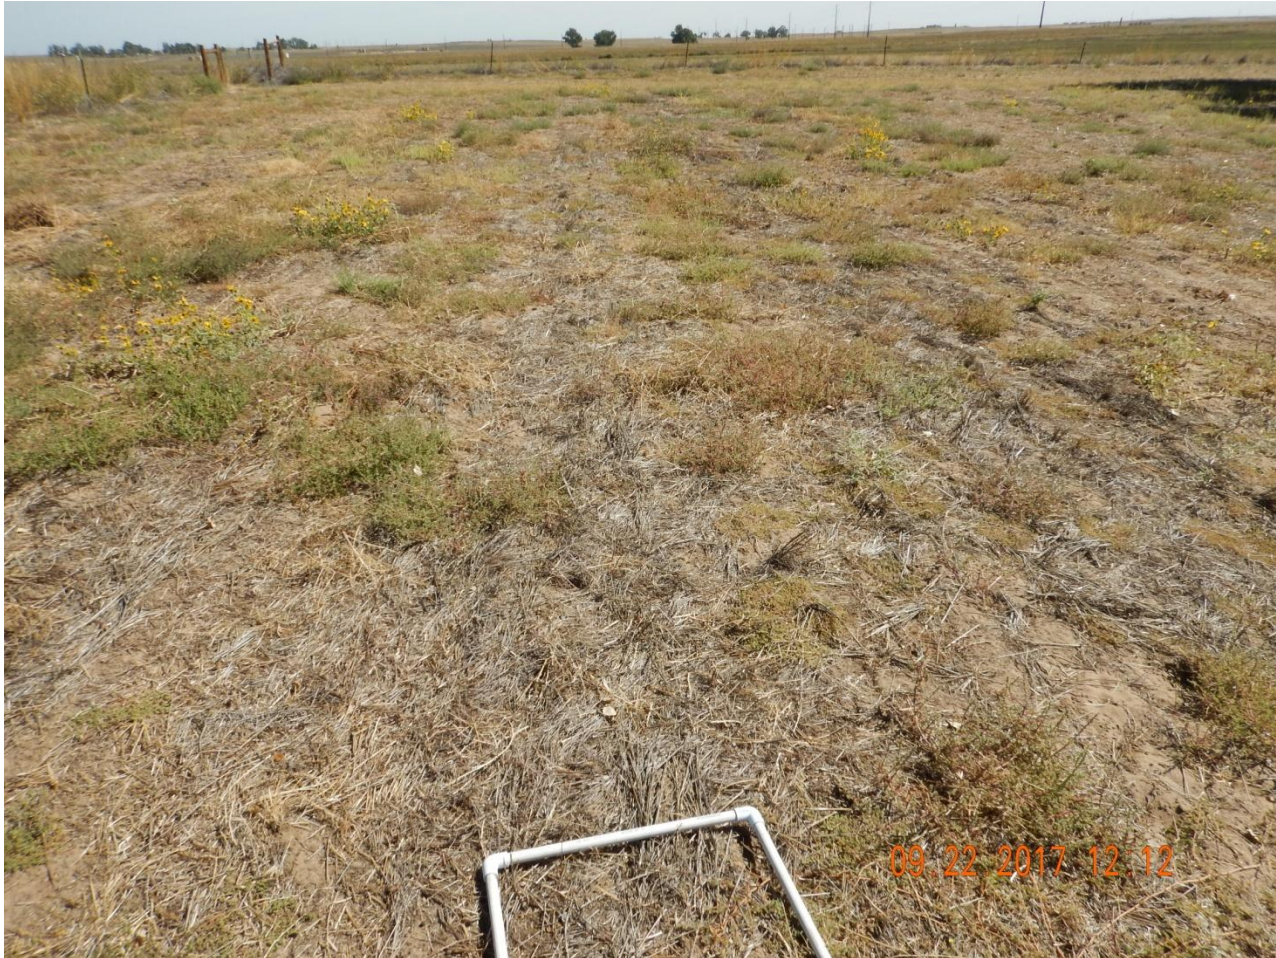
Photo 14. Photo taken from the previous photo location, facing East. Photo illustrates undesirable vegetative cover dominants along the northern reclamation area with little, to no, germination of smooth brome.

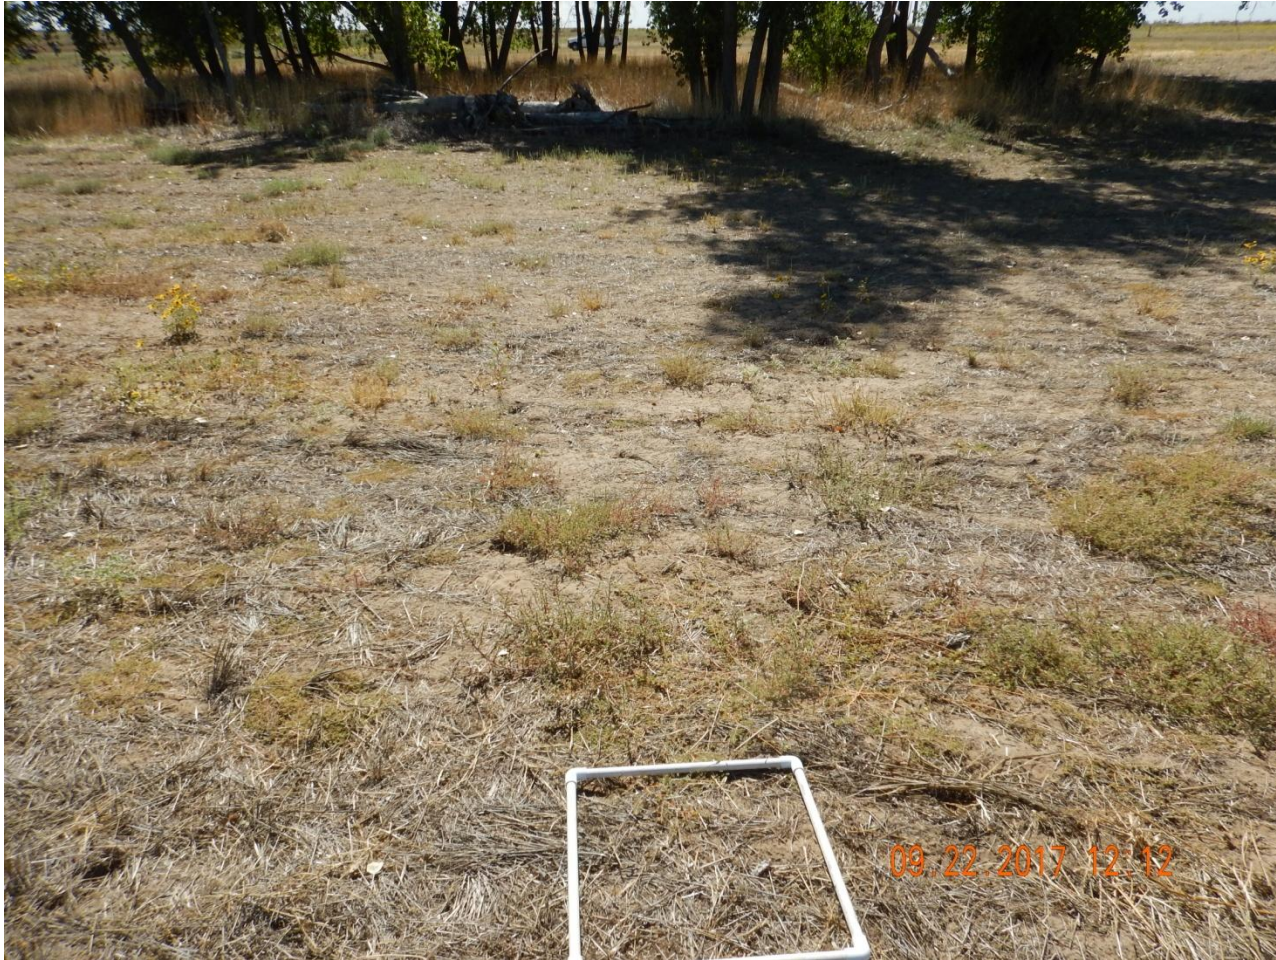
Photo 15. Photo taken from the previous photo location, facing South. Photo illustrates undesirable vegetative cover dominants along the northern reclamation area with little, to no, germination of smooth brome.

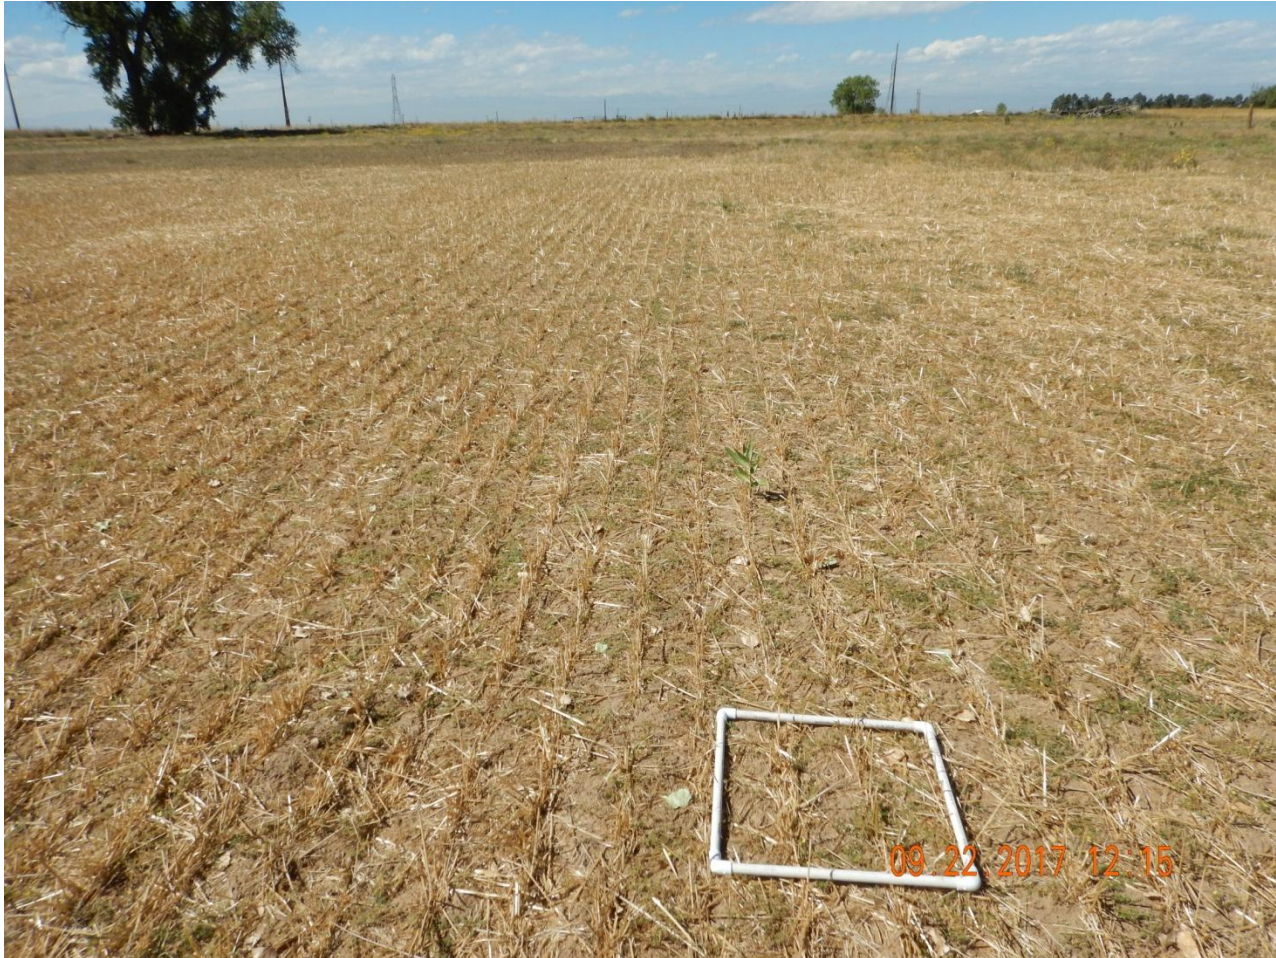
Photo 16. Photo taken north of the Turner #21-34 well, facing West. Appears an area north of the Turner #21-34 well was disturbed from plugging operations on the HSR-VADNEY 6-34 well (API 123-16878) in late June 2017. Photo illustrates no germination of smooth brome observed within this area. Puncture vine (*Tribulus terrestris*) was observed in high abundance throughout this area.

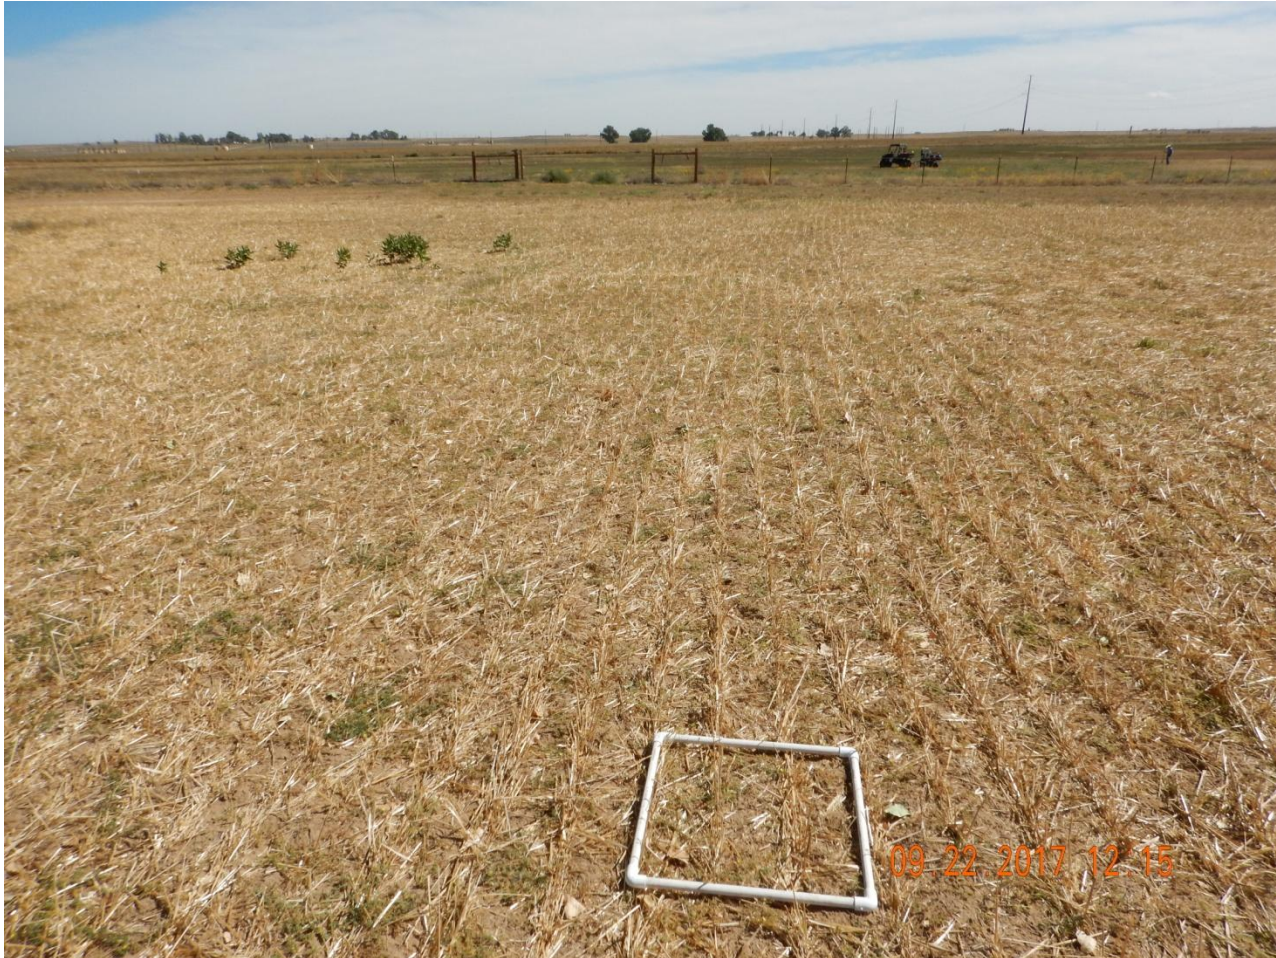
Photo 17. Photo taken from the previous photo location, facing East. Photo illustrates no germination of smooth brome observed within this area. Puncture vine (*Tribulus terrestris*) was observed in high abundance throughout this area.
