Interim Reclamation Inspection

September 22, 2017

Operator: Kerr McGee Oil & Gas ONSHORE LP - #47120

API: 05-123-25854

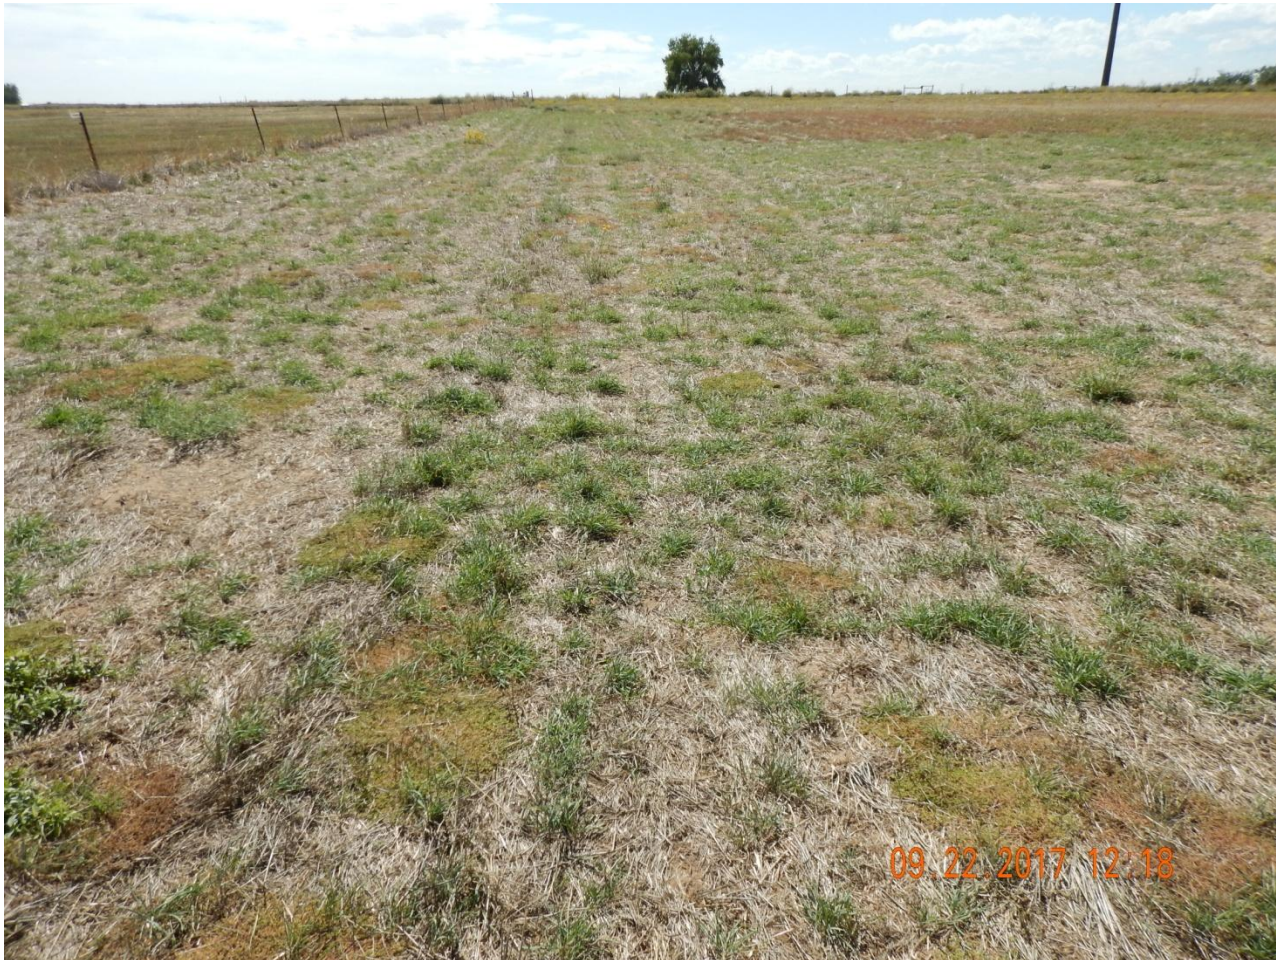
Photo 18. Photo taken from the eastern reclamation area, facing South. Appears smooth brome, and possibly a wheat grass mix, has established along the central to southeastern reclamation area.
