Inspection Photos

Operator: HRM RESOURCES II LLC - 10548

Location ID: 313925

Inspection Doc. Number: 682502644

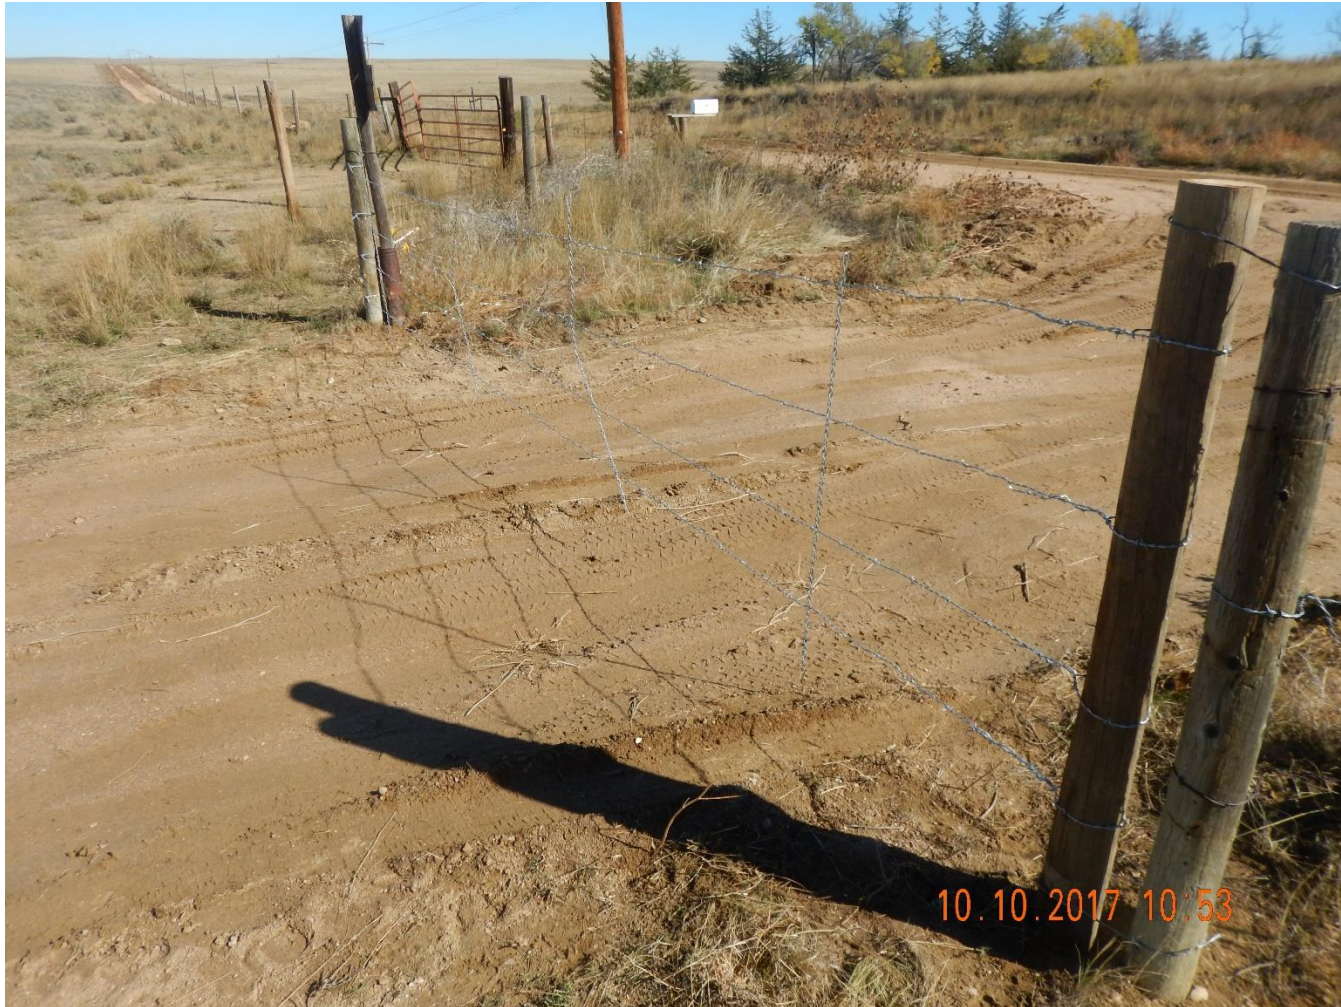
Photo 1: Photo taken from the access road entrance. Photo shows cattle guard equipment has been removed and filled.

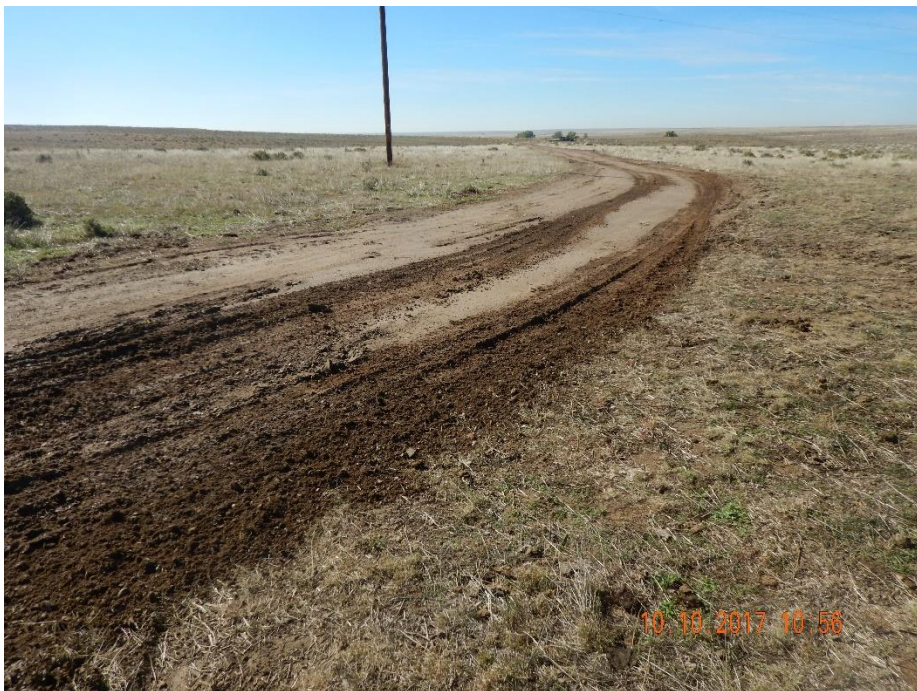
Photo 2: Photo taken from the access road, north of the location. Photo shows portion of the North/South access road requiring reclamation. The contractor on site had stated topsoil had been brought in to fill the road.

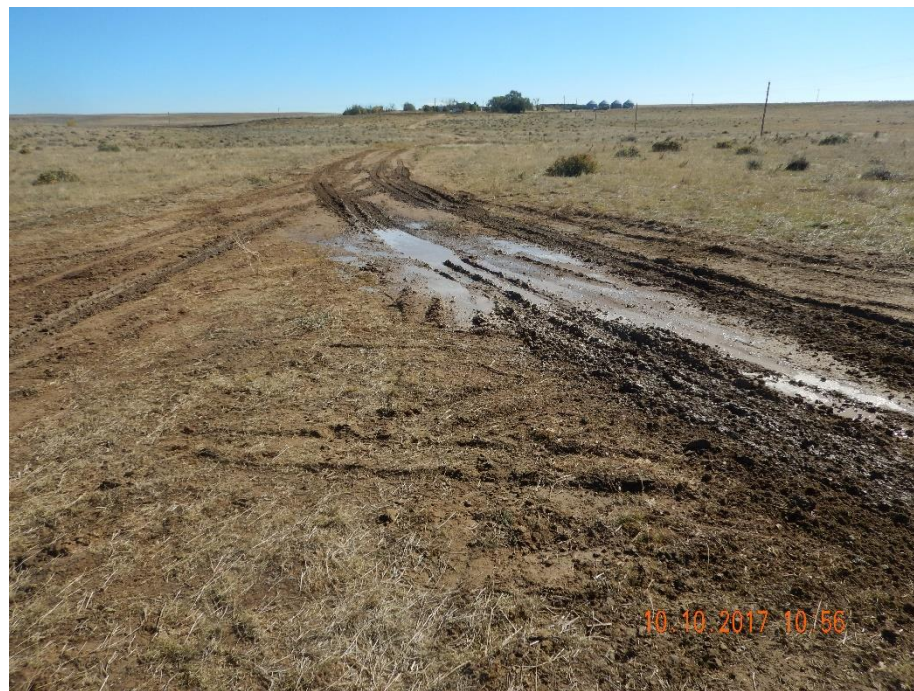
Photo 3: Photo taken from the access road, north of the location. Photo shows portion of the East/west portion of the road not being reclaimed. The contractor on site had stated that any gravel or road base removed from the access road, had been placed on this section of the road for the surface owner.

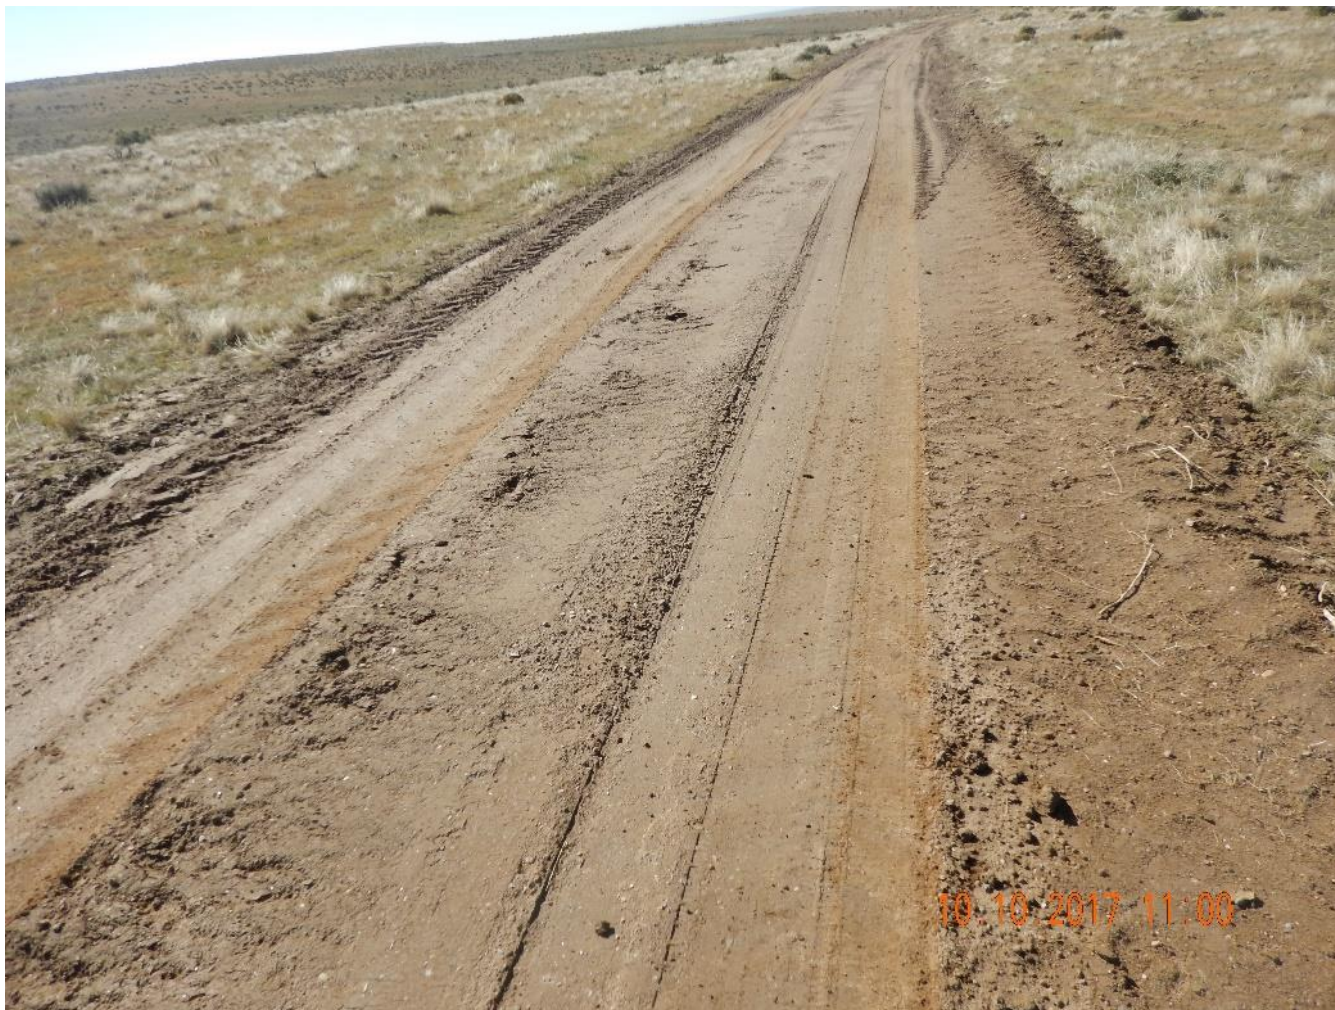
Photo 4: Photo taken from the access road, north of the location. Photo shows topsoil had been brought in for the road. Note: COGCC reclamation rules require access roads to be cross ripped to a depth of 18 inches. After conversations with the contractor on site at time of inspection, it was indicated that the required compaction alleviation had not yet been conducted, and that there was no schedule to perform the work.

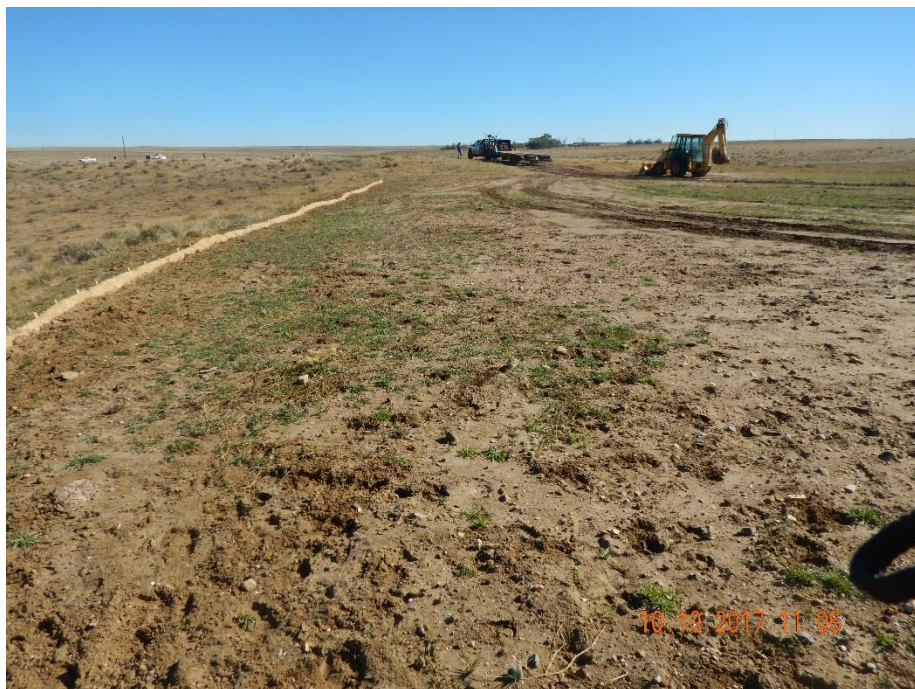
Photo 5: Photo taken from the southwest end of the location, facing north. Photo shows the well location. Straw wattle stormwater BMP on the west end of the location appear to be in proper functioning condition.

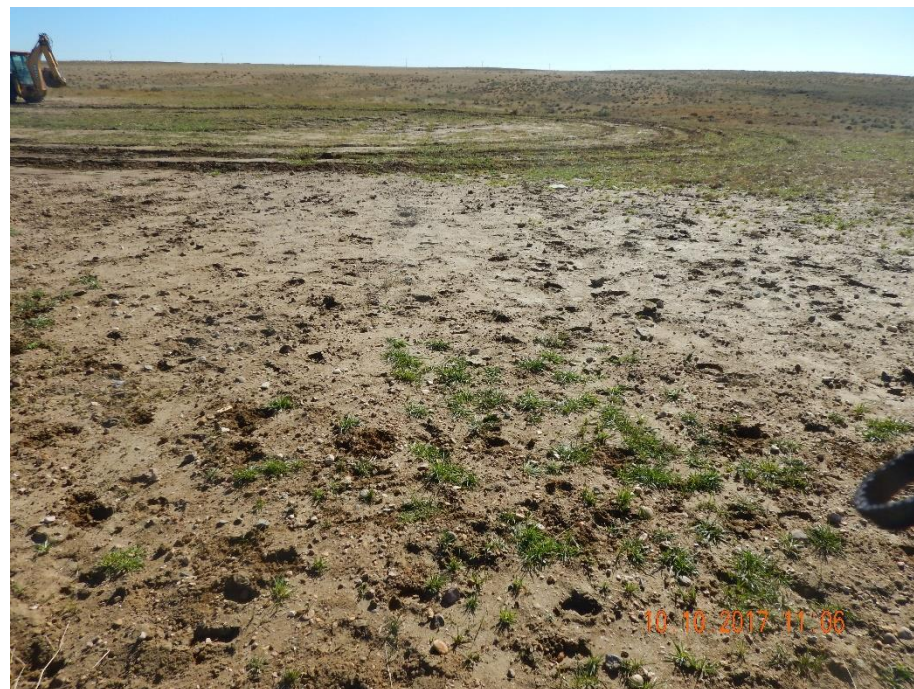
Photo 6: Photo taken from the southwest end of the location, facing east. Photo shows the well location. Well location had been seeded spring 2017. Though some areas may require additional work, large areas of the location appear to be progressing towards reclamation requirements. Continue to monitor and manage well location and perform reclamation as needed.

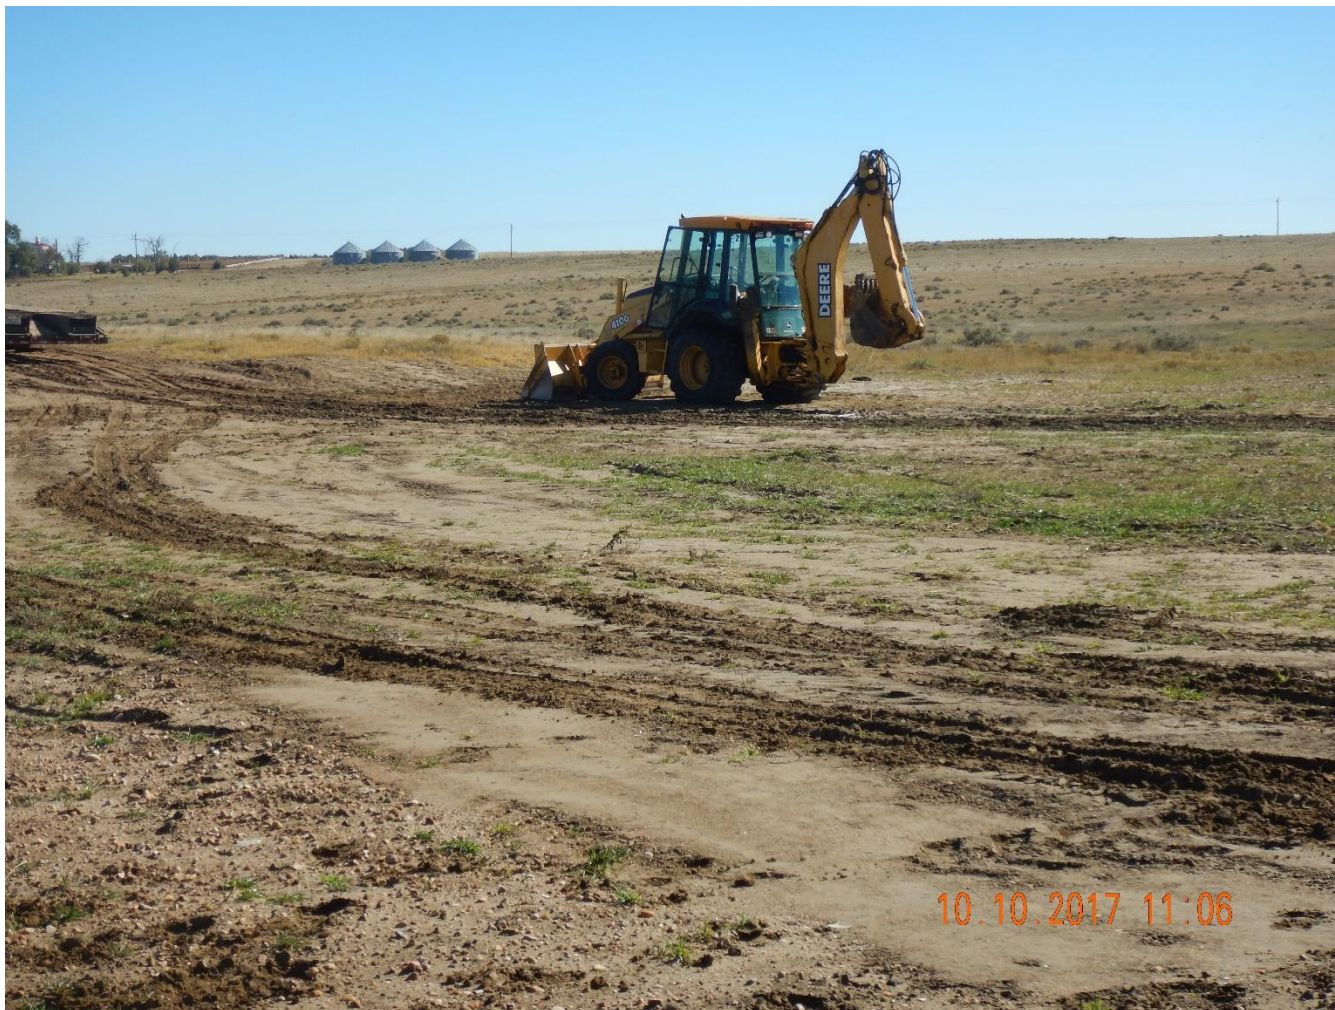
Photo 7: Photo taken from the location, facing northeast. Photo shows equipment on site. Contractor indicated backhoe had been used for all dirt work conducted on access road.
