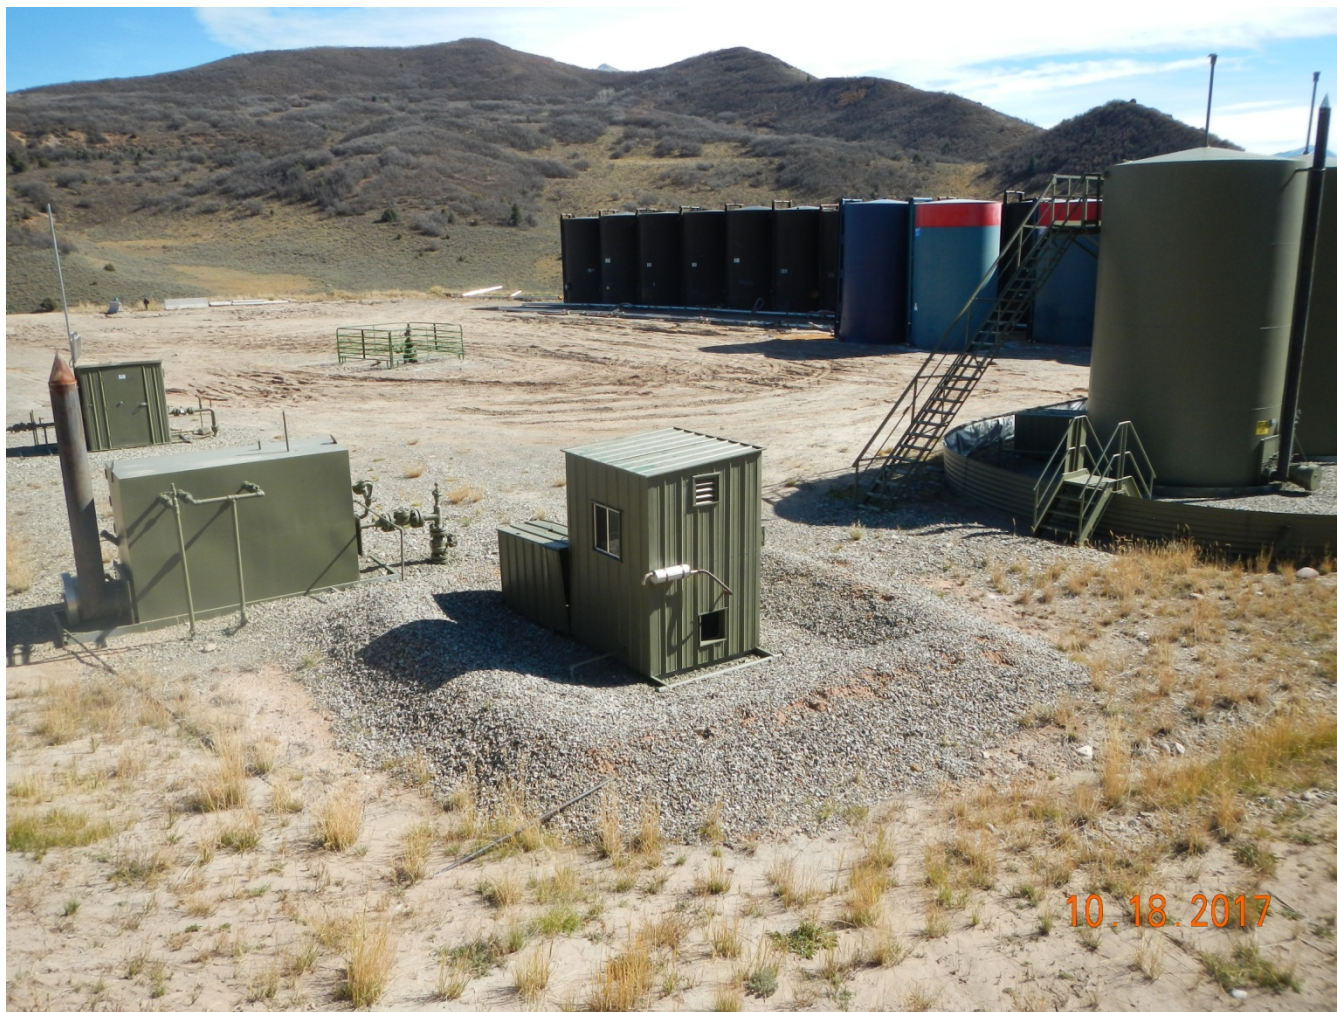
Photo 1. View from the northwestern corner of the project area facing center. Black and blue tanks in the background do not appear to be in use for this well.

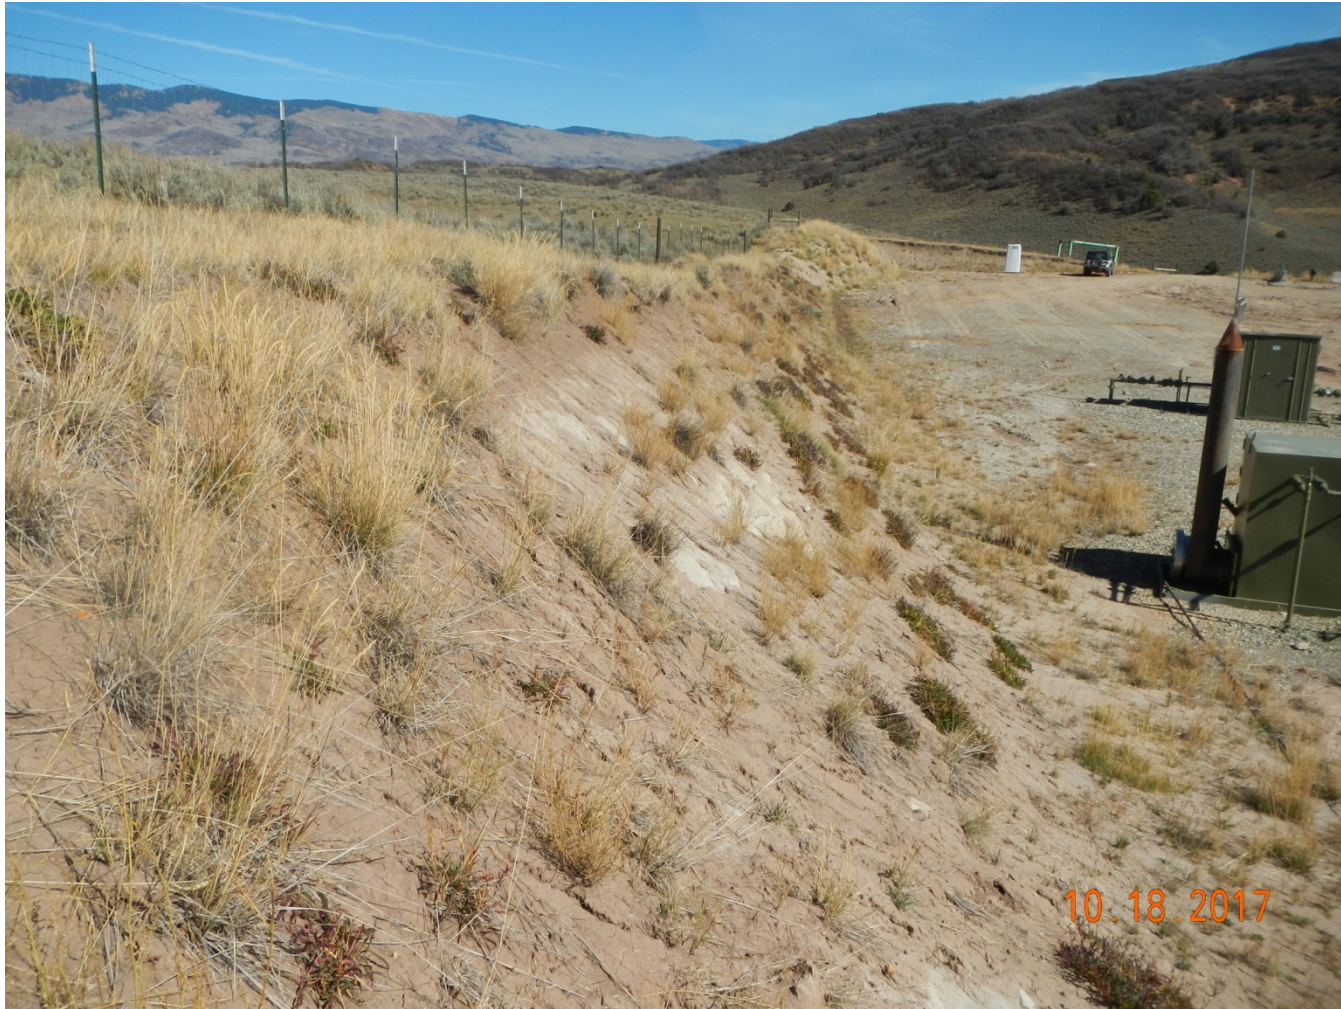
Photo 2. View of the northern portion of the project area from the northwestern corner facing eastward. Revegetation in the outer portions of the project disturbance is progressing with grasses and forbs such as western wheatgrass (*Pascopyrum smithii*), giant squirreltail (*Elymus multisetus*), and penstemon (*Penstemon* sp.).

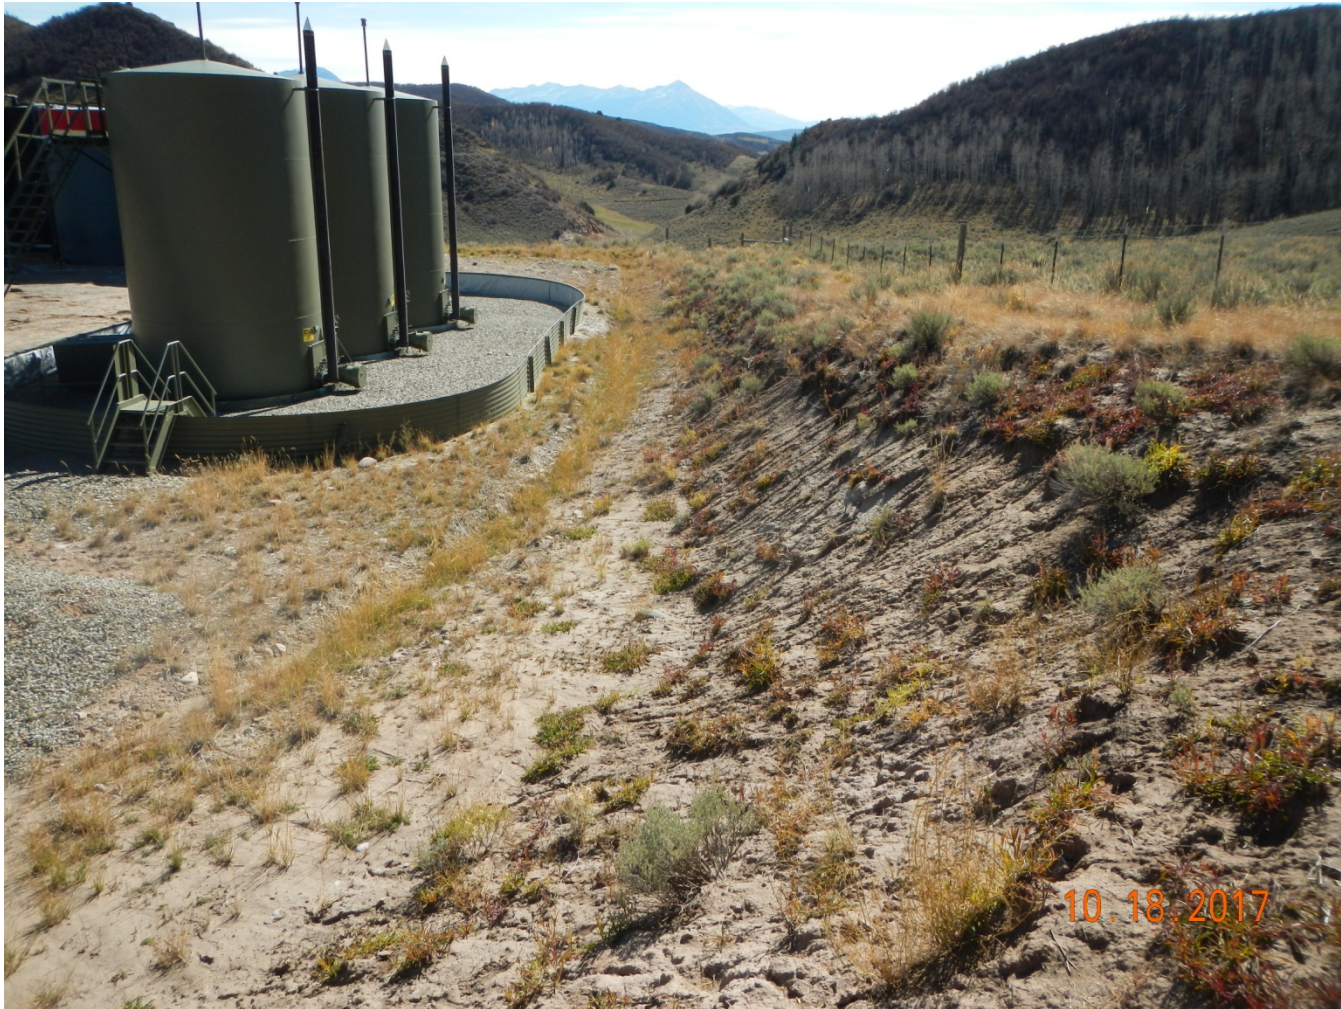
Photo 3. View of the western portion of the project area from the northwestern corner facing southward.

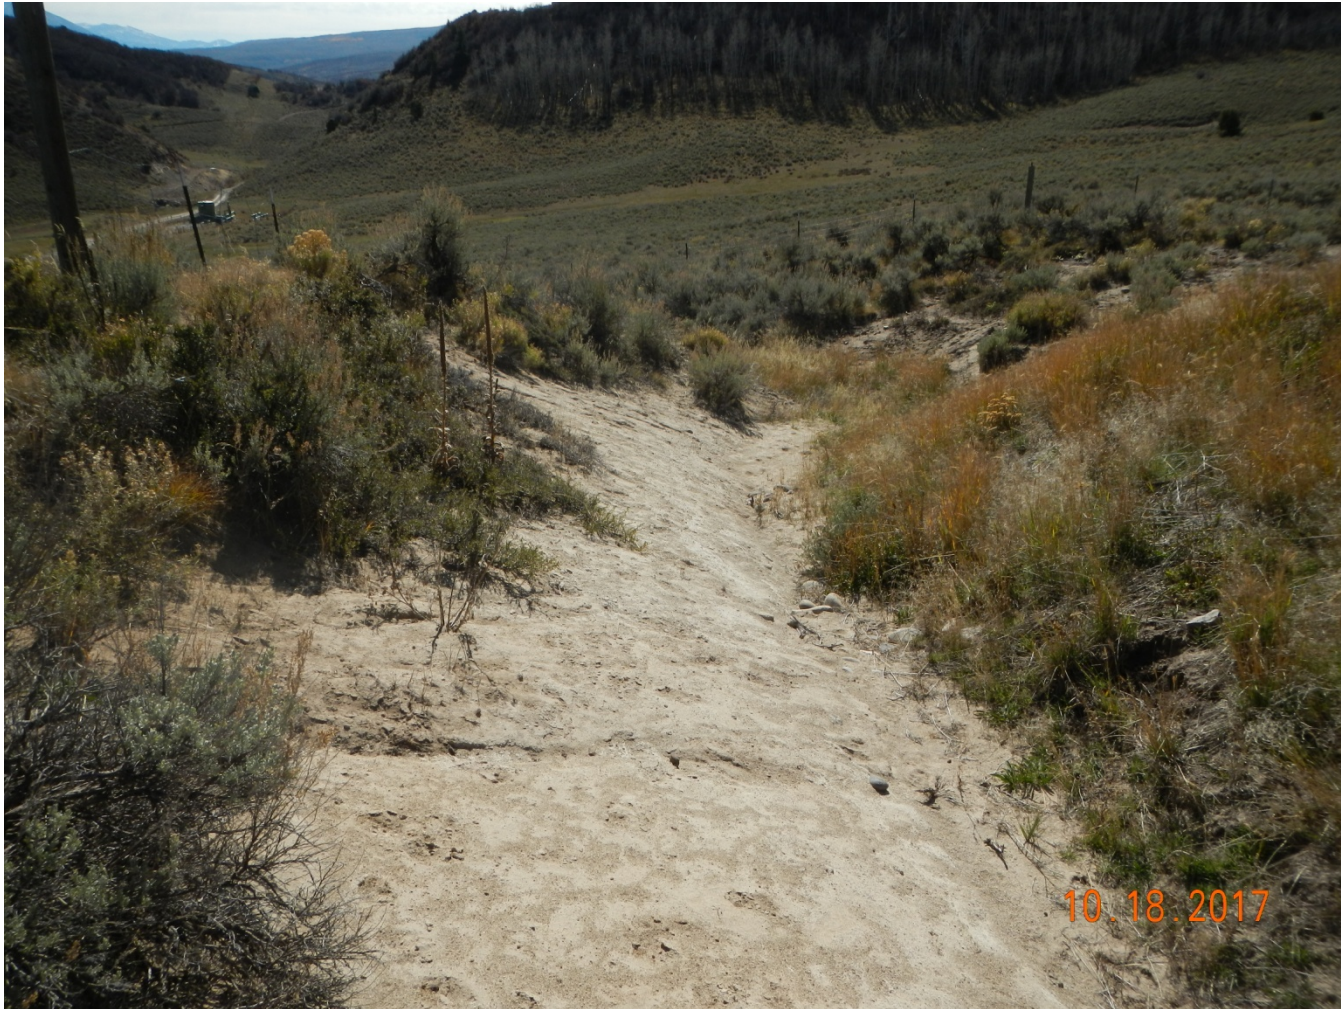
Photo 4. View of area in the southwestern portion of the project area with erosive scouring. This channeling pattern is evident before construction of the well pad and significant erosion does not appear to be occurring at this time. However, these sensitive areas should be monitored and stormwater controls installed if erosion worsens, as concentrated runoff from the well pad could increase the rate of erosion.

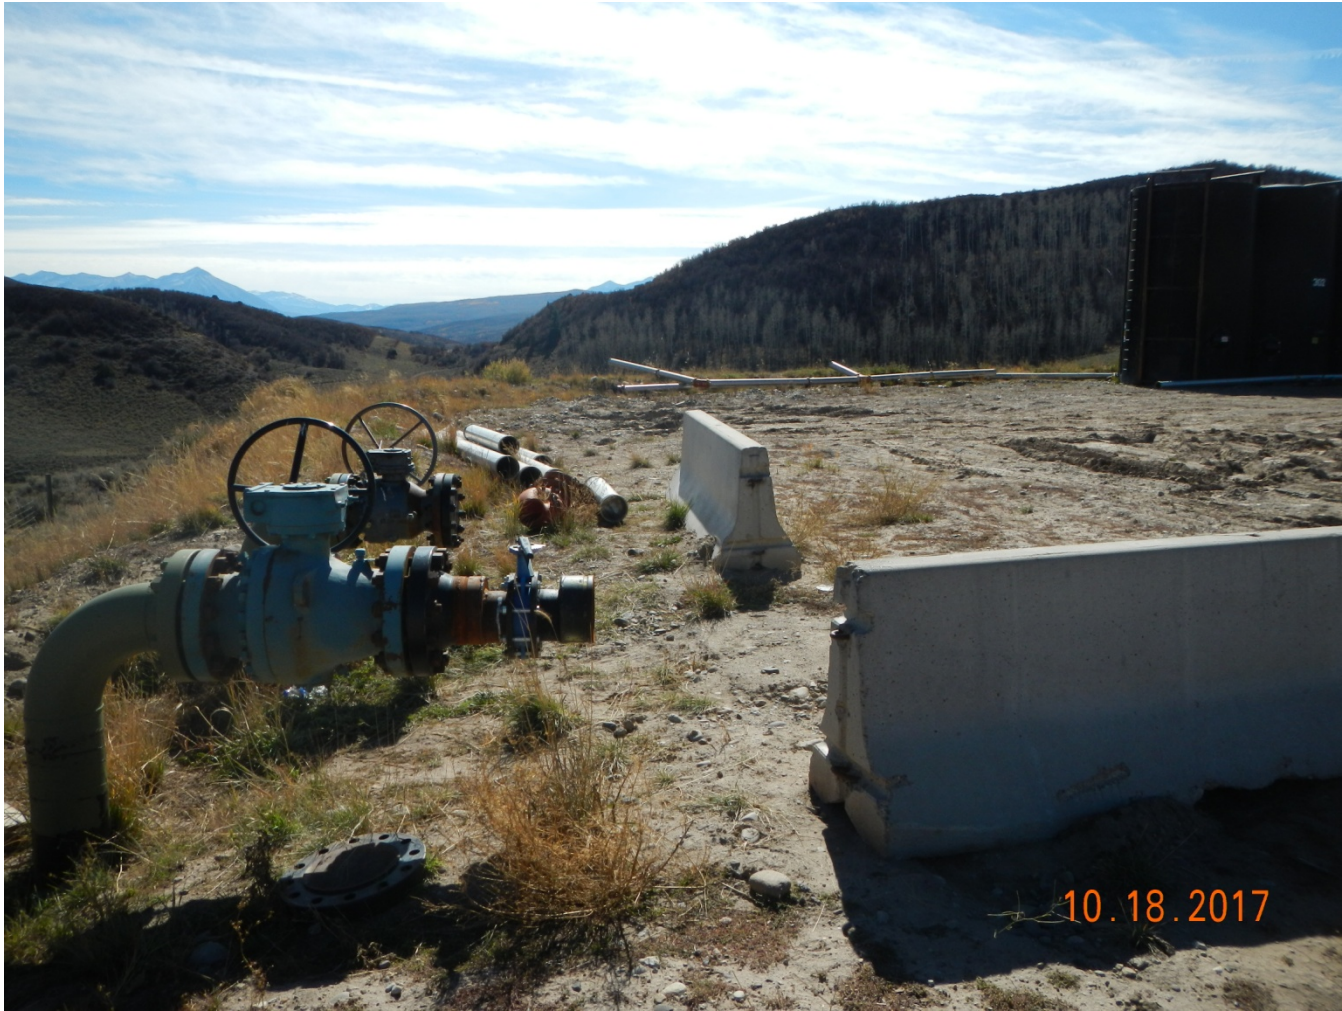
Photo 5. View of the eastern portion of the project area from the well pad entrance facing southward. Pipes and jersey barriers do not appear to be in use.

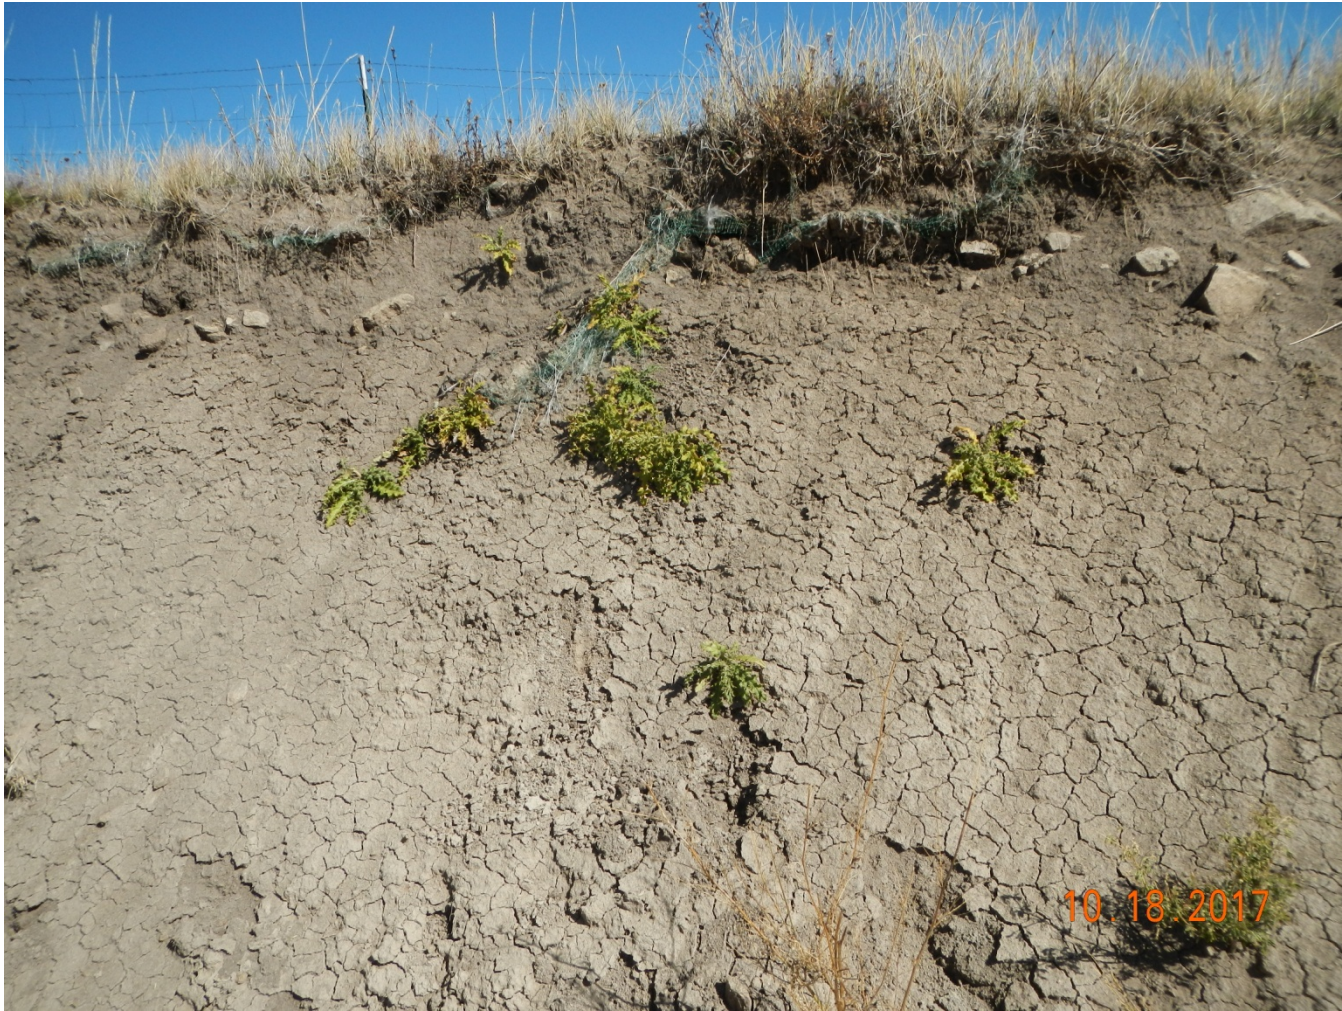
Photo 6. View of Canada thistles (*Cirsium arvense*) within the northeastern cut-slope.
