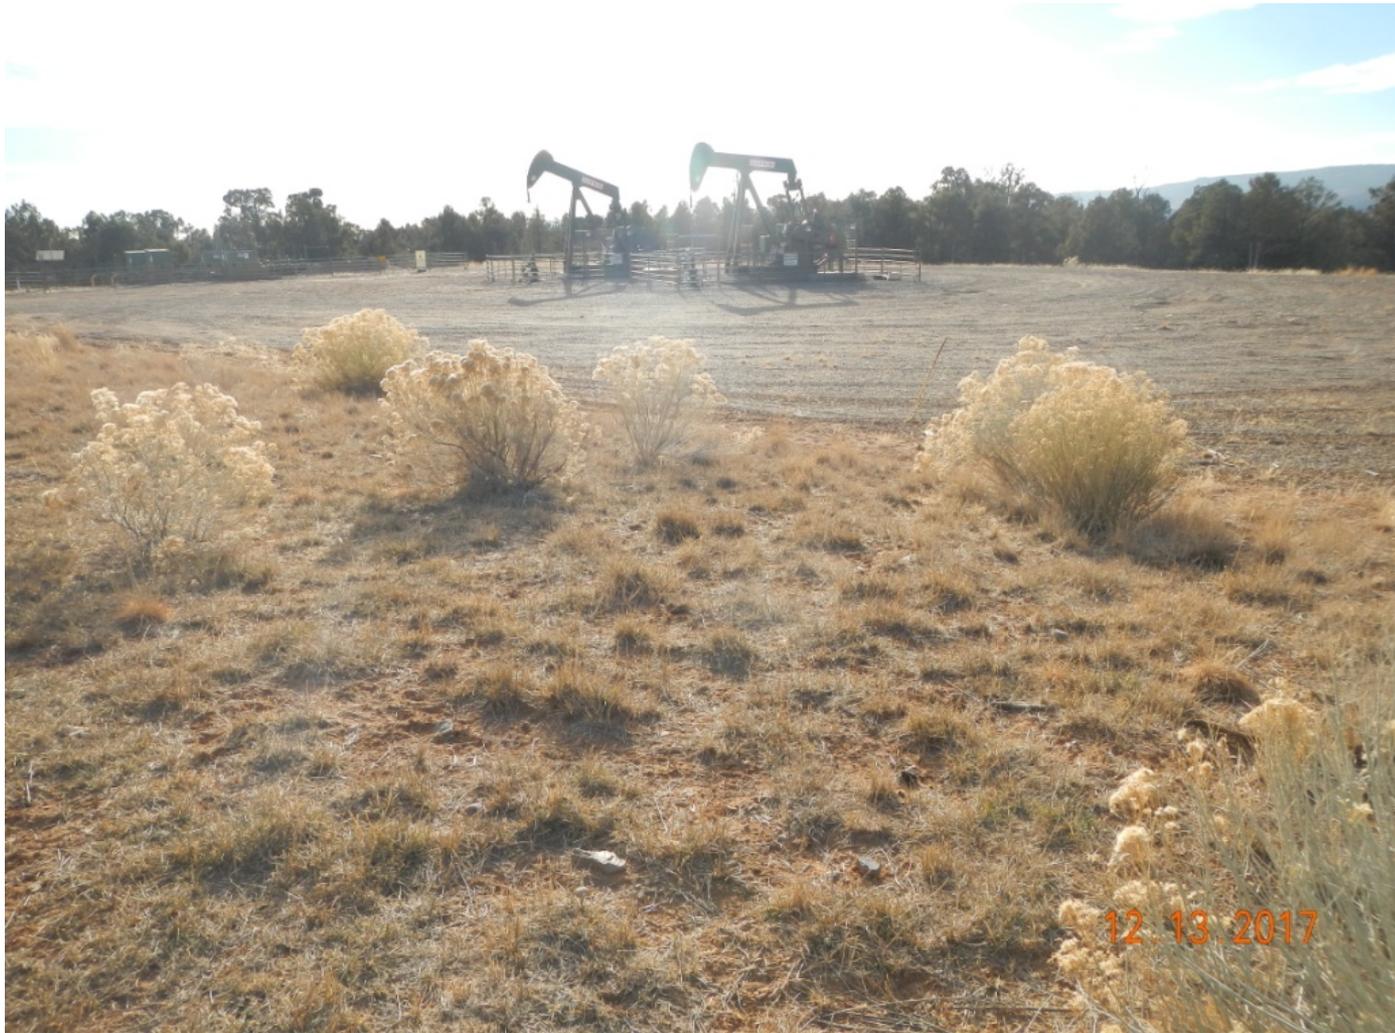
Photo 1. View of the project area from the northeastern corner facing center.

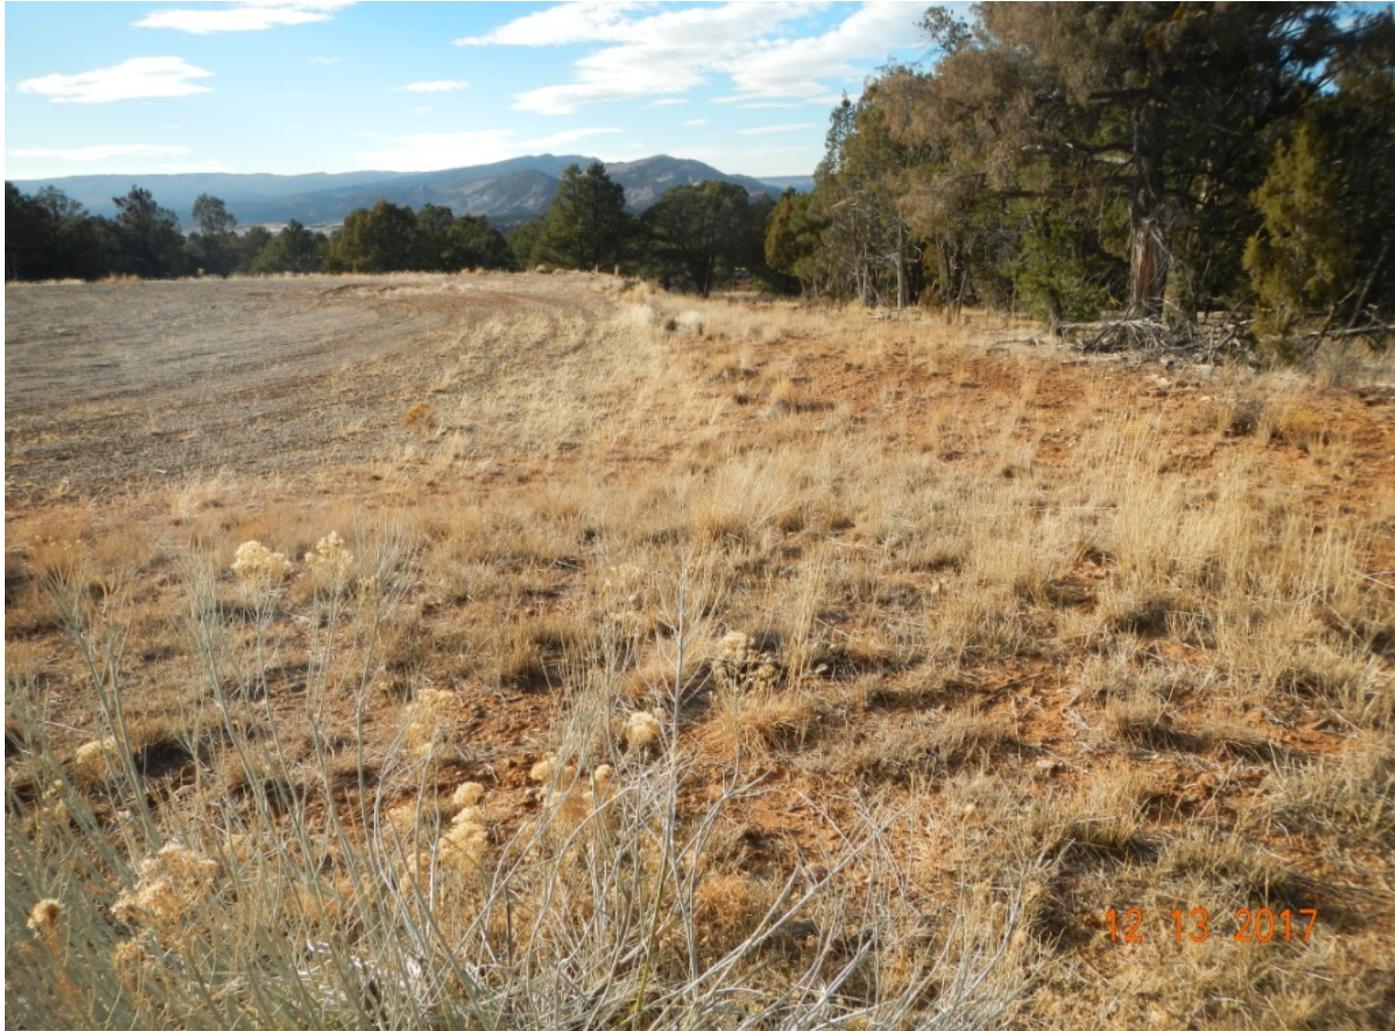
Photo 2. View of the northern portion of the project area from the northeastern corner facing westward.

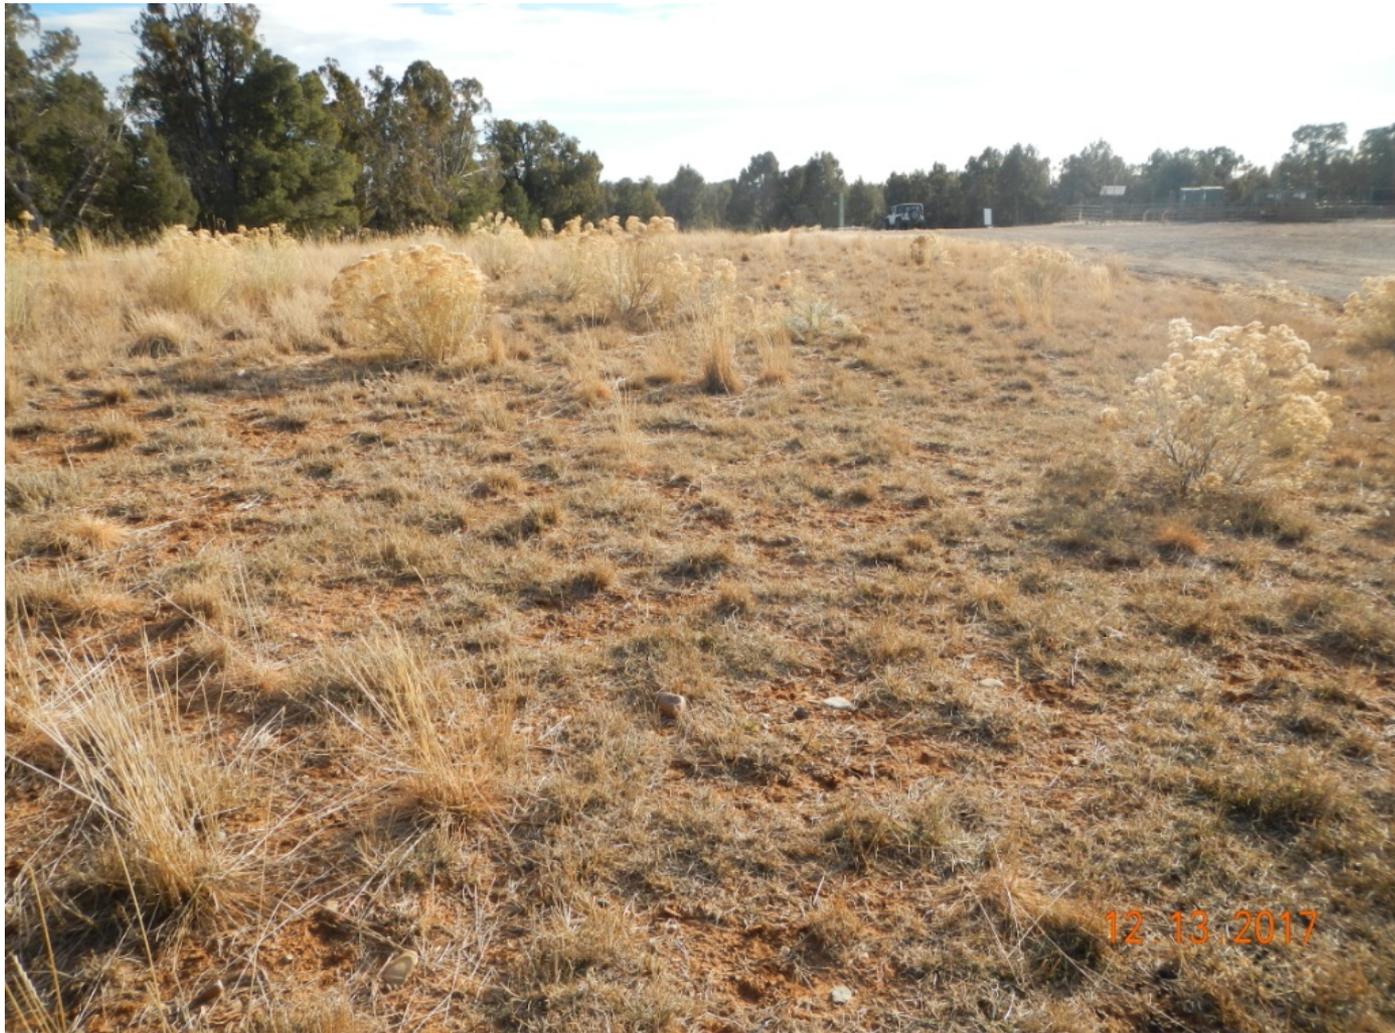
Photo 3. View of the eastern portion of the project area from the northeastern corner facing southward. Revegetation is progressing with grasses such as intermediate wheatgrass (*Thinopyron intermedium*), western wheatgrass (*Pascopyrum smithii*), and rubber rabbitbrush (*Chrysothamnus nauseosus*).

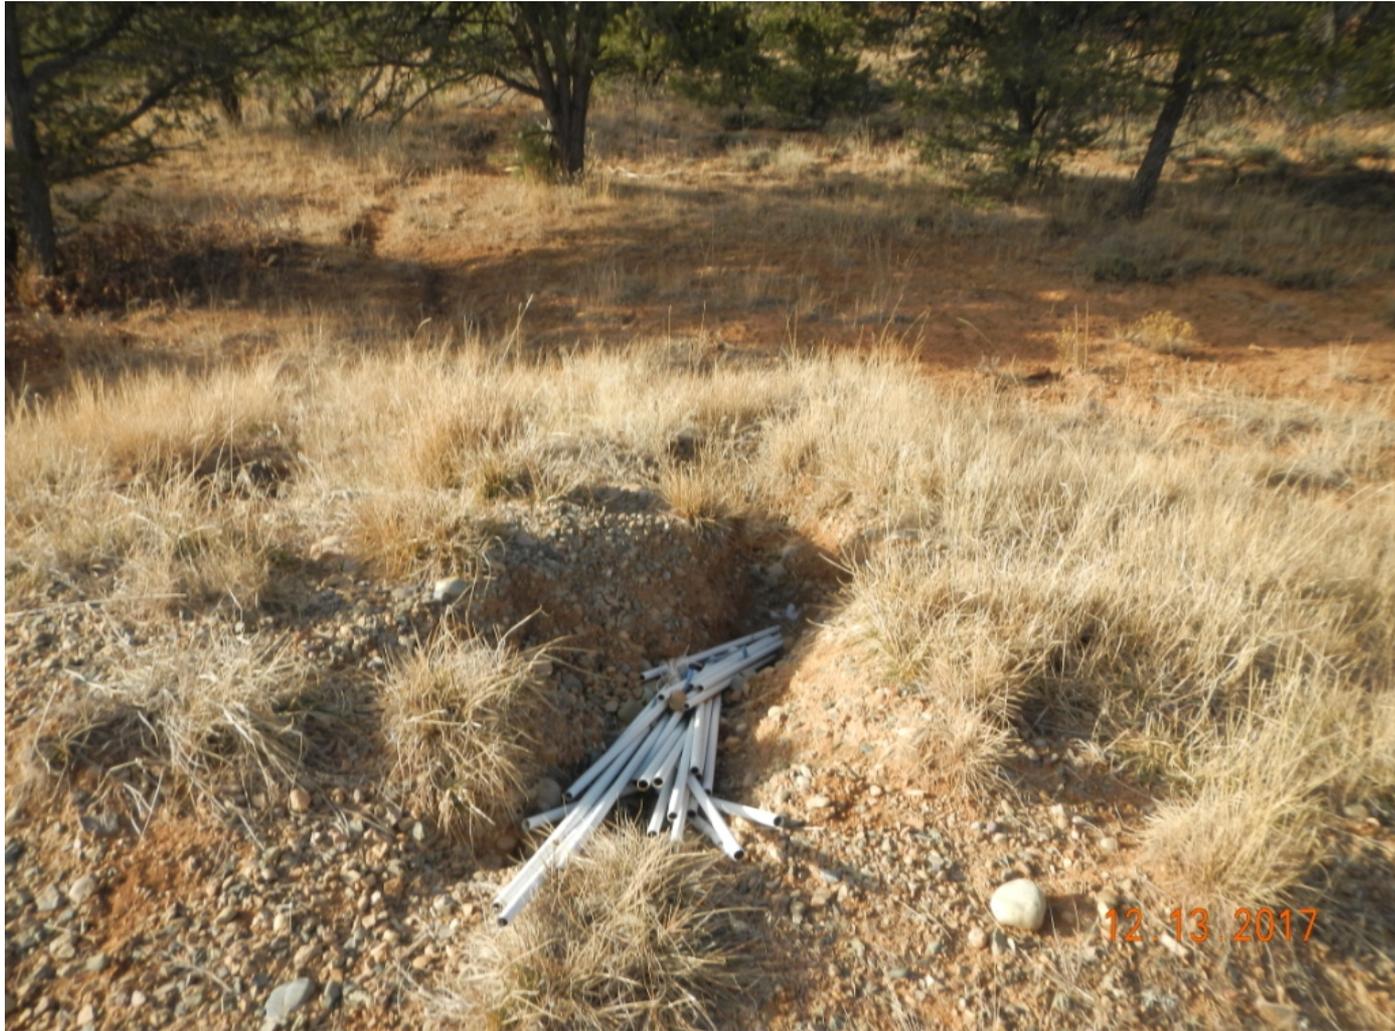
Photo 4. View of erosional channel and pipe debris within the western portion of the project area.

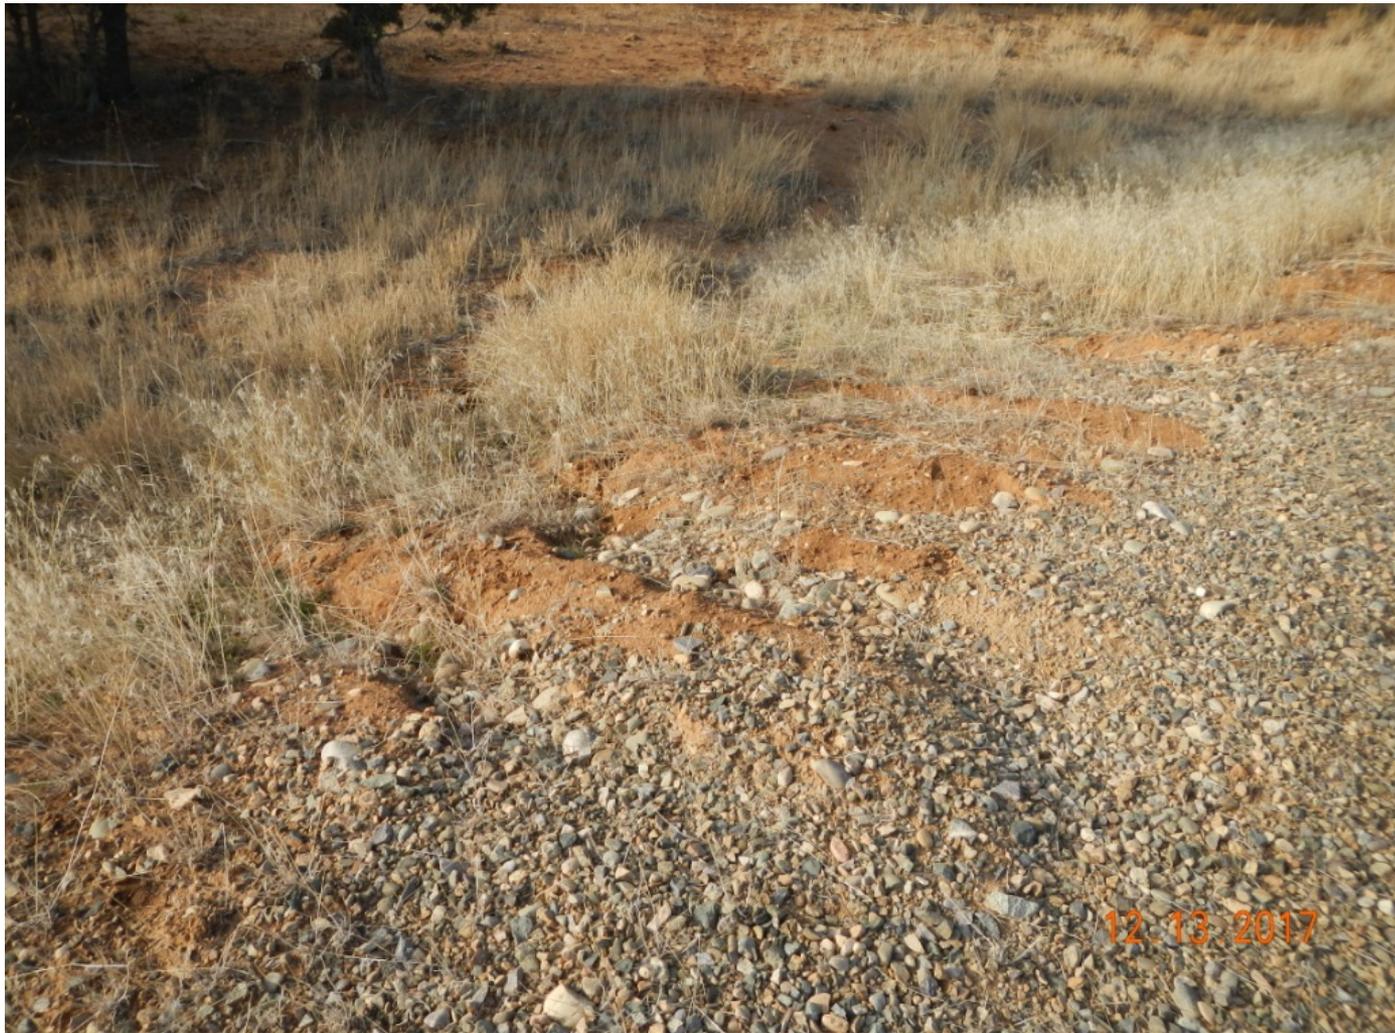
Photo 5. View of erosional rilling in the western portion of the project area.

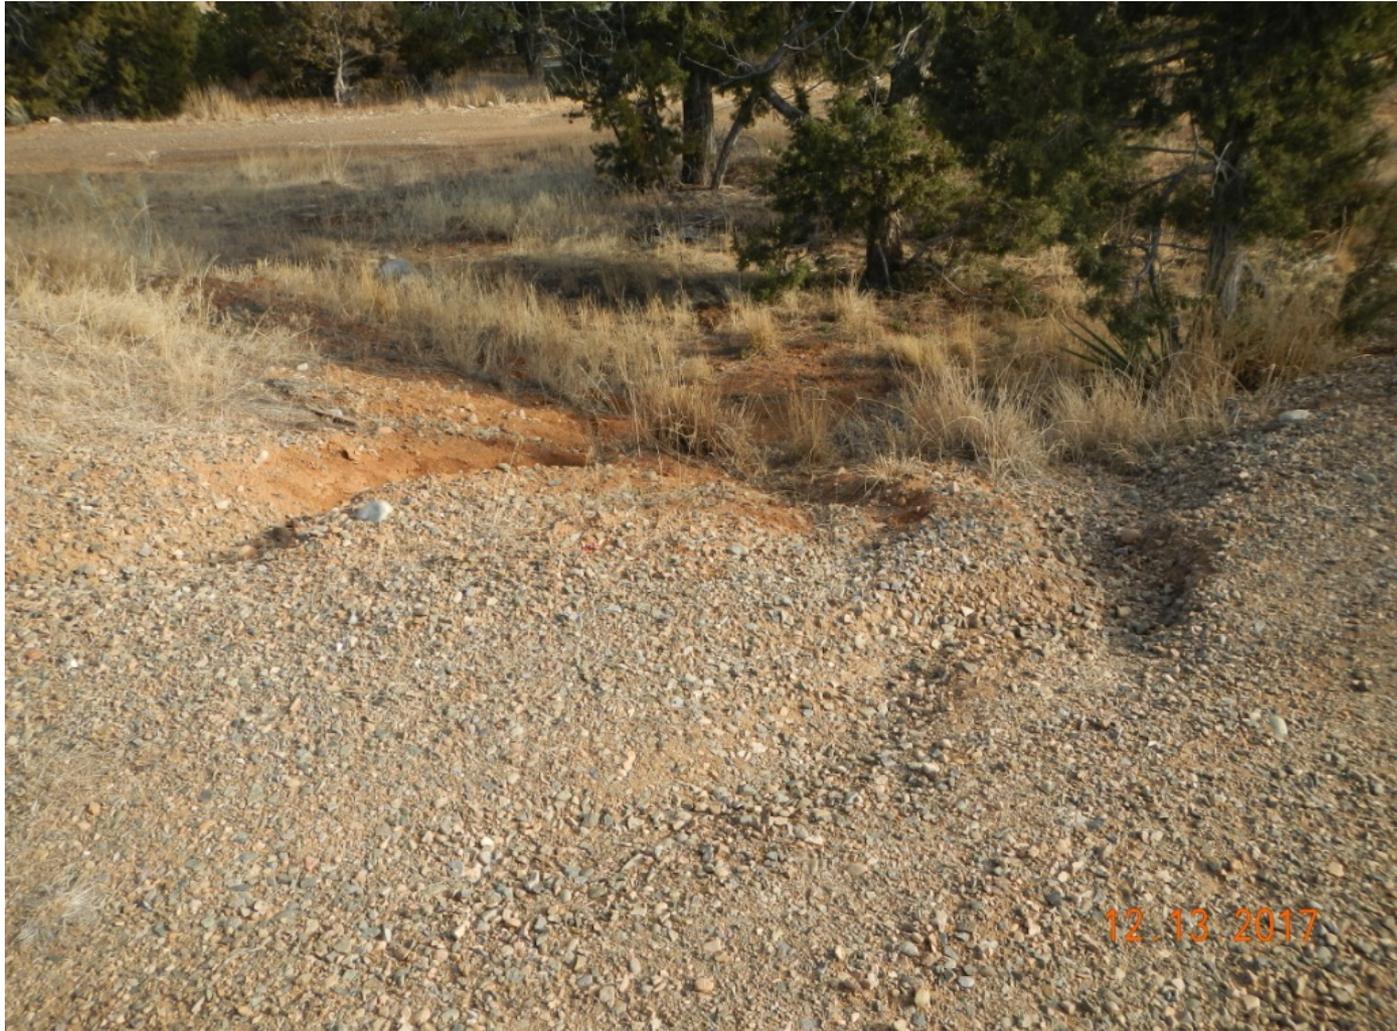
Photo 6. View of erosional channels near the entrance to the well pad.
