**Inspection Photo  
McPherson A-3  
API# 045-14477  
Inspection # 689301178**

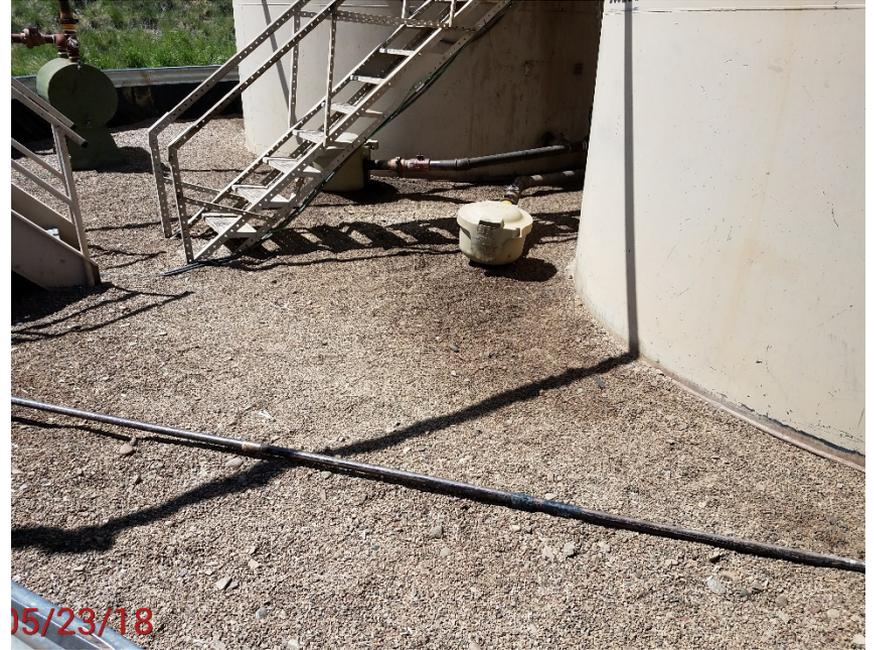
**Location Photo #2, Stained material in tank containment**

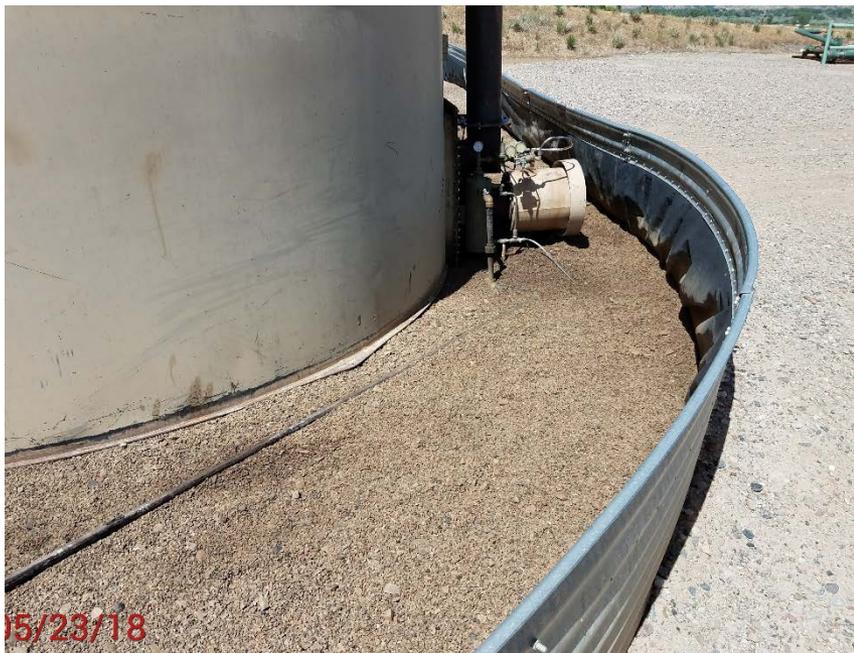
**Location Photo #3, Stained material in tank containment**

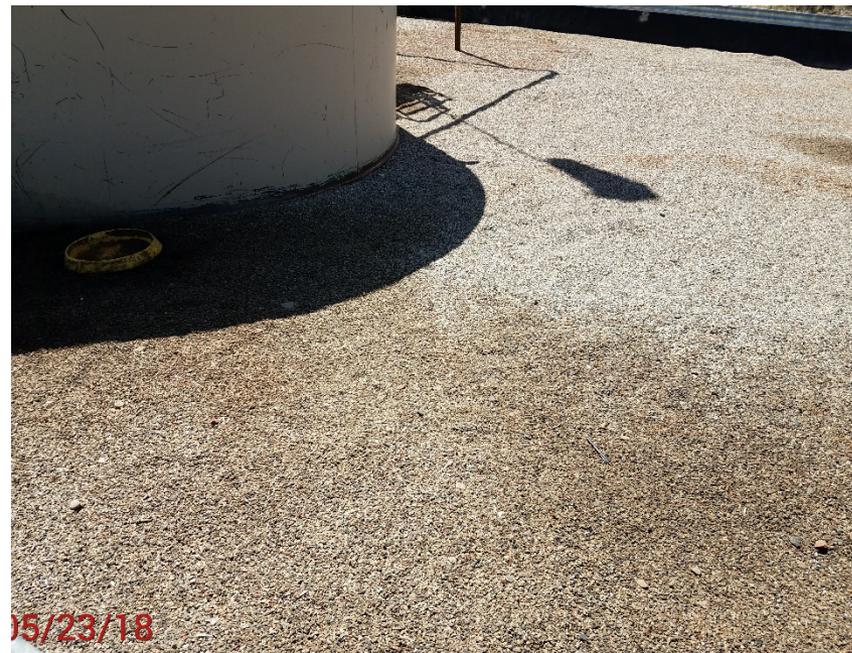
**Location Photo #4, Stained material in tank containment**

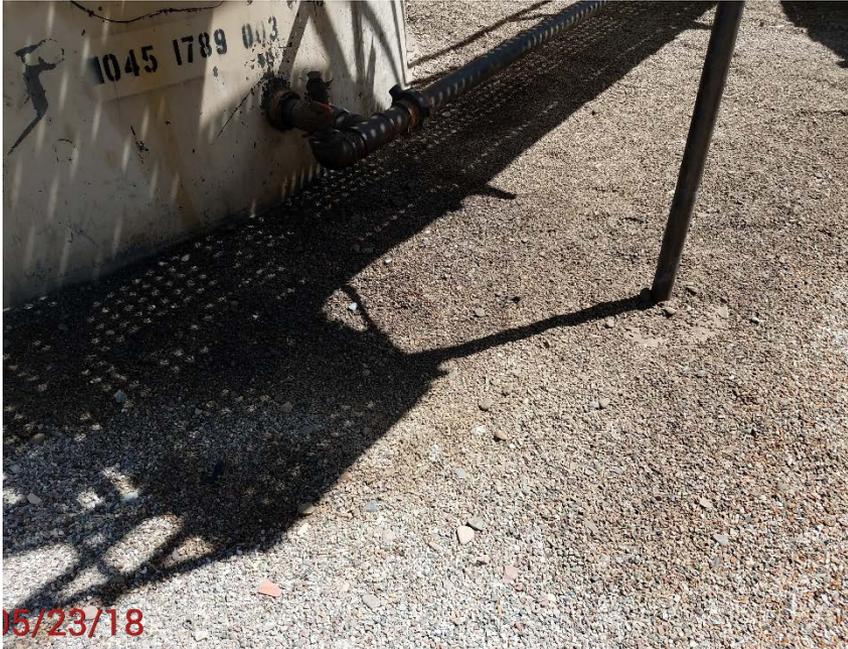
**Location Photo #5, Stained material in tank containment**

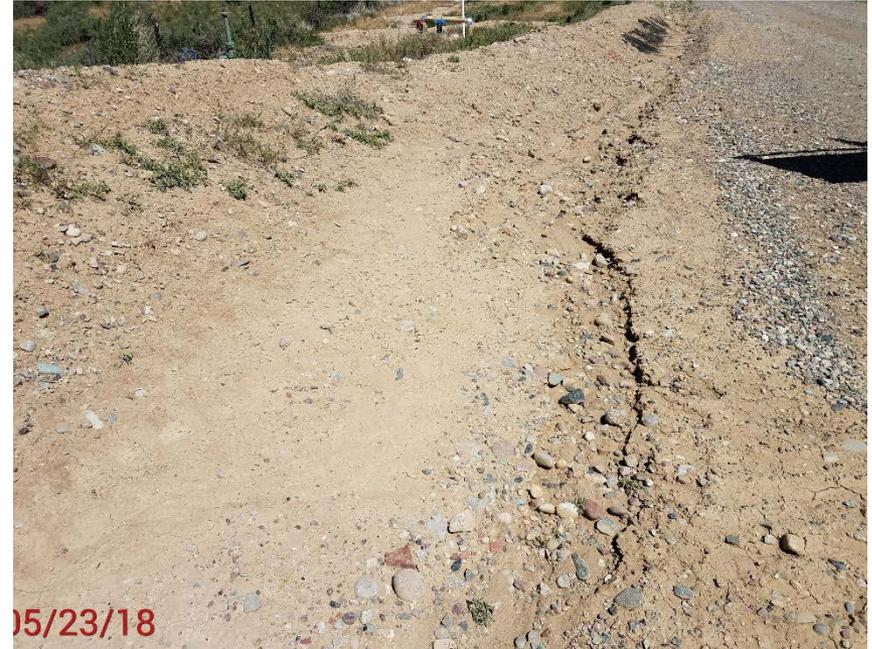
**Location Photo #6, Erosion along West side of access road**

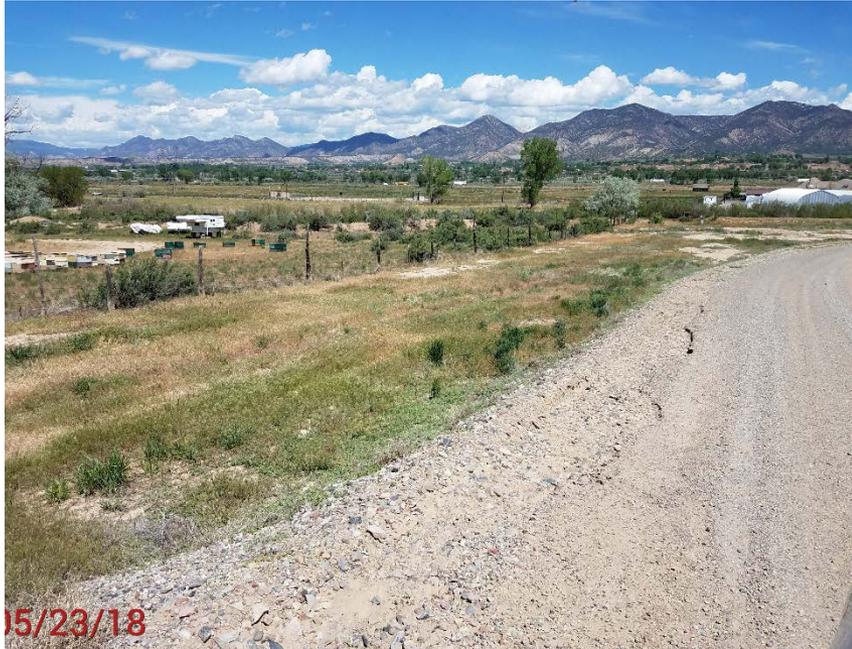
**Location Photo #7, Erosion along West side of access road**

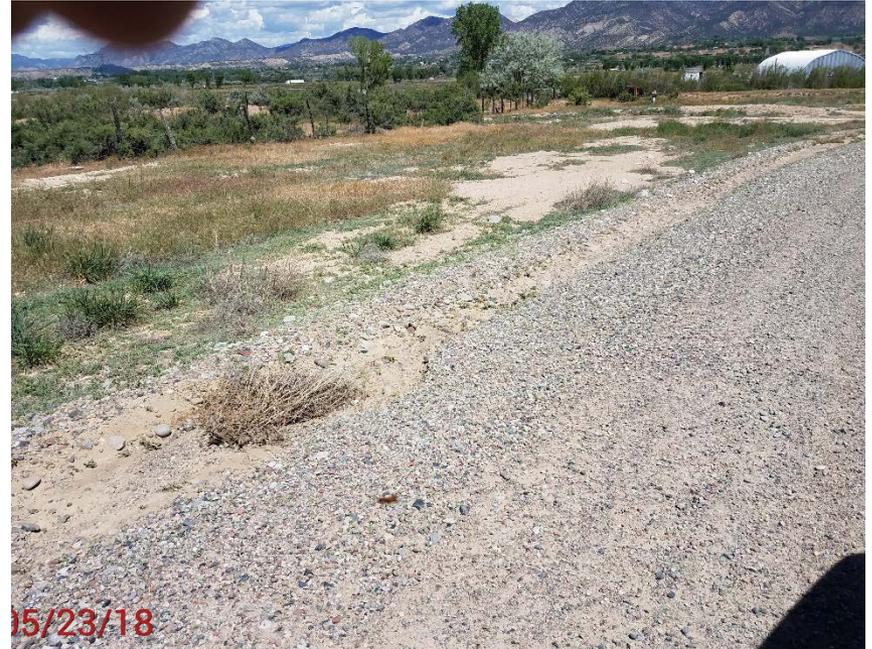
**Location Photo #8, Erosion along West side of access road**
