Inspection Photos 5/22 – 5/31/18 (J. MacLaren)
Location: Hyndrex Resources Flowline System
Spill ID #455229

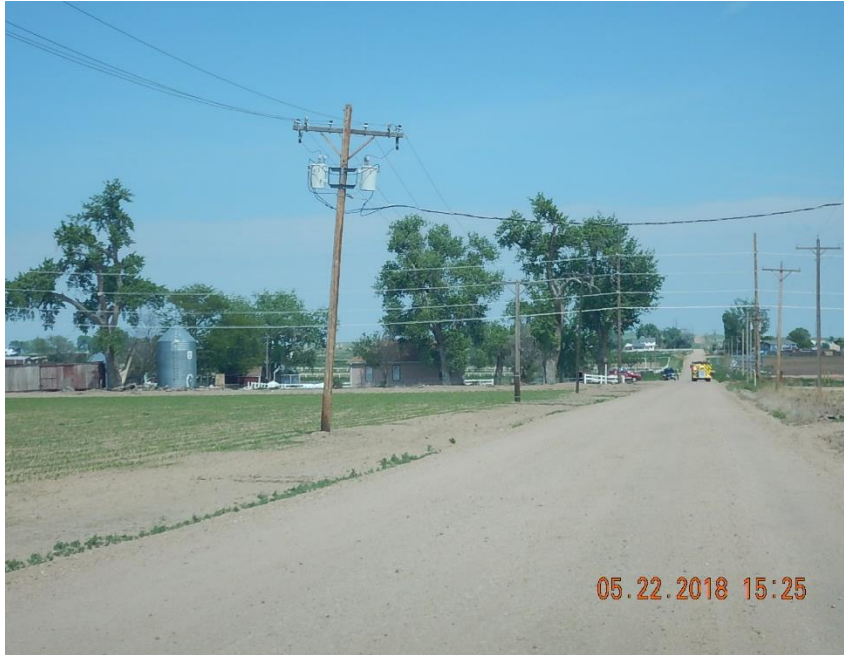
View of first responders to natural gas/ fluid release (looking east from intersection of Hwy 85/ WCR 18.5 on 5/22/18)

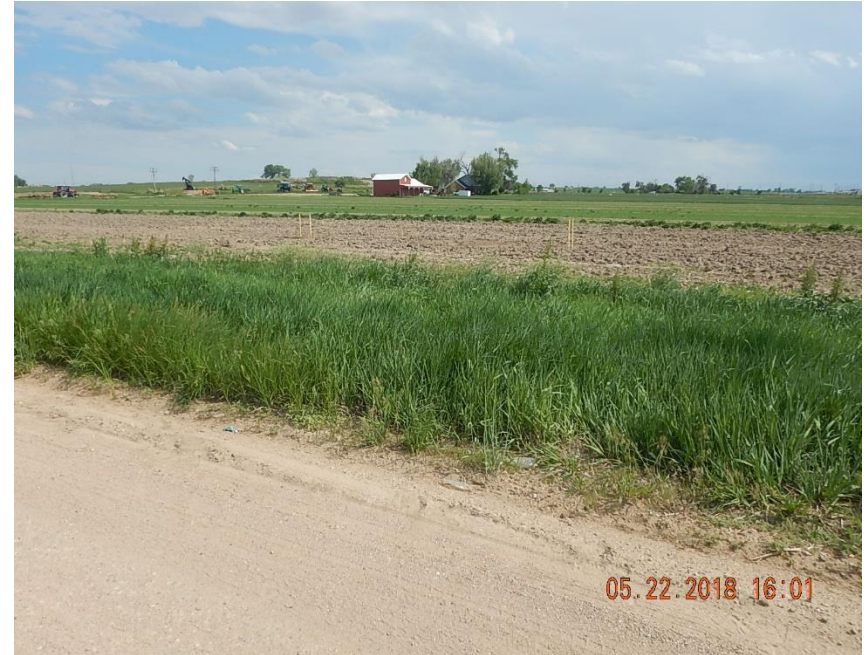
View (looking SE) of impacted area where flowline failed resulting in release (from WCR 18.5)

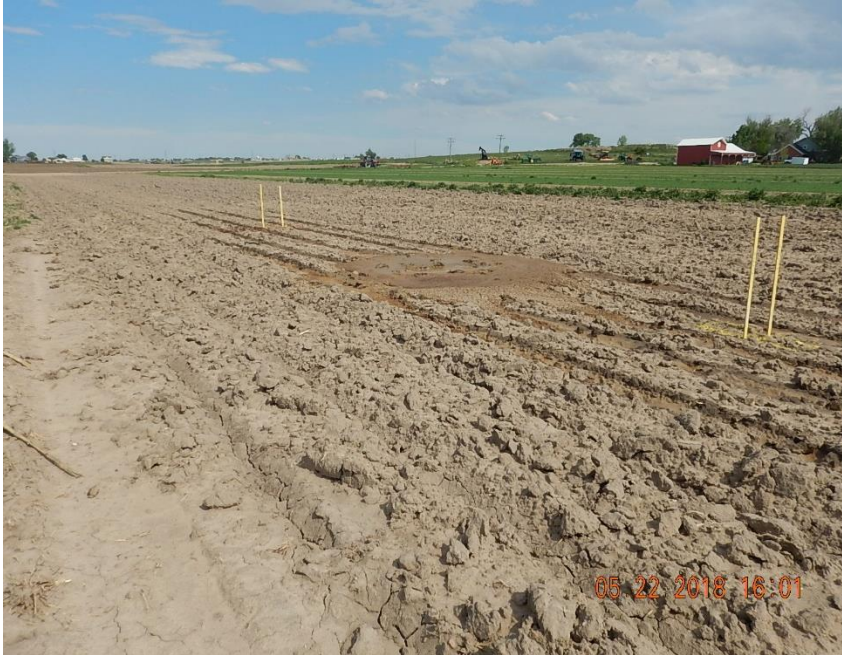
**View of pooled fluid in agricultural field (marked/ staked)
where flowline failed resulting in release (looking SE)**

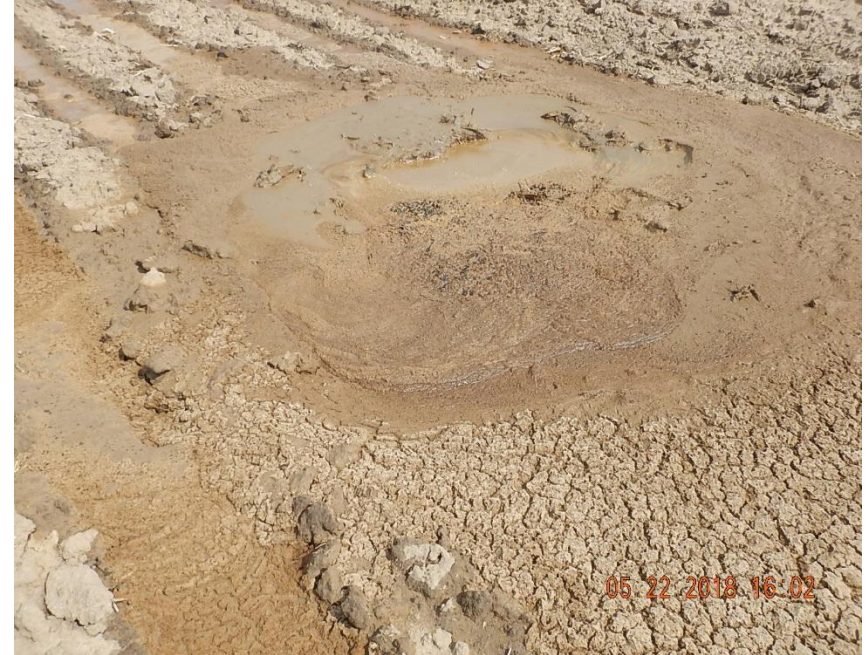
Close up view of pooled fluids (primarily water) at surface

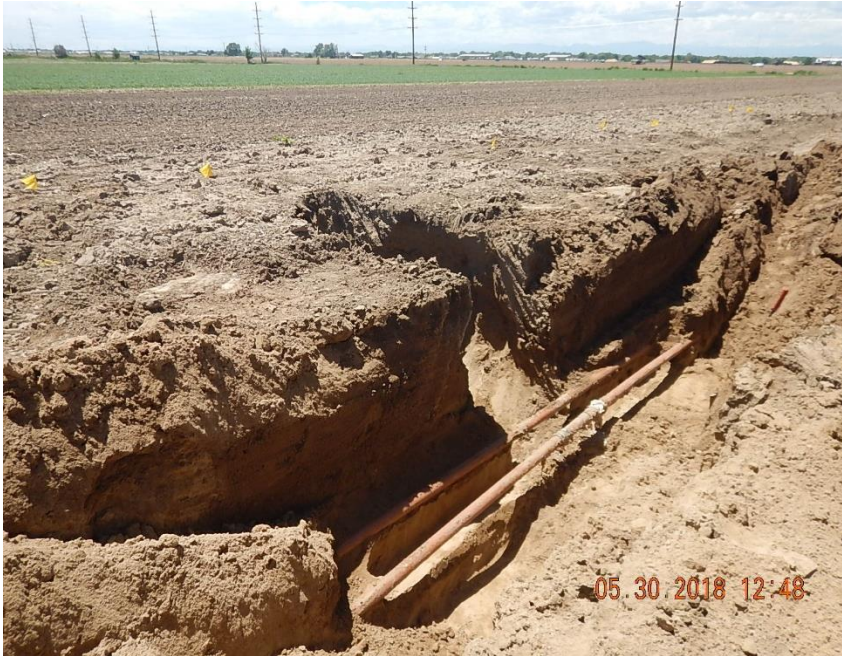
Photo taken 5/30/18 of excavation exposing (2) Hyndrex Resources 3" fiberglass flowlines; initial (failed) repair can be seen on Northern most flowline

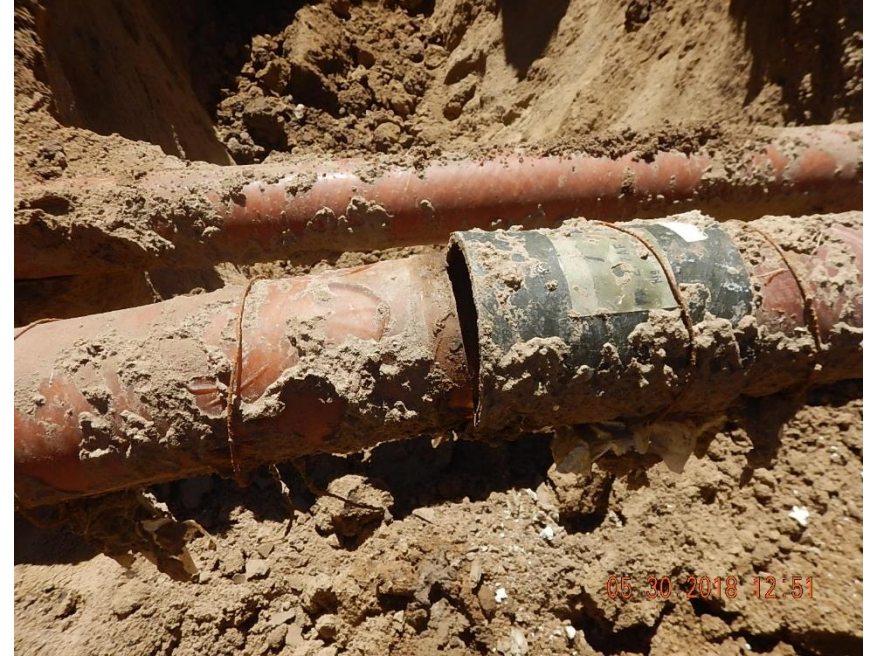
Photo of failed repair completed by contractor (no longer working on this project); Fiberglass coupler improperly installed, no adhesive used to complete connection
