**Inspection Photos**  
**Location Name: Lilli Unit #16-6**  
**Location ID: 326799**

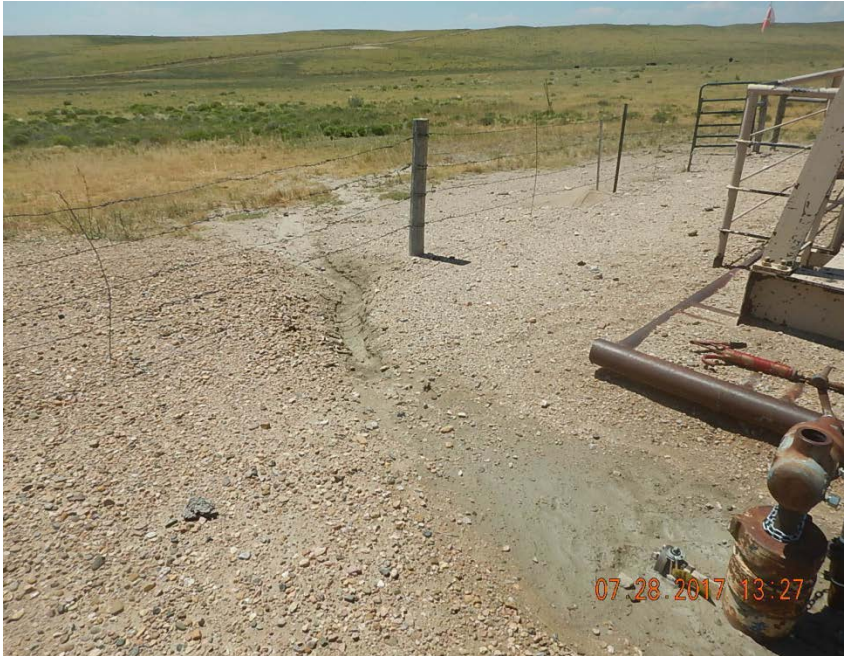
**Photo from prior inspection for comparison**

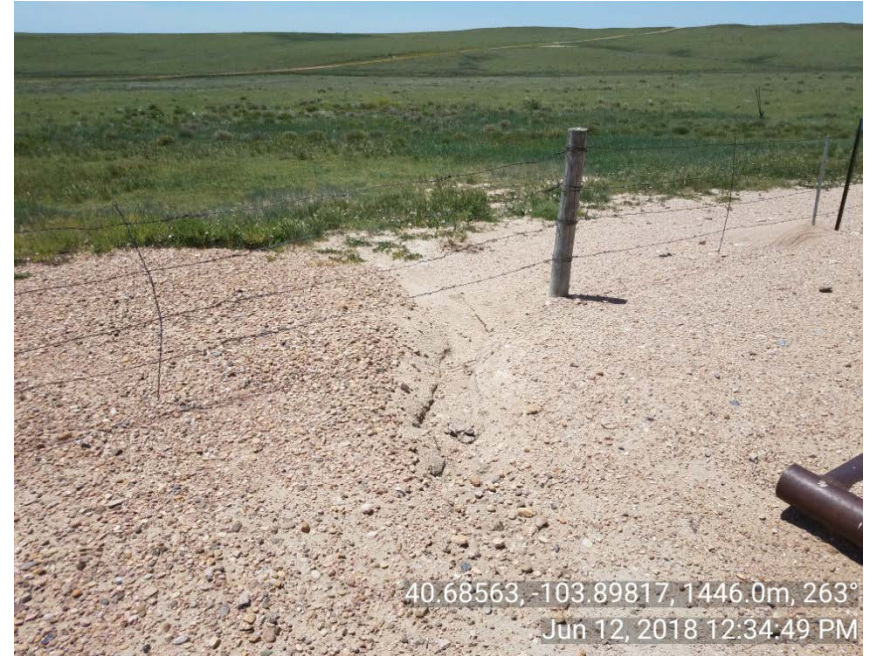
**Photo 3: Stormwater erosion S of wellhead**

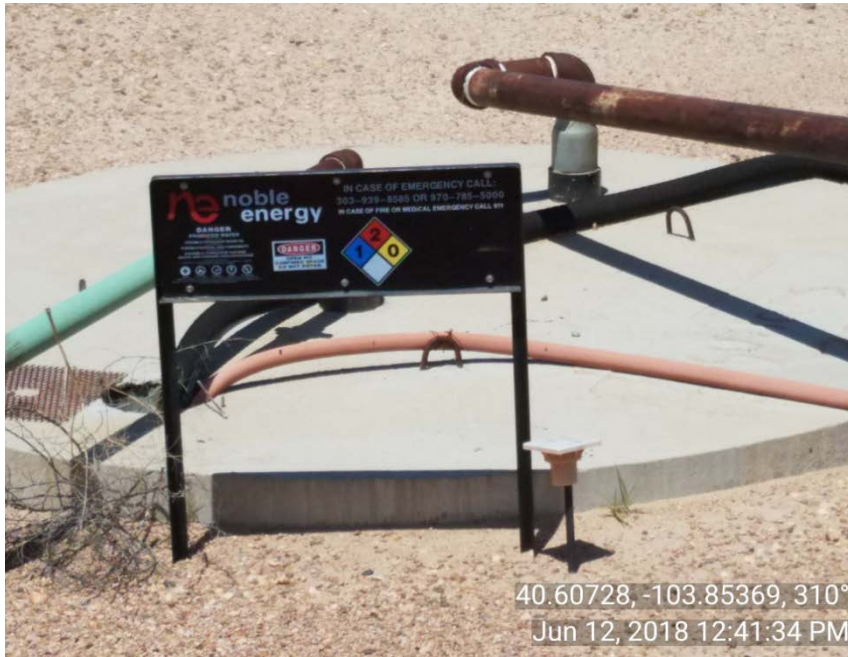
**Photo 4: No capacity at produced water vault**
