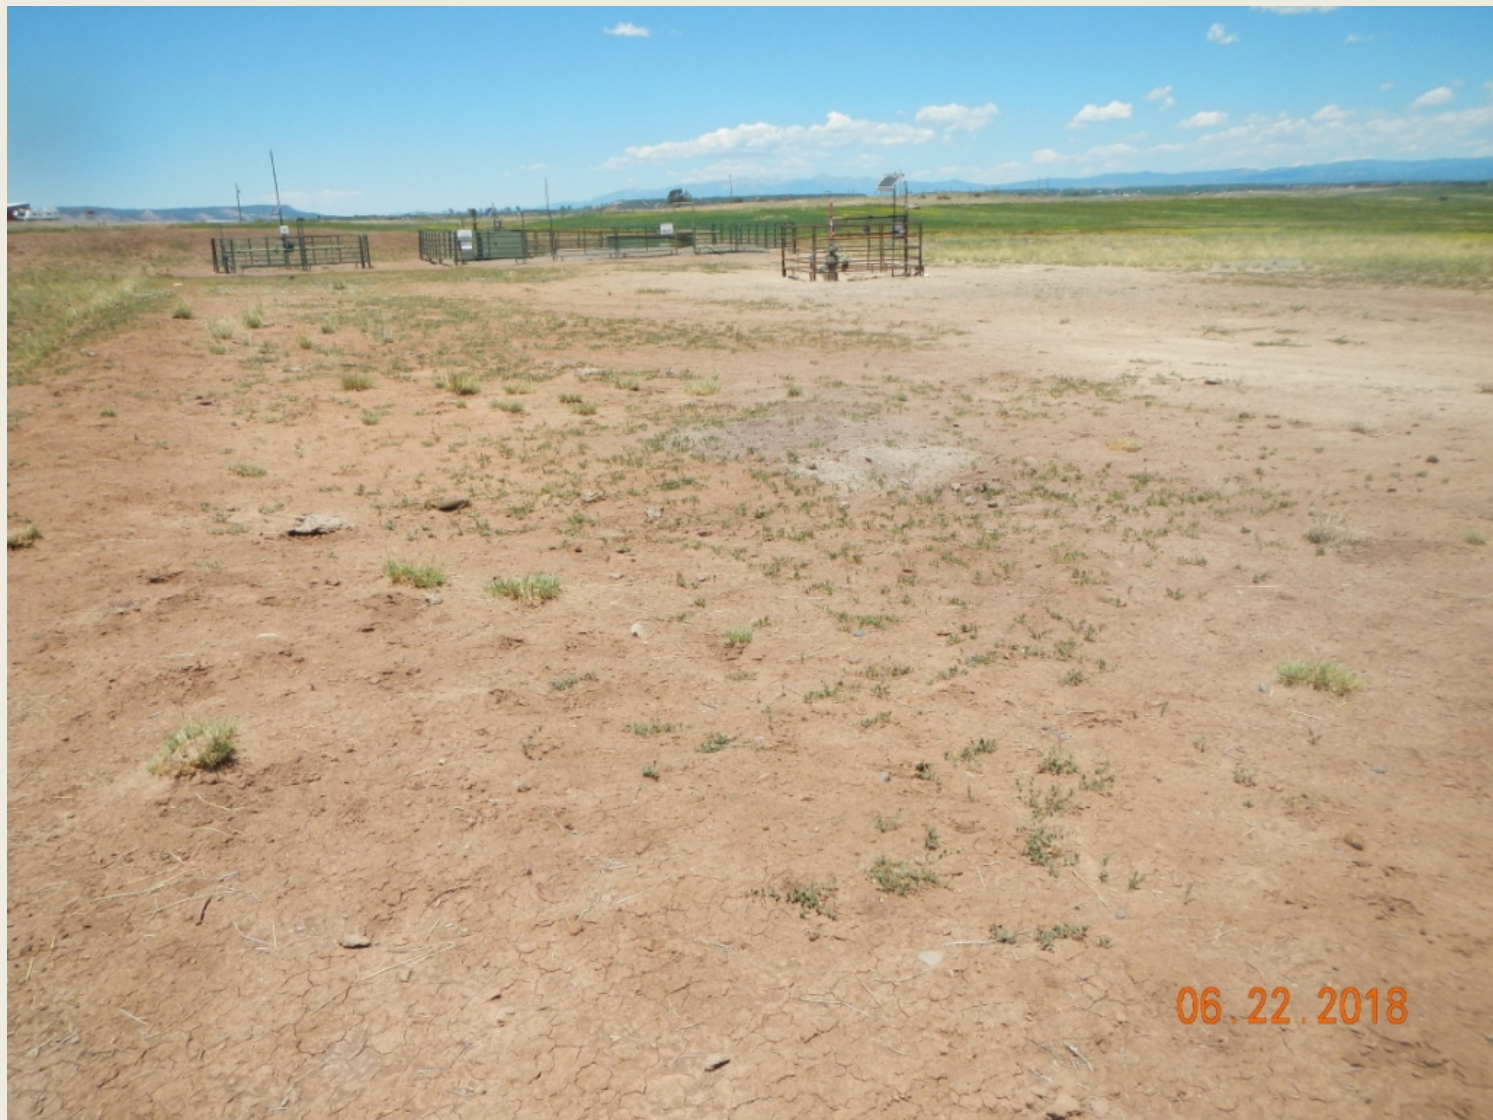
Photo 1. View of the project area from the southeastern corner of the working area facing center.

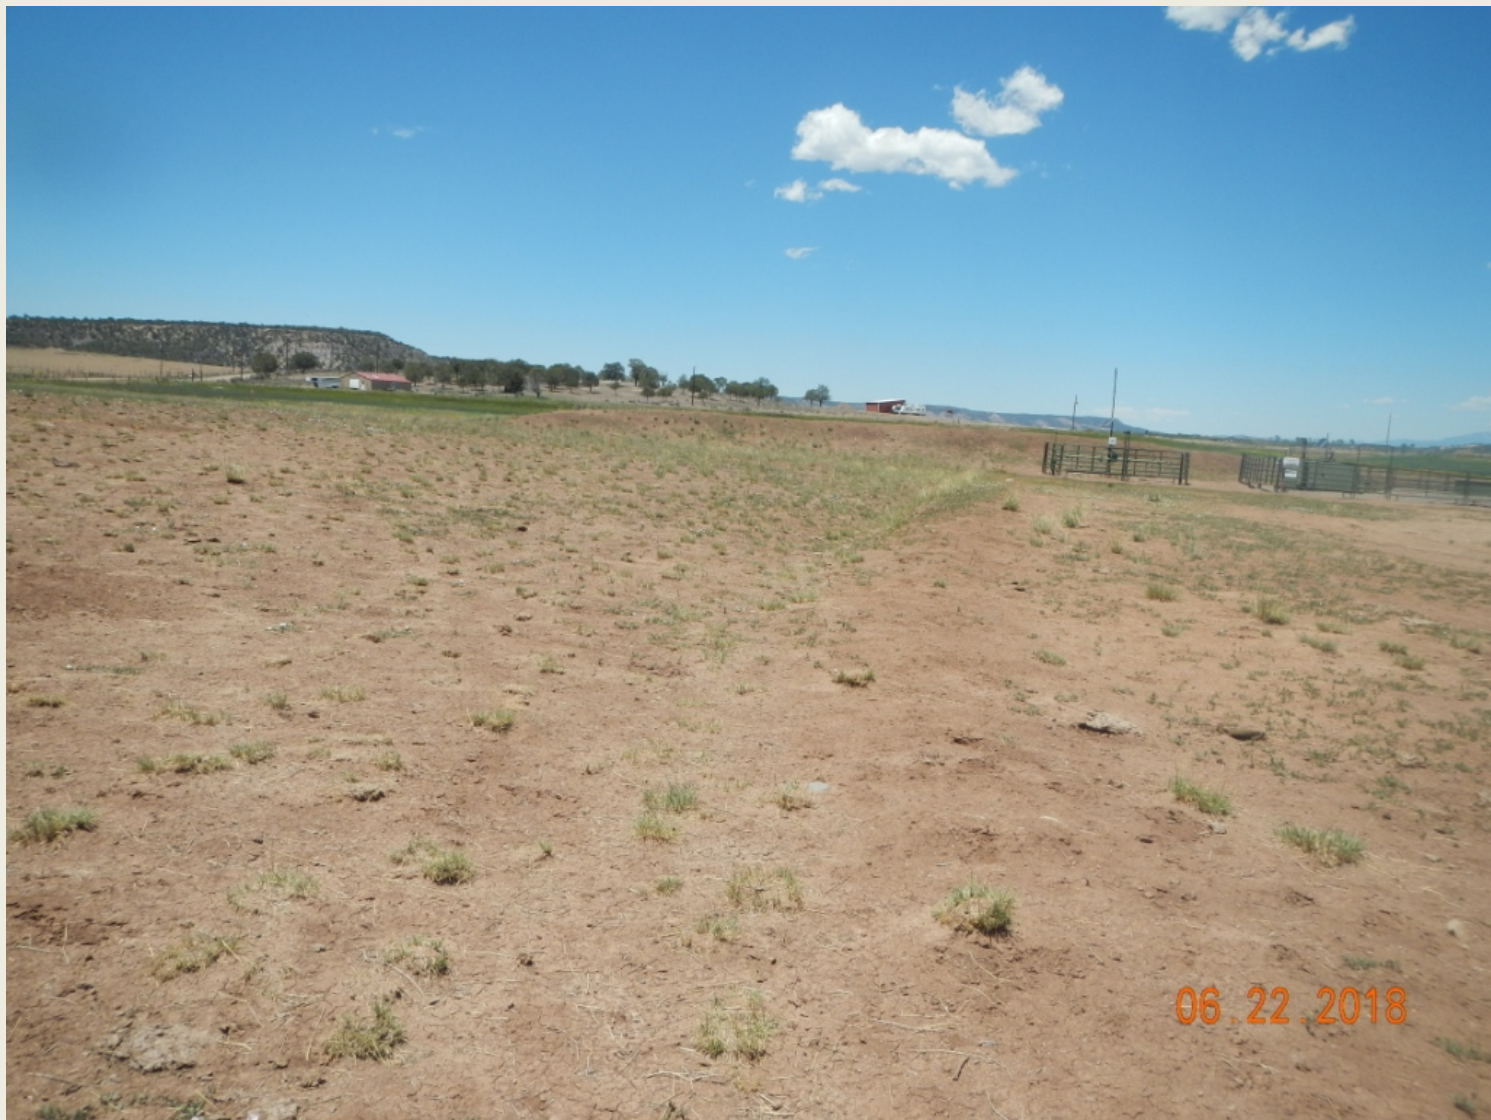
Photo 2. View of the southern portion of the project area from the southeastern corner facing westward. Revegetation is progressing within grasses such as western wheatgrass (*Pascopyrum smithii*) and sand dropseed (*Sporobolus cryptandrus*).

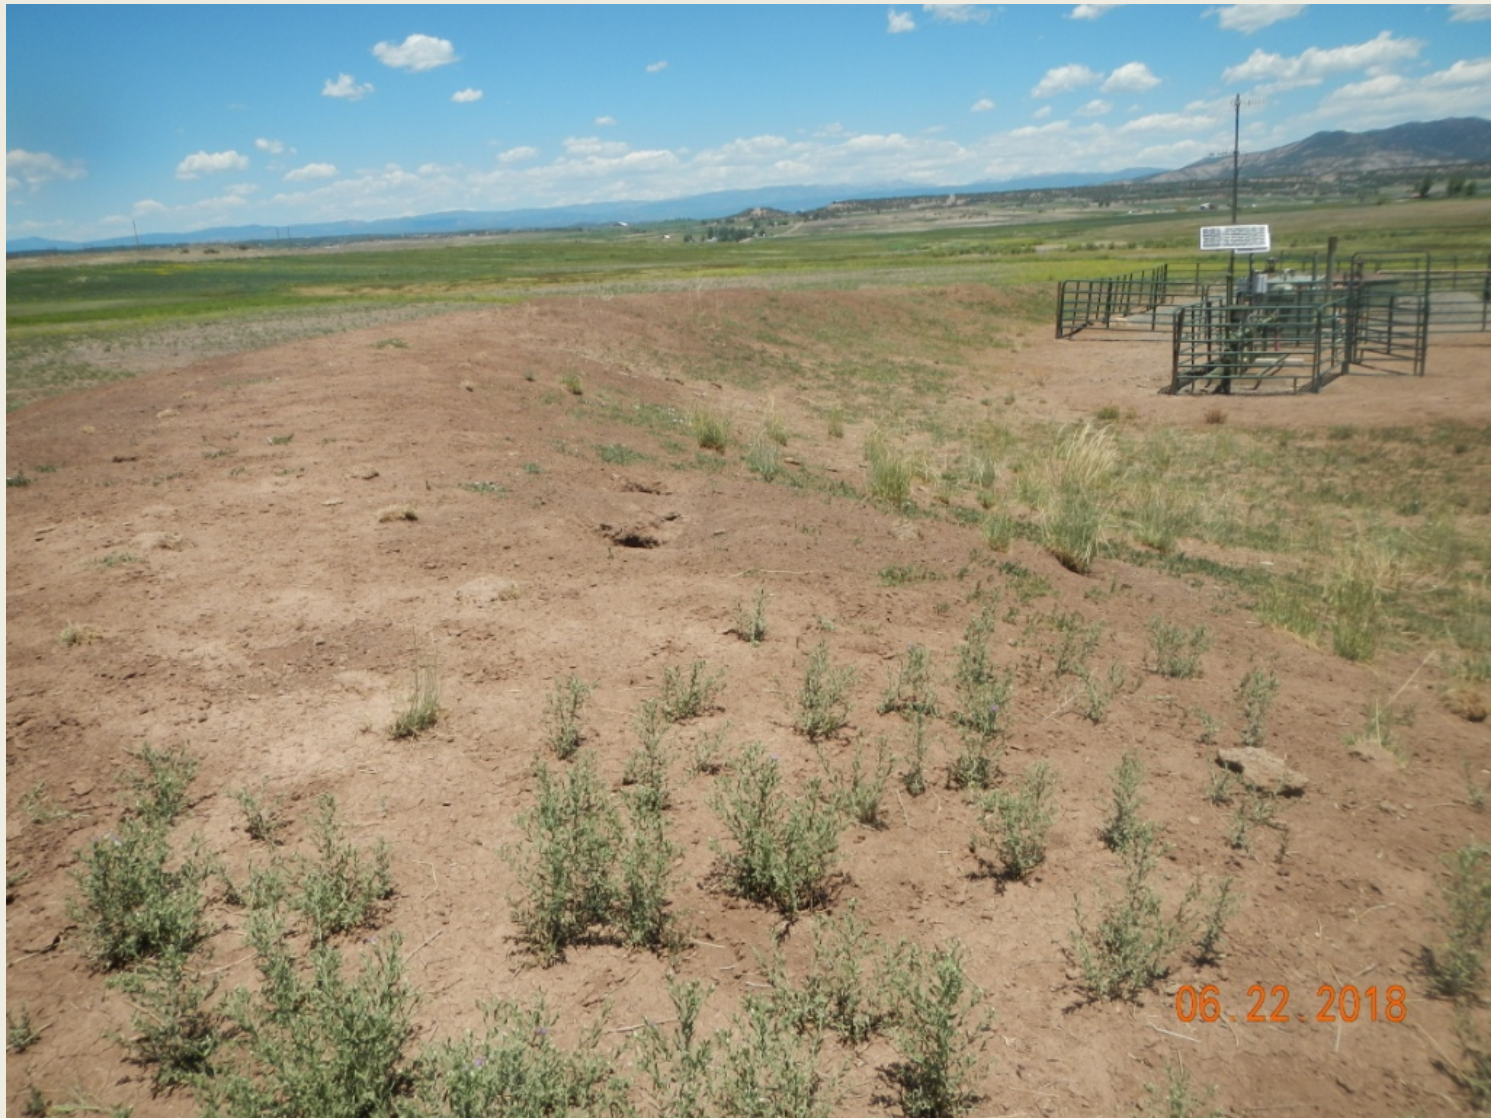
Photo 3. View of the western portion of the project area from the southwestern corner facing northward. Russian knapweeds (*Rhaponticum repens*) are growing in the foreground on berm.

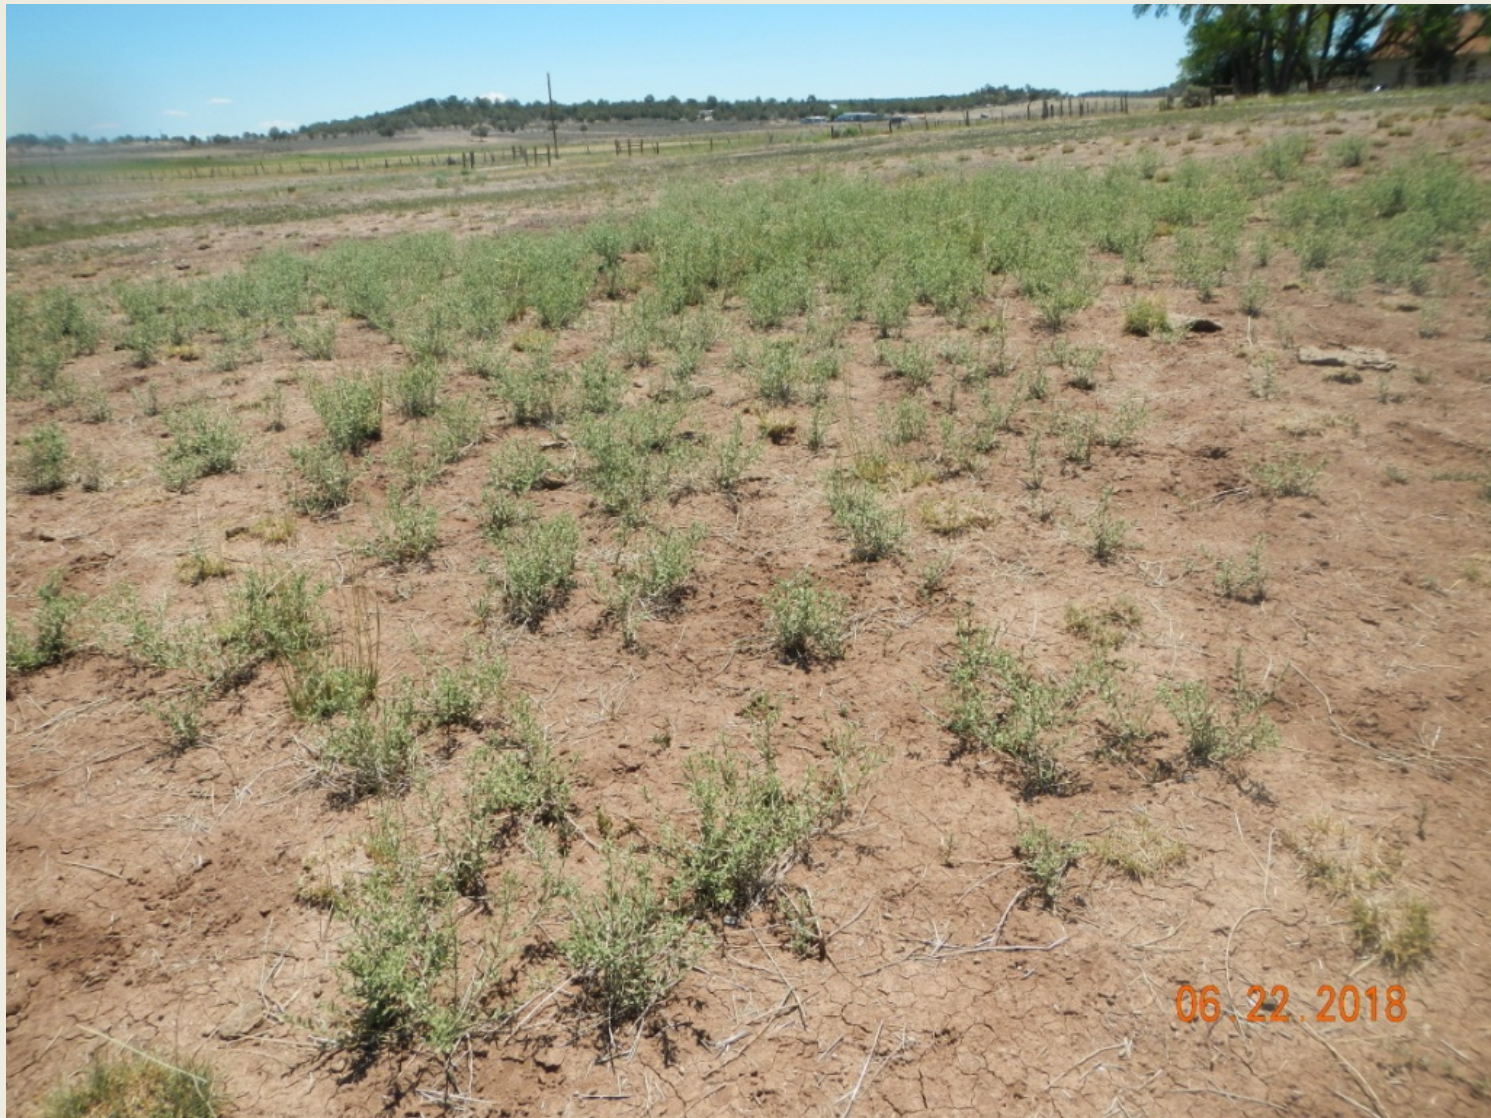
Photo 4. View of Russian knapweeds within the southeastern portion of the project area. Project area is defined as all areas disturbed for the project. Aerial imagery indicates knapweed infestation is within project area. Additional knapweed is outside of the project area, so monitoring and subsequent treatments will be needed.

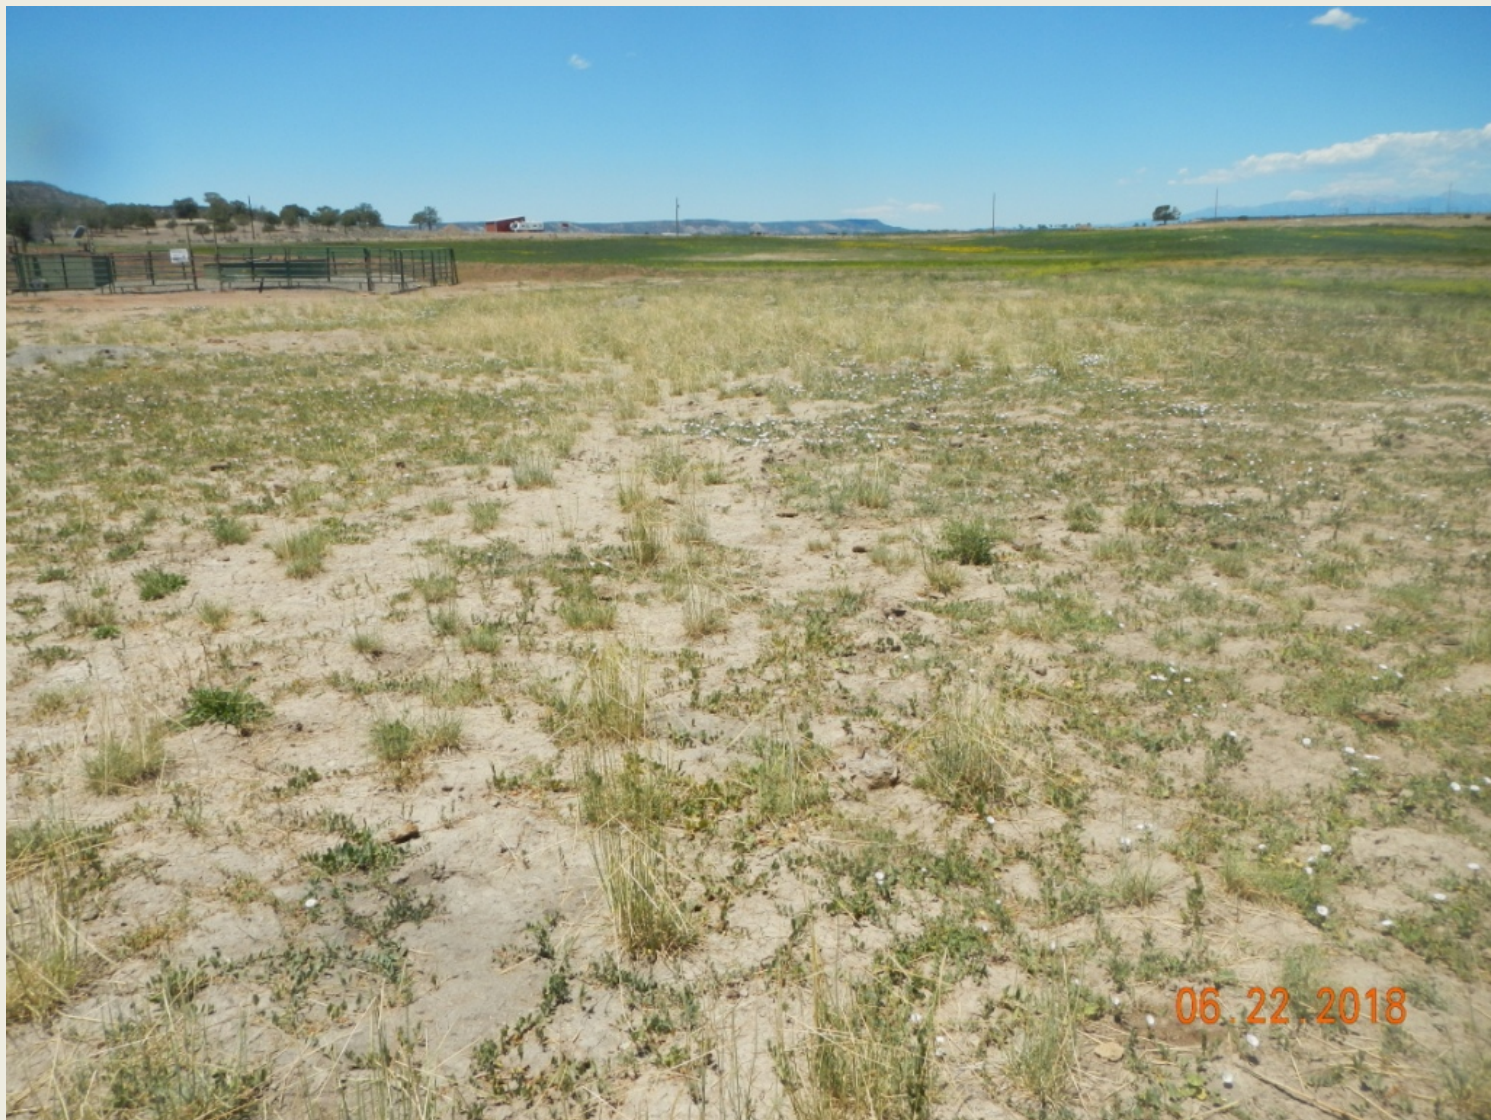
Photo 5. View of the northern portion of the project area from the northeastern corner facing westward.

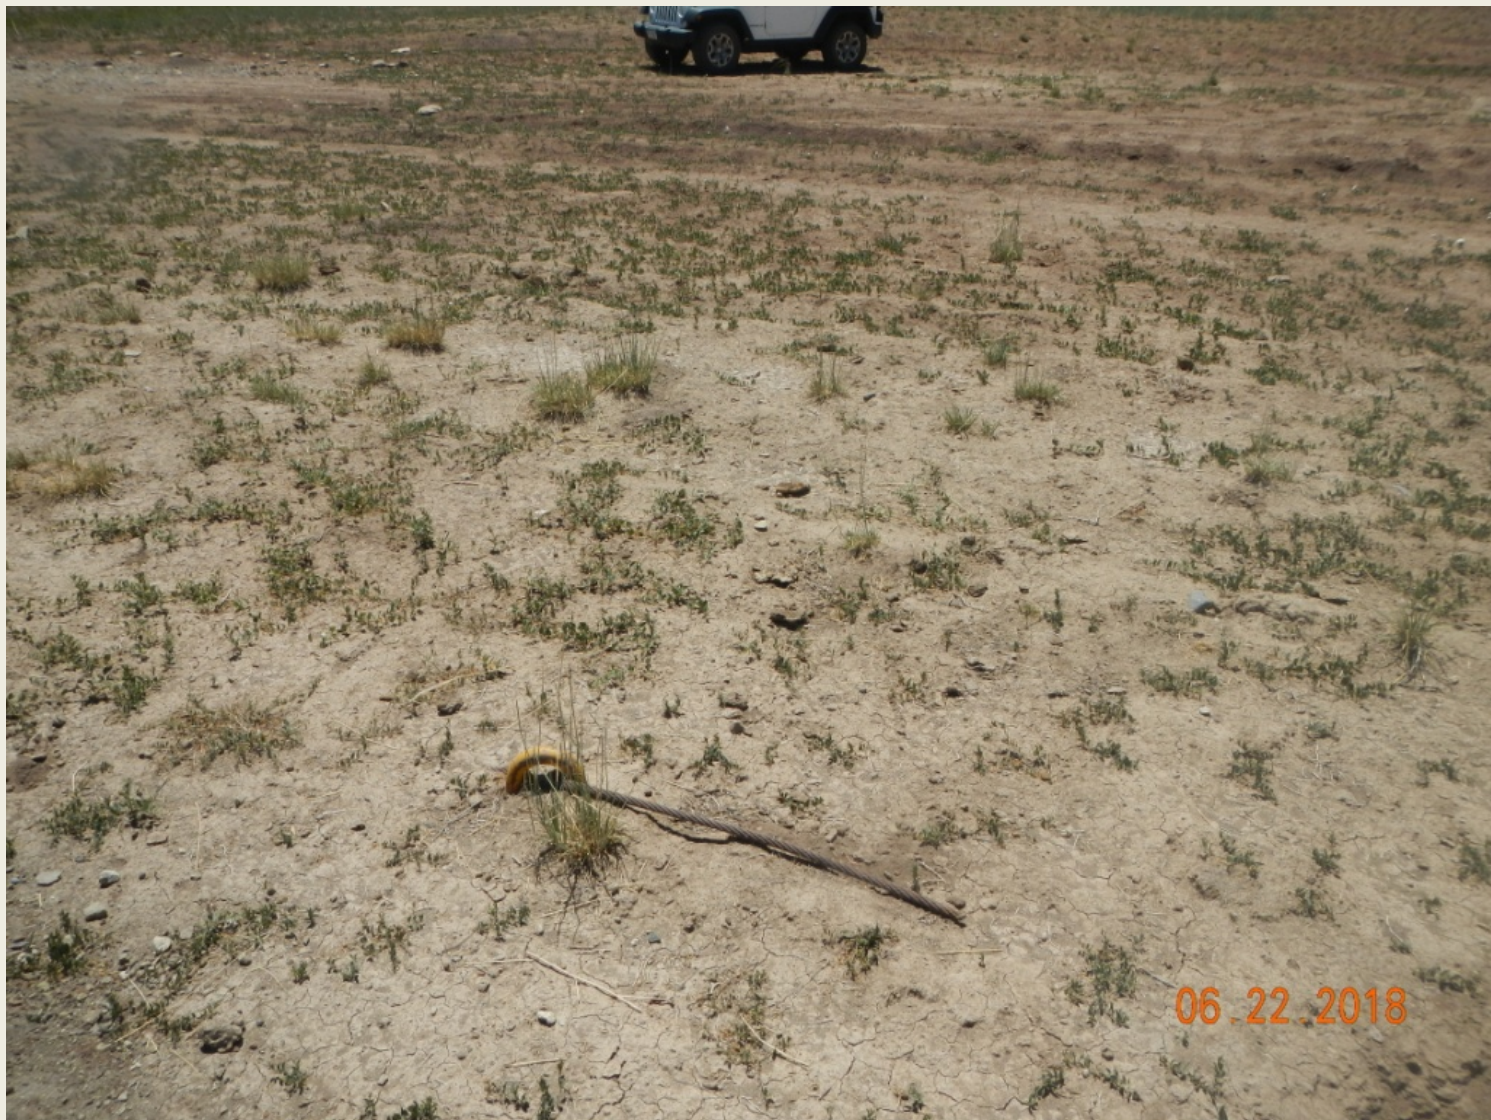
Photo 6. View of unmarked rig anchor within the project area.
