Inspection Photos
Location Name: Joker / 36-9-62
Location #: 417683

Joker 36-9-62 (API # 05-123-31719) tank battery

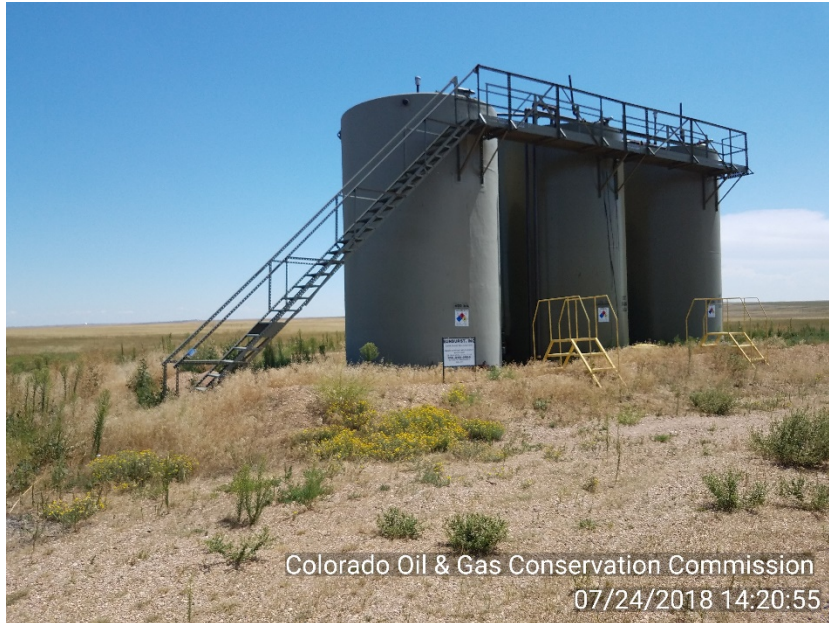
Photo #1

Stained tank, weeds

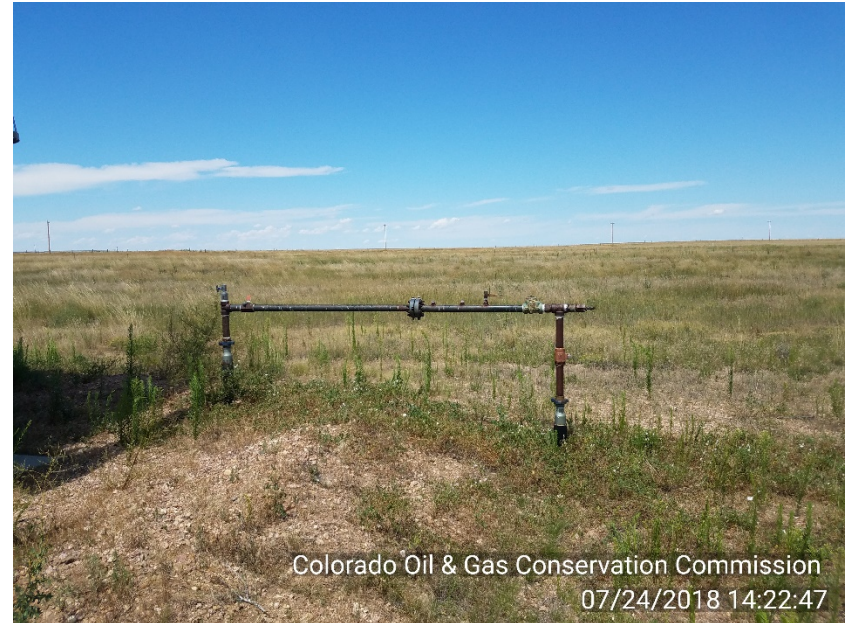
Photo #2

Joker 36-9-62 (API # 05-123-31719) Gas meter run

Weeds

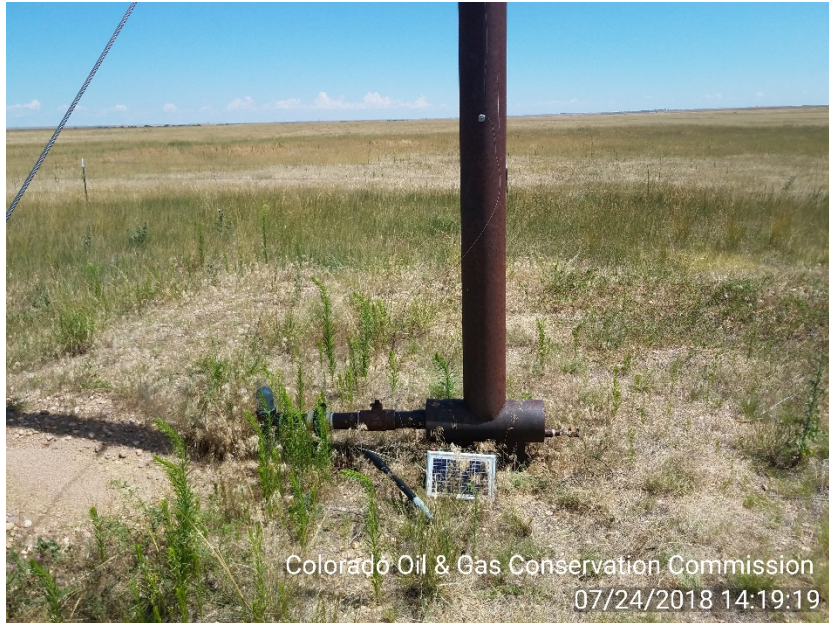
Photo #3

Joker 36-9-62 (API # 05-123-31719)
Candlestick flare battery

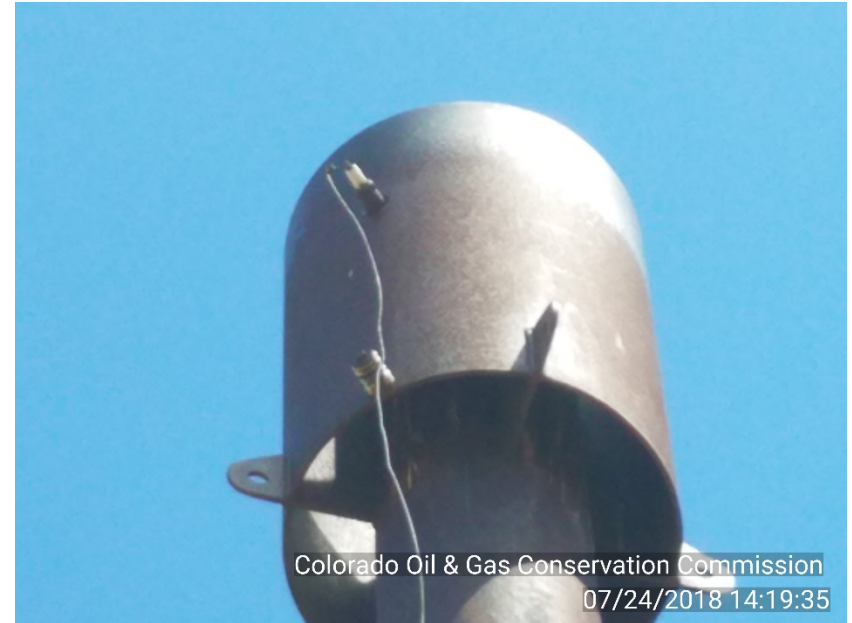
Photo #4

Joker 36-9-62 (API # 05-123-31719)
Disconnected flare ignition wire

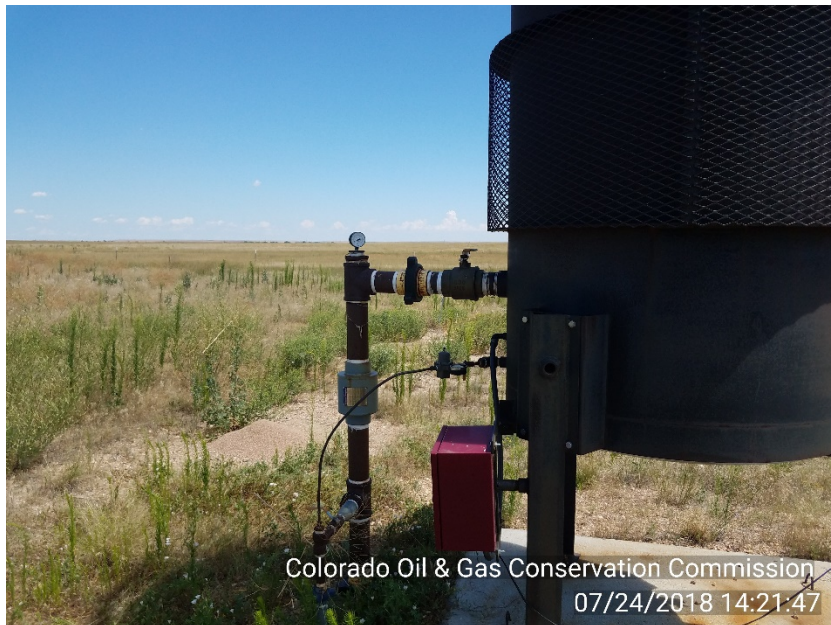
Photo #5

Joker 36-9-62 (API # 05-123-31719) ECD

Closed inlet valve

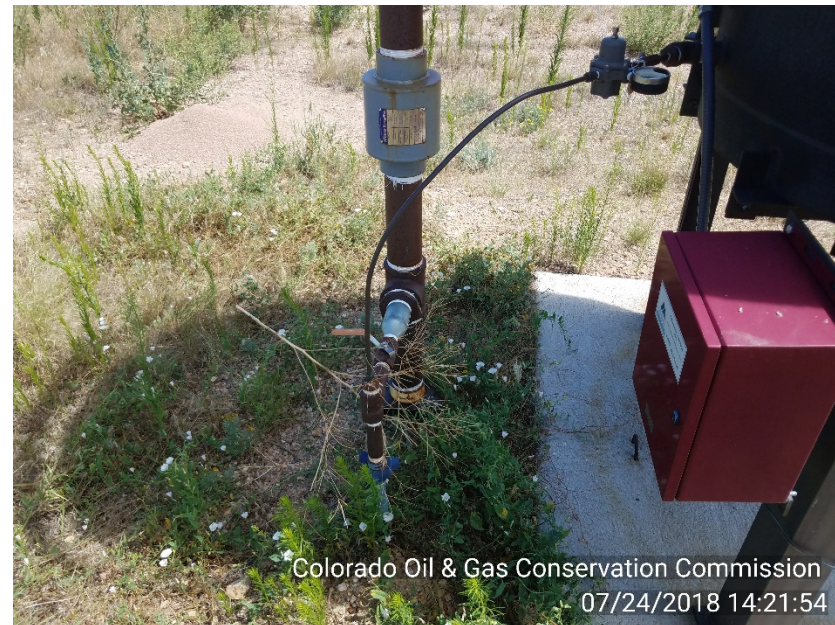
Photo #6

Joker 36-9-62 (API # 05-123-31719) ECD

Closed supply gas valve

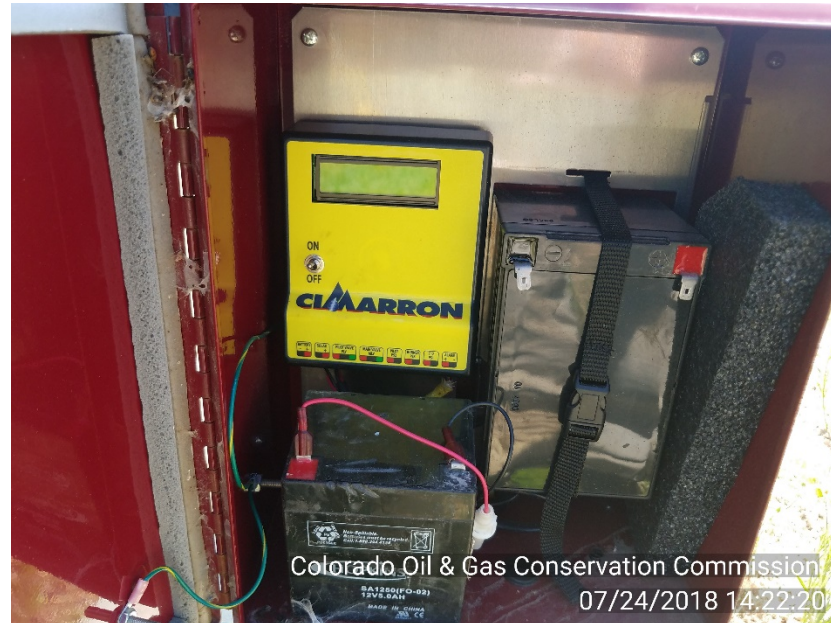
Photo #7

Joker 36-9-62 (API # 05-123-31719) ECD

Ignition Control appears to have no power
