Inspection Photos

07/31/2018

Operator: WINSLOW RESOURCES INC - 97065

Location ID: 390108

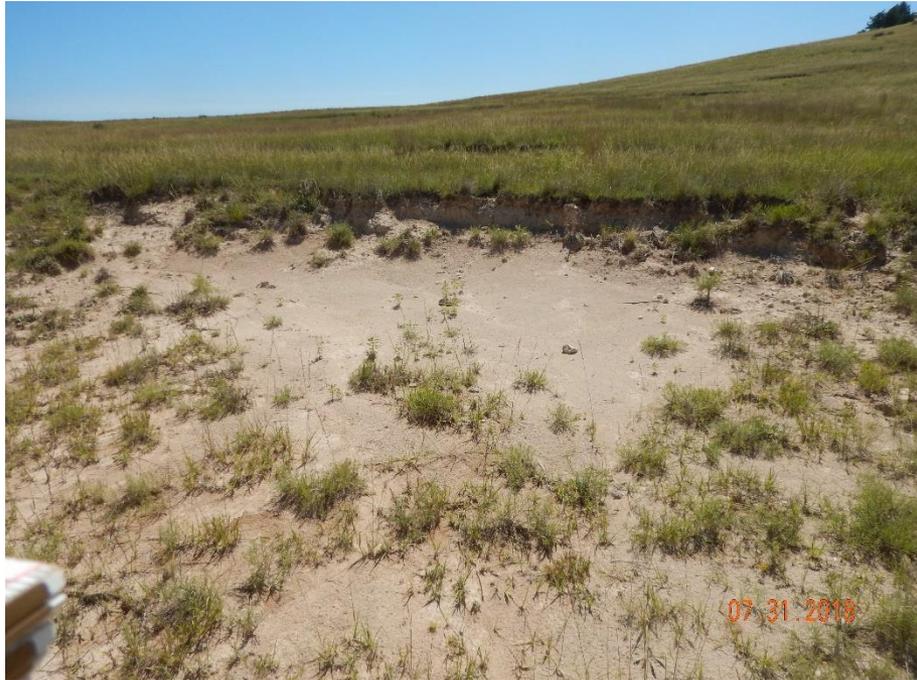
Photo 1: Photo taken from the east end of the location, facing north. Previous inspections documented that areas on the east end of the location and access road have not achieved a uniform desirable perennial vegetative cover, and stormwater has caused erosion degradation. Inspections required operator to perform reclamation and stormwater management. Photo shows no management activities per the corrective action appear to have been conducted; location/access road has not been adequately contoured/graded and re-vegetated, stormwater has continued to cause erosion degradation.

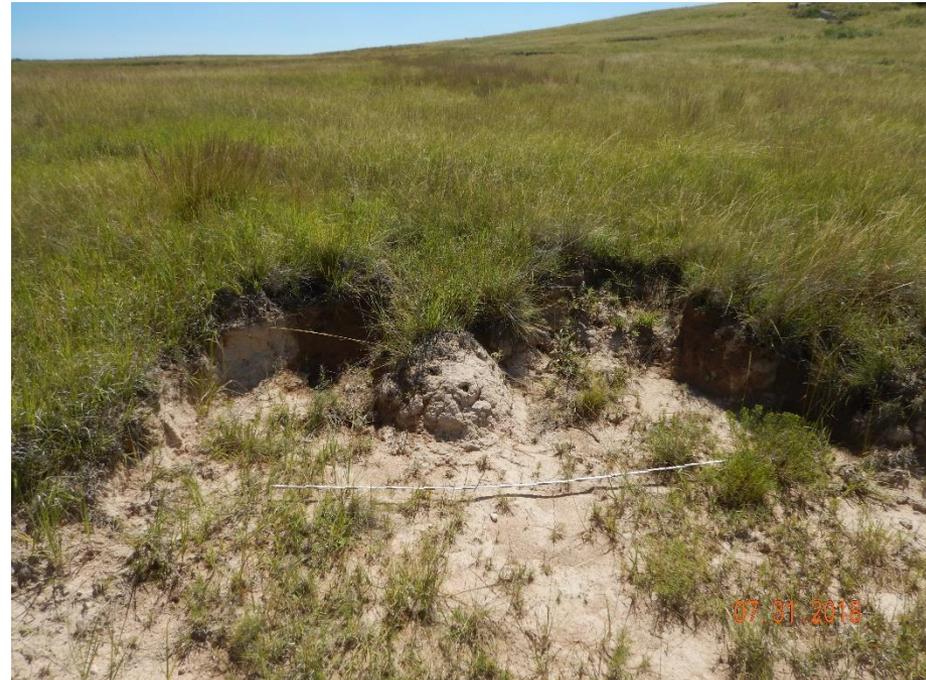
Photo 2: See comments under photo 1. 6 foot measuring stick for reference.

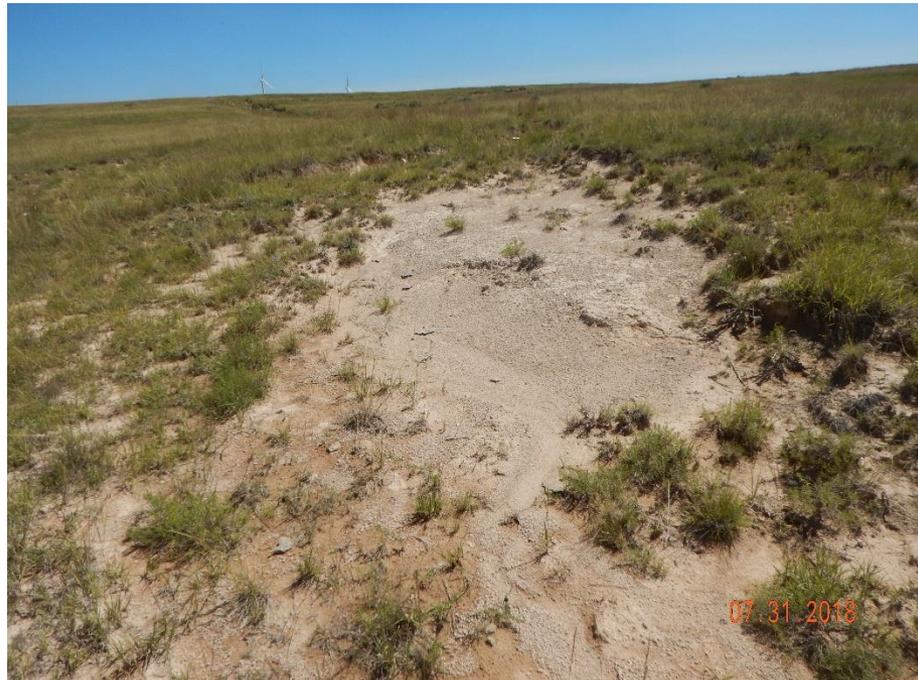
Photo 3: See comments under photo 1.

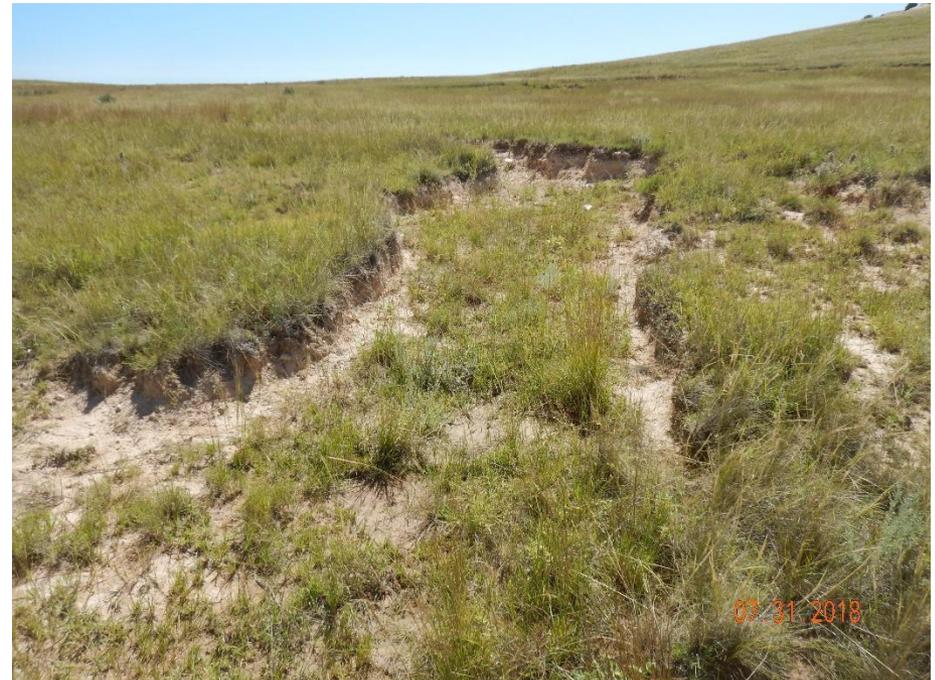
Photo 4: Photo taken from the east end of the location, facing east. Photo shows gully erosion where the access road meets location. See comments under photo 1.

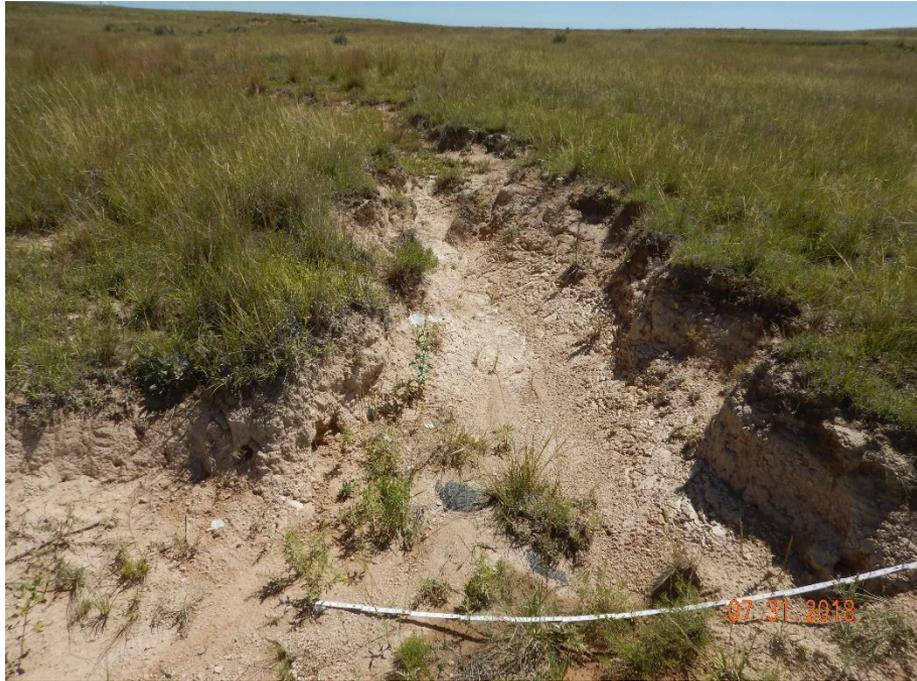
Photo 5: Photo taken from the access road, northeast of the location, facing northeast. Photo shows access road has not been recontoured/regraded to the adjacent lands and stormwater has continued to degrade and channelize the access road creating a gully. 6 foot measuring stick for reference.

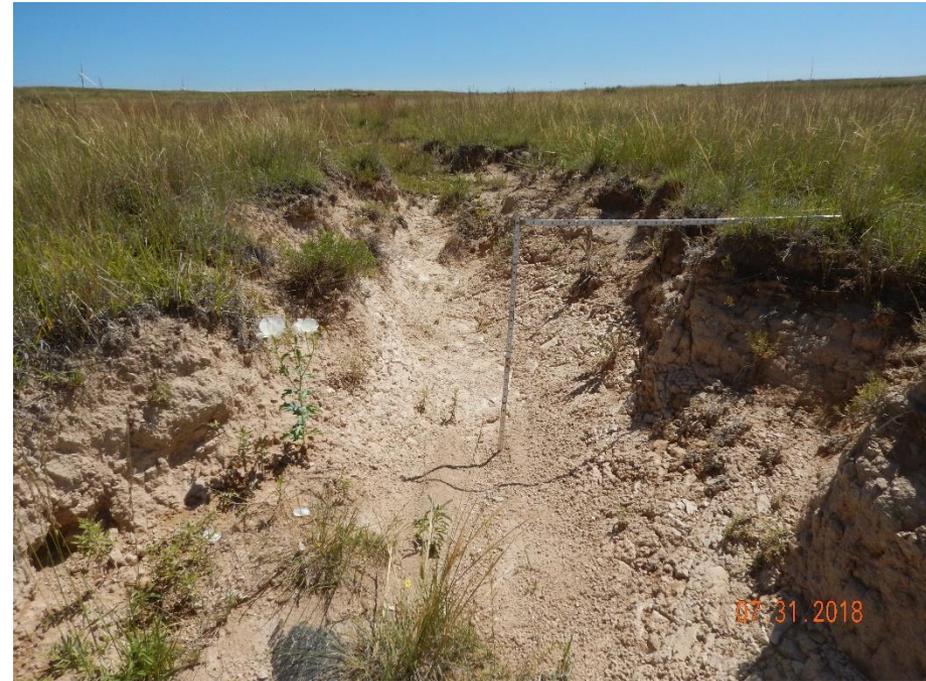
Photo 6: See comments under photo 5. Photo shows gully is ~2.5 feet deep.

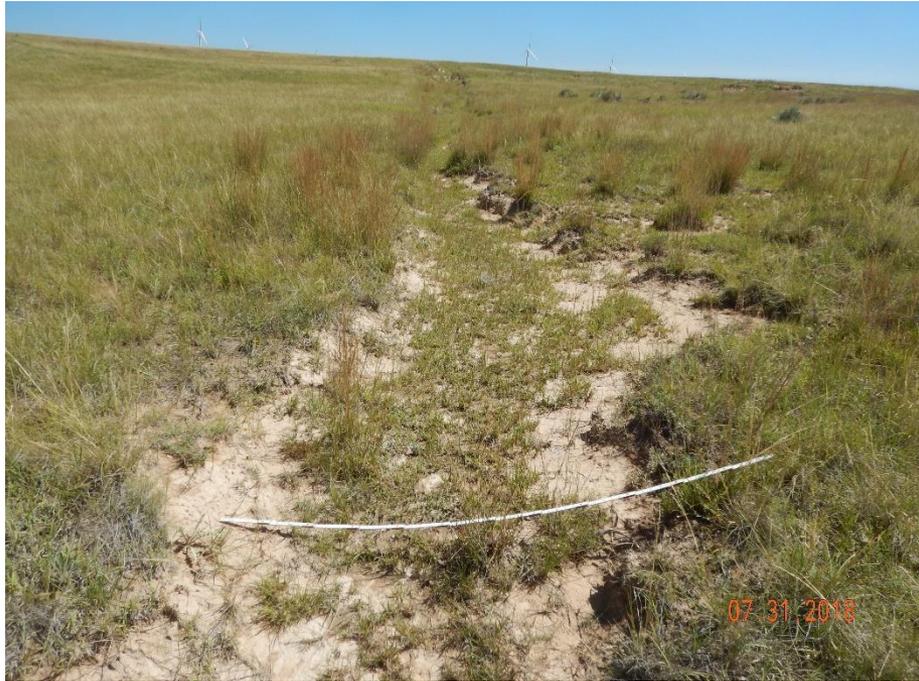
Photo 7: See comments under photo 5. 6 foot measuring stick for reference.

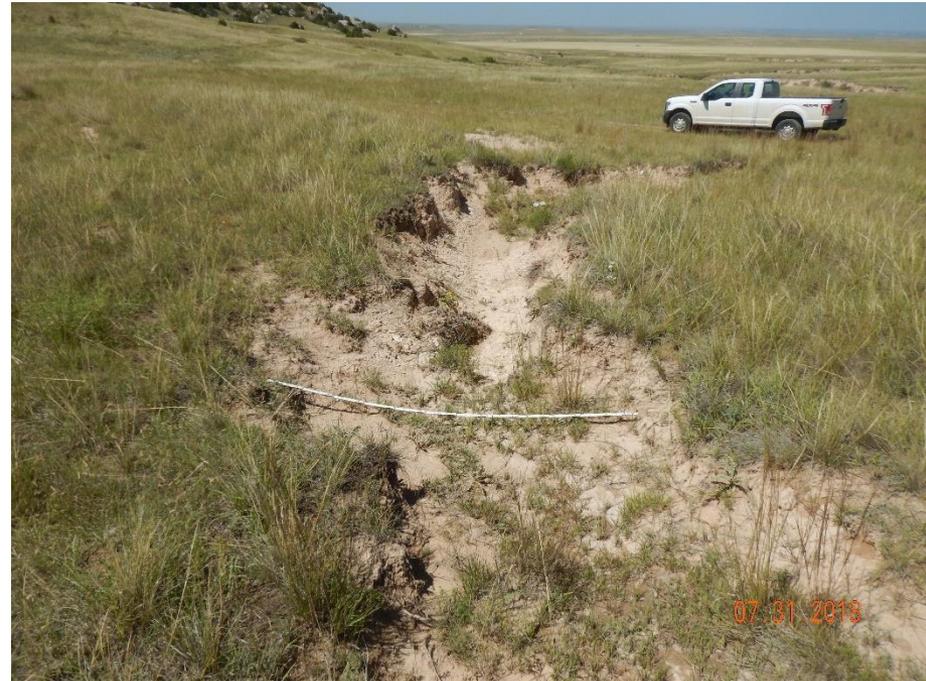
Photo 8: Photo taken from the access road, east of the location, facing southwest. See comments under photo 5. 6 foot measuring stick for reference.

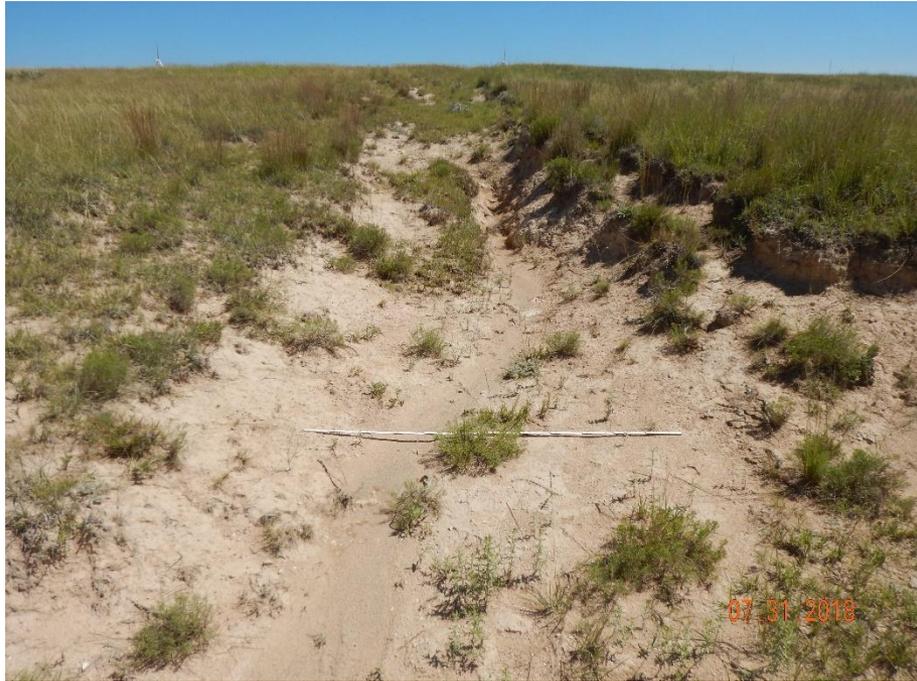
Photo 9: Photo taken from the access road, northeast of the location, facing northeast. See comments under photo 5. 6 foot measuring stick for reference.

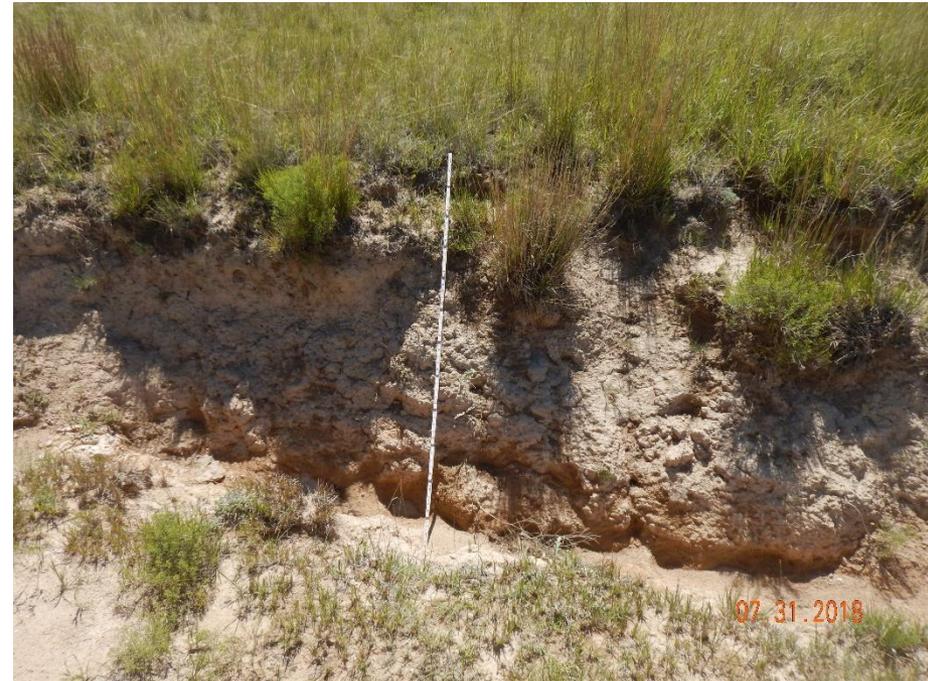
Photo 10: Photo taken from the access road. Photo shows 6 foot measuring stick. Photo shows stormwater erosion degradation has incised to a depth of almost 6 feet in areas of the access road

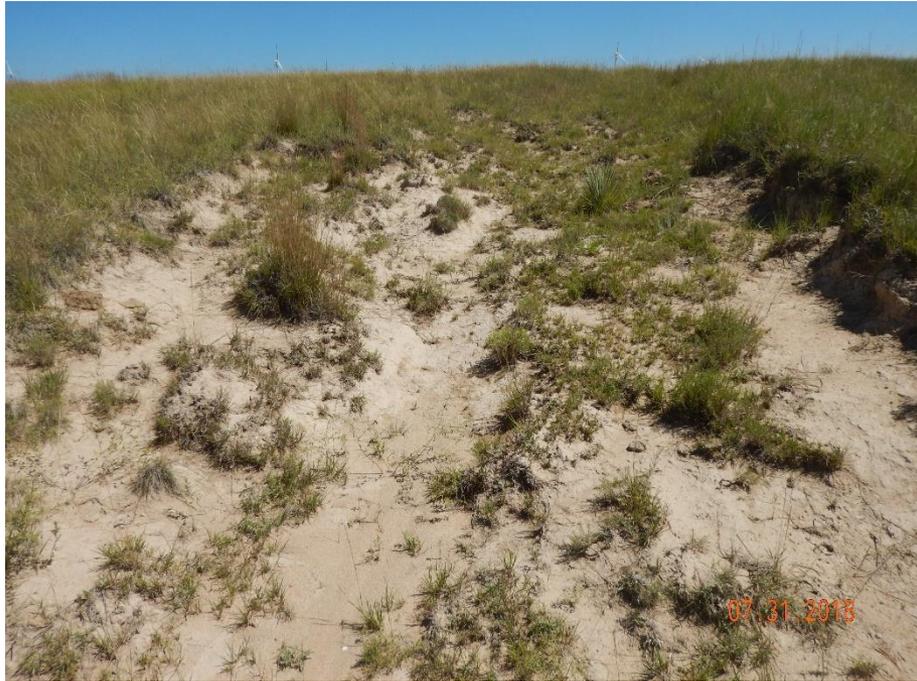
Photo 11: Photo taken from the access road, northeast of the location, facing northeast. See comments under photo 5

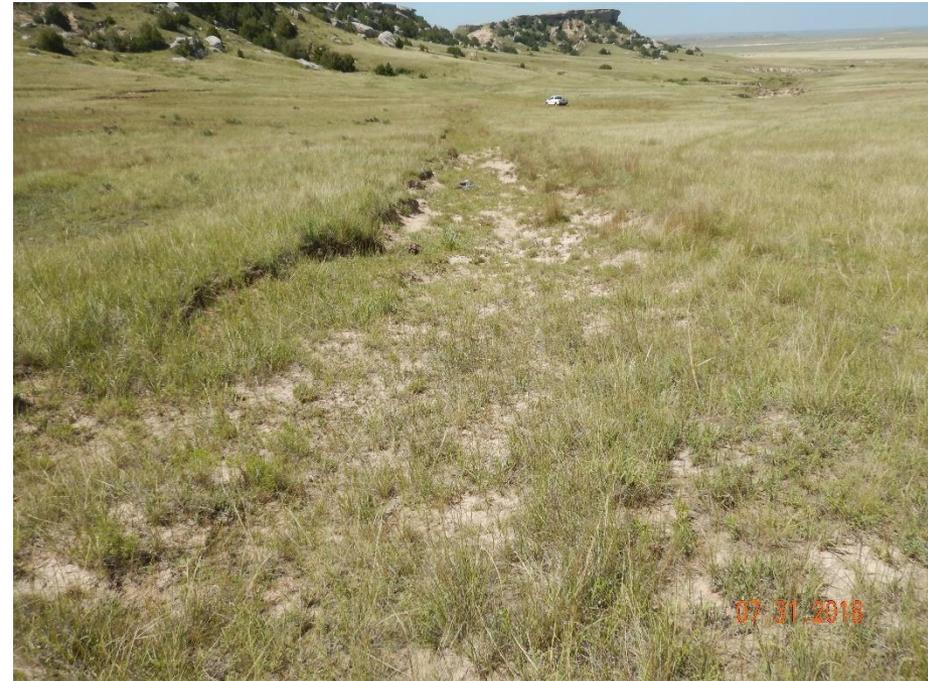
Photo 12: Photo taken from the access road, northeast of the location, facing southwest. See comments under photo 5.

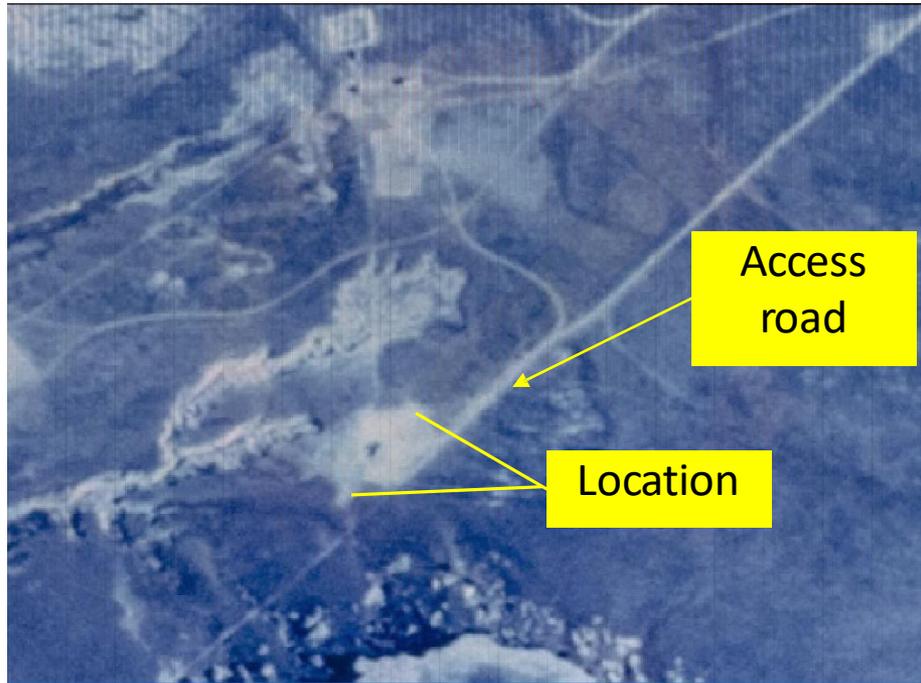
Photo 13: 1985 Aerial imagery Well was PA in 1987. Photo shows the active location and access road

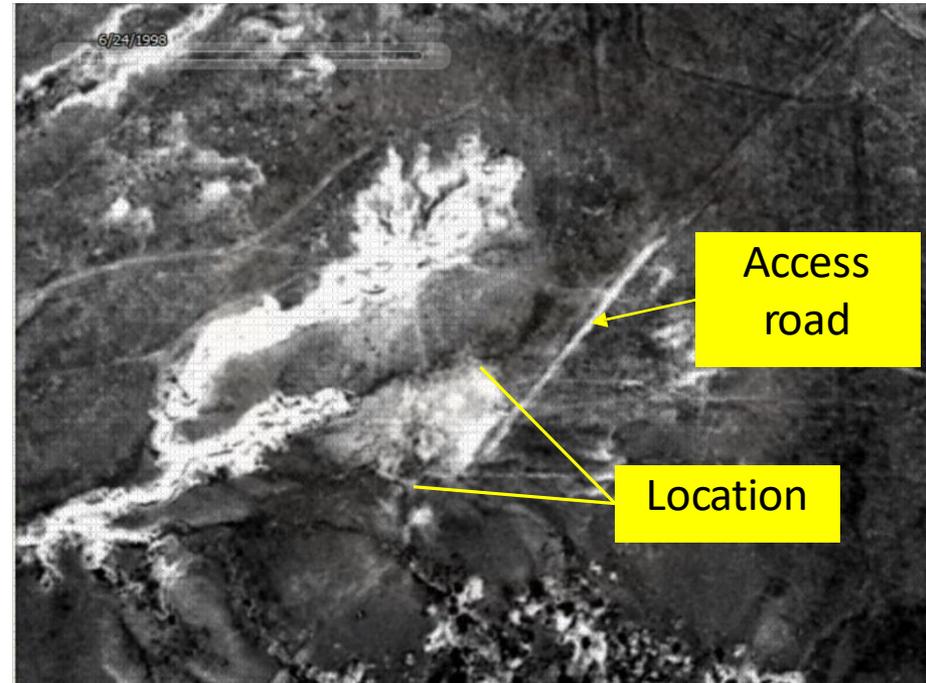
Photo 14: 1998 aerial imagery PA in 1987. Photo shows location and access road remains evident 11 post plugging and abandonment.

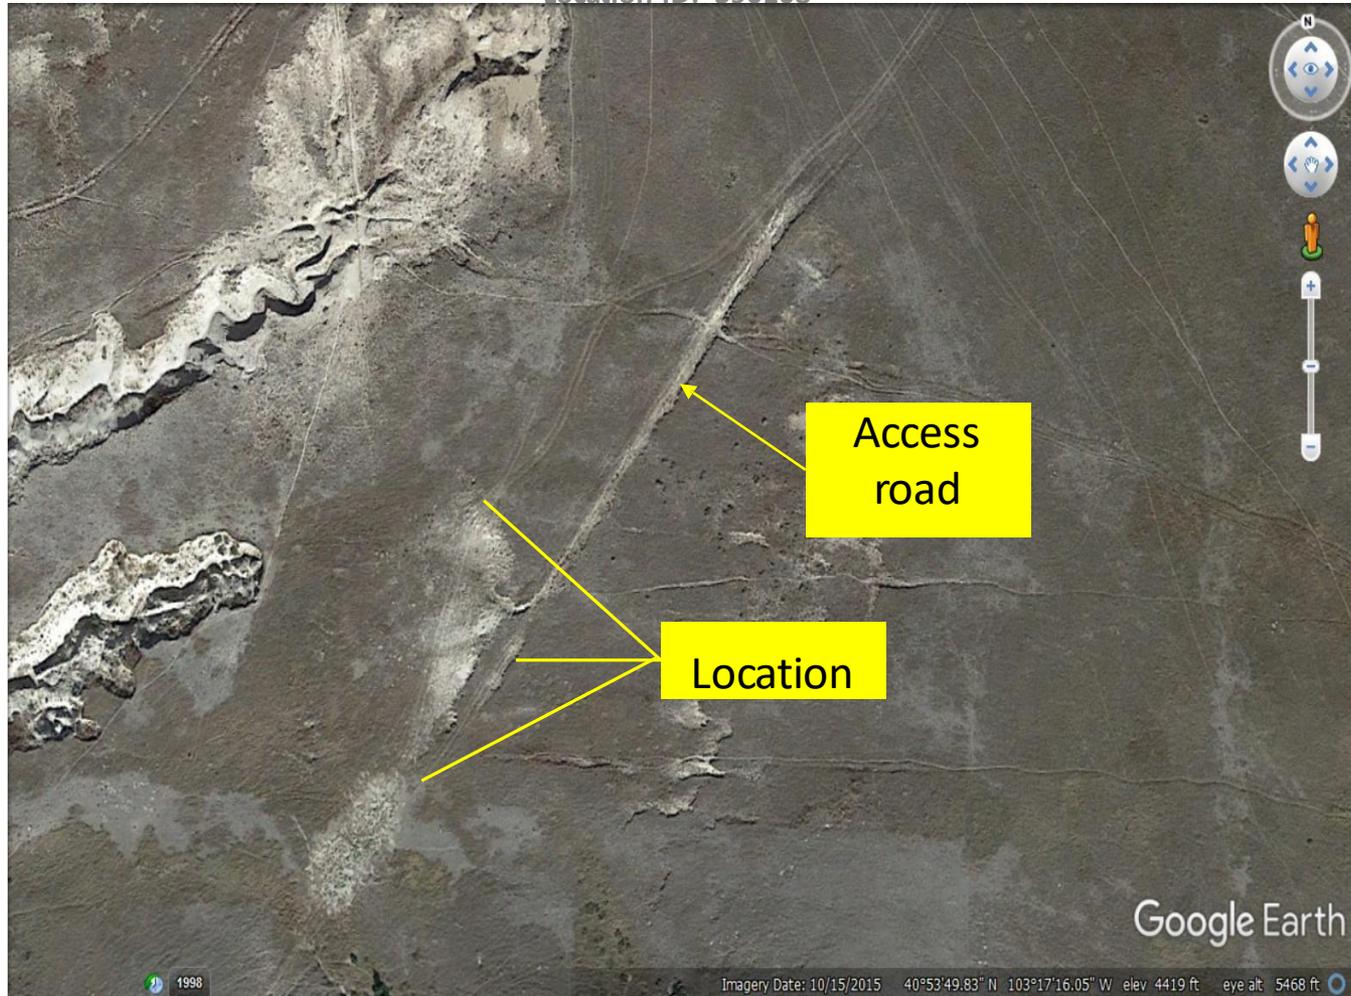
Photo 15: Current available aerial imager (2015). Photo shows access road and well location.
