Inspection Photos

06/19/2018

Operator: ABILENE PERFECT ENERGY JV LLC -
10581

Inspection Doc. Number: 682503510
Lincoln County, CO

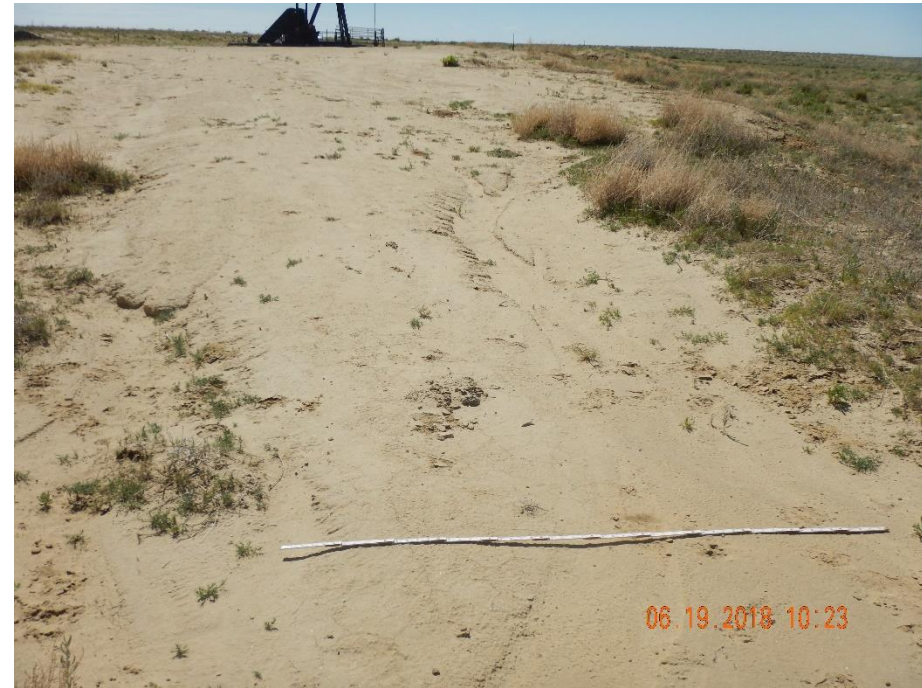
Photo 2: Photo taken from the access road on the north end of the location, facing north. Photo shows stormwater erosion has continued to degrade the location. 6 foot measuring stick for reference.

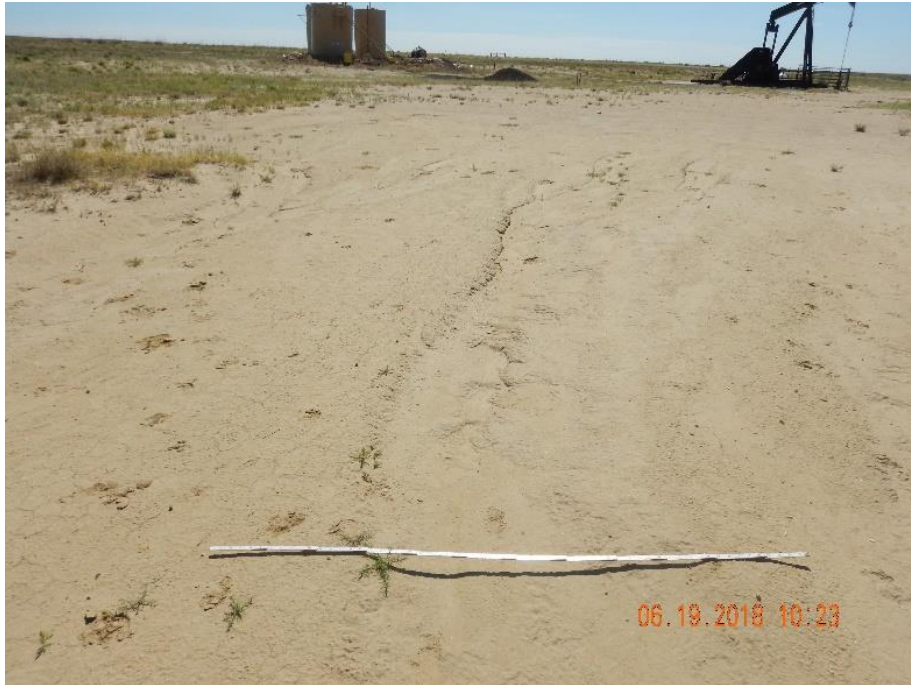
Photo 3: Photo taken from the access road on the north end of the location, facing north. Photo shows stormwater erosion has continued to degrade the location. 6 foot measuring stick fore reference.

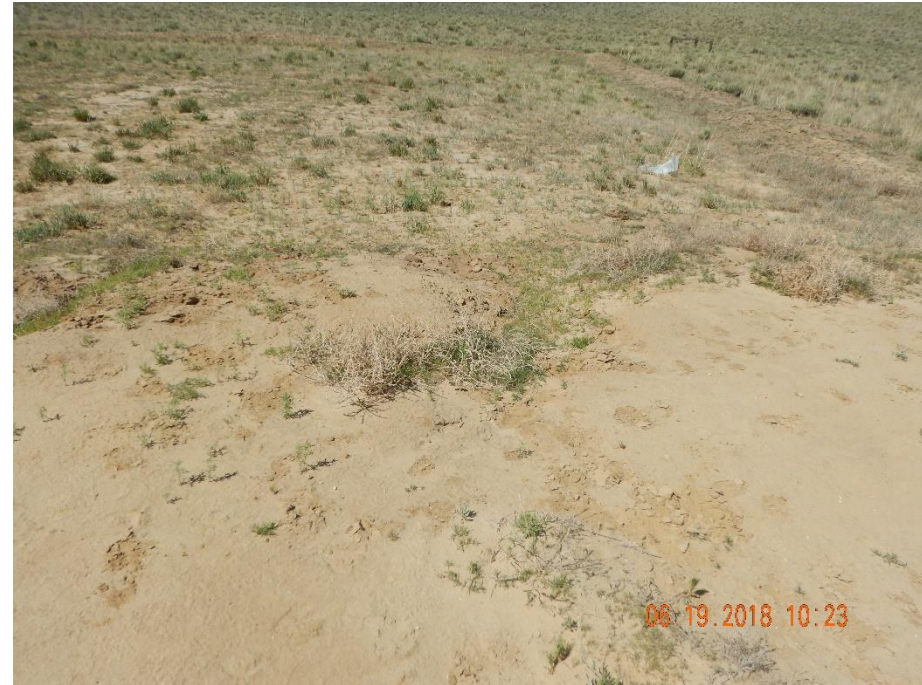
Photo 4: Photo taken from the access road on the north end of the location, facing north. Photo shows stormwater erosion has continued to degrade the location. 6 foot measuring stick fore reference.

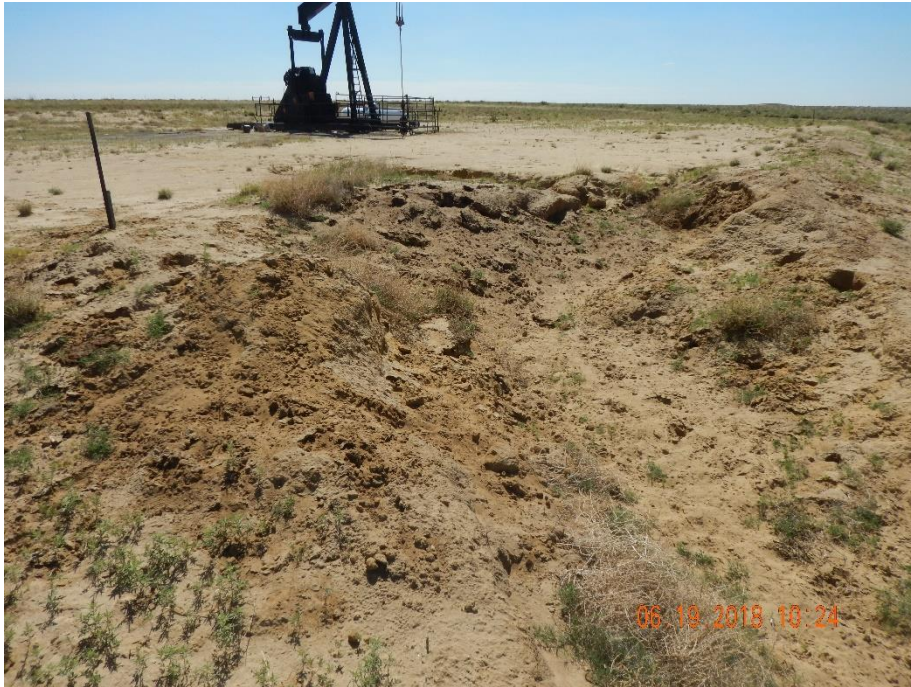
Photo 5: Photo taken from the northwest end of the production area, facing south. Photo shows stormwater erosion has continued to degrade the location. The large gully has continued to expand. 6 foot measuring stick fore reference.

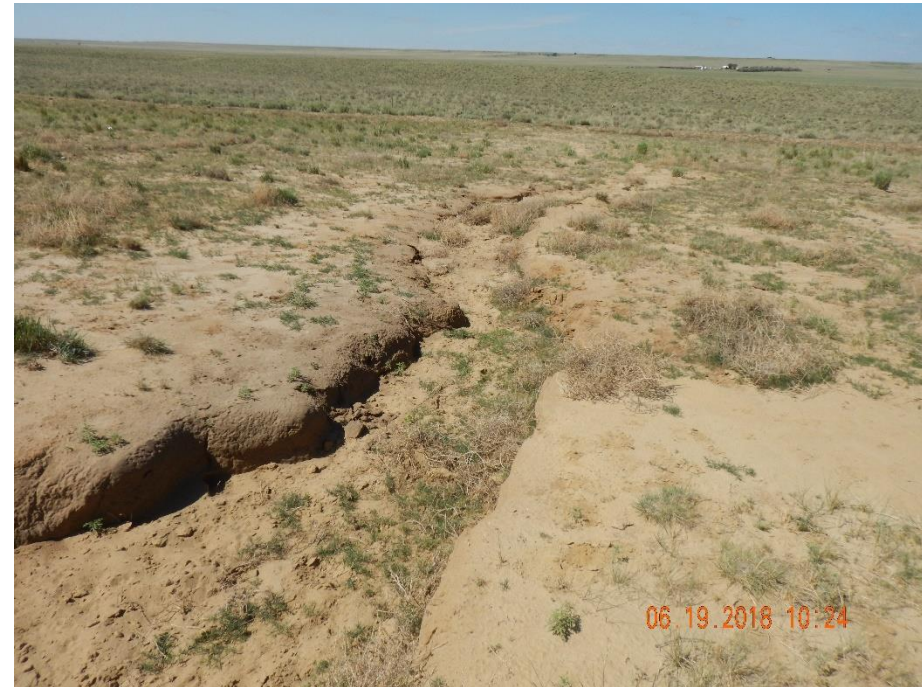
Photo 6: Photo taken from the large gully on northwest end of the production area, facing west. Photo shows erosion degradation has continued to expand and degrade both the production and interim area.

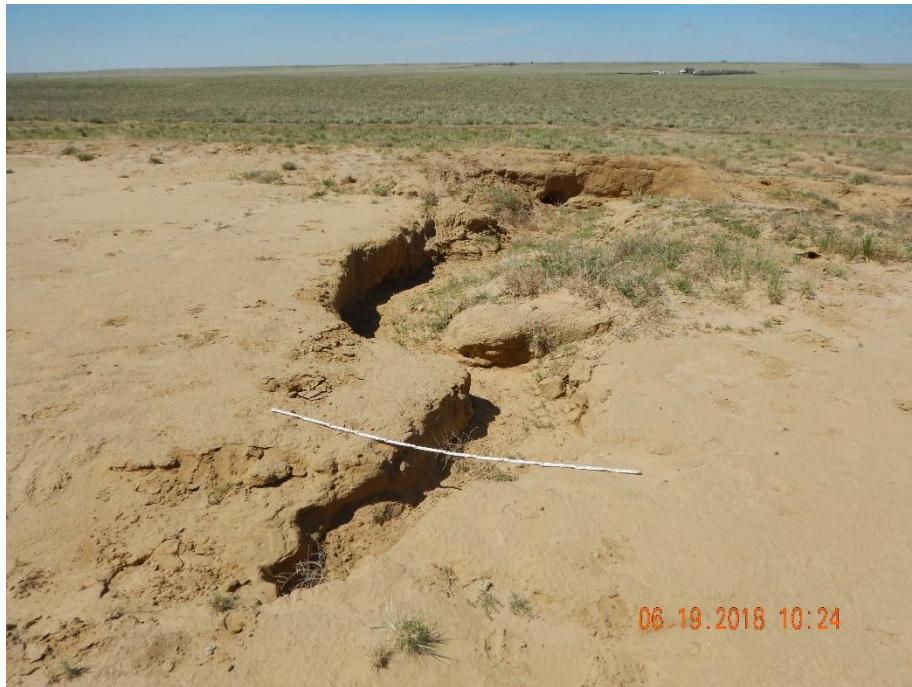
Photo 7: Photo taken from the large gully on northwest end of the production area, facing west. Photo shows erosion degradation has continued to expand and degrade both the production and interim area. 6 foot measuring stick for reference

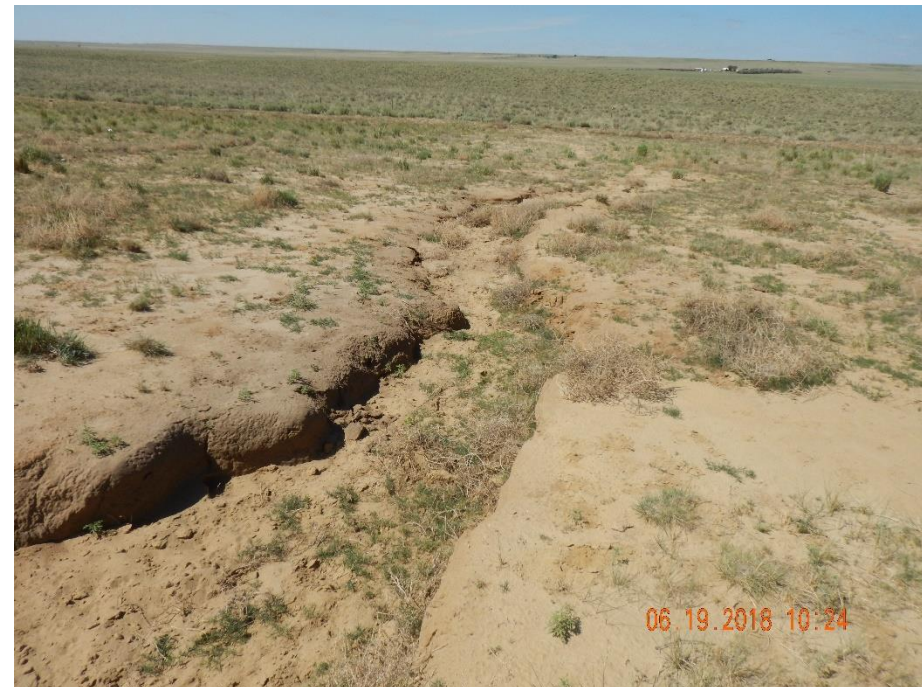
Photo 8: Photo taken from the large gully on northwest end of the production area, facing west. Photo shows erosion degradation has continued to expand and degrade both the production and interim area.

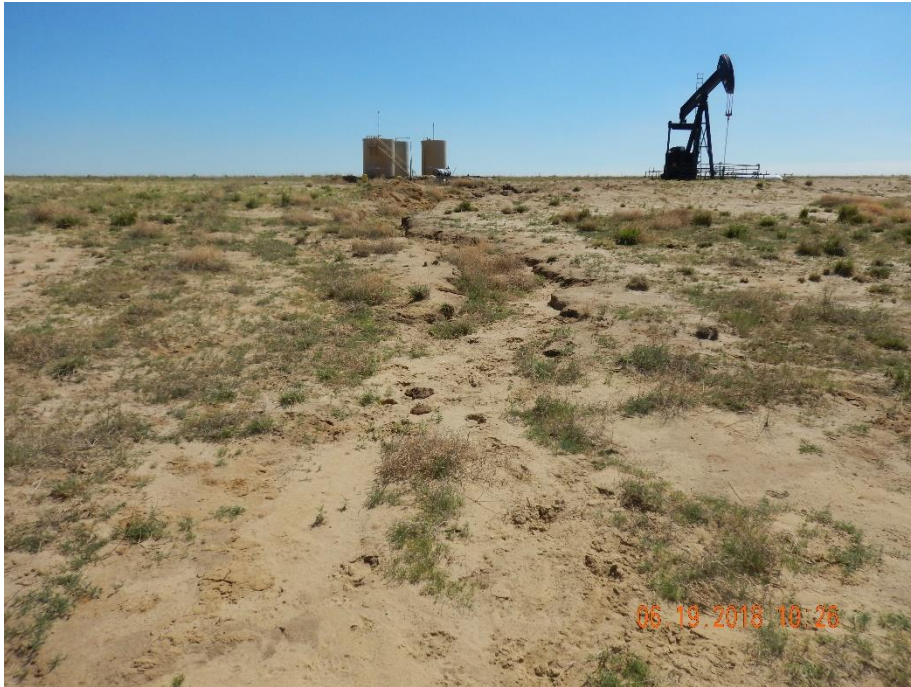
Photo 9: Photo taken from interim areas on the west end of the location, facing east. Photo shows erosion degradation has continued to expand and degrade both the production and interim area.

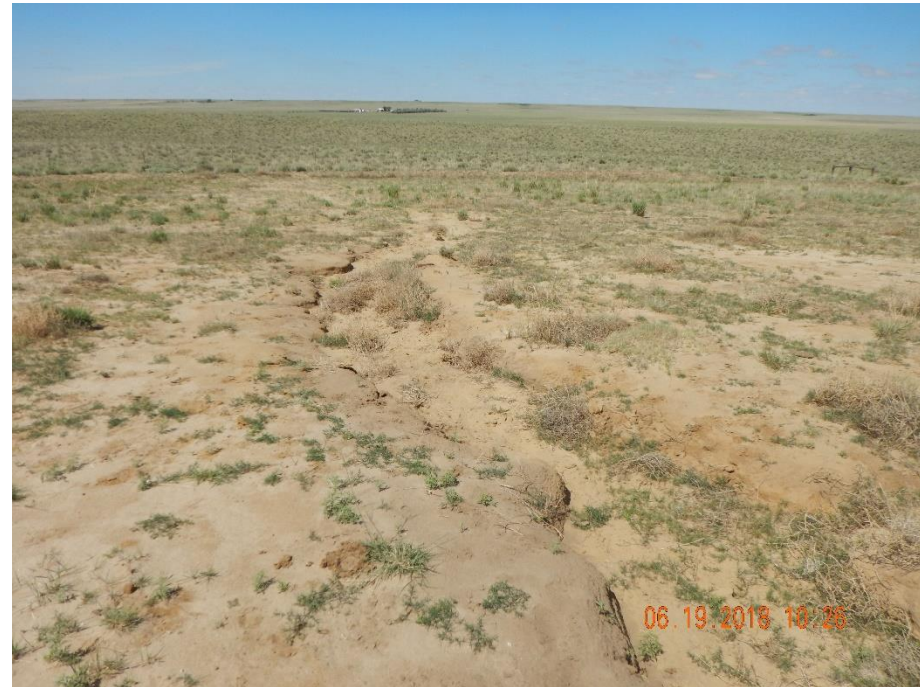
Photo 10: Photo taken from interim areas on the west end of the location, facing west. Photo shows erosion degradation has continued to expand and degrade both the production and interim area.

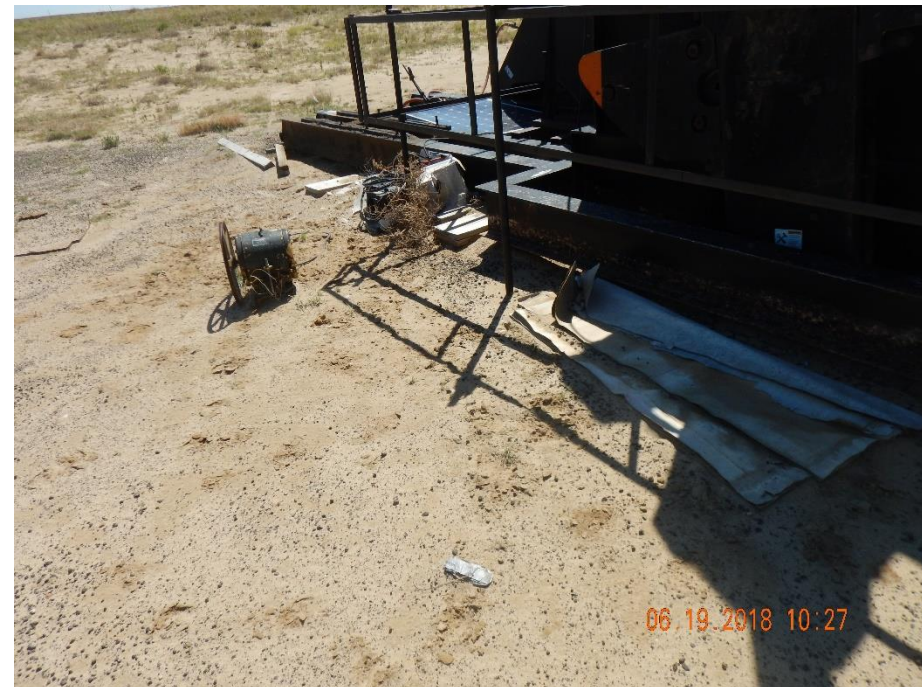
Photo 12: Photo taken from the north end of the well. Photo shows various trash debris and unused equipment strewn about the well.

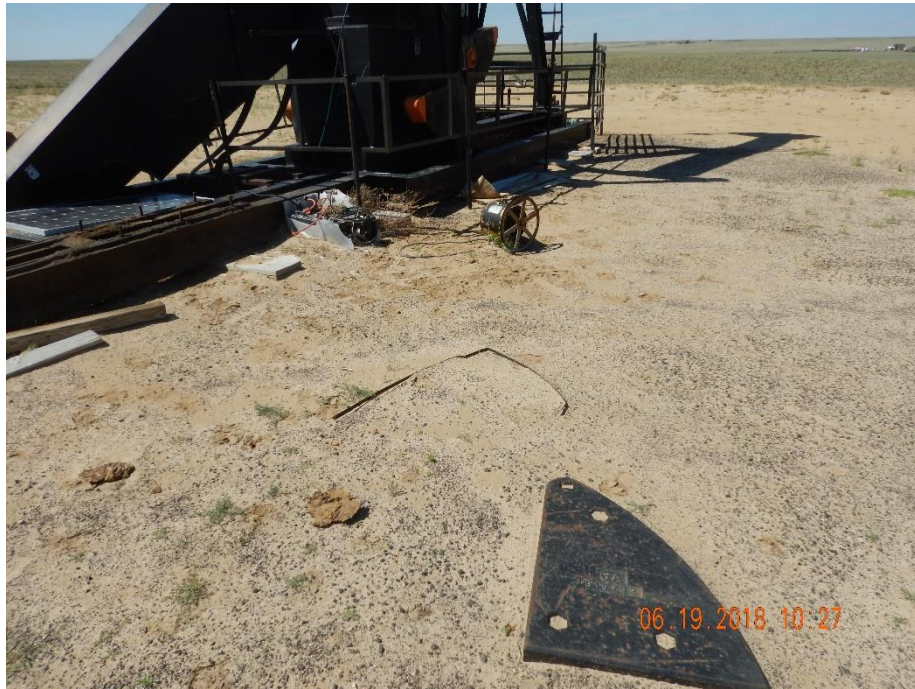
Photo 13: Photo taken from the north end of the well. Photo shows various trash debris and unused equipment strewn about the well.

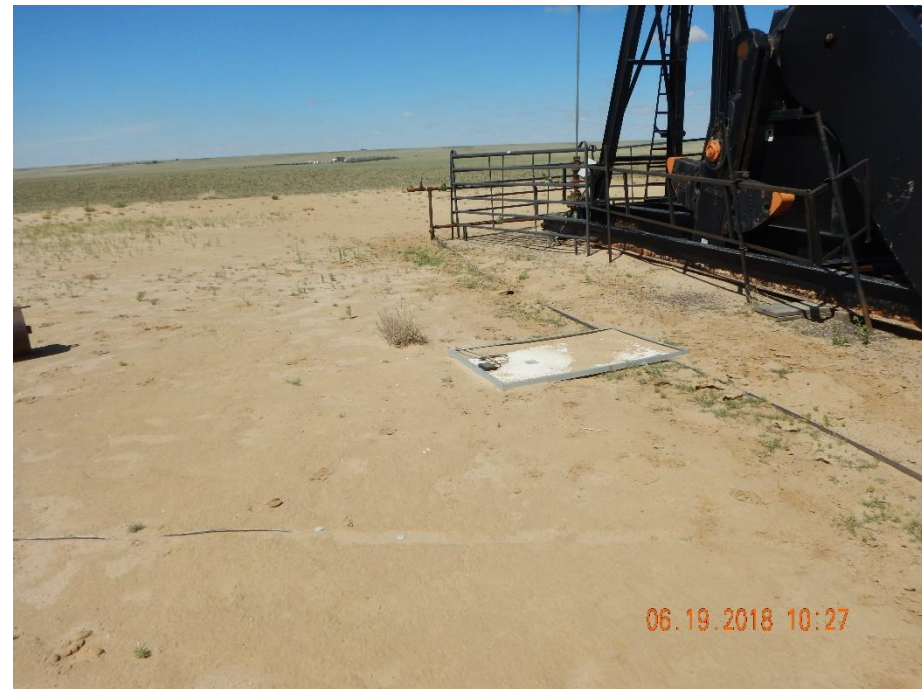
Photo 14: Photo taken from the south end of the well. Photo shows various trash debris and unused equipment strewn about the well.

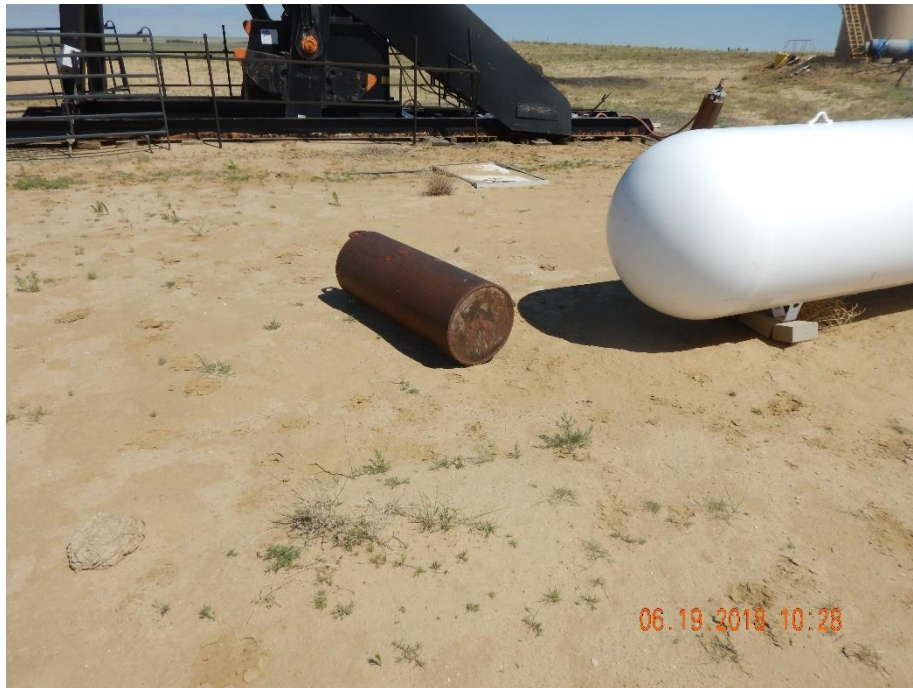
Photo 15: Photo taken from the north end of the well, facing north. Photo shows various trash debris and unused equipment strewn about the well.

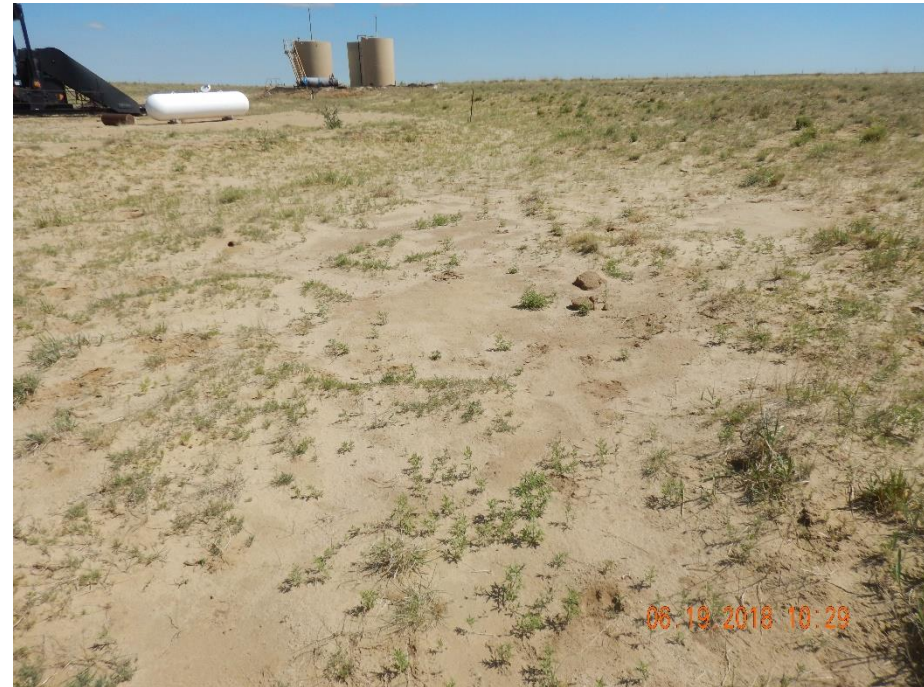
Photo 16: Photo taken from the southeast end of the tanks facing north. See comments under photo 12.

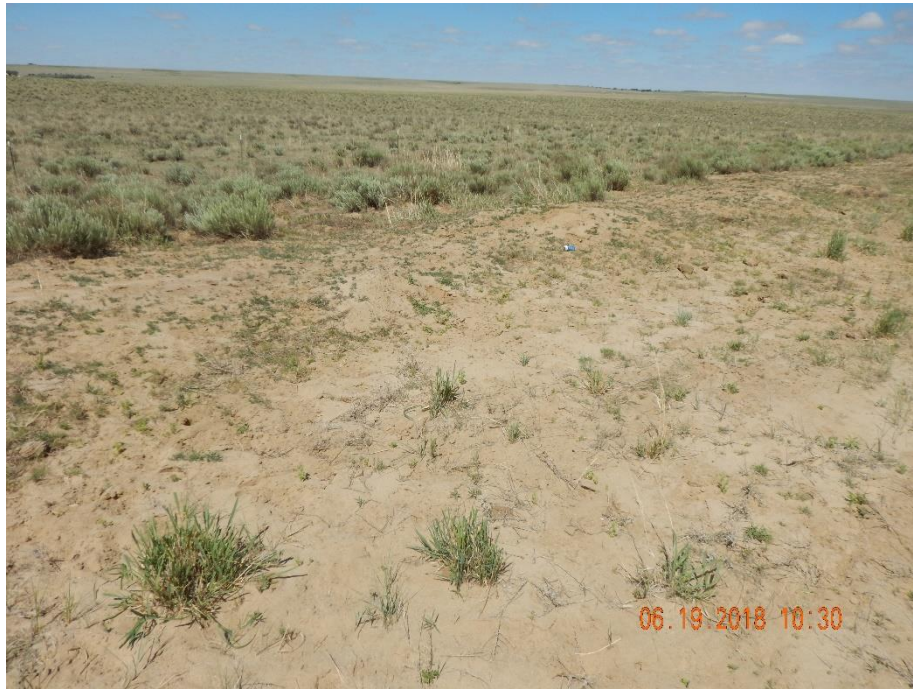
Photo 17: Photo taken from the west end of the location, facing northwest. Photo shows ditch along the perimeter of the location that has not been maintained, is no longer in proper functioning condition, and should have been reclaimed during interim reclamation.

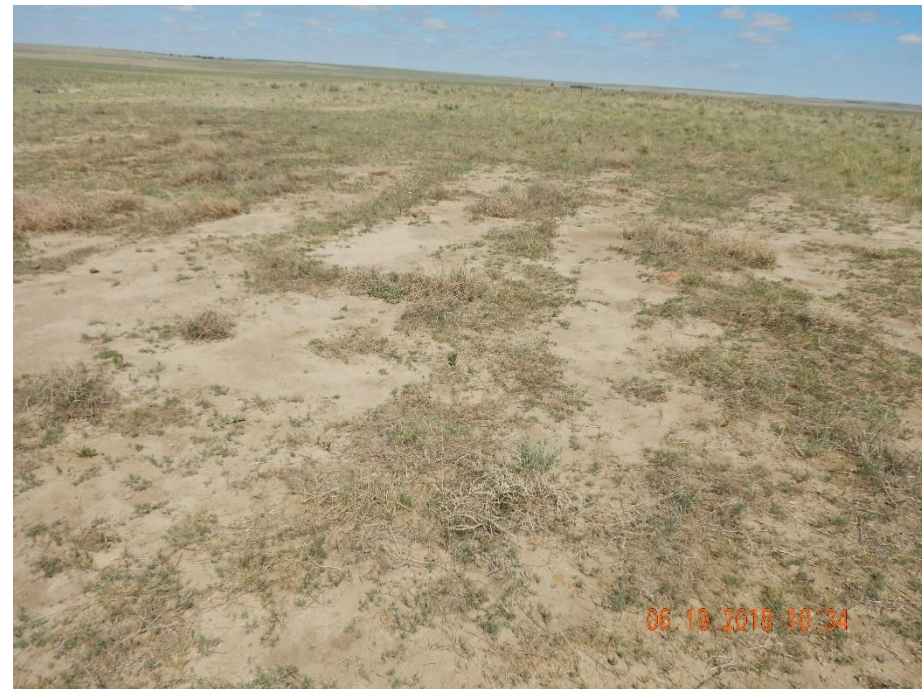
Photo 18: Photo taken from the northeast end of the interim area. Area appears to be where the pit was located. Photo shows large areas of the interim area that remains predominantly bare and exposed soil.

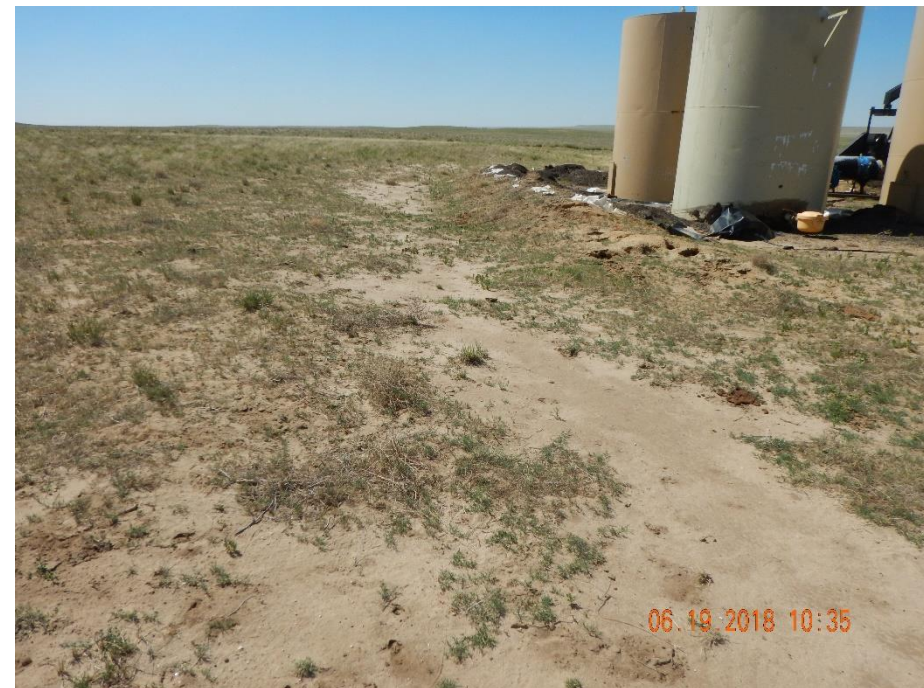
Photo 20: Photo taken from the northeast end of the interim area, facing south. Area appears to be where the pit was located. Photo shows large areas of the interim area that remains predominantly bare and exposed soil.

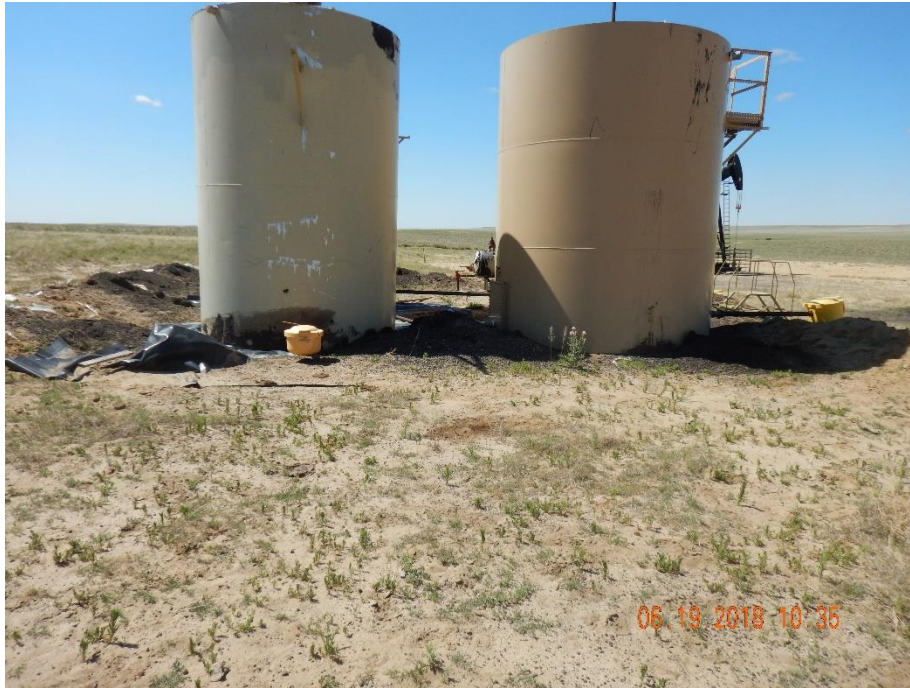
Photo 21: Photo taken from the north end of the tanks on location, facing south. Previous photos documented that the berms around the tanks were inadequate and required operator to repair or install berms, or other secondary containment devices. Photo shows berms, or other secondary containment devices have not been repaired or installed. Photo also shows incomplete signage on tanks, including NFPA diamond labeling.

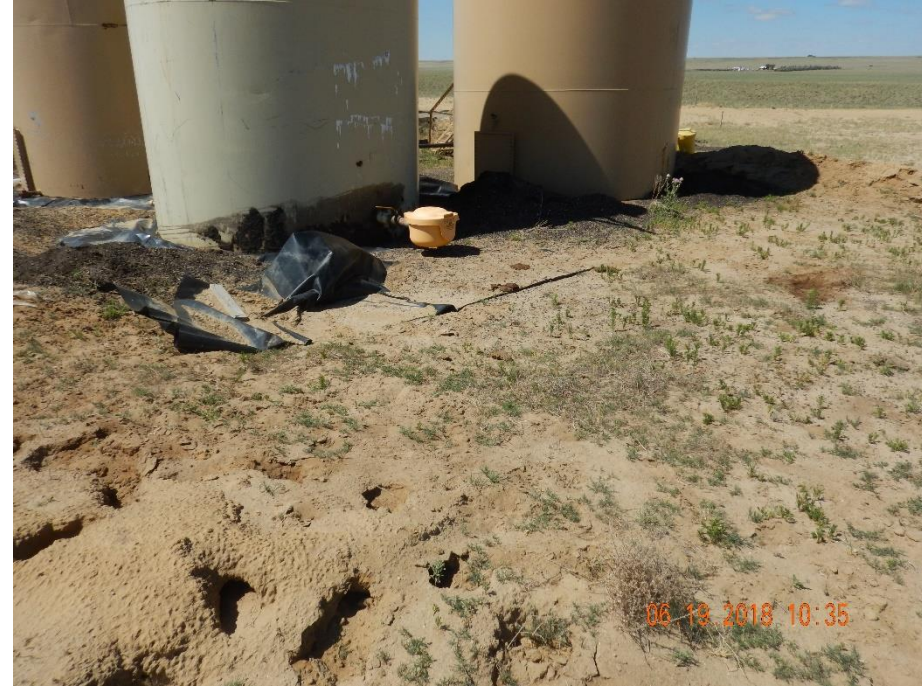
Photo 22: Photo taken from the north end of the tank battery, facing west. See comments under photo 21

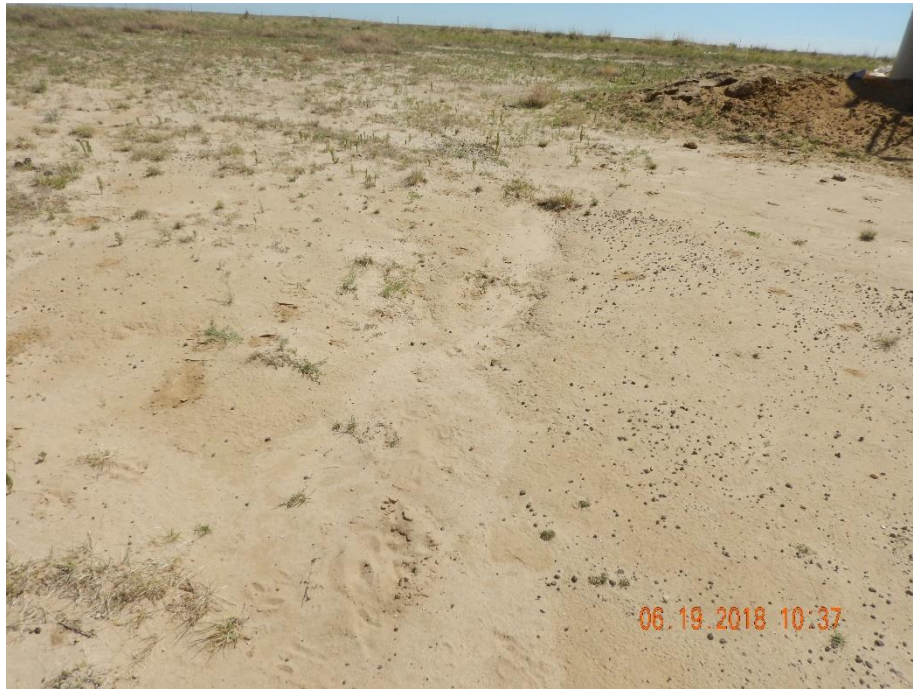
Photo 23: Photo taken from the northwest corner of the tank battery, facing east. Photo shows erosion degradation. Stormwater appears to be running off from the area of the tank battery, traveling downhill towards the location.

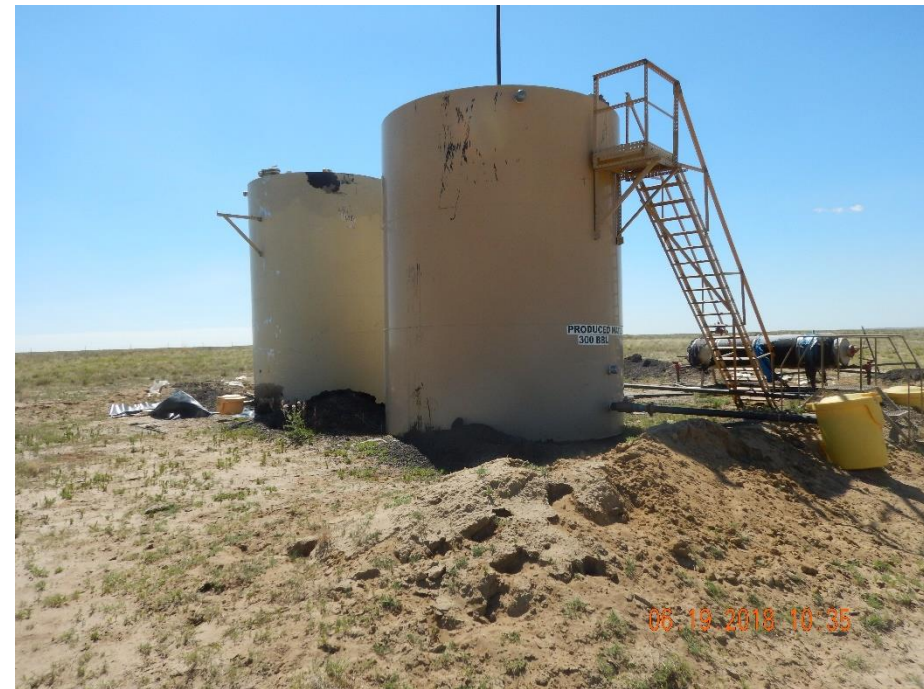
Photo 24: Photo taken from the northwest end of the tank battery, facing east. See comments under photo 21

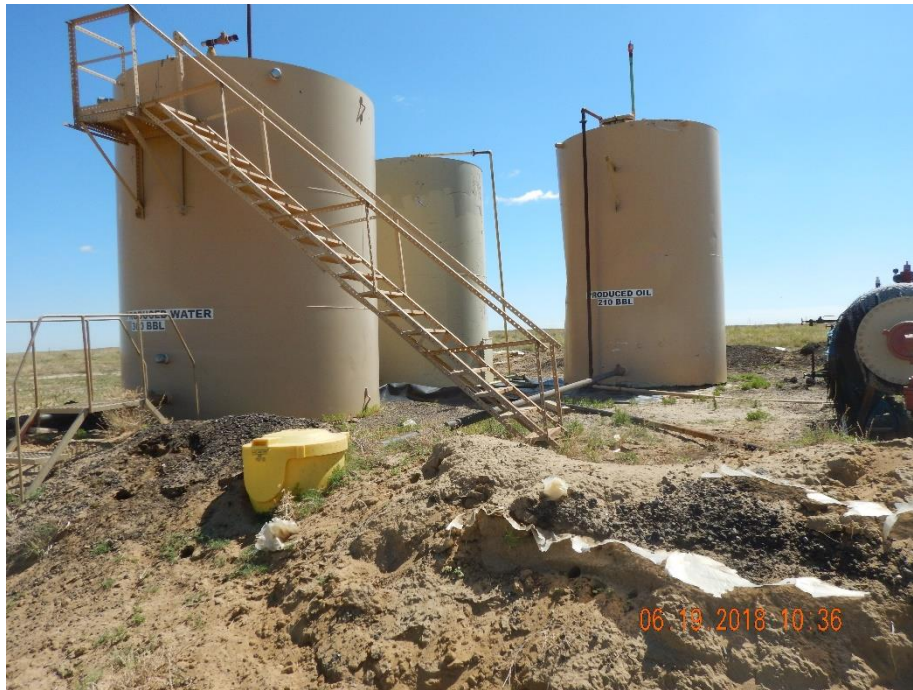
Photo 25: Photo taken from the west end of the tank battery, facing east. See comments under photo 21

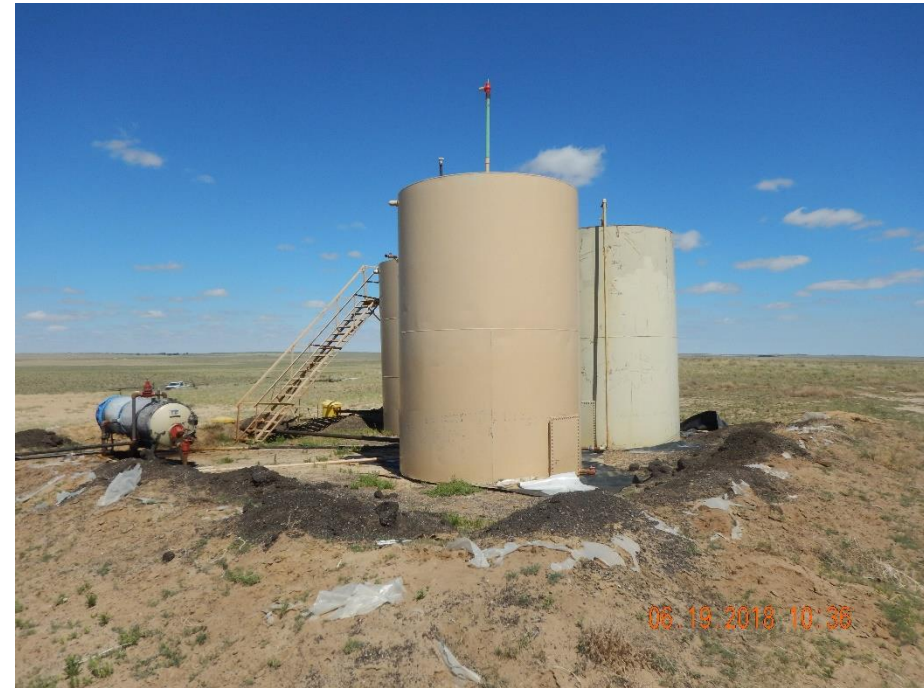
Photo 26: Photo taken from the south end of the tank battery, facing north. See comments under photo 21

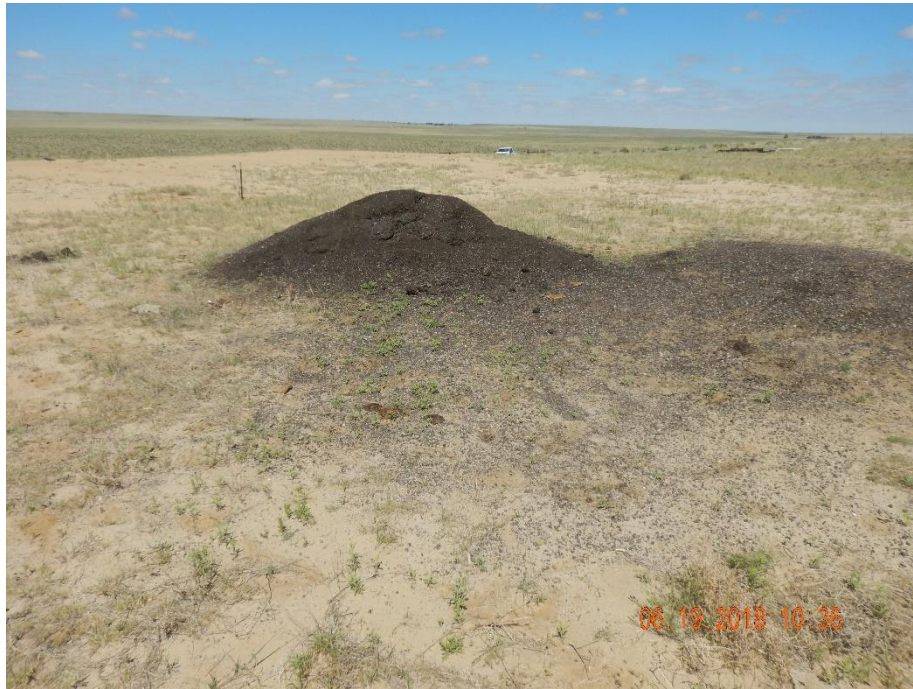
Photo 27: Photo taken from the central area of the pad, facing northwest. Previous inspections required operator to remove gravel pile from the location. Photo shows travel pile remaining.

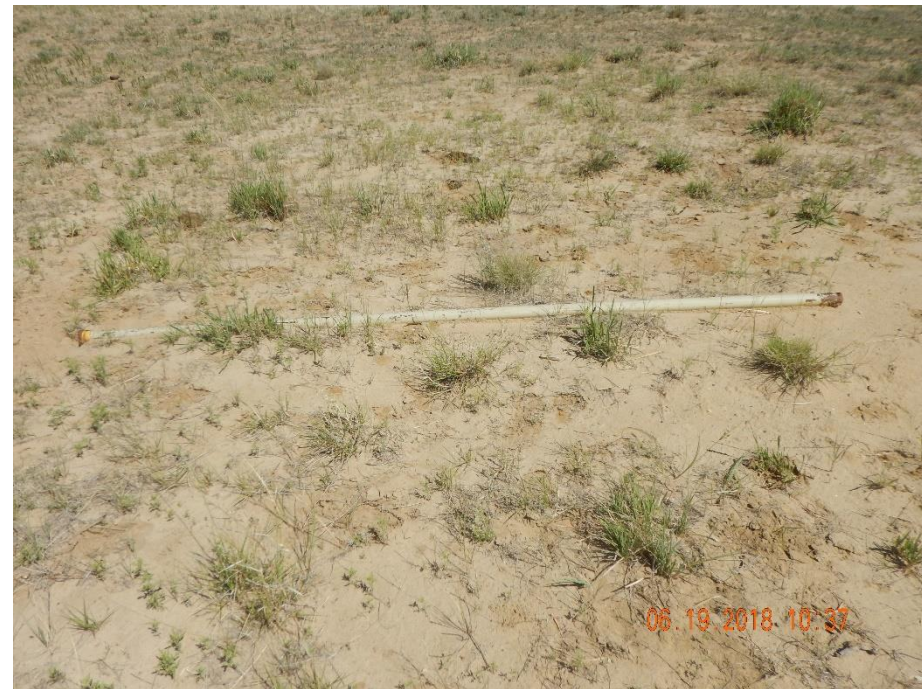
Photo 28: Photo taken from the north end of the location. Previous inspections documented various debris and unused equipment remaining on the location and required removal. Photo shows equipment/debris has not been removed.

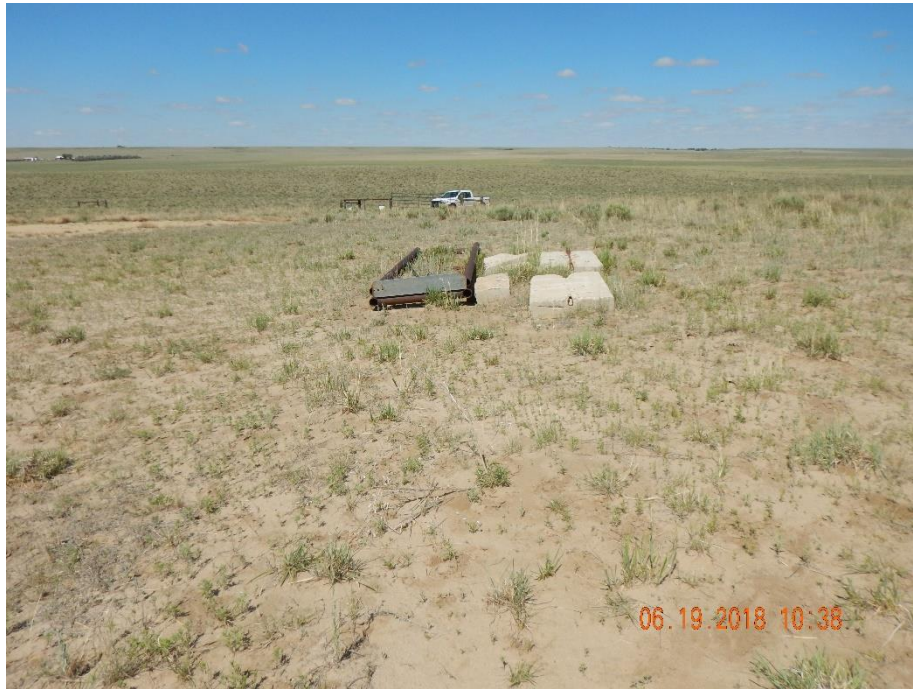
Photo 29: Photo taken from the north end of the location, facing north. Previous inspections documented various debris and unused equipment remaining on the location and required removal. Photo shows equipment/debris has not been removed.

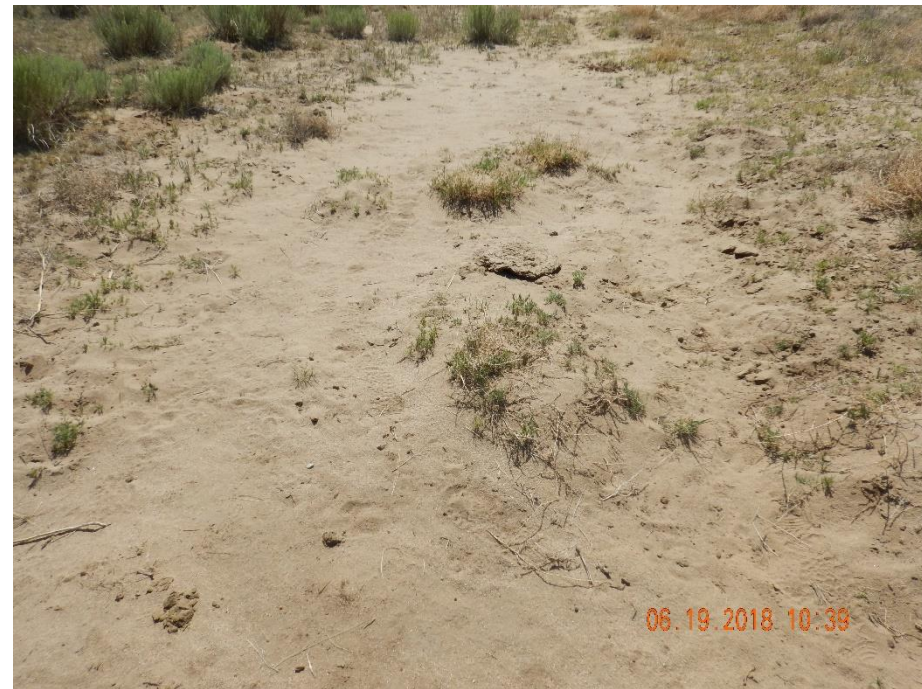
Photo 30: Photo taken from the access road. Photo shows pedestal formations due to stormwater degradation. Pedestals form when stormwater erodes away un-stabilized areas of soil around vegetation.

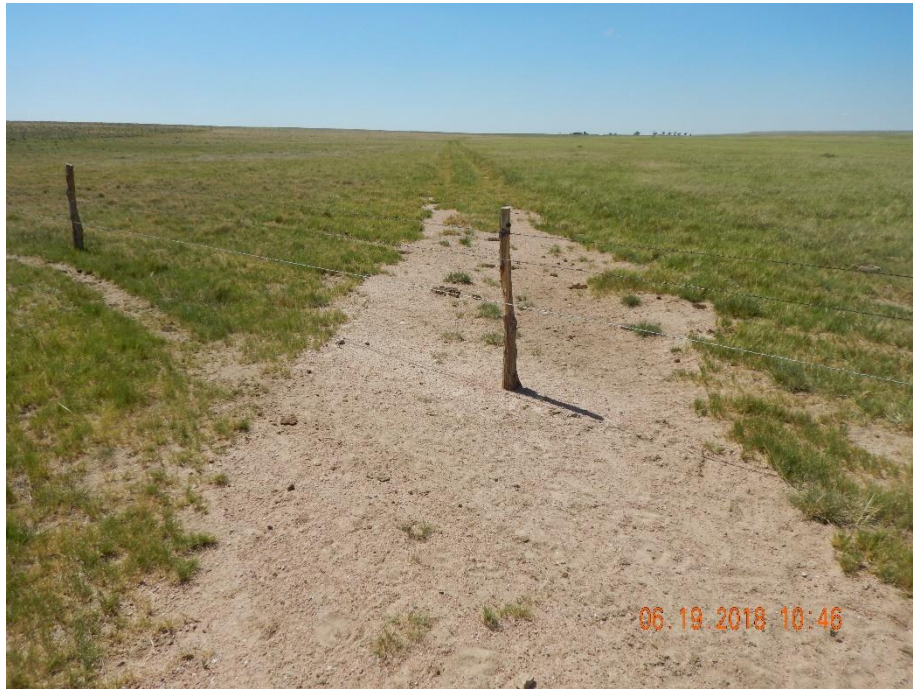
Photo 31: Photo taken from the access road, southwest of the location at coordinates 38.94974 / -10339839. Photo shows fence blocks off access road. No gate has been installed to allow vehicular travel to the location. Vehicles are forced to travel off road to a corner of the fence to the east.

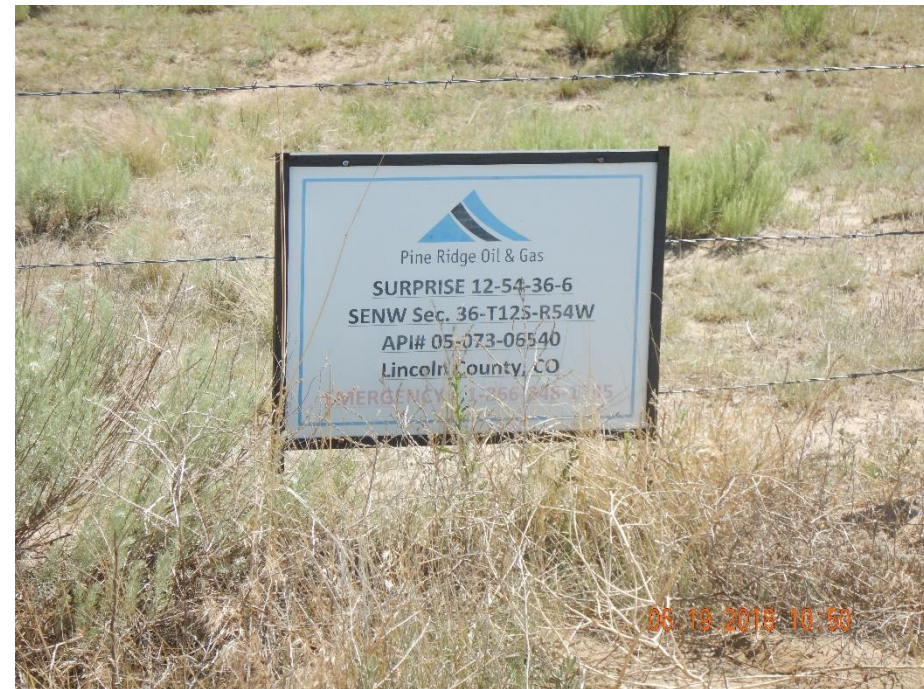
Photo 32: Photo taken from access road entrance at county road 26. Photo shows signage has not been updated with the correct operator information.
