Inspection Photos

Operator: GRAND MESA OPERATING CO - 35080

Location ID: 455191

Inspection Doc. Number: 682503769

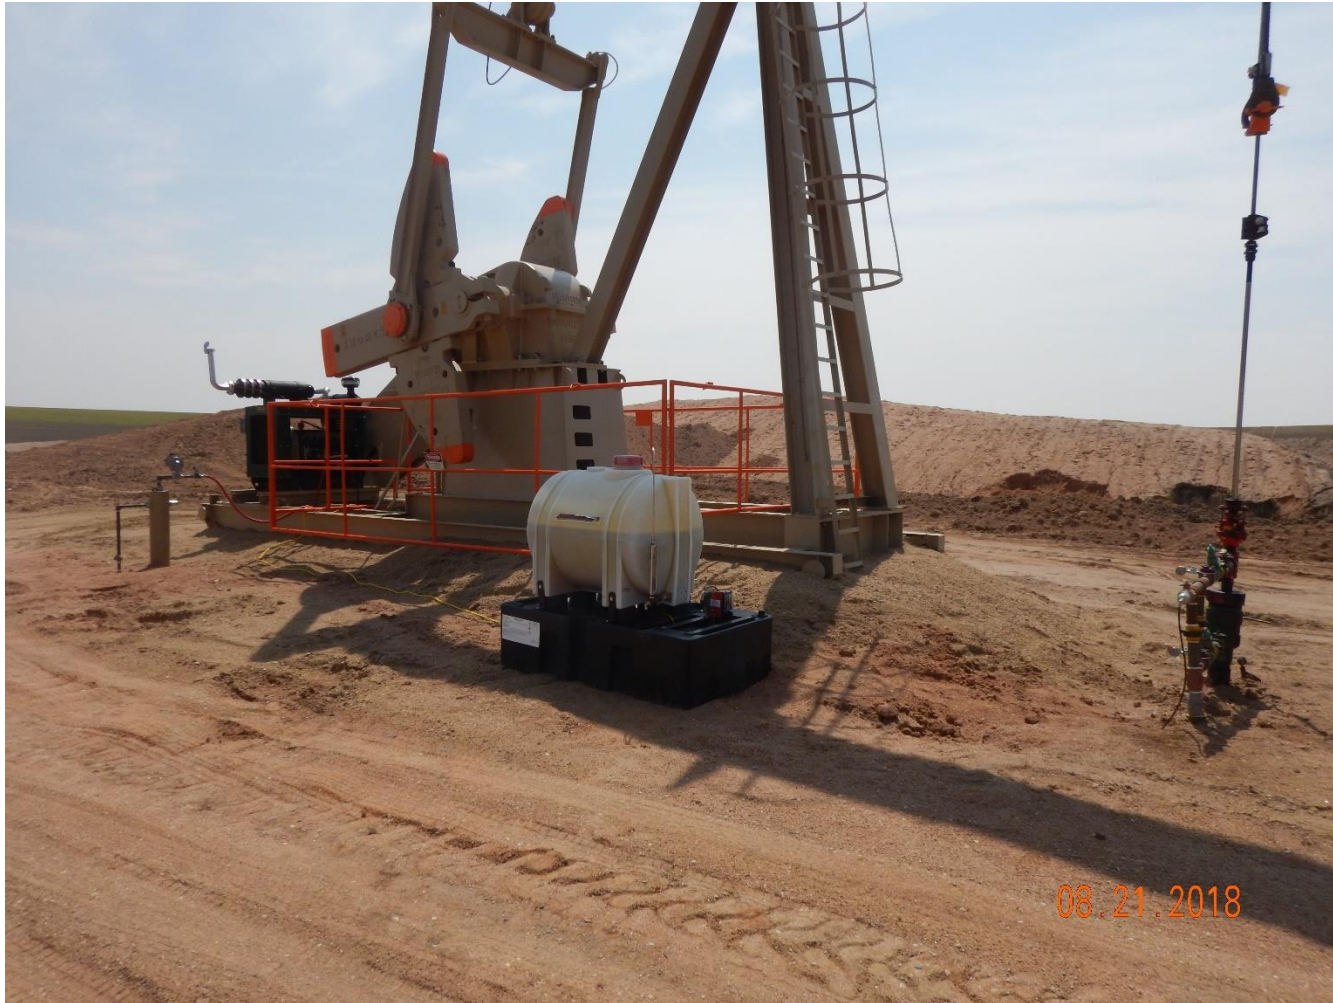
Photo 1: Photo taken from the pumpunit. Well is currently active, recent inspection shows well status as “Producing”.

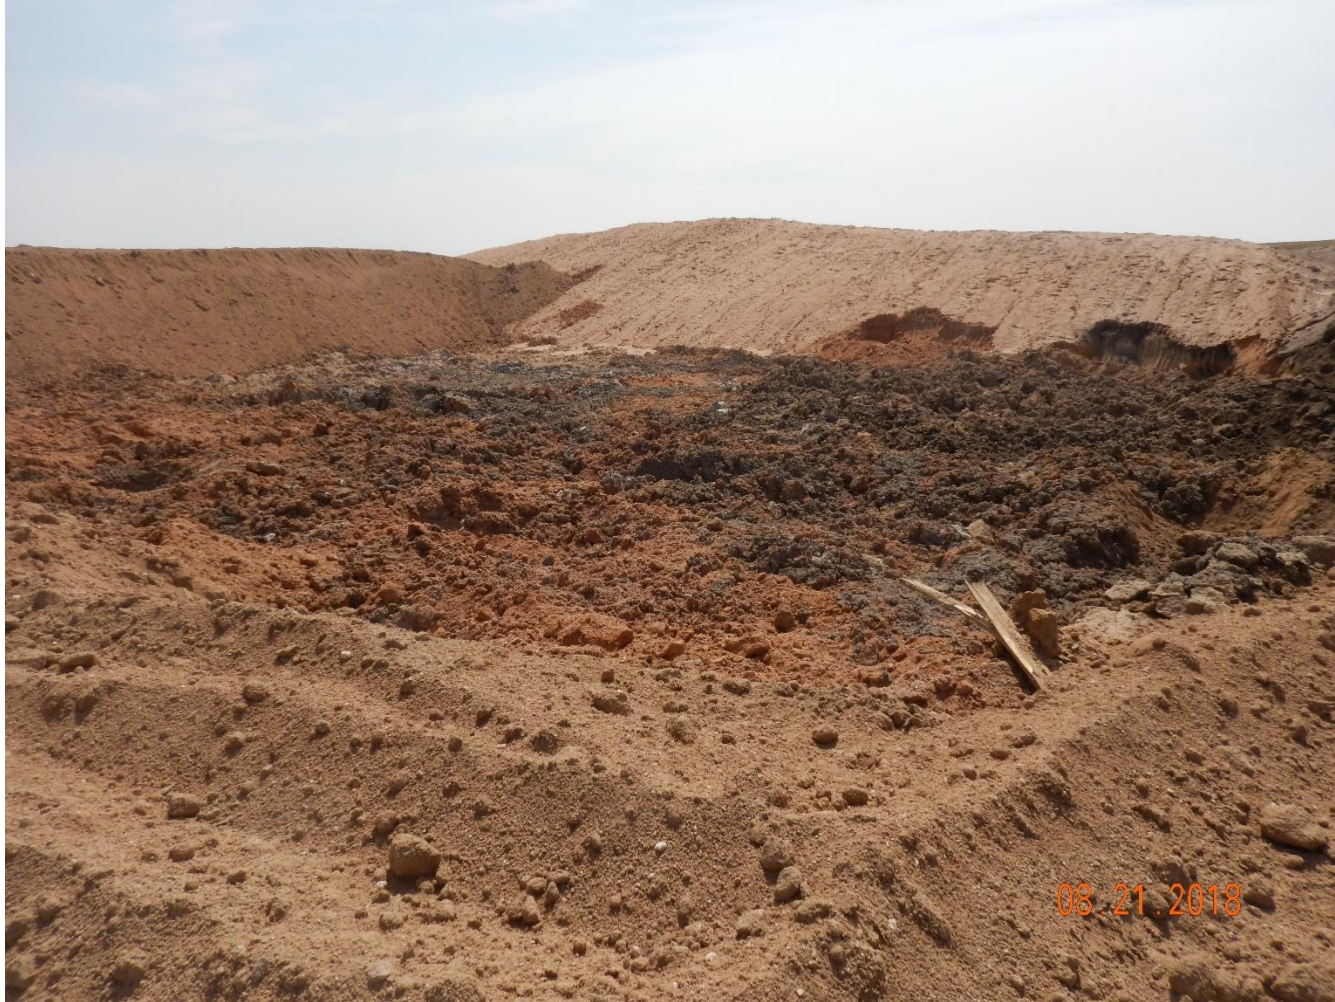
Photo 2: Photo taken from northwest corner of the drill pit, facing southeast. Photo shows drill pit remains open.

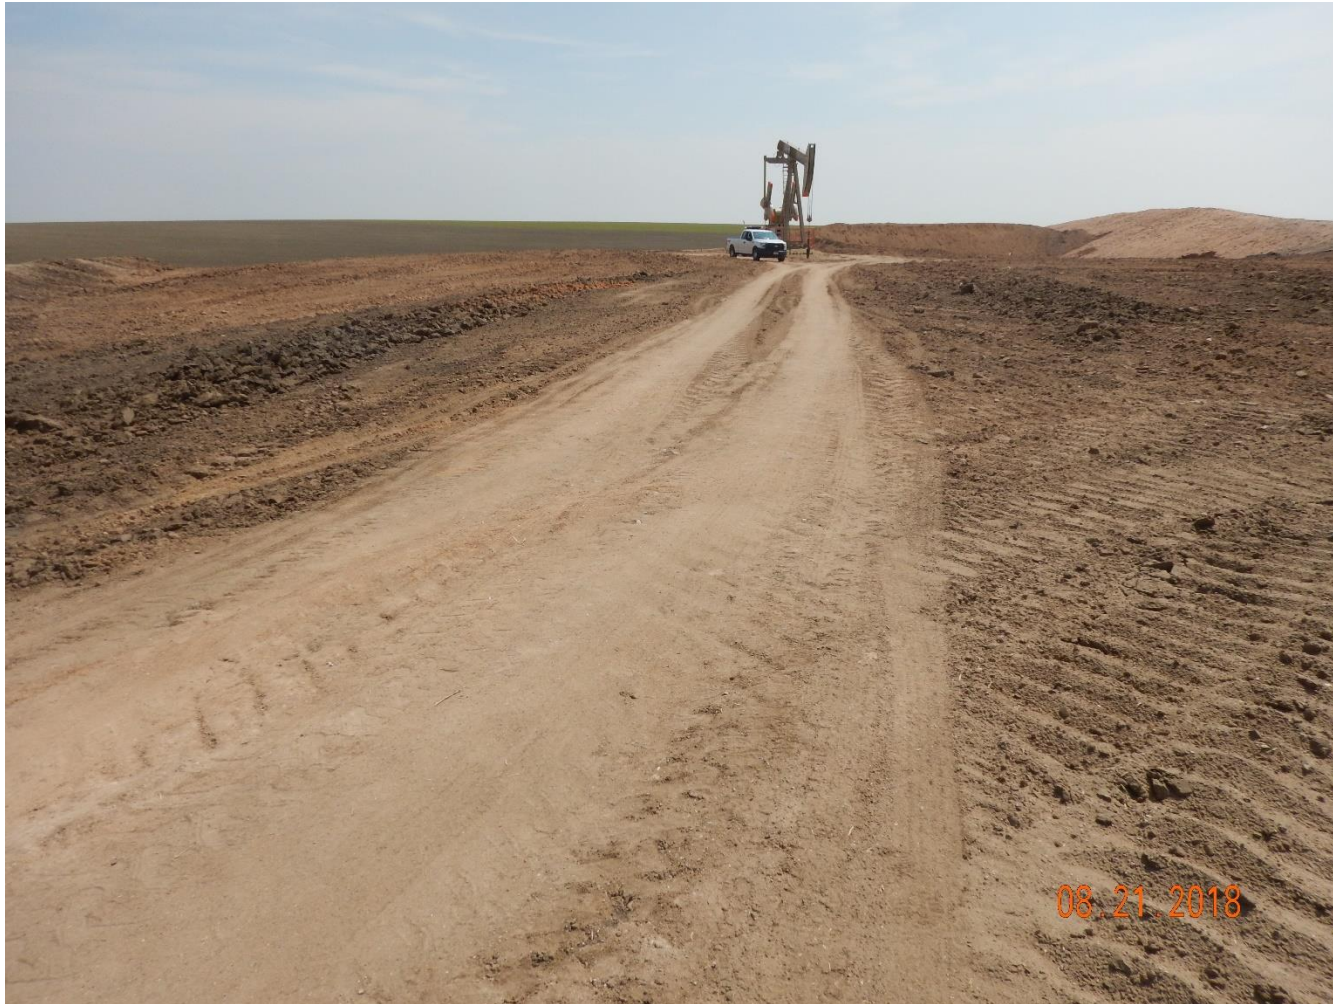
Photo 3: Photo taken from the west end of the location, facing east. Photo shows over view of the location. Initial interim reclamation work appears to have begun.

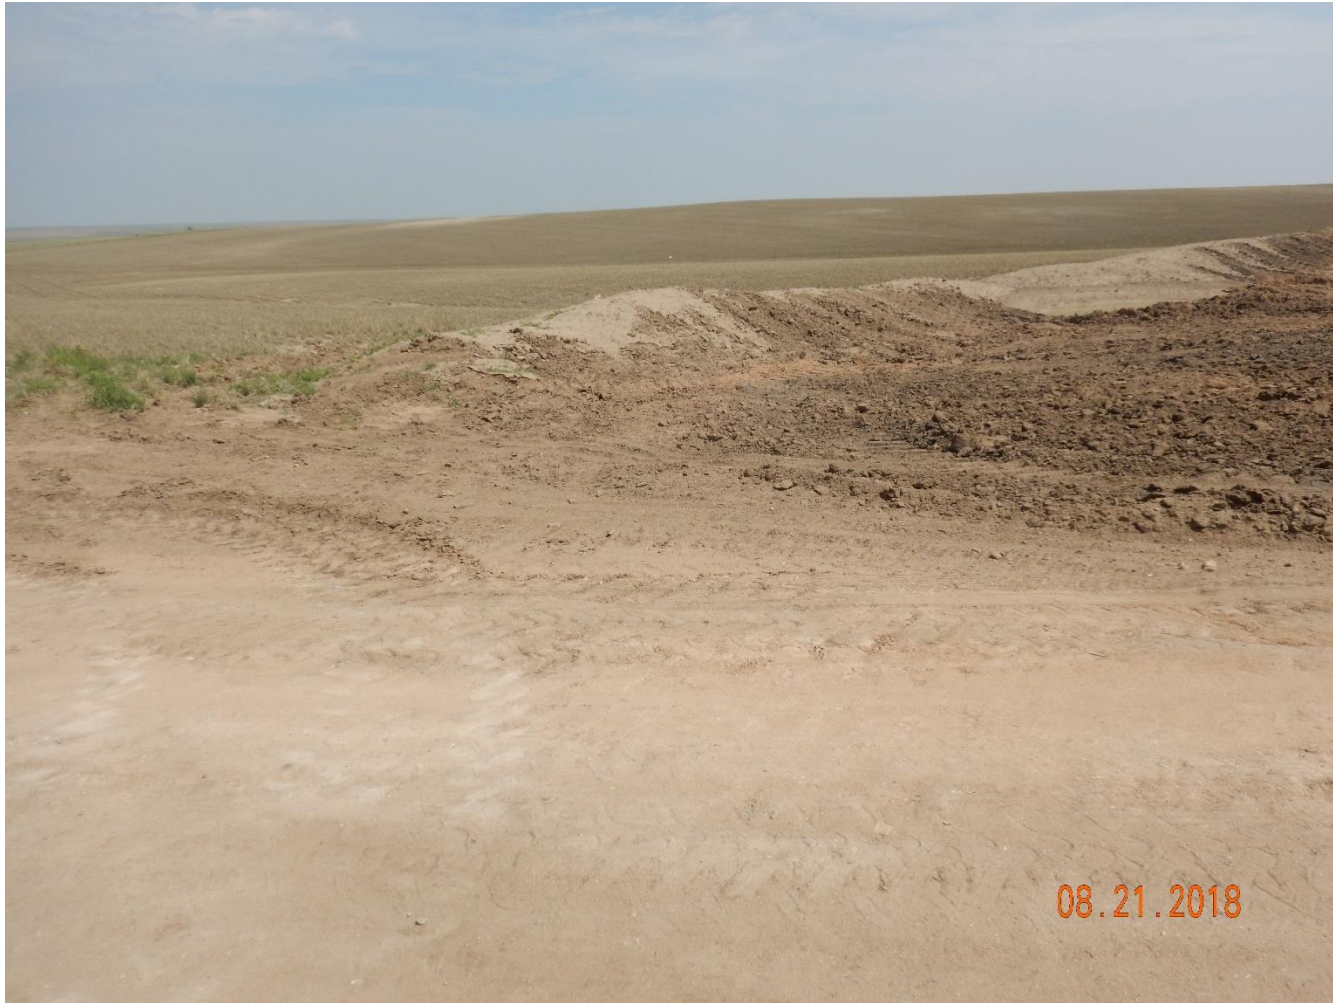
Photo 4: Photo taken from the northwest corner of the location, facing south. See comments under photo 2

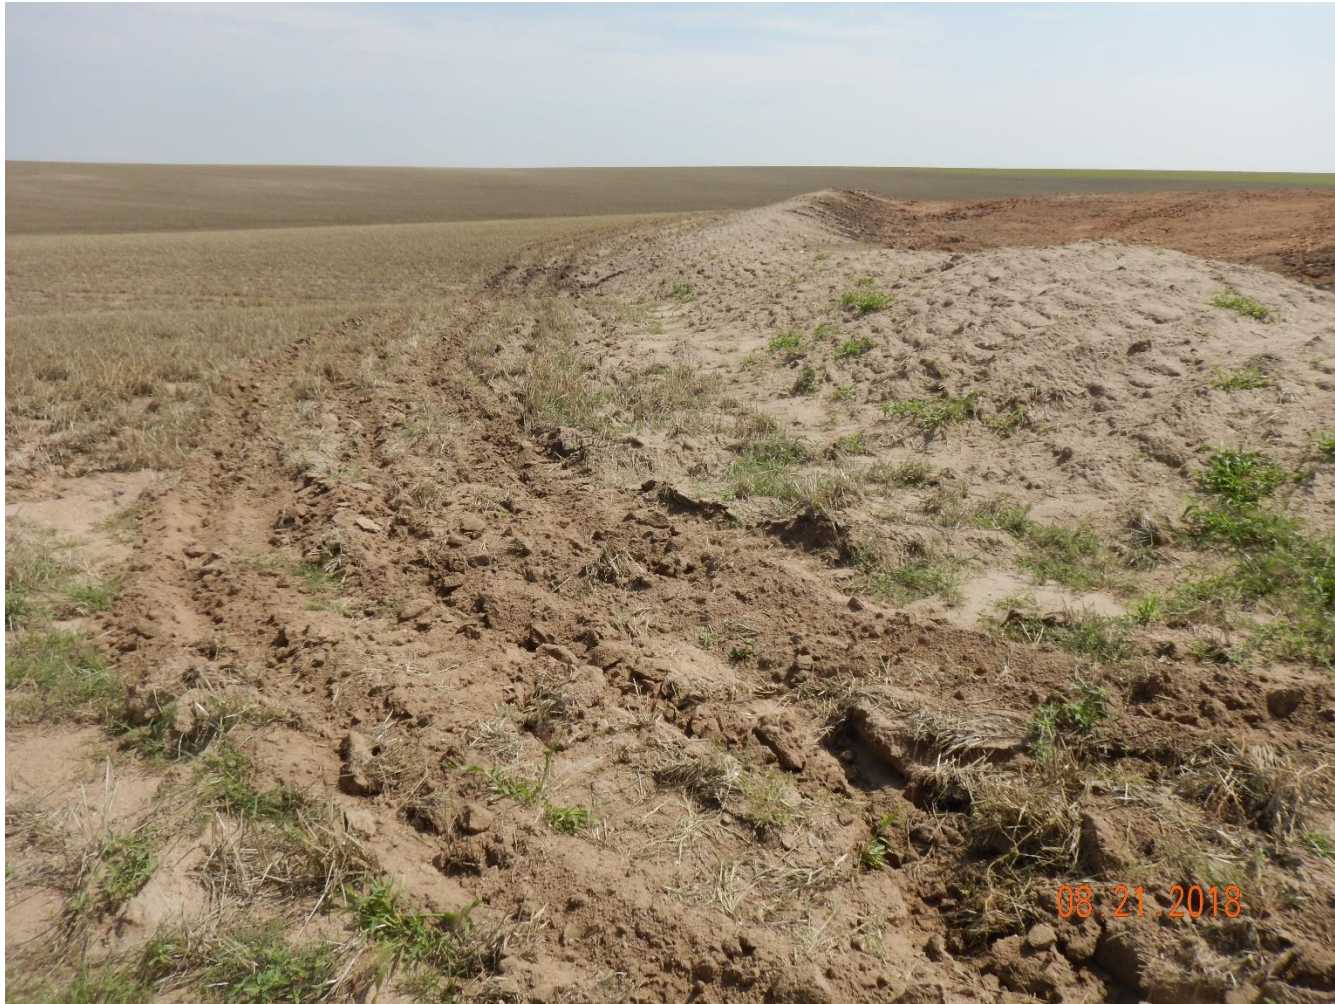
Photo 5: Photo taken from the northwest corner of the location, facing east. Photo shows stormwater and erosion control BMPs. Berm appears to have been constructed with topsoil. Berm does not appear to have been compacted, stabilized or constructed in accordance with good engineering practices. Photo also shows surface roughening along perimeter.

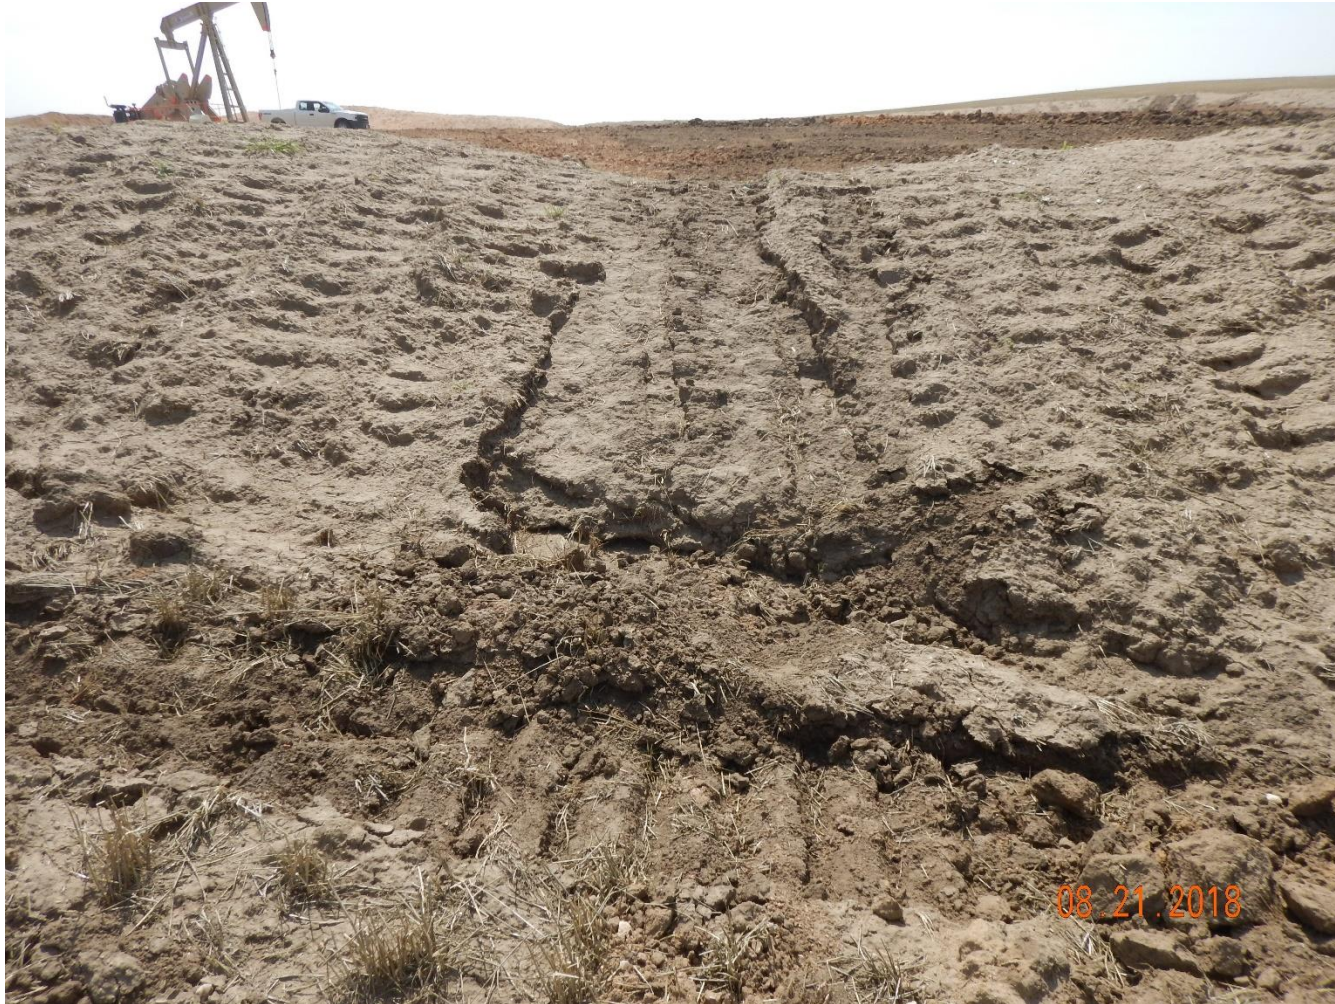
Photo 6: Photo taken from the north end of the location, facing south. Berm appears to have been constructed with topsoil. Berm does not appear to have been compacted, stabilized or constructed in accordance with good engineering practices.

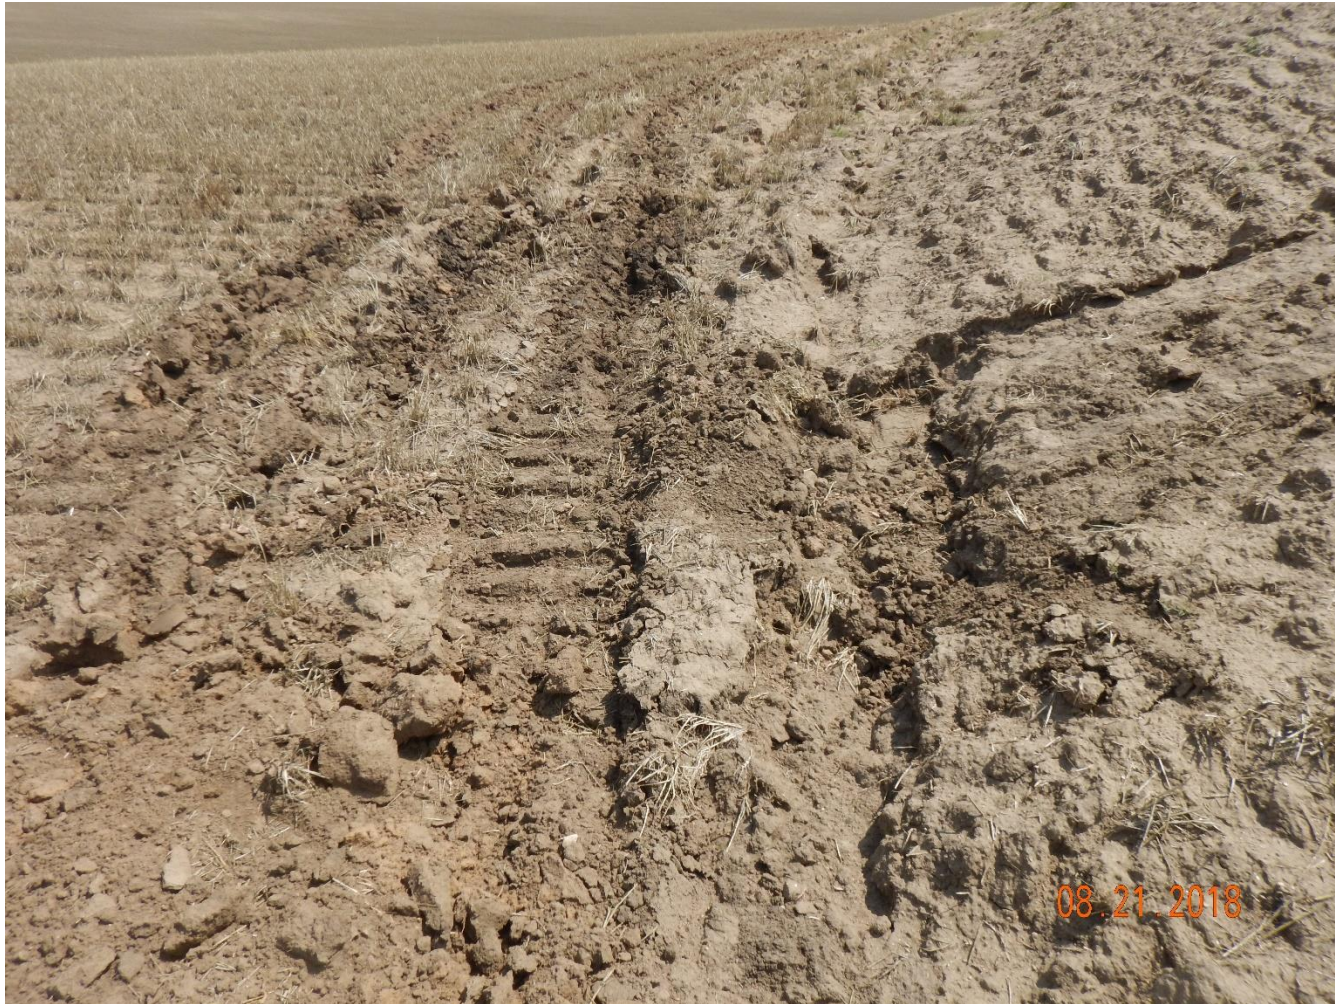
Photo 7: Continued from photo 6. Photo shows erosion degradation. BMPs appear to be insufficient and not constructed in accordance with good engineering practices.

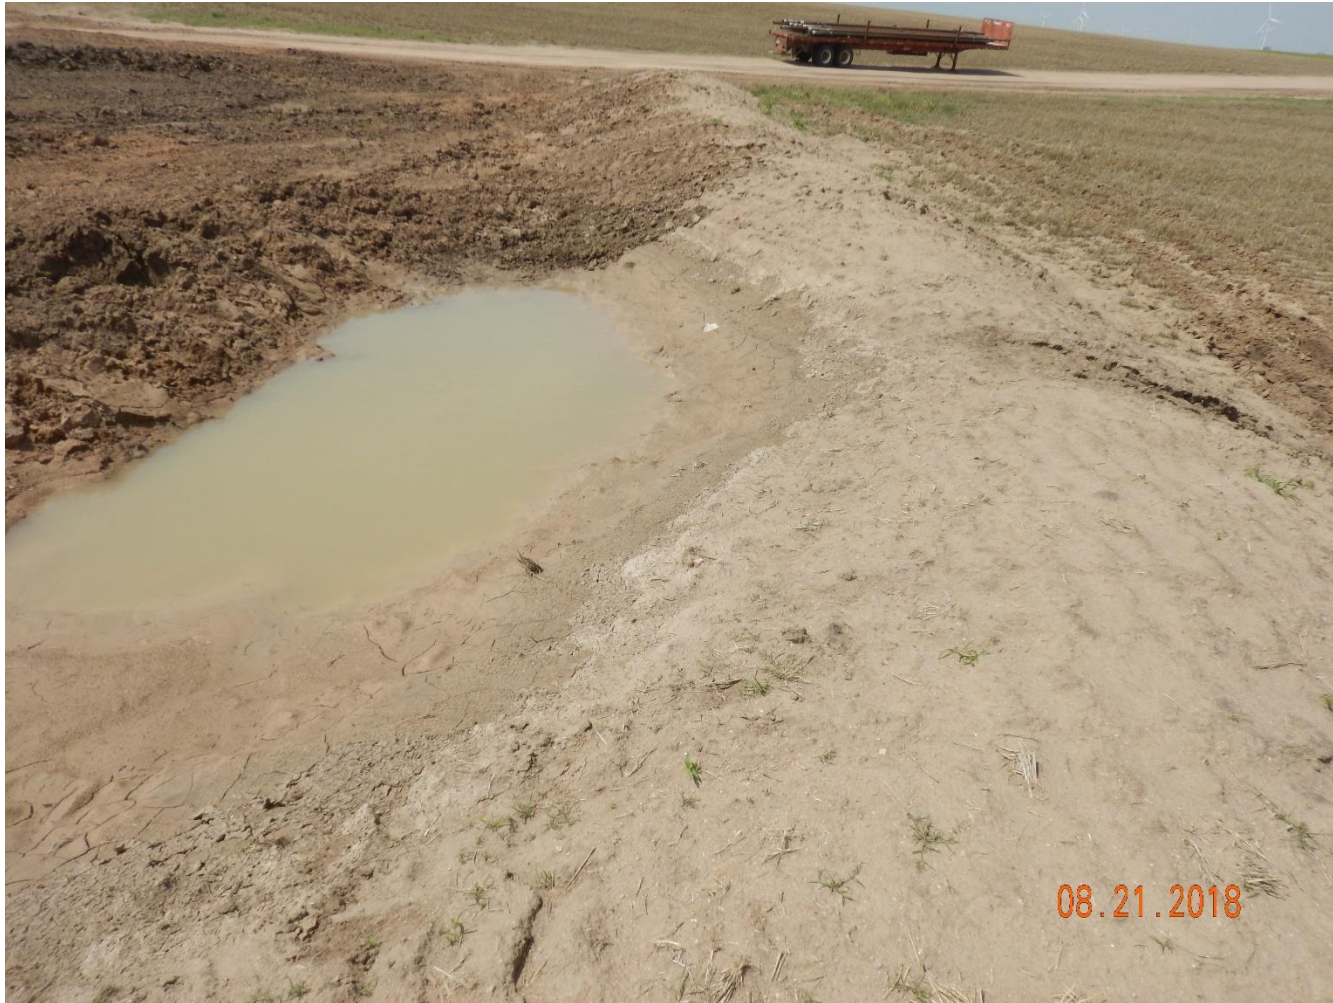
Photo 8: Photo taken from the north end of the location, facing west. Operator appears to have implemented a sediment trap, or retention pond on the southern end of the location. BMP does not appear to be appropriate in size to mitigate runoff from the 4.26 acre location. Trap/pond missing sufficient inlet and outlet protection and does not appear to be designed in such a manner to allow for sediment-laden free stormwater discharge from the location; BMP does not appear to have been constructed in accordance with good engineering practice.

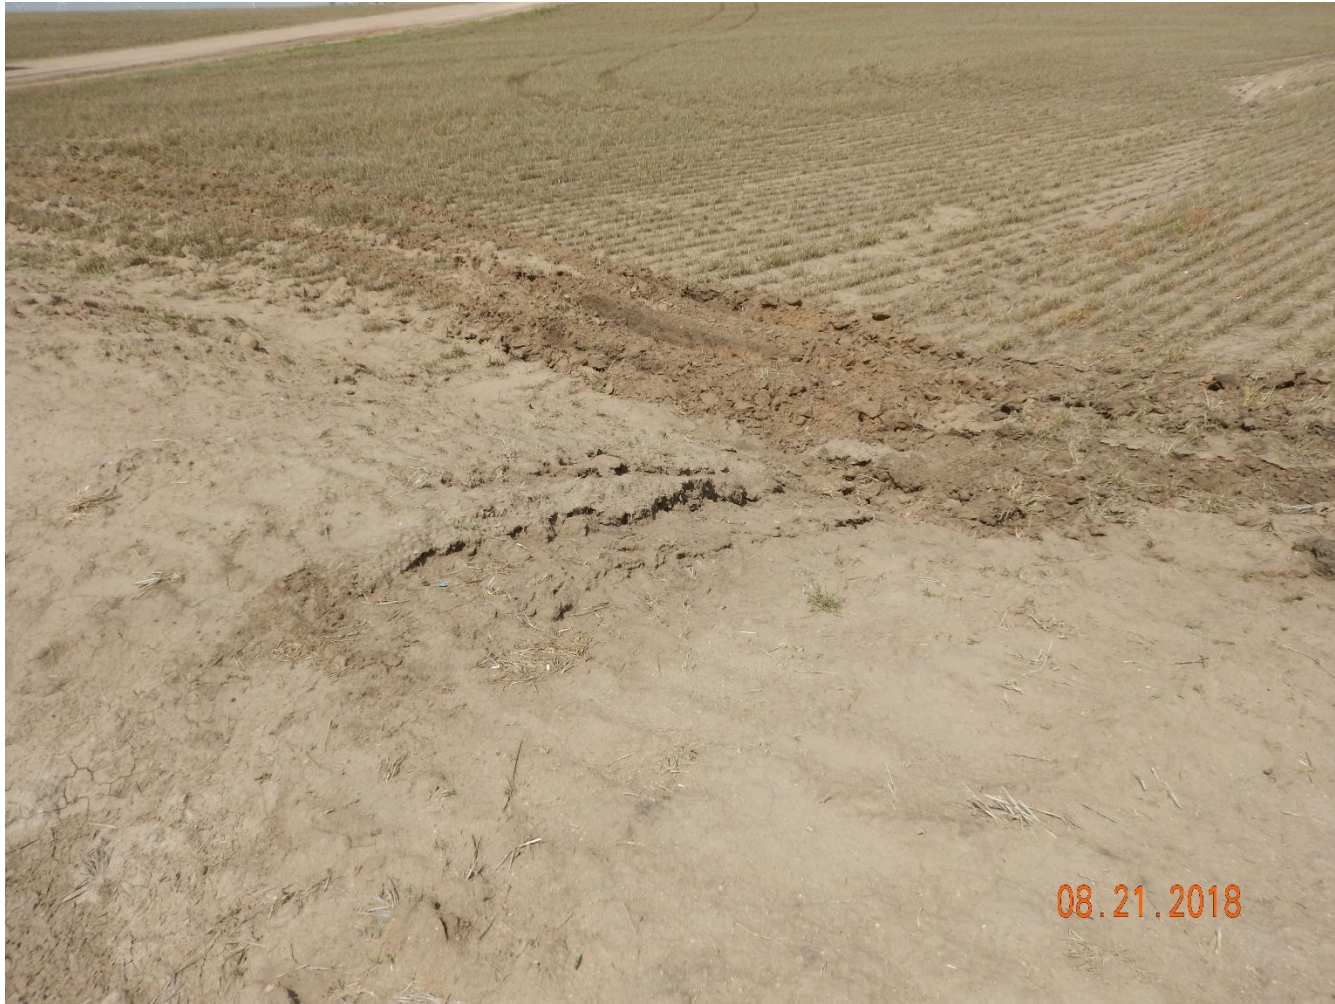
Photo 9: Continued from photo 8. Photo shows trap/pond does not have sufficient inlet or outlet protection in accordance with good engineering practice.

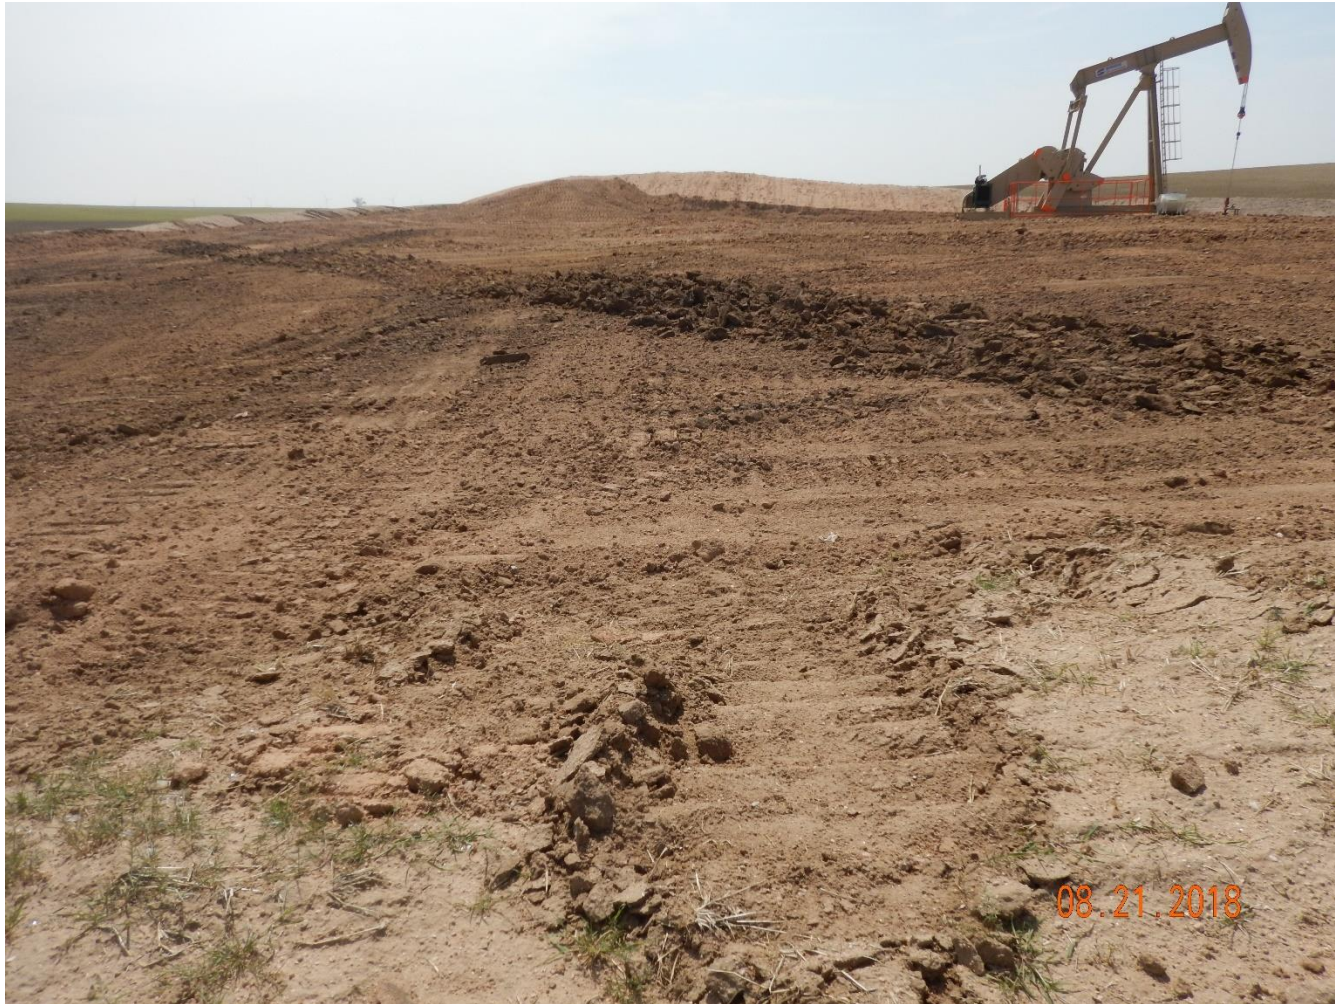
Photo 10: Photo taken from the northeastern area of the location. Initial interim work appears to be in process.

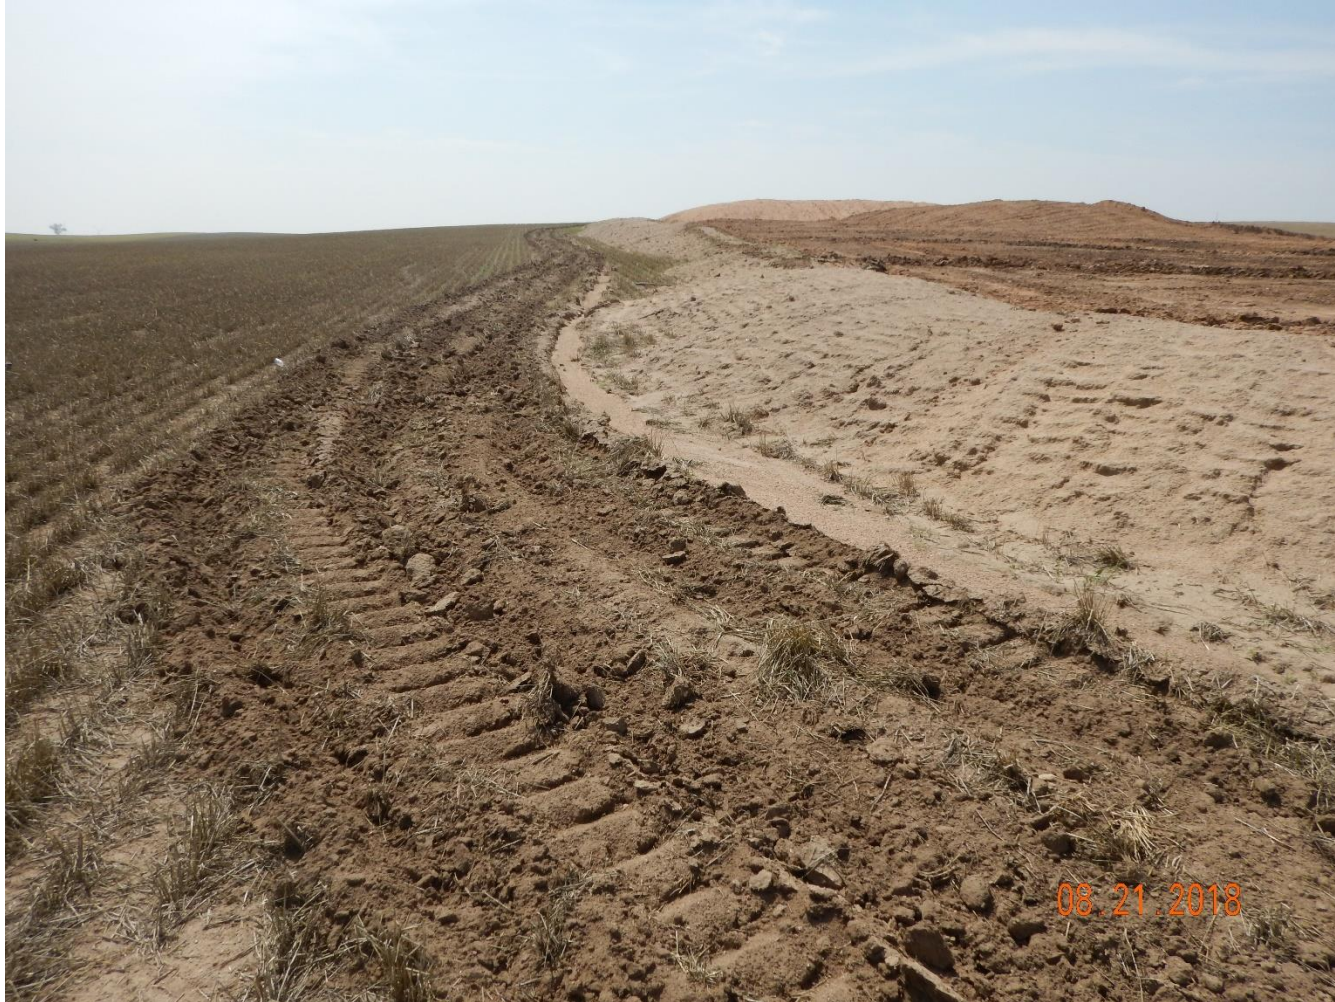
Photo 11: Photo taken from the northeast corner of the location, facing south. Photo of perimeter controls.

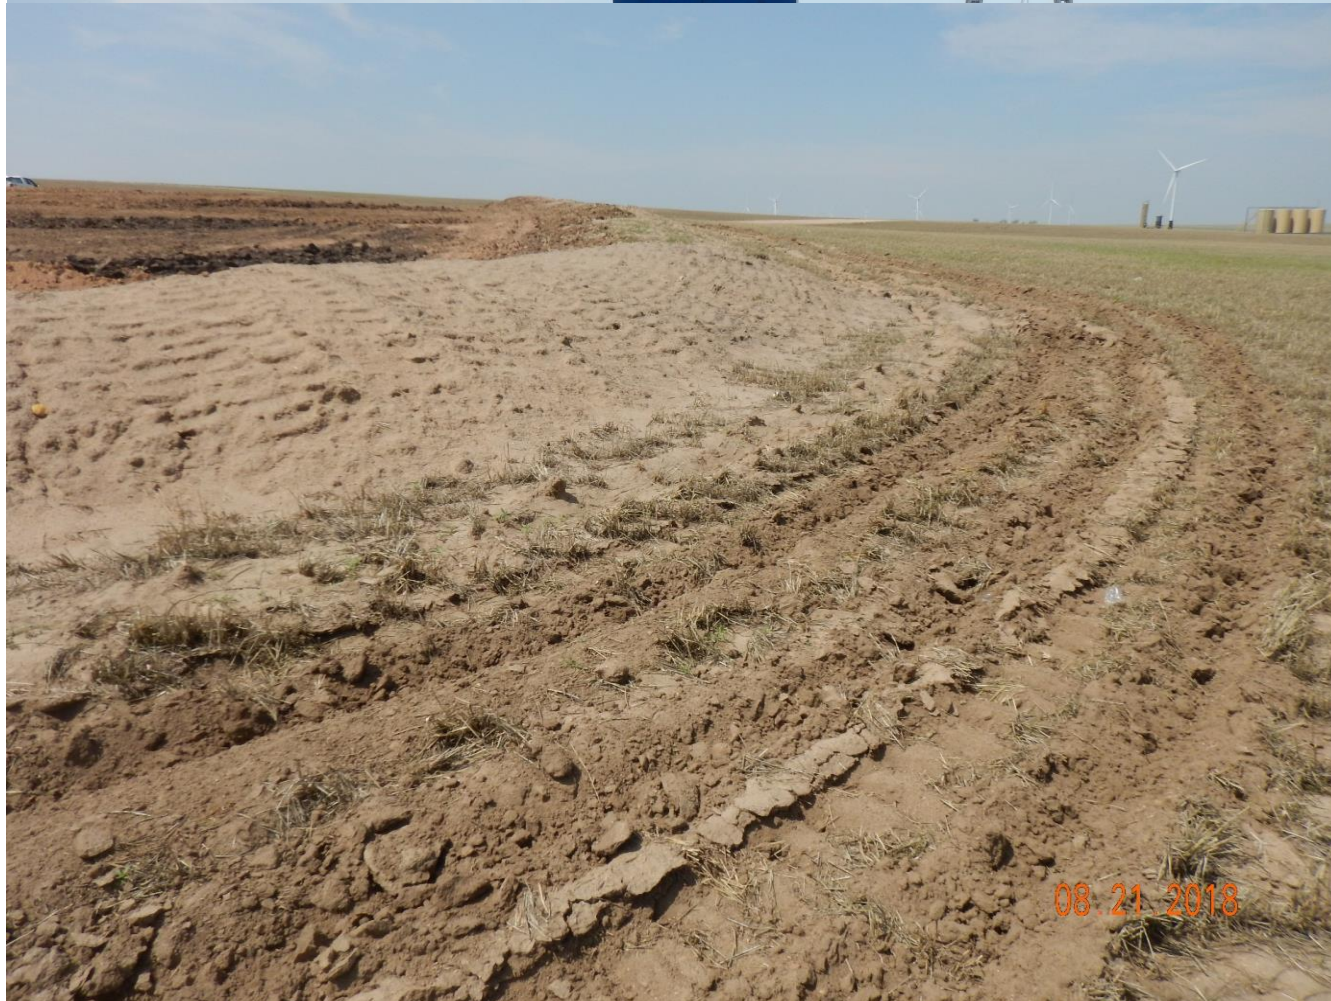
Photo 12: Photo taken from the northeast corner of the location, facing west. Photo of perimeter controls.

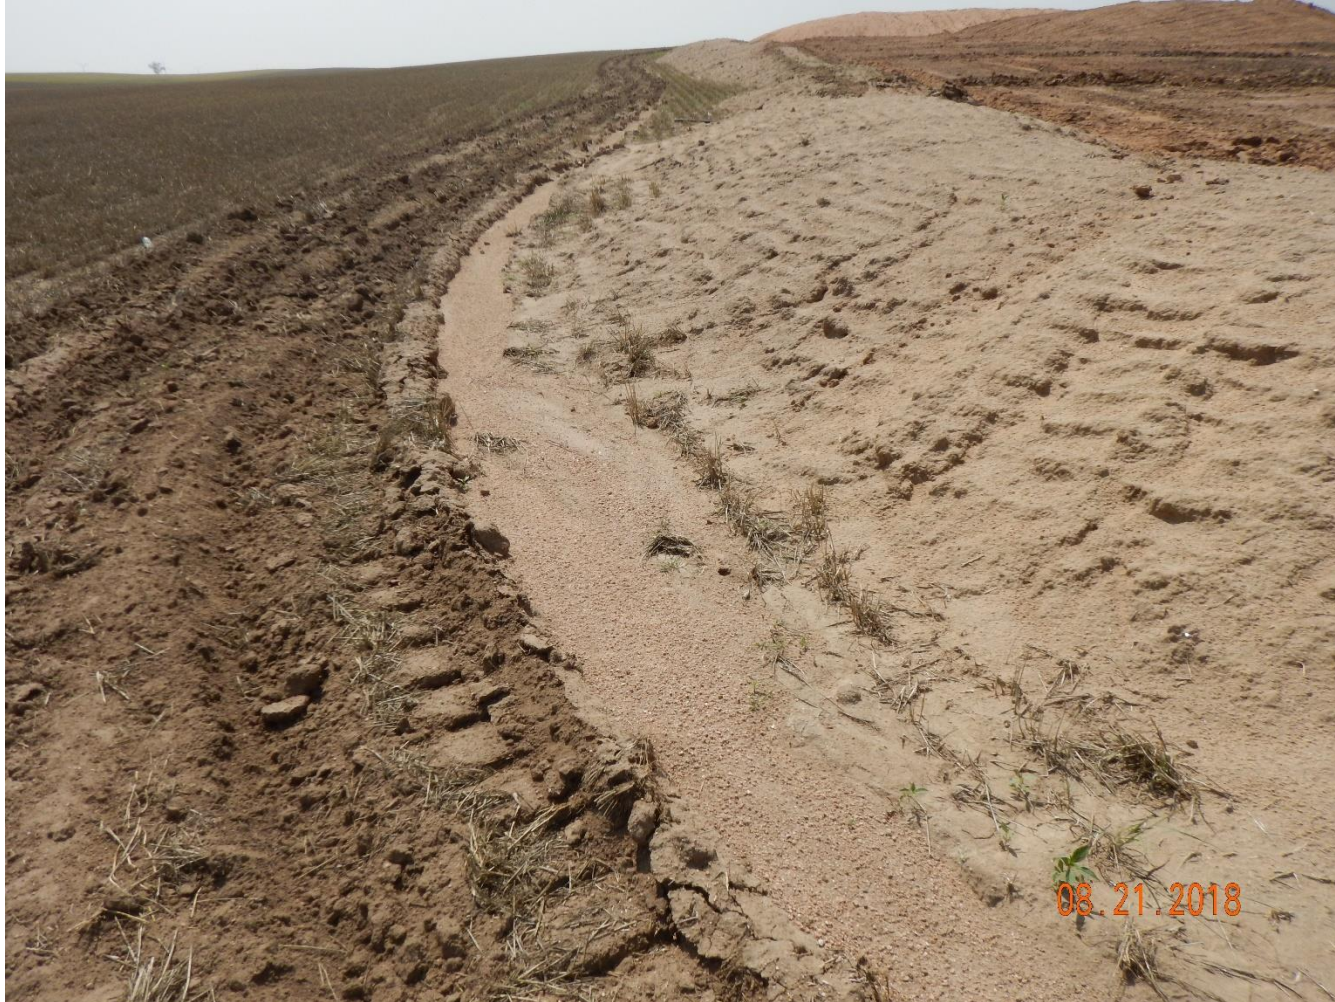
Photo 13: Photo taken from the northeast corner of the location, facing south. Photo shows erosion degradation occurring on berms as well as the resulting sediment transport and deposition. Berms do not appear to be stabilized or compacted in accordance with good engineering practices.

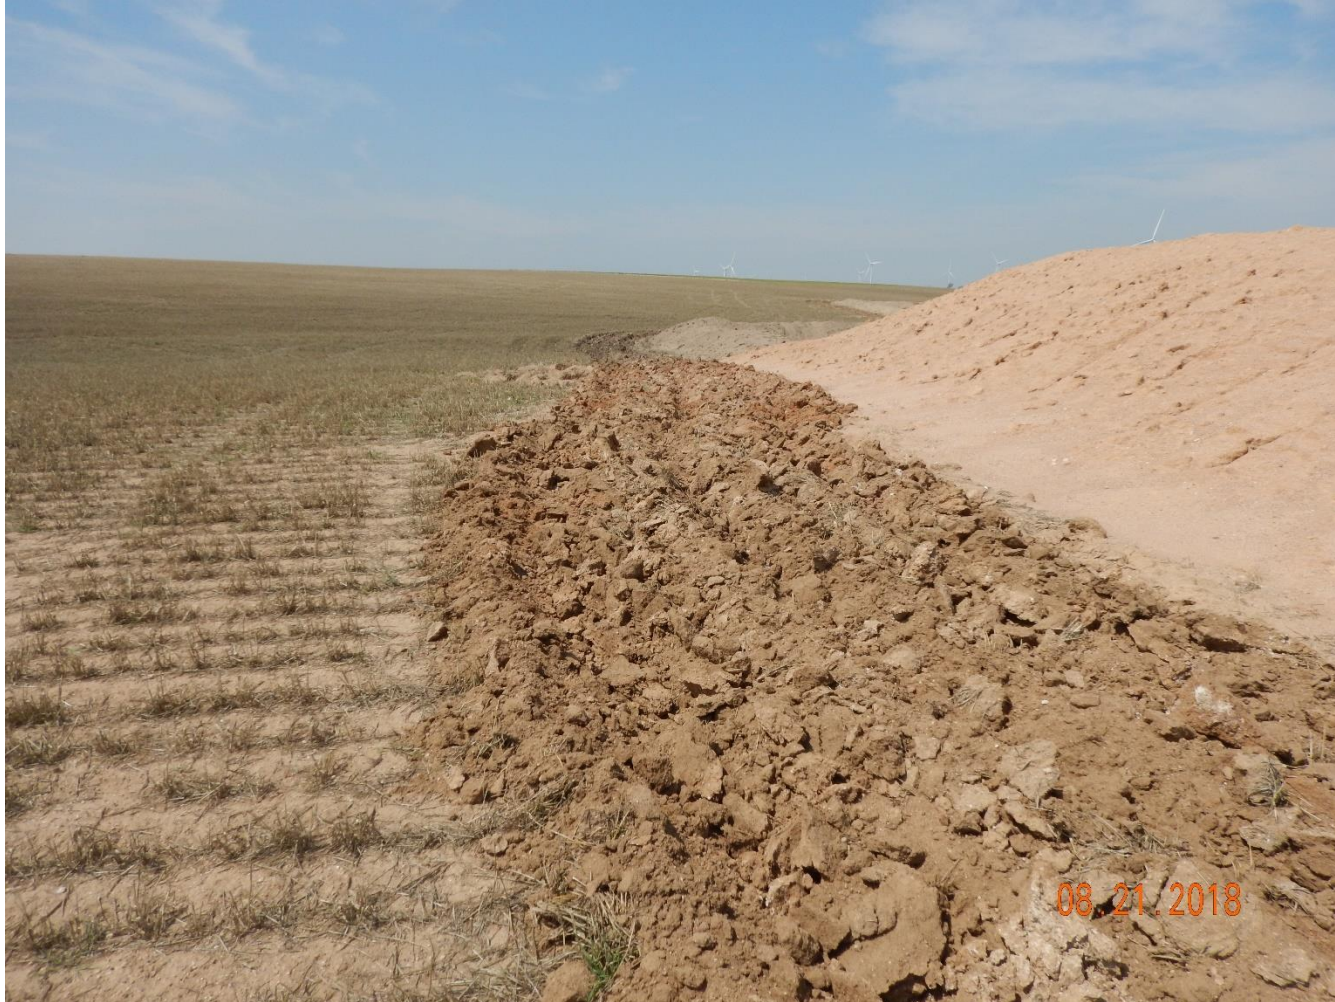
Photo 14: Photo taken from the southeast corner of the location, facing west. Photo shows surface roughening. Surface roughening is a temporary that needs to be implemented in conjunction with other stormwater and erosion control BMPs

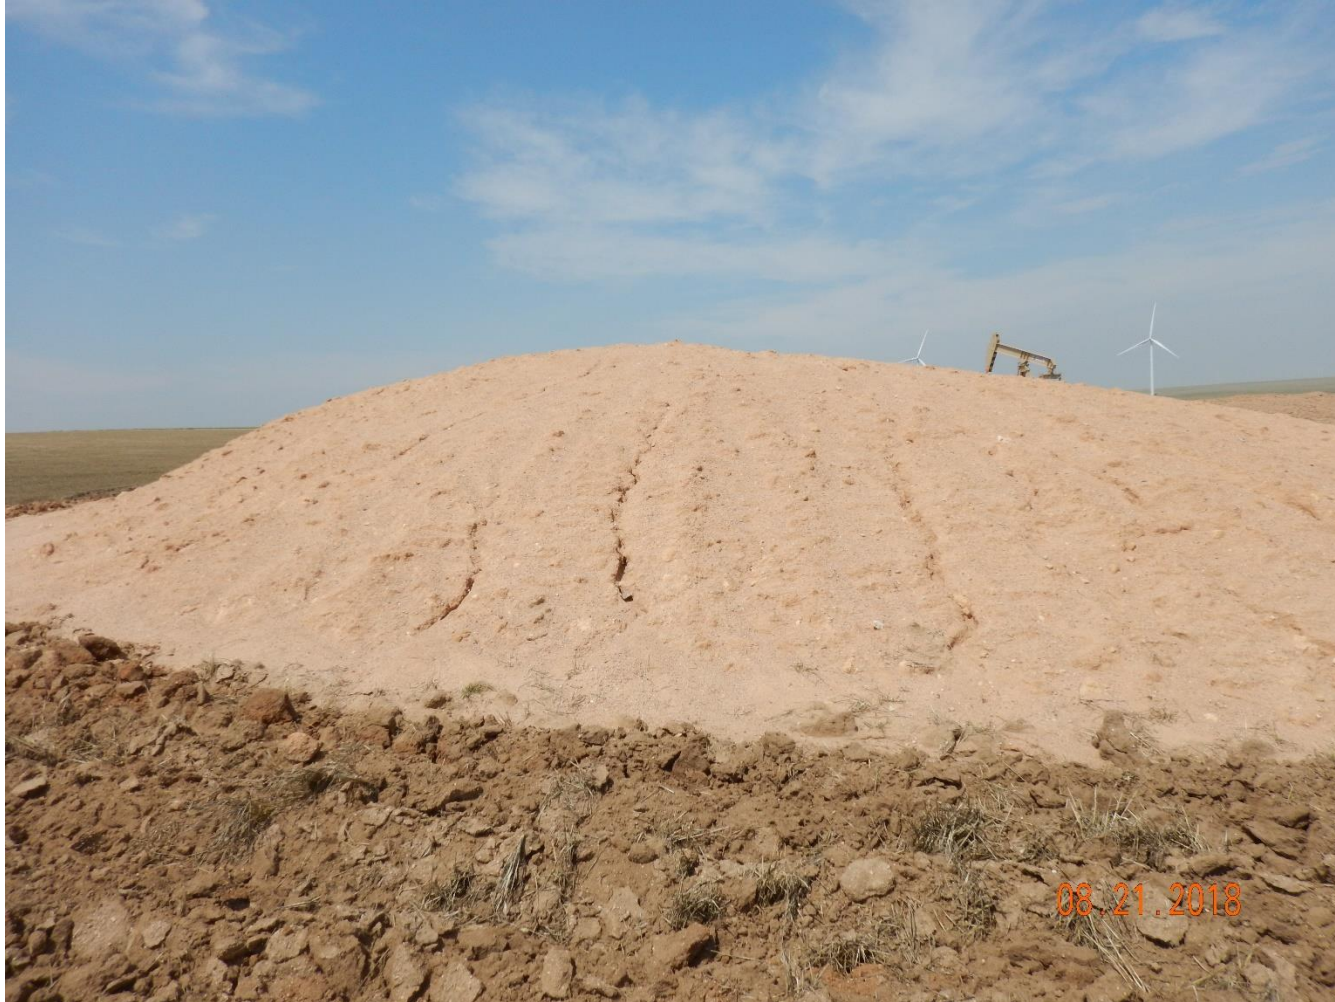
Photo 15: Photo taken from the southeast corner of the location, facing northwest. Photo shows sub-soil stockpile on locaiton. Erosion degradation evident on stockpile.

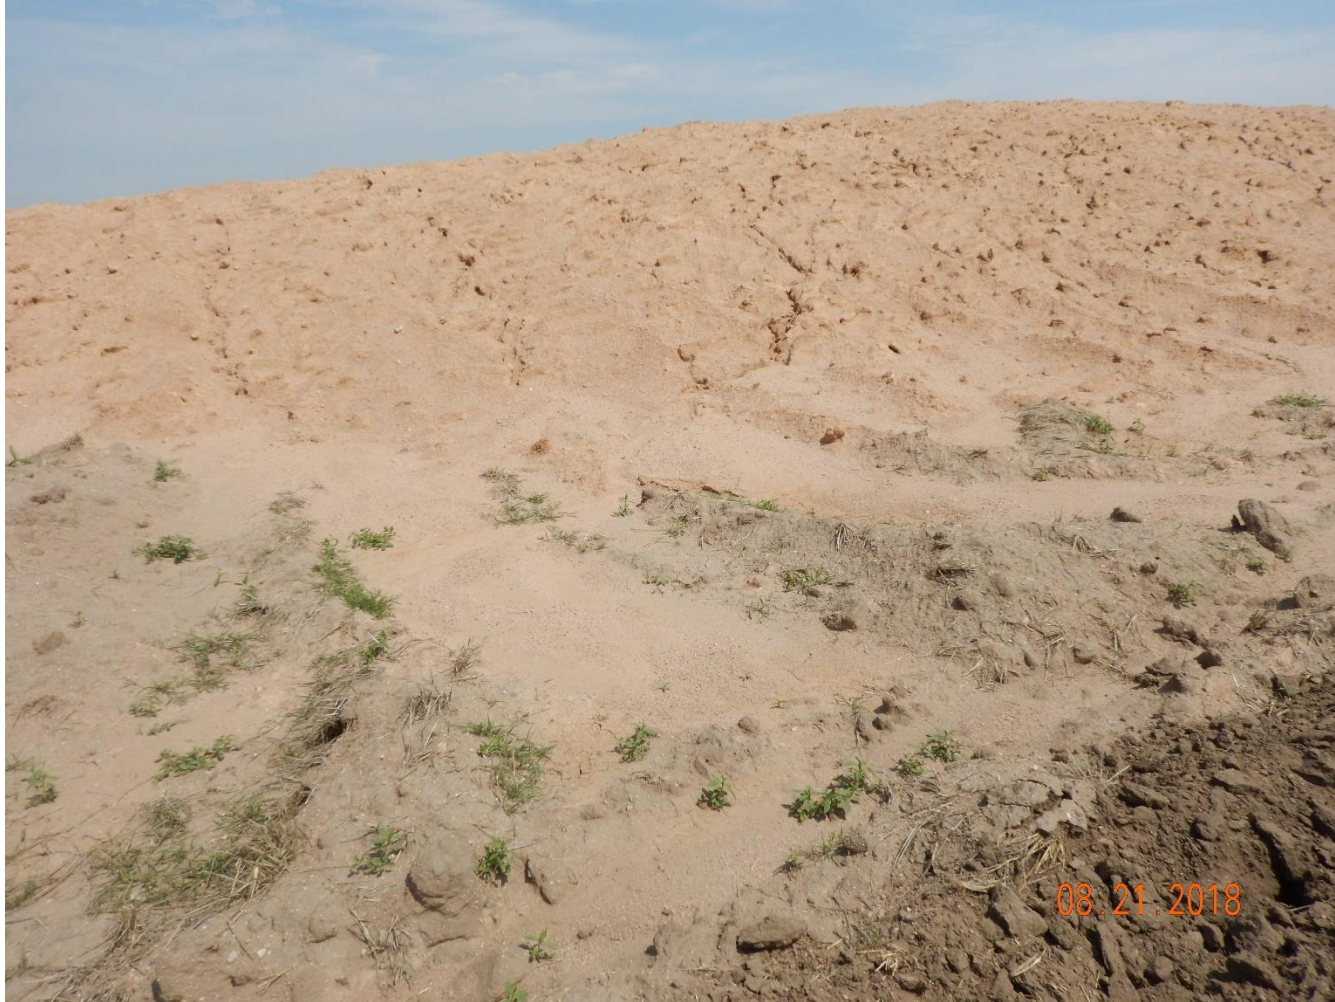
Photo 16: Photo taken from the south end of the location, facing north. Photo shows erosion degradation and sediment deposition from the sub-soil stockpile.
