Inspection Photos

Operator: GRAND MESA OPERATING CO - 35080

Location ID: 455191

Inspection Doc. Number: 682503769

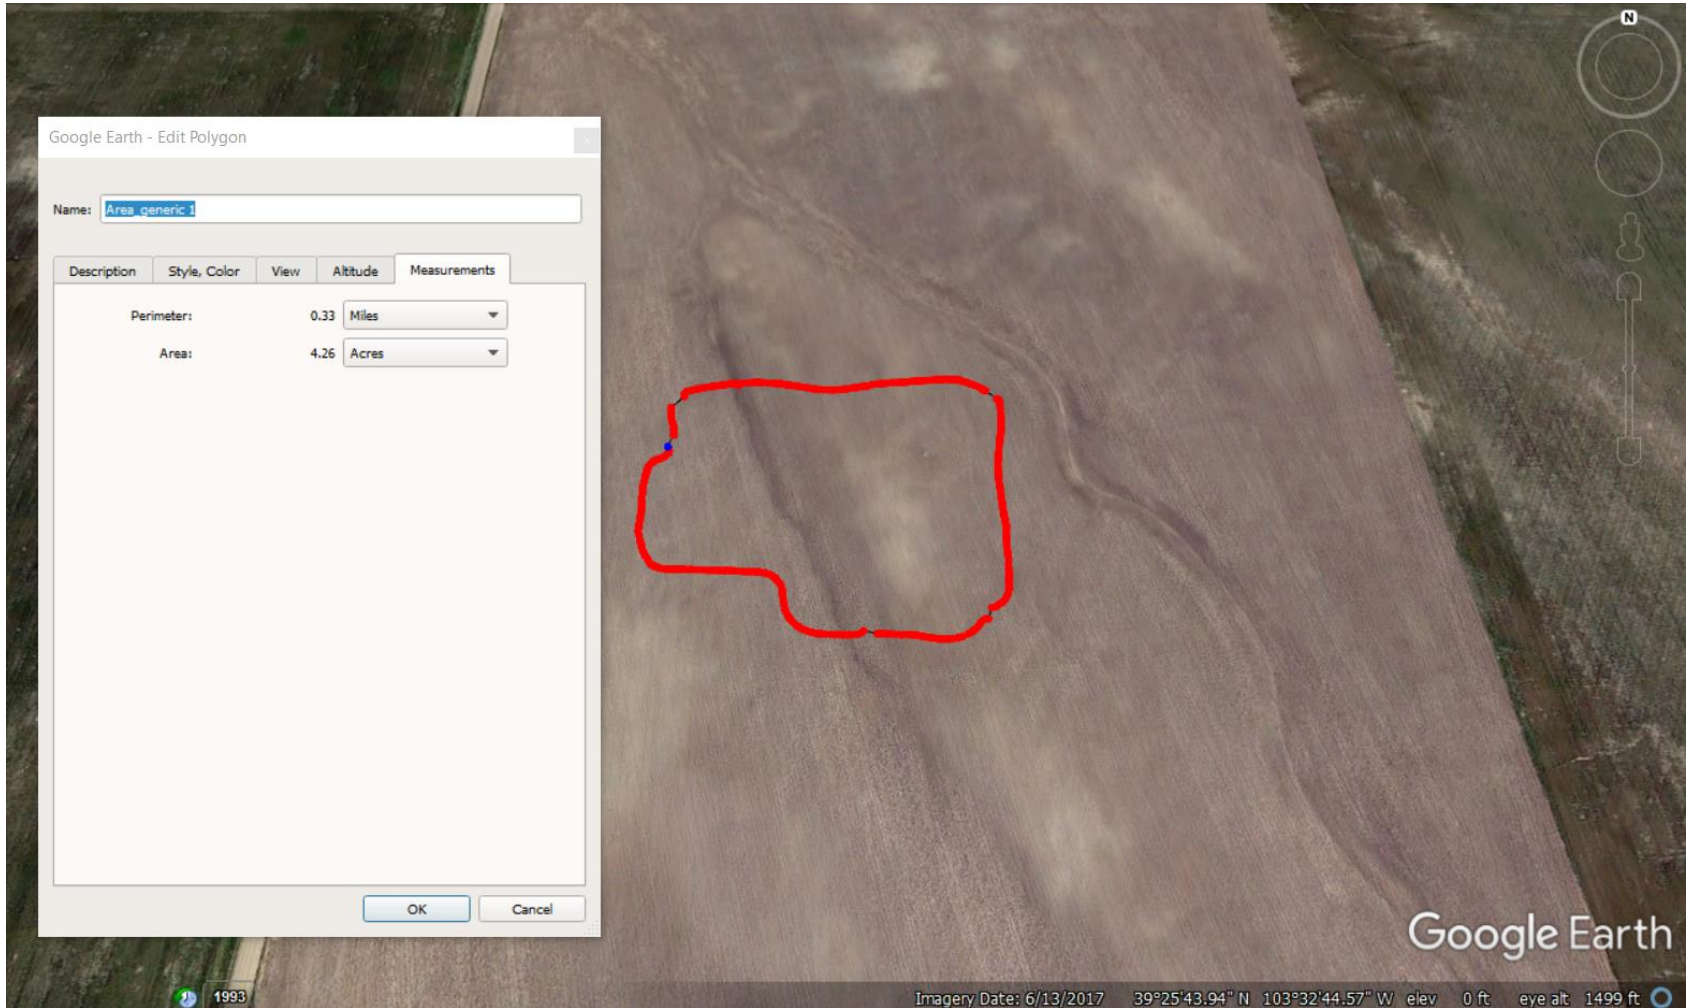
Photo 19: 2017 Google Earth aerial imagery. 2A doc. #401589228 states size of disturbance area during construction will be 2.5 acres in size. GPS measurements were conducted indicating that the disturbance area is 4.26 acres in size.
