Inspection Photo
Downing 24-22-6S-94W
API # 045-06633
Inspection # 689302116

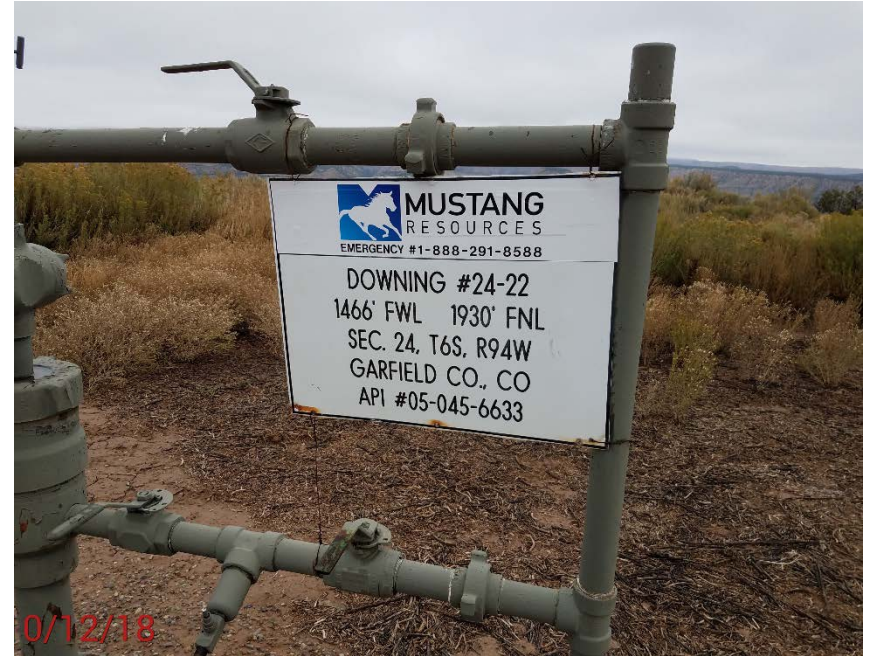
Location Photo #2, Inaccurate wellhead sign.

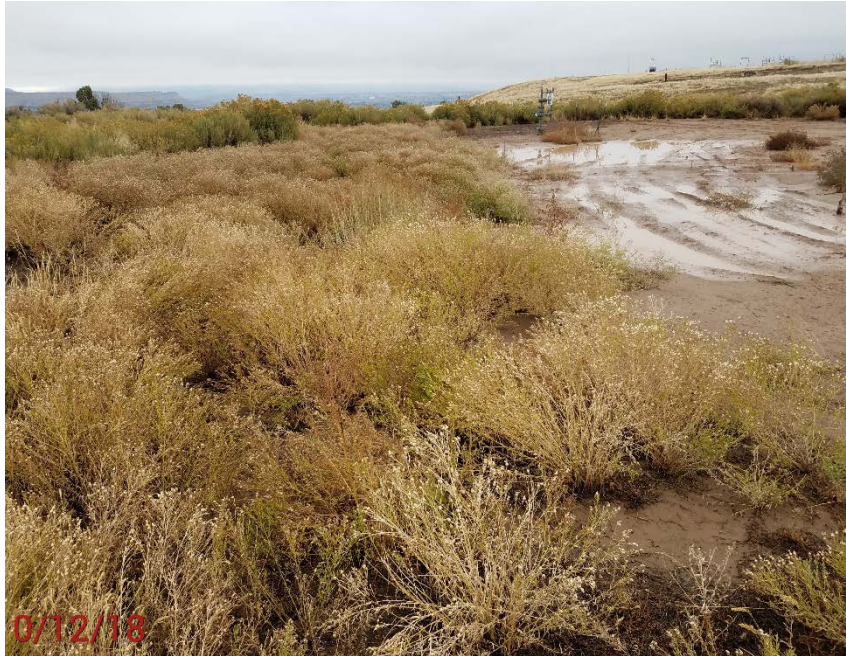
Location Photo #3, Uncontrolled weeds on location.

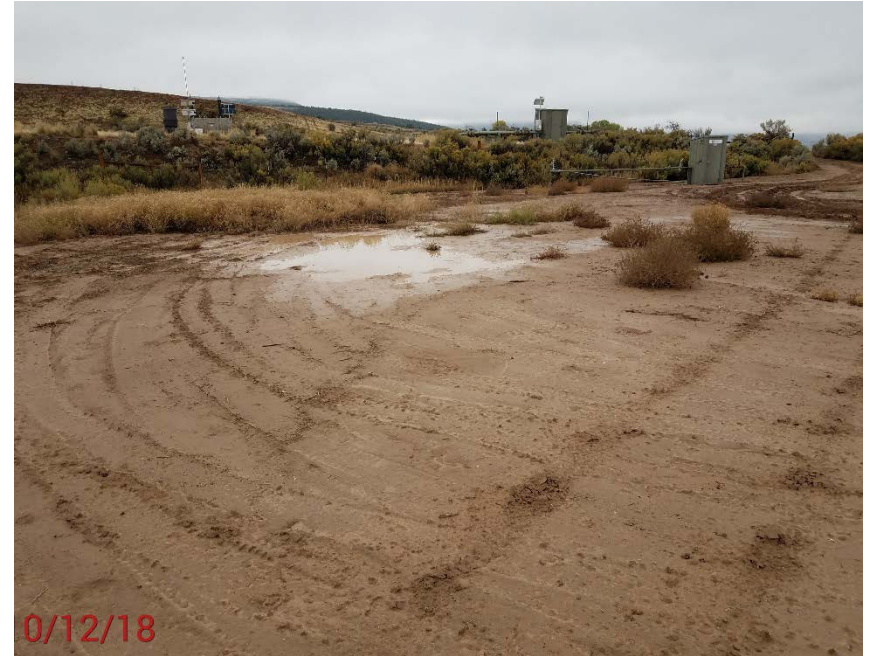
Location Photo #4, Uncontrolled weeds on location.

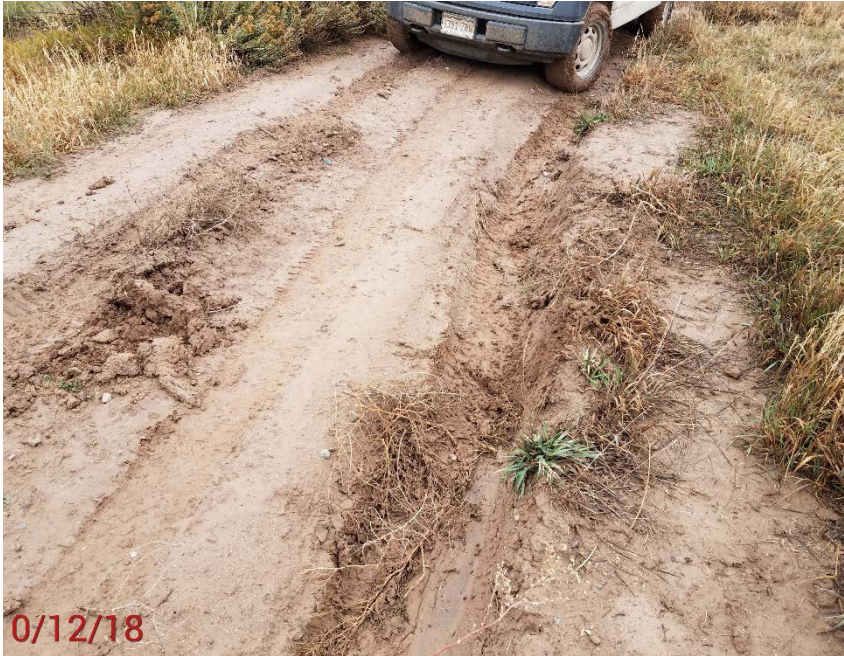
Location Photo #5, Rutted access road

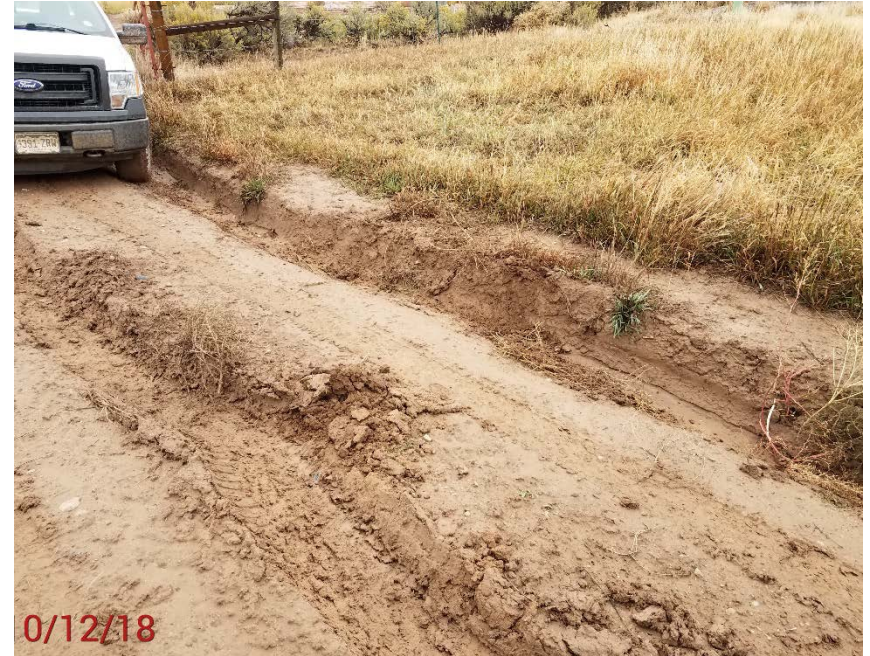
Location Photo #6, Rutted access road

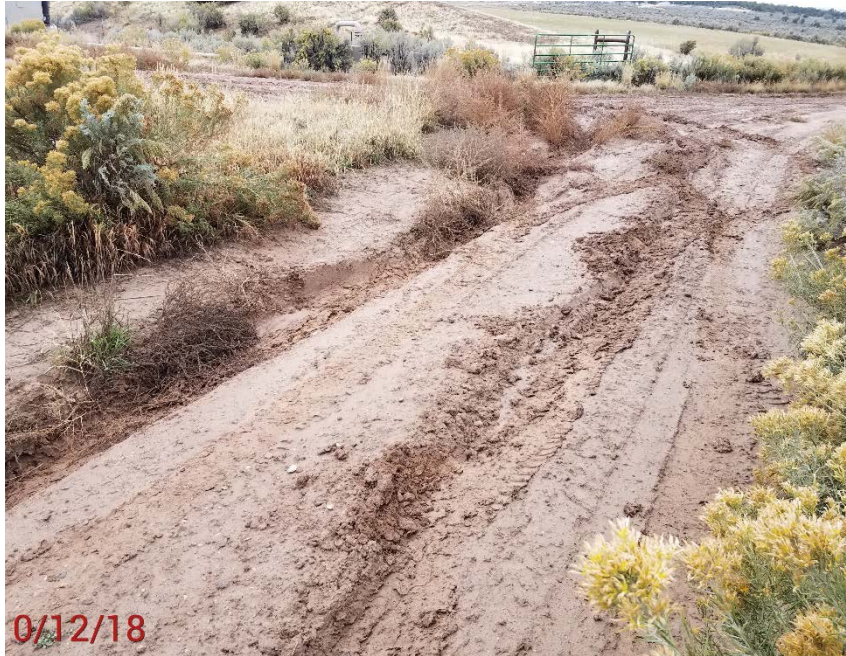
Location Photo #7, Rutted access road

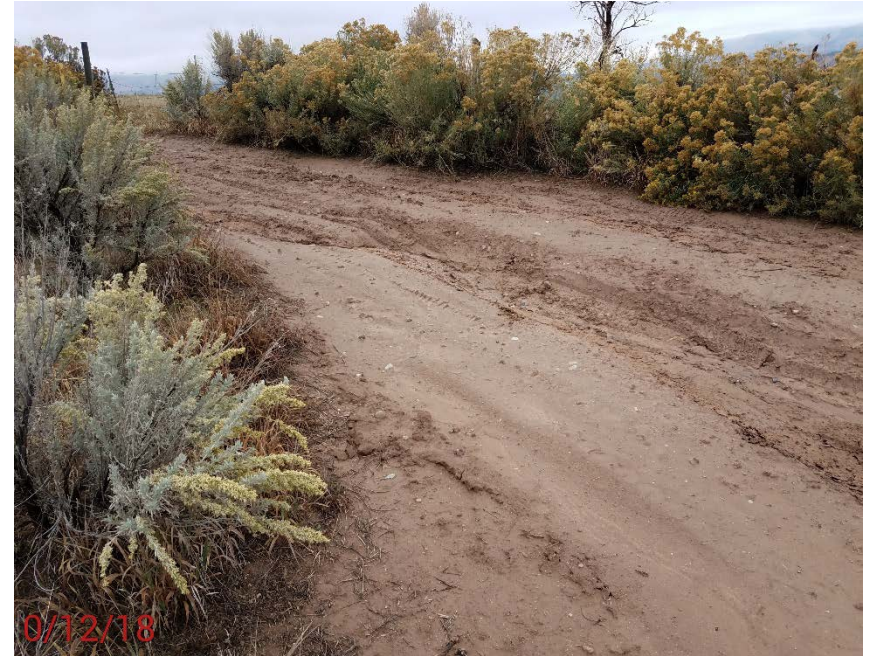
Location Photo #8, Rutted access road

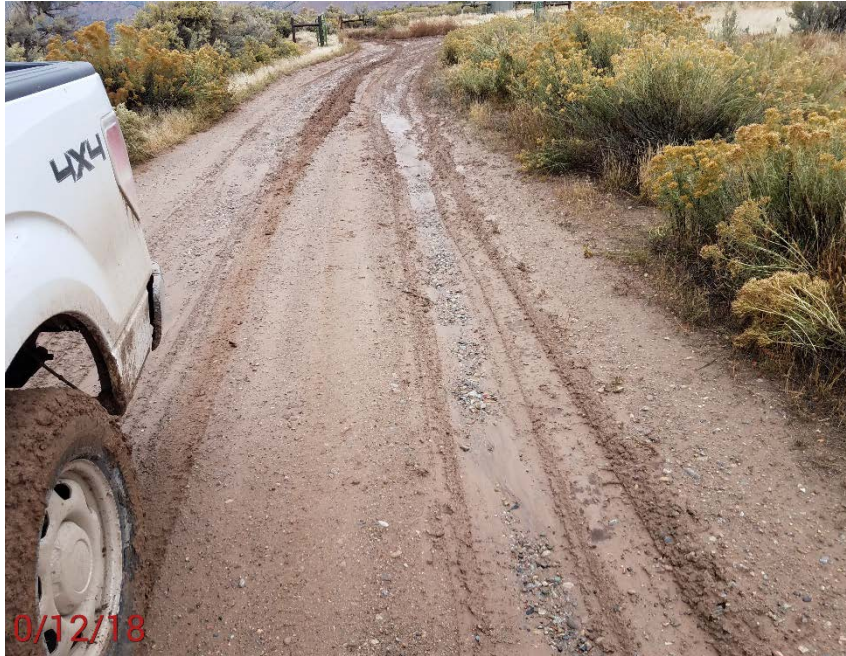
Location Photo #9, Rutted lease access road

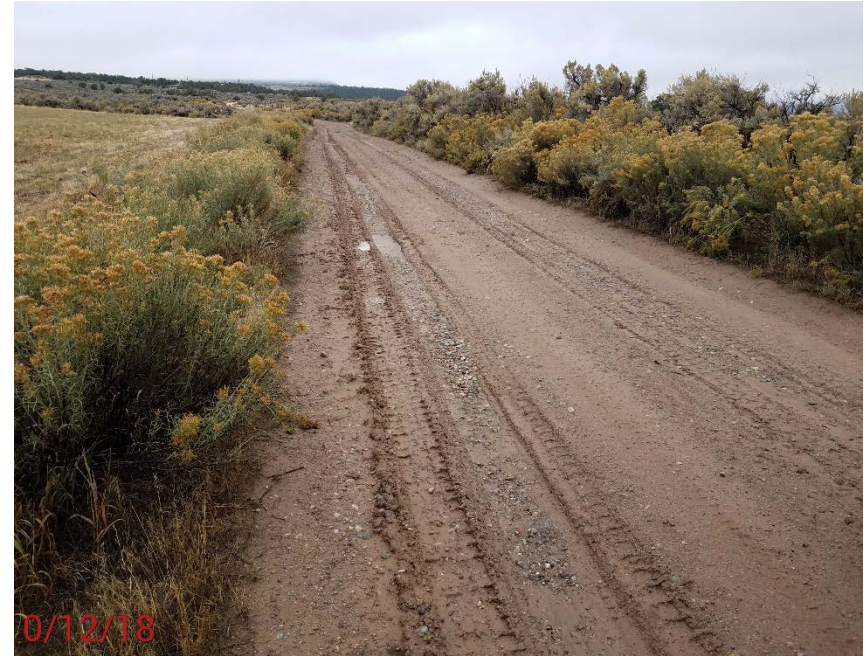
Location Photo #10, Rutted lease access road.
