# Inspection Photos

Operator: BP Production

API: 05-067-07868

Date: 10/05/2018

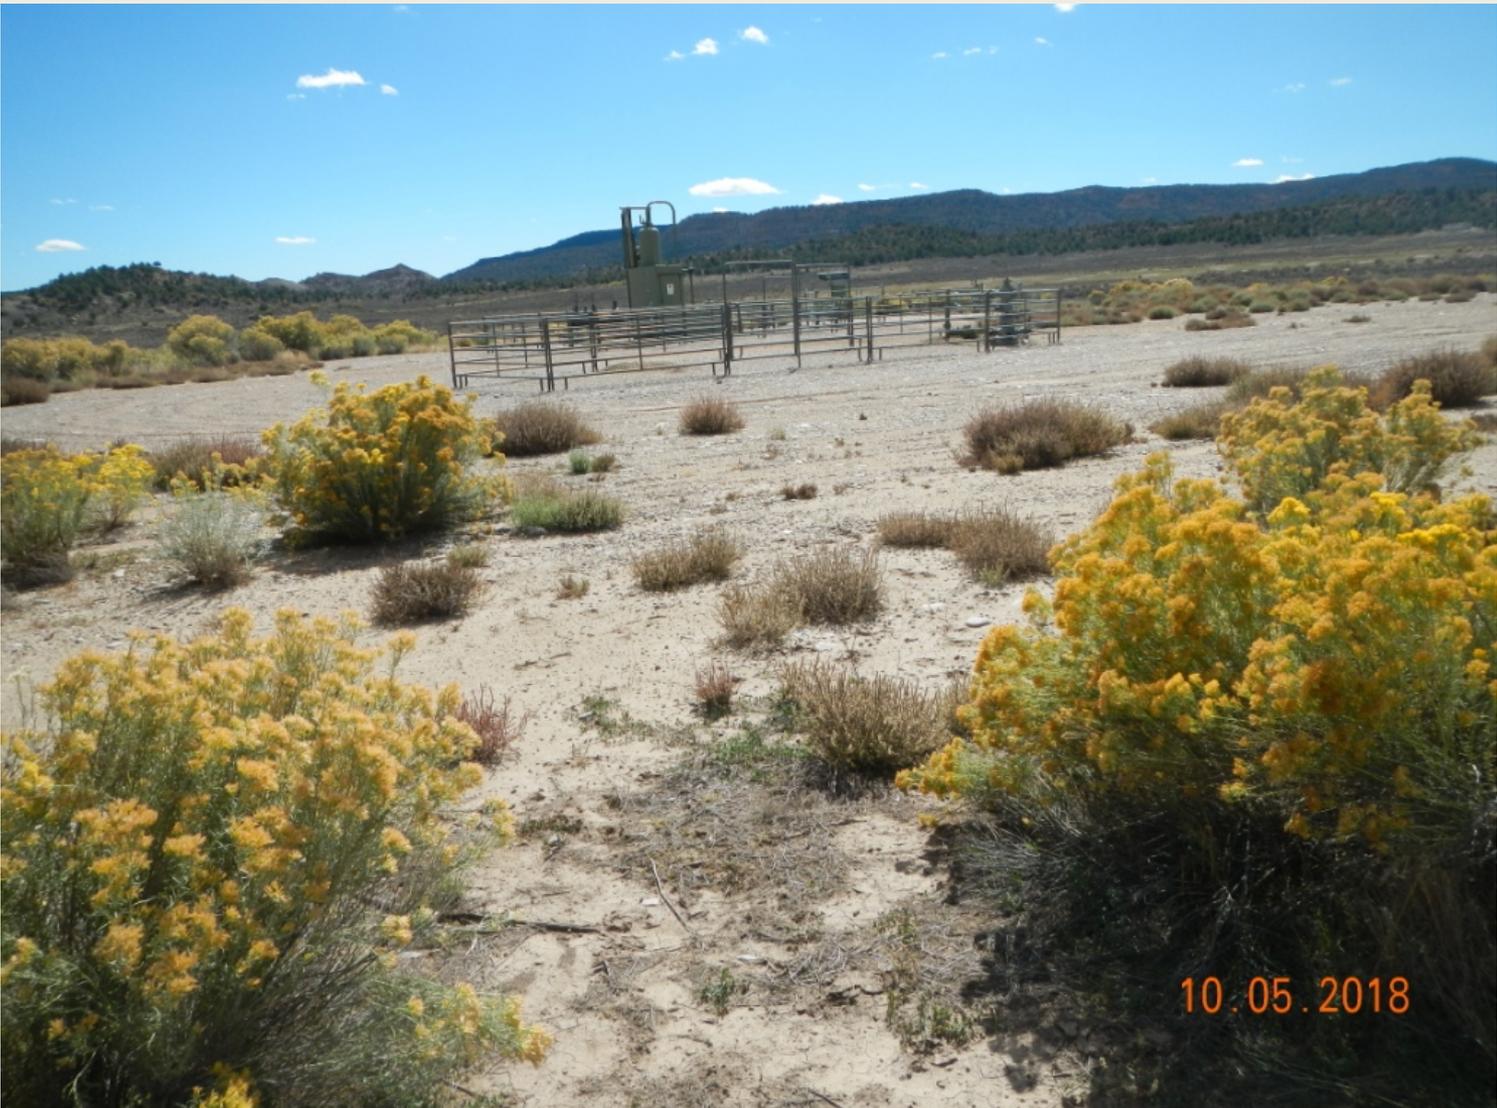
**Photo 1. View of the project area from the southern edge facing center**

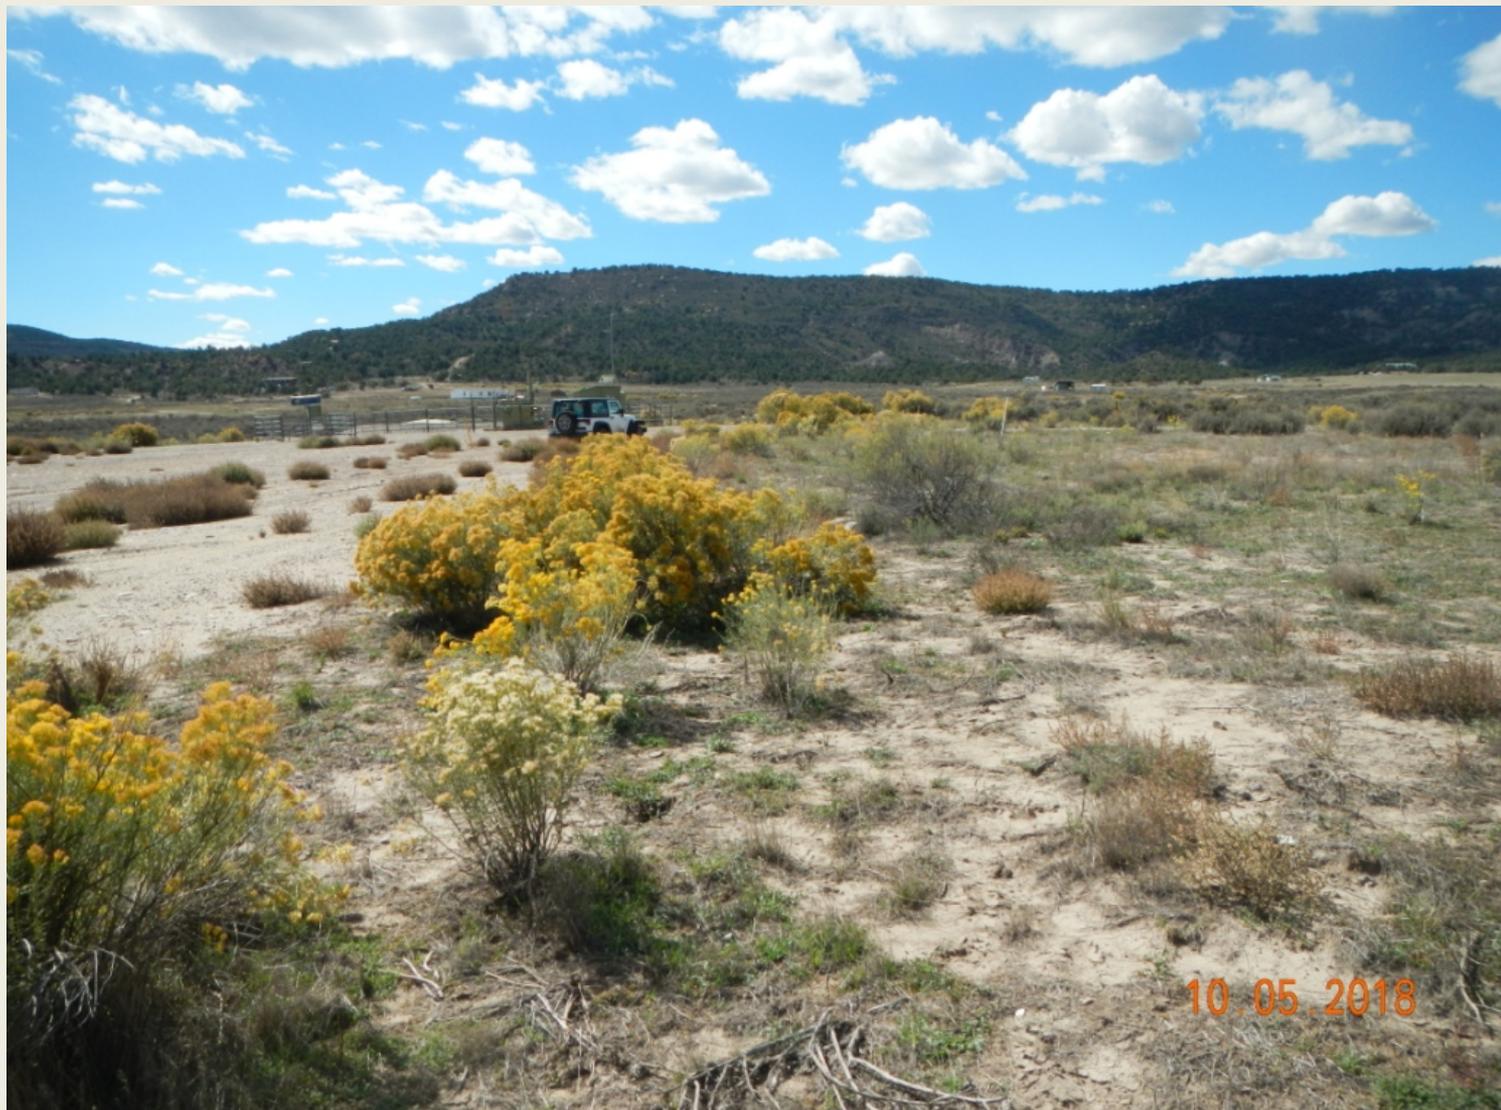
**Photo 2. View of the southern project area from the southwestern corner facing eastward. Revegetation is progressing within the interim reclamation areas with shrubs such as rabbitbrush (*Chrysothamnus nauseosus*), and grasses such as western wheatgrass (*Pascopyrum smithii*) and sand dropseed (*Sporobolus cryptandrus*).**

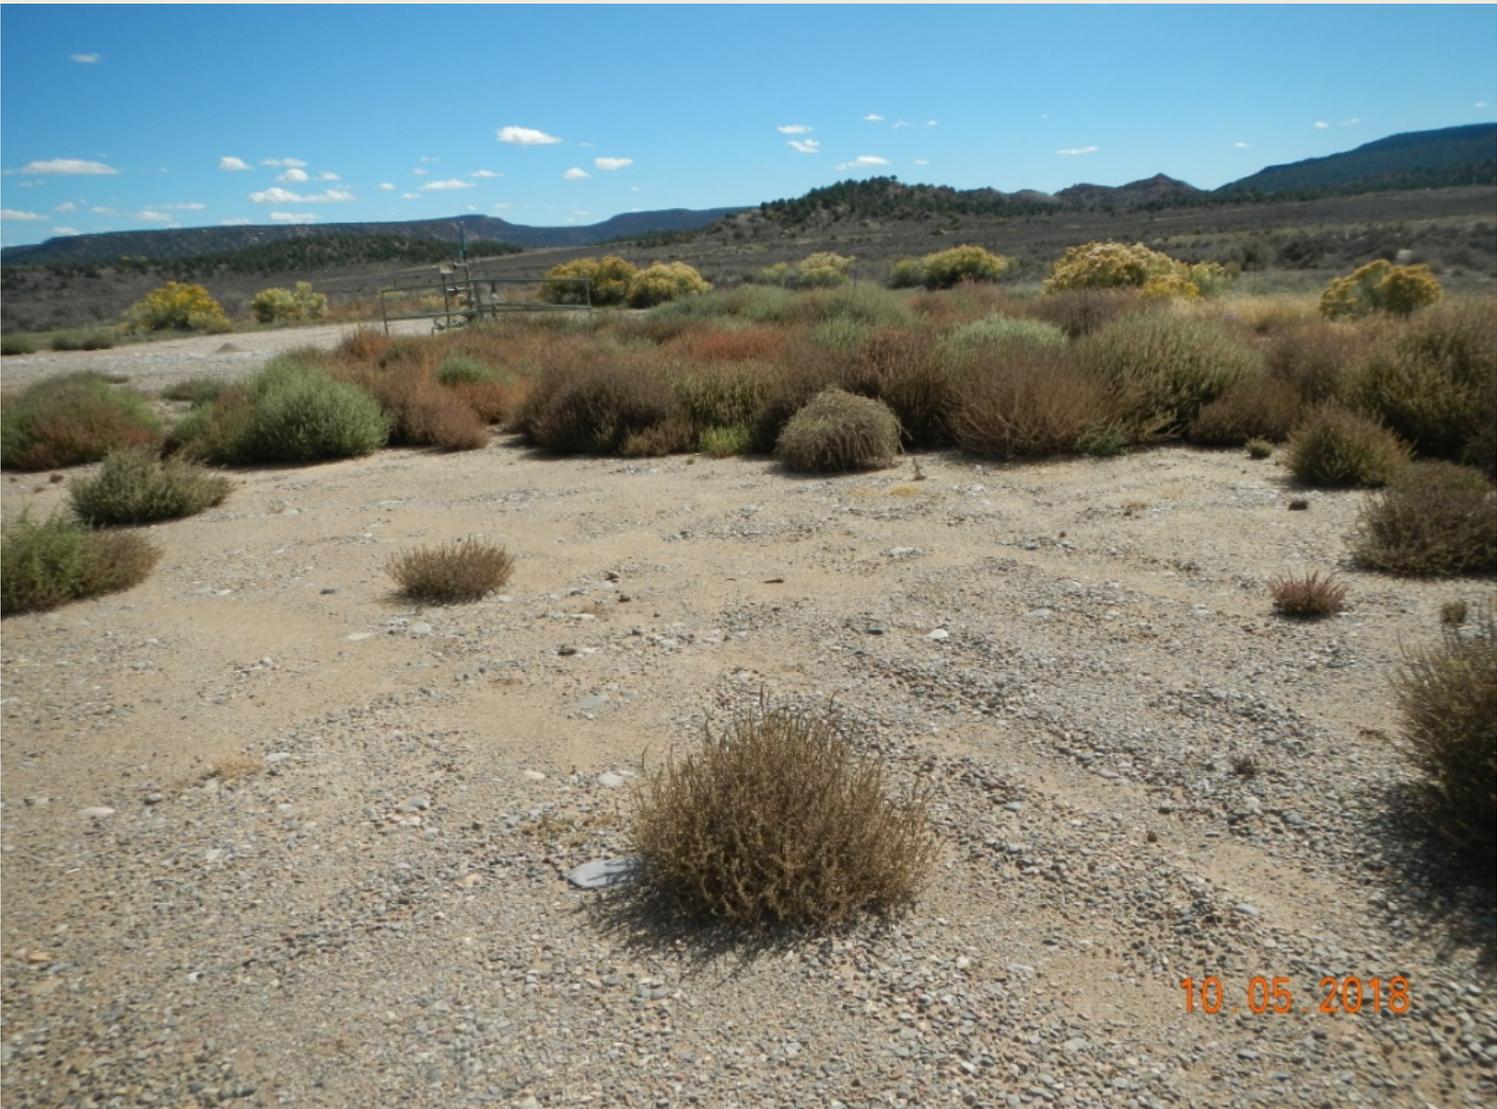
**Photo 3. View of Russian thistle (*Salsola tragus*) debris within the southern portion of the working area facing eastward.**

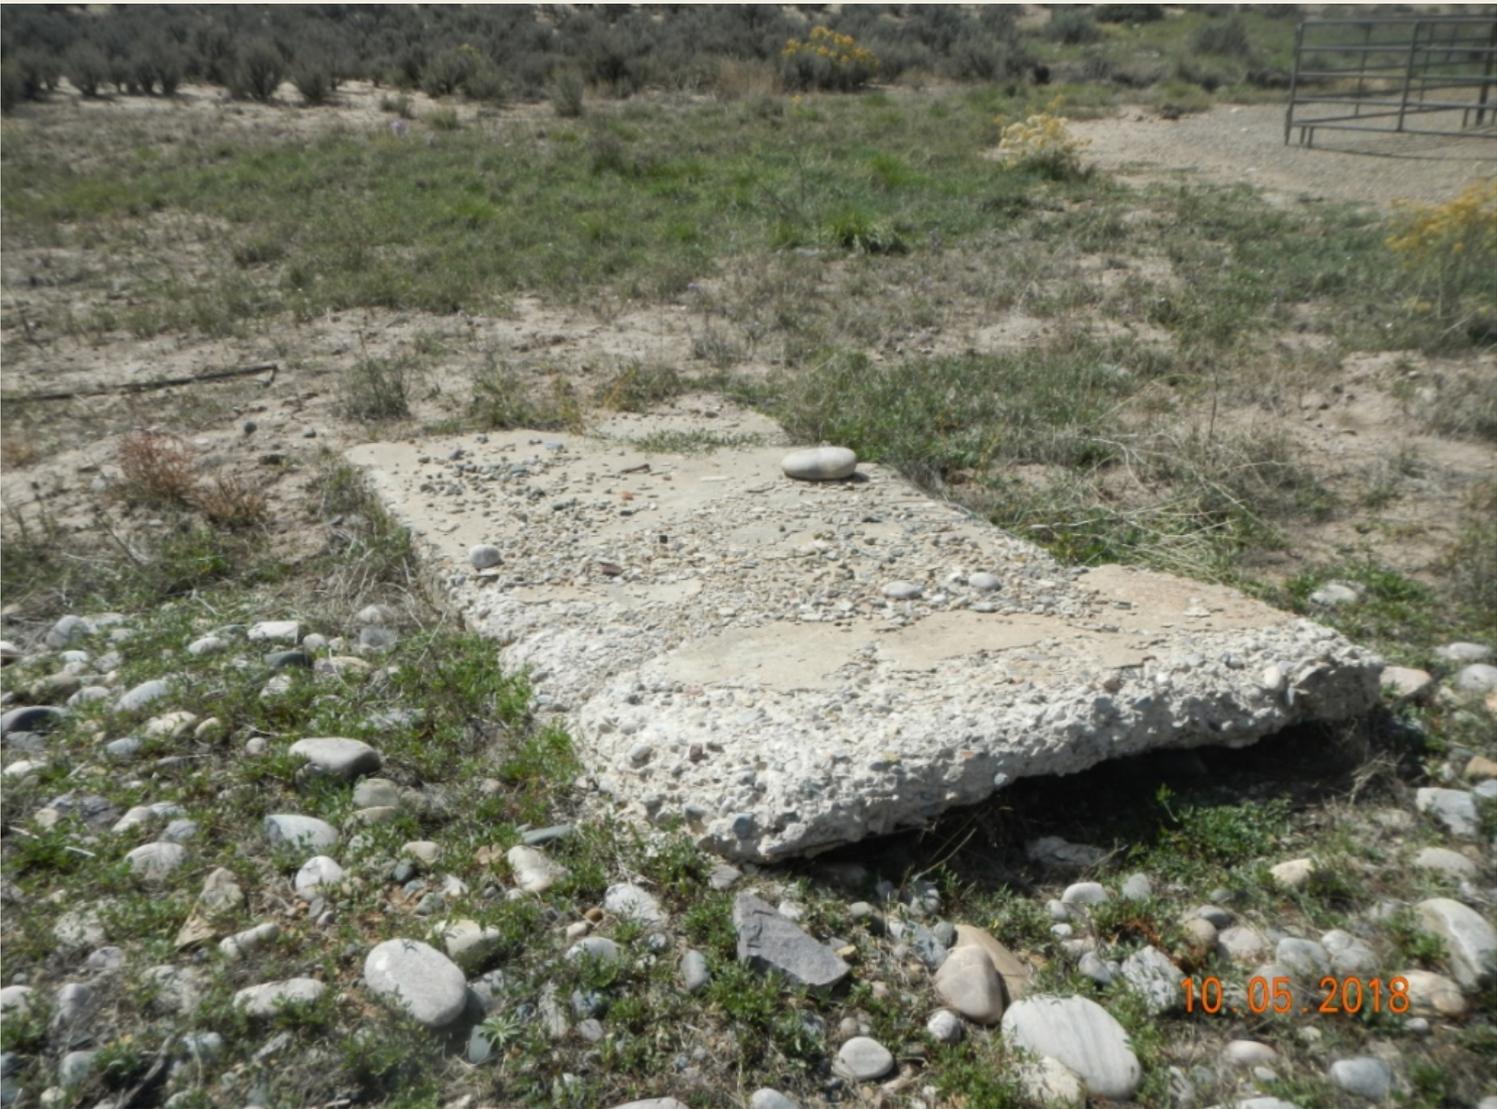
**Photo 4. View of cement debris approximately 2 feet wide and 5 feet long within the southern project area.**

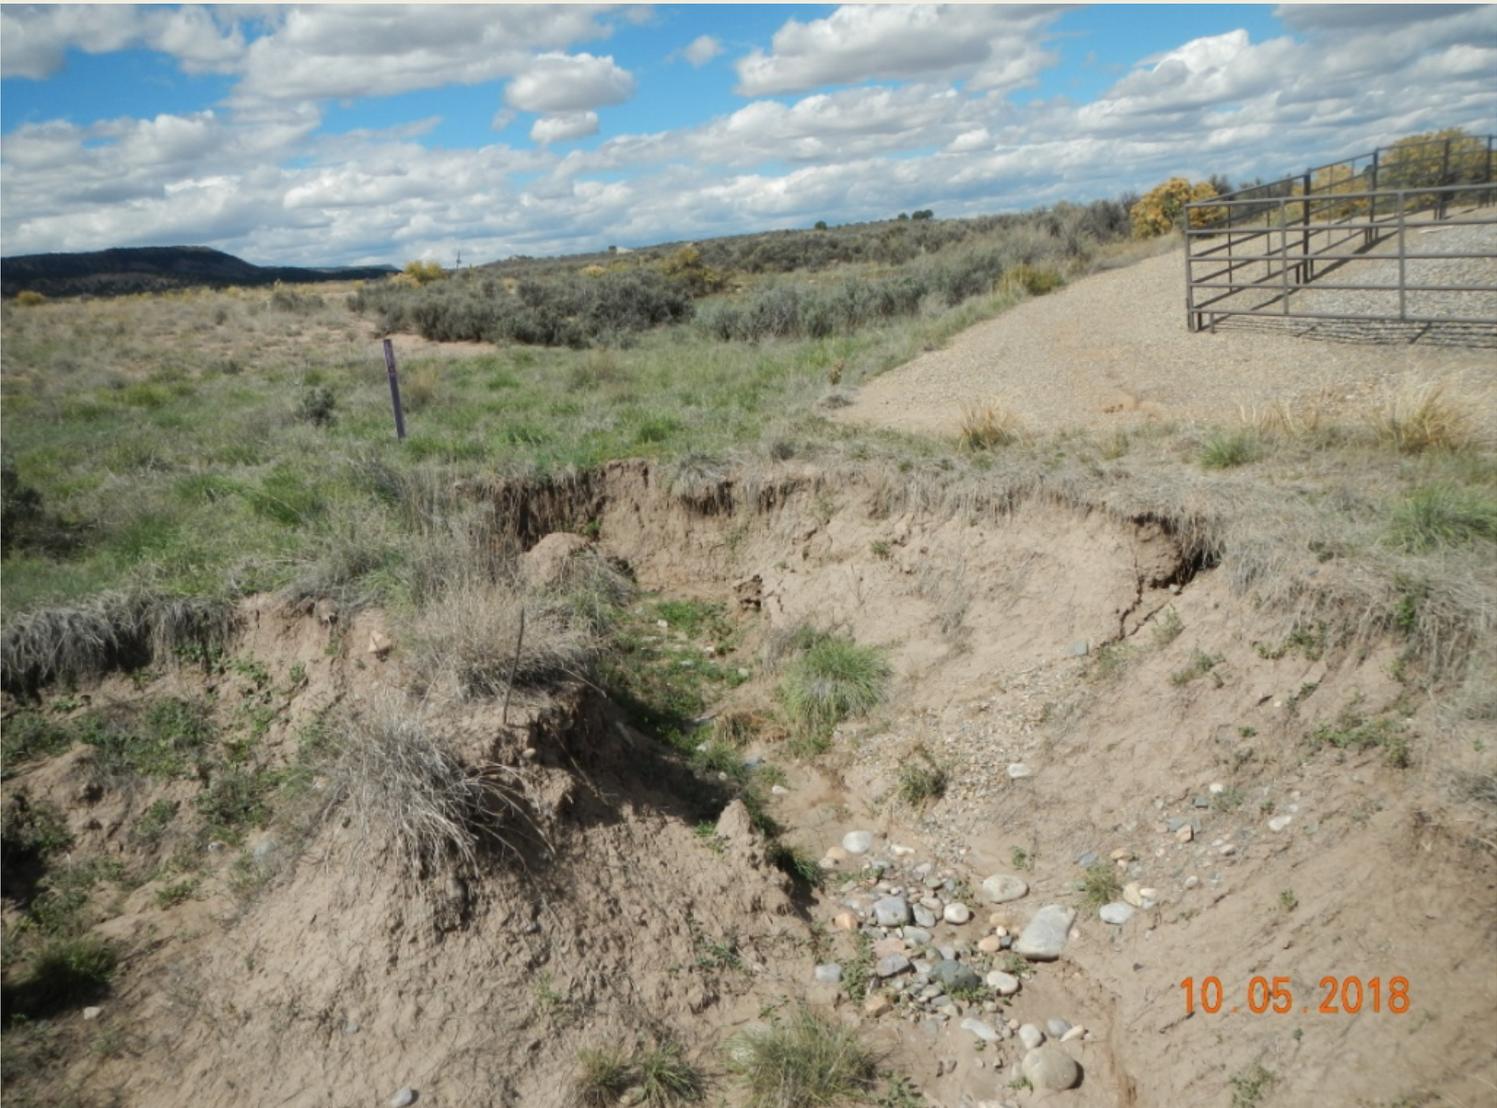
**Photo 5. View of headcut erosion, approximately 5 feet deep in the southwestern project area, needs stabilization.**

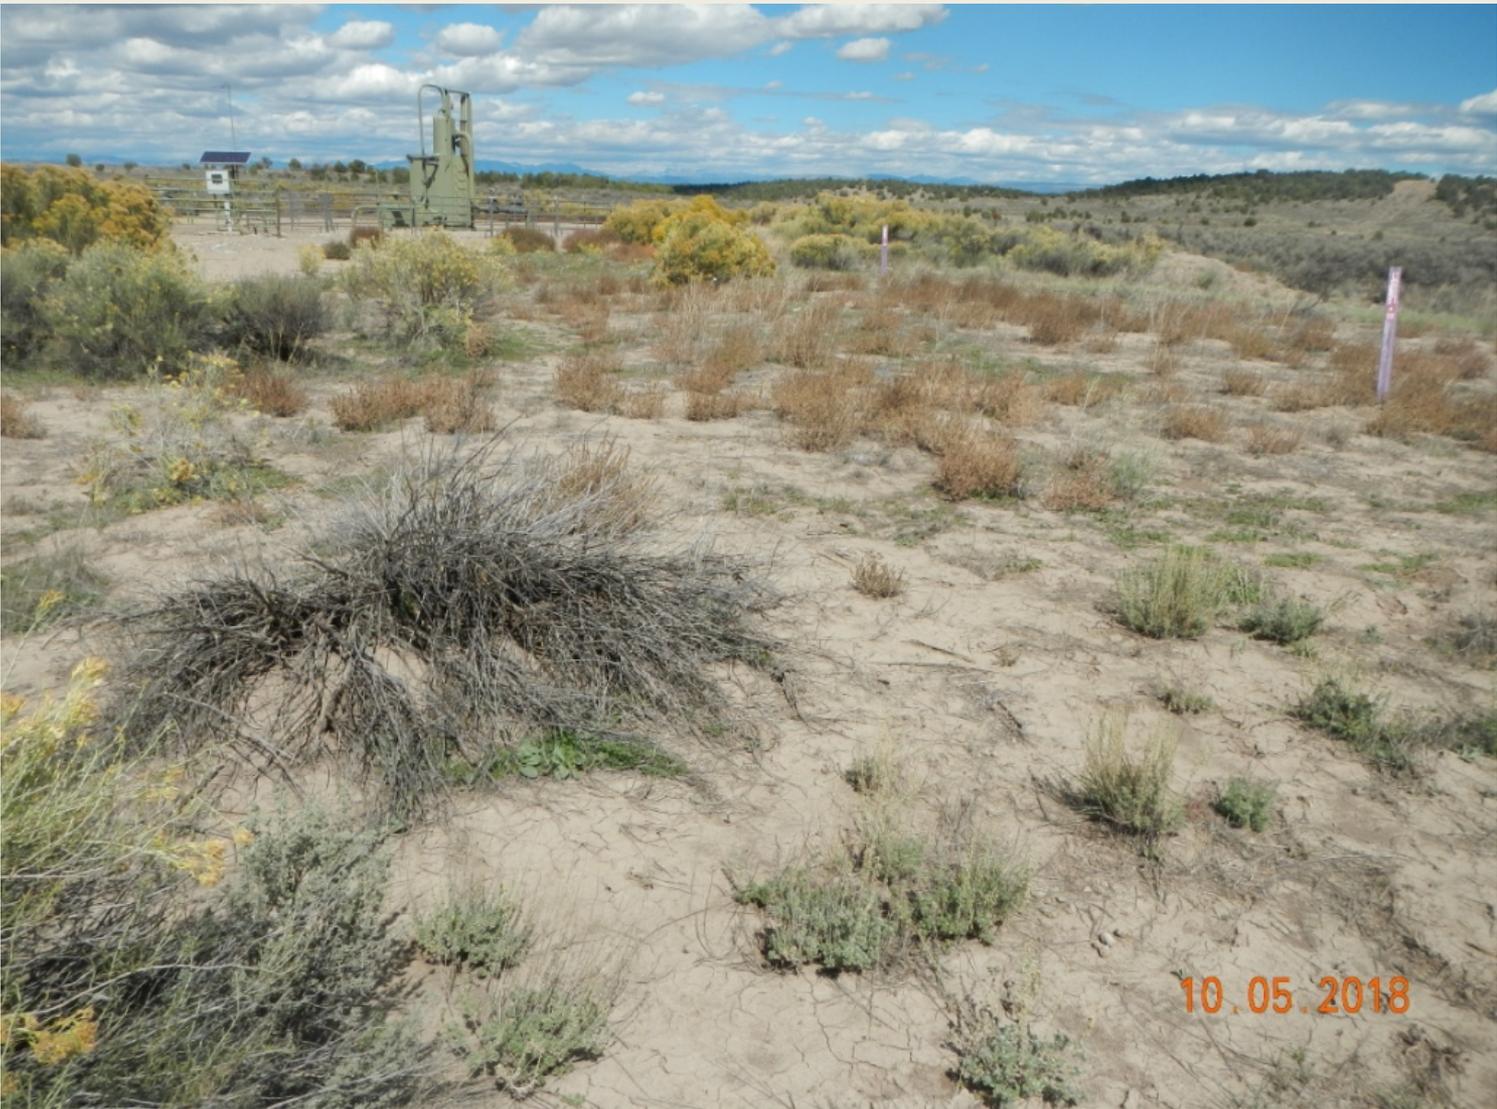
**Photo 6. View of the eastern project area from the southeastern corner facing northward.**

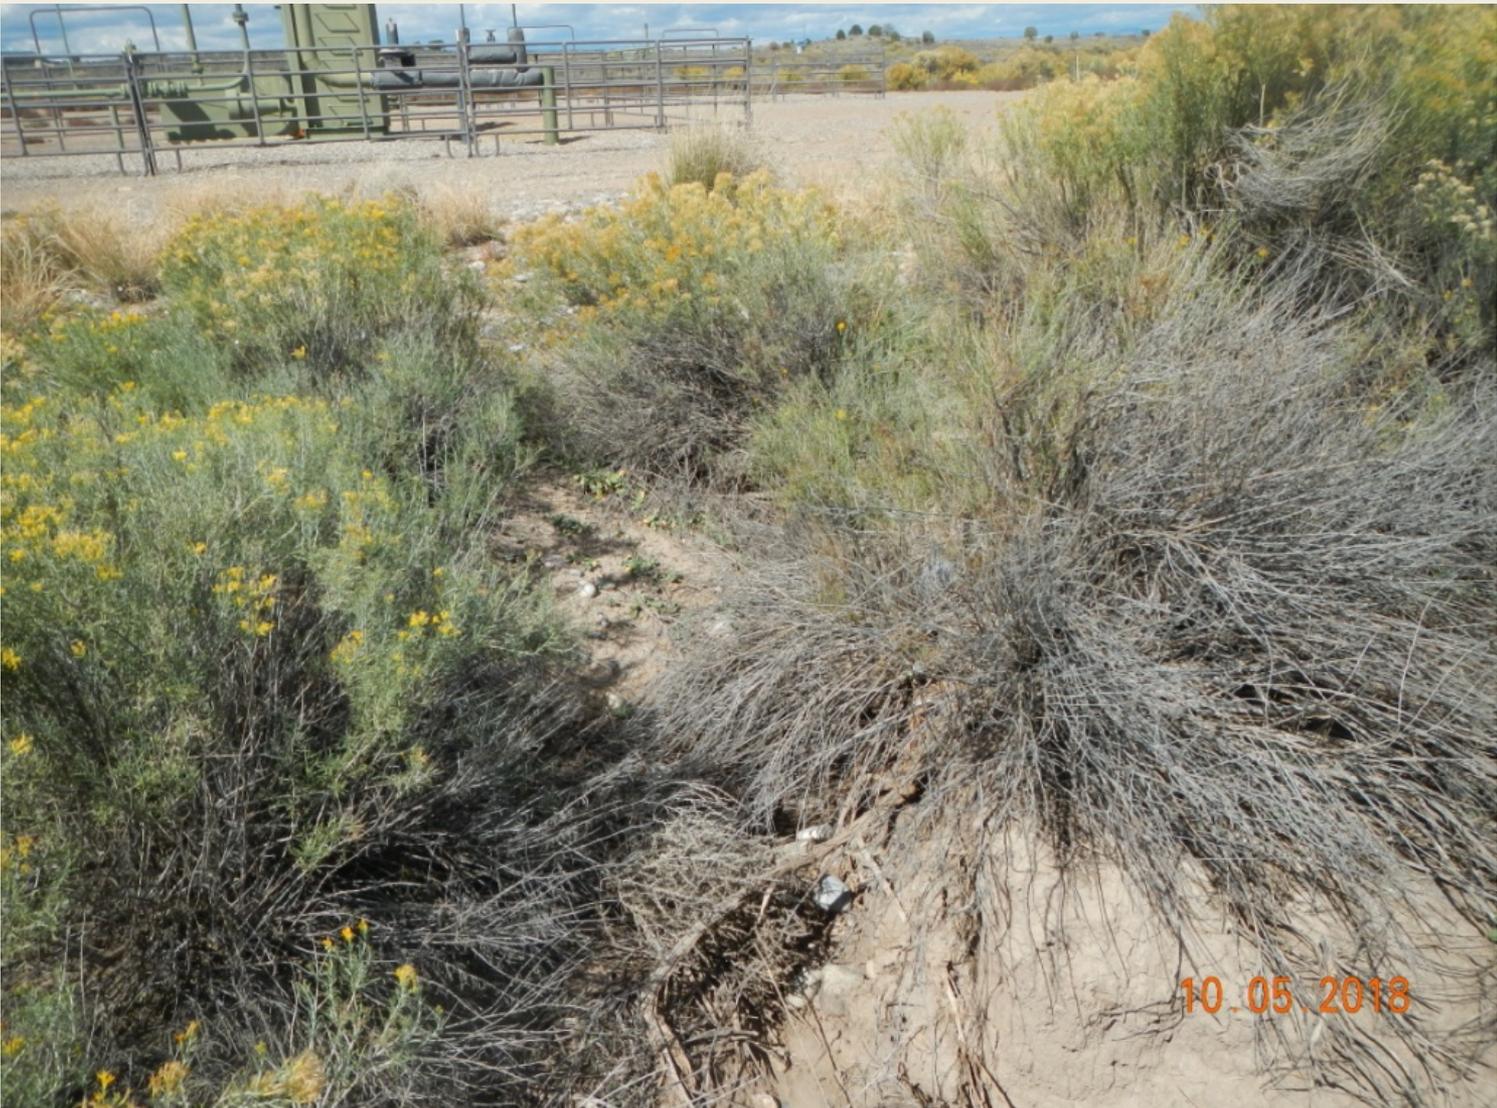
**Photo 7. View of an area in the southeastern project area where concentrated stormwater flows exit the well pad, creating a headcut approximately 3 feet wide and deep that flows through dense rabbitbrush shrubs.**
