Inspection Photos

Operator: FOUNDATION ENERGY
MANAGEMENT LLC - 10112

Location ID: 327492

Inspection Doc. Number: 682504197
Weld County, CO

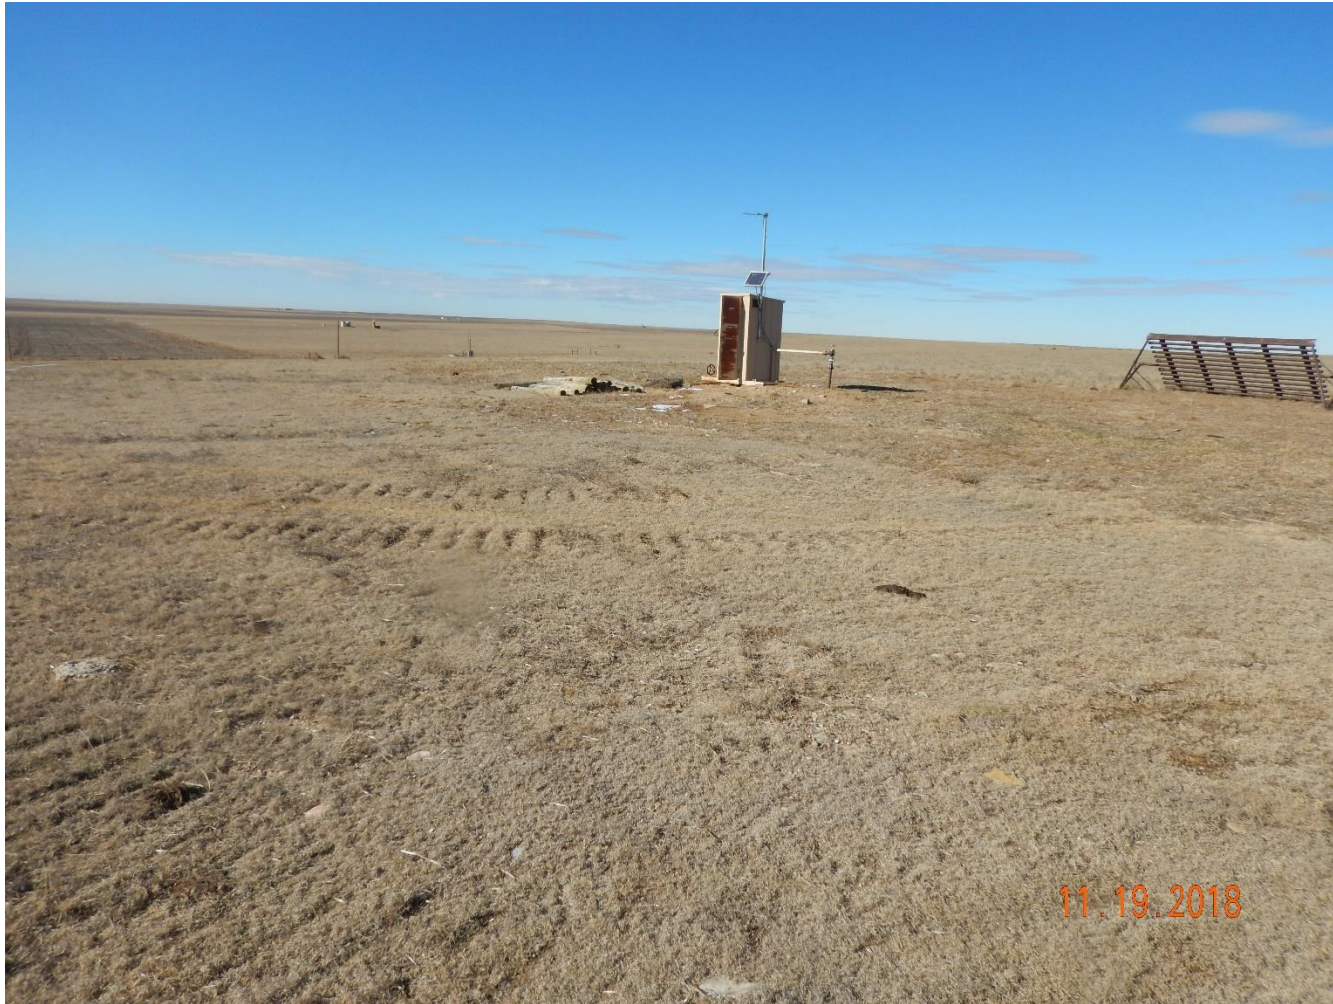
Photo 2: Photo taken from the south end of the battery location facing west. Photos 2-4 provide an overview of the location from west, north, to east. Photos also show operator has failed to remove equipment and conduct reclamation of the location.

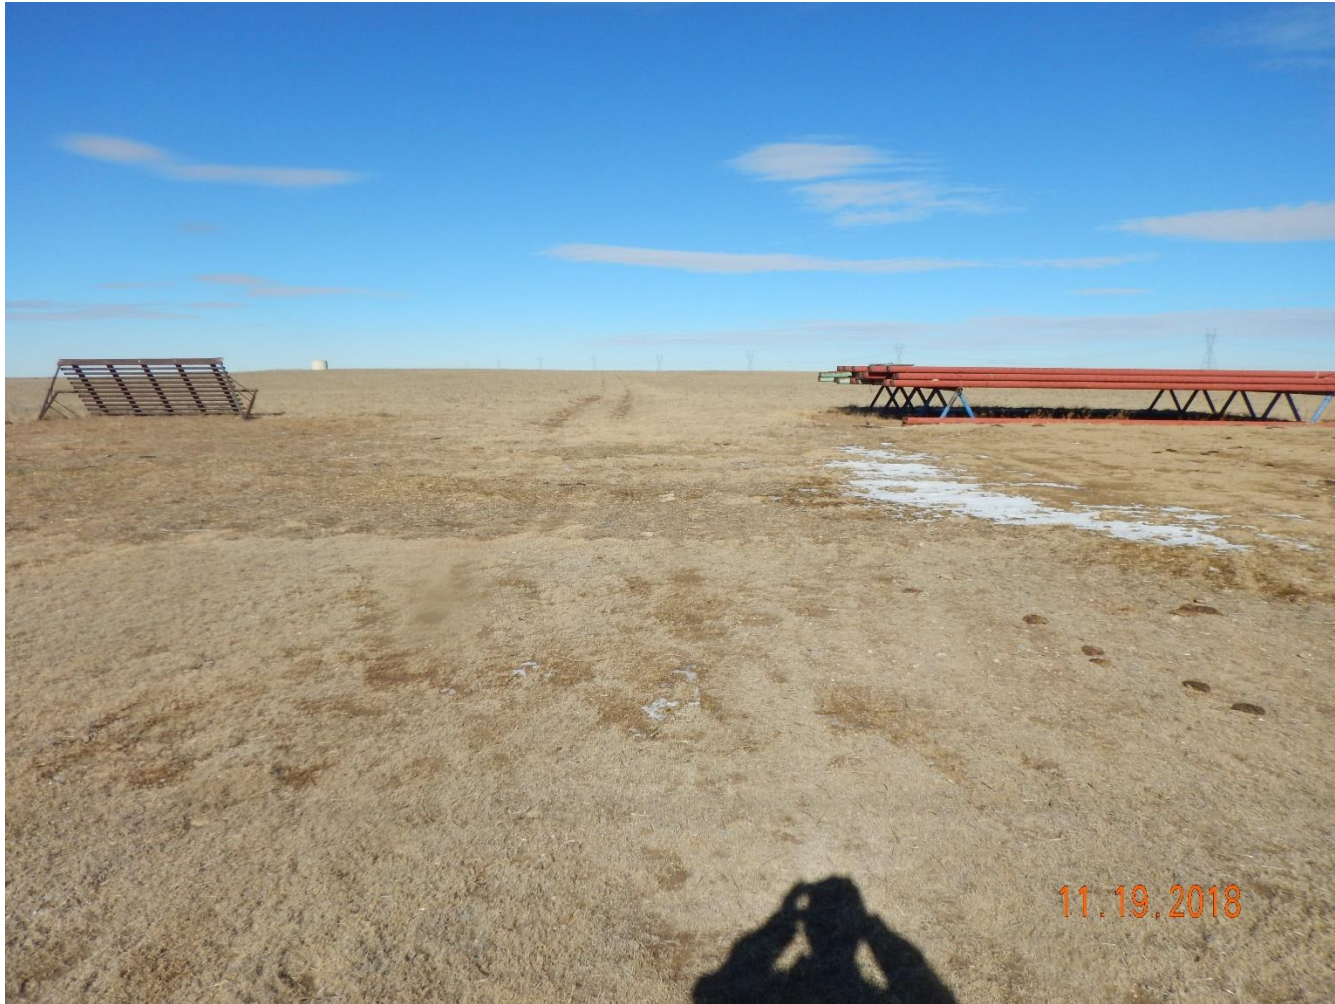
Photo 3: See Comments under photo 2.

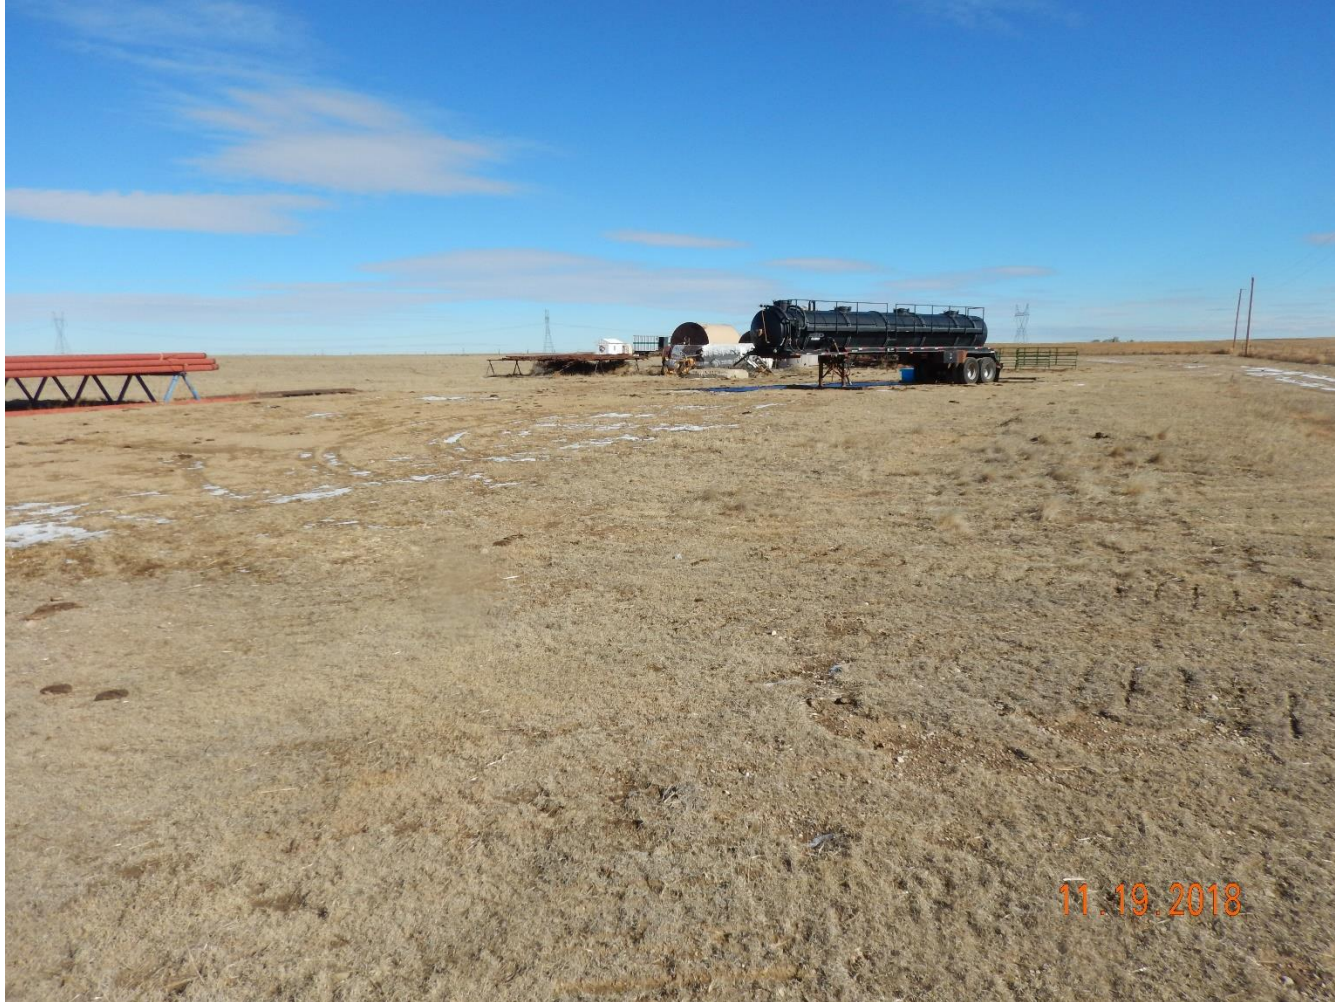
Photo 4: See comments under photo 2.

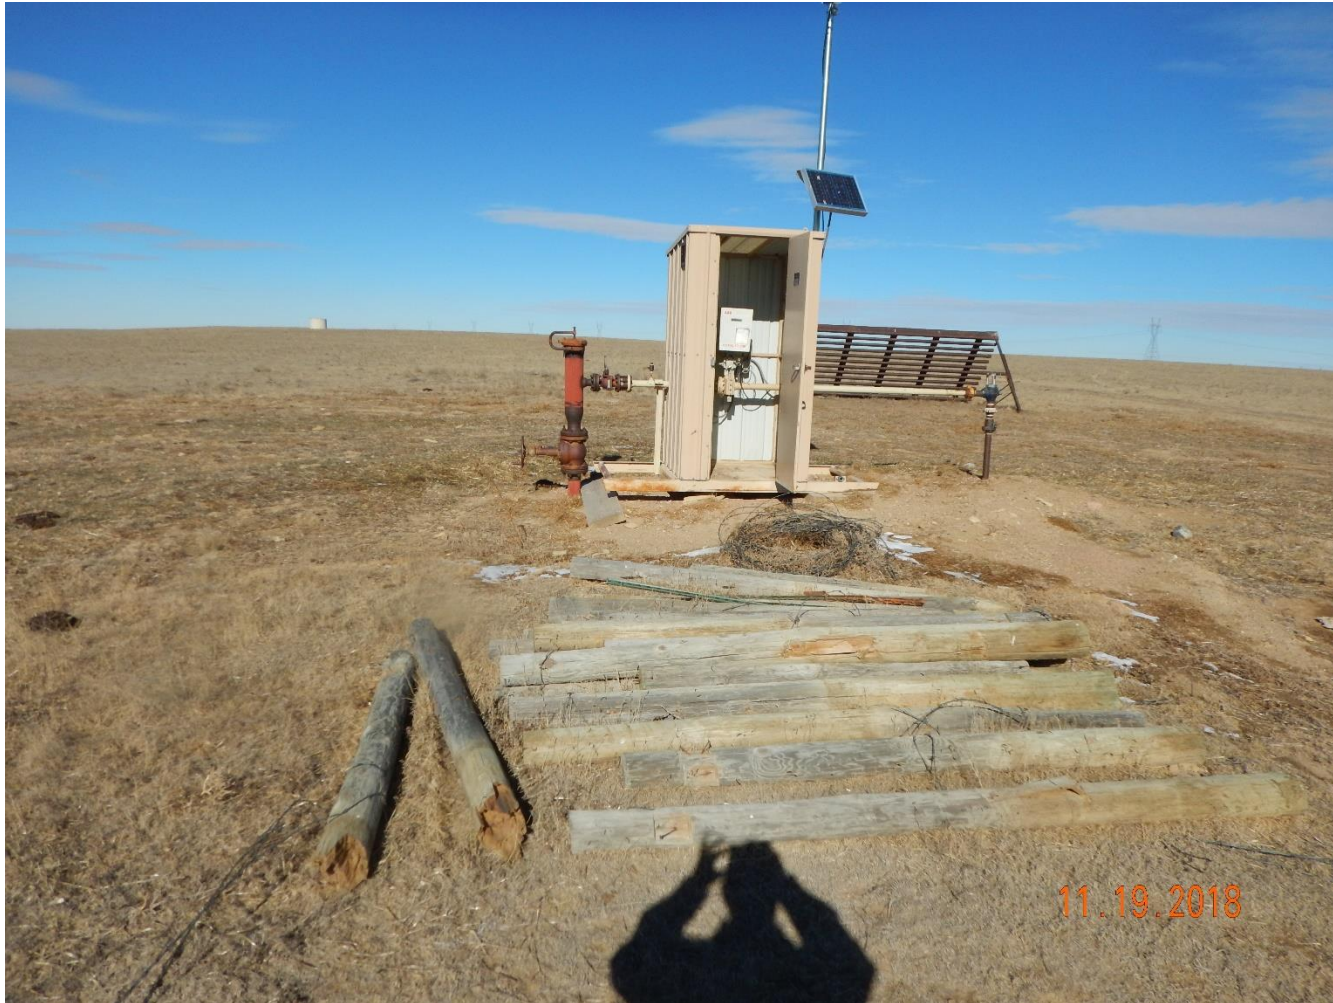
Photo 5: Photo taken from the battery location, facing north. Photo shows operator has failed to remove equipment within 3-months of plugging the well.

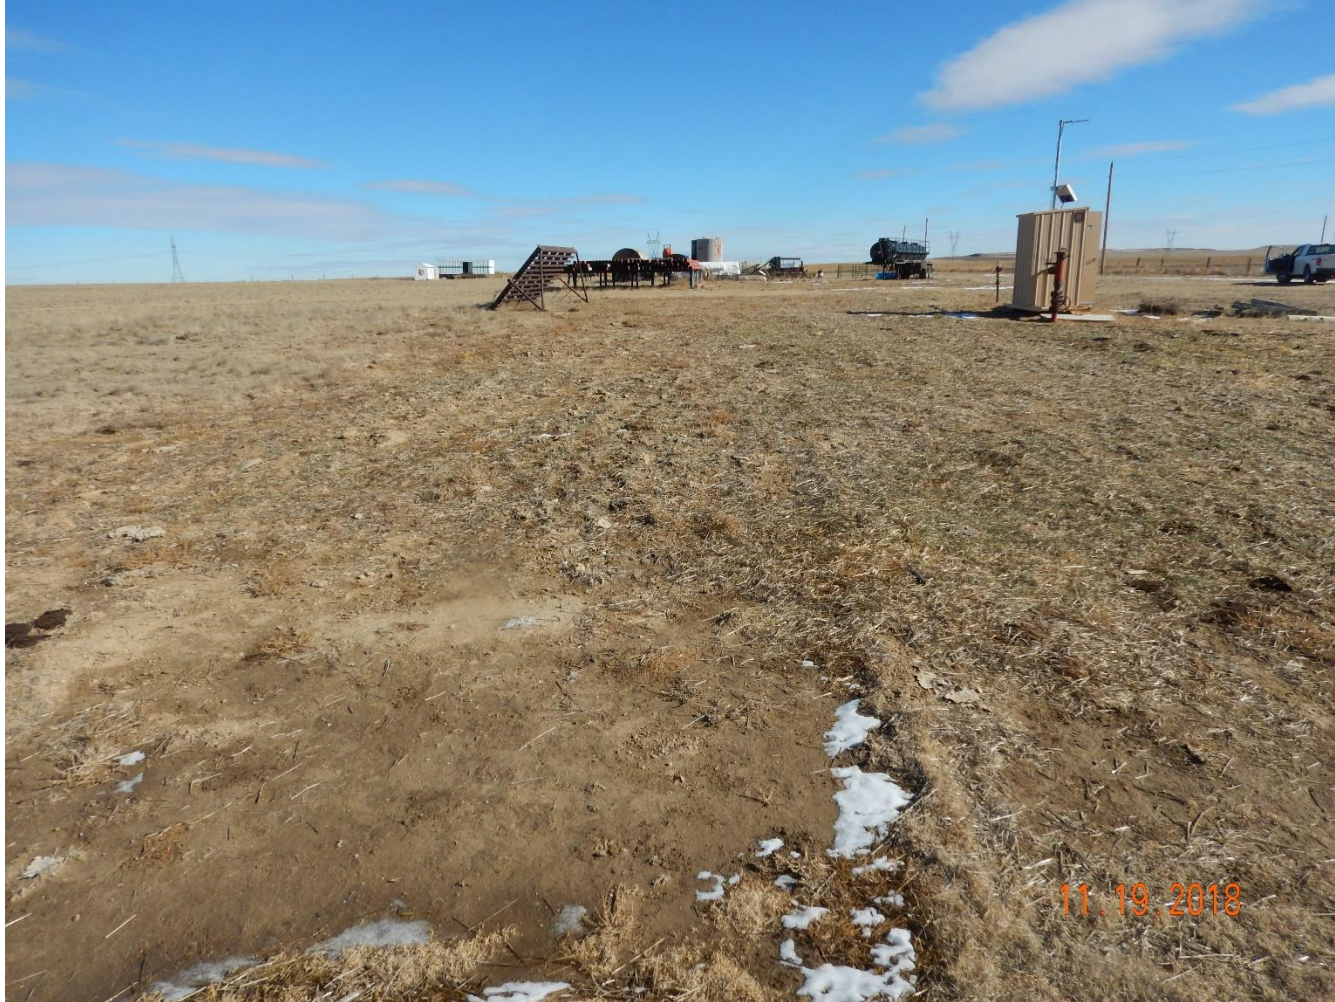
Photo 6: Photo taken from the west end of the battery location, facing east. Photo shows pits appear to have been closed.

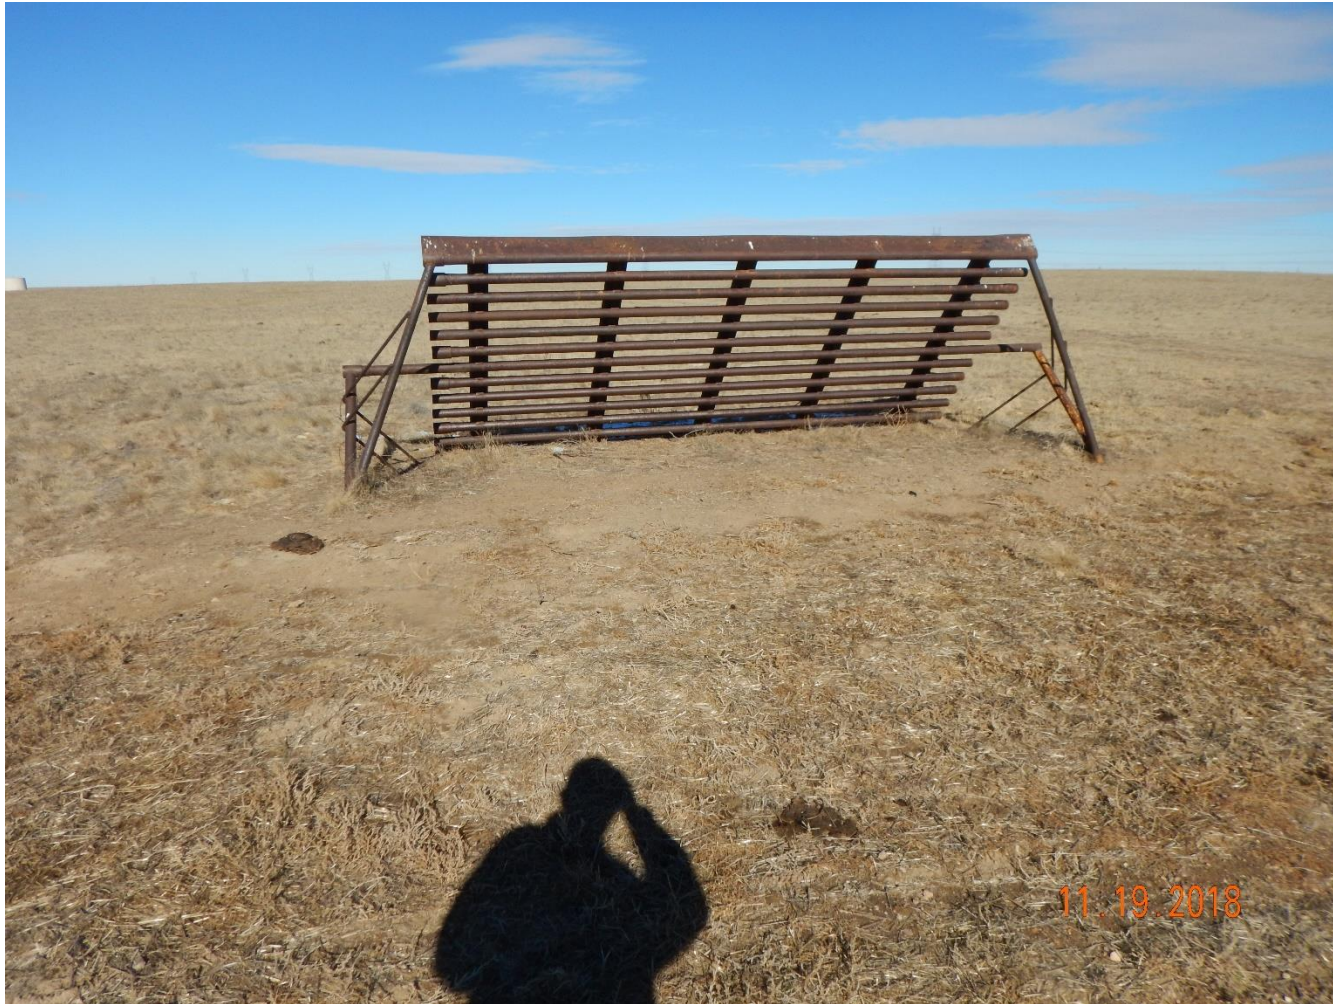
Photo 7: Photo taken from the battery location, facing north. Photo shows operator has failed to remove equipment from the location per 603.f and 1004.a.

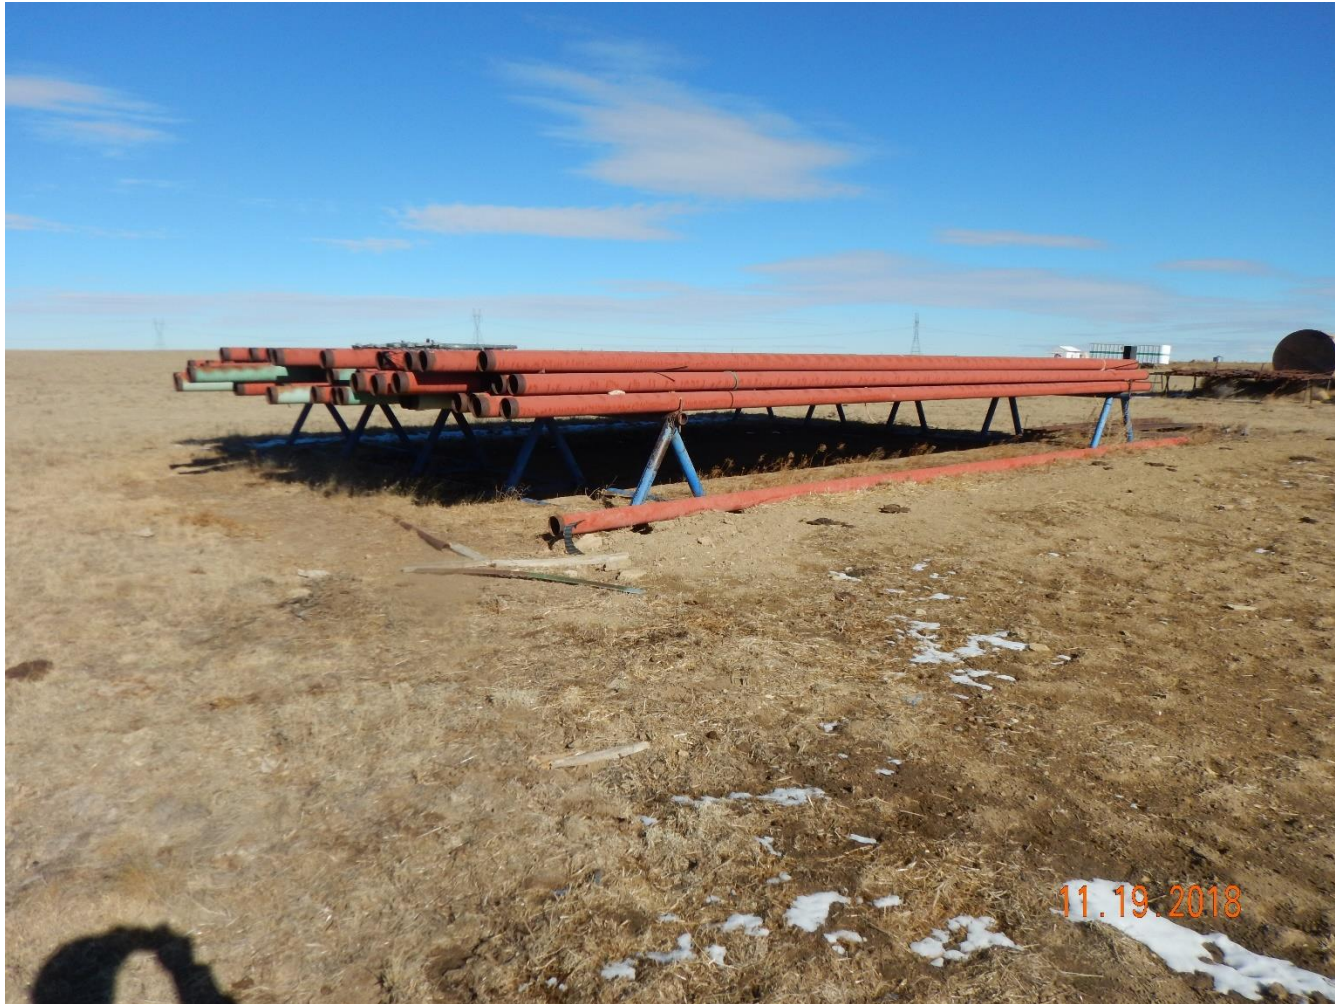
Photo 8: Photo taken from the battery location, facing northeast. See comments under photo 7

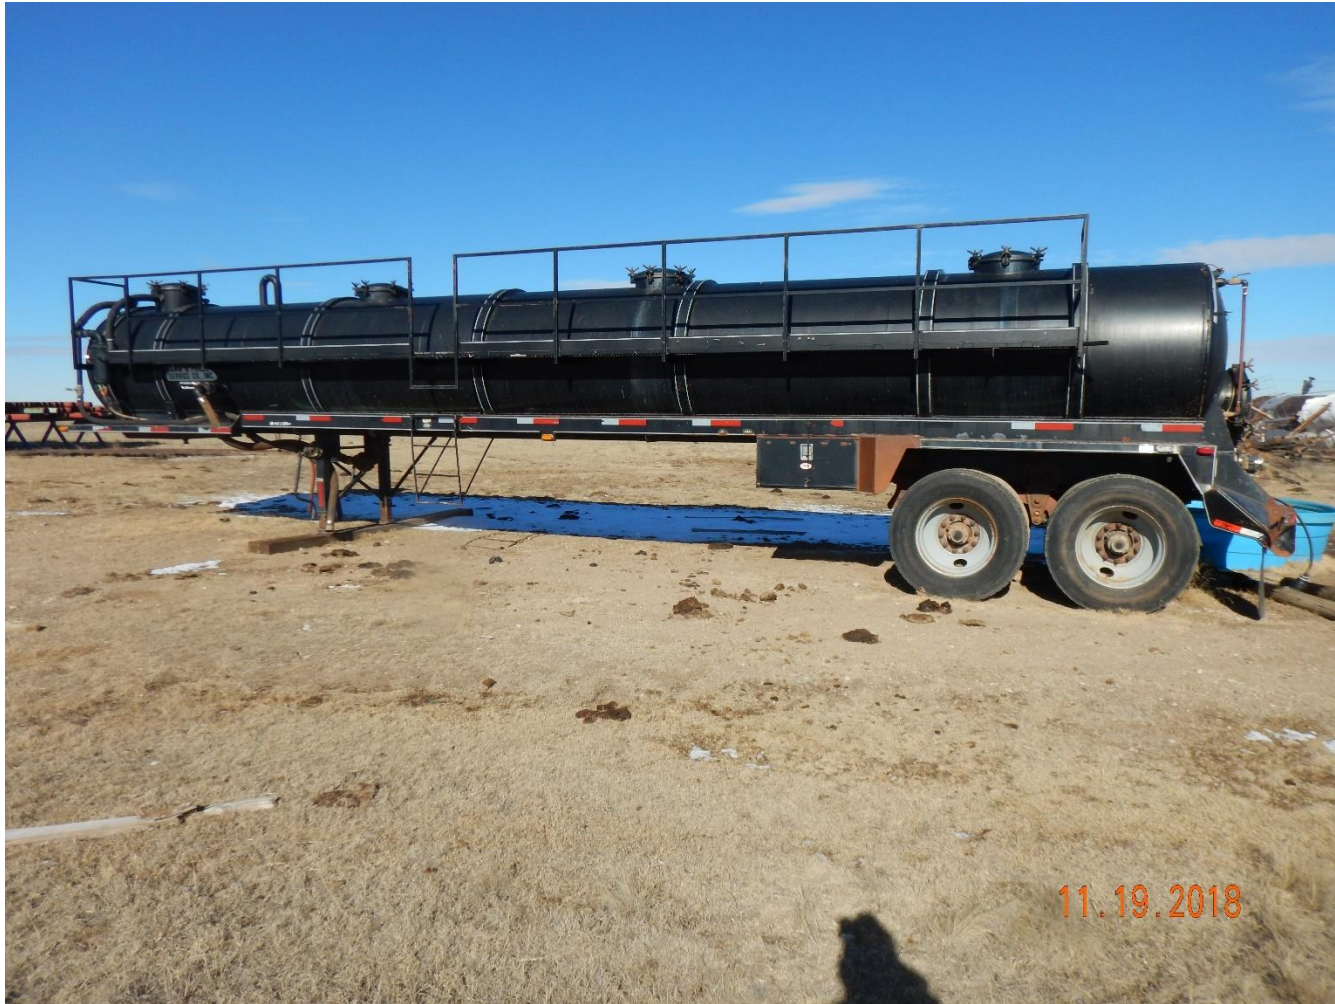
Photo 9: Photo taken from the battery location, facing north. See comments under photo 7

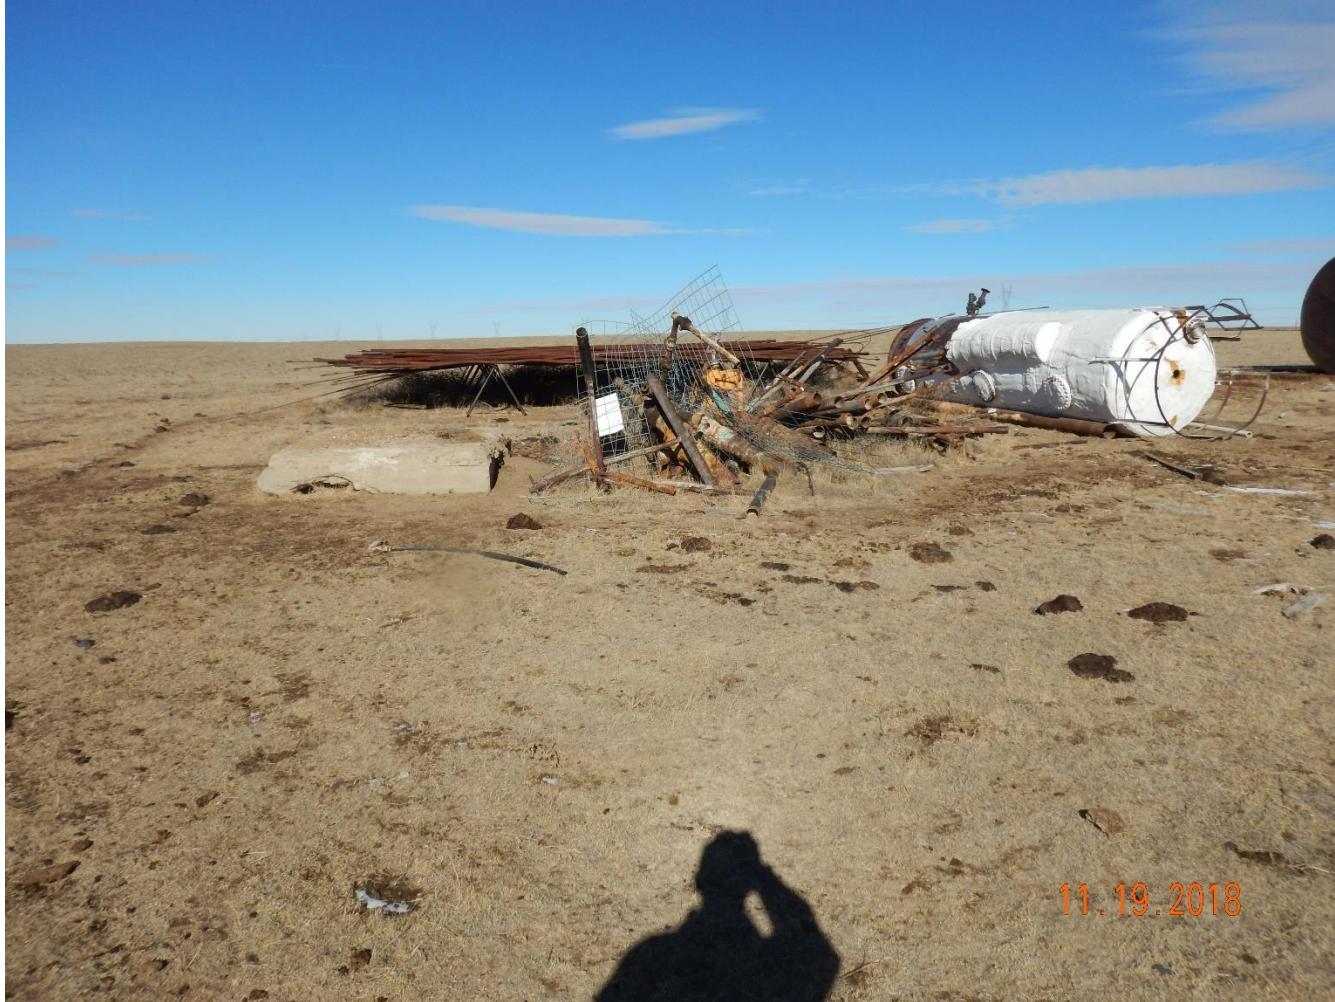
Photo 10: Photo taken from the battery location, facing northeast. See comments under photo 7

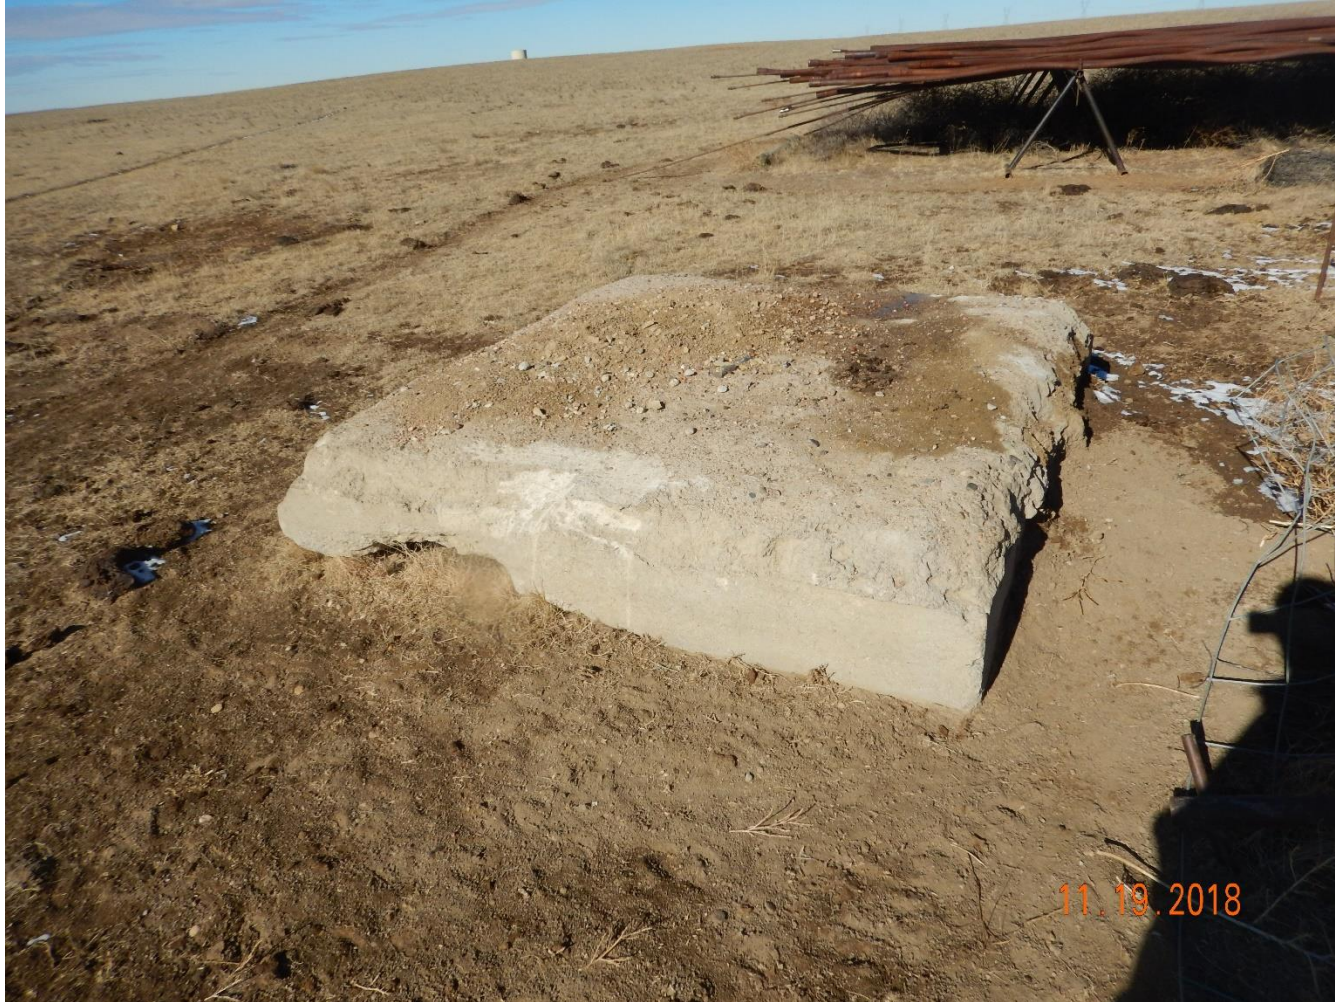
Photo 11: Photo taken from the battery location, facing north. See comments under photo 7

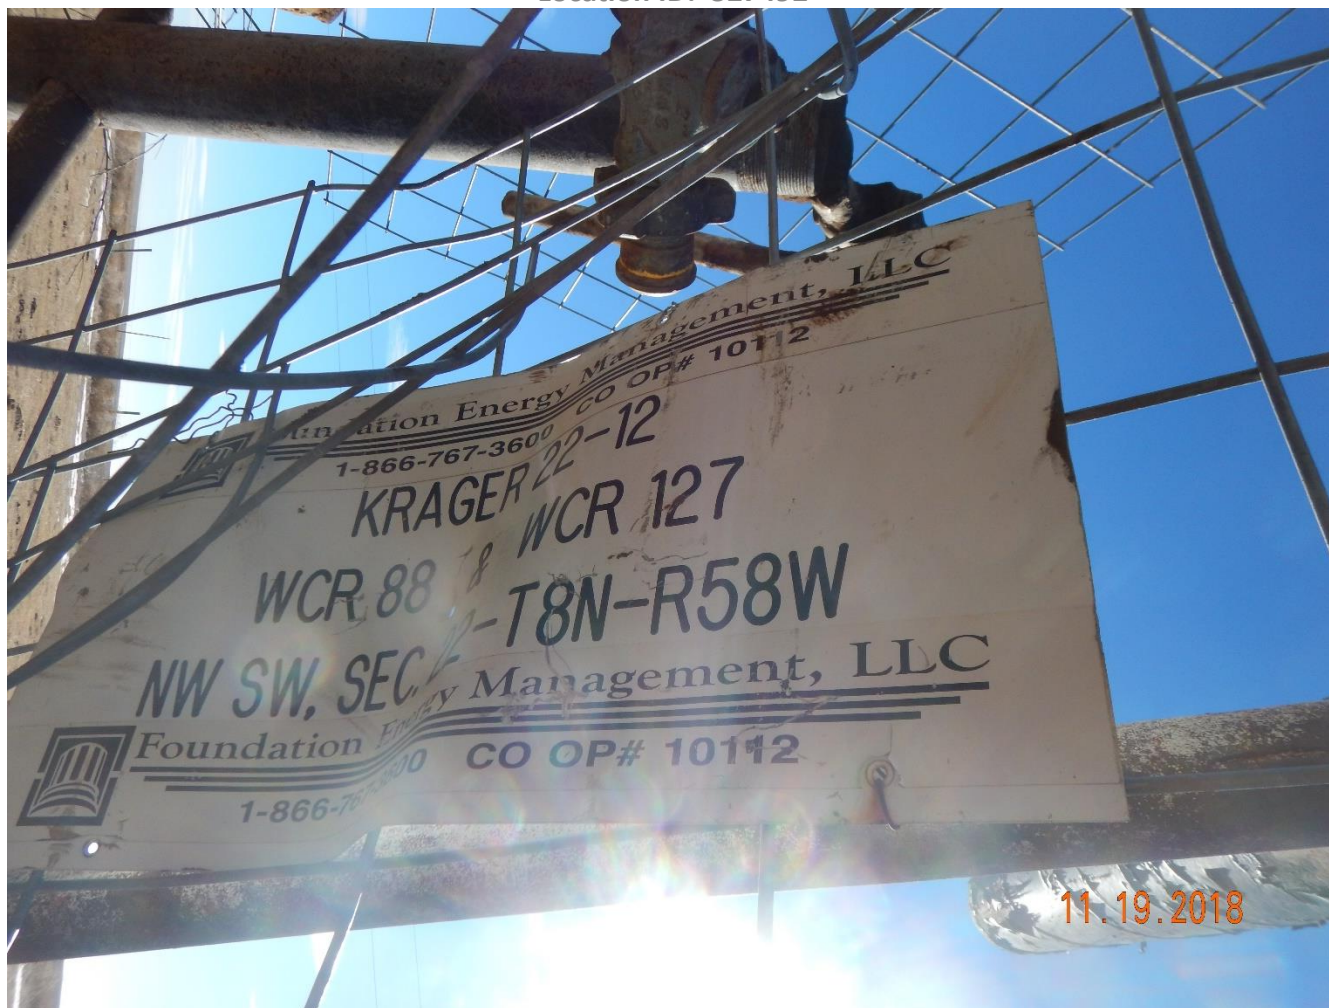
Photo 12: Photo taken from the battery location, facing north. Photo shows "Foundation" sign amongst debris on site.

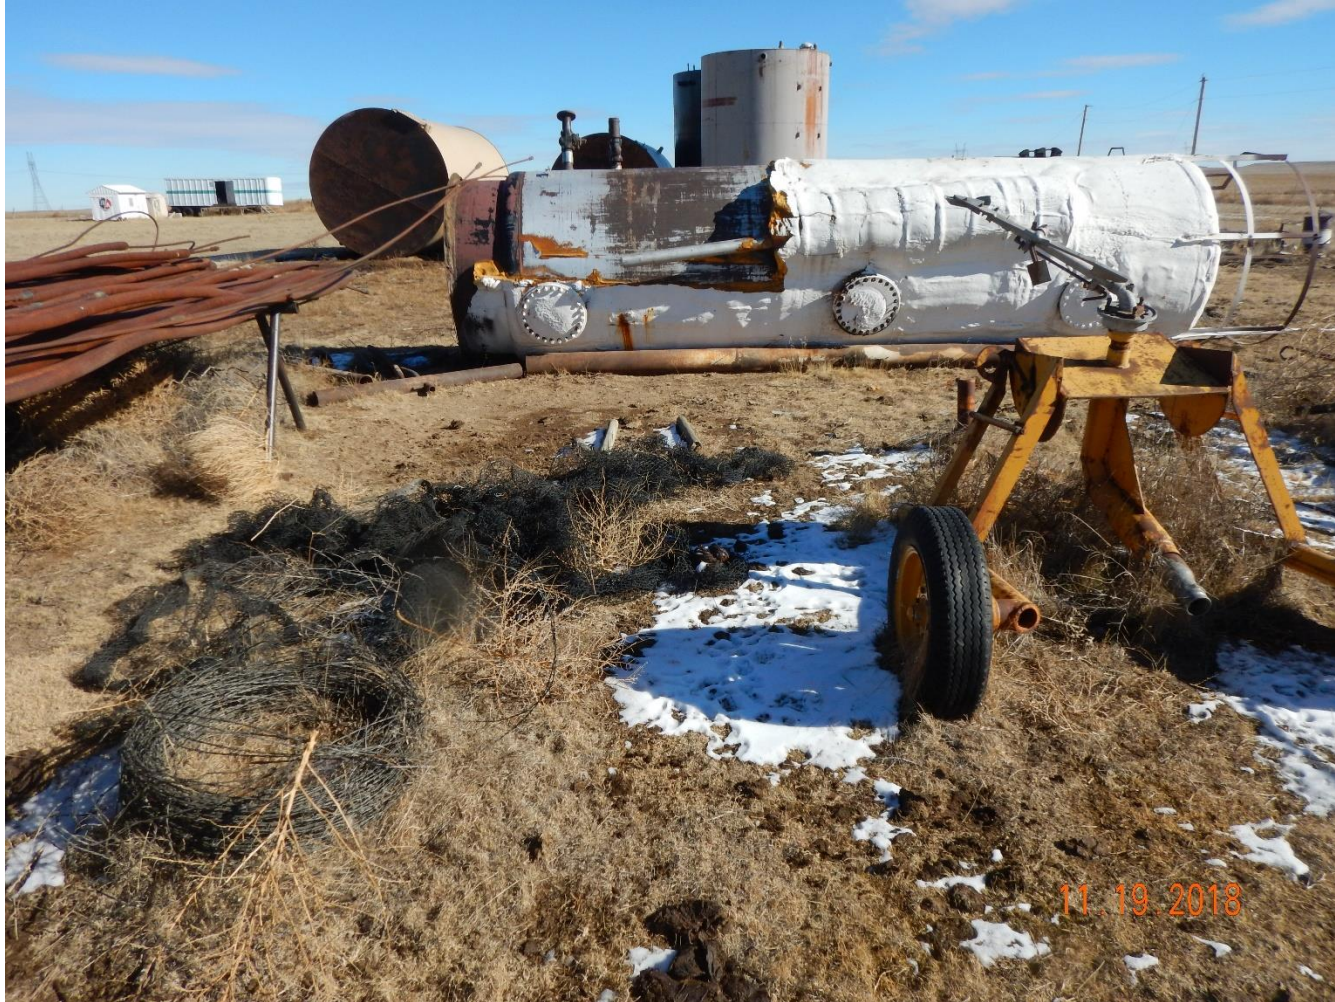
Photo 13: Photo taken from the battery location, facing east. See comments under photo 7

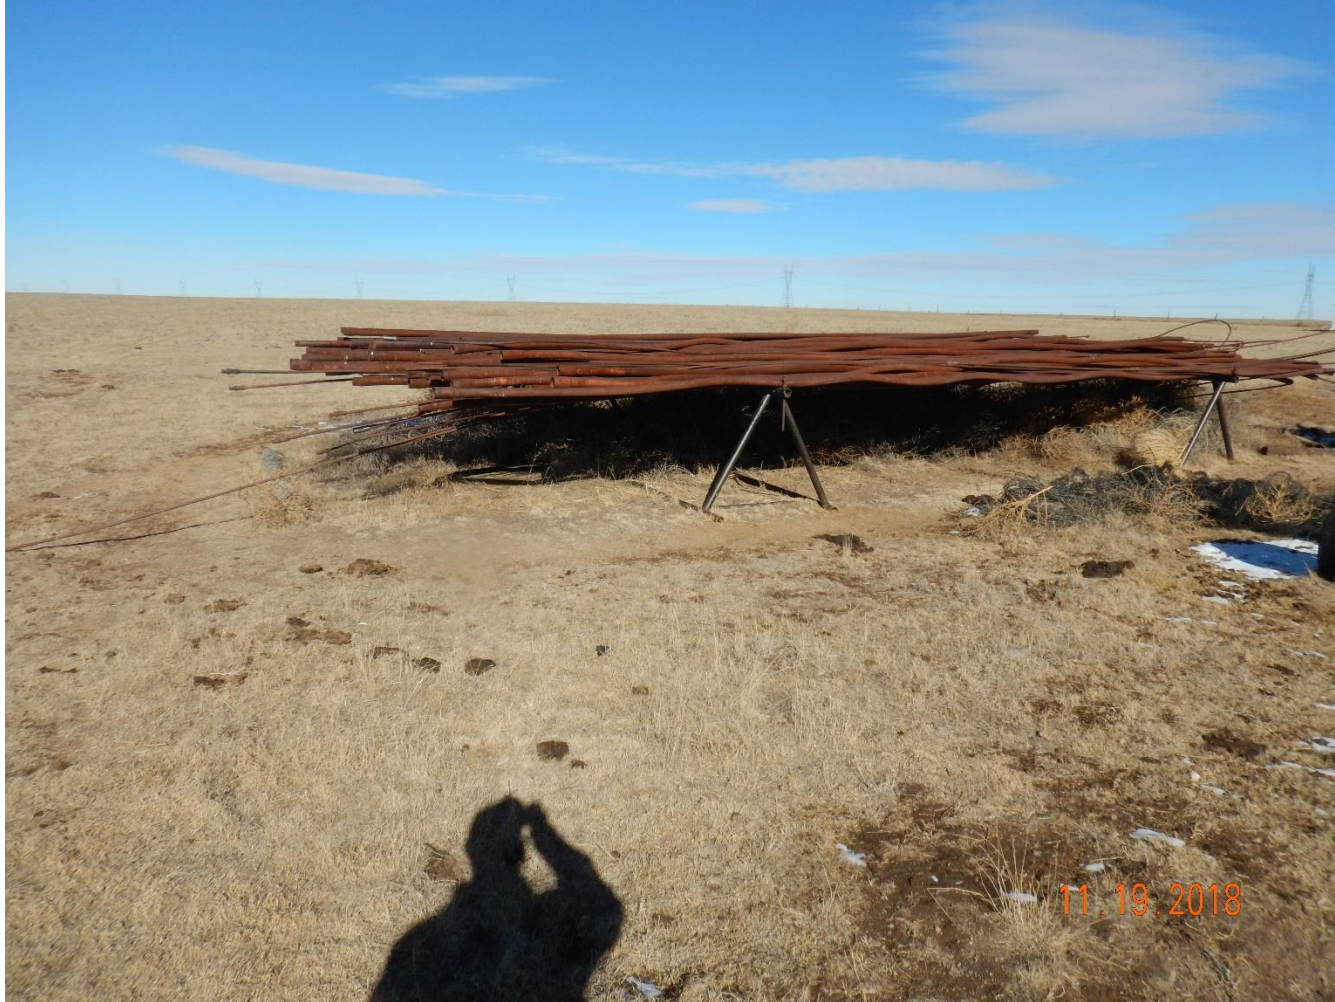
Photo 14: Photo taken from the battery location, facing north. See comments under photo 7

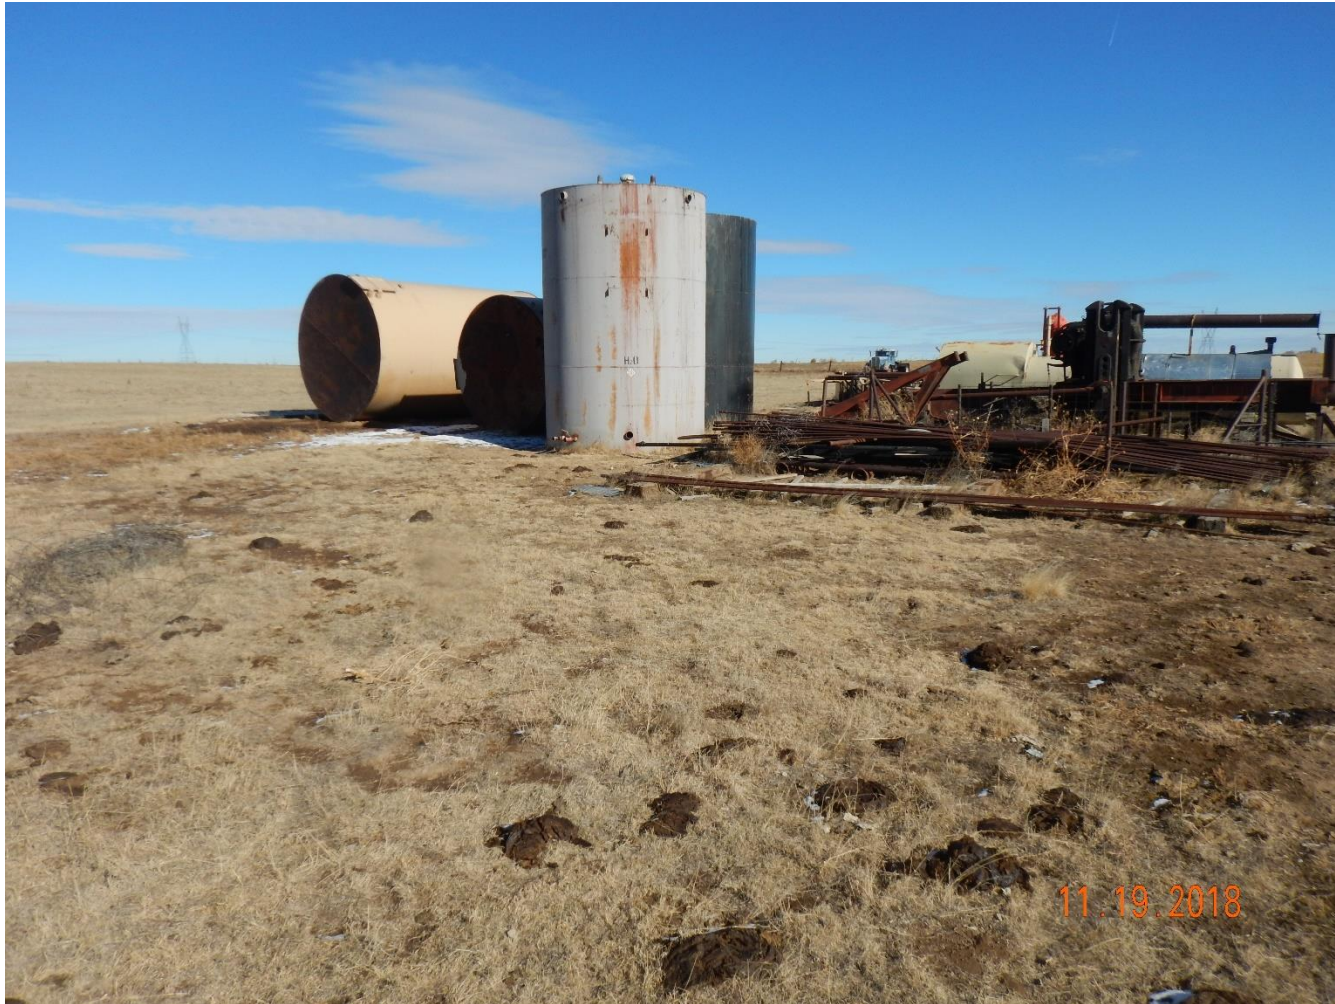
Photo 15: Photo taken from the battery location, facing east. See comments under photo 7

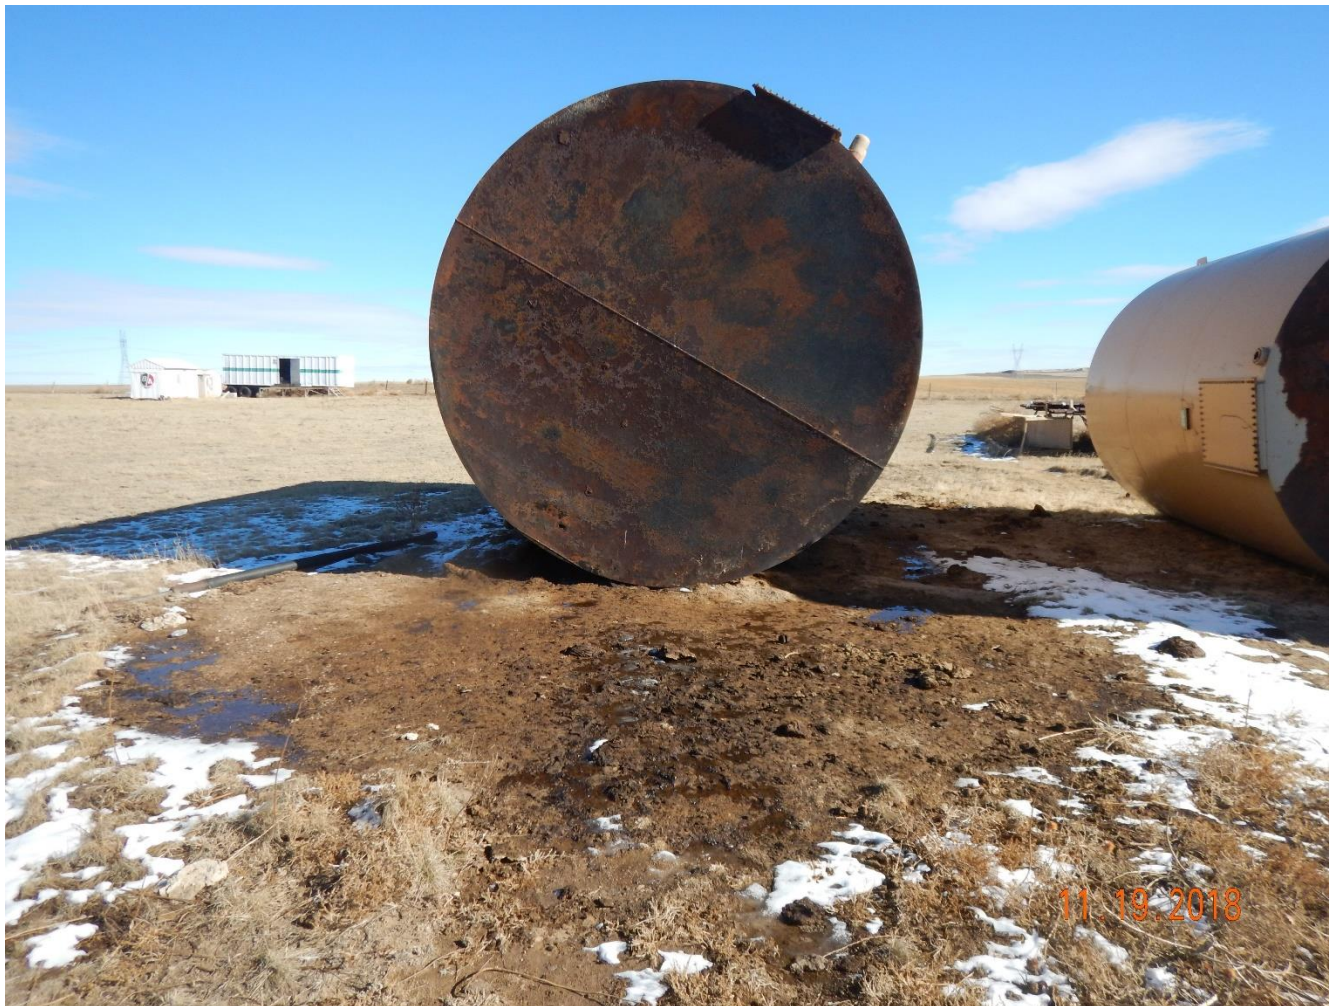
Photo 16: Photo taken from the battery location, facing north. Photo shows tank laying on side. Base of tank appears to have a hole. Photo also shows contaminated soils at tank base.

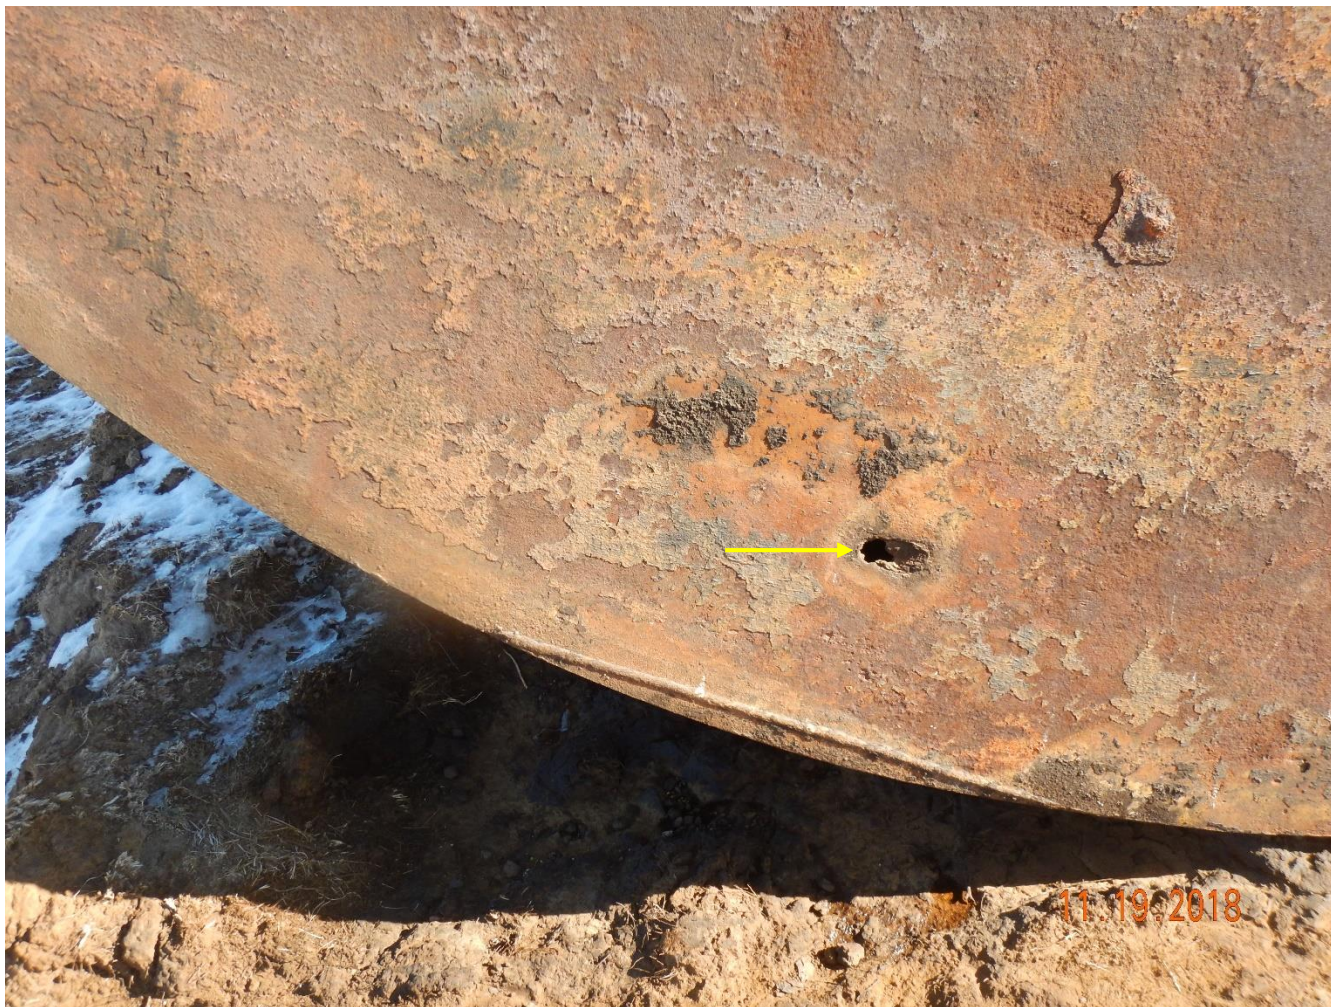
Photo 17: Photo taken from the battery location, facing north. Photo shows tank laying on side. Base of tank appears to have a hole. Photo also shows contaminated soils at tank base.

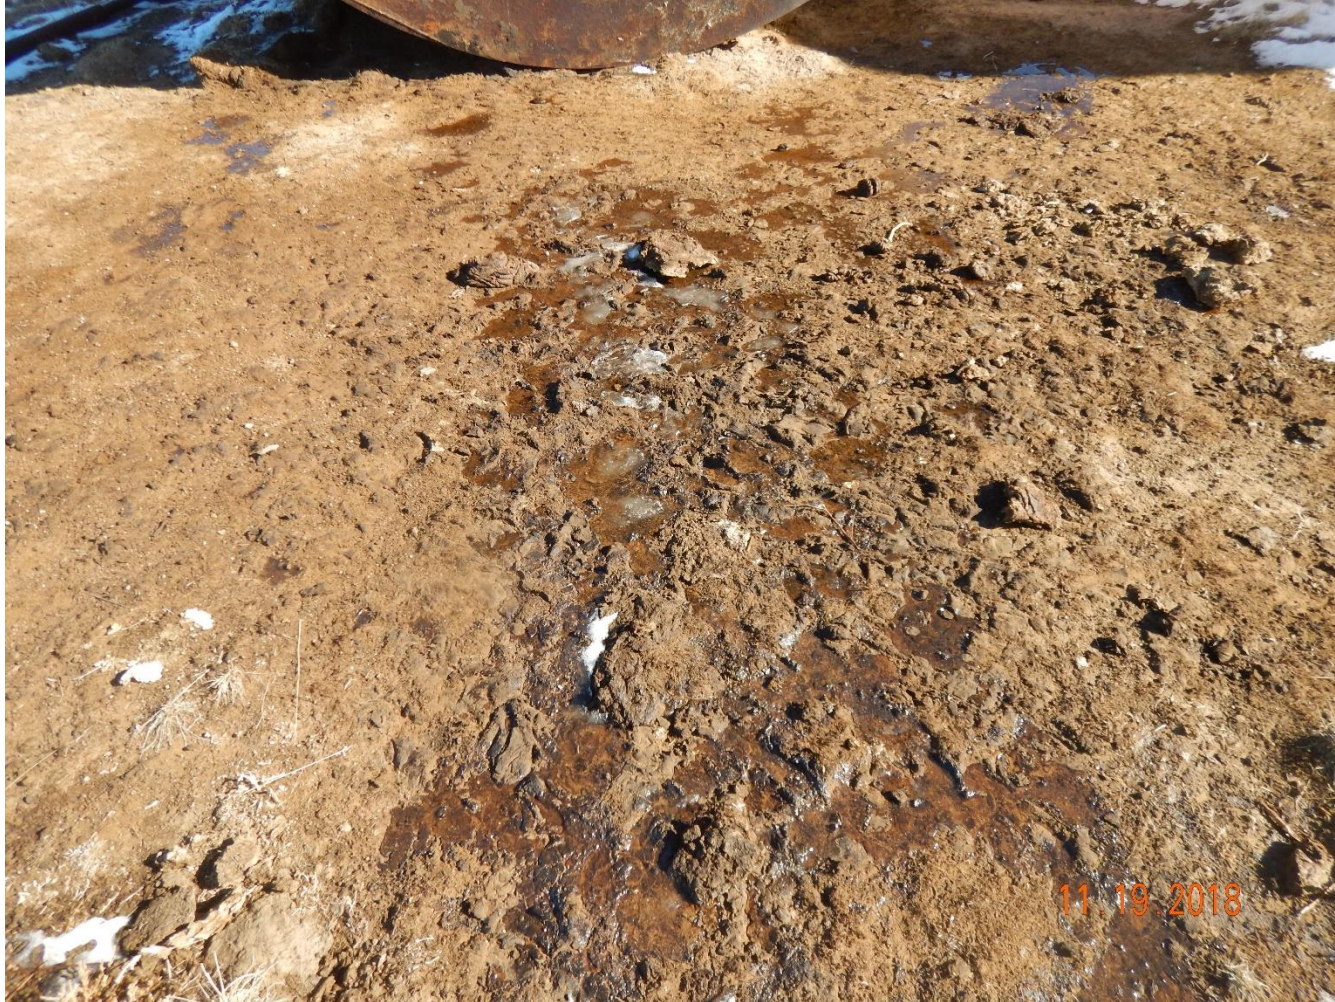
Photo 18: Continued from photo 17. Photo shows contaminated soils at tank base.
