Inspection Photos

Operator: FOUNDATION ENERGY
MANAGEMENT LLC - 10112

Location ID: 327492

Inspection Doc. Number: 682504197
Weld County, CO

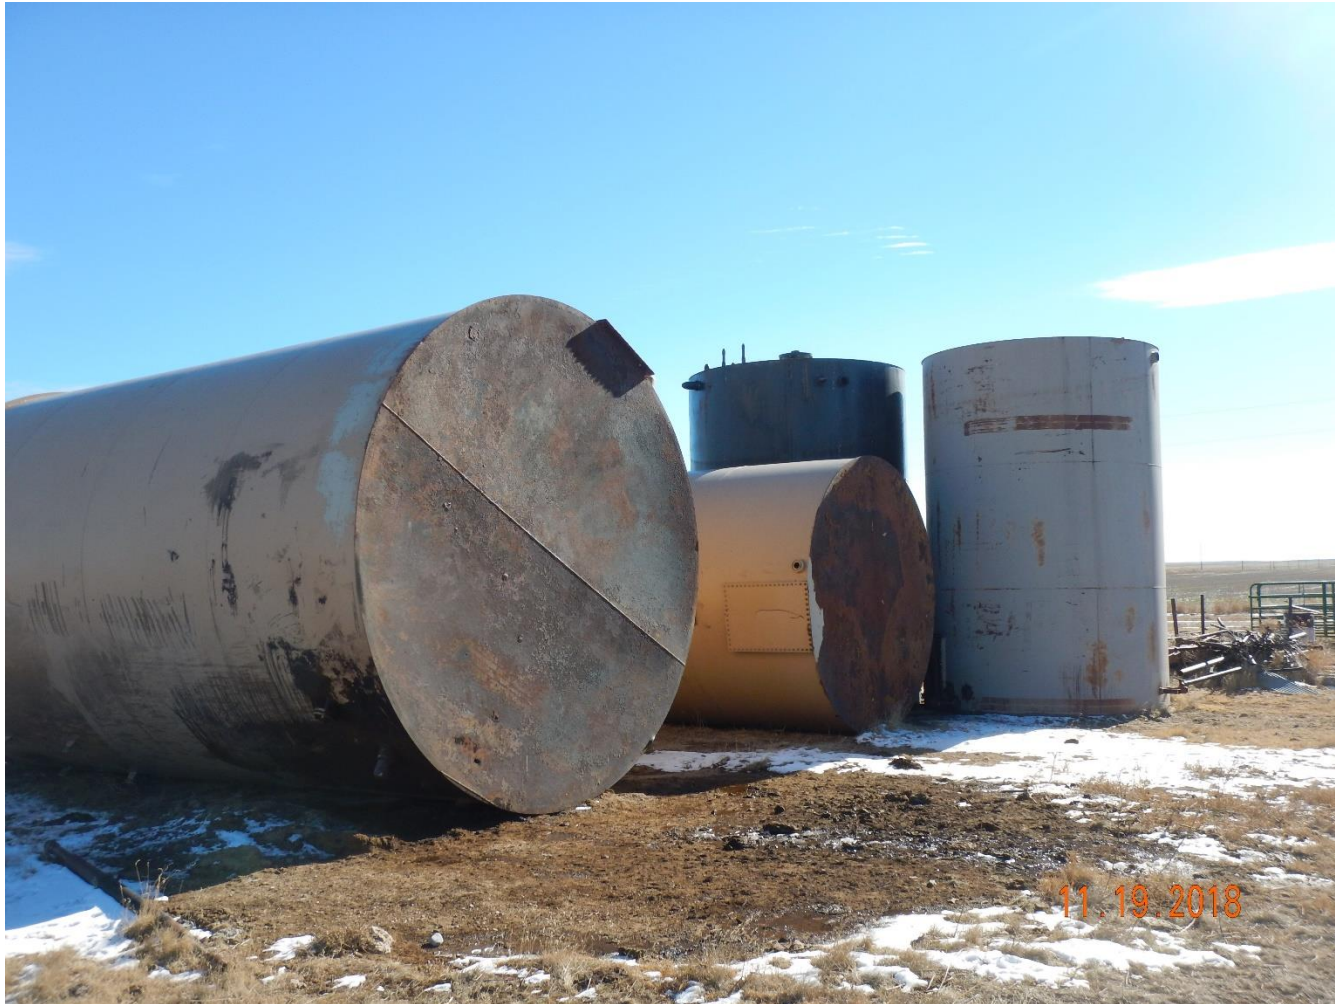
Photo 7: Photo taken from the battery location, facing north. Photo shows operator has failed to remove equipment from the location per 603.f and 1004.a.

Photo 19: Photo taken from the battery location, facing southeast. See comments under photo 7

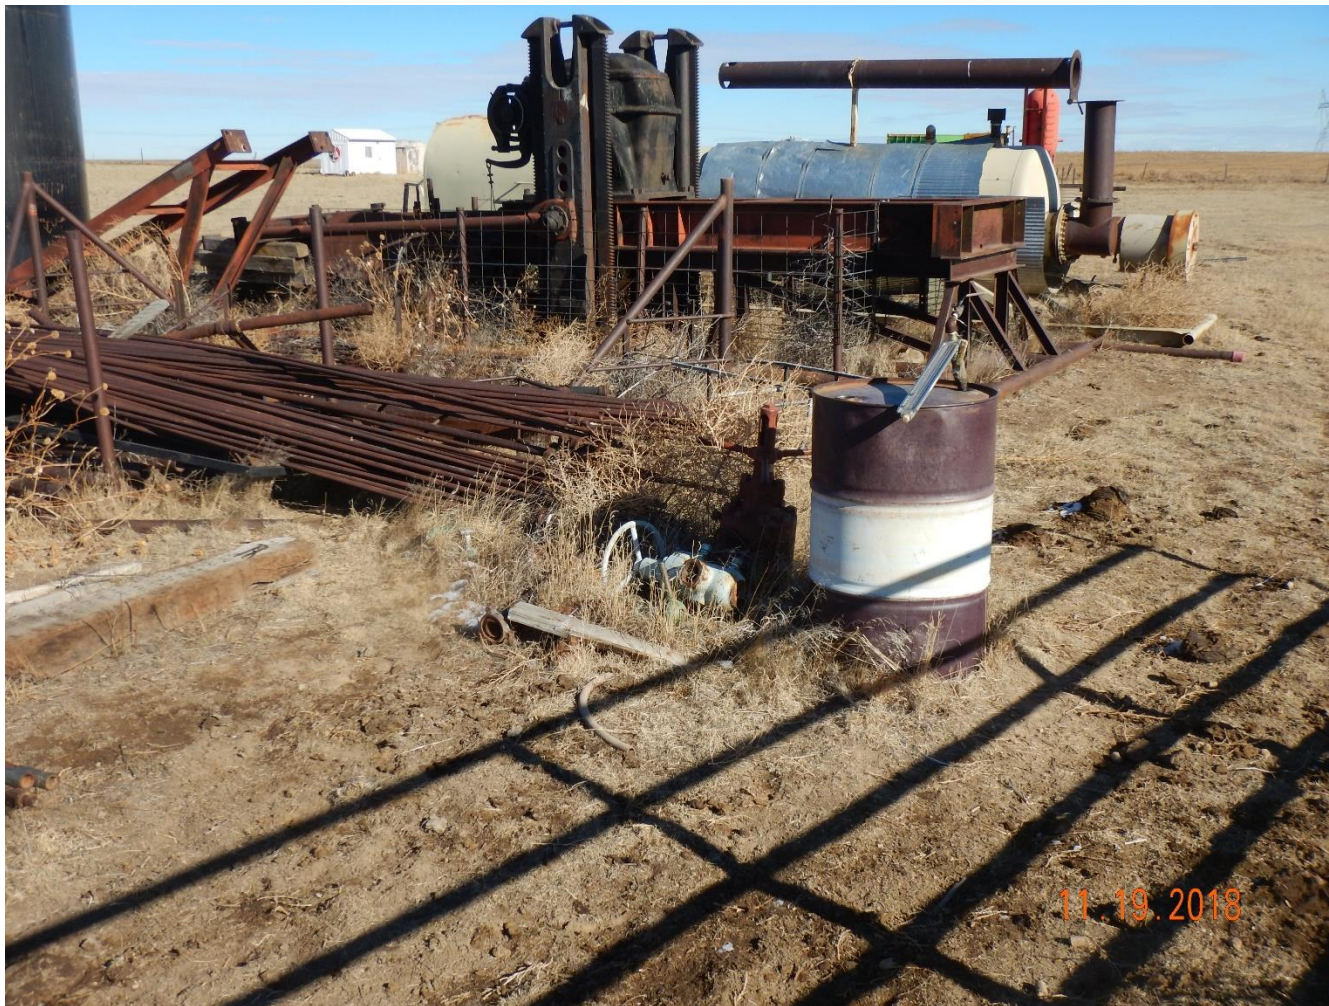
Photo 20: Photo taken from the battery location, facing east. See comments under photo 7. Photo also shows a barrel filled with chemical not in secondary containment.

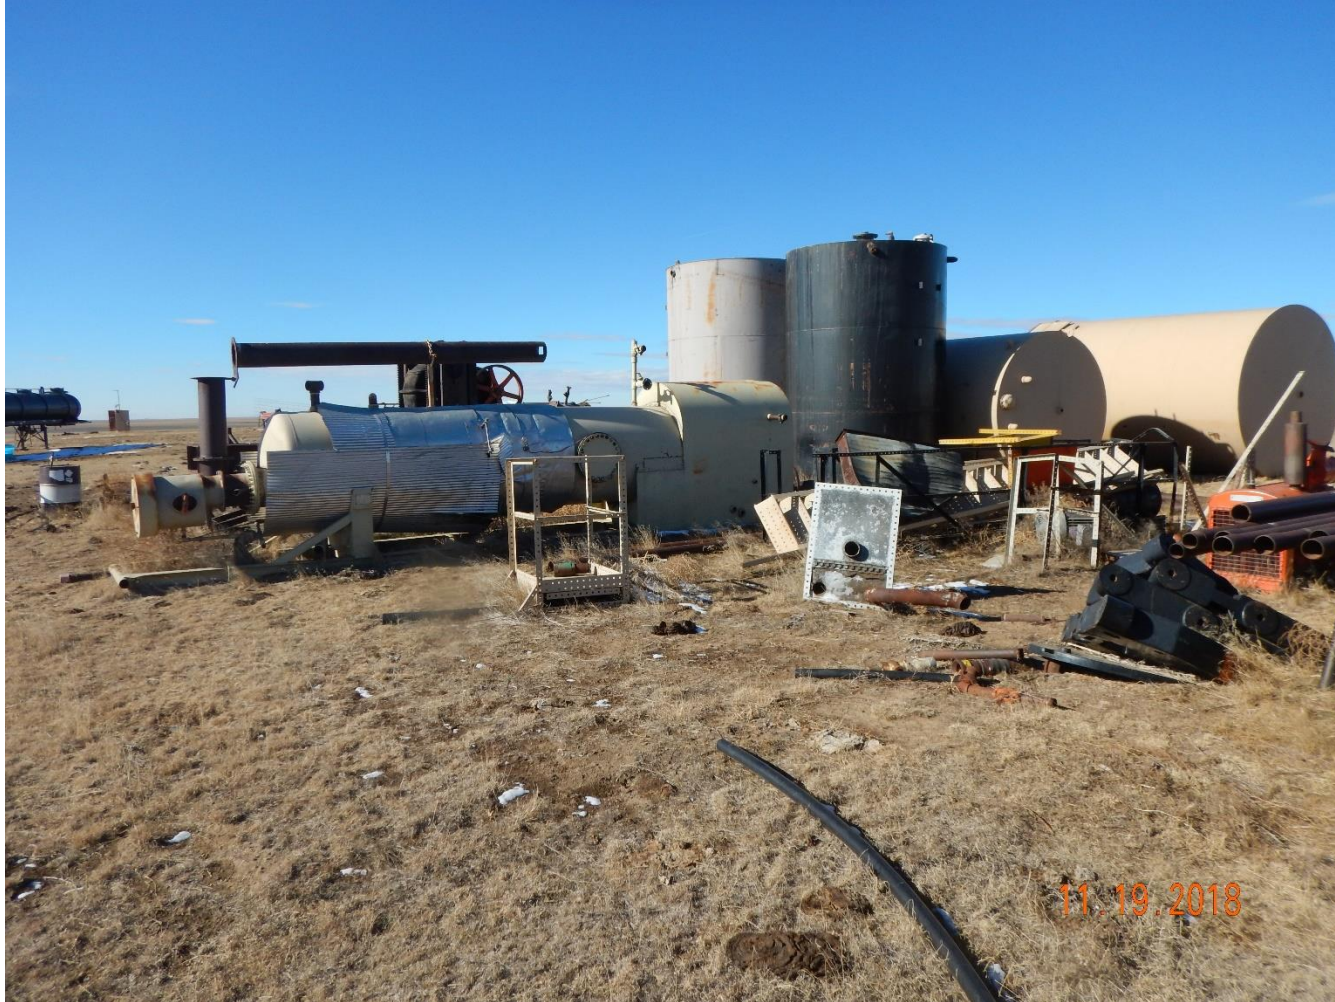
Photo 22: Photo taken from the battery location, facing west. See comments under photo 7

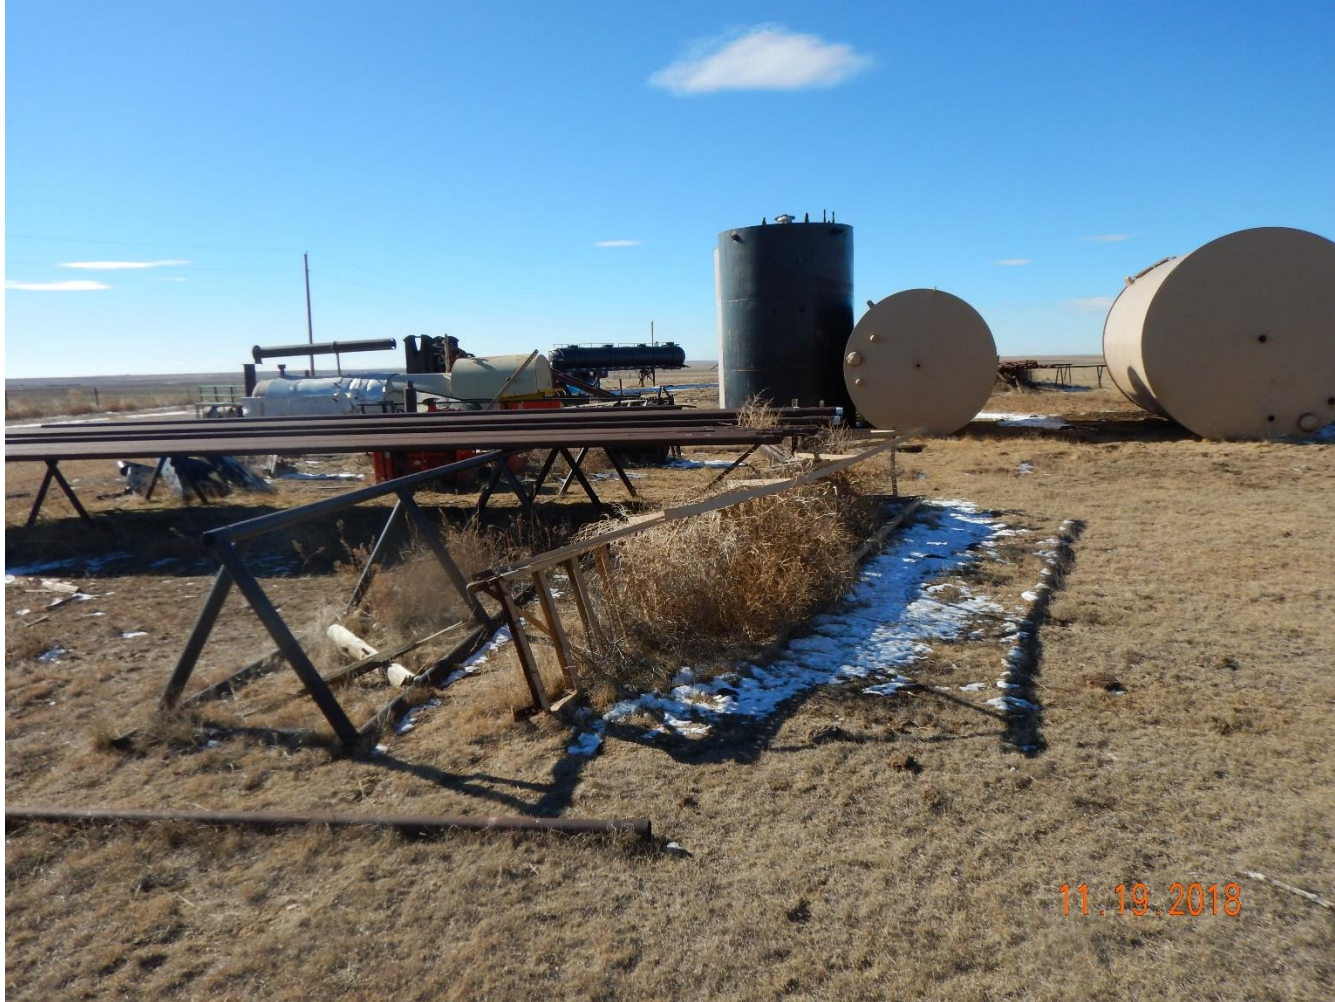
Photo 23: Photo taken from the battery location, facing west. See comments under photo 7

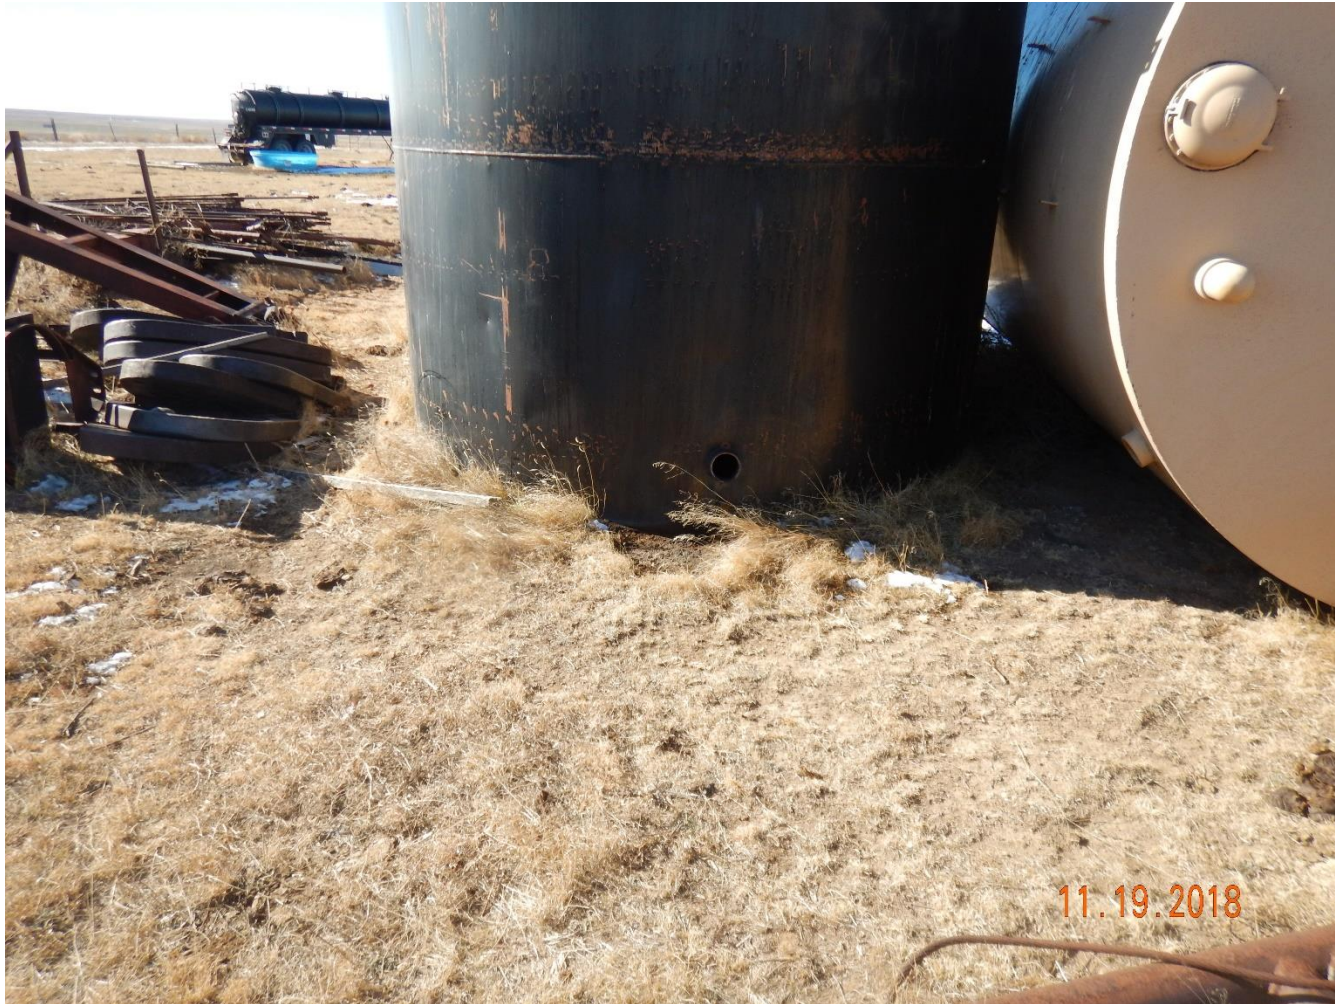
Photo 24: Photo taken from the battery location, facing north. Photo shows tank appears to have been leaking as contaminated soils evident at tank base.

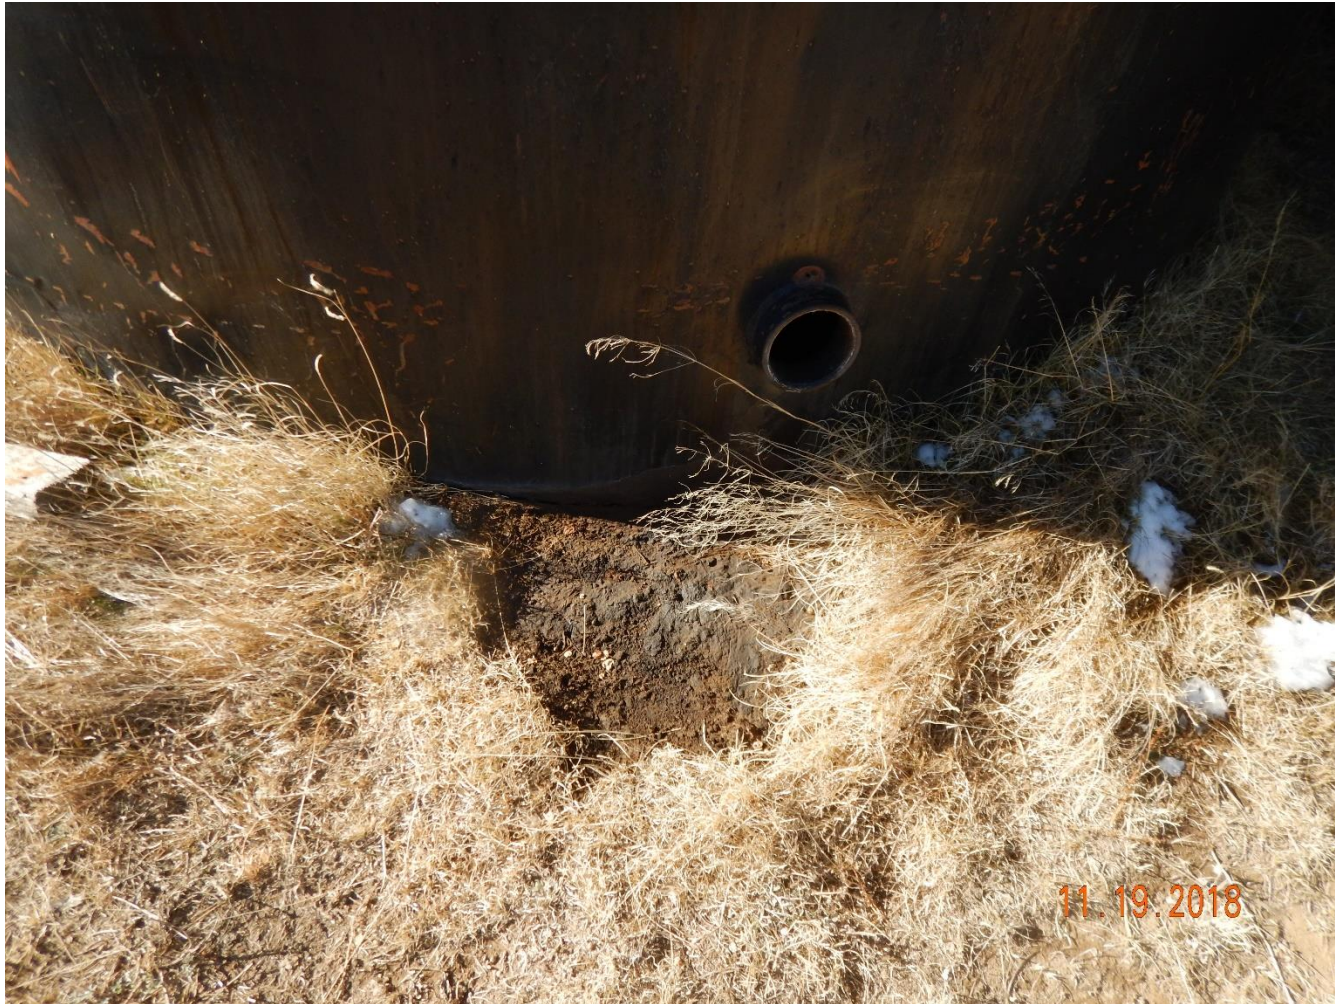
Photo 25: See comments under photo 25.

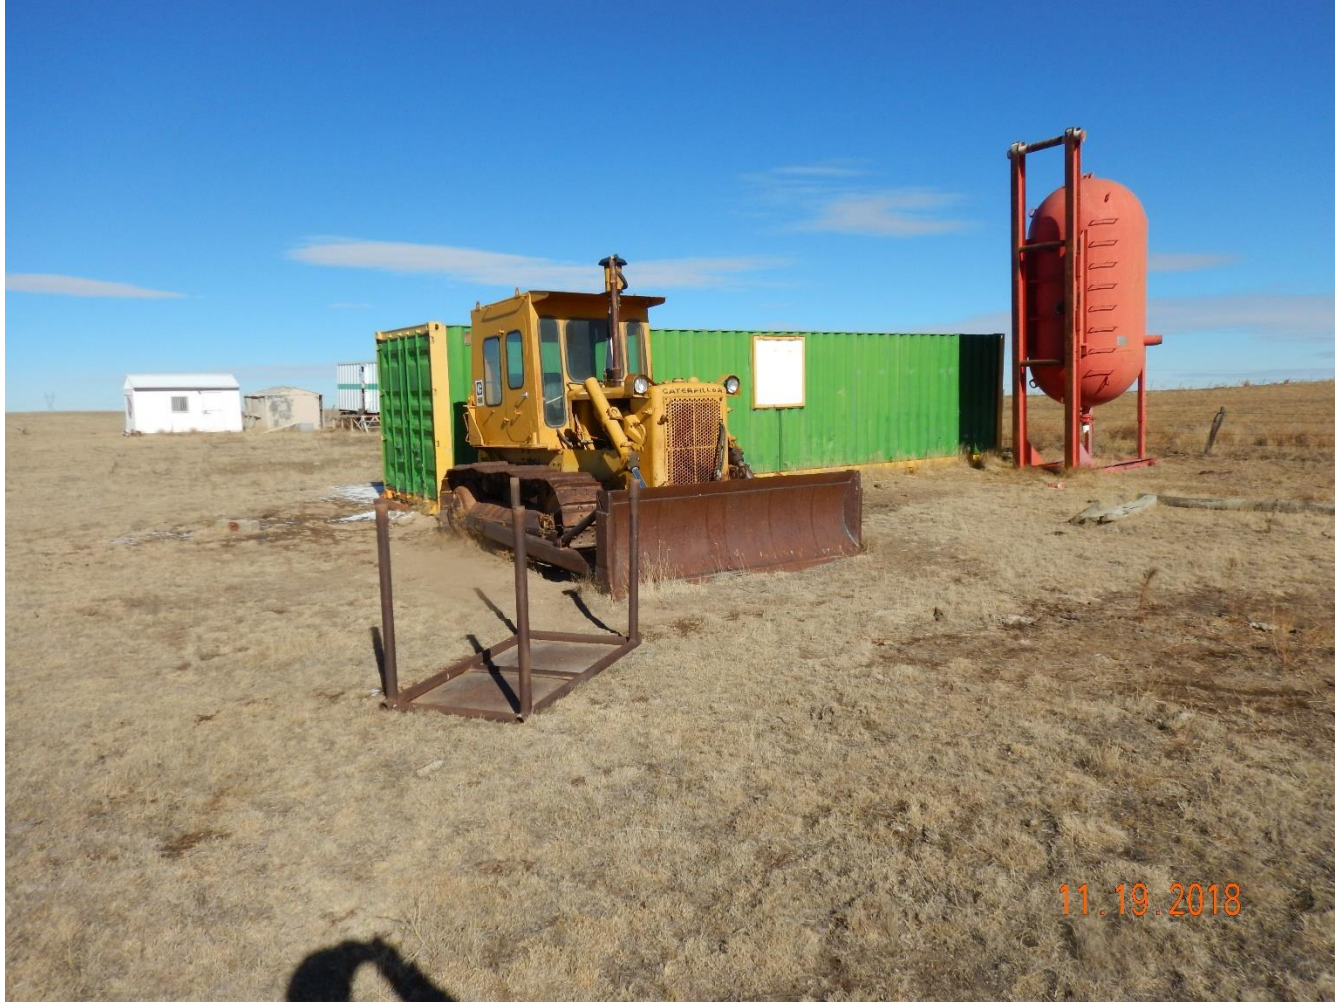
Photo 26: Photo taken from the battery location, facing north. See comments under photo 7

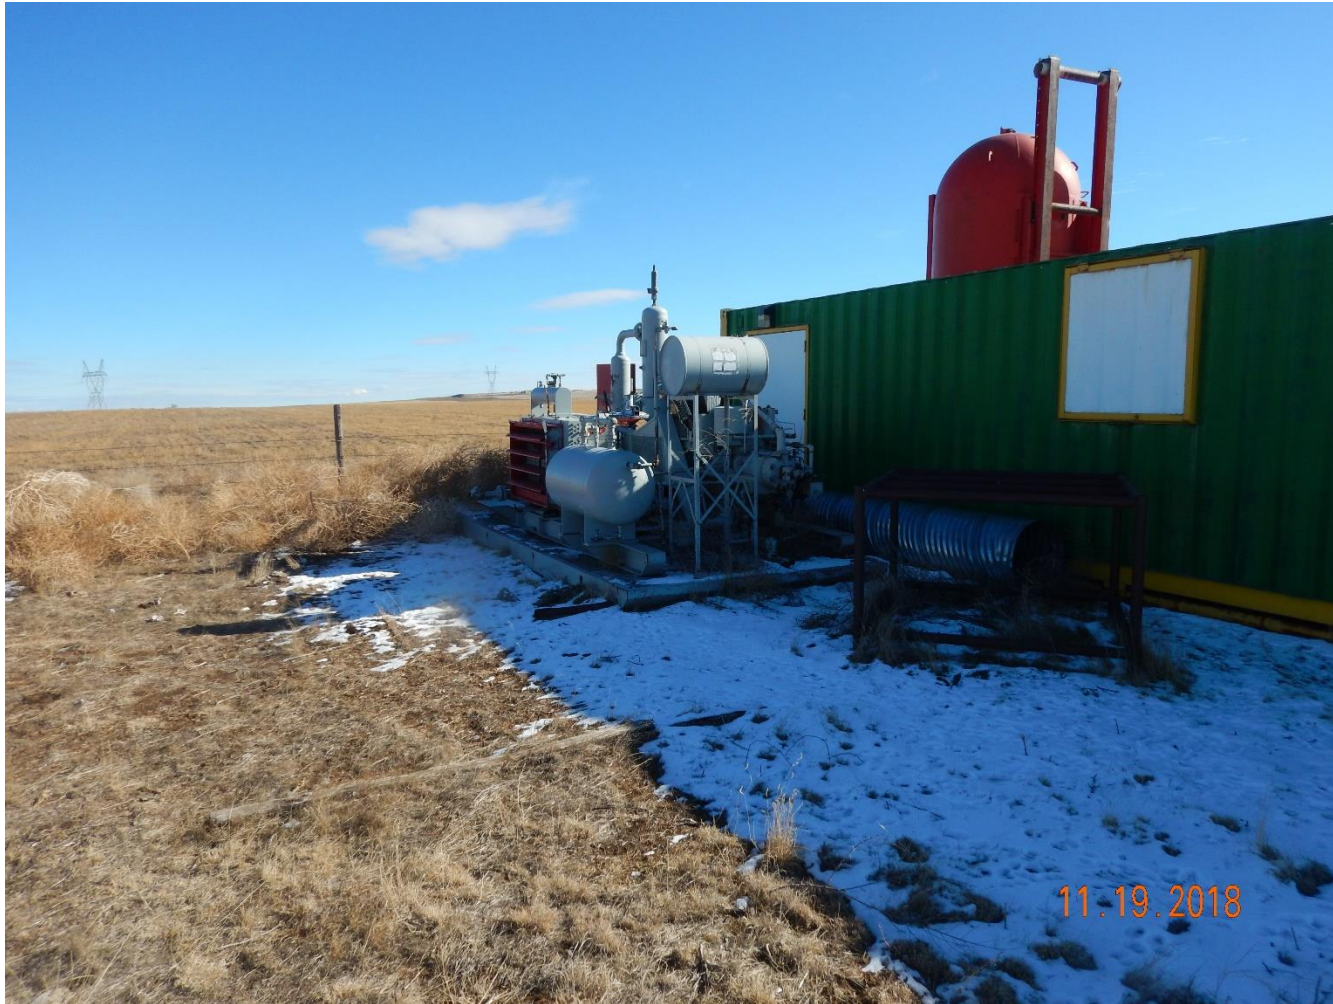
Photo 27: Photo taken from the battery location, facing east. See comments under photo 7

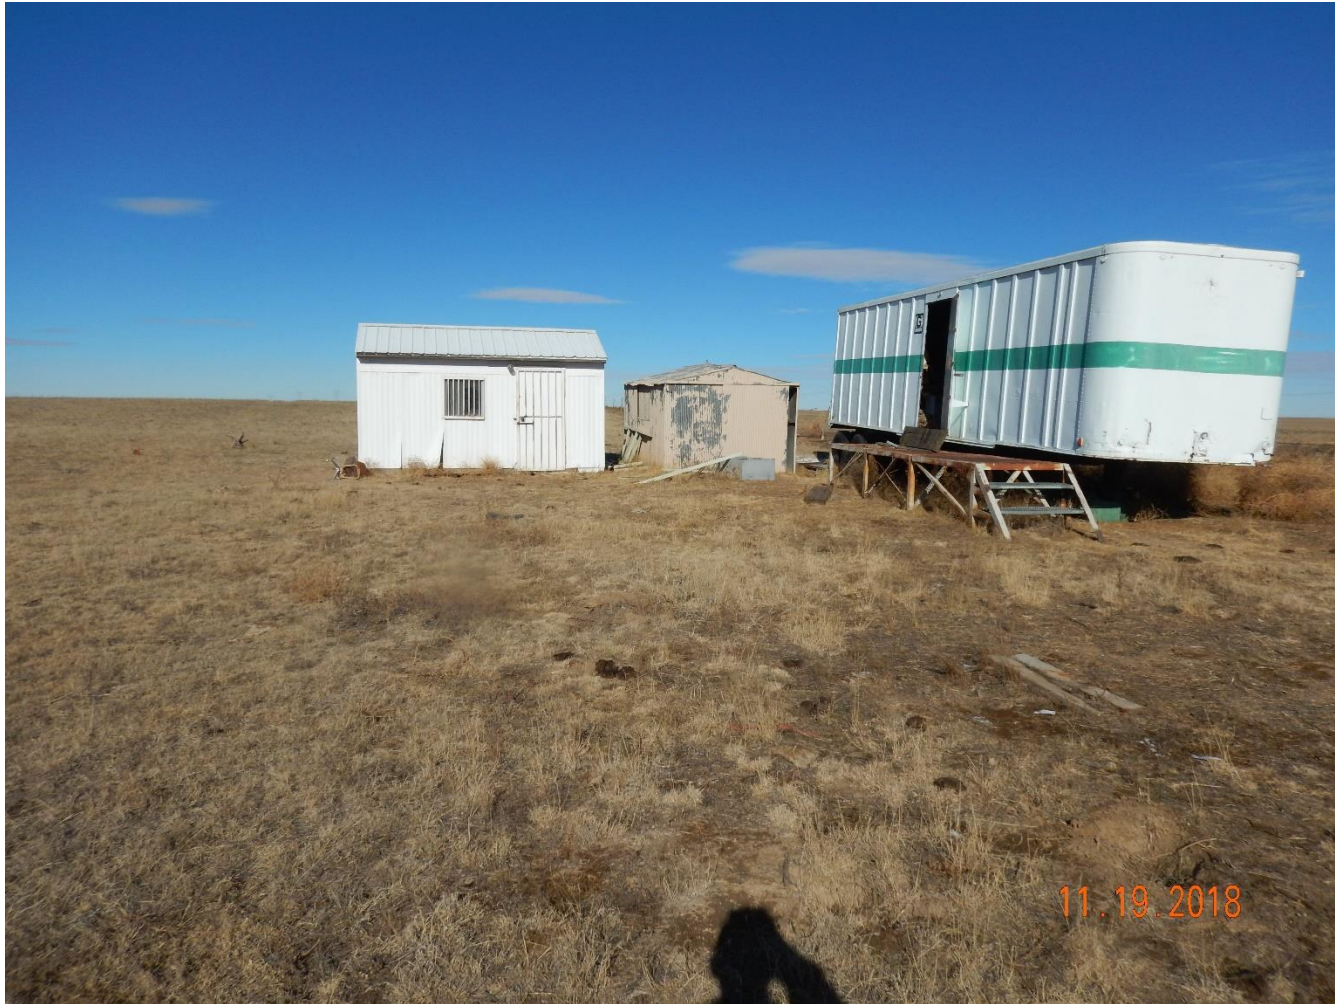
Photo 28: Photo taken from the battery location, facing north. See comments under photo 7

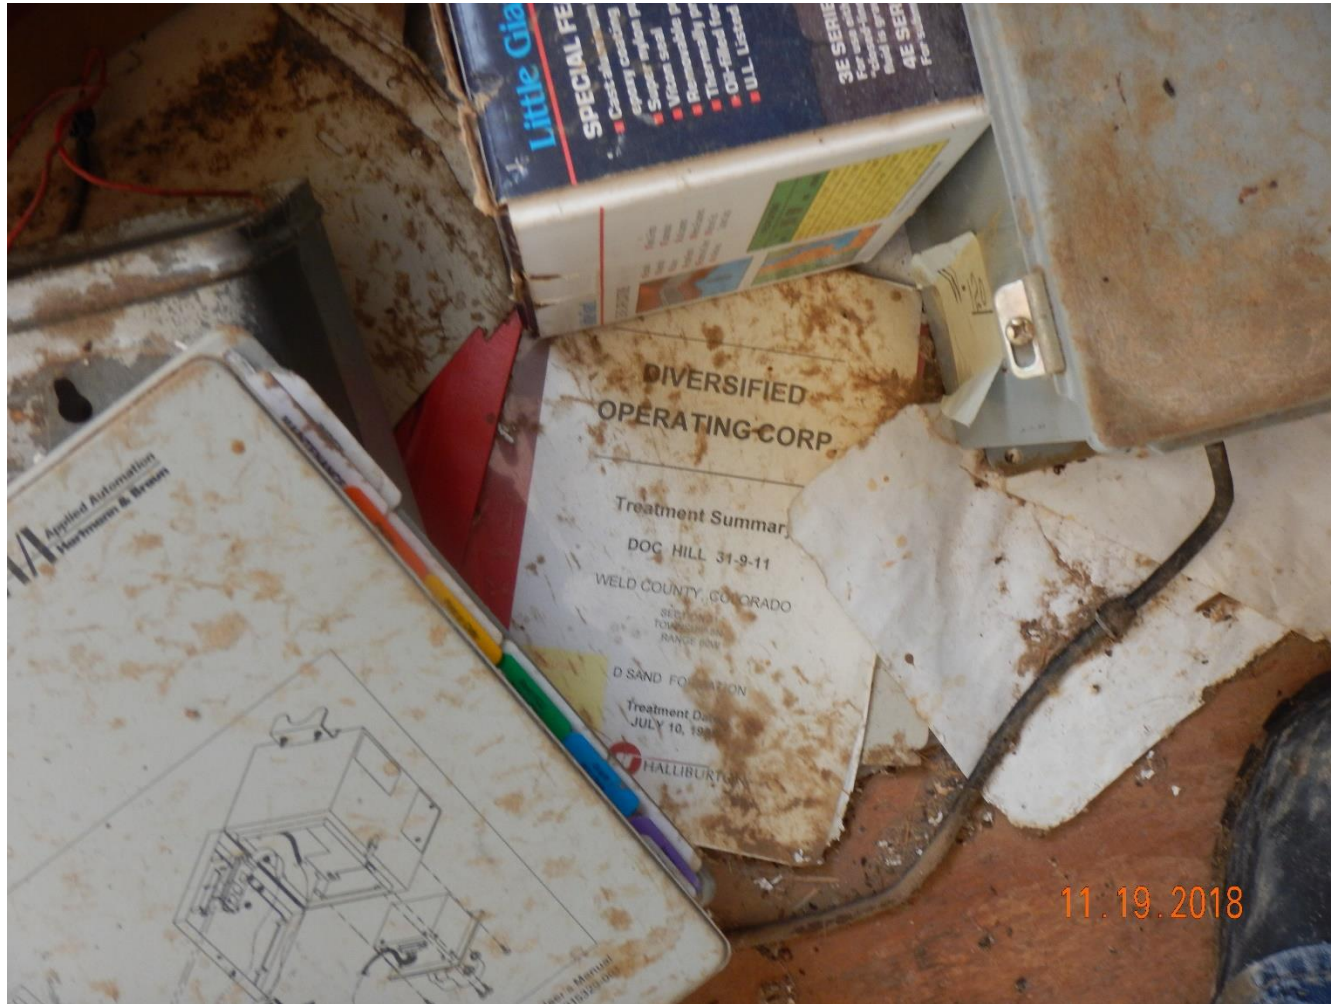
Photo 29: Photo taken from shed in photo 28. Multiple documents from the operator “Diversified Operating Corp” were observed within the building. Diversified was a previous operator for this location. Photo shows sheds observed on the east are associated with oil and gas.
