Inspection Photo (s)
Couey 31-2
API # 05-045-07843
Inspection # 6893026037

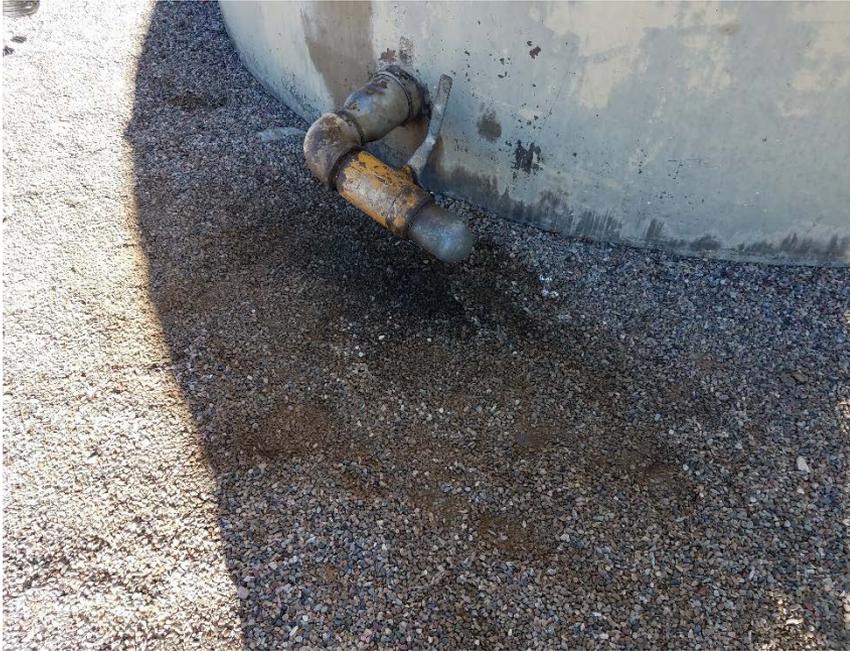
Location Photo #4, Oil stained rock in battery containment.

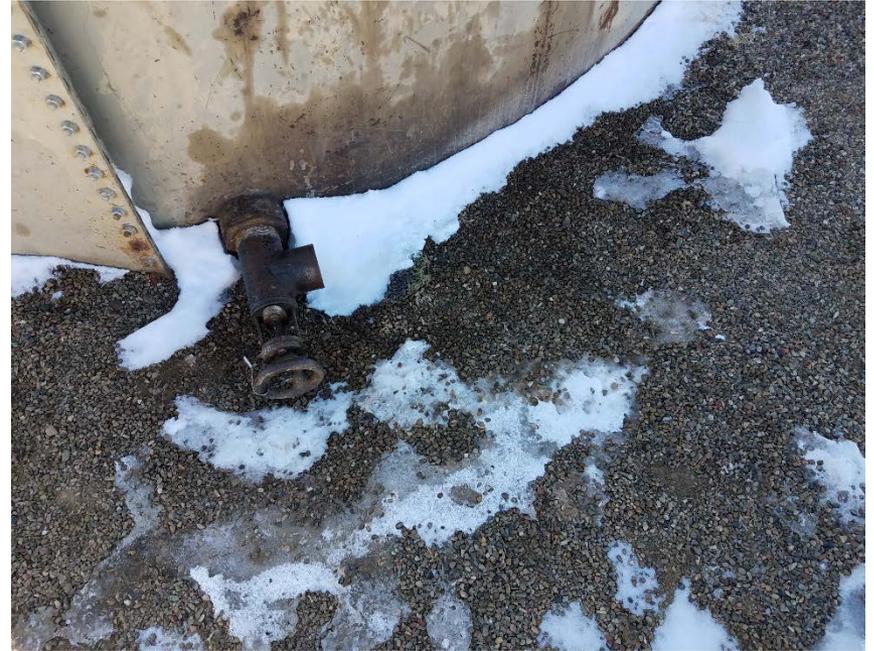
Location Photo #5, Oil stained rock in battery containment.
