Inspection Photos

Operator: ST CROIX OPERATING INC # 81490

Location ID: 458423

Inspection Doc. Number: 682504291

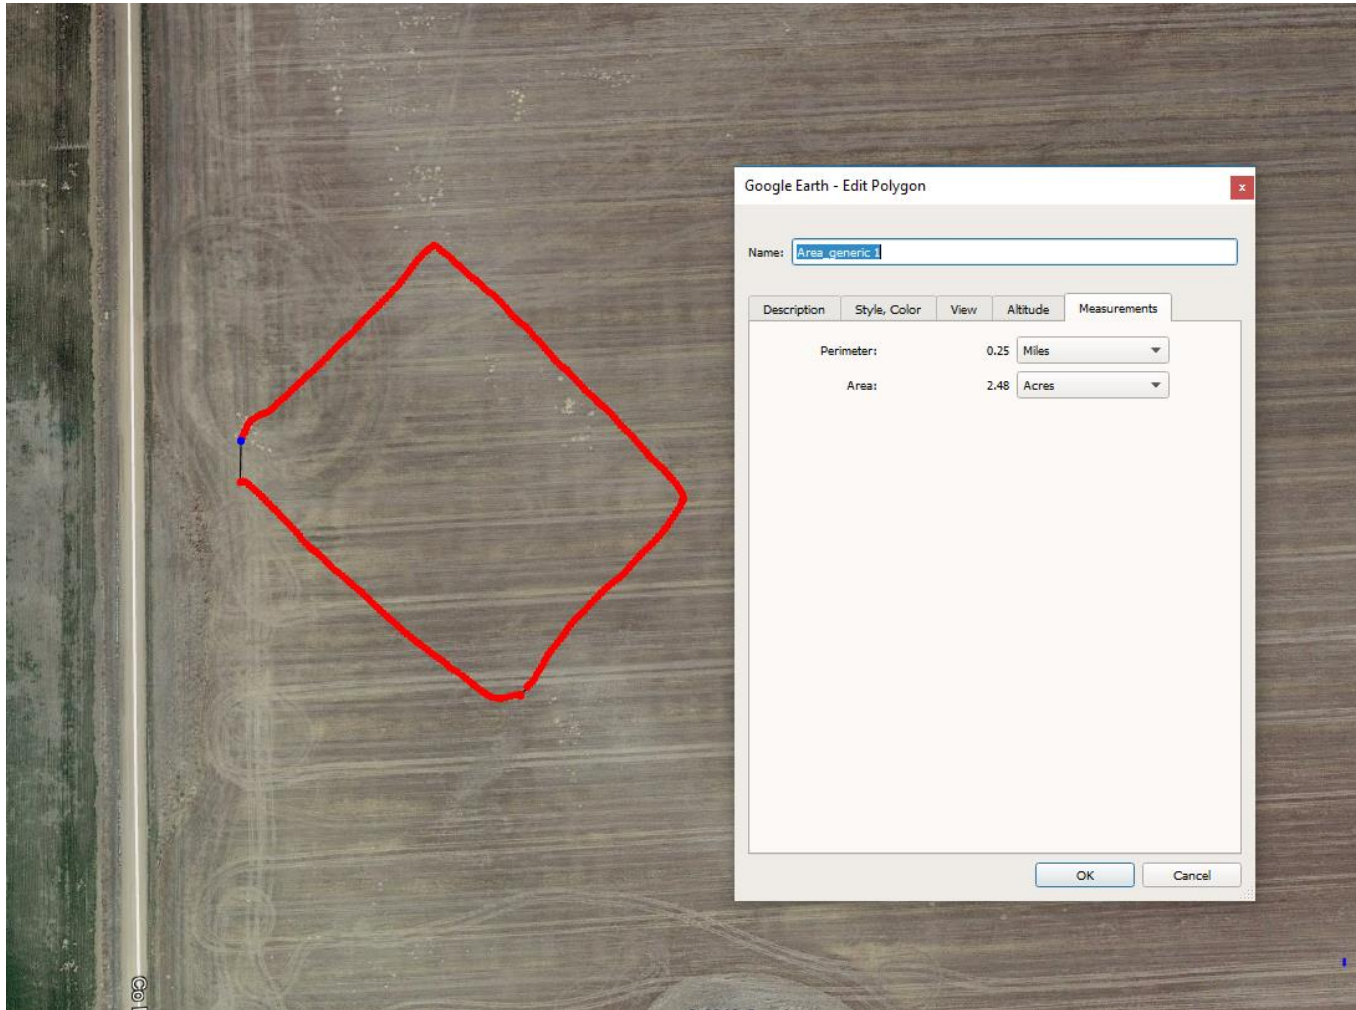
Photo 1: Aerial image of construction location. A disturbance area of 2.48 acres was mapped on 12/19/2018 using a Trimble Juno 3B handheld device; this appears to exceed the permitted 2A disturbance area of 2 acres.

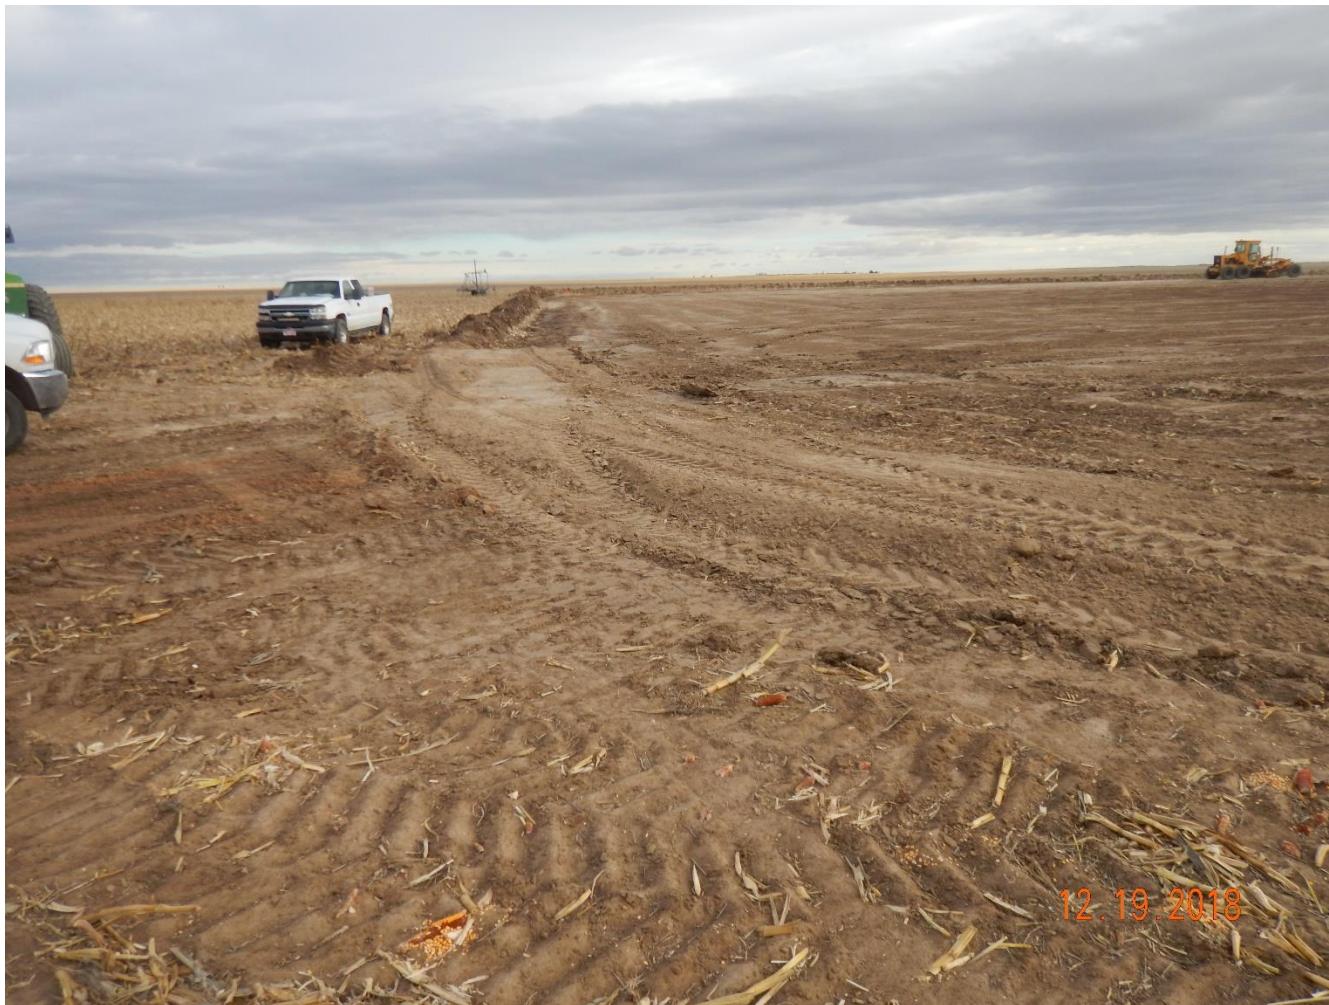
Photo 2: Photo taken from the southwest end of the construction disturbance, facing north. Photo provides an overview of the location. Photo also shows that perimeter stormwater and erosion control BMPs have not been installed in accordance with good engineering practices prior to and during construction activities.

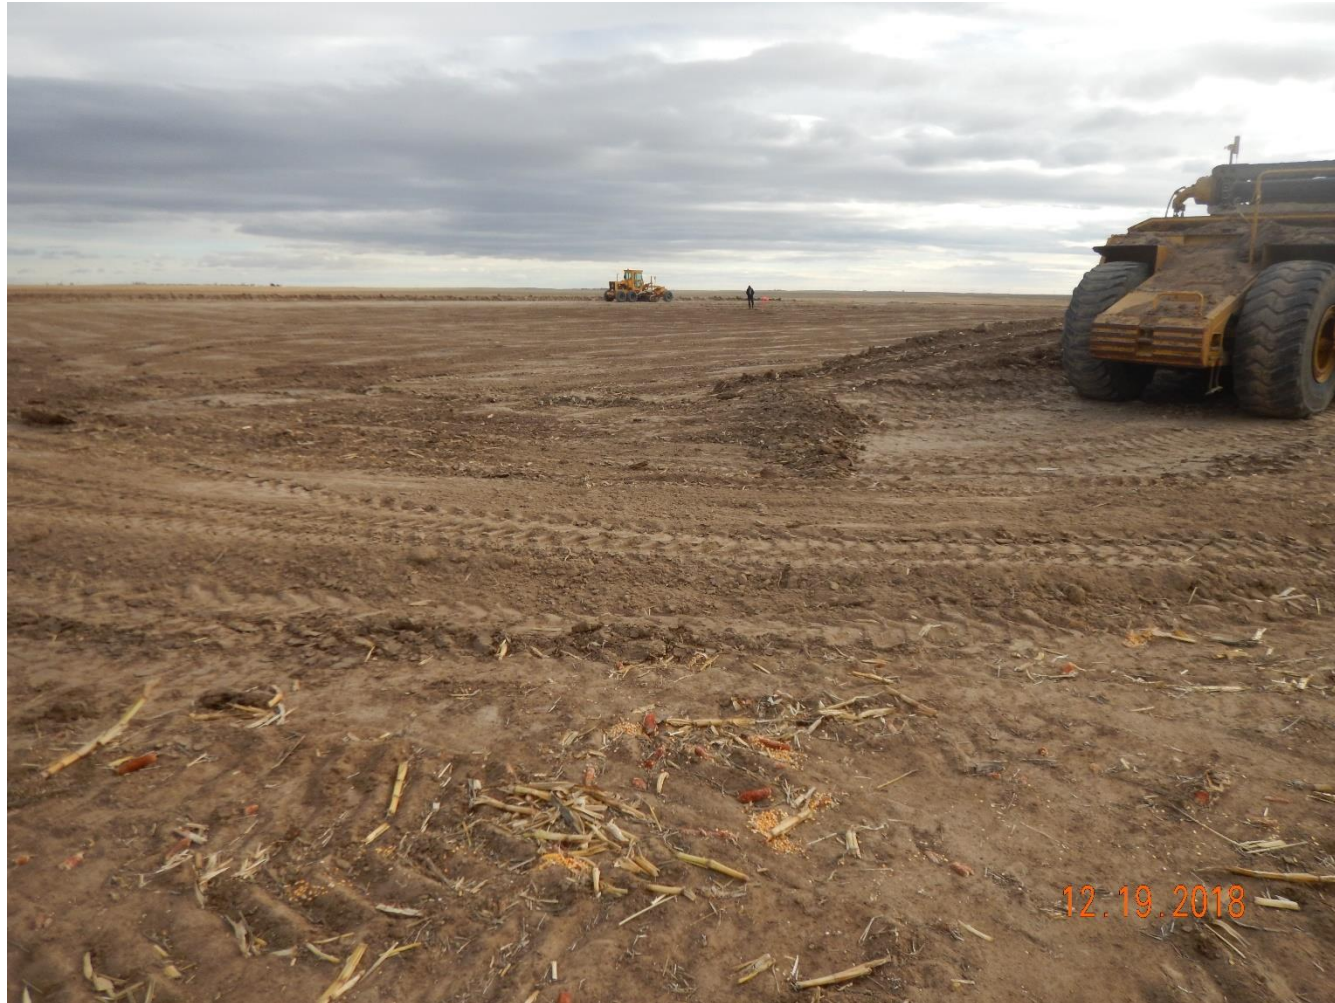
Photo 3: Photo taken from the southwest end of the construction disturbance, facing east. Photo provides an overview of the location. Photo also shows that perimeter stormwater and erosion control BMPs have not been installed in accordance with good engineering practices prior to and during construction activities.

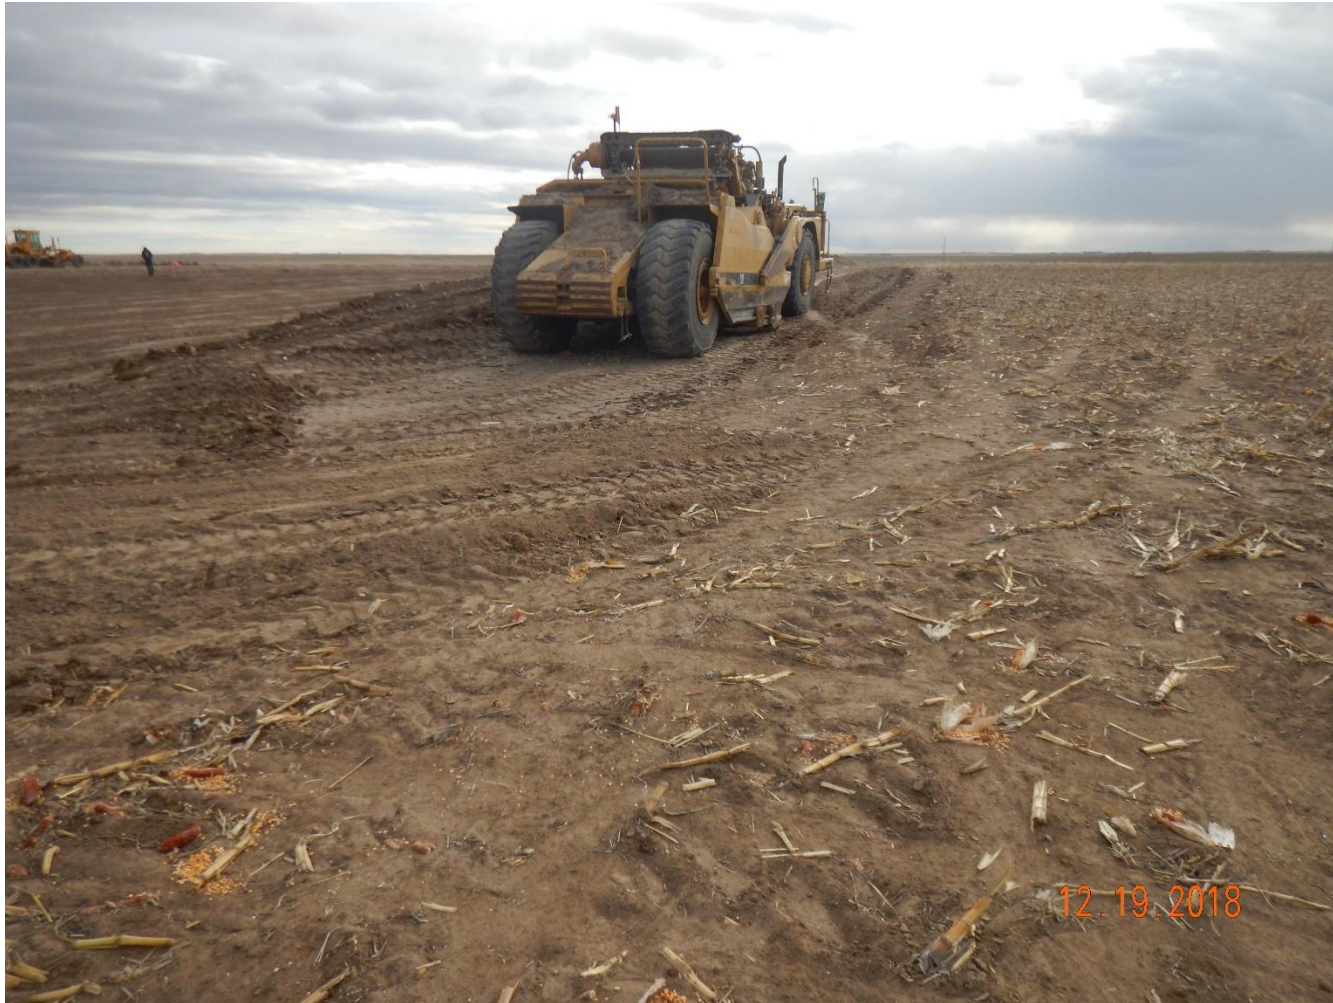
Photo 4: Photo taken from the southwest end of the construction disturbance, facing southeast. Photo provides an overview of the location. Photo also shows that perimeter stormwater and erosion control BMPs have not been installed in accordance with good engineering practices prior to and during construction activities. Photo also shows topsoil stockpile

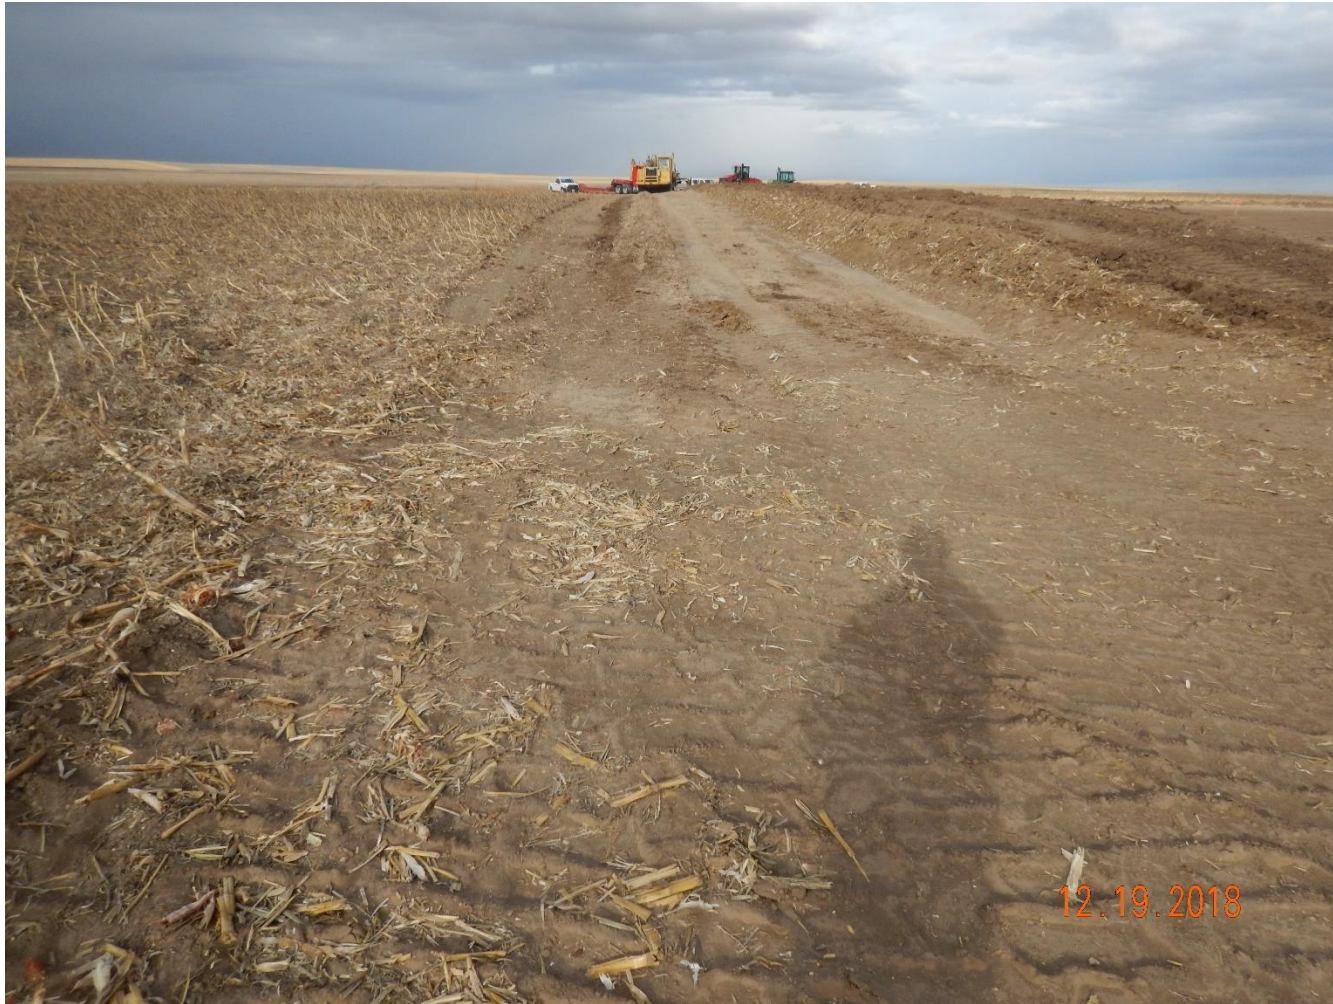
Photo 5: Photo taken from the southeast end of the construction disturbance, facing northwest. Photo provides an overview of the location. Photo also shows that perimeter stormwater and erosion control BMPs have not been installed in accordance with good engineering practices prior to and during construction activities. Photo also shows topsoil stockpile

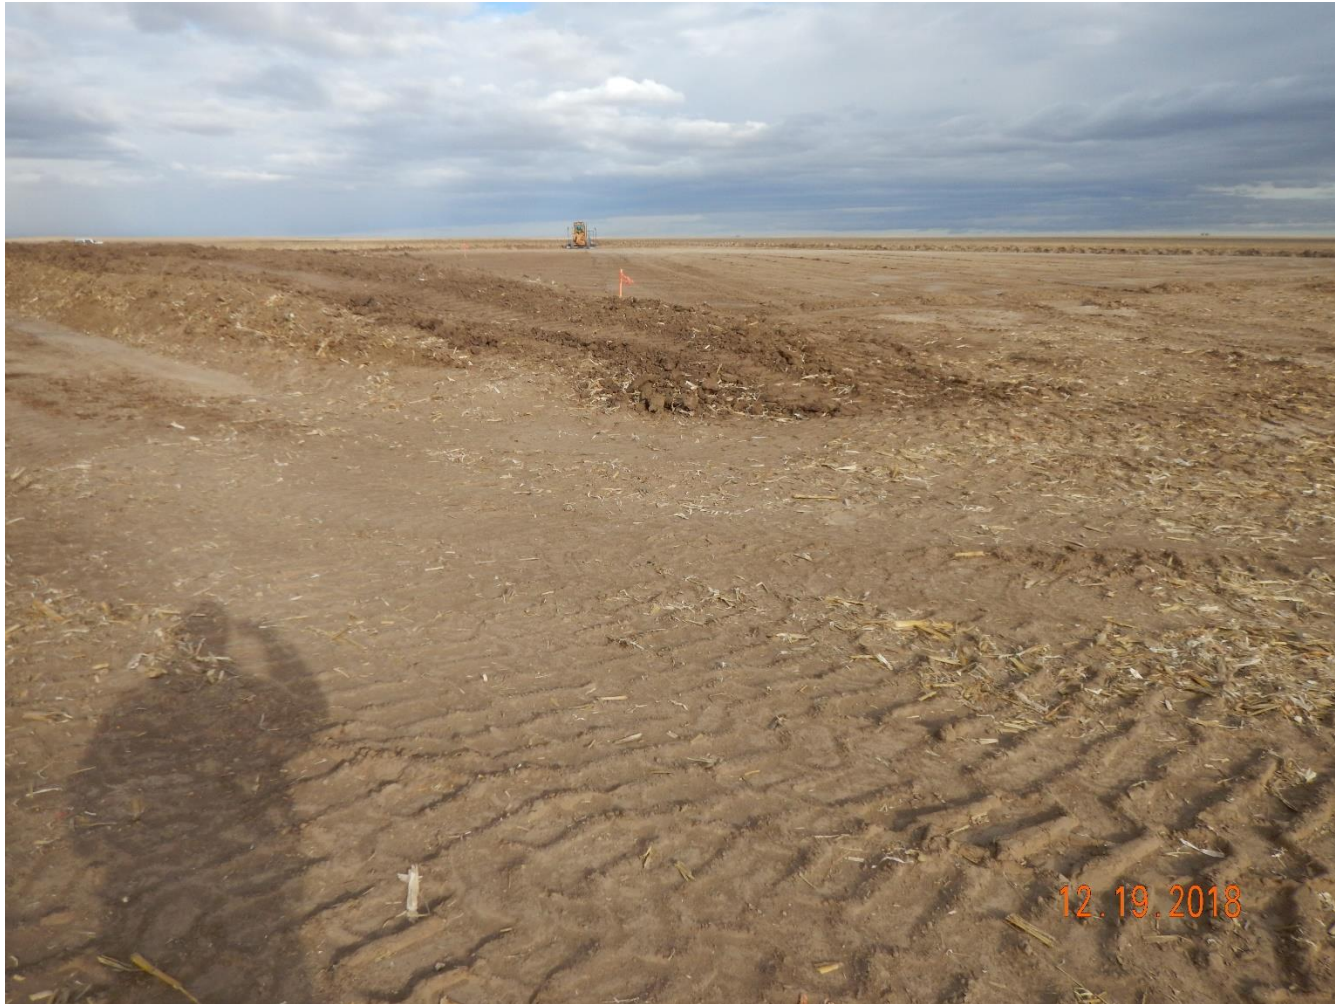
Photo 6: Photo taken from the southeast end of the construction disturbance, facing north. Photo provides an overview of the location. Photo also shows that perimeter stormwater and erosion control BMPs have not been installed in accordance with good engineering practices prior to and during construction activities. Photo also shows topsoil stockpile

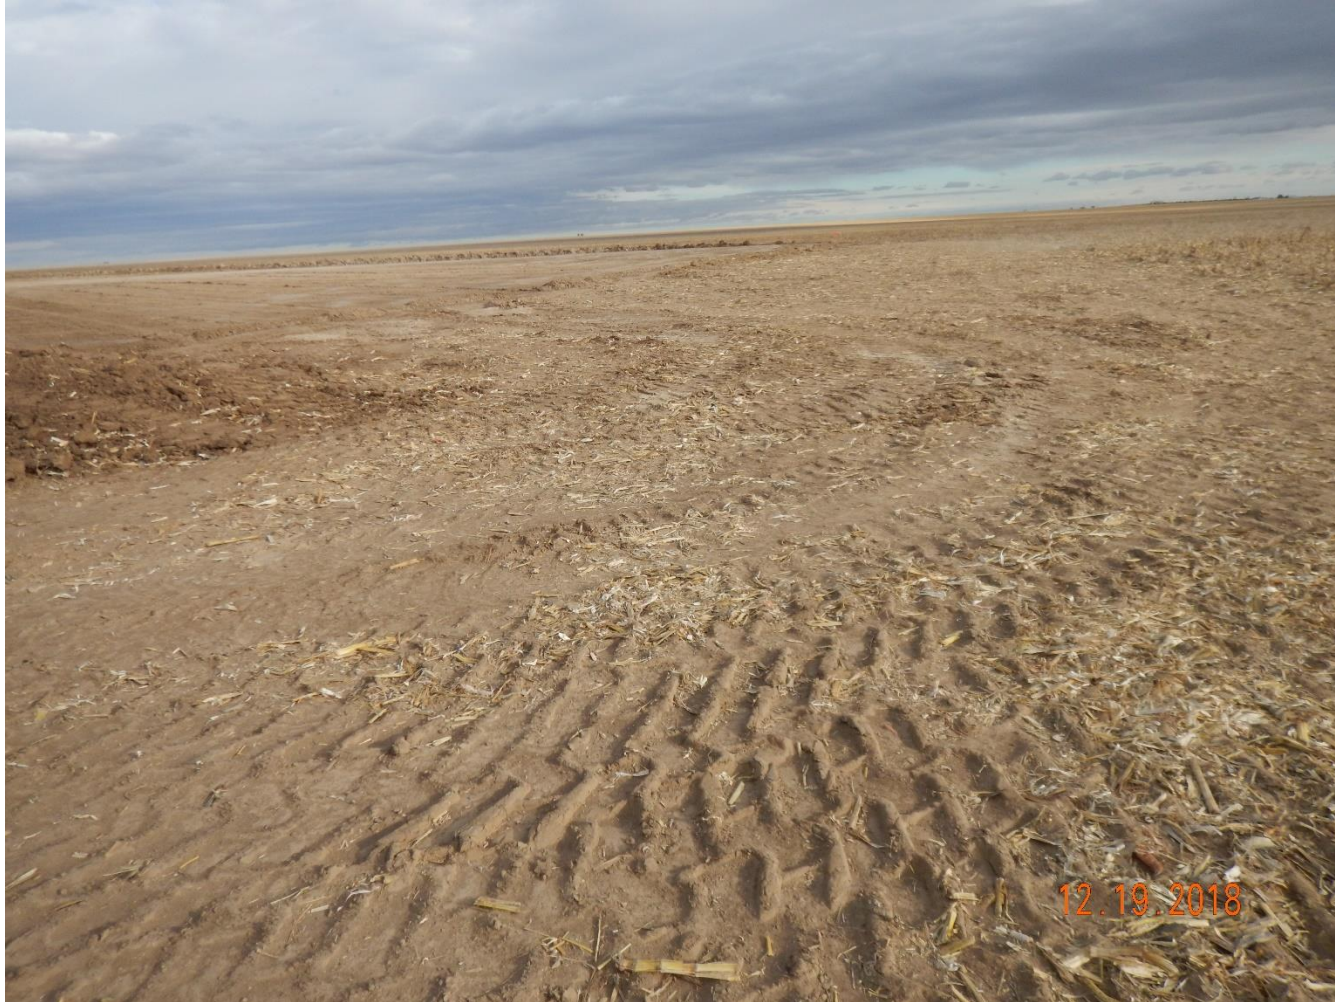
Photo 7: Photo taken from the southeast end of the construction disturbance, facing north. Photo provides an overview of the location. Photo also shows that perimeter stormwater and erosion control BMPs have not been installed in accordance with good engineering practices prior to and during construction activities. Photo also shows topsoil stockpile

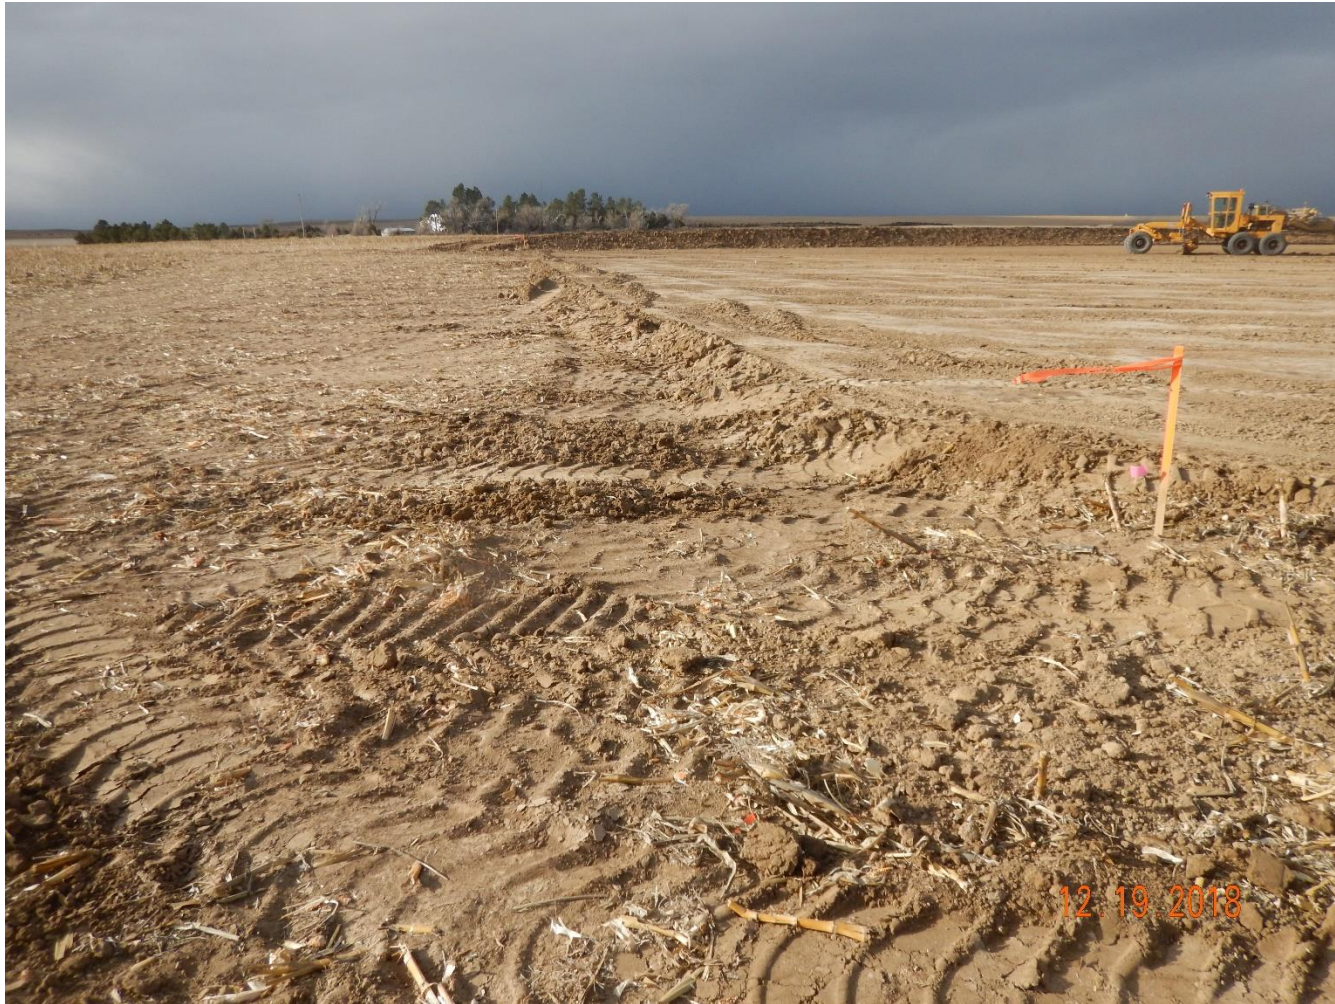
Photo 8: Photo taken from the northeast end of the construction disturbance, facing southwest. Photo provides an overview of the location. Photo also shows that perimeter stormwater and erosion control BMPs have not been installed in accordance with good engineering practices prior to and during construction activities.

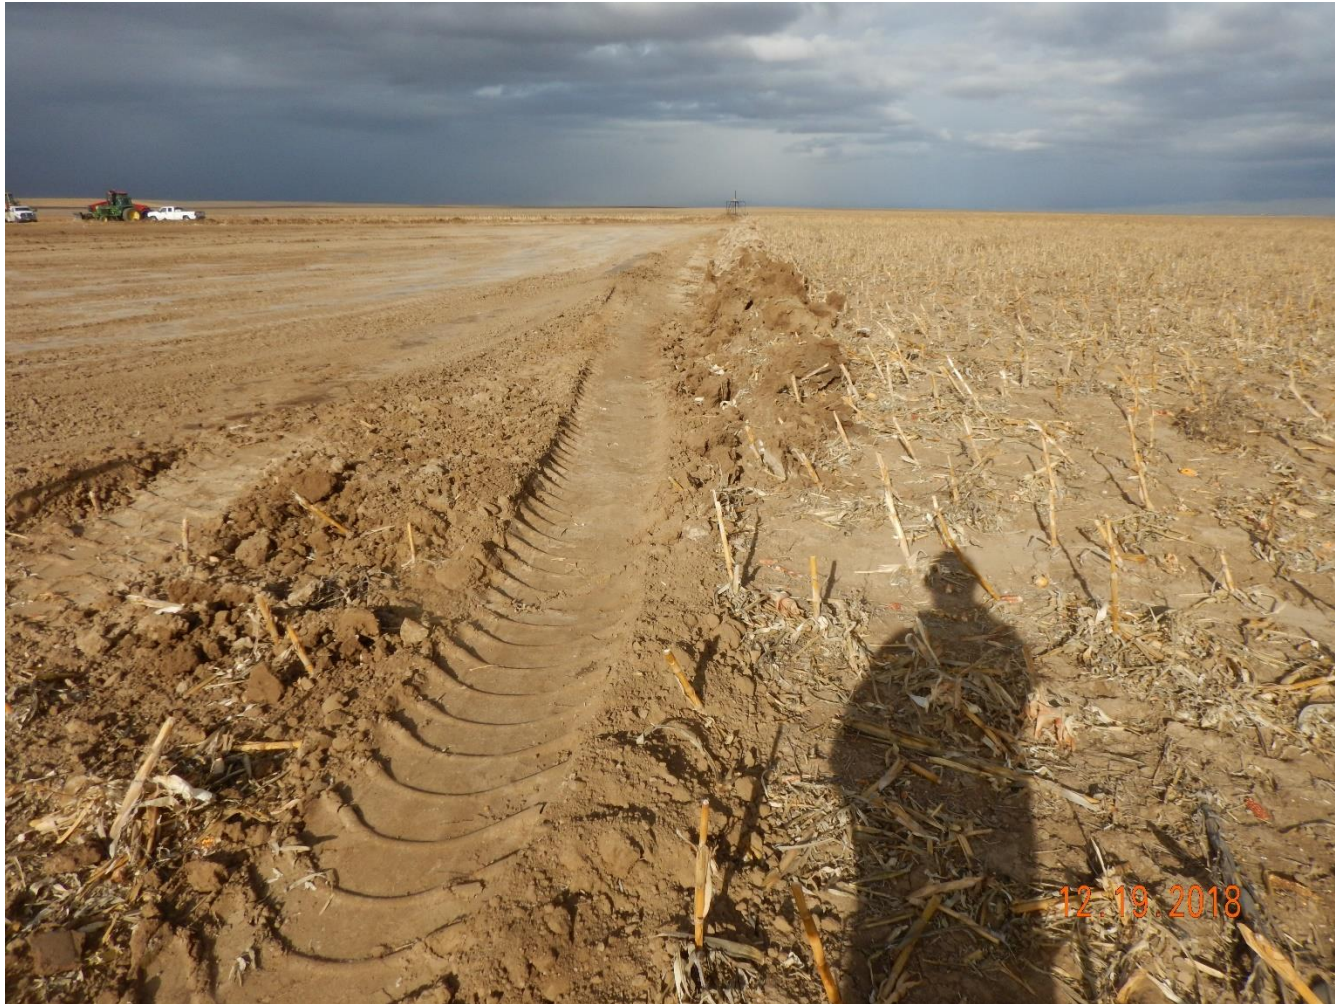
Photo 9: Photo taken from the northeast end of the construction disturbance, facing northwest. Photo provides an overview of the location. Photo also shows that perimeter stormwater and erosion control BMPs have not been installed in accordance with good engineering practices prior to and during construction activities.

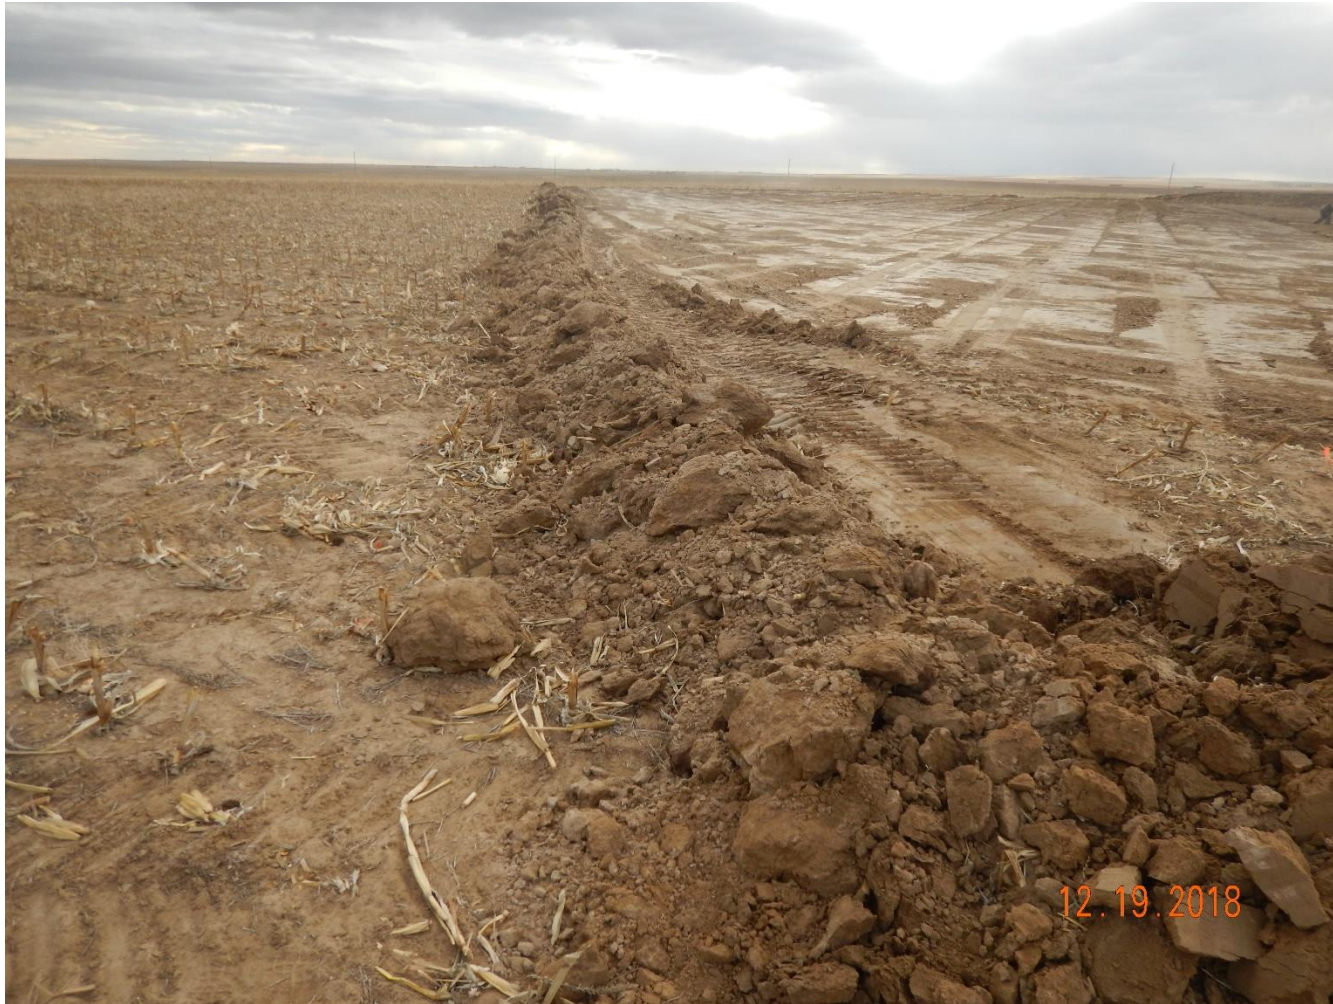
Photo 10: Photo taken from the northwest end of the construction disturbance, facing east. Photo provides an overview of the location. Photo also shows that perimeter stormwater and erosion control BMPs have not been installed in accordance with good engineering practices prior to and during construction activities.

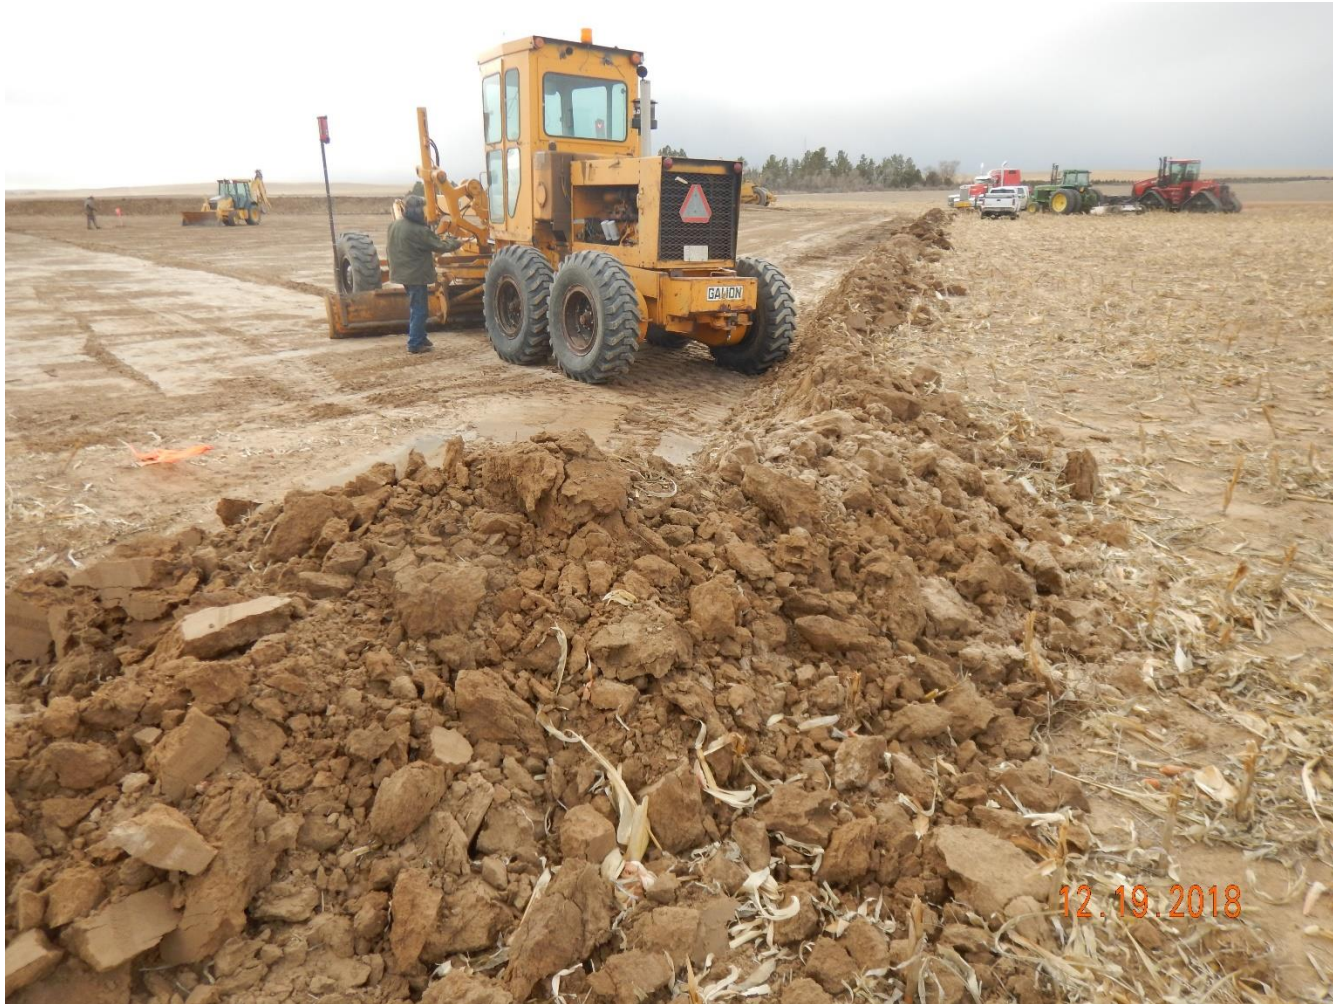
Photo 11: Photo taken from the northwest end of the construction disturbance, facing southwest. Photo provides an overview of the location. Photo also shows that perimeter stormwater and erosion control BMPs have not been installed in accordance with good engineering practices prior to and during construction activities.

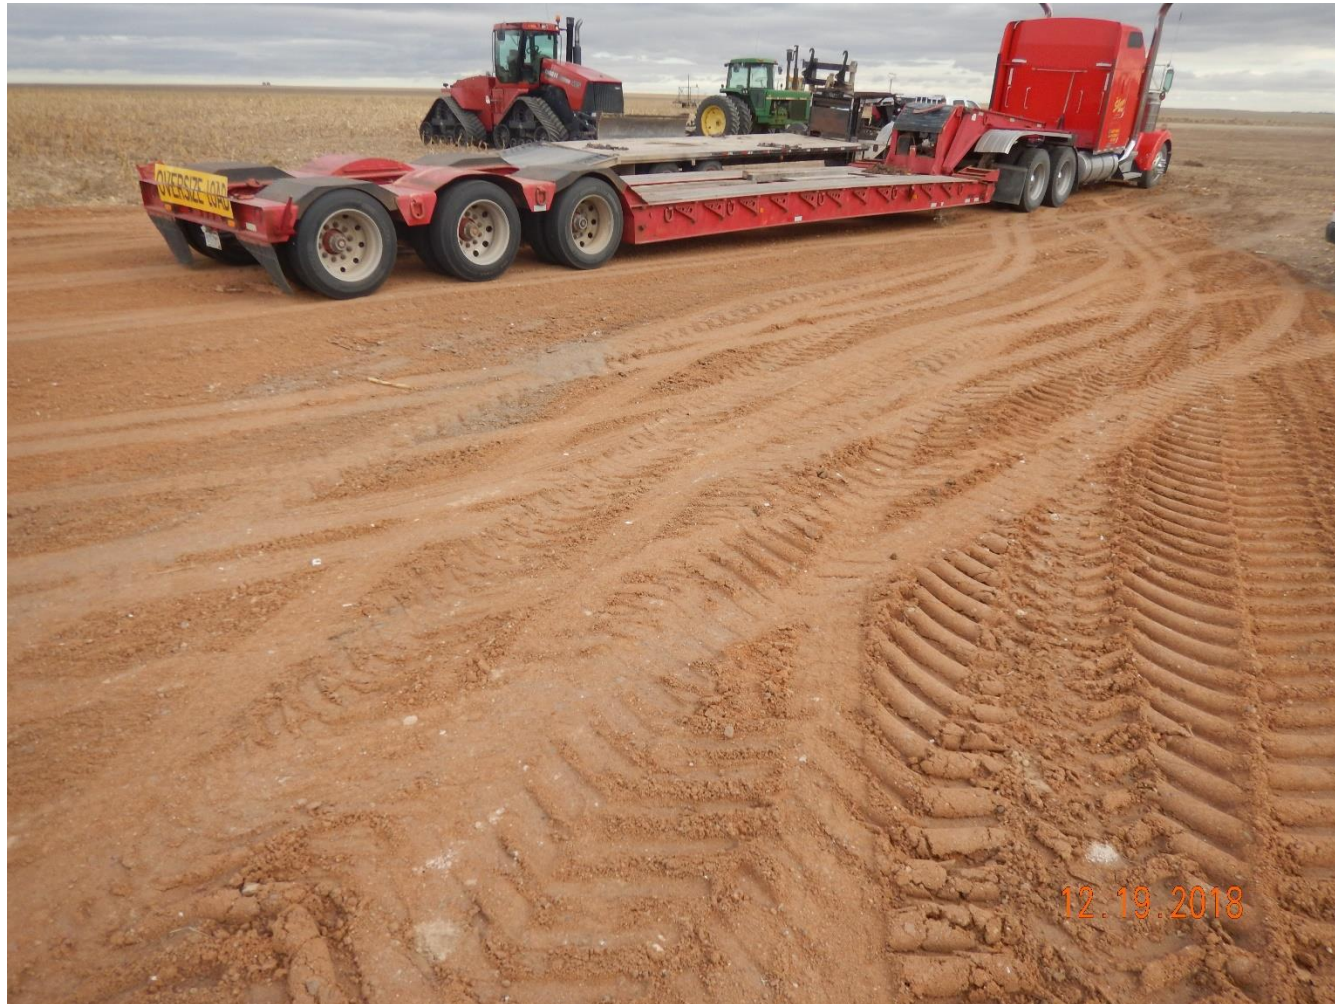
Photo 12: Photo taken from the access road, on the southwest end of the location, facing east. Photo shows fill material appears to have been brought onto the location to construct access road.
