Inspection Photos  
Location Name: SU 0680 3-9H16  
API: 05-057-06551

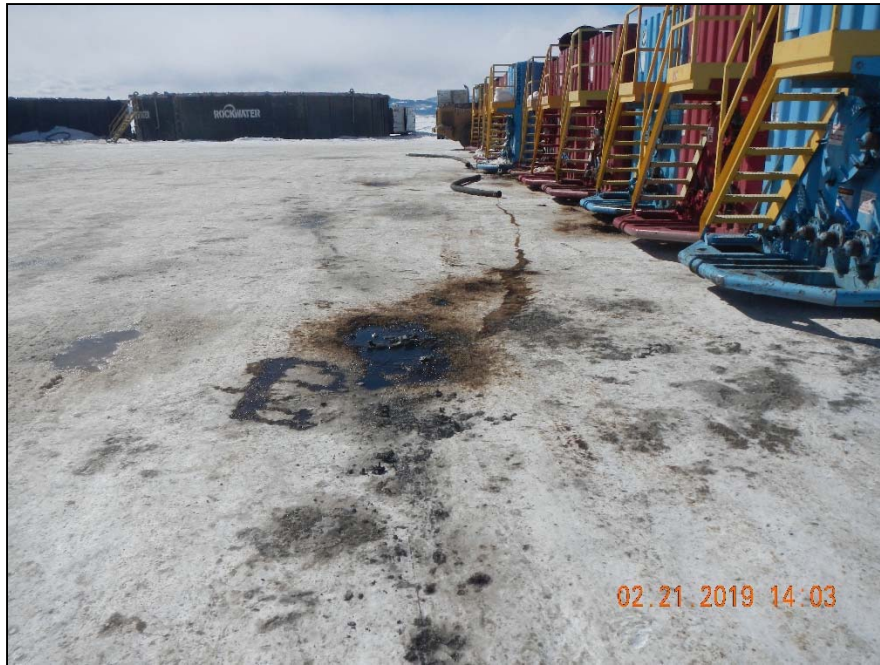
**Photo 1. Spills and staining.**

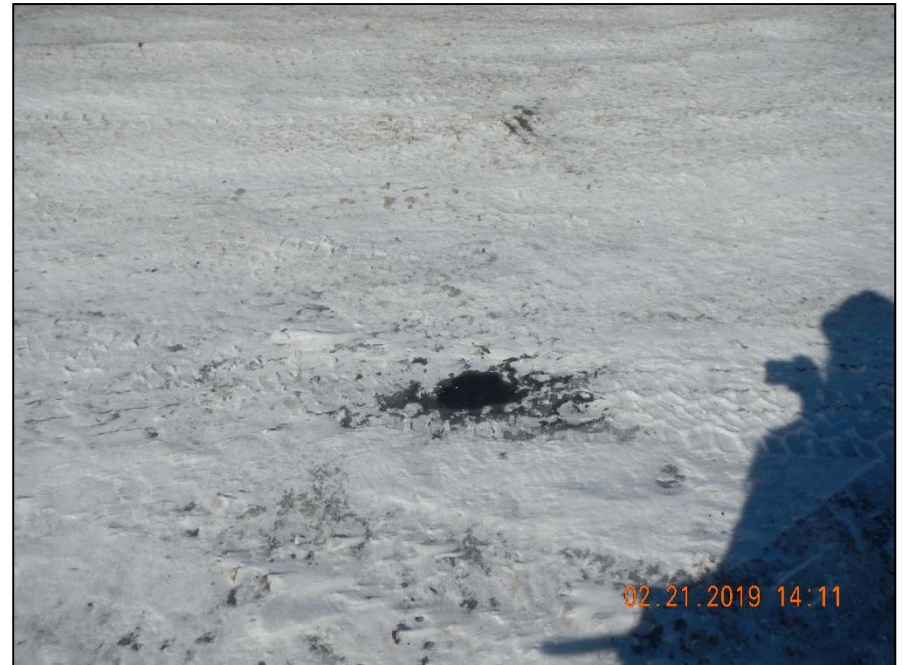
**Photo 2. Spills and staining.**

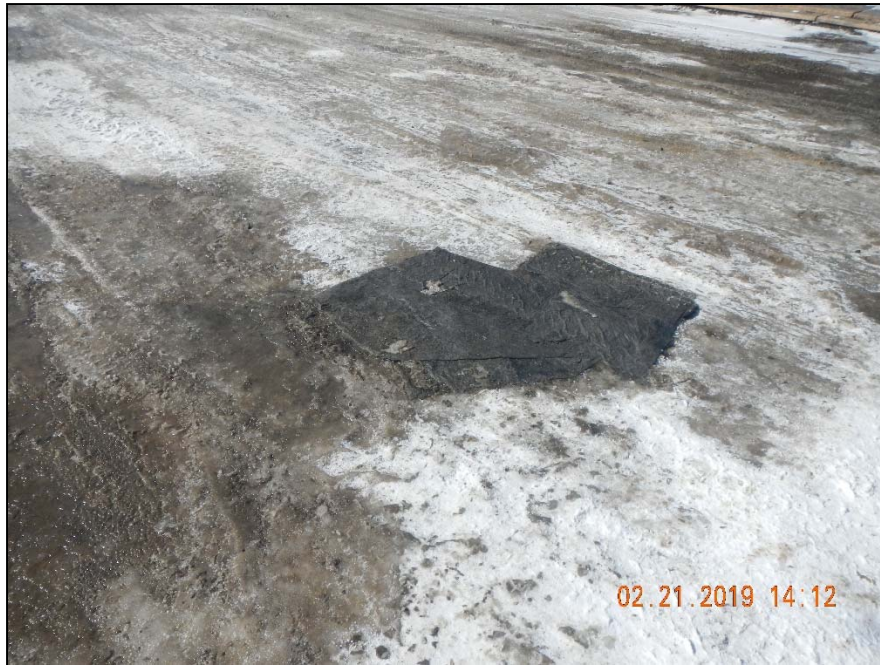
**Photo 3. Spills and staining.**

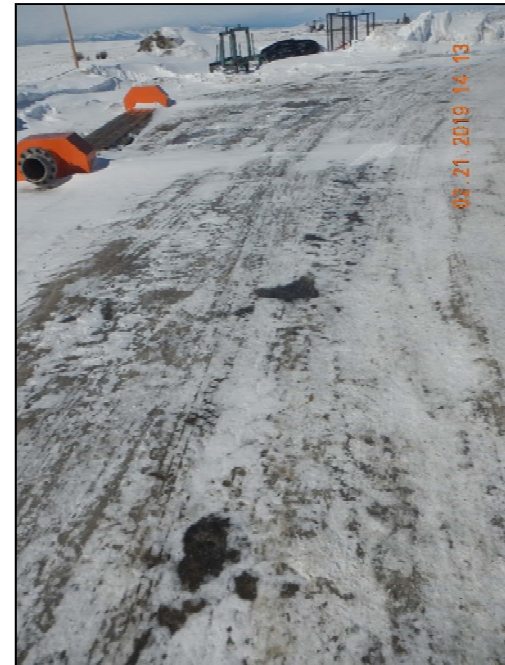
**Photo 4. Spills and staining.**

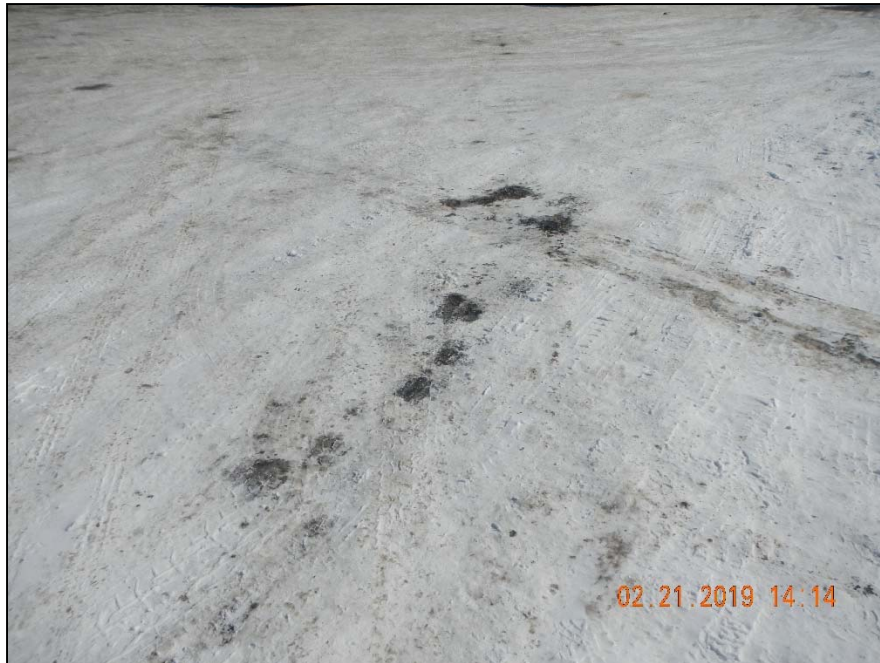
Photo 5. Spills and staining.

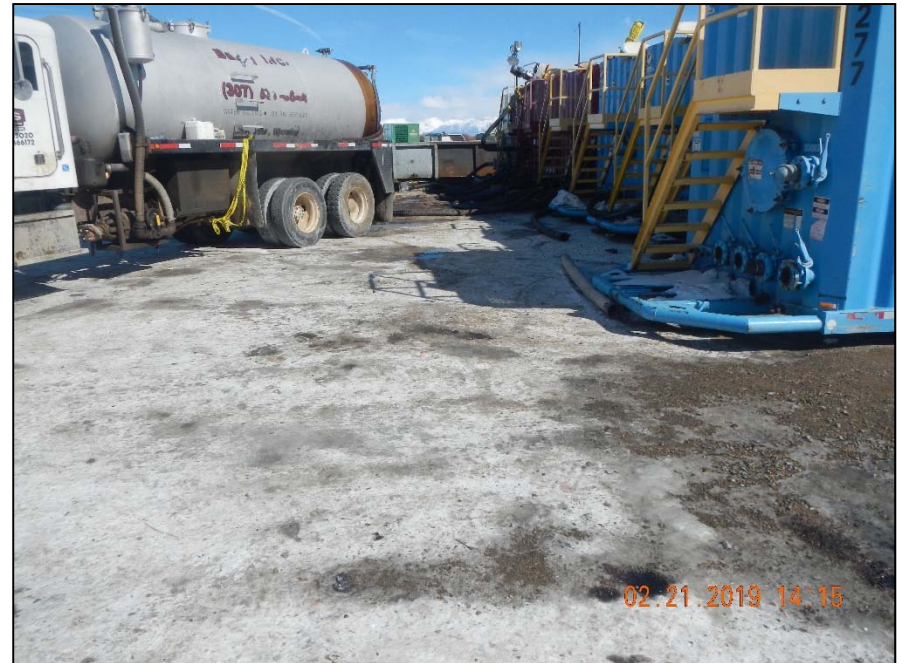
Photo 6. Spills and staining.

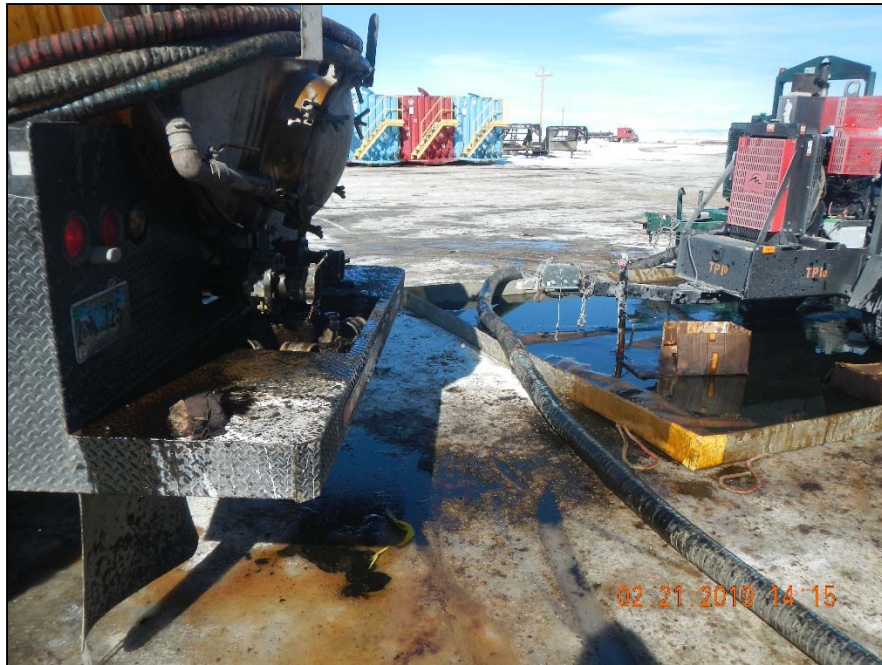
Photo 7. Spills and staining.

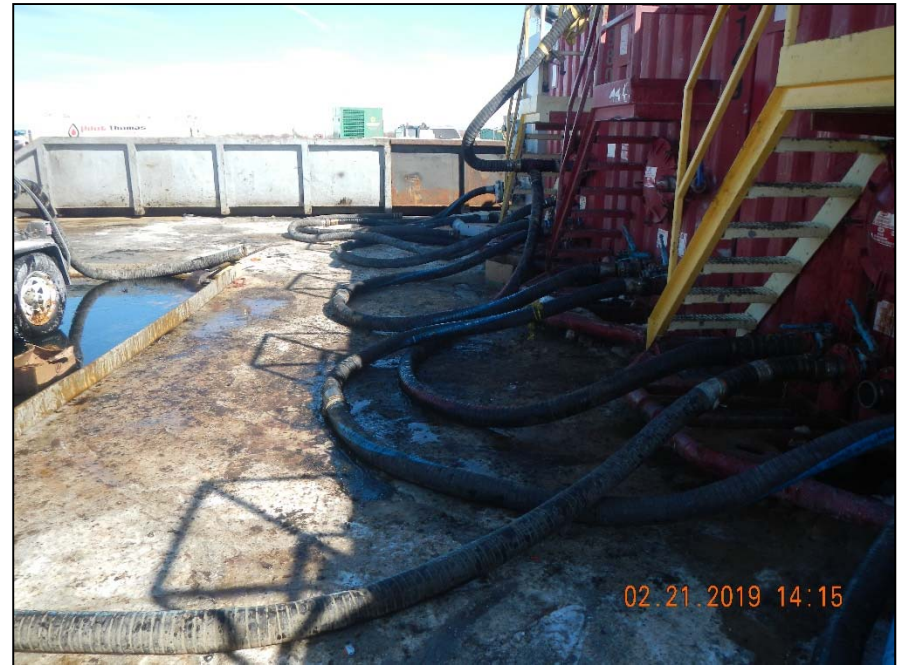
Photo 8. Spills and staining.

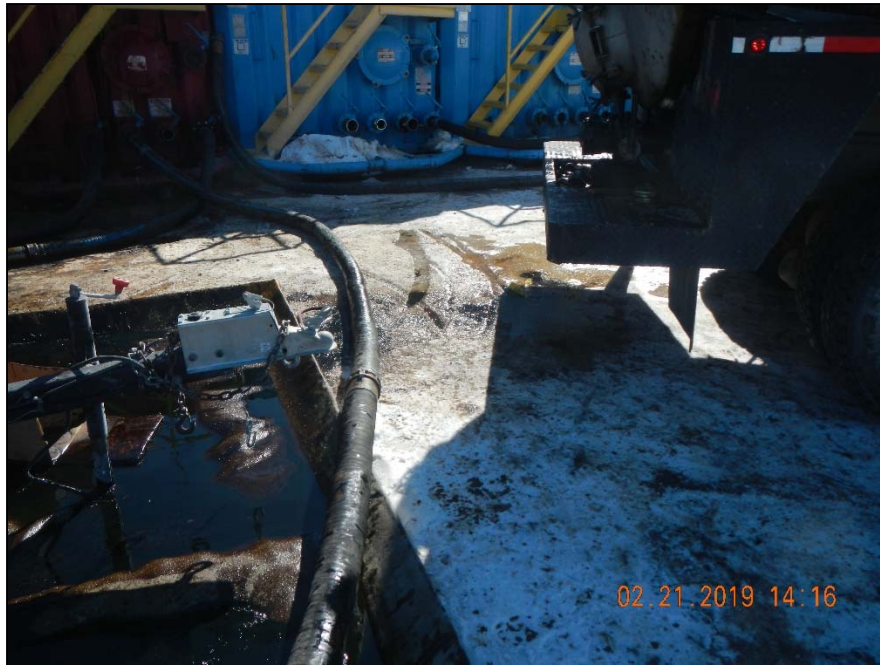
Photo 9. Spills and staining.

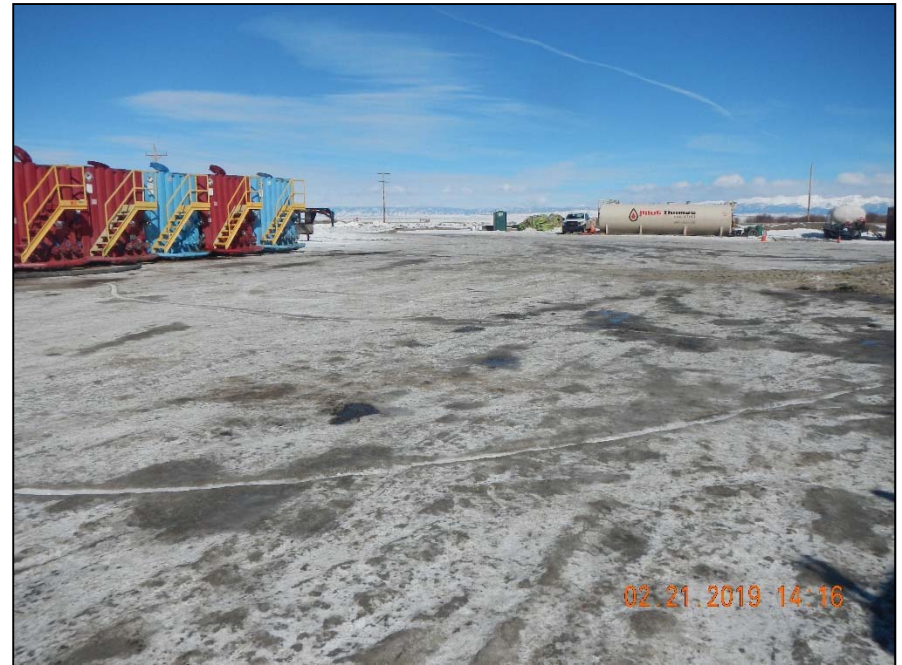
Photo 10. Spills and staining.

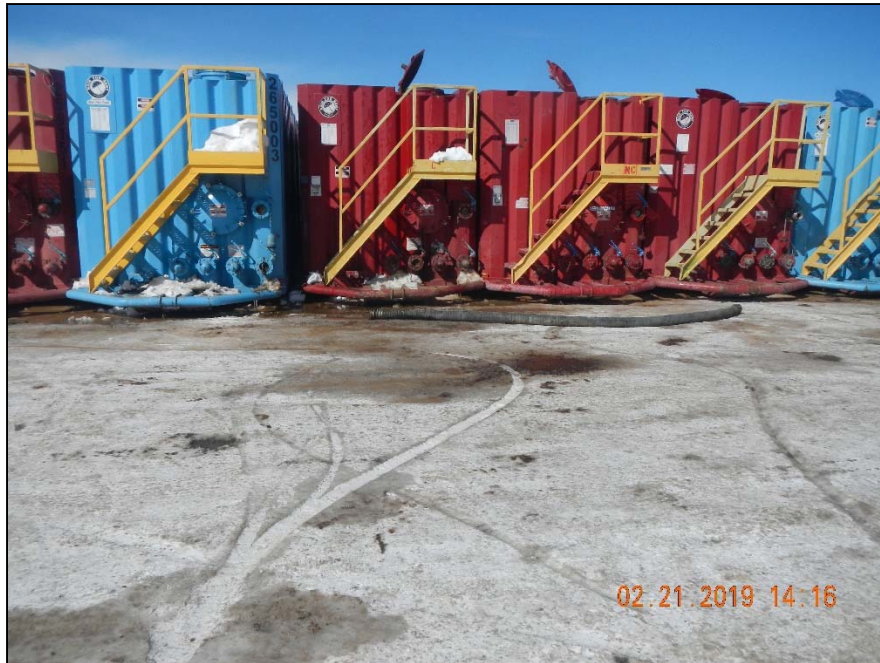
**Photo 11. Spills and staining.**

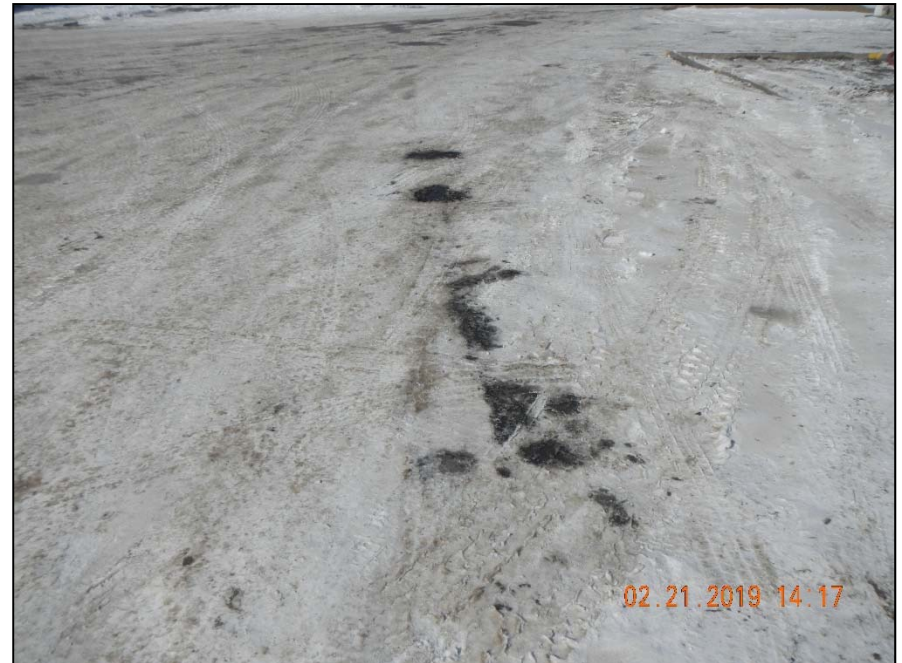
**Photo 12. Spills and staining.**

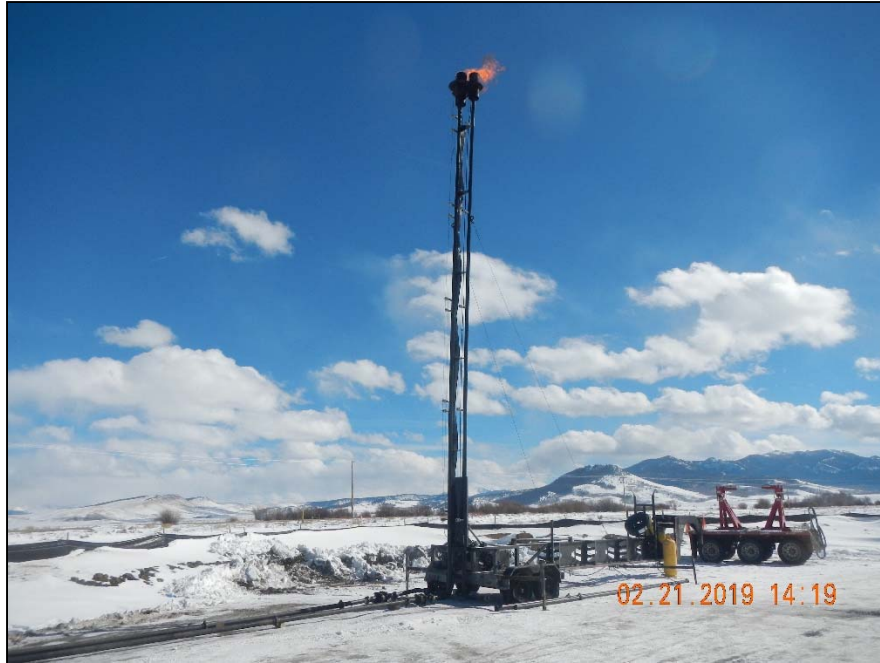
**Photo 13. Flare stack where fire occurred.**

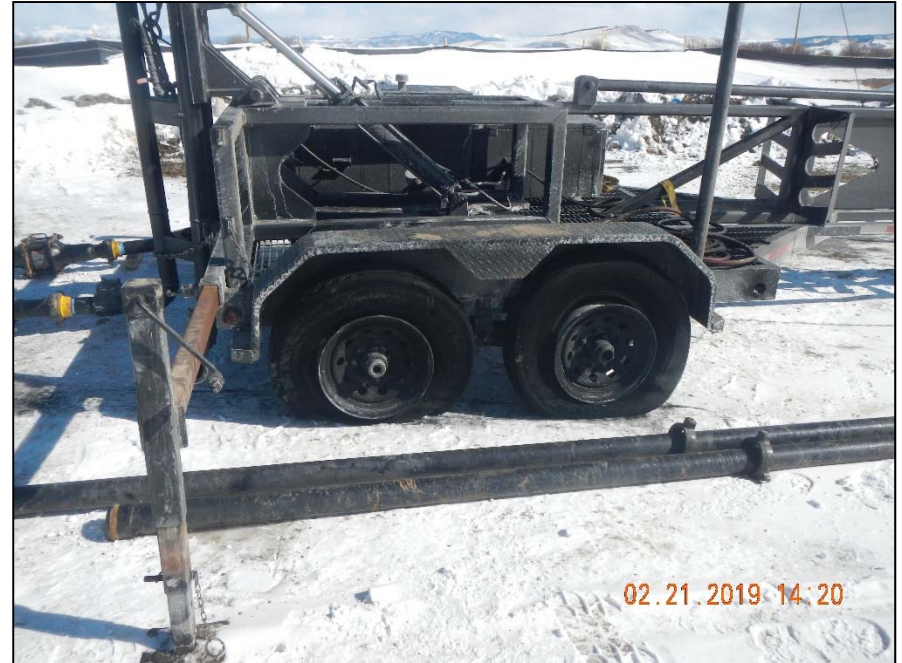
**Photo 14. Burned tires on stack trailer from fire.**

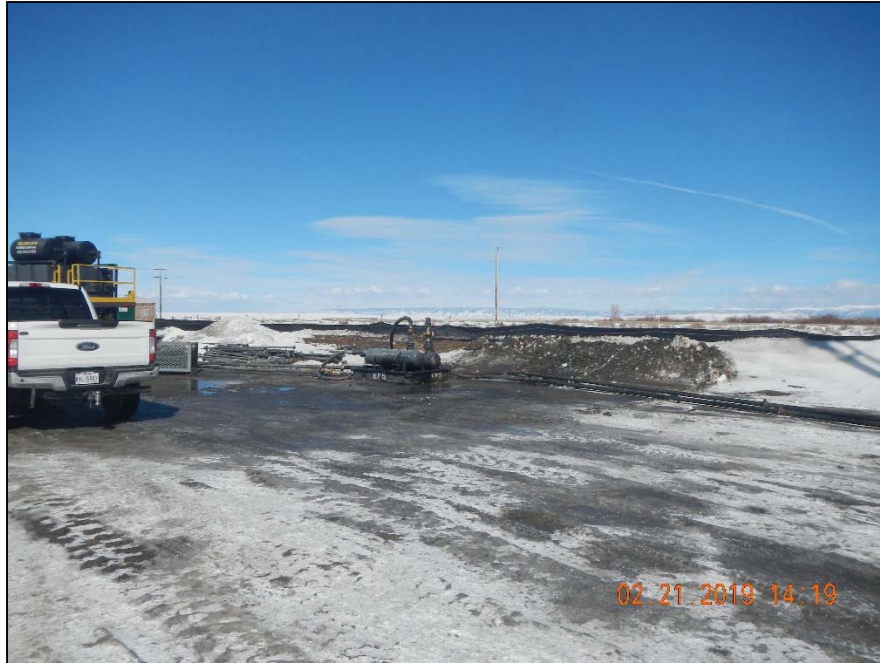
**Photo 15. No evidence of remaining fluids. Ice/snow melt with no visible sheen.**

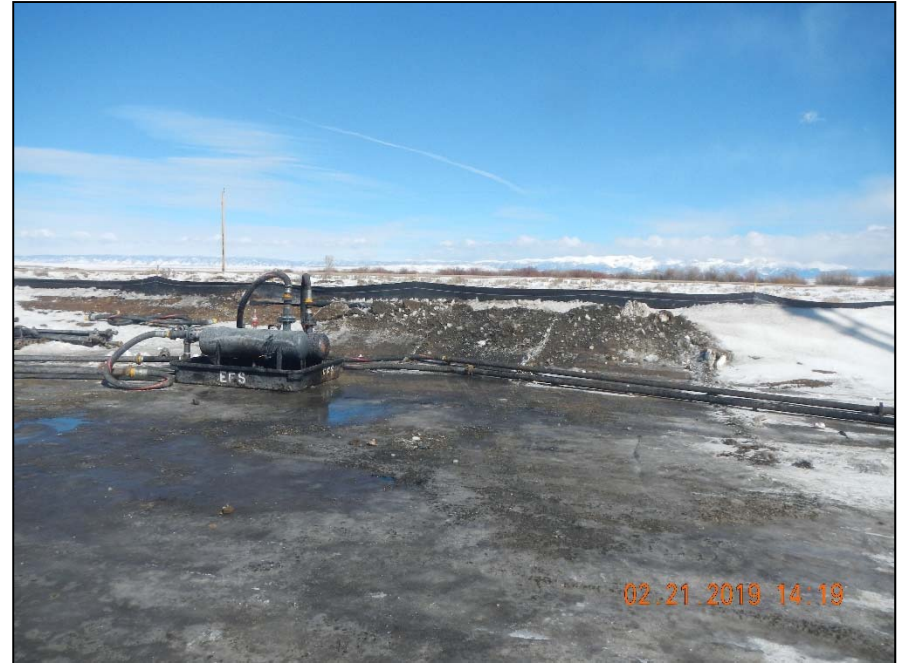
**Photo 16. No evidence of remaining fluids. Ice/snow melt with no visible sheen.**
