Inspection Photo (s)
GMR 33-15D
API #05-045-10173
FIR Inspection # 689303410

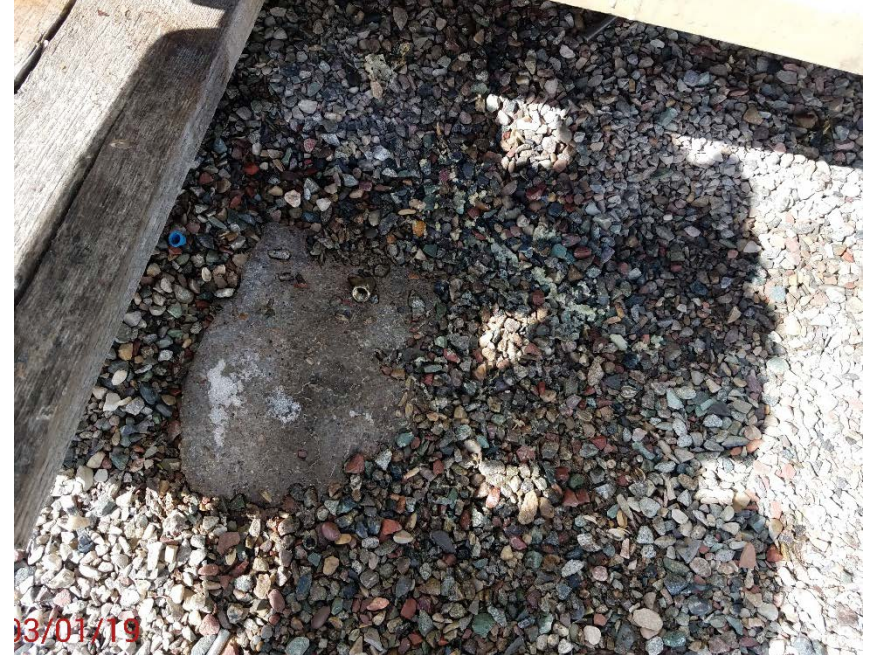
Location Photo #4, Stained rock around the separator.

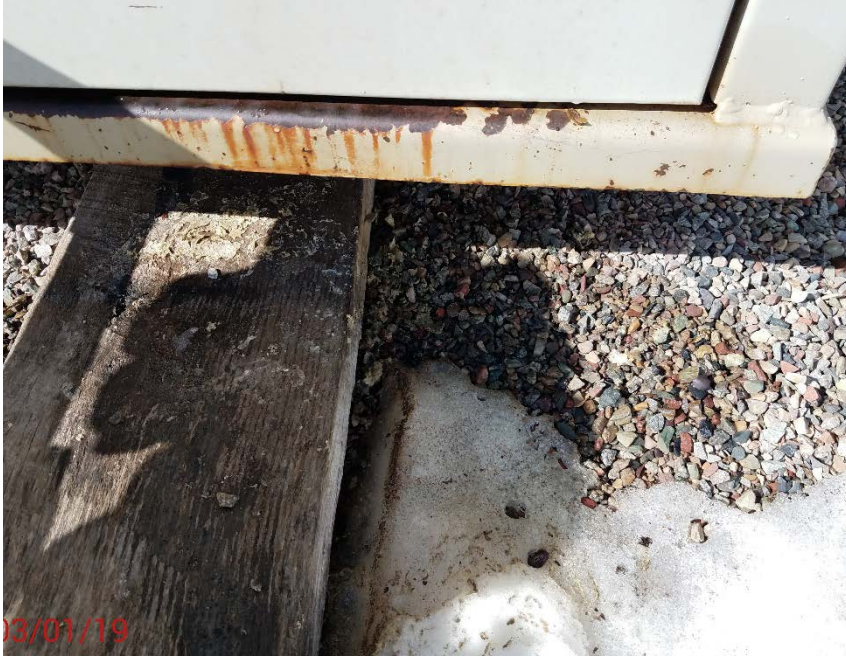
Location Photo #5, Stained rock at corner of separator.

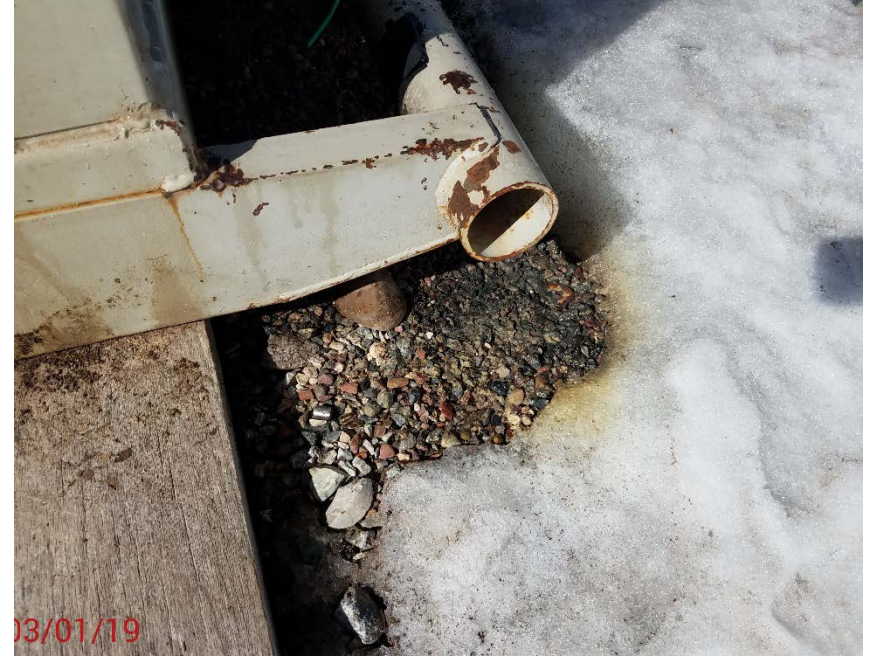
Location Photo #6, Stained rock at corner of separator.

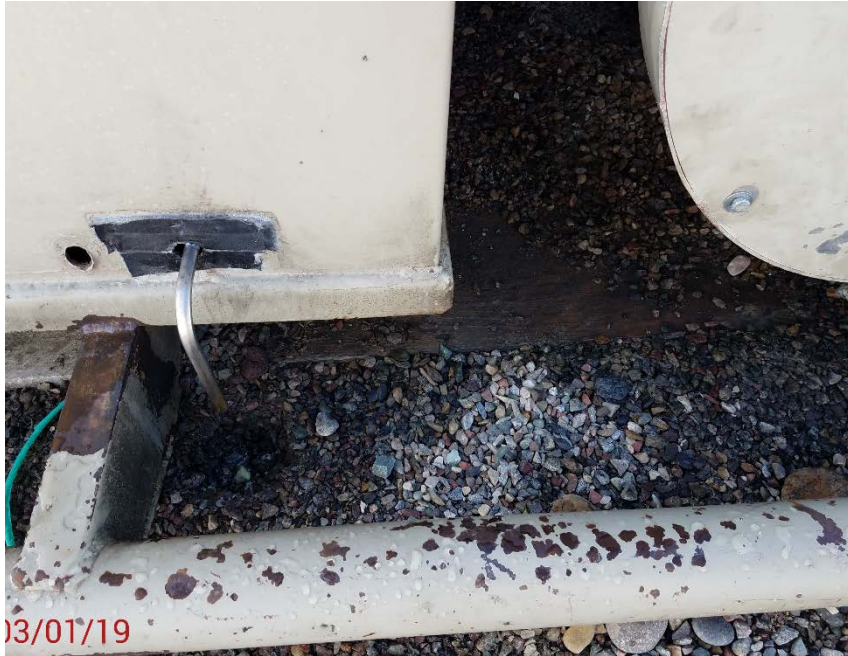
Location Photo #5, Stained rock under the heater of the separator.
