Inspection Photos

API: 05-025-06021

Operator: VAL ENERGY INC

Inspection Date: 3/11/2019

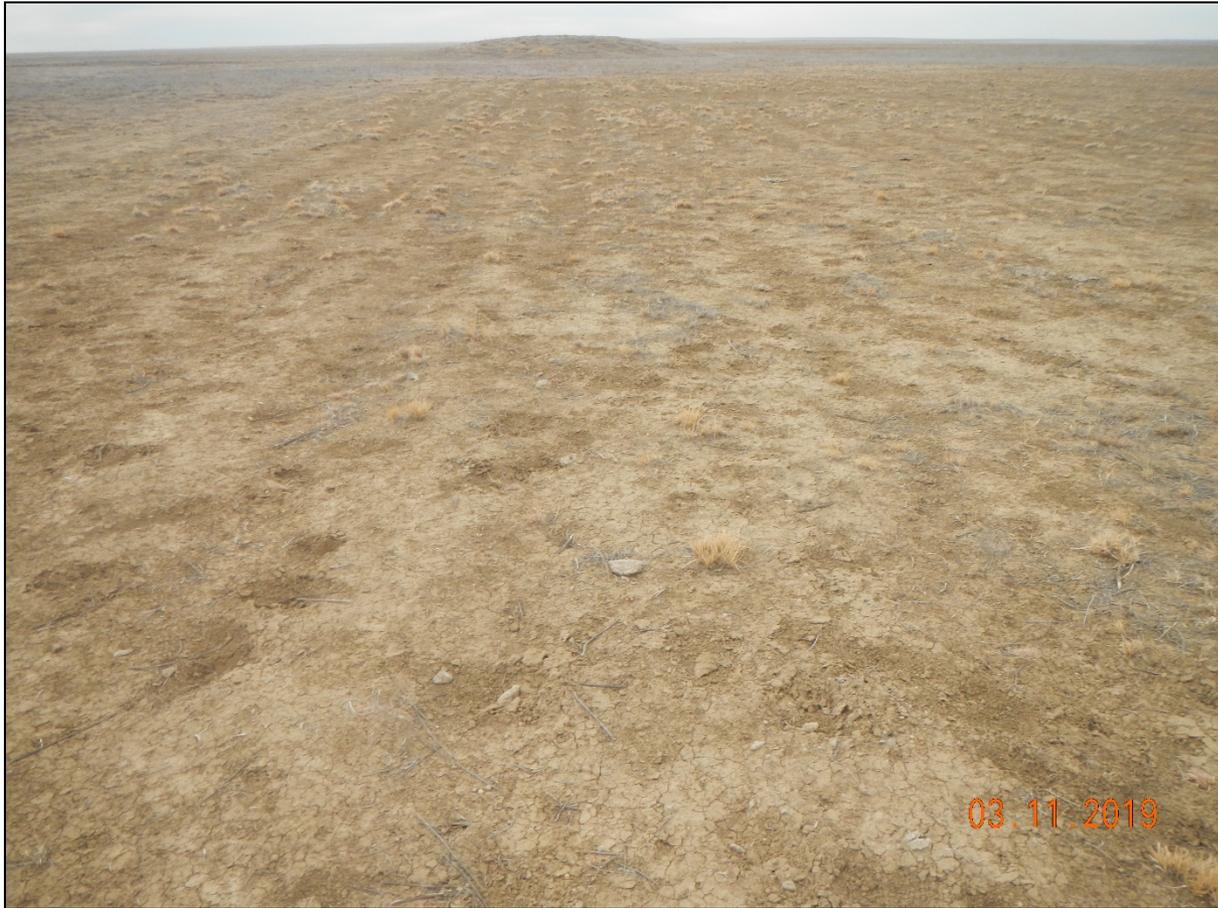
Photo 1. Facing southwest toward the location. There is sparse vegetation establishment.

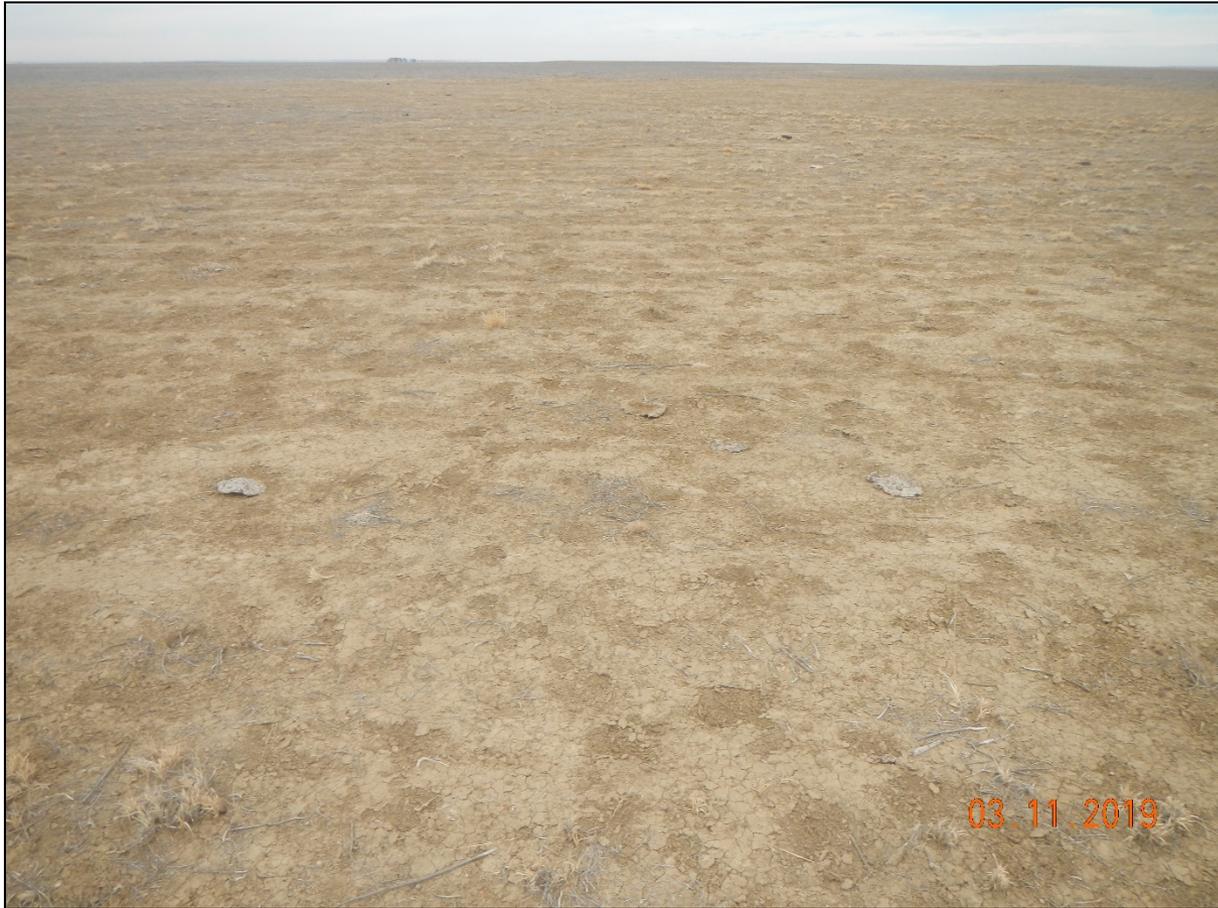
Photo 2. Facing northwest toward the location. There is sparse vegetation establishment.

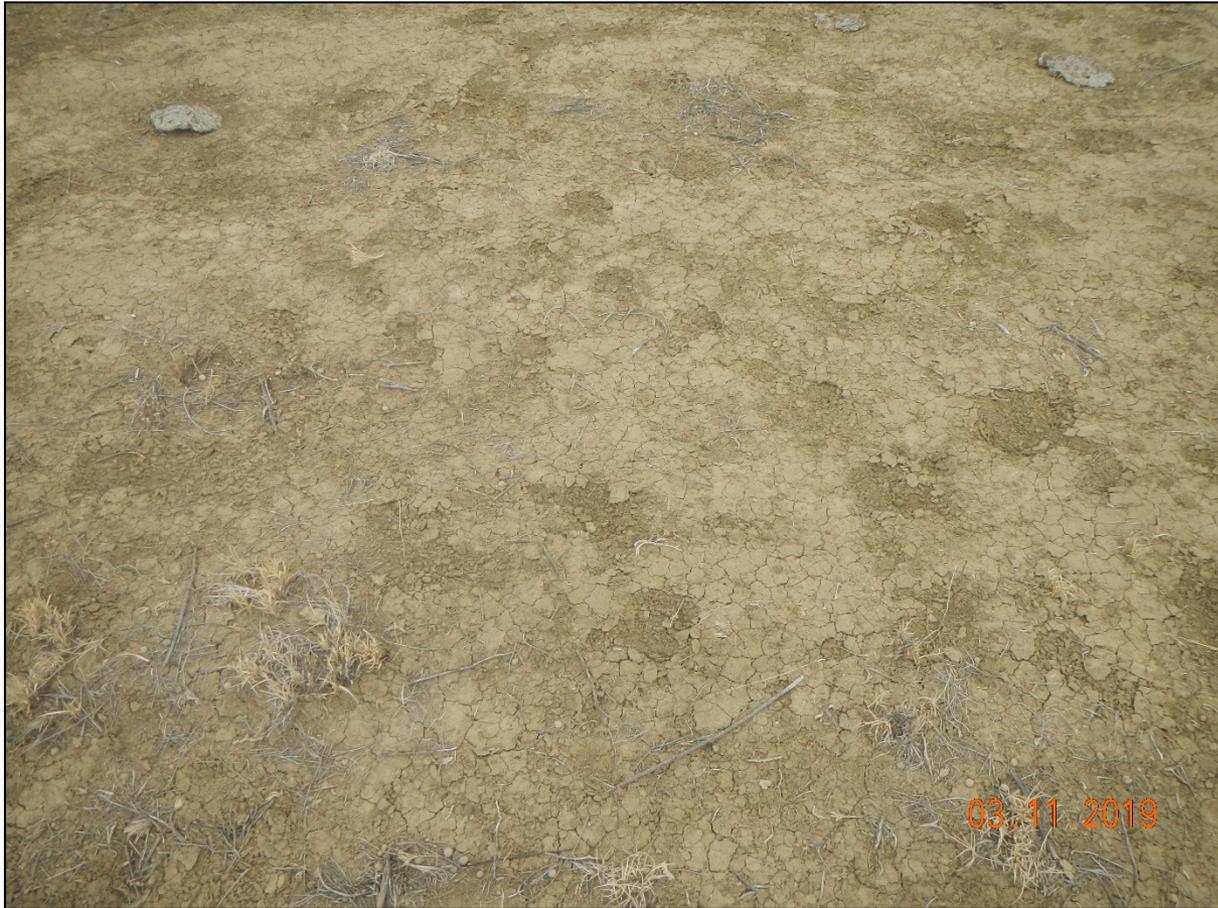
Photo 3. View of groundcover which is mostly bare soil.

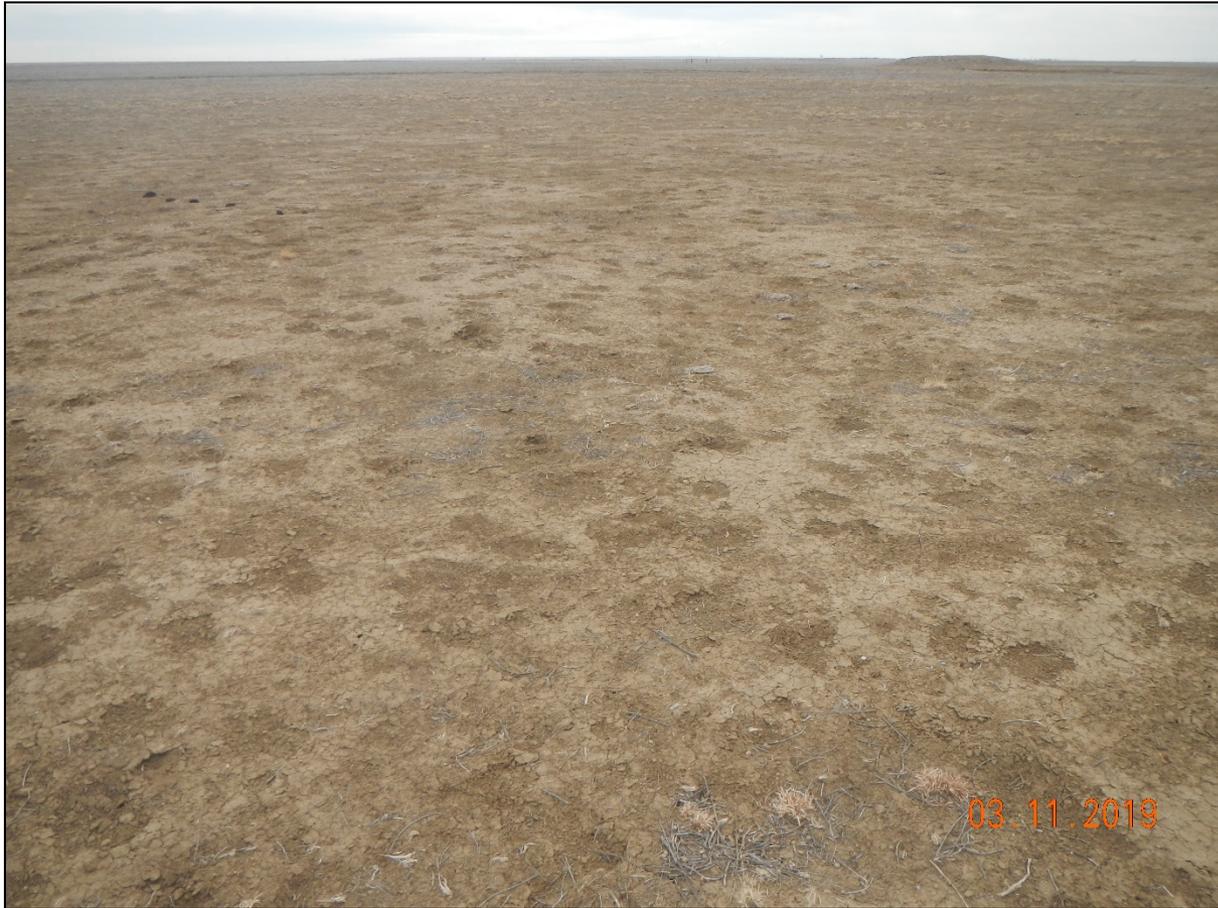
Photo 4. Facing south toward the location. There is sparse vegetation establishment.

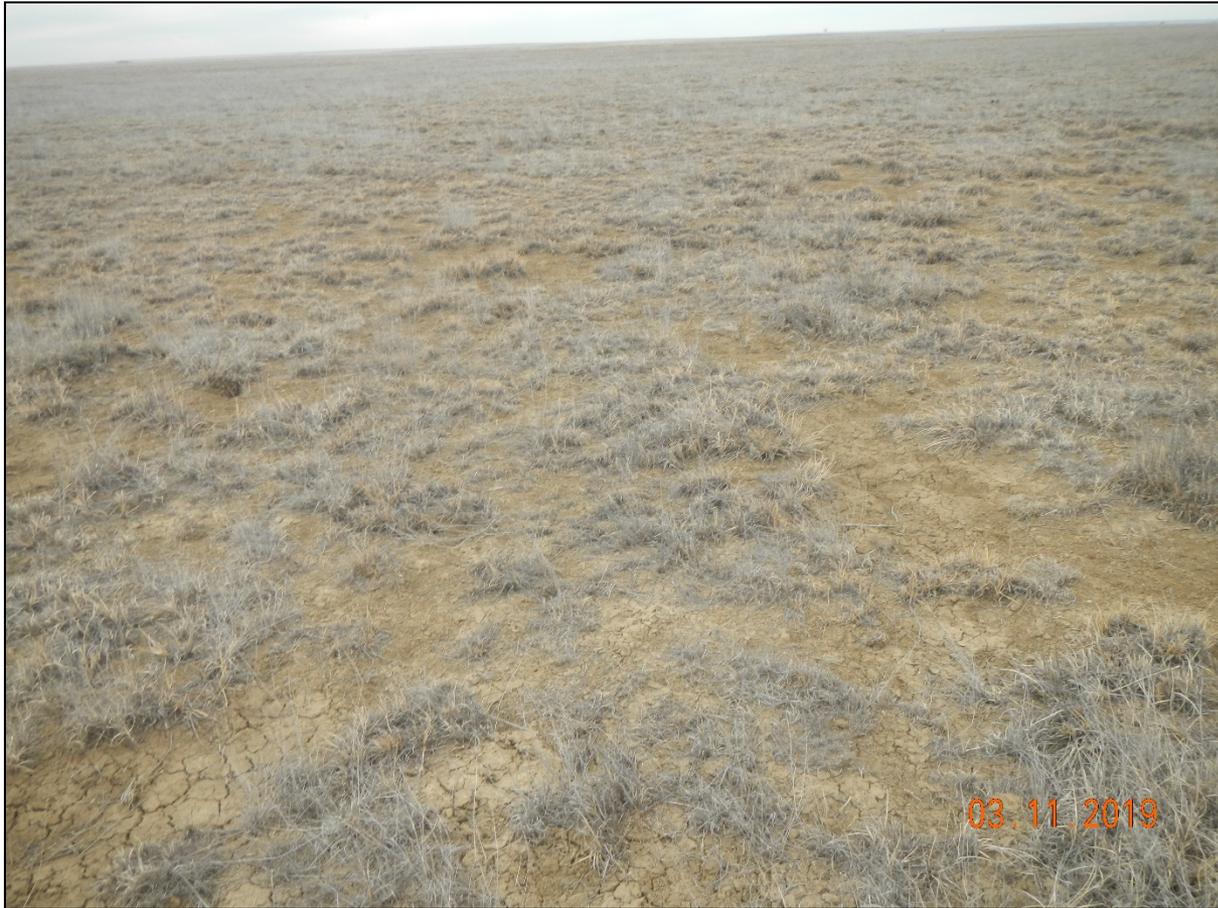
Photo 5. Facing west toward the undisturbed surrounding pasture.

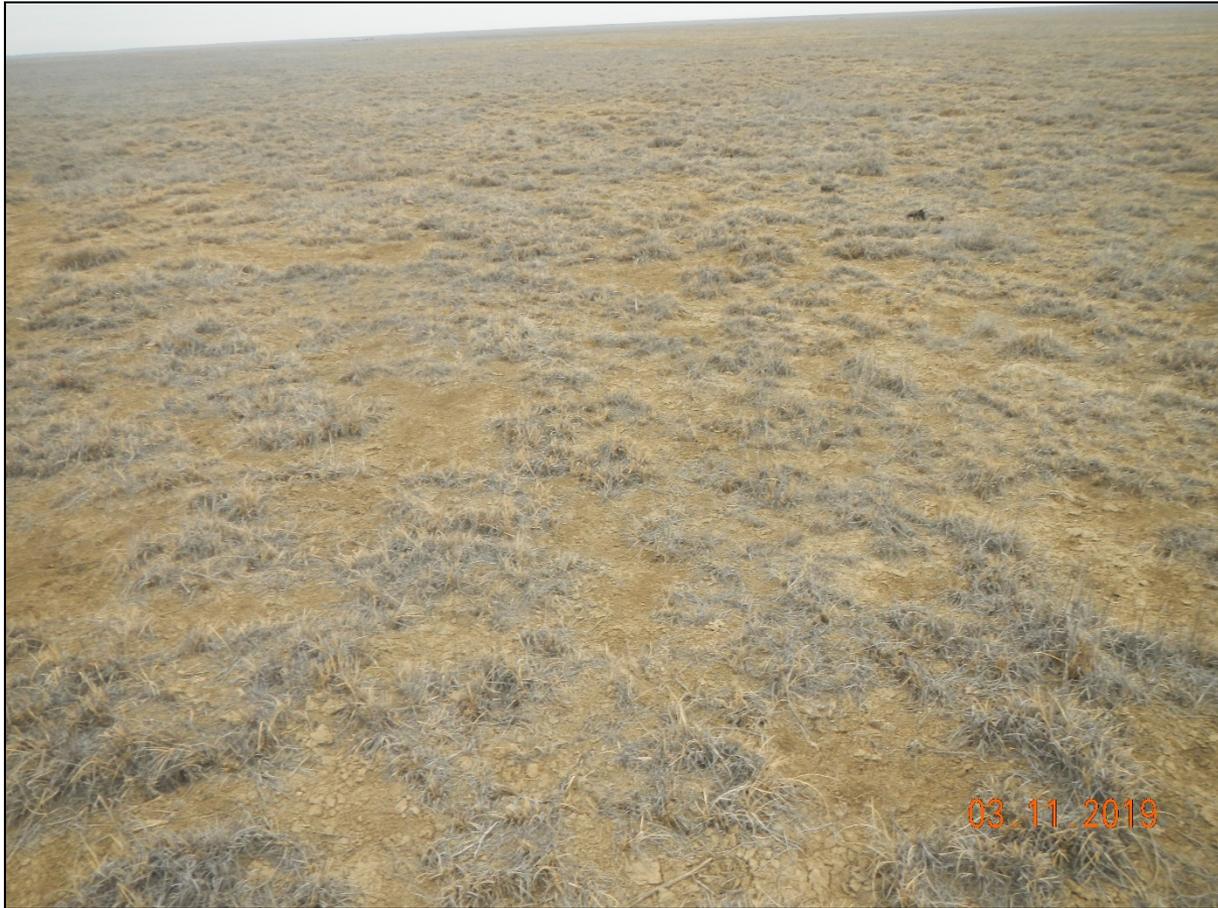
Photo 6. Facing east toward the undisturbed surrounding pasture.
