# Inspection Photos

API: 05-025-06022

Operator: GRAND MESA OPERATING CO

Inspection Date: 3/11/2019

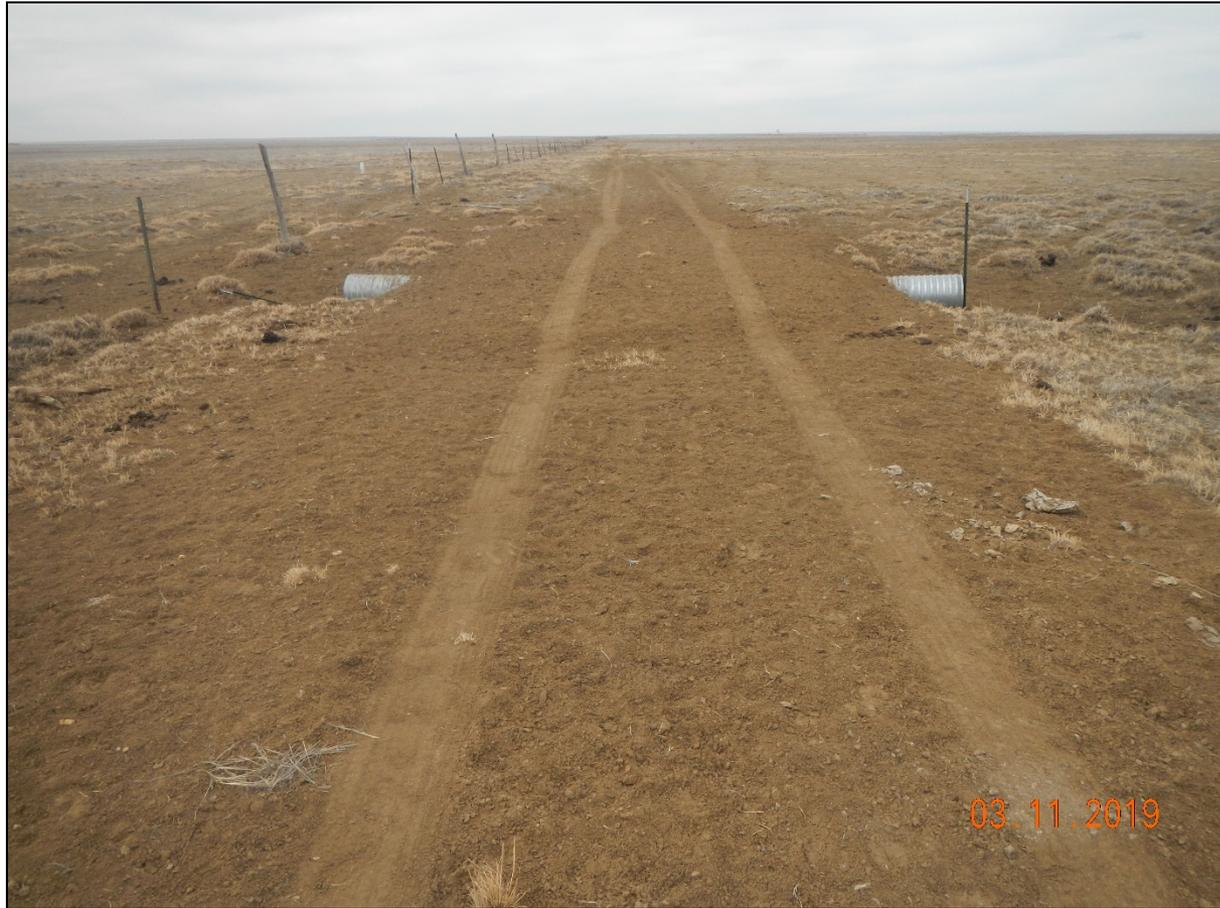
**Photo 1.** Facing west along the access road. Culverts remain along the road.

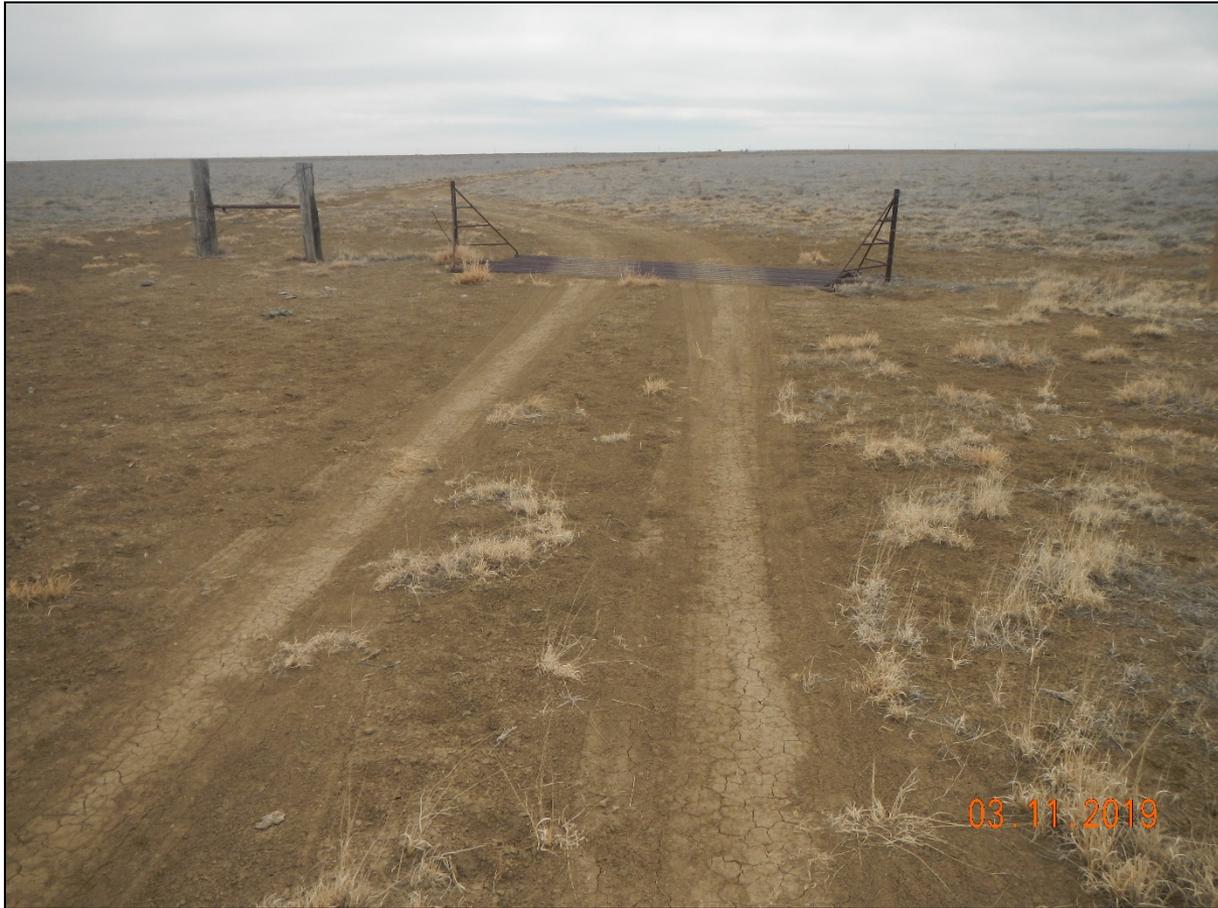
**Photo 2.** Facing south along the access road. The cattle guard remains.

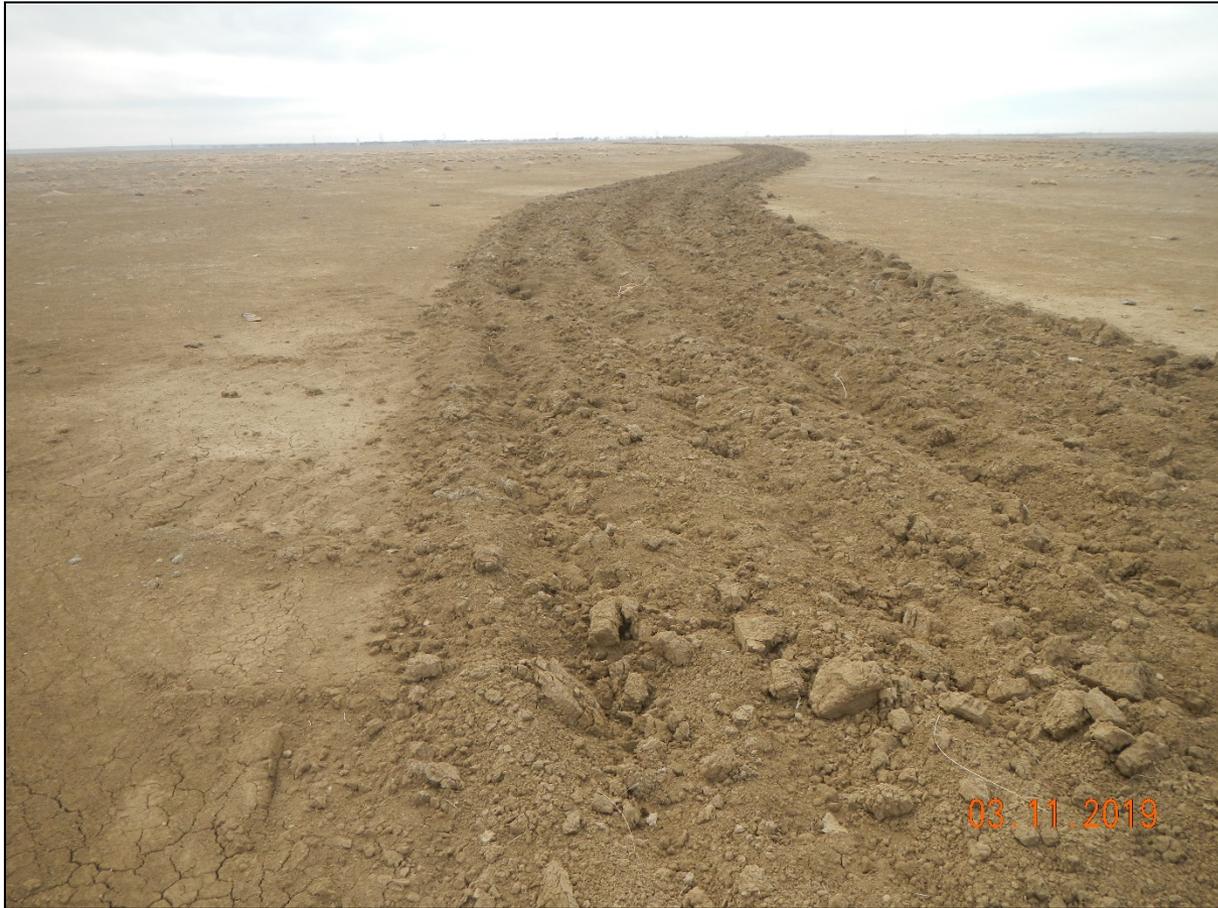
**Photo 3.** Facing southwest near the location. Decompaction of the soil begins at this point to the location.

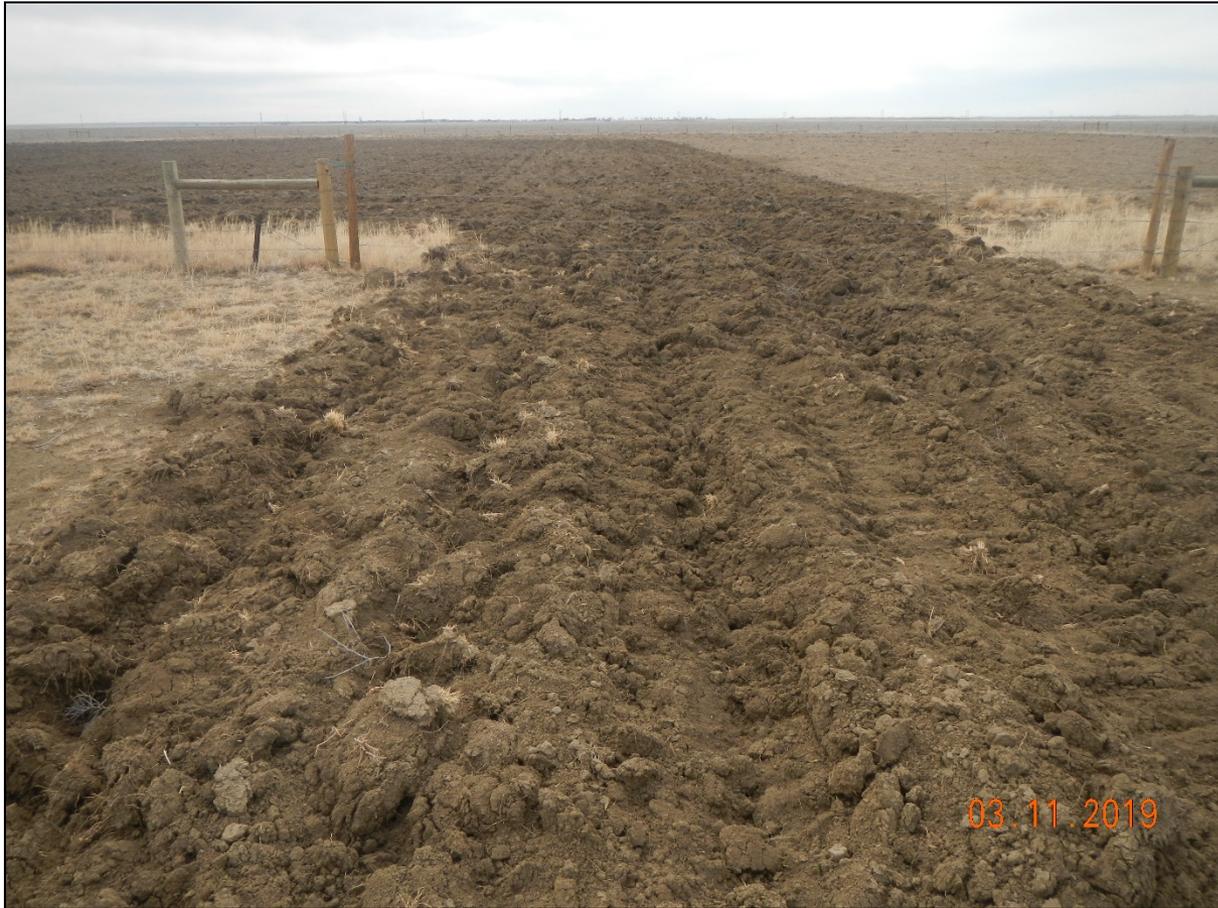
**Photo 4.** Facing toward the location. Decompaction has occurred at the location.

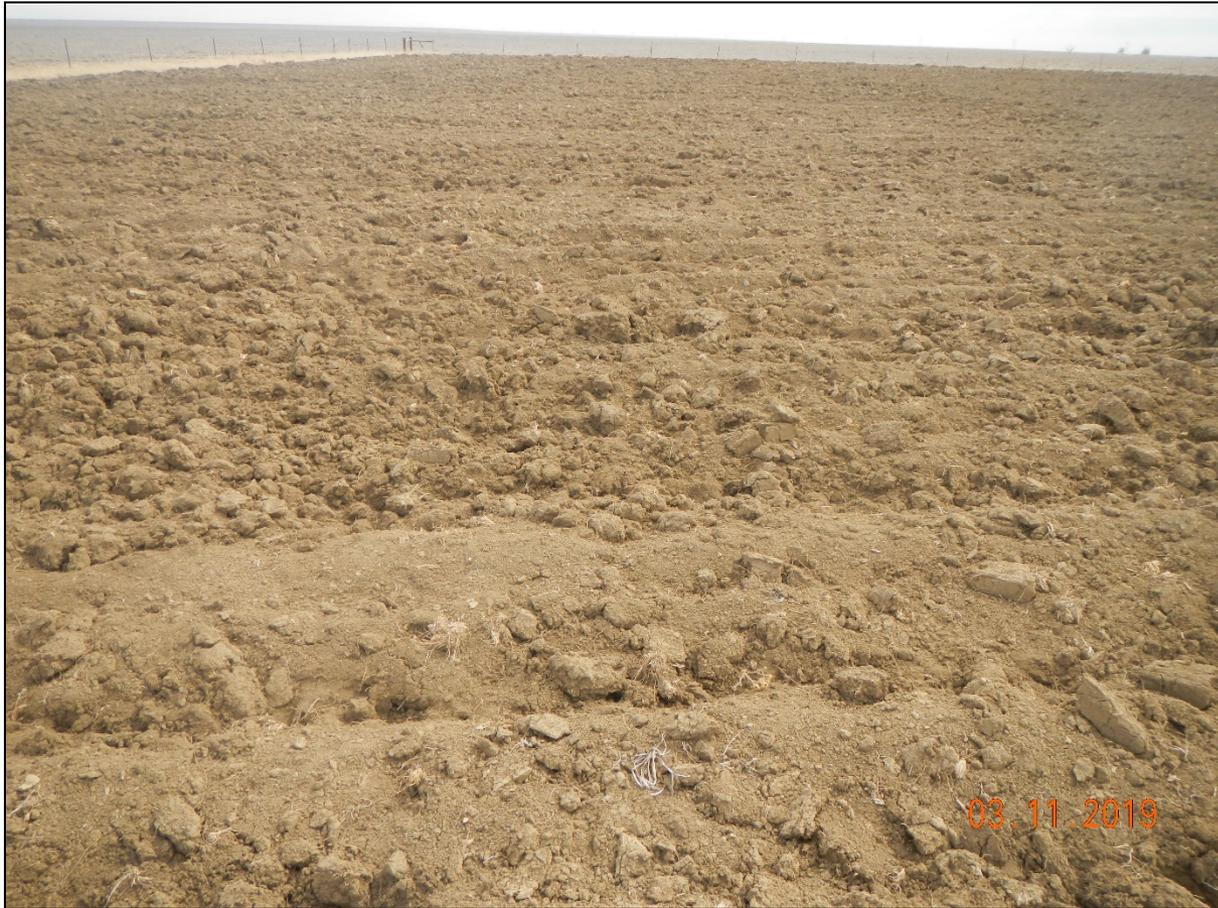
**Photo 5.** Facing east at the location. Soil decompaction has occurred at the location. The soil has not been seeded and stabilized.

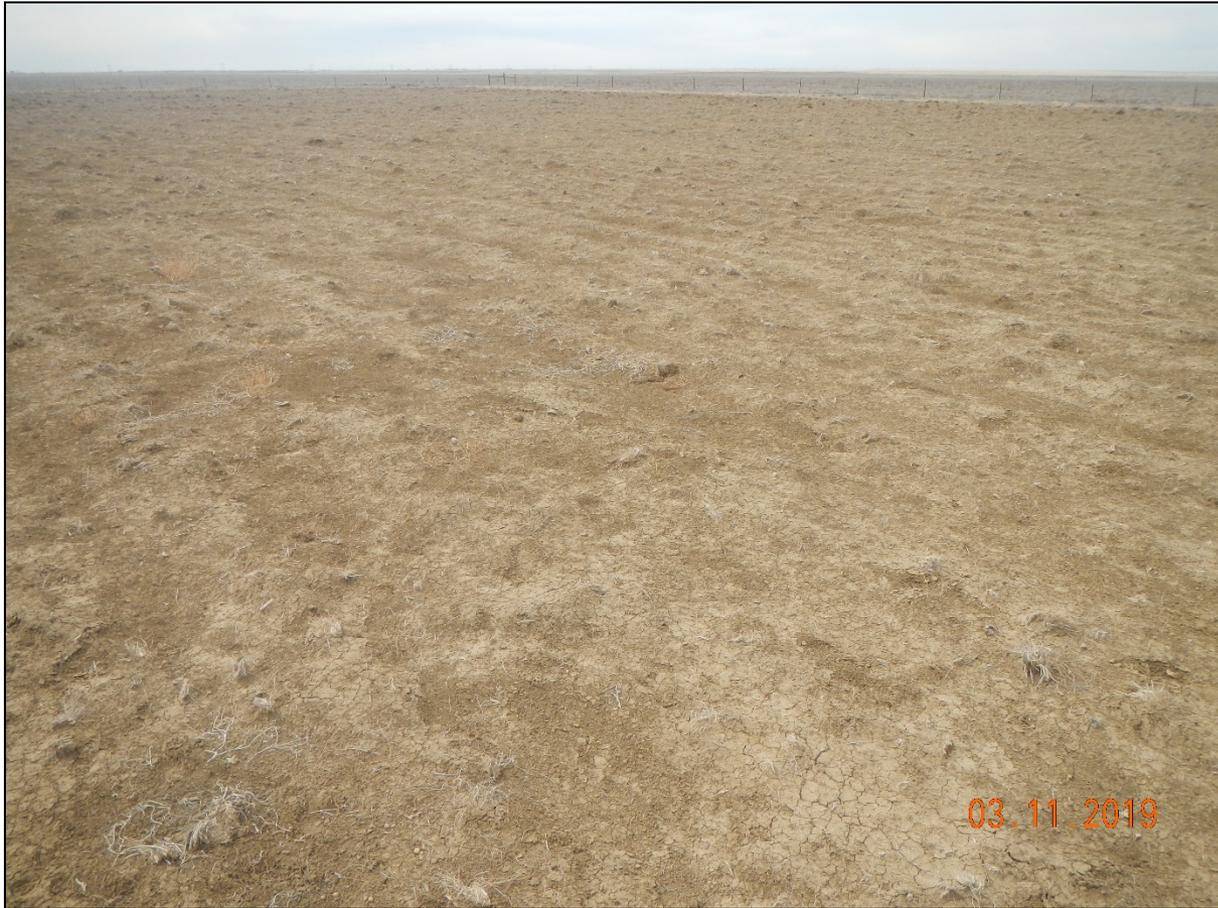
**Photo 6.** Facing southwest at the location. This area appears to have been previously decompacted. Does not look like it has been seeded.
