Inspection Photos
Location Name: LARRY 14-26
API #: 05-071-07676
Insp. Doc. # 695100347

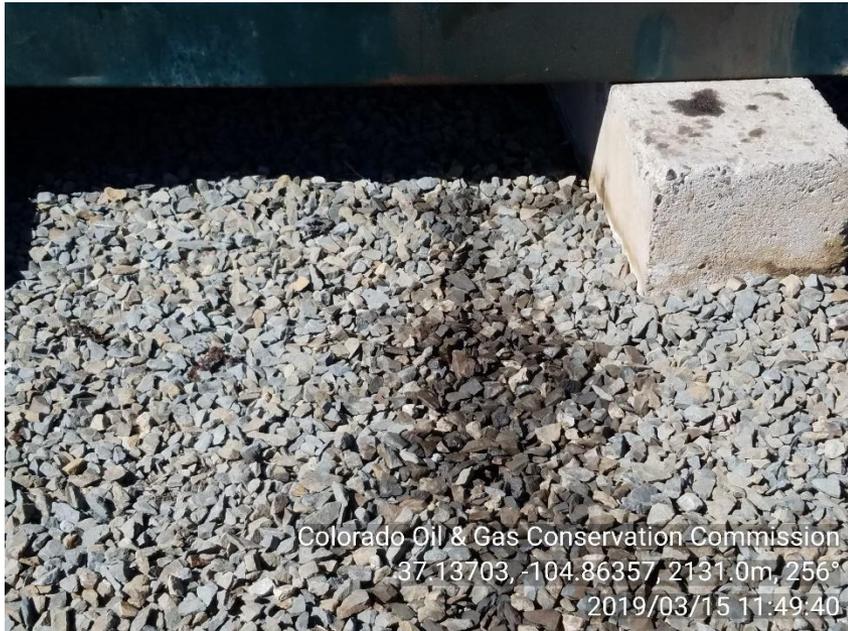
PHOTO 3: IMPACTED SOIL ON EAST SIDE OF ENGINE SKID

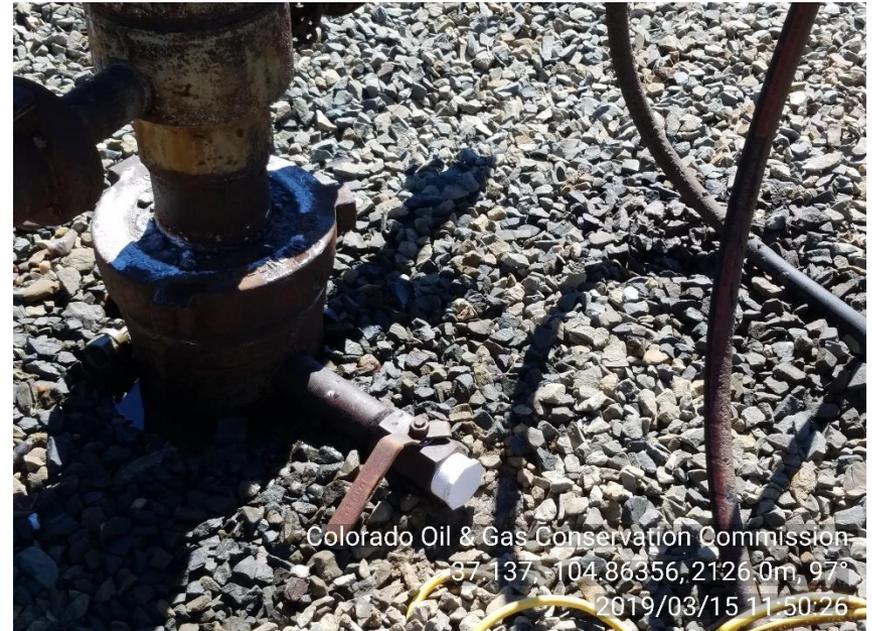
PHOTO 4: IMPACTED SOIL AROUND WELLHEAD

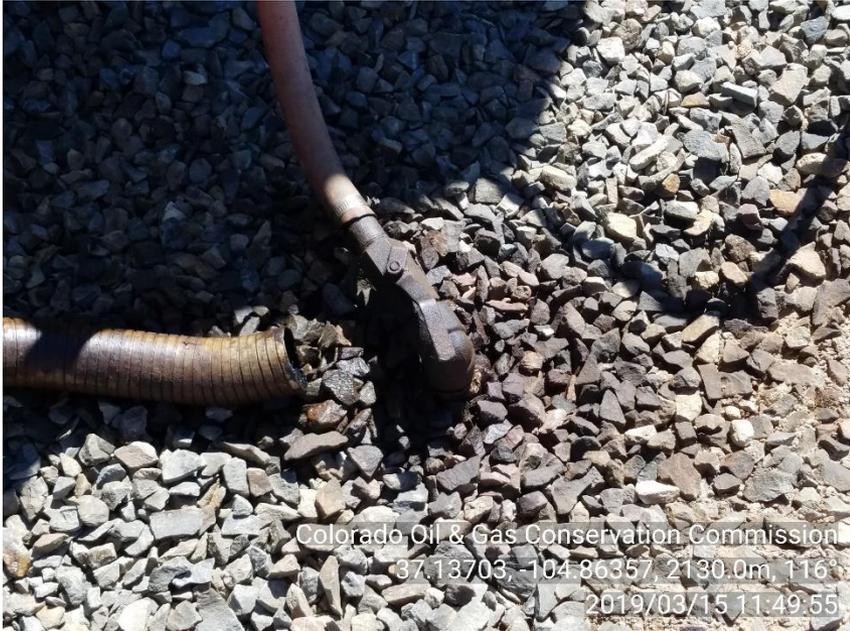
PHOTO 5: IMPACTED SOIL ON WEST SIDE OF ENGINE SKID

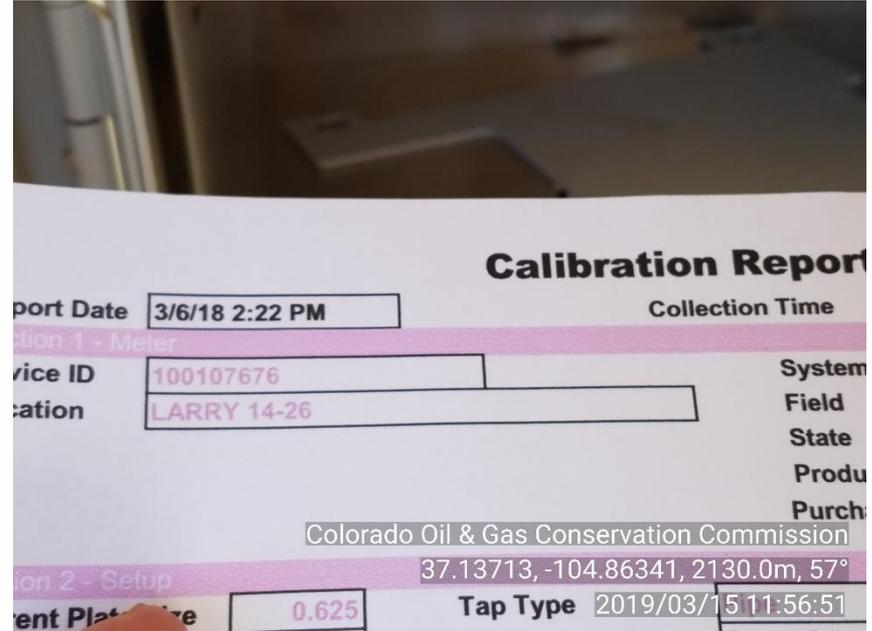
PHOTO 6: CALIBRATION REPORT IS PAST DUE
