Inspection Photos
Location Name: File 3R-32H-K268
Location ID: 434248

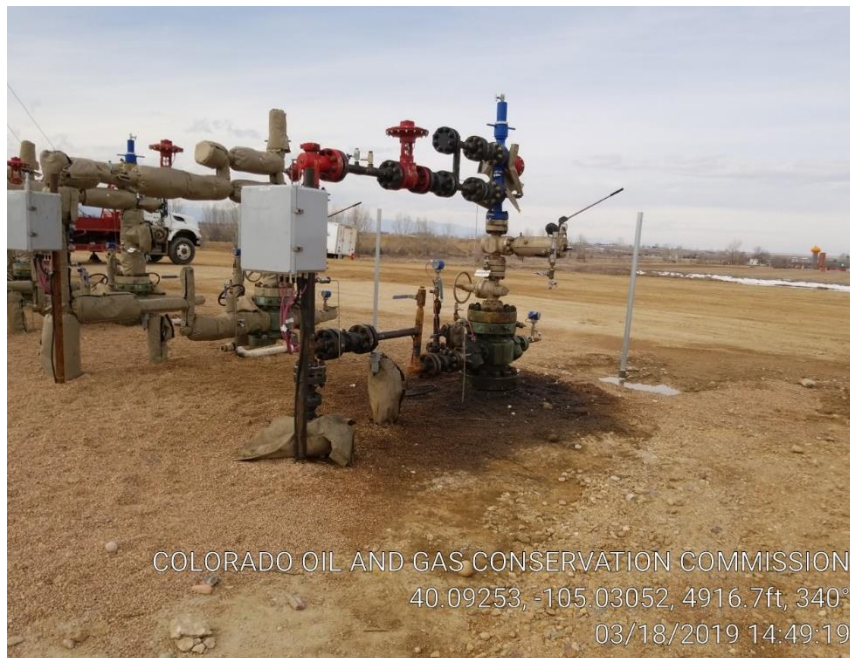
Pic 1, stained soil around wellhead from workover.

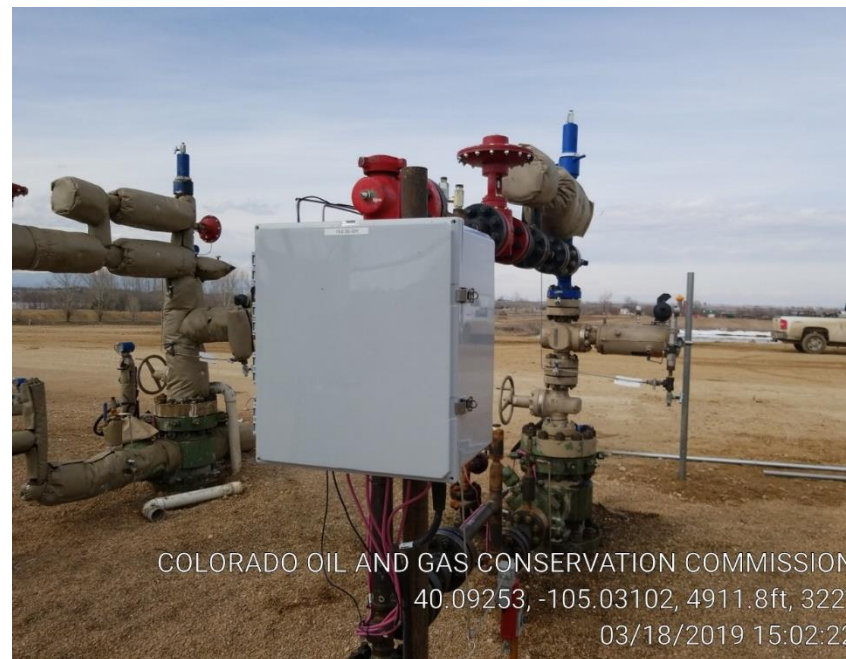
Pic 14 Stained soil

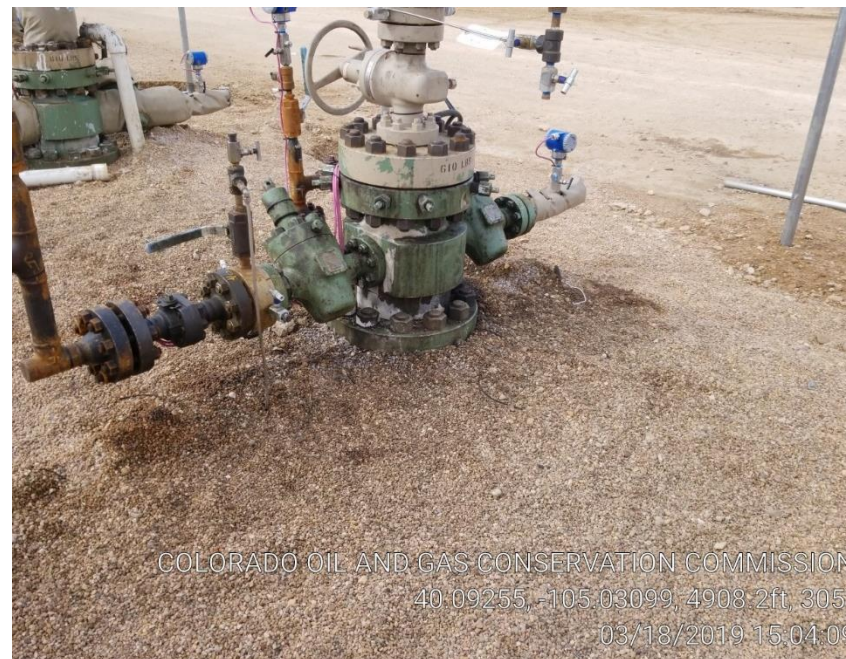
Pic 24 stained soil

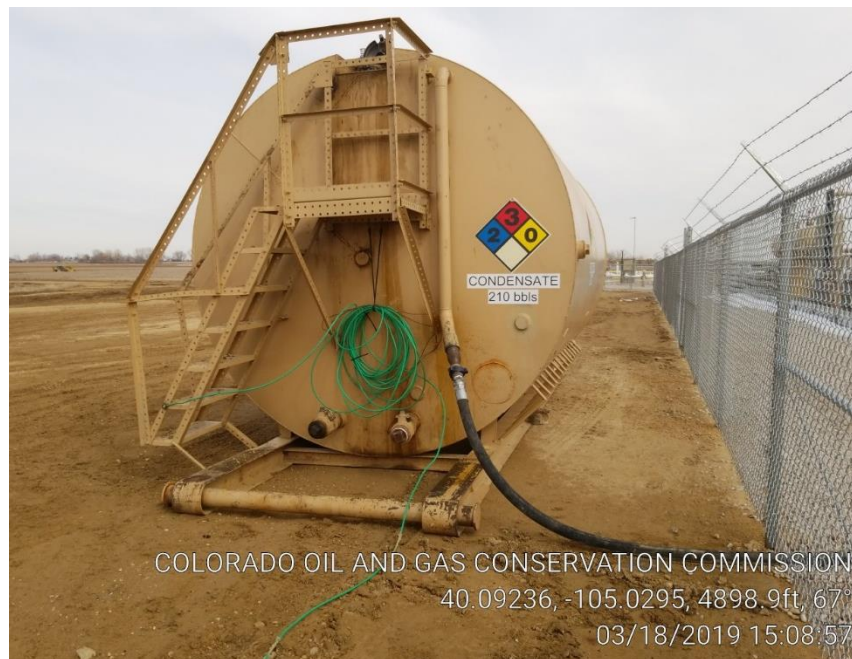
Pic 25. Temporary tank being used to collect crude oil.

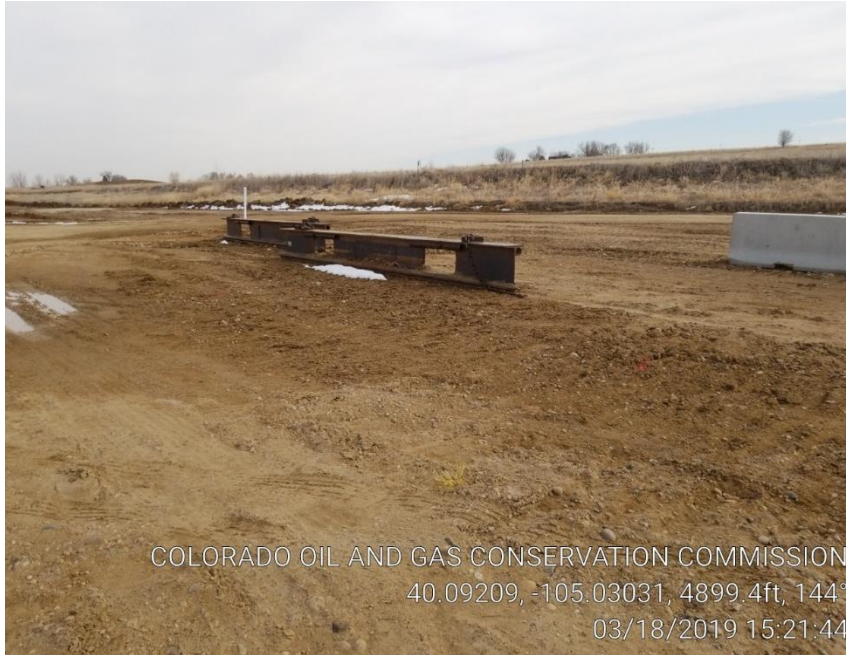
Pic 33Unused equipment

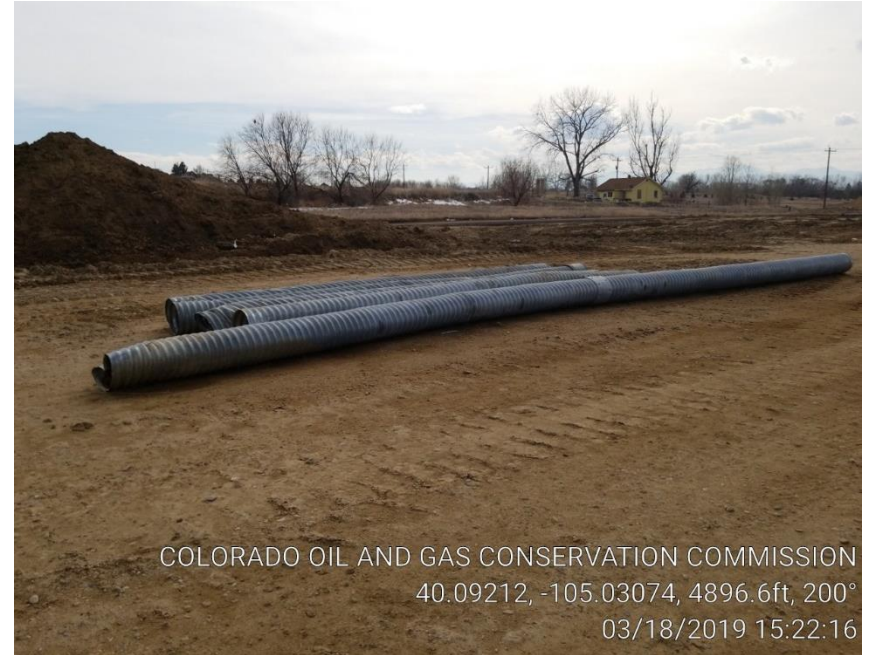
Pic 34 Debris on location.
